UNITED STATES ENVIRONMENTAL PROTECTION AGENCY
REGION 1
5 Post Office Square, Suite 100
Boston, MA 02109-3912

Memorandum

Date: April 27, 2010
Subject: Post-flood Inspection of April, 15, 2010
To: Memo to CMRP Site File
From:

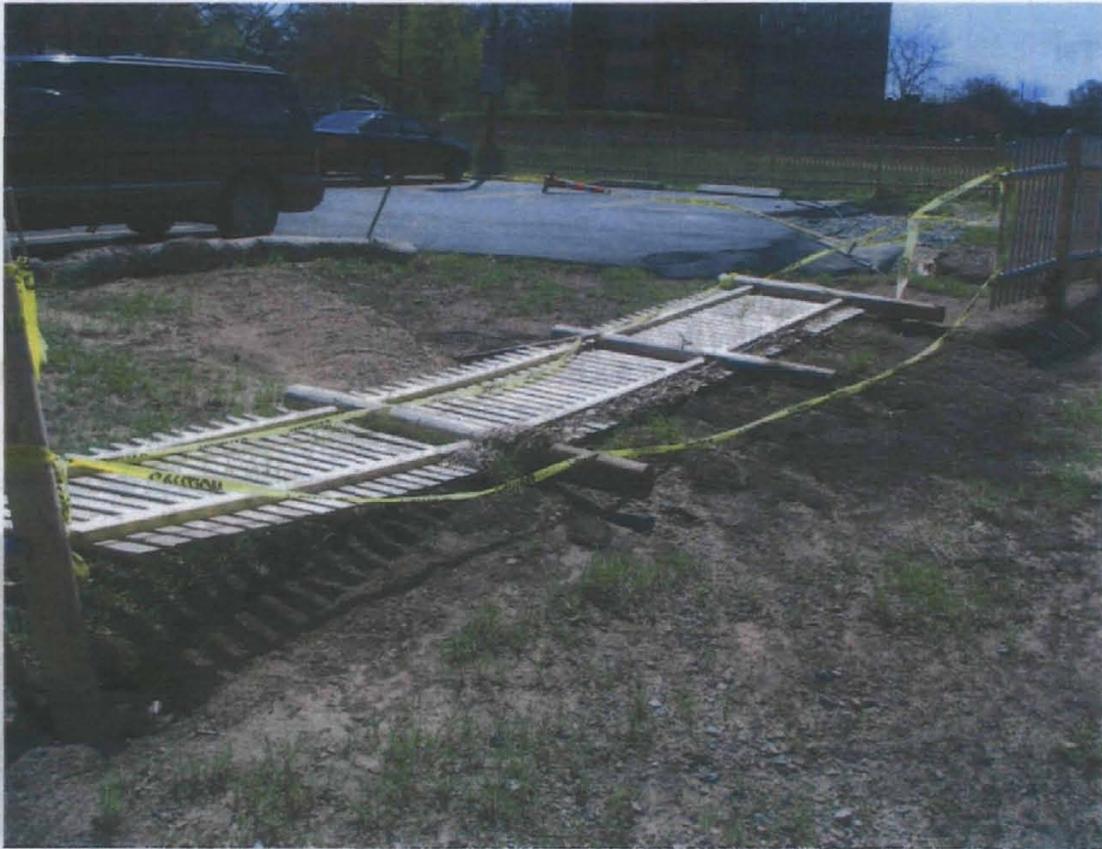
Some erosion occurred on the steepest gradients where water velocity was highest. Several fence posts washed out, causing three sections of new fence on the riverbank to collapse. This was likely caused by the turbulent flow of water around the posts, causing the soil to erode. Although some excavation had occurred in this area last fall, erosion did not penetrate the geosynthetic fabric that was placed over clean fill in this area.

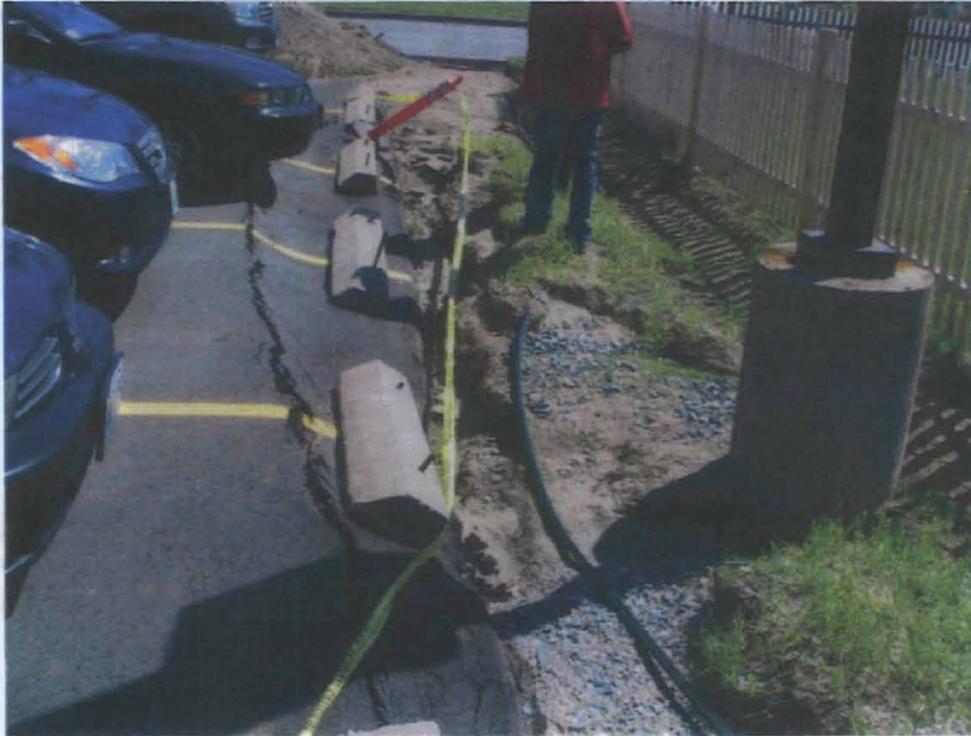
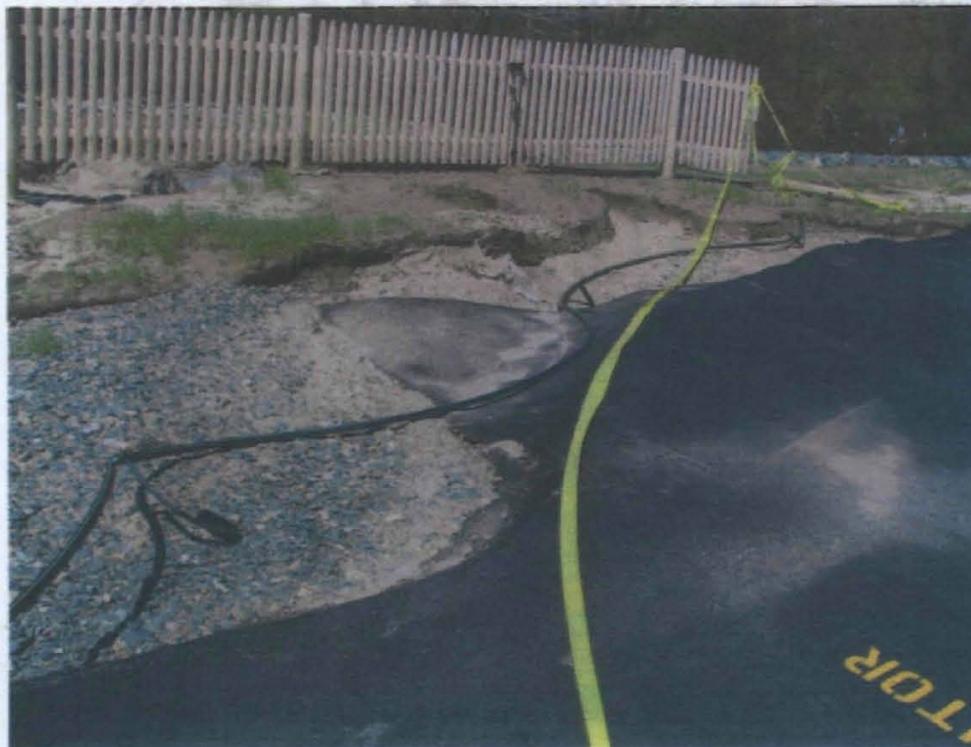
Swiftly moving water did erode the base materials for the parking lot pavement in several areas, but again did not impact underlying fill materials. Concerns that the earthen cap #'s 1,2,3,4 had been compromised by the water and current were unfounded. Visual inspection showed that although the river water had flowed near the caps, no evidence of erosion or other impact were seen. No contaminated soils were eroded, released, or otherwise impacted by the flood waters.

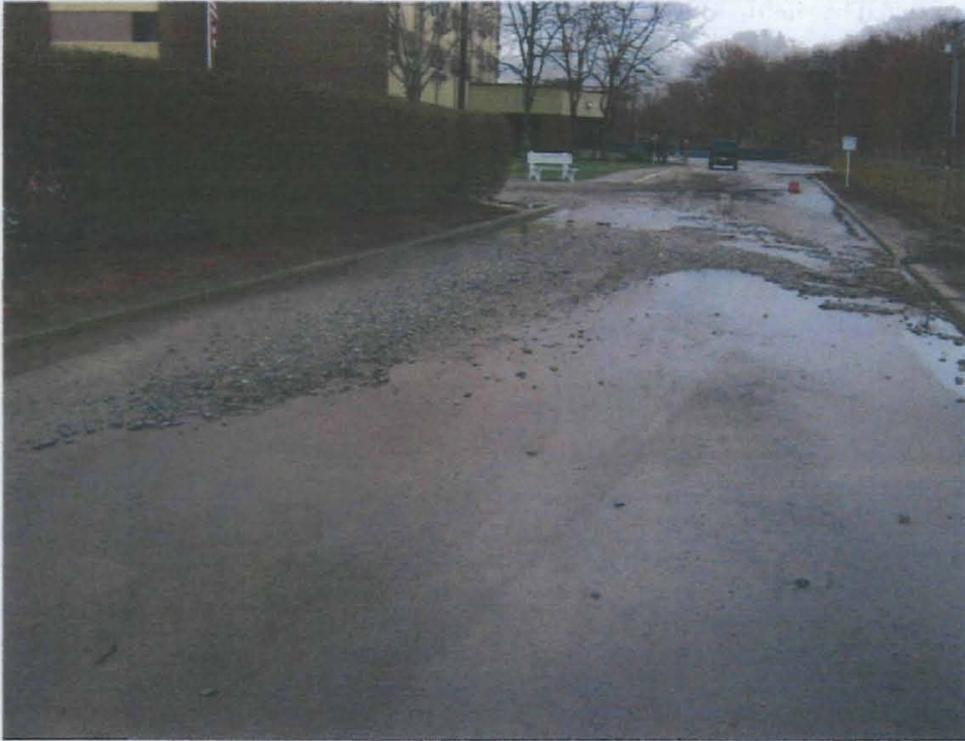
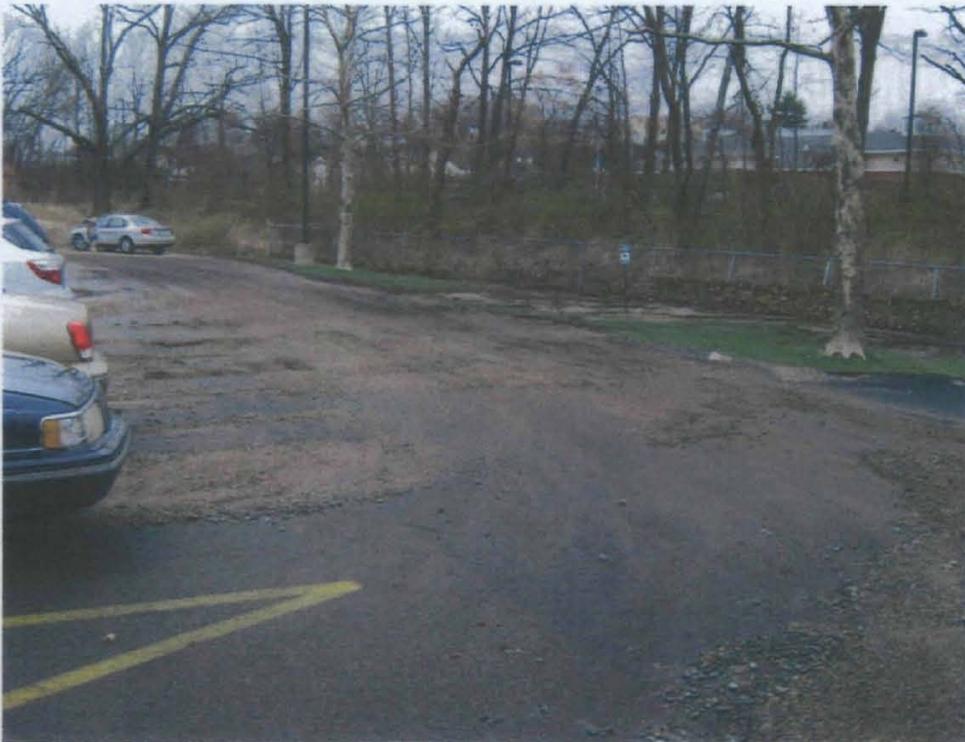
Some sedimentation did occur on the main driveway. The deposited materials were fairly coarse grained and resembled the clean backfill used to regrade the parking lot following excavation last fall.

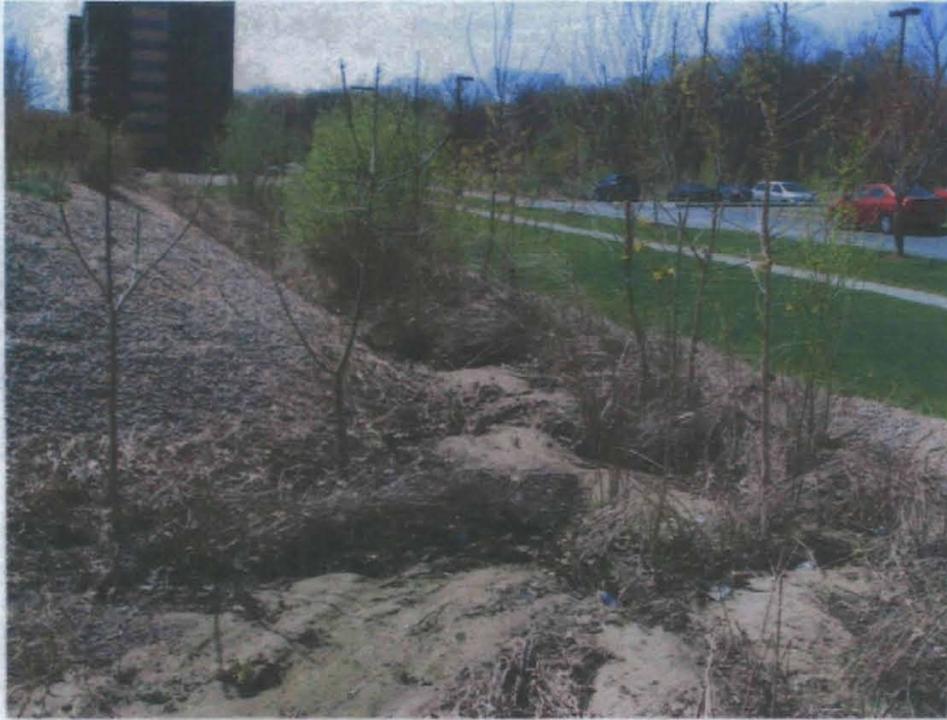
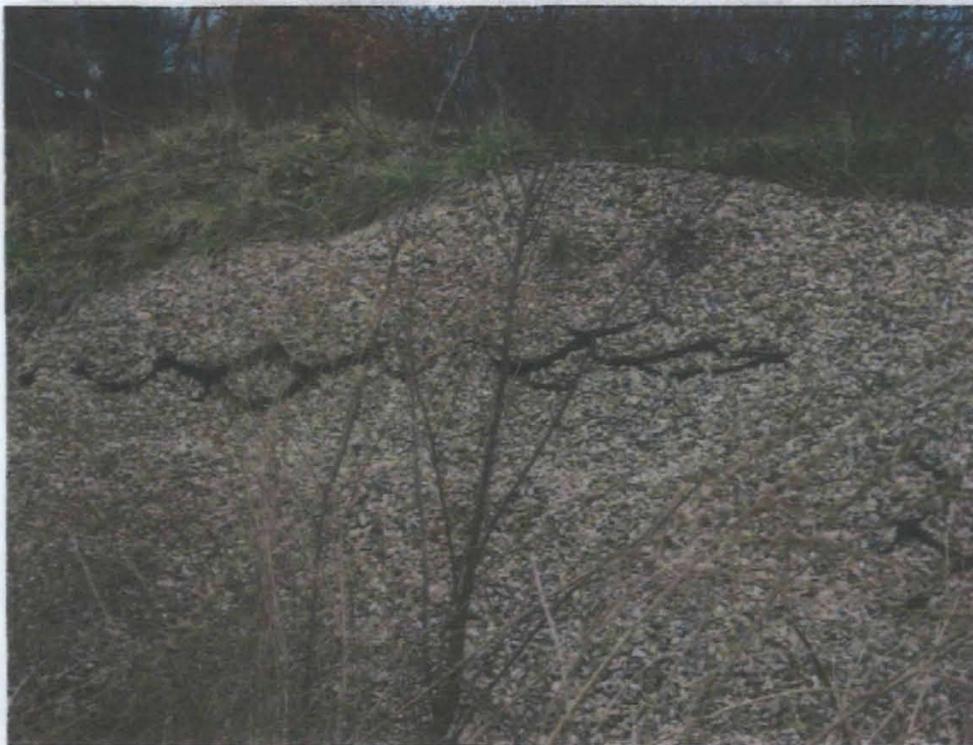
The tailrace outfall and drainage channel did not appear to be significantly impacted by the floodwaters. Some stone on the steepest slope had slumped in a few areas, exposing the anchoring web system, but no erosion occurred. The drainage channel is overgrown with vegetation and should be cleared. Although there was evidence that the water had risen to several feet deep, the gravel in the channel did not appear to be disturbed.

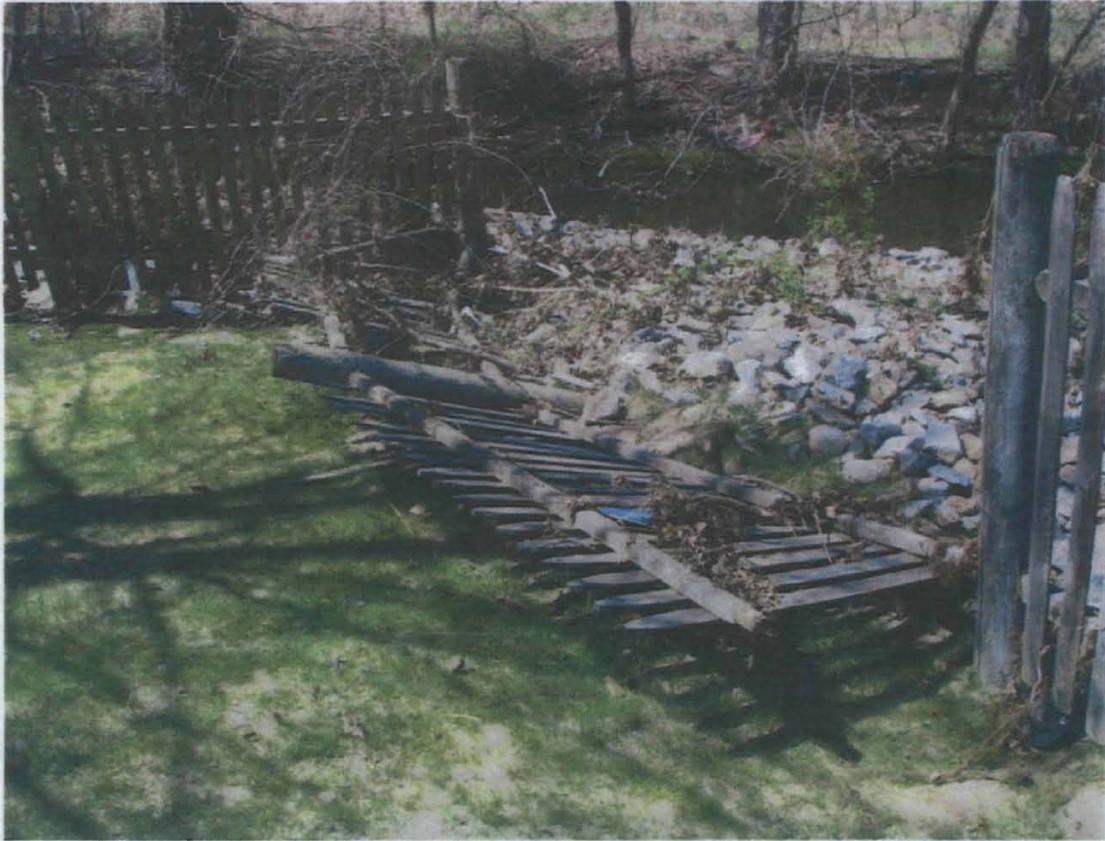
One other section of fence was disturbed near the riverbank at the Centredale Manor parking lot. This was an older section of fencing and likely required replacement regardless of the flood impact.
