# AERIAL PHOTOGRAPHIC ANALYSIS CENTREDALE MANOR SITE SUBAREA

## North Providence, Rhode Island

TS-PIC-20001120S  
July 2000

AERIAL PHOTOGRAPHIC ANALYSIS  
CENTREDALE MANOR SITE SUBAREA

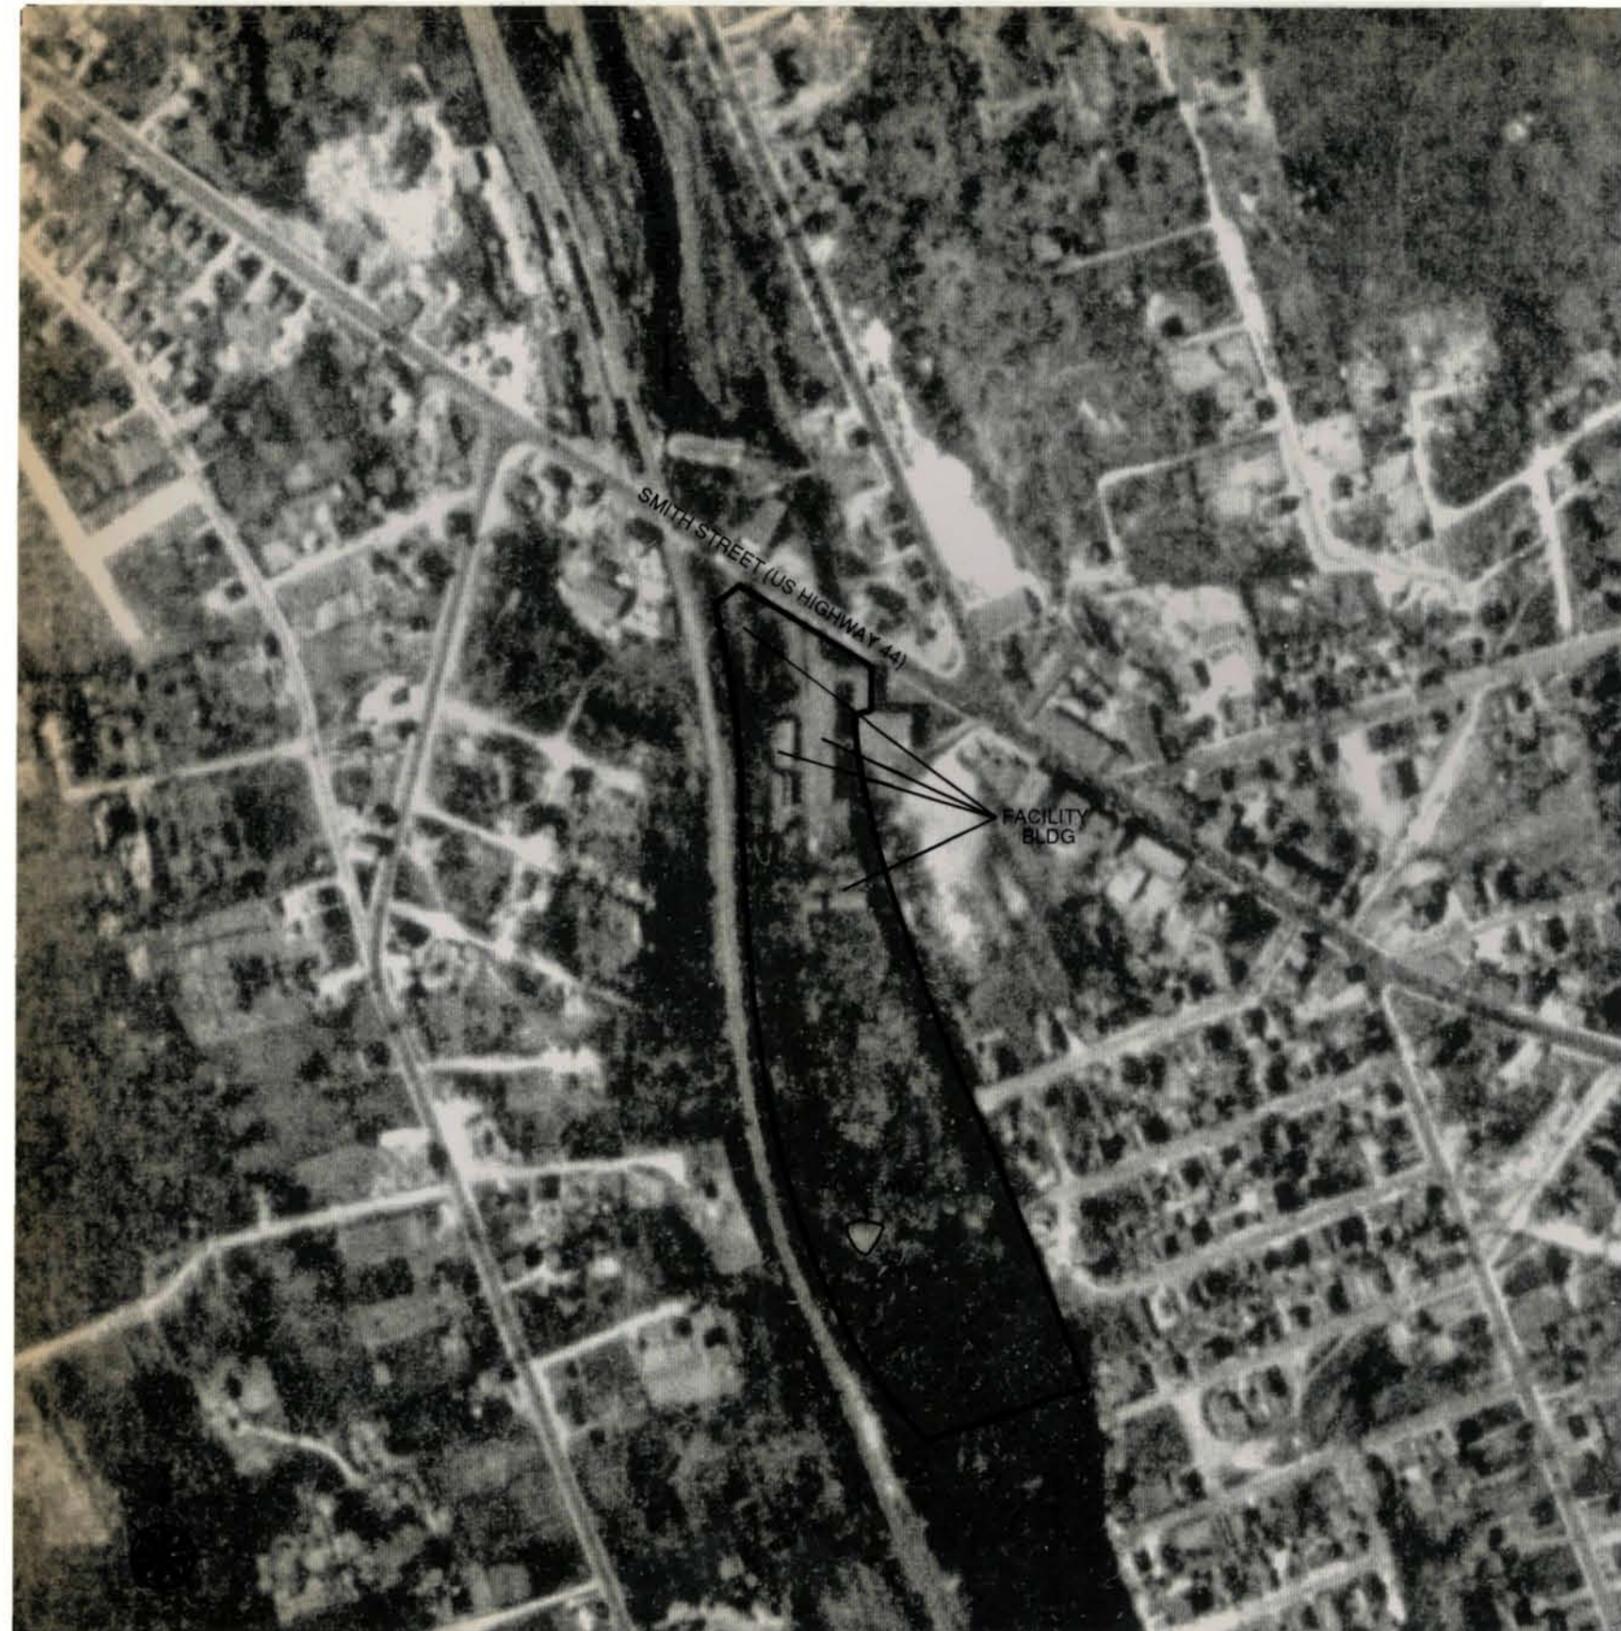
MAY 15, 1939 (FIGURE 3)

A monoscopic ozalid paper copy of the original 1939 photograph was available for analysis of the subarea; however, photographic resolution was poor and very little information was obtained from it. The northern portion of the subarea consists of industrial facilities while the southern half was comprised primarily of herbaceous, shrub, and forested wetlands. The surrounding area consists of commercial, industrial, and residential properties. The larger facility buildings are visible and one area south of the buildings appears to coincide with the location of a waste disposal area (WDA) observed in 1951 (Figure 4). There do not appear to be any other disturbances of the natural landscape south of the buildings.

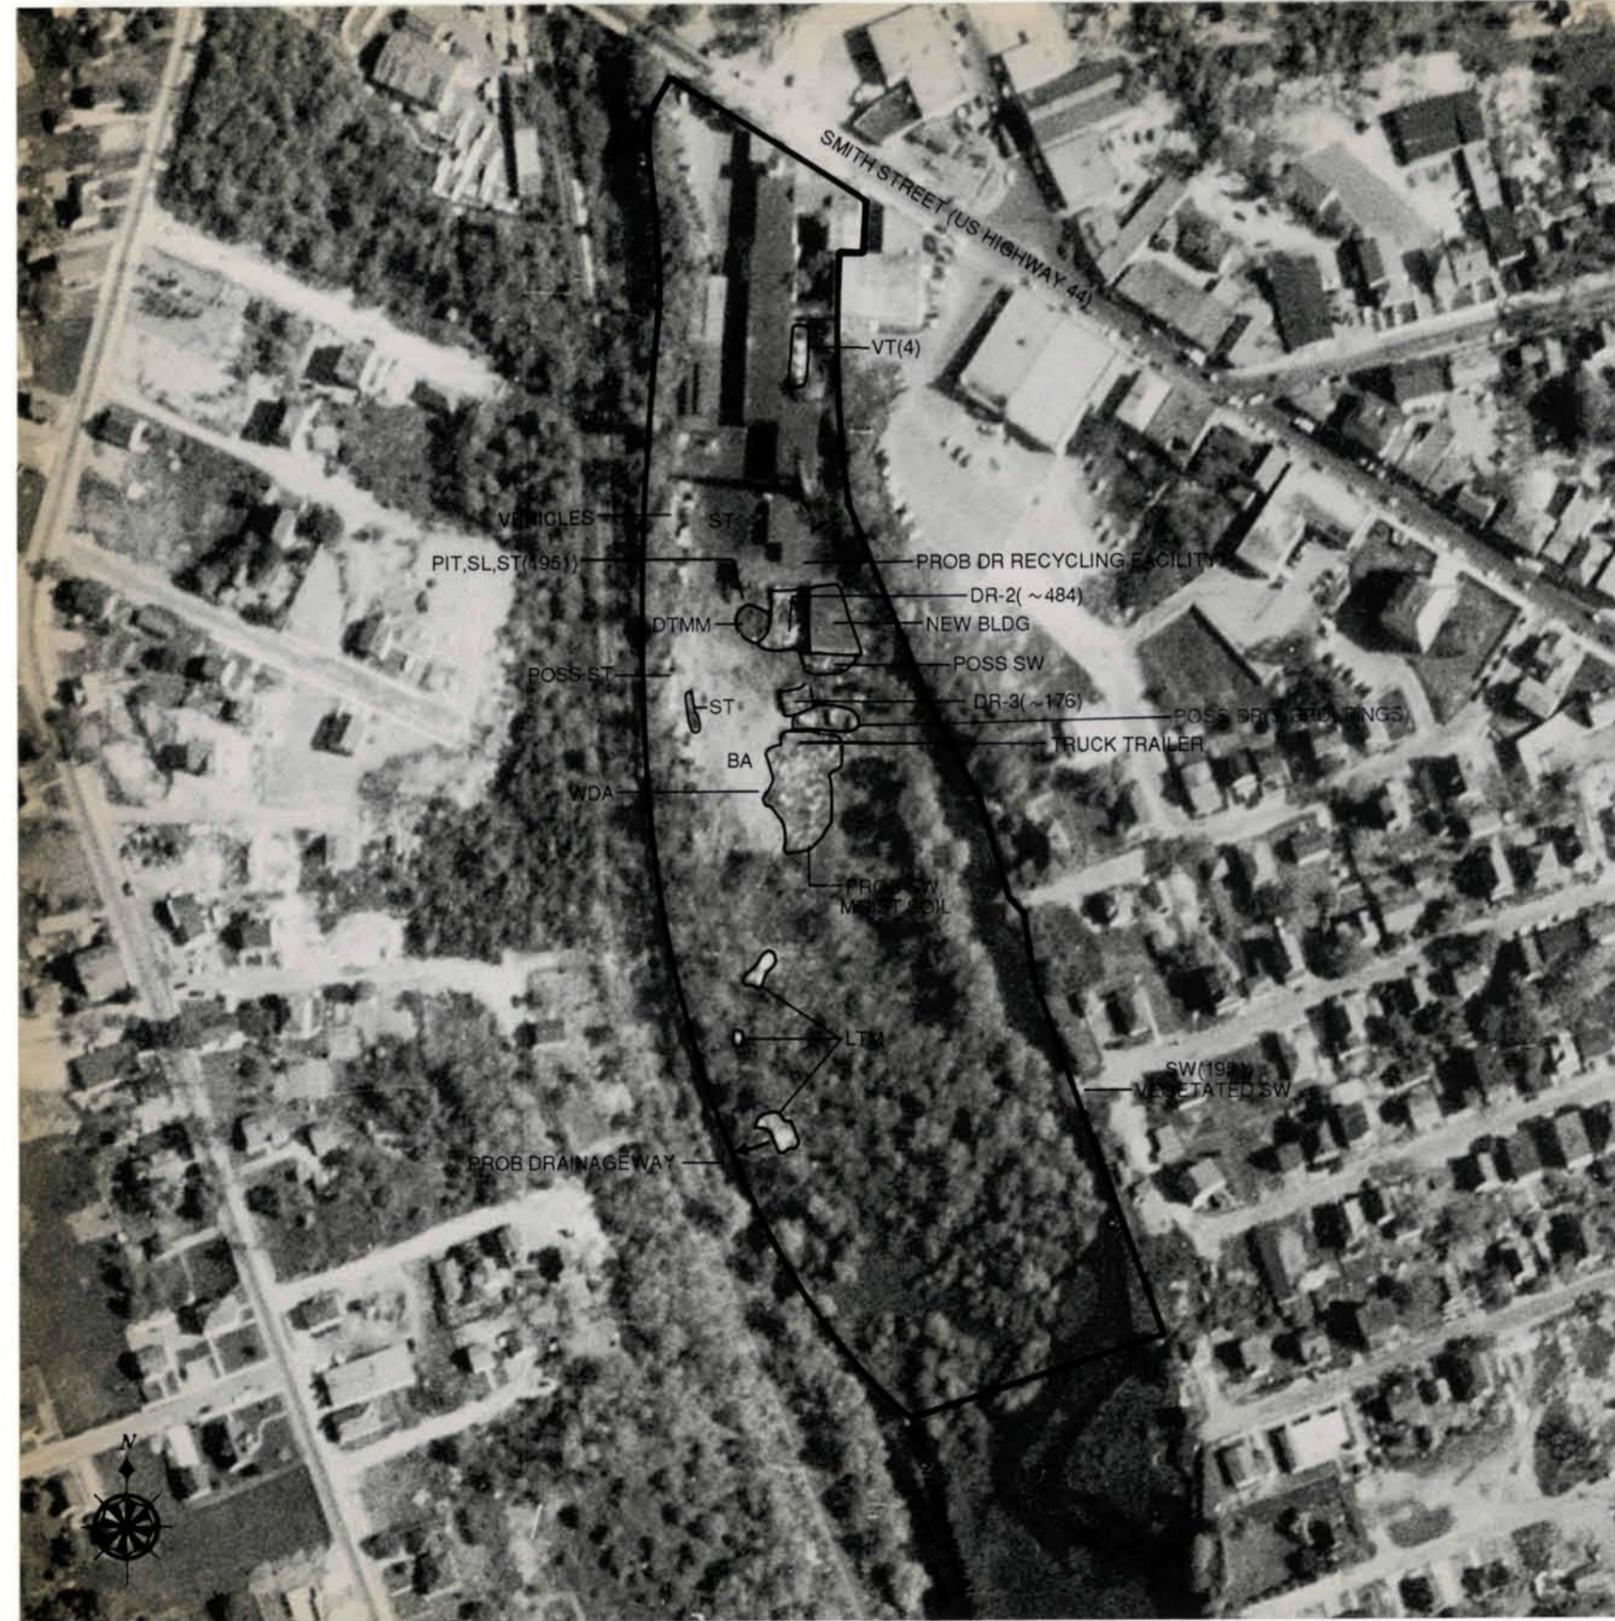
OCTOBER 26, 1951 (FIGURE 4)

In the northern portion of the subarea, the southernmost building in the building complex is probably the drum recycling facility referenced in the collateral information (EPA 1999). On the south side of the facility is a stain (ST) and a small pit containing possible standing liquid (SL). The pit is approximately 3 square meters (32 square feet) in extent. A possible drainageway leads west from the pit towards the Woonasquatucket River. A smokestack is also observed adjacent and north of the drum recycling facility. To the west of the probable drum recycling facility\* are vehicles parked at the end of an access road that leads to Smith Street. Approximately 128 stacked probable drums (DR-1) are located to the south. An access road leads south to a waste disposal area where solid waste (SW), scattered light-toned material (LTM), a possible horizontal tank (HT), and a small building are located. North of the waste disposal area is a vegetated possible excavation (EX) where waste-related activities may have taken place between 1939 and 1951. A small area of possible staining is present to the west. South of the waste disposal area is a second waste disposal area with a deposit of earthen material that is elevated at its southern end. Light-toned material is also present. This is the approximate location of the possible waste disposal observed in 1939. To the east of the subarea is a small deposit of solid waste at the west end of a residential street.

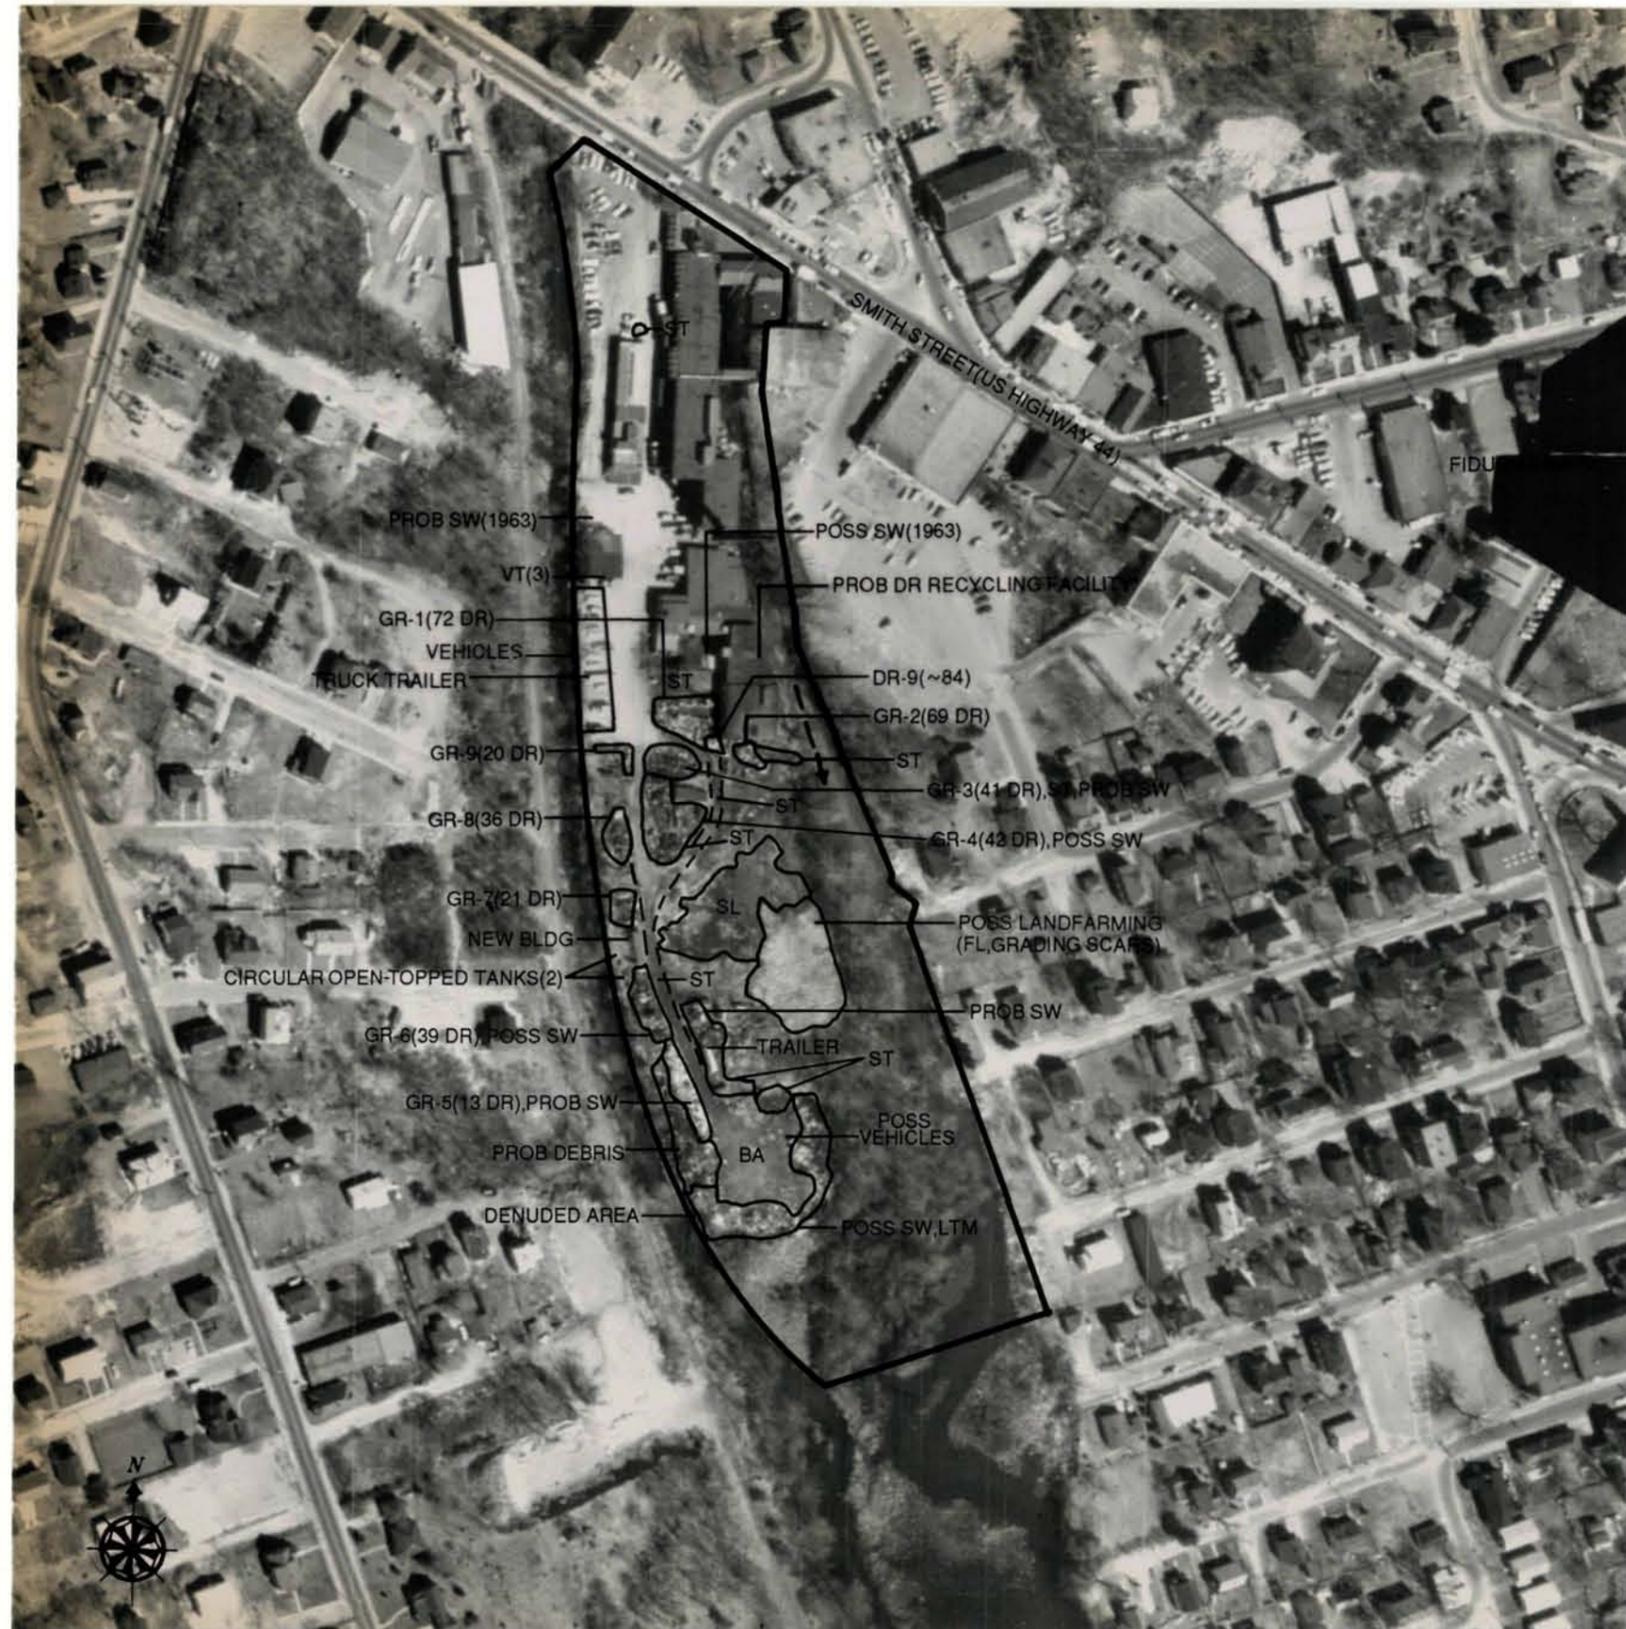
Figure 9. Centredale Manor site subarea, April 5, 1965. Approximate scale 1:2,870.

An area of possible solid waste and an area of probable solid waste noted in 1963 are not present. Several stains (not annotated) observed in the northern portion of the subarea in 1963 are no longer present. Adjacent to a new building first observed in 1963 is DR-9 which consists of approximately 84 probable drums. Note: The prefix "GR" is used to denote drum groupings where partial drum counts were conducted. Adjacent to the probable recycling facility, 72 drums are counted at GR-1. To the southeast at GR-2, 69 drums are observed. East of and contiguous to GR-2 is a large area of staining which trends towards the eastern drainageway. To the south, 41 drums are counted at GR-3 and staining and probable solid waste are also observed. A total of 42 drums along with possible solid waste are noted at GR-4. Staining is visible across an access road on the southeast side of GR-4. Possible landfarming is evident in the central portion of the subarea where a large area of standing liquid and a large area of fill exhibiting grading scars are located. Possible landfarming was also observed in this area in 1956. Continuing south, probable solid waste, a trailer, and staining are observed. To the east is a large area of staining.

In this portion of the subarea it appears that waste-related activity has resumed since it was last observed in 1962. Possible solid waste and light-toned material are located around the large bare area at the end of the subarea access road. Possible vehicles are noted on the large bare area.

At the northern end of this Section and along the river the probable solid waste observed in 1963 is not present. To the south are vehicles, a truck trailer, and three vertical tanks. Proceeding southward along the river are several drum groupings where partial counts of drums were performed. Totals of 36 and 20 drums, are noted at GR-8 and GR-9, respectively. North of a new building, 21 drums are evident at GR-7 and two circular open-topped tanks are evident nearby. A total of 39 drums are observed at GR-6 along with possible solid waste while at GR-5 there are 13 drums and probable solid waste. Probable debris is noted to the south. At the extreme southern end of this portion of the subarea is a denuded area situated between the Woonasquatucket River and deposits of possible solid waste and light-toned material.

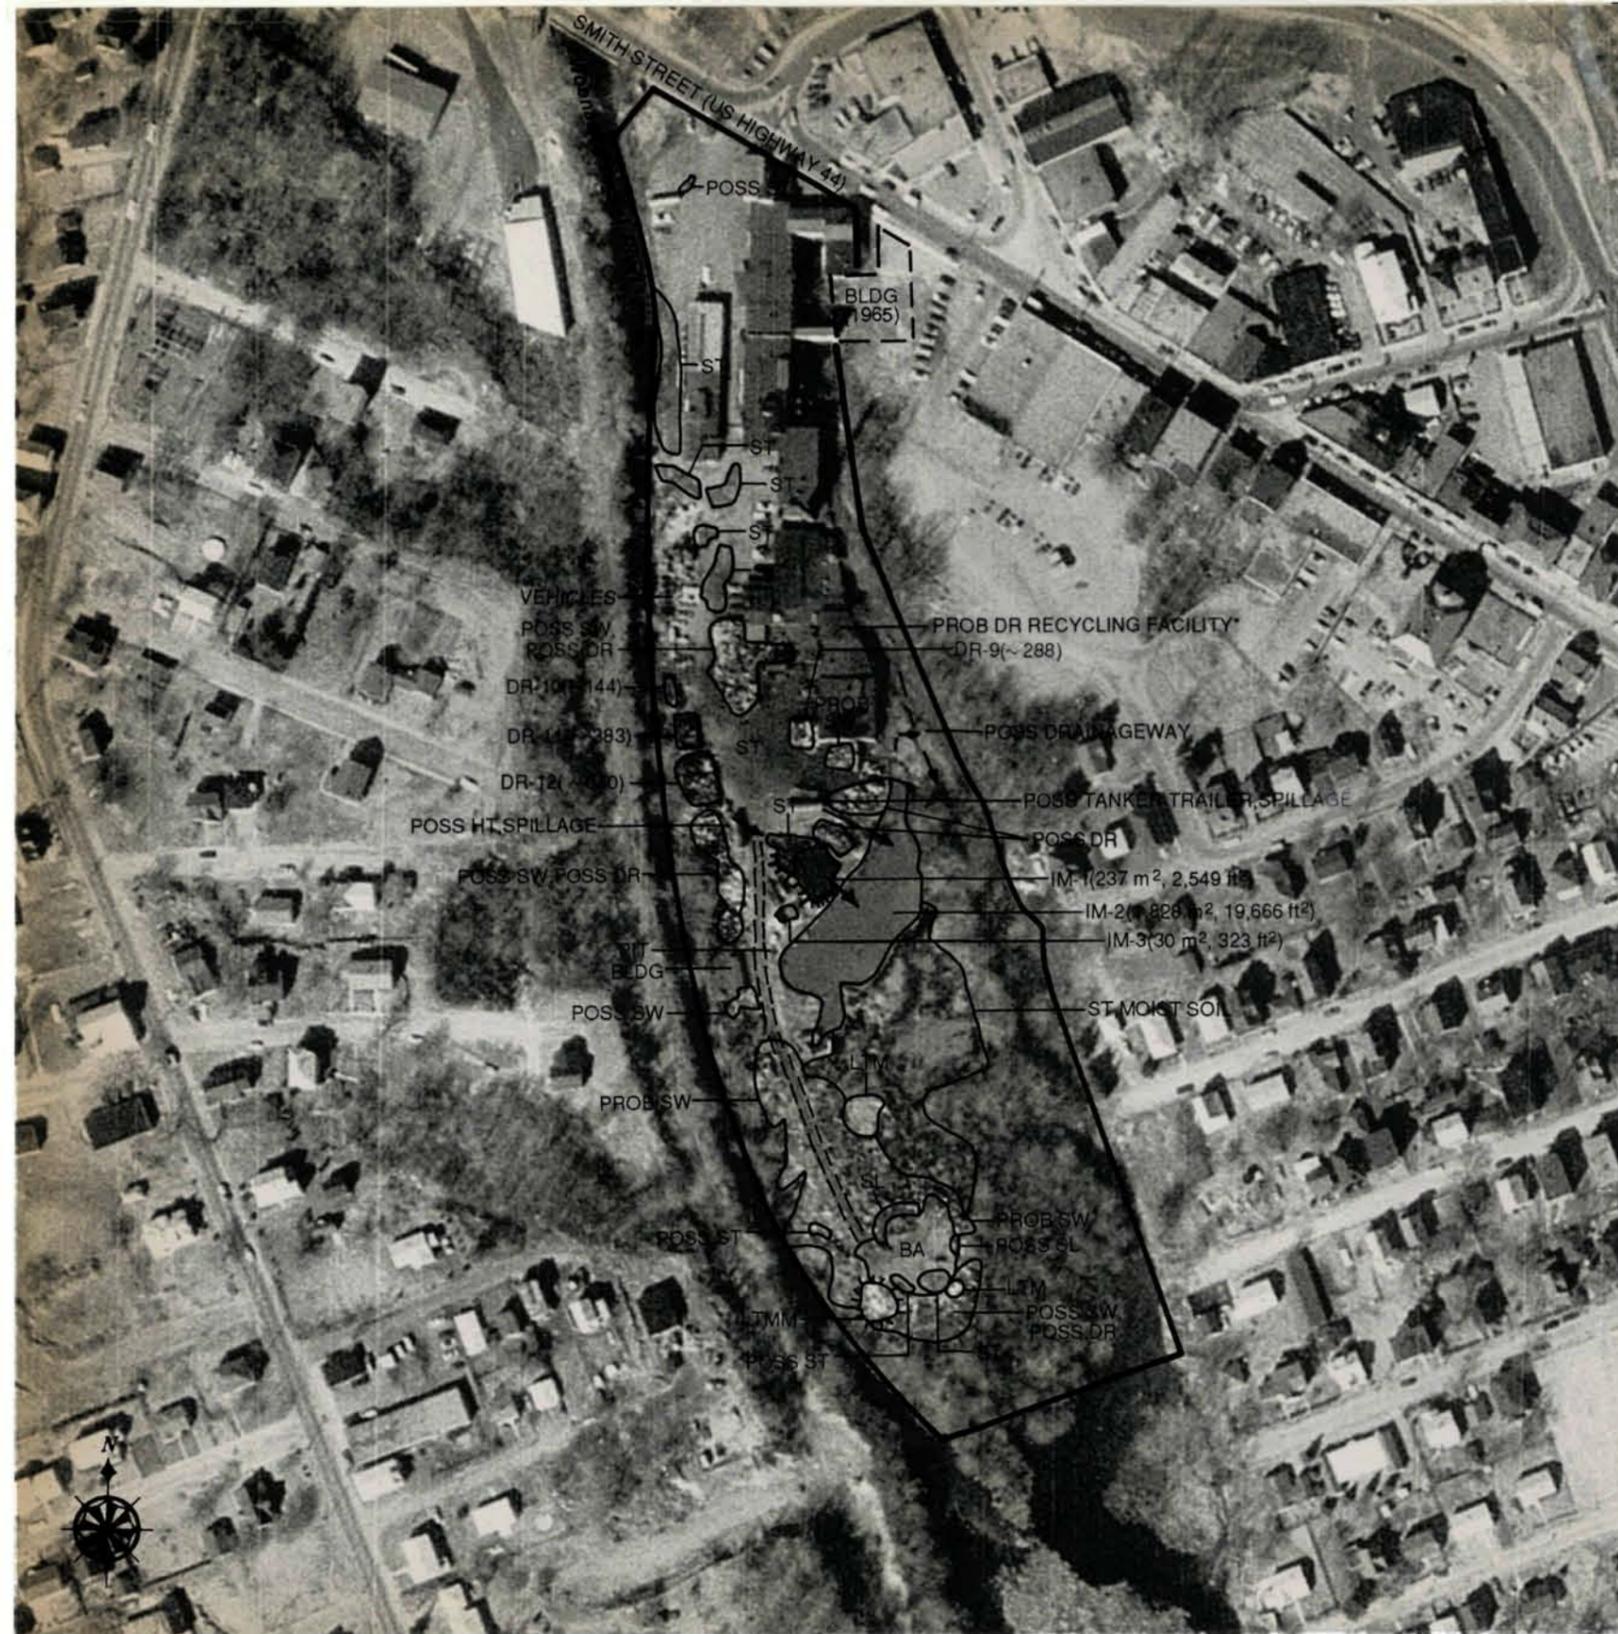
MARCH 9, 1970 (FIGURE 10)

A large building adjacent to the eastern side of the subarea (not previously discussed) has been removed since 1965. A possible stain is visible in the northern portion of the subarea. To the south are five large stains. A large area of possible solid waste and possible drums is present south of these stains. Continuing south is DR-9 where 84 probable drums were observed in 1965 and 288 probable drums are now noted. An area of probable solid waste is observed adjacent to and south of a building which was first noted in 1963. A possible tanker trailer, scattered unidentified rectilinear objects (not annotated), and possible drums are observed southeast of DR-9. South of the possible tanker trailer is Impoundment 1 (IM-1), with an areal extent of approximately 237 square meters (2,549 square feet; see Table 3) and containing dark-toned liquid (not annotated). IM-1 occupies the area where a large area of standing liquid was noted in 1965. A large area of staining is observed on the northwest side of IM-1. Dark-toned discharge from IM-1 flows into IM-2 which is approximately 1,828 square meters (19,666 square feet) in extent. Also, spillage appears to be flowing to the southeast from the possible tanker trailer into IM-2. A possible drainageway at the northern end of the impoundment may allow release of liquid wastes into the drainageway along the eastern side of the subarea. Impoundment 3 (IM-3), with an areal extent of approximately 30 square meters (323 square feet), is southwest of IM-1 and also discharges into IM-2. A small pit and unidentified rectilinear objects (not annotated) are located nearby. South of IM-2 is a large area where stains and moist soil are evident. This is possibly due to overflow from IM-2 and the possible spreading (landfarming) of wastes as was observed in 1956 and 1965. An area of light-toned material is observed to the southwest.

The waste disposal area continues to be active. A large deposit of probable solid waste is present along both sides of the southernmost extent of the subarea access road. At the end of the road are a bare area, standing liquid, possible standing liquid, possible stains, areas of light-toned mounded material, and possible solid waste and possible drums.

Near the Woonasquatucket River on the west-central side of the subarea, are vehicles and three groupings of stacked probable drums (DR-10, DR-11, and DR-12). The approximate number of probable drums, respectively, are, 144, 383, and 640. Further south is a possible horizontal tank that appears to be leaking or discharging dark-toned liquid southeast (spillage) and across the access road into IM-1. Possible drums and possible solid waste are observed south of the possible horizontal tank. Another area of possible solid waste is noted further south.

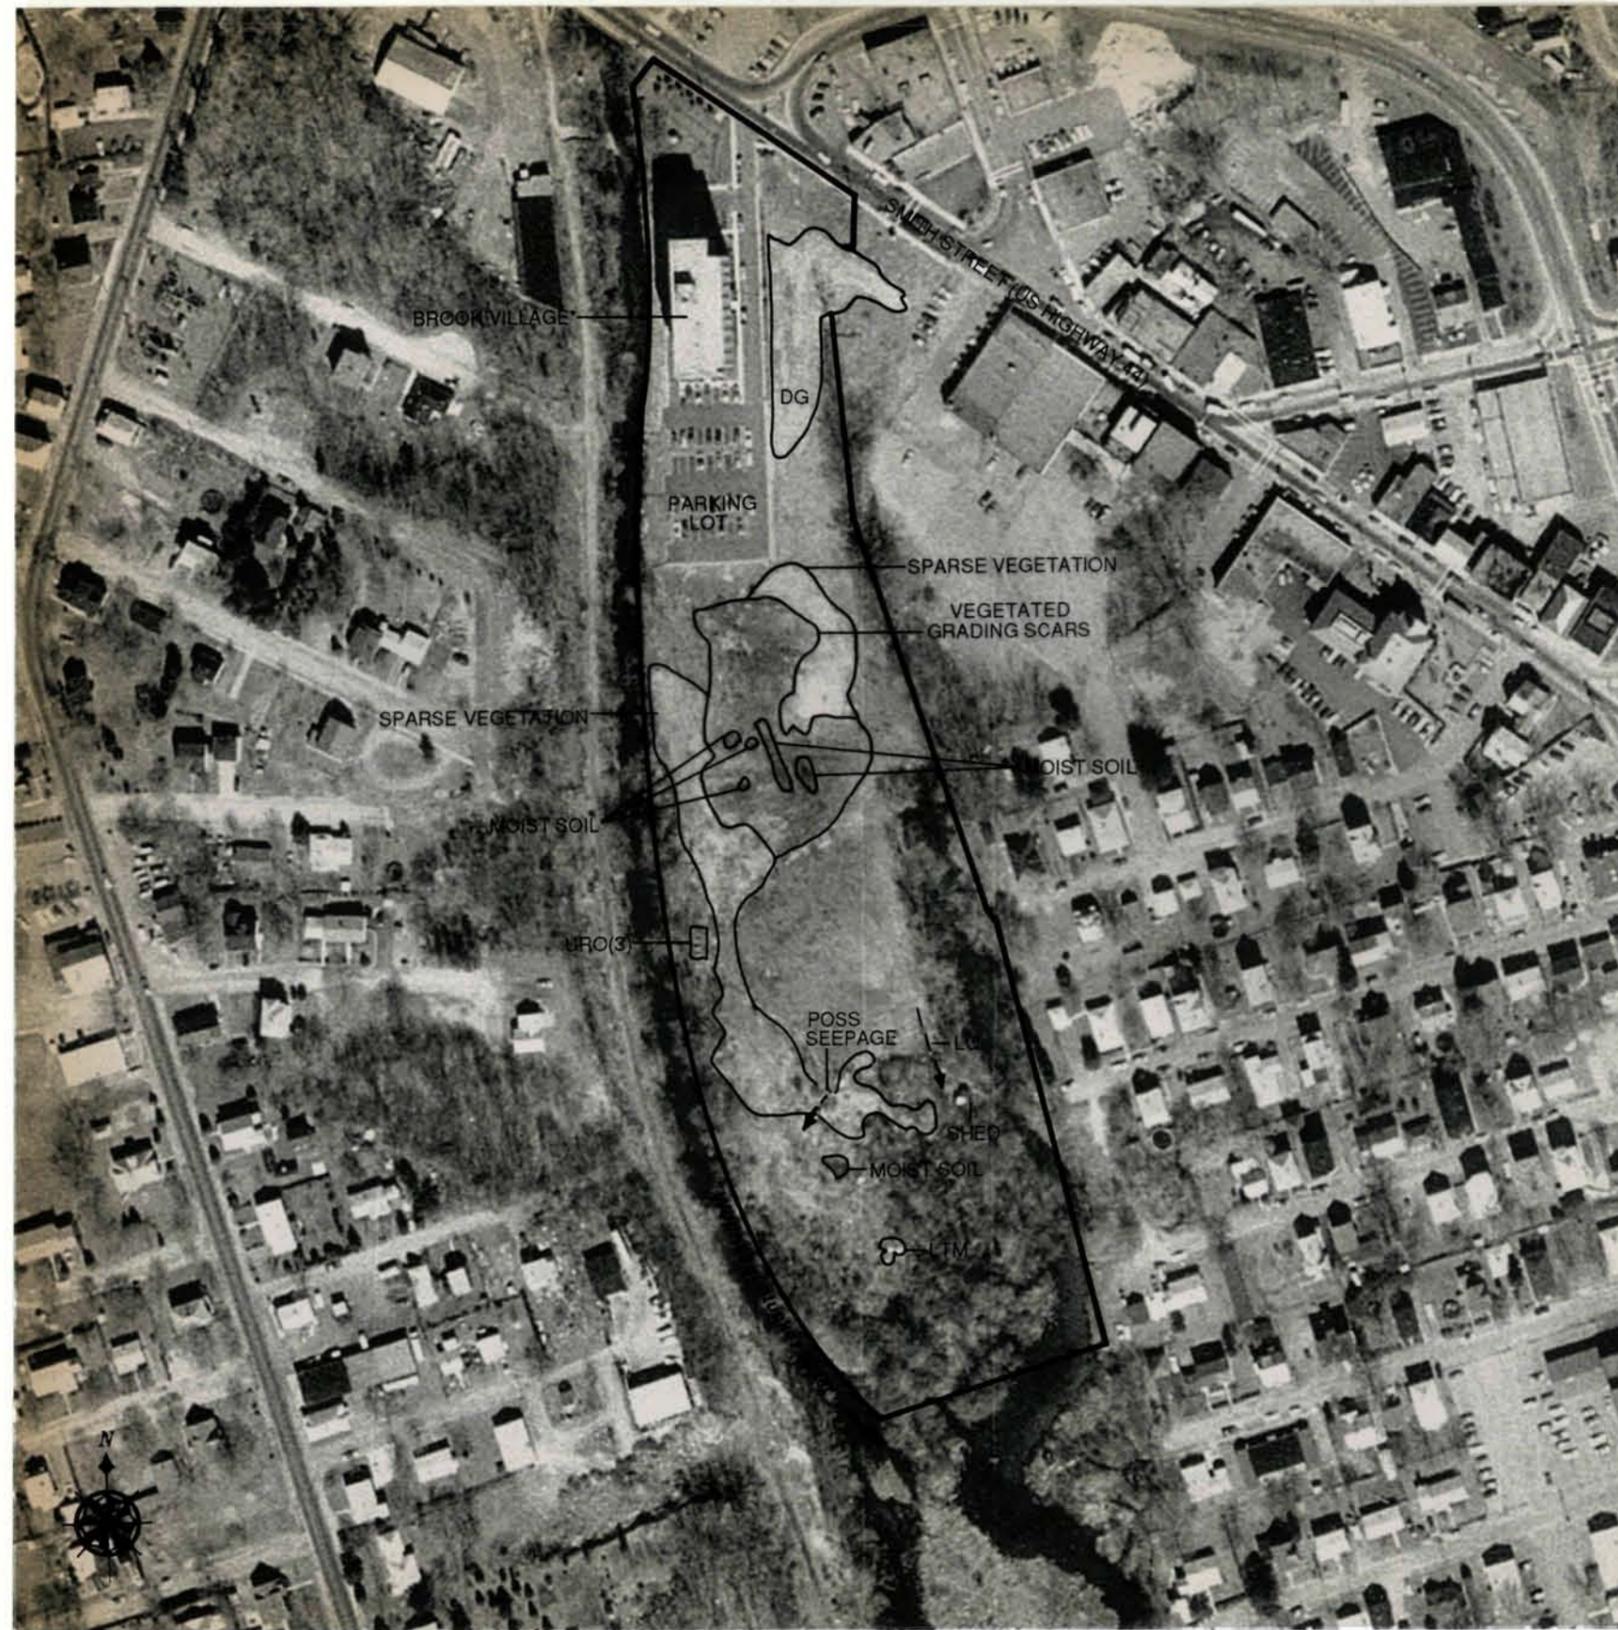
MARCH 18, 1981 (FIGURE 12)

Disturbed ground, probably attributable to construction and landscaping activities, is evident east of the large building in the northern (Brook Village) portion of the subarea. A large area of vegetated grading scars, indicative of ground disturbance since 1979, is observed south of the building parking lot. Five areas of moist soil are evident within the grading scars area. Two large areas of sparse vegetation are noted, one to the northeast and the other to the south of the moist soil areas. Also to the south are three small unidentified rectilinear objects. Possible seepage flowing to the southwest is noted in the southern portion of the subarea. Other features located in this general vicinity include a small drainageway where liquid is evident, a small shed (an unidentified rectilinear object in 1979), and an area of moist soil. To the south is the small deposit of light-toned material observed in 1970 and 1979.

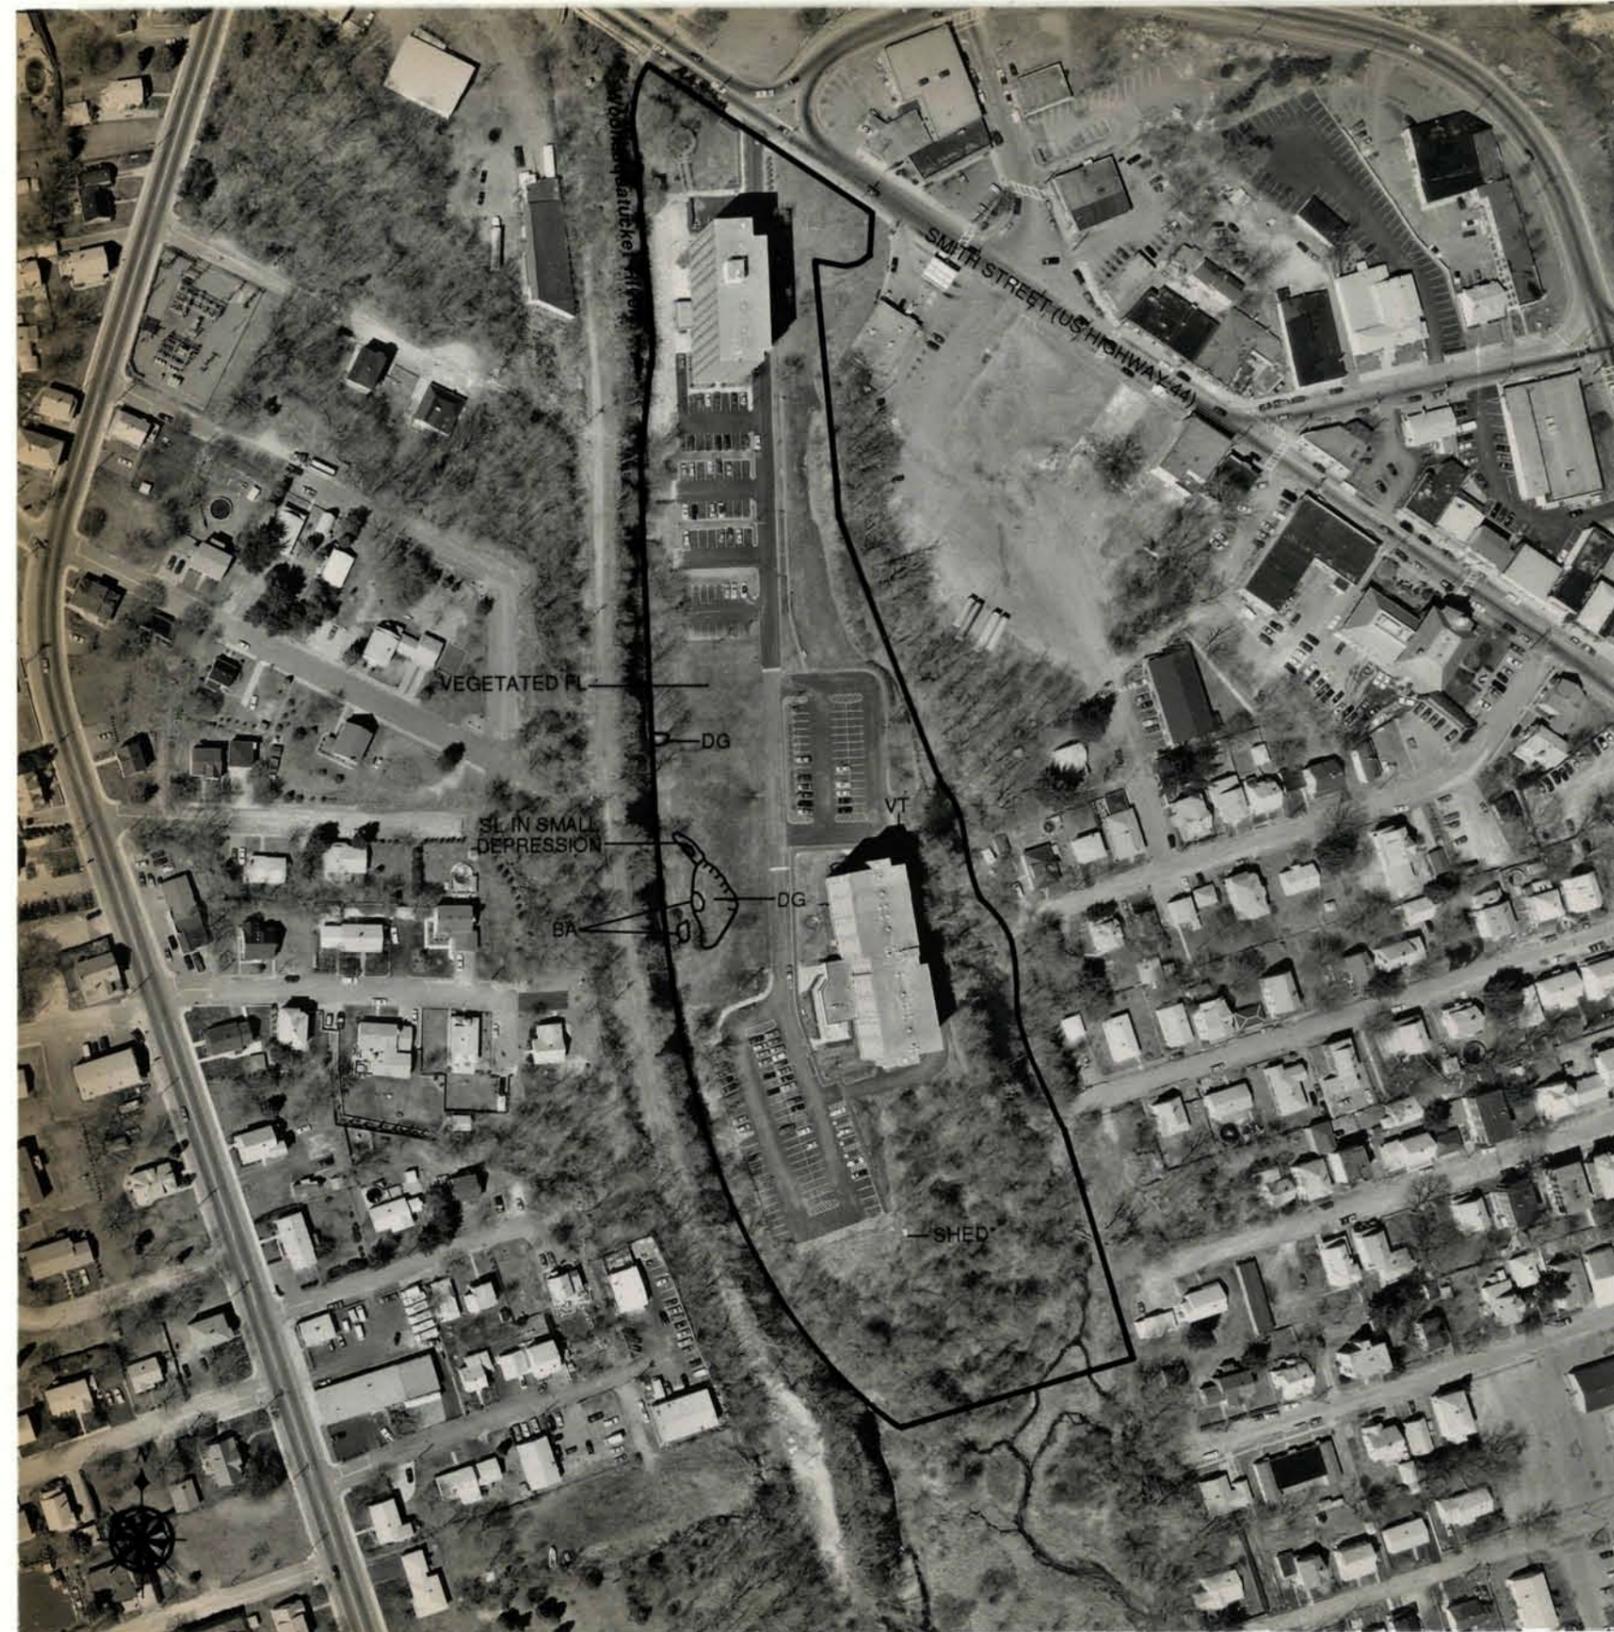
APRIL 7, 1995 (FIGURE 14)

West of the Centredale Manor building is disturbed ground (DG), bare areas, and standing liquid within a small depression. This is the same area where sparse vegetation and standing liquid were noted in 1985. A small area of disturbed ground is evident to the north. The possible shed present in 1985 is now confirmed as the shed cited in the collateral information (EPA 1999). A single vertical tank (VT) is present on the north side of the Centredale Manor building. The partially vegetated fill noted in 1985 south of the Brook Village parking lot is now completely vegetated.
