PHOTOGRAPHY LOG SHEET

Centredale Manor Restoration Project • North Providence, Rhode Island

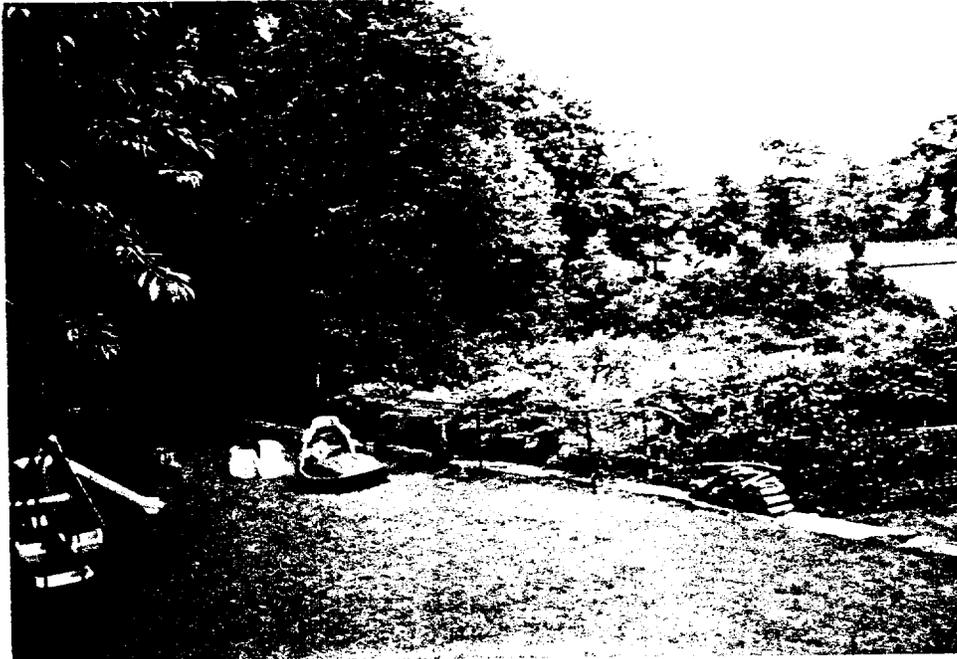
FRAME NUMBER: 14 **DATE:** 1 July 1999
PHOTOGRAPH BY: Renata Wynnyk
CAMERA: Minolta **SETTING:** Automatic

SCENE: View of high visibility fencing installed at 562 Woonasquatucket Avenue. Note Allendale Pond in background. Photograph taken facing west.

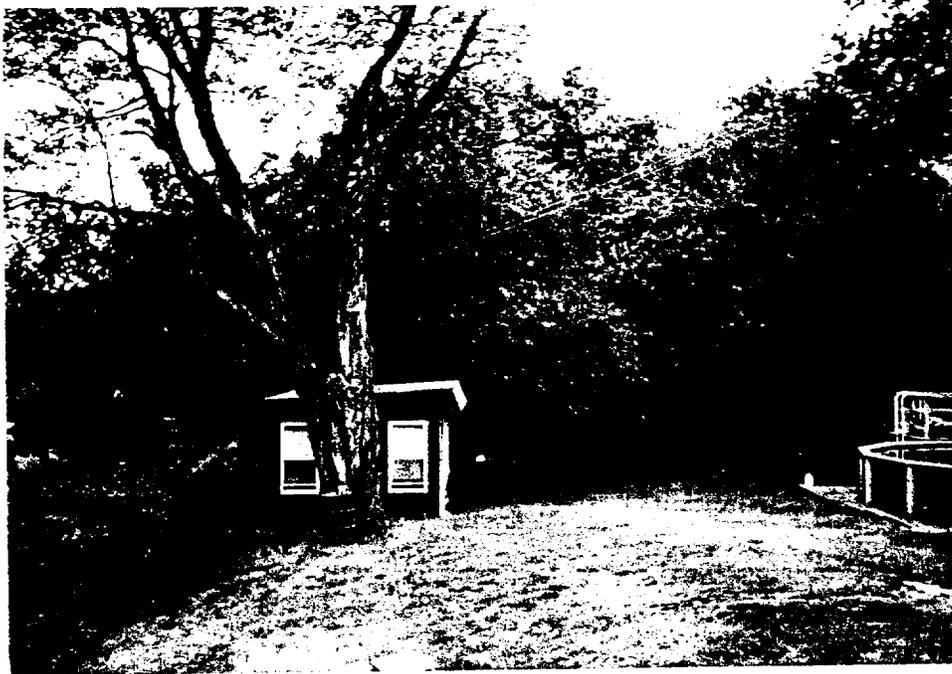
FRAME NUMBER: 15 **DATE:** 1 July 1999
PHOTOGRAPH BY: Renata Wynnyk
CAMERA: Minolta **SETTING:** Automatic

SCENE: View of high visibility fencing installed at 562 Woonasquatucket Avenue. Allendale Pond is located in the background. Photograph taken facing west.

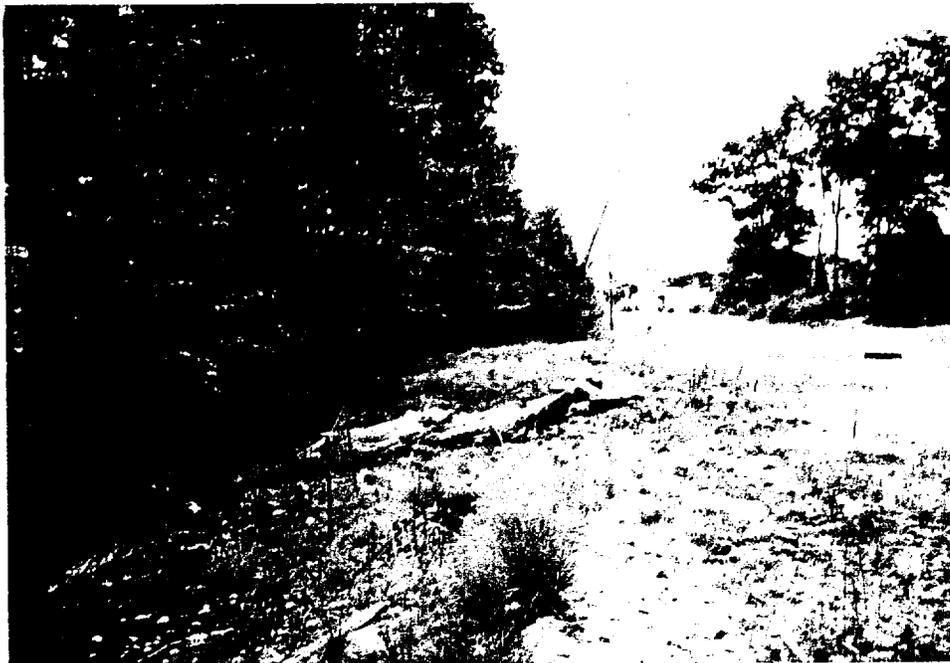
FRAME NUMBER: 16 **DATE:** 20 July 1999
PHOTOGRAPH BY: Renata Wynnyk
CAMERA: Minolta **SETTING:** Automatic

SCENE: View of high visibility fencing installed on the NEC greenway. The Woonasquatucket River is located on the extreme left. Photograph taken facing south.

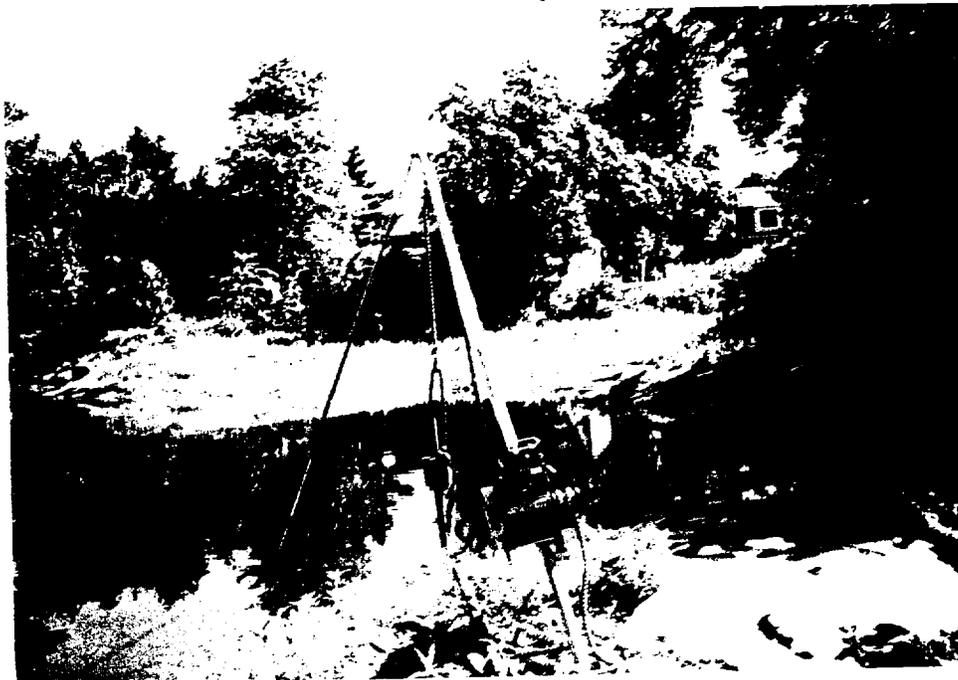
FRAME NUMBER: 17 **DATE:** 20 July 1999

SCENE: View of sediment sampling (by Geologic, Inc) at the Allendale Dam (sample location AD-03). Note residential properties in the background. Photograph taken facing east.

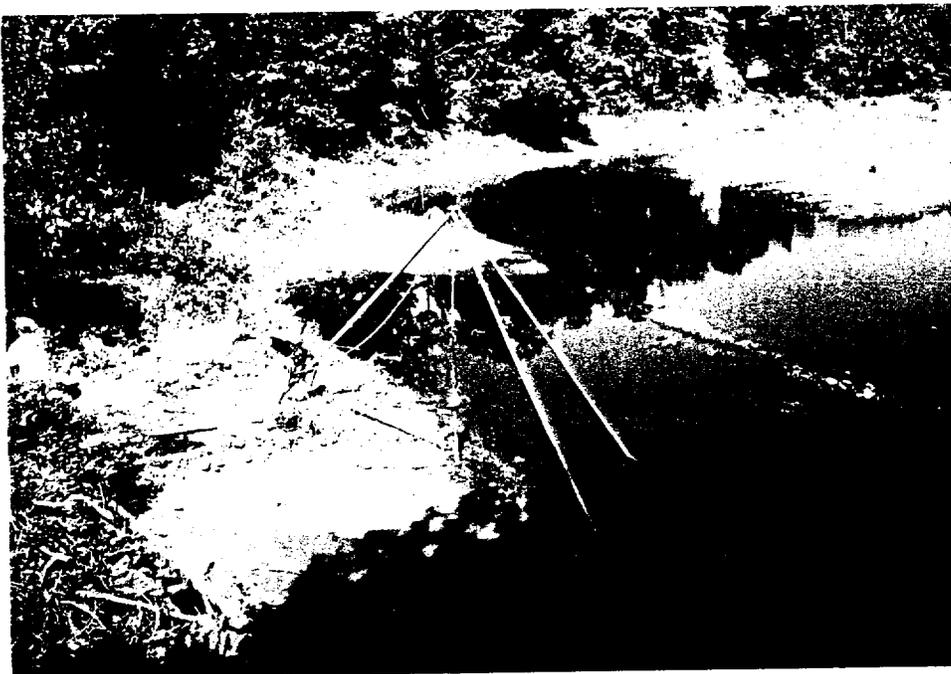
FRAME NUMBER: 18 **DATE:** 20 July 1999

SCENE: View of sediment sampling (by Geologic, Inc.) at the Allendale Dam (sample location AD-03). Photograph taken facing west.

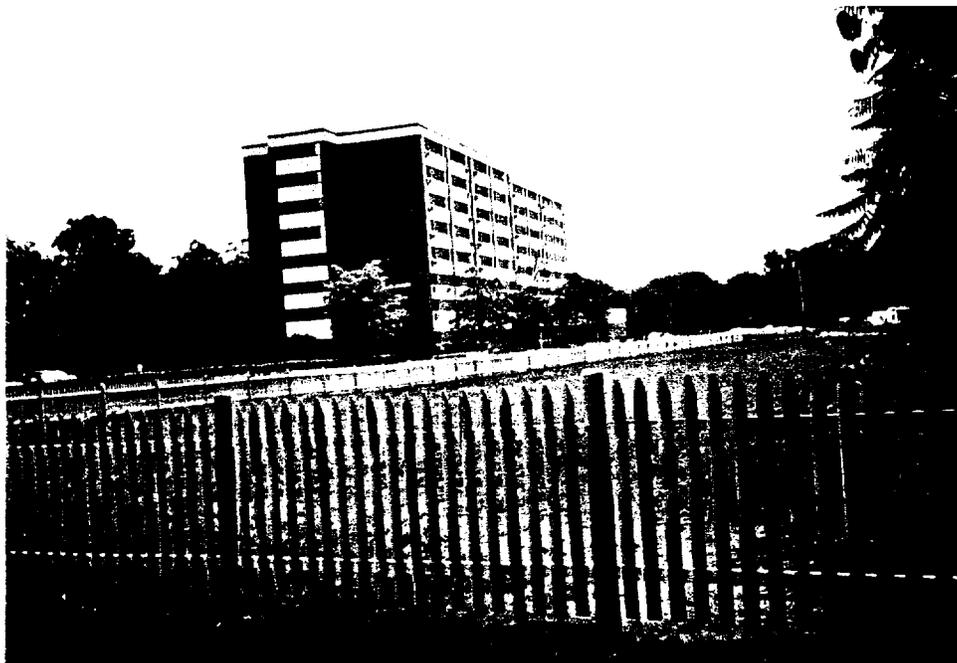
FRAME NUMBER: 21 DATE: 23 August 1999
PHOTOGRAPH BY: Renata Wynnyk
CAMERA: Minolta SETTING: Automatic

SCENE: View of completed cedar fence installation, with the Centredale Manor apartment in the background. Note the site trailers to the extreme right. Photograph taken facing southeast.

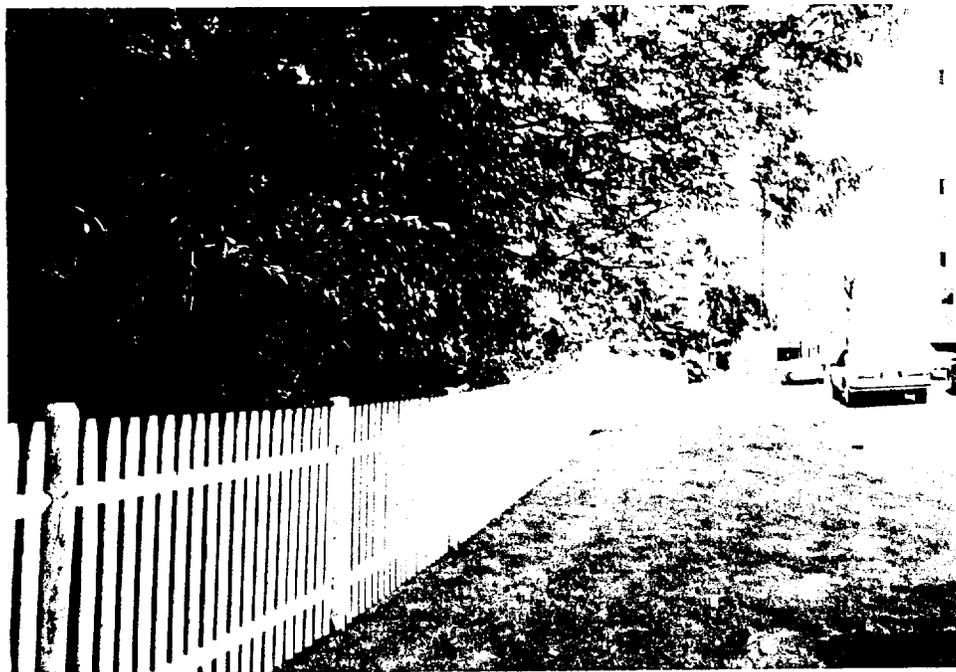
FRAME NUMBER: 22 **DATE:** 24 August 1999
PHOTOGRAPH BY: Renata Wynnyk
CAMERA: Minolta **SETTING:** Automatic

SCENE: View of completed cedar fence installation. The Brook Village apartment building is in the background. Photograph taken facing north.

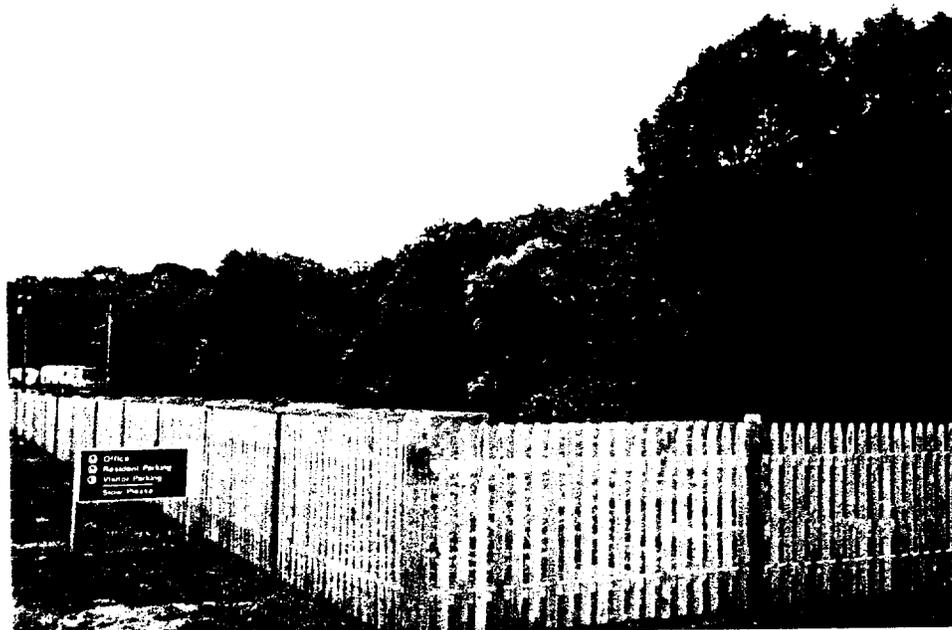
FRAME NUMBER: 23 **DATE:** 24 August 1999
PHOTOGRAPH BY: Renata Wynnyk
CAMERA: Minolta **SETTING:** Automatic

SCENE: View of completed cedar fence installation. Note site office trailers located at the extreme left. Photograph taken facing southwest.

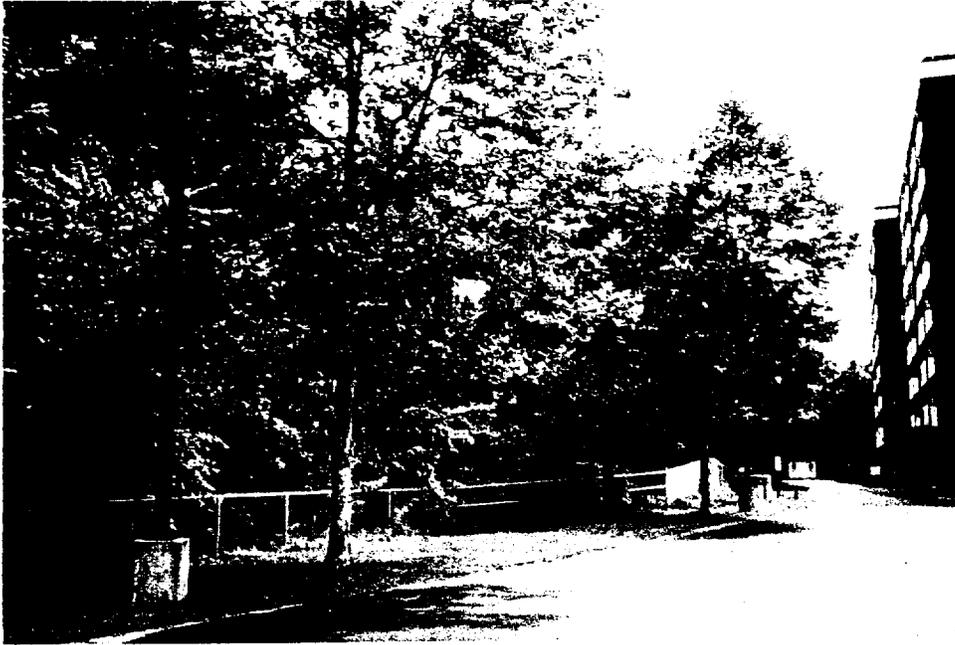
FRAME NUMBER: 24 **DATE:** 24 August 1999

SCENE: View of chain-link fence installed between drainage swale/wetlands area and the Centredale Manor building. Note shed in far right background. Photograph taken facing south.

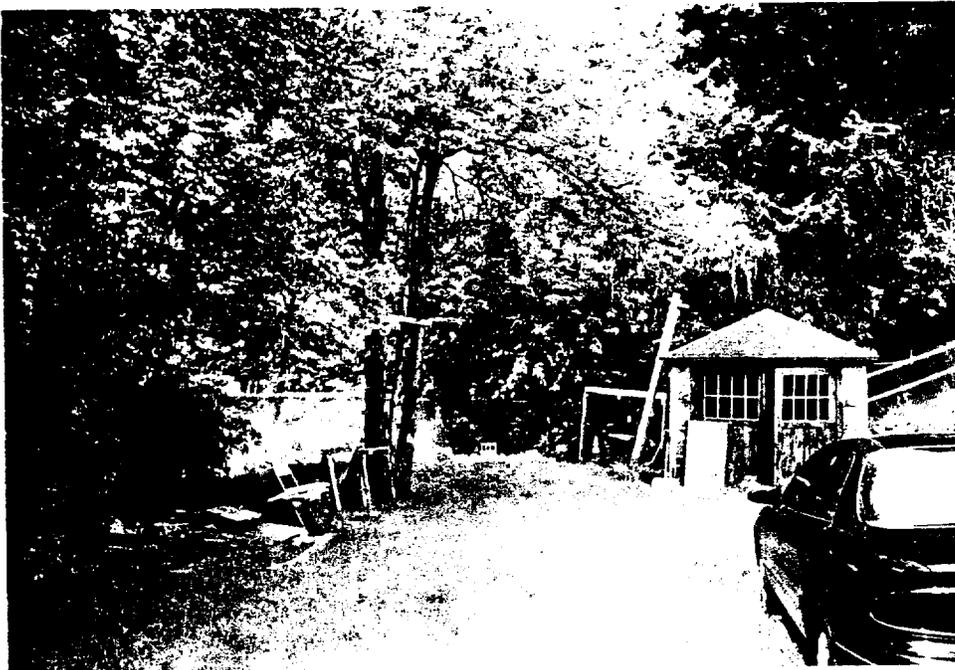
FRAME NUMBER: 00 **DATE:** 24 August 1999

SCENE: View of installed chain-link fencing at 41 Steere Avenue. The drainage swale/wetlands area is located behind the fence to the left. Photograph taken facing north.

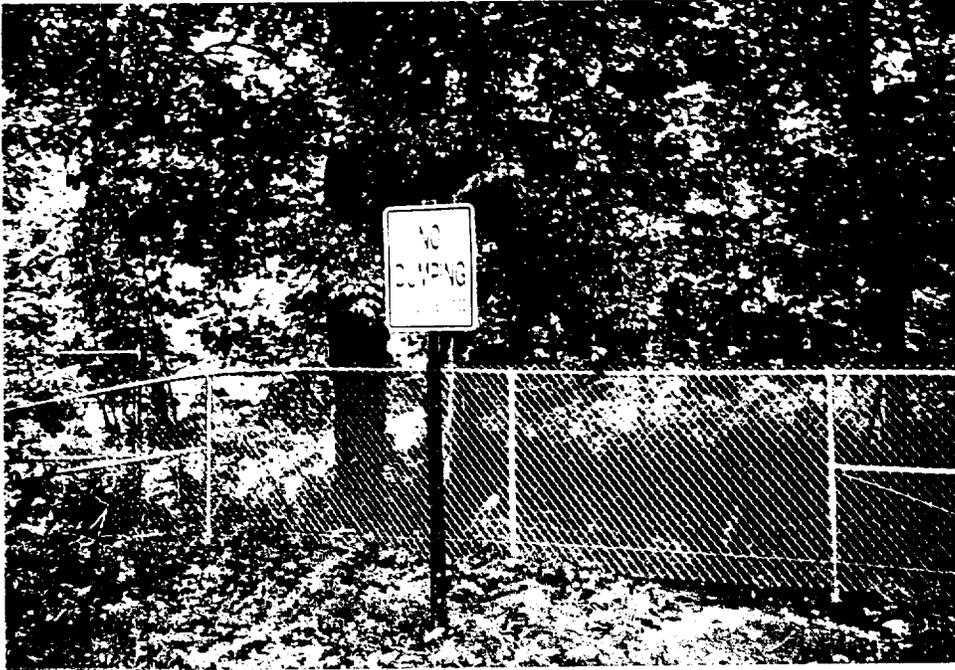
FRAME NUMBER: 01 **DATE:** 24 August 1999

SCENE: View of chain-link fencing installed across the dead end at Steere Avenue. The Centredale Manor building is located behind the fence. Photograph taken facing west.

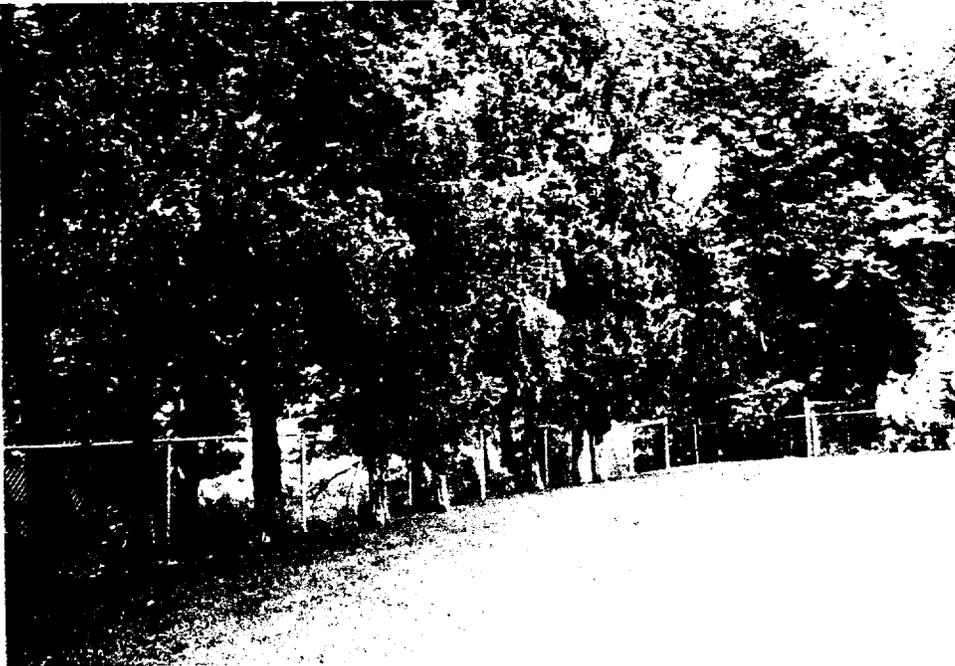
FRAME NUMBER: 03 **DATE:** 24 August 1999

SCENE: View of chain-link fencing installed at 45 Grover Street. Note the red sample flags in foreground. The site wetlands area is located behind the fence. Photograph taken facing northwest.

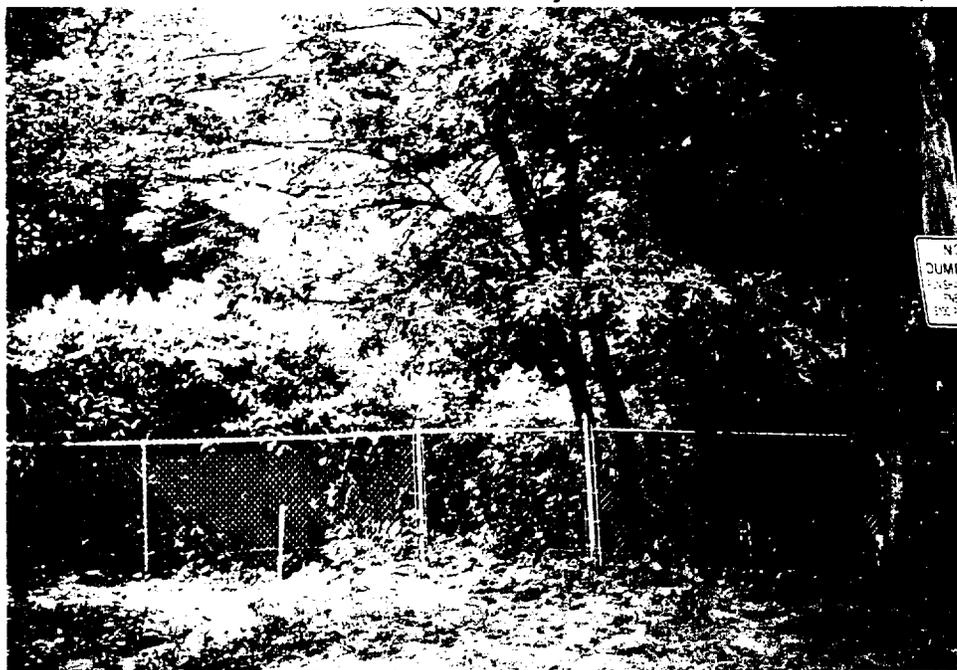
FRAME NUMBER: 04 **DATE:** 24 August 1999
PHOTOGRAPH BY: Renata Wynnyk
CAMERA: Minolta **SETTING:** Automatic

SCENE: View of chain-link fence installed across the dead end of Grover Street. Photograph taken facing west.

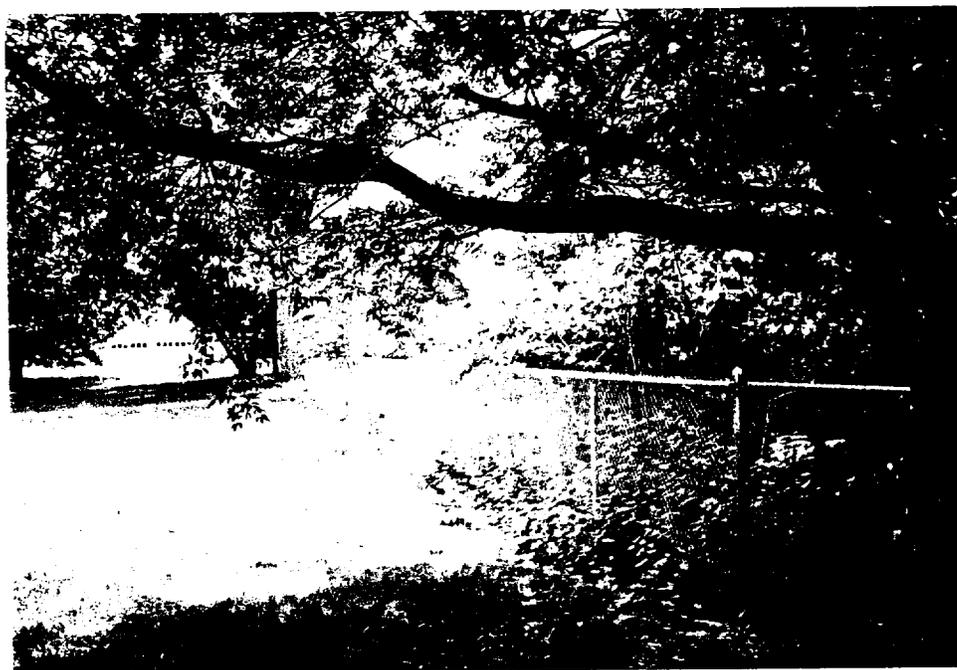
FRAME NUMBER: 05 **DATE:** 24 August 1999
PHOTOGRAPH BY: Renata Wynnyk
CAMERA: Minolta **SETTING:** Automatic

SCENE: View of chain-link fencing installed at the vacant property at 41 Grover Street. Note residential property at 42 Redfern Street in the background. Photograph taken facing south.
