**Third Five-Year Review Report**  
**for**  
**Charles George Land Reclamation Trust Landfill Superfund Site**  
**Tyngsborough,**  
**Middlesex County, Massachusetts**

**June 2005**

**United States Environmental Protection Agency**  
**Region 1**  
**Boston, Massachusetts**

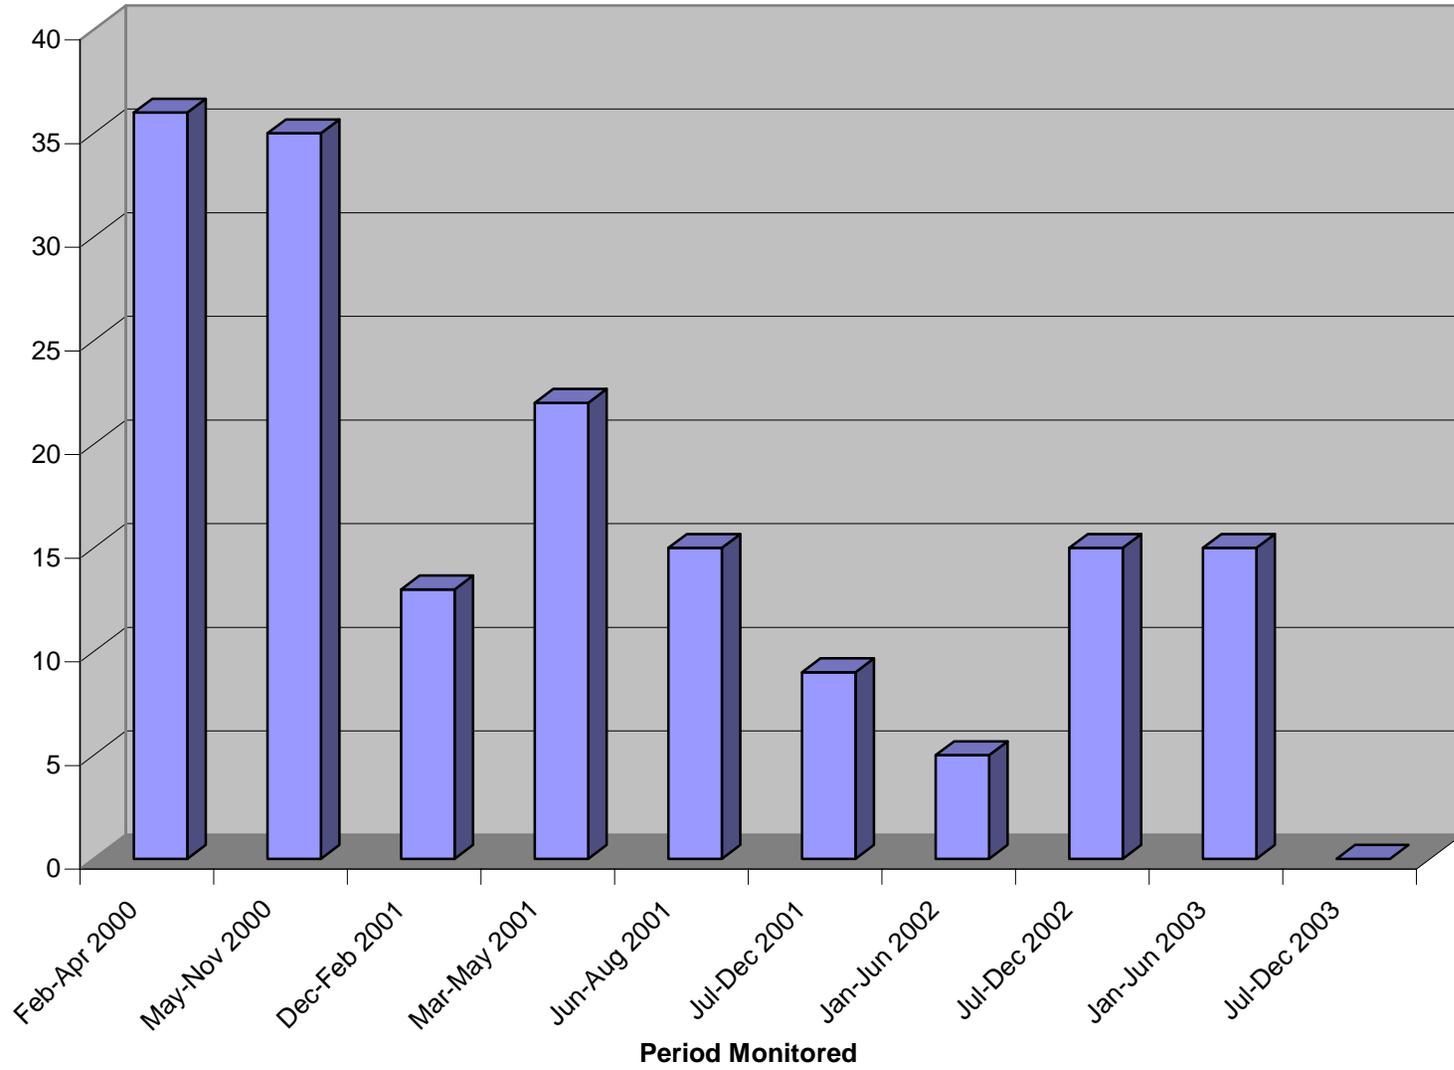
Figure 7  
Landfill Gas Flare  
Percent Operational During Monitoring Period

The March 2000 to December 2003 weekly inspection logs prepared by Clean Harbors were reviewed to evaluate flare O&M activities. Figure 7 is a plot showing the percentage of Site visits for which the flare was found to be operational during each semiannual or quarterly reporting period. Weekly flare inspection logs indicate that overall, the flare has had no major operational or maintenance problems, but has had more down time than operating time since the last Five Year Review.

Based on the above information, the frequent shutdown of the flare indicates that the landfill may not be generating enough methane to keep the flare running as currently configured and that there may likely be O<sub>2</sub> infiltration into the header system at the toe drain connection. However, as discussed below, based on landfill gas monitoring performed in soil gas probes located around the perimeter of the landfill, it appears that landfill gas is being contained within the gas collection system and is not apparently migrating beyond the landfill cap.

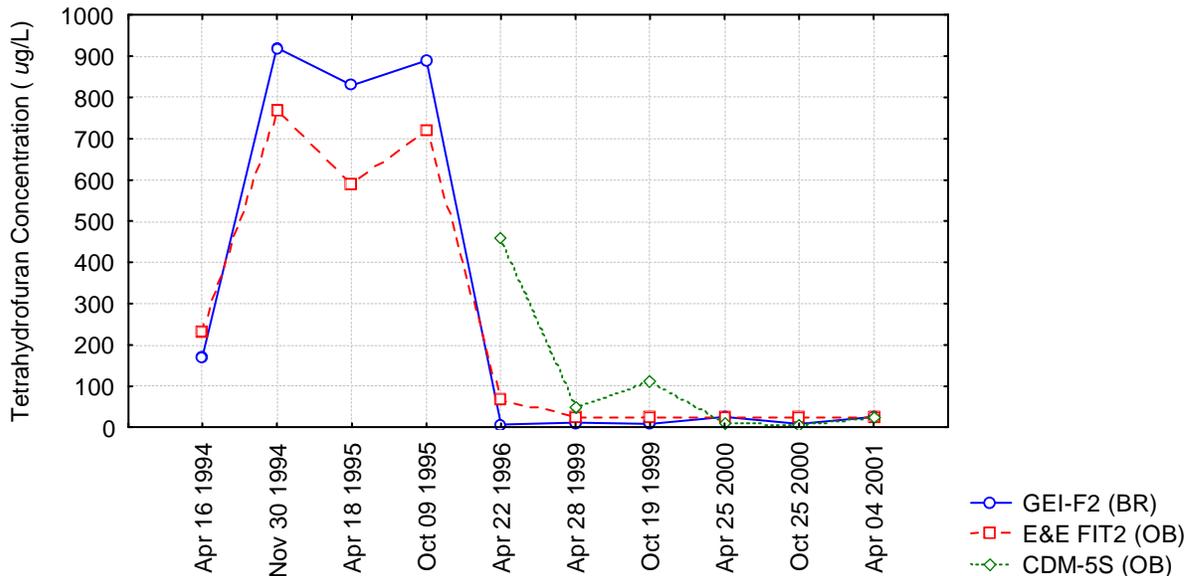
**Figure 2-1. Temporal trend in tetrahydrofuran concentrations (ug/L).**

A line plot of the data indicate that there is a pronounced decrease in THF starting in late April 1996 within bedrock well GEI-F2 (BR) and overburden well E&E FIT2 (OB) (Figure 2-1). The decrease in THF does not occur within overburden well CDM-5S (OB) until three years later in late April 1999. THF concentrations have remained low up through April 2001.

The Mann-Kendall Test indicates that the decrease in THF concentrations is only significant within overburden well E&E FIT2 (OB).

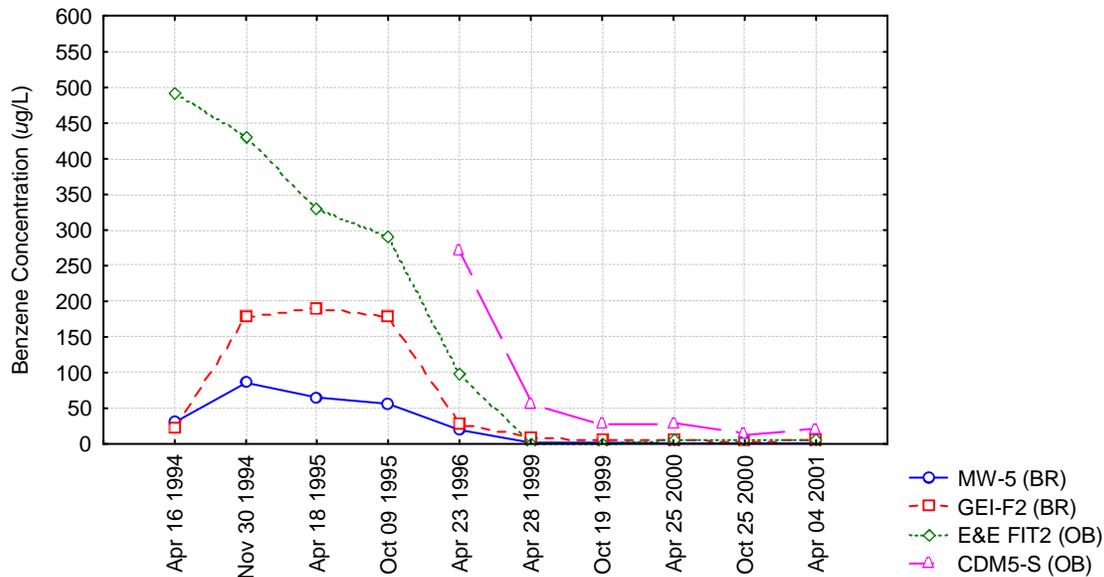
Figure 2-2. Temporal trend in benzene concentrations (ug/L).

All overburden and bedrock wells exhibit a decreasing trend in benzene concentrations with time (Figure 2-2) and this is highly significant in all wells examined (Table 2-6). Benzene concentrations have remained low through April 2001.

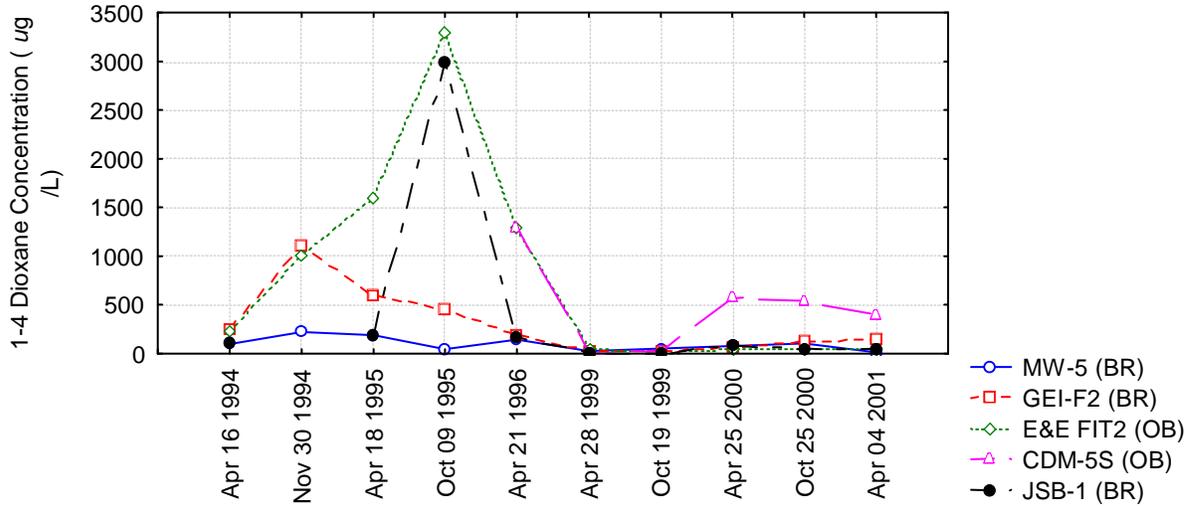
Figure 2-3a. Temporal trend in 1,4 Dioxane concentrations (ug/L) (Well Set 1).

The trend in 1,4 Dioxane concentrations in all wells examined is episodic (Gilbert, 1987) (Figures 2-3a and 2-3b) but exhibit a general decrease with time. The decrease with time is however, only statistically significant within bedrock well GEI F2 (BR) (Table 2-9).

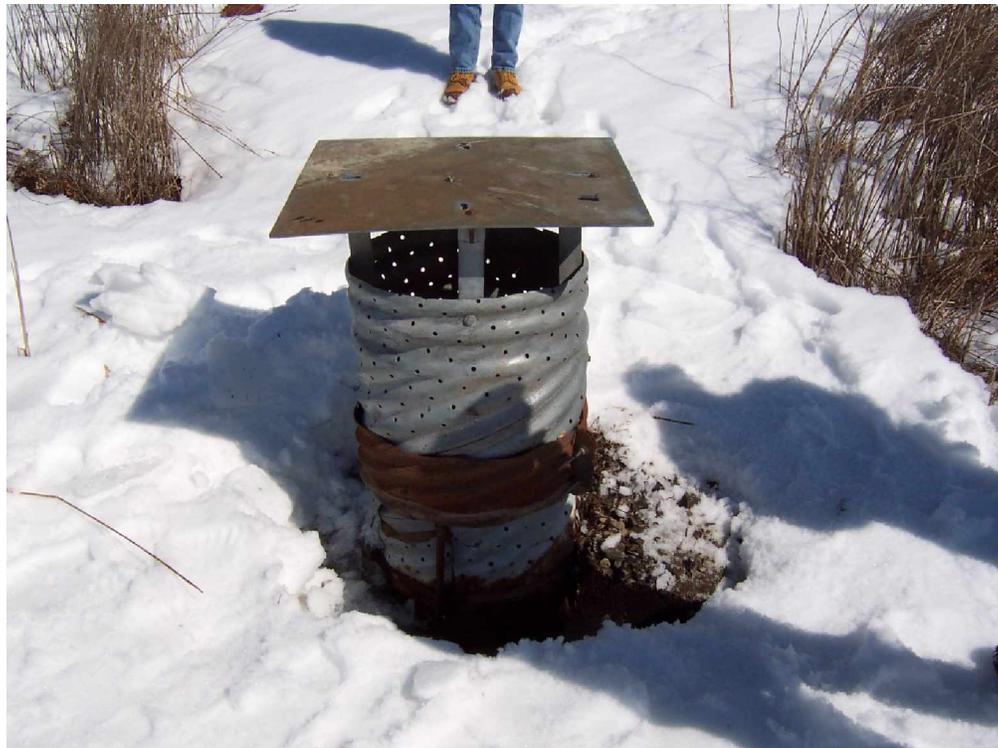
**Photo 8: Riser pipe of East Sedimentation Basin outlet structure.**

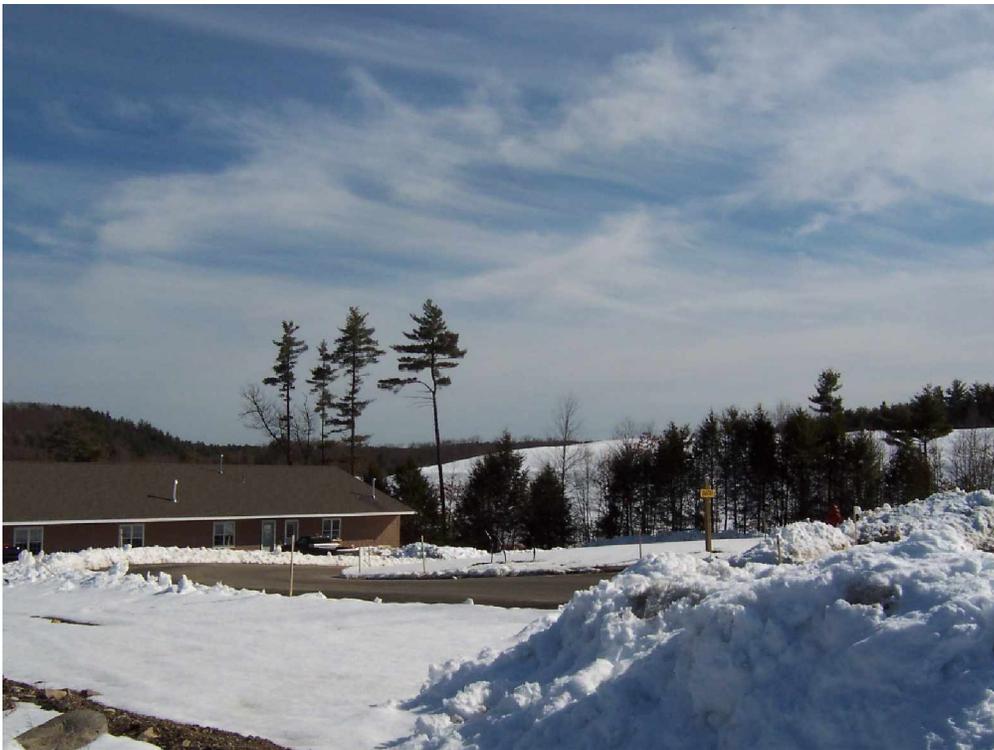
**Photo 17: Landfill gas flare.**
