AERIAL PHOTOGRAPHIC AND FRACTURE TRACE ANALYSES OF CHLOR-ALKALI FACILITY Berlin, New Hampshire

TS-PIC-20801101S
February 2008

AERIAL PHOTOGRAPHIC AND FRACTURE TRACE ANALYSES OF
CHLOR-ALKALI FACILITY

Berlin, New Hampshire

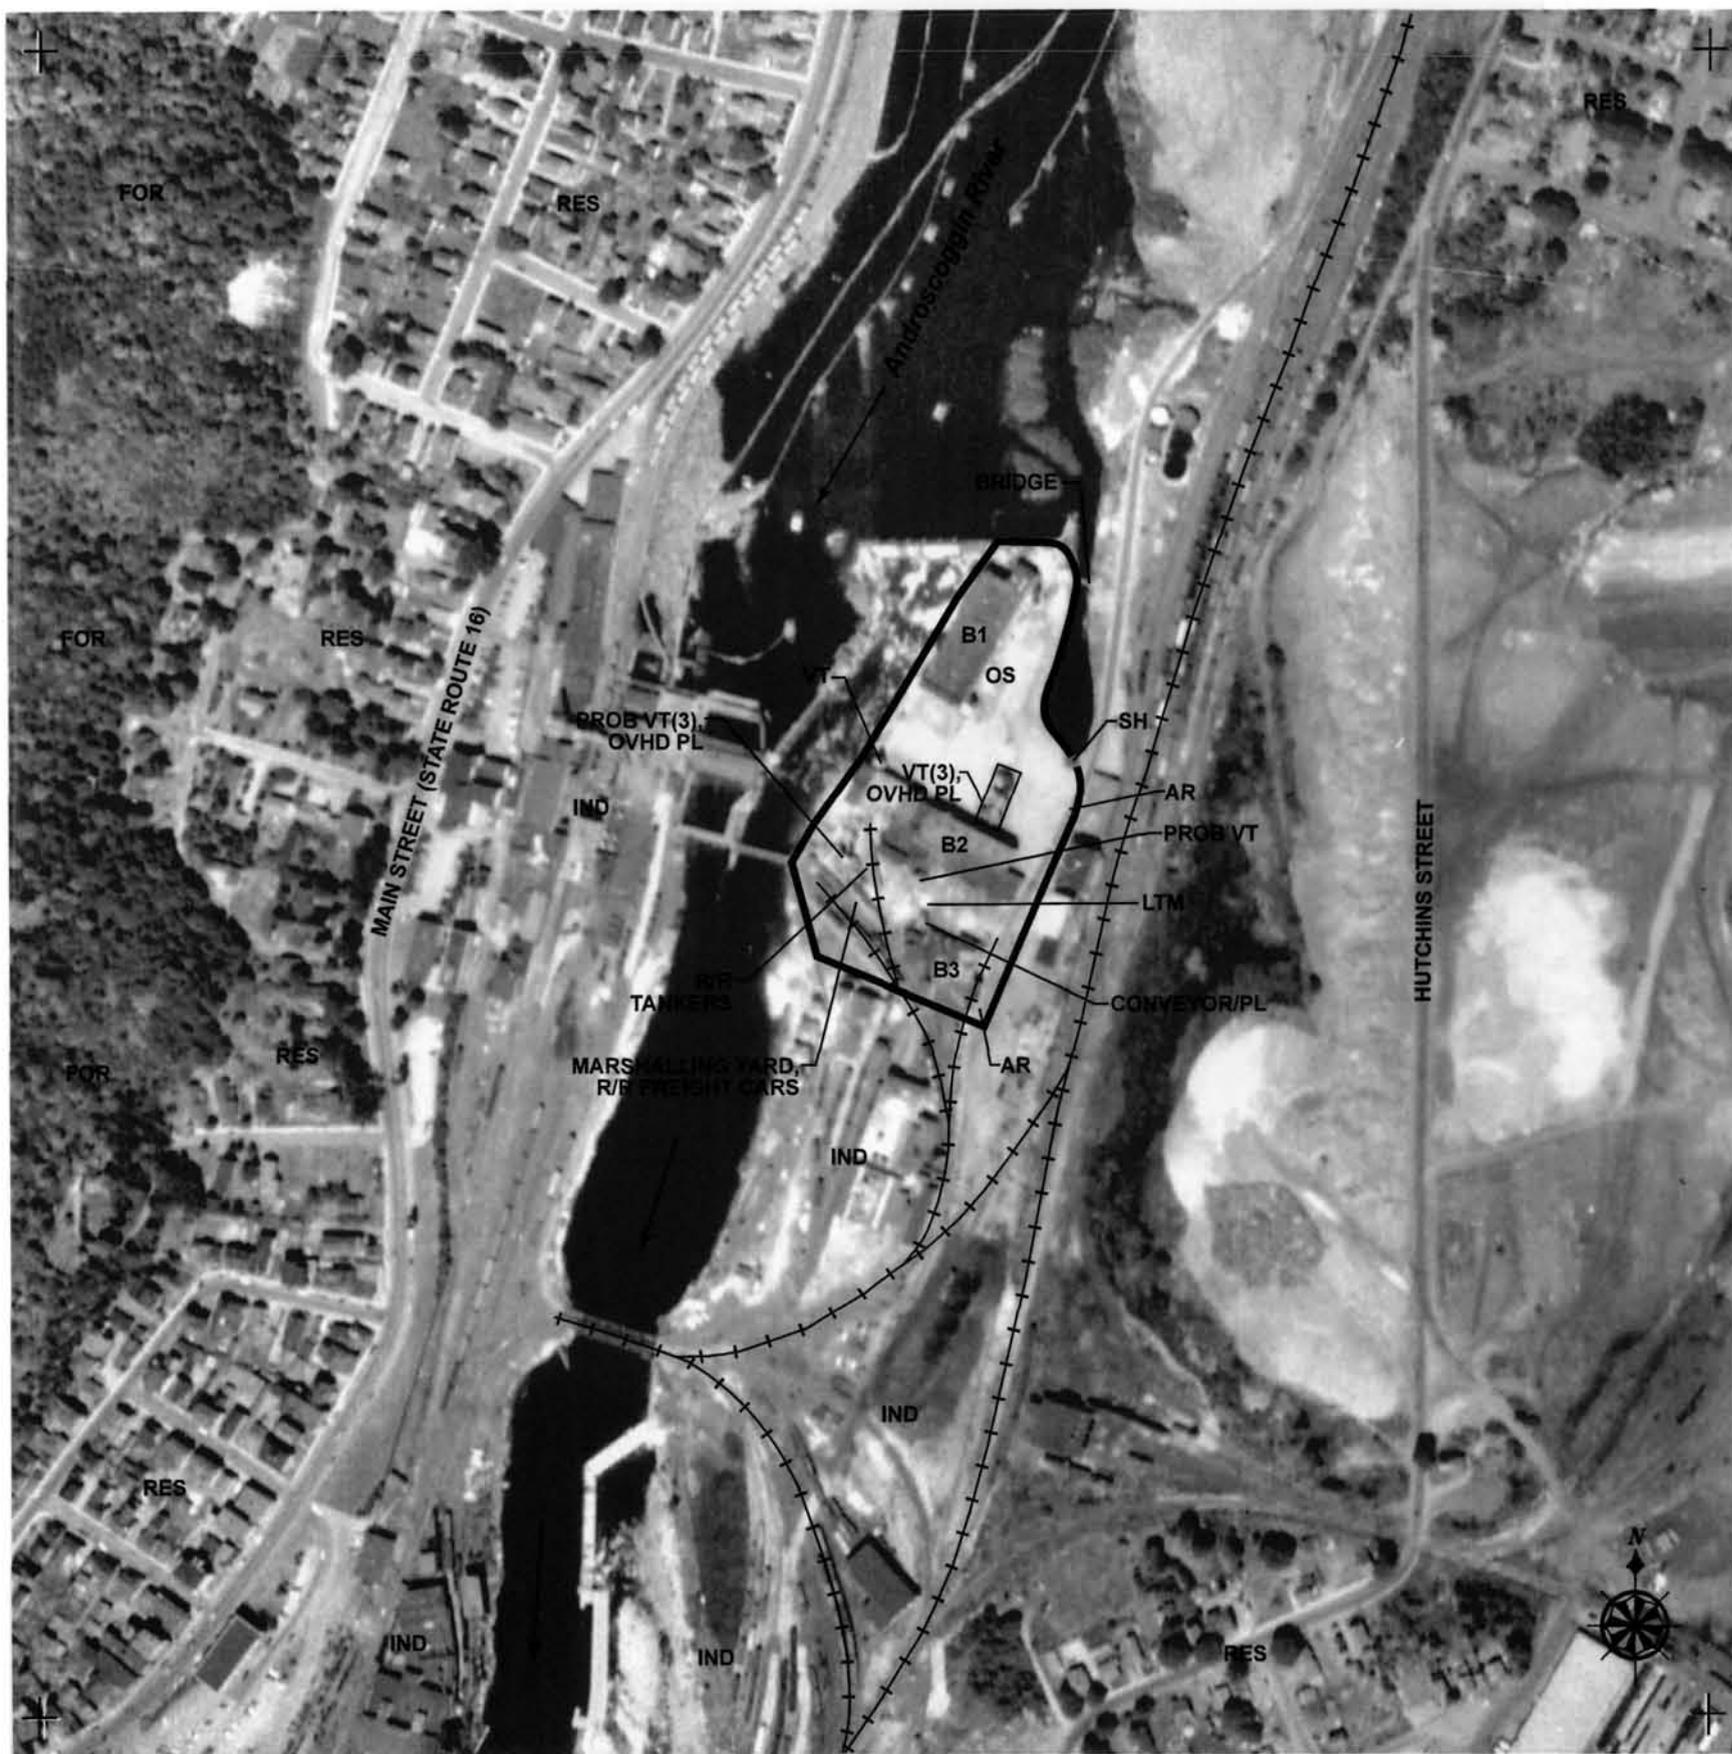
Figure 5. Chlor-Alkali Facility, August 4, 1955. Approximate scale 1:3,600.

Structures which appear to be associated with an industrial processing facility are on the site. These structures consist of three large buildings (B1, B2, and B3), a small shed (SH), and numerous storage tanks. Access to the site is via a railroad (R/R) system and a north-south oriented access road (AR) that extends along the eastern boundary of the site north to Bridge Street. The access road will no longer be annotated or discussed in the text. Several railroad spurs, railroad freight cars and tankers, and a railroad marshalling yard are located in the southern part of the site.

Near building B1, located in the northern part of the site adjacent to the Androscoggin River, there is an open storage area (OS) containing light-toned objects (not annotated). In the northeast corner of the site there is a walking bridge. Building B2, located in the center of the site, appears to be an assemblage of numerous connected smaller buildings, amassed during past expansions. The smaller individual buildings have roof designs of different heights and shapes. Adjacent to building B2 are a vertical storage tank (VT), a probable vertical storage tank, and along the north side of the building a grouping of three vertical storage tanks. The largest of these three tanks is an open-topped tank. An overhead pipeline (OVHD PL) connects this grouping of storage tanks to building B2. A grouping of three probable vertical storage tanks and overhead pipelines is located between building B2 and the railroad marshalling yard. This area is likely used as a loading zone. In the

southeast corner of the site is building B3. A conveyor/pipeline connects this building to building B2. Also noted between these buildings is a circular patch of light-toned material (LTM).

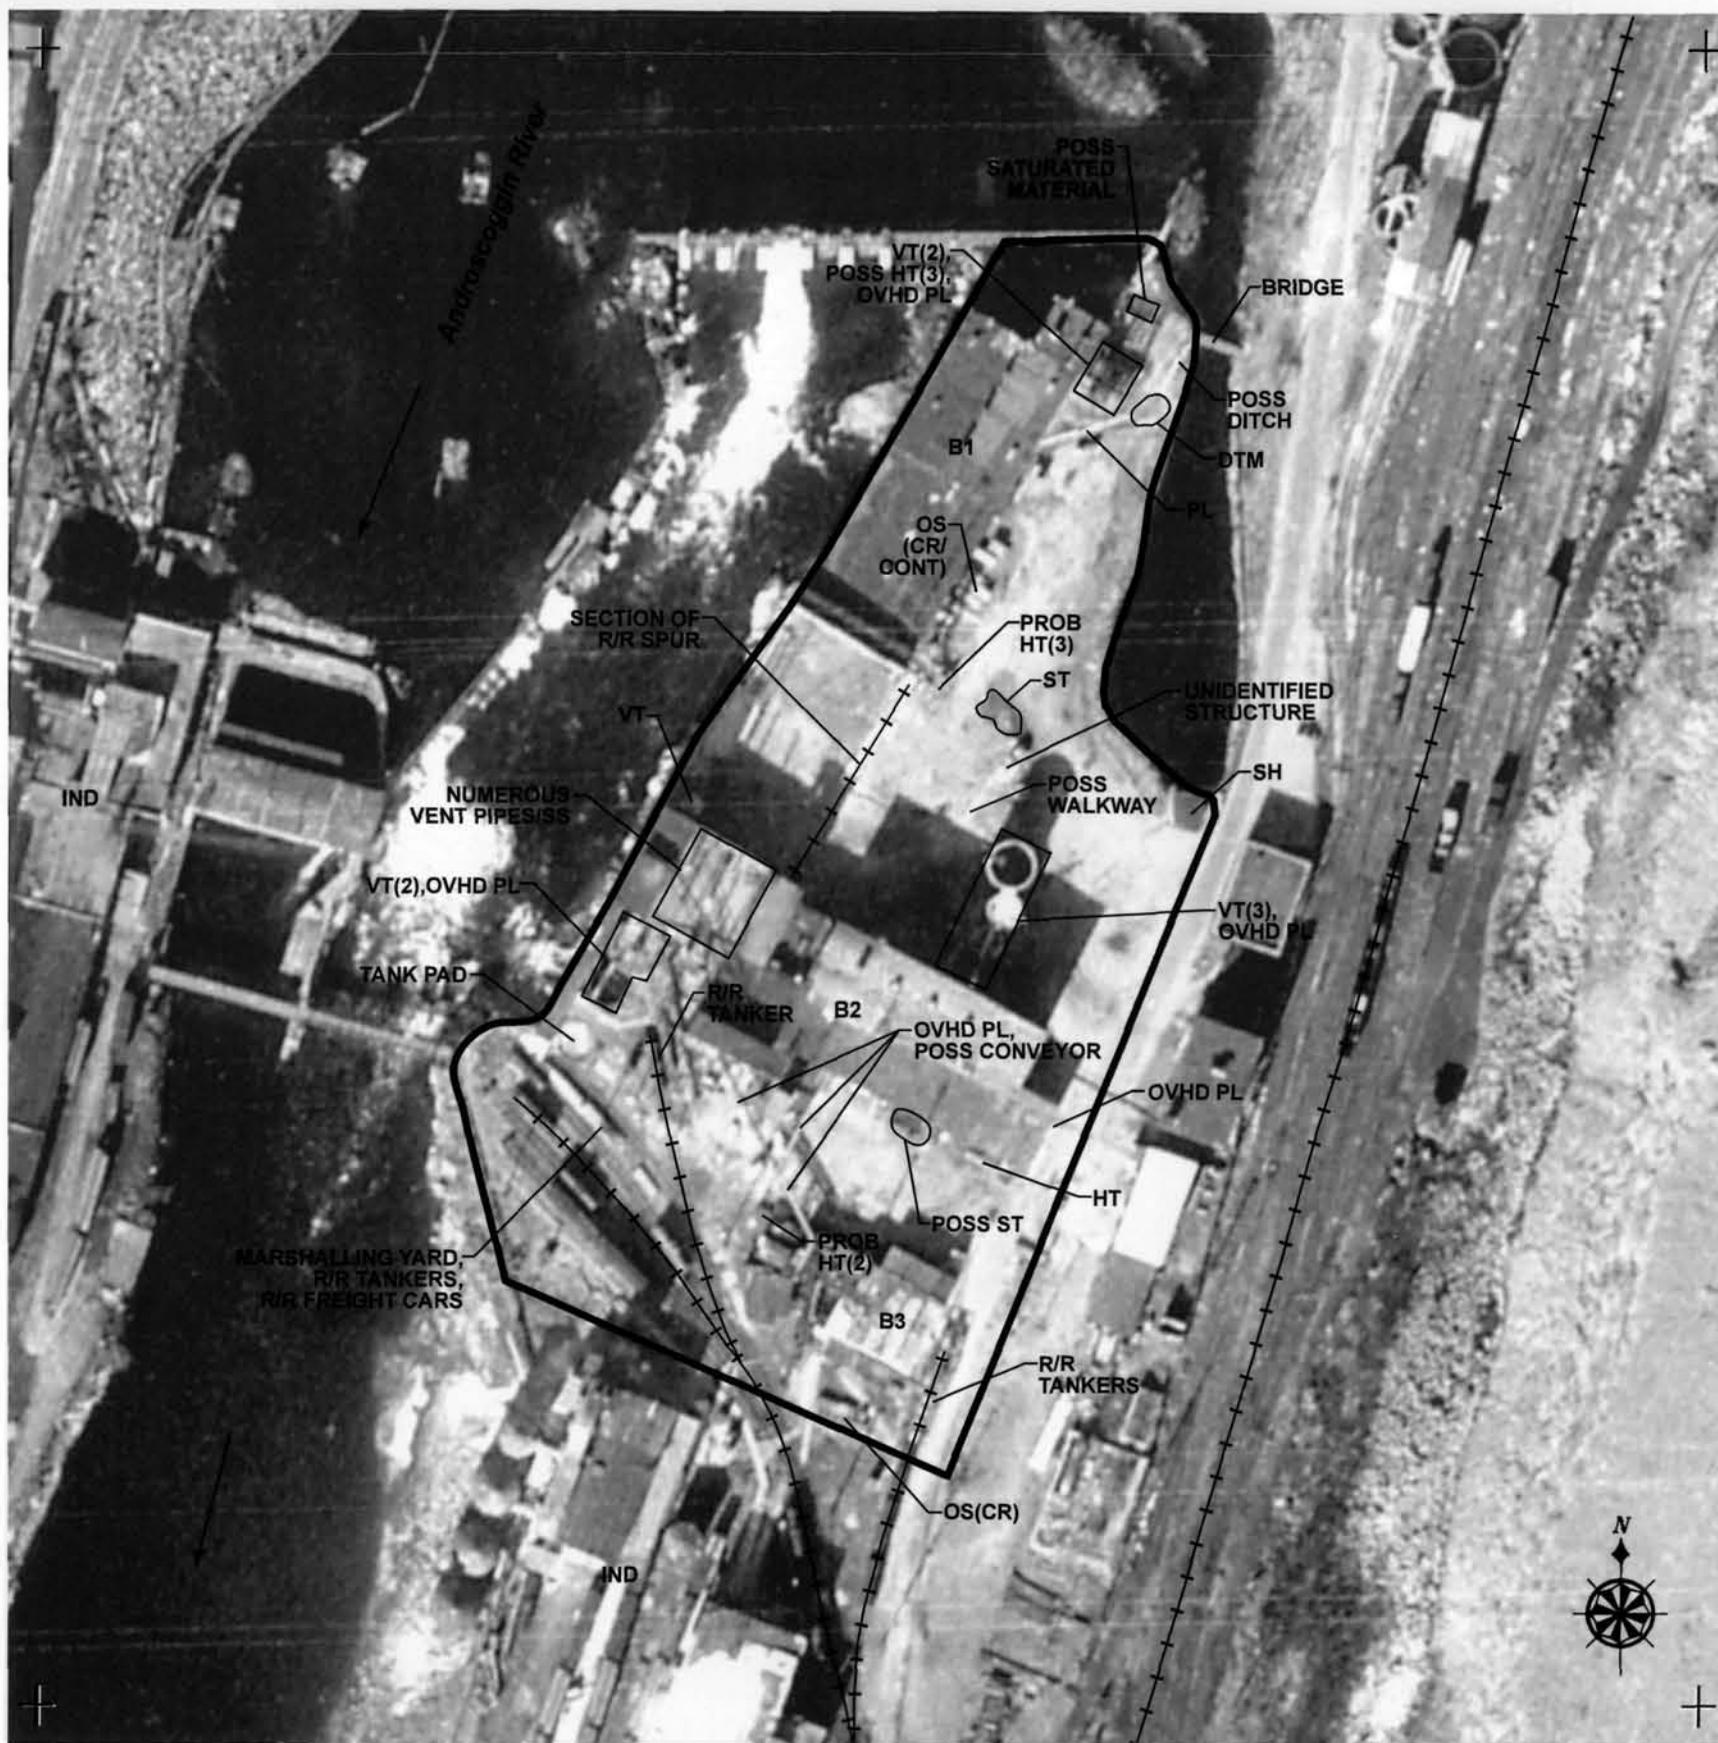
Figure 6. Chlor-Alkali Facility, November 4, 1964. Approximate scale 1:1,475.

Buildings B1, B2, and B3 and the small shed remain at the site. Since 1955 two vertical storage tanks and three possible horizontal storage tanks (HT) have been placed along the east side of building B1. The tanks appear to be connected to building B1 by a lattice of overhead pipelines. Just to the north is a rectangular-shaped area of possible saturated material. A pipeline extends northeast from building B1 to a possible ditch which terminates at the edge of the waterway near the walking bridge. At the connection point of the pipeline and possible ditch is a patch of dark-toned material (DTM) or stain (not annotated), suggesting a collection point for liquid. The open storage area, located along the east wall of building B1, now houses crates (CR), containers (CONT), and a grouping of three probable horizontal storage tanks. A section of a railroad track, likely a remnant of a dismantled rail spur, is visible between buildings B1 and B2. Due to the relatively lower film resolution of the 1955 photograph it is not possible to ascertain if this feature is in place at that time.

Numerous vent pipes and smokestacks (SS) are noted protruding from the roof of the western section of building B2. Connected to building B2 by overhead pipelines are two groupings of two vertical storage tanks. The storage tanks located on the north side of the building were visible in 1955. Near the tanks is a light-toned possible walkway which likely extends from the building, to an unidentified structure and adjacent stain (ST). The function of this structure cannot be determined. A grouping of two vertical storage tanks is located alongside the Androscoggin River. In 1955, three probable vertical storage tanks were observed at this location. Since 1955, one storage tank has been removed, a circular-shaped tank pad remains. A vertical storage tank remains in place on the northeast side of building B2 and a horizontal storage tank is now located on southeast side of the building. Building B2 is connected to an offsite building (not annotated), located due east of the site, via an overhead pipeline. Additional overhead pipelines or possible conveyors connect building B2 to building B3. An open storage area consisting of small crates, and two probable horizontal storage tanks is located near building B3.

Numerous railroad tanker cars are parked in the marshalling yard and adjacent to buildings B2 and B3.

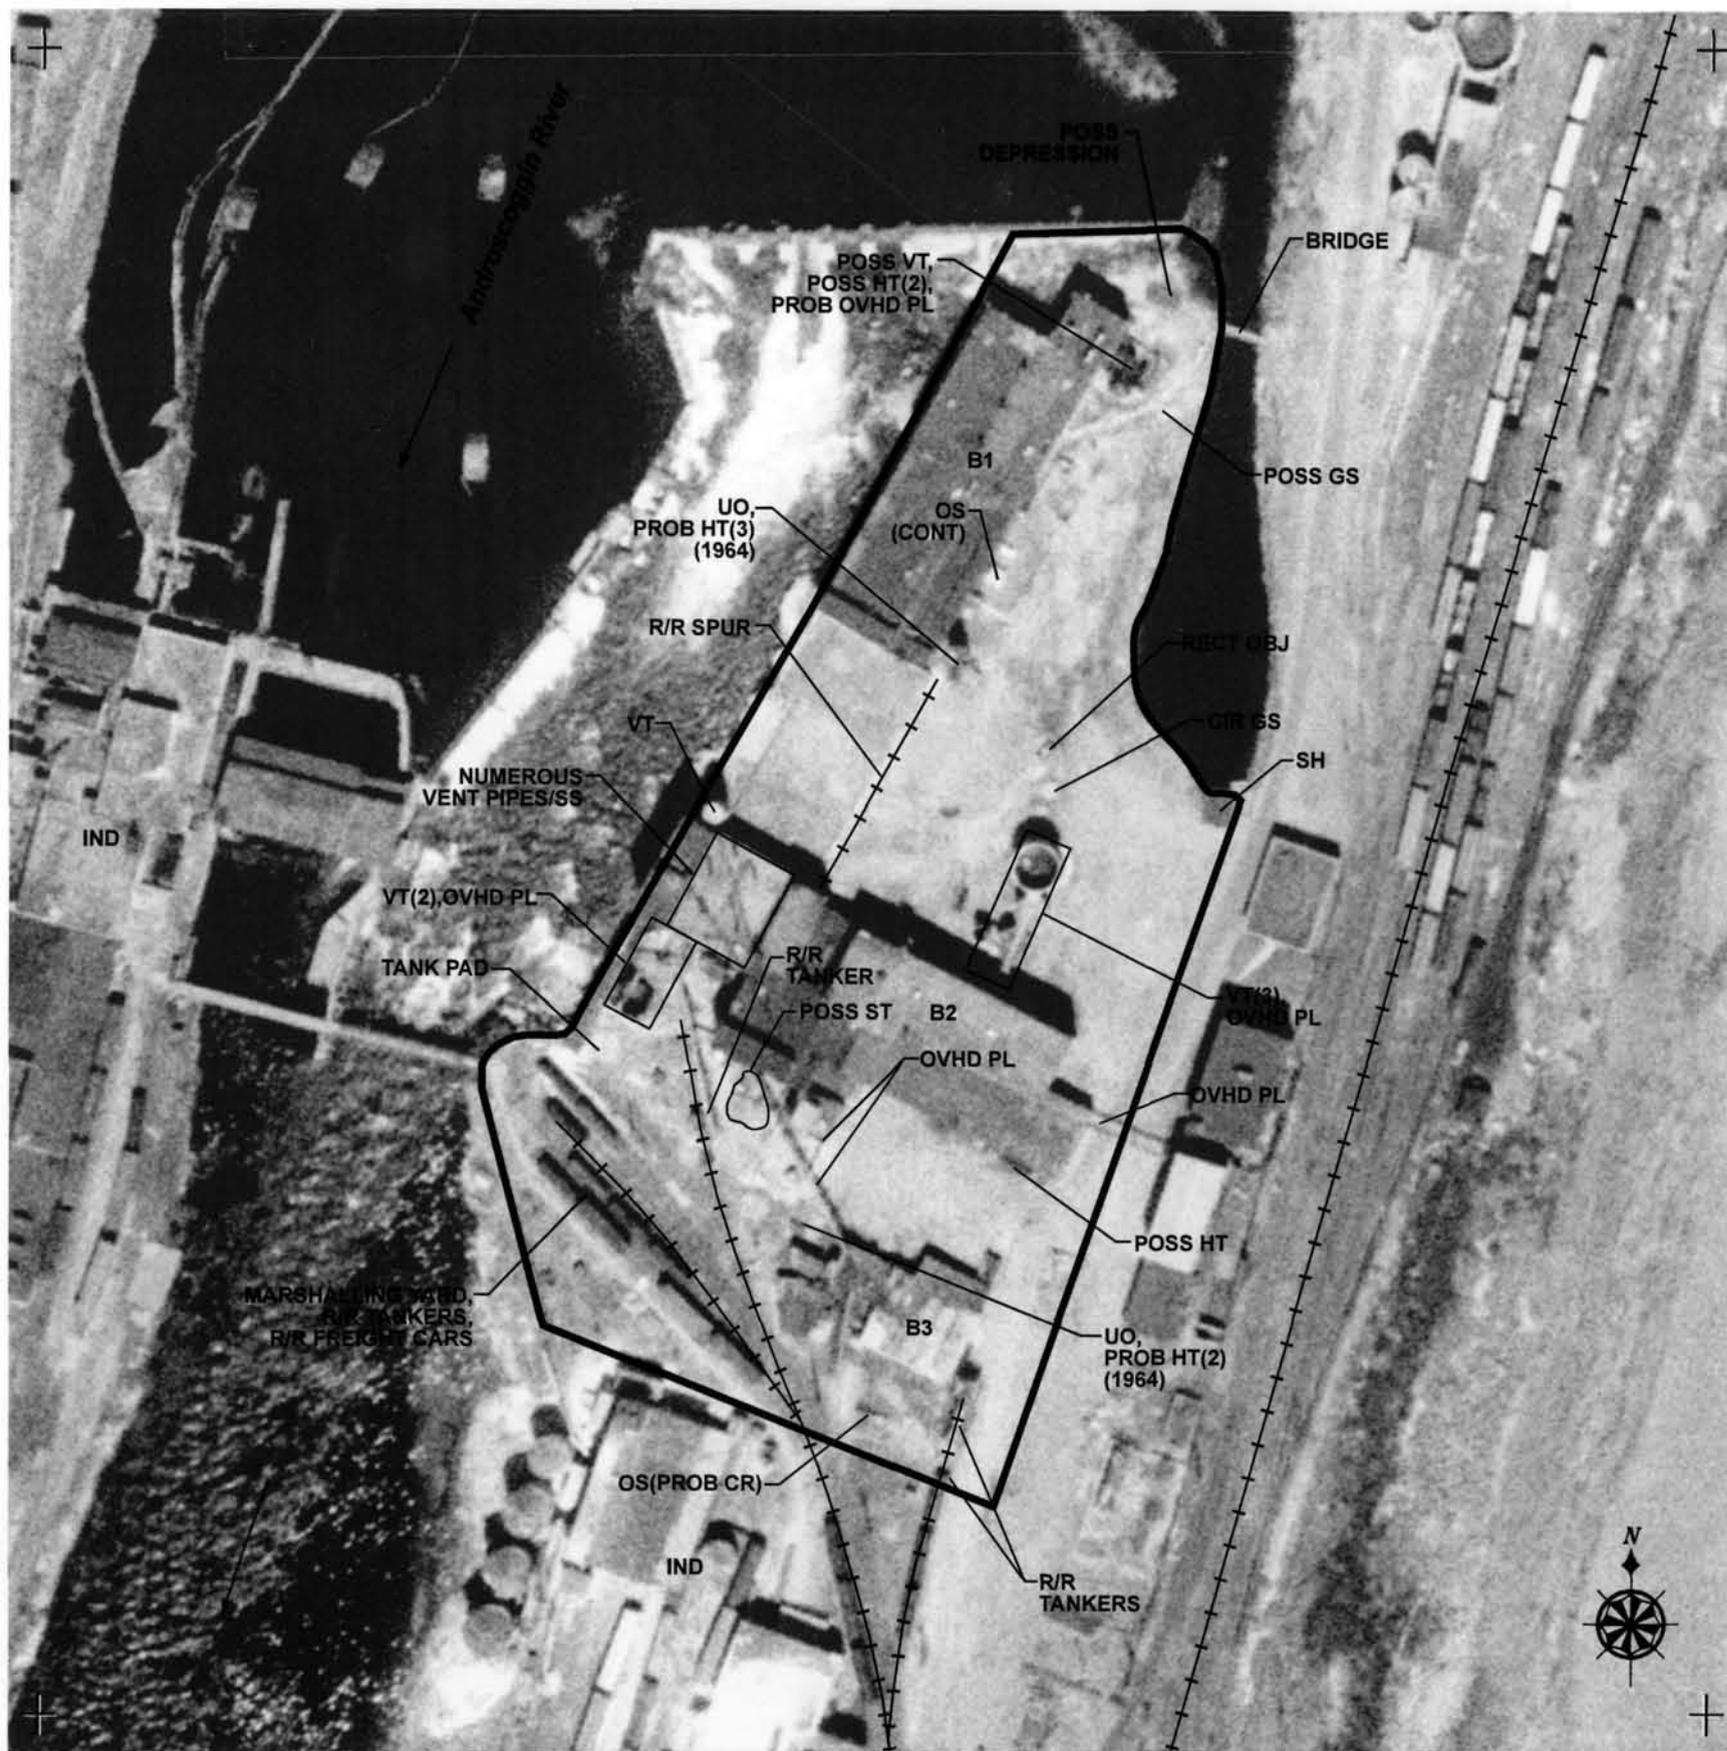
Figure 7. Chlor-Alkali Facility, May 6, 1965. Approximate scale 1:1,475.

Buildings B1, B2, and B3 and the small shed remain visible at the site which does not appear to be active at this time. Connected to building B1 by a lattice of probable overhead pipelines are a possible vertical storage tank and two possible horizontal storage tanks. A linear, possible ground scar extends from the building to near the bridge. In 1964, a pipeline, possible ditch, and a patch of dark-toned material were noted at this location. Near the bridge there is a rectangular-shaped possible depression; in 1964 possible saturated material was noted at this location. Containers remain at the open storage area and an unidentified object (UO) is located alongside building B1 at the terminus of the railroad spur remnant. This unidentified object is approximately one-half the height of building B1 and located near to where three probable horizontal storage tanks were seen in 1964.

The grouping of three vertical storage tanks (one of which is open-topped) and a connecting overhead pipeline remain on the north side building B2. Just north of these storage tanks are a rectangular-shaped object (REC OBJ) and a circular-shaped ground scar (CIR GS). The symmetry of this ground scar suggests the former location of a storage tank, but no tank was observed at the location in 1955 or 1964. The grouping of two vertical storage tanks (one of which appears open-topped), overhead pipelines, and large-diameter tank pad remain in place alongside the Androscoggin River. The vertical storage tank located on the northwest side of building B2 remains in place and a possible horizontal storage tank is noted alongside the southeast side of the building. Building B2 remains connected to an offsite building (not annotated) via an overhead pipeline and overhead pipelines continue to connect building B2 to building B3. Adjacent to building B3 is the open storage area housing small probable crates. Also noted near this building is an unidentified object where in 1964, two probable horizontal storage tanks were observed.

In the railroad marshalling yard there are numerous parked railroad tanker cars and several freight cars. Additional railroad tanker cars are located adjacent to building B3.

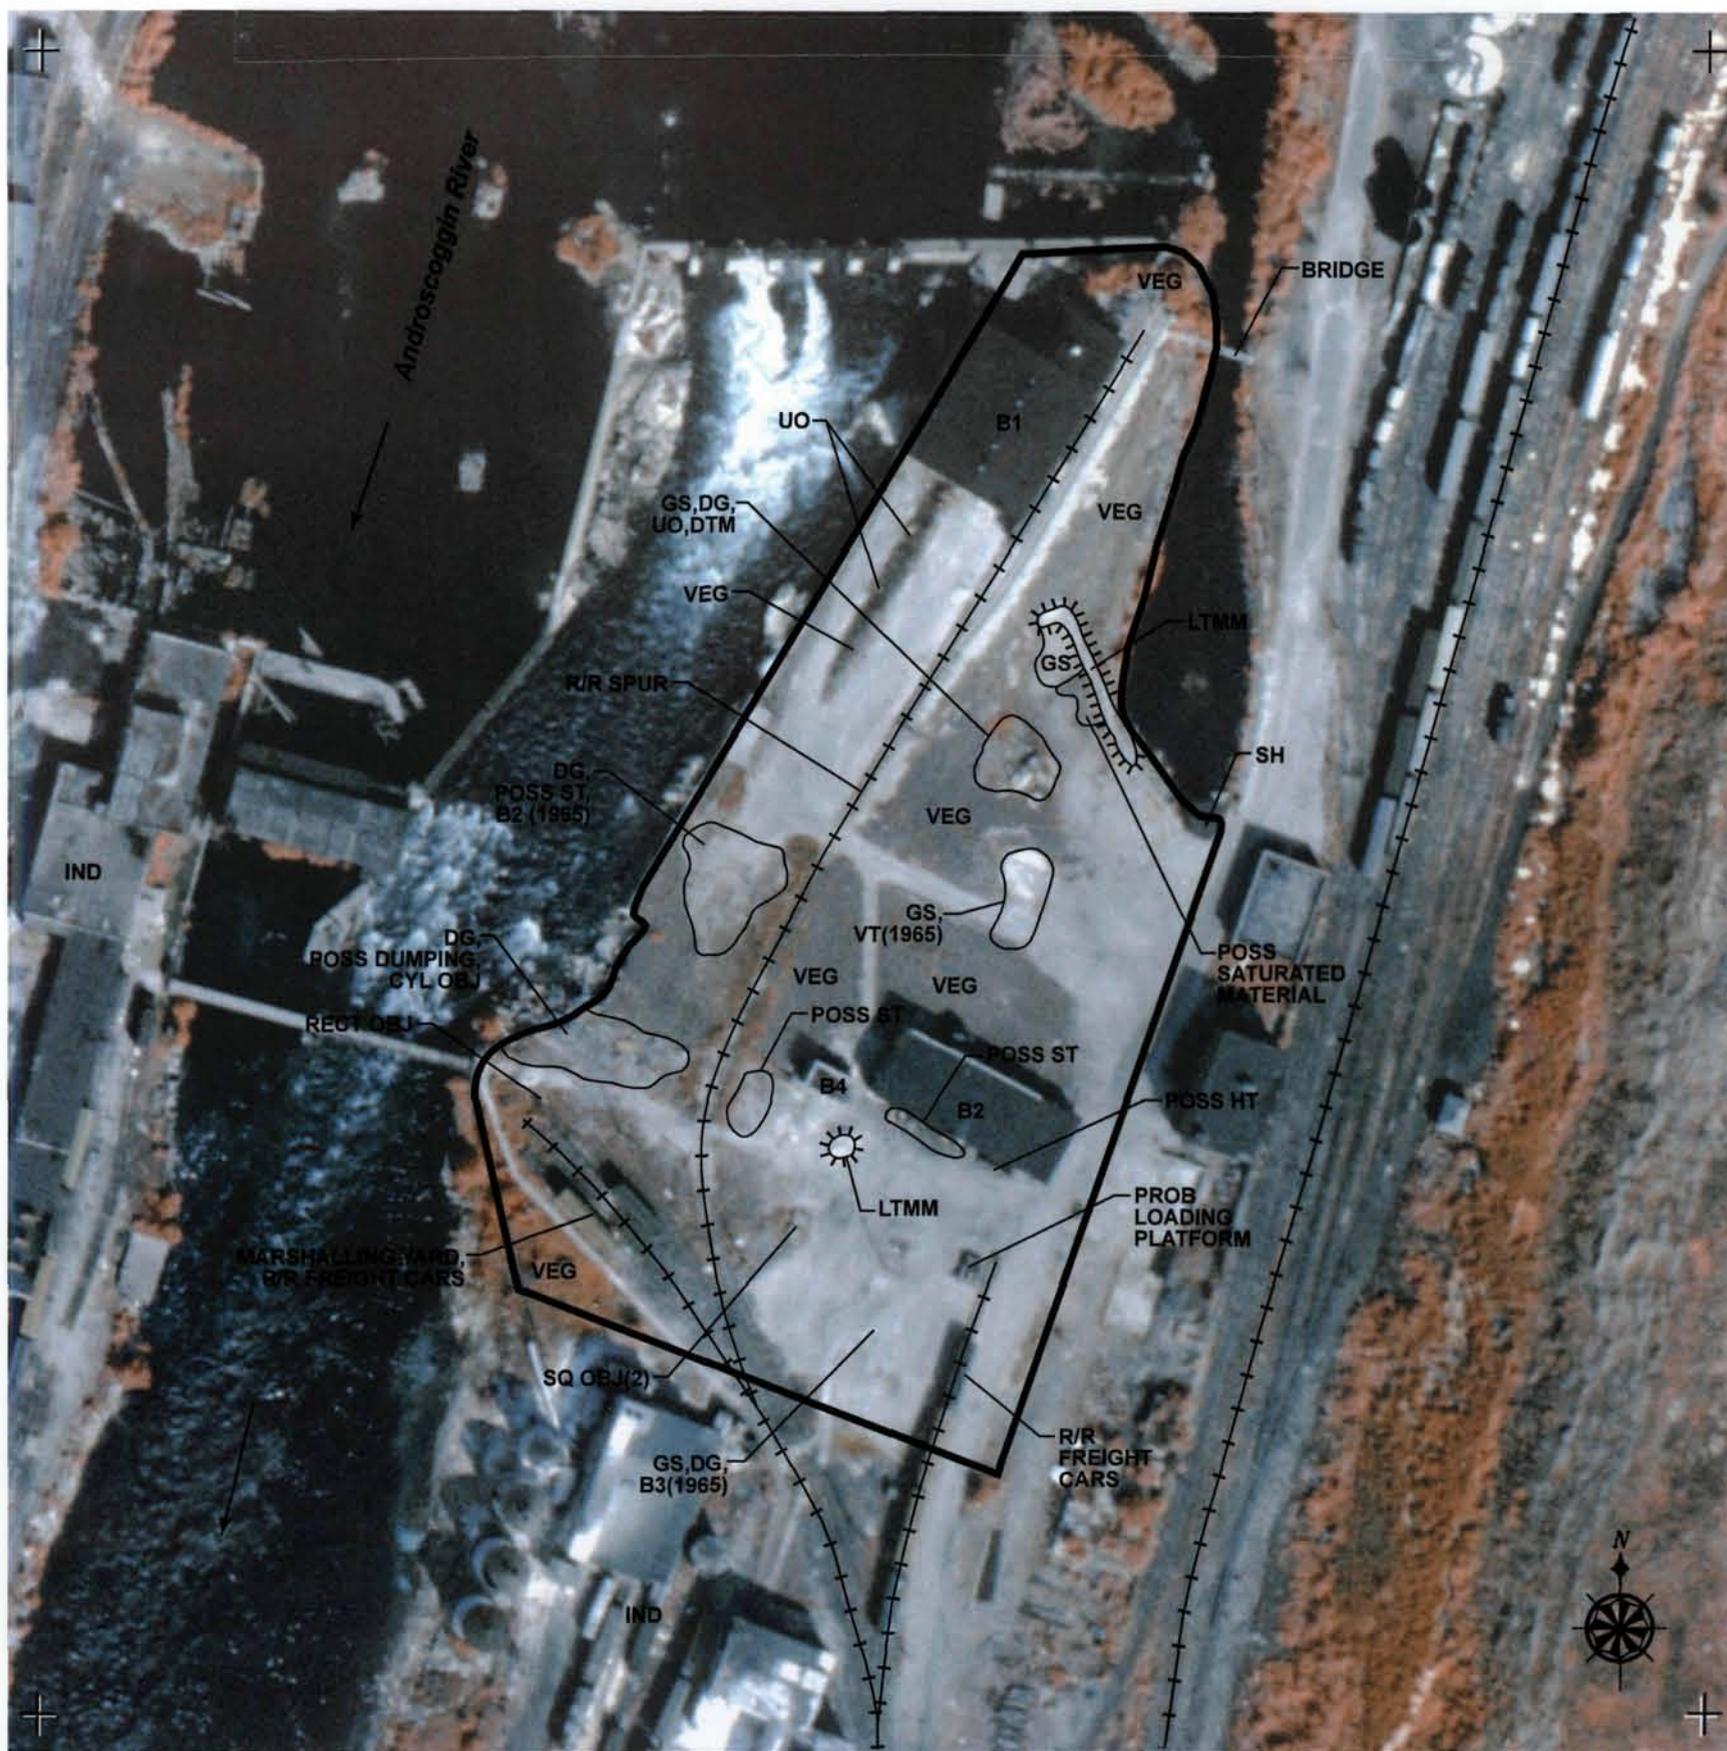
Figure 8. Chlor-Alkali Facility, September 14, 1969. Approximate scale 1:1,505.

Major portions of buildings B1 and B2, adjoining storage tanks, overhead pipelines, and open storage areas have been removed from the site since 1965. The small shed remains visible and a new building (B4) is noted near building B2. This new building may have originally been part of building B2 seen in previous photographs, but this cannot be confirmed.

Near building B1 is a railroad spur which incorporates the track remnant noted in 1964 and 1965. The spur extends northeast from the railroad marshalling area along the east side of building B1. This spur terminates near a vegetated area (VEG; shrubs) on the shoreline of the Androscoggin River. Two unidentified objects, approximately the size of the hood on an automobile, are located on a thin strip of vegetation (grass). In previous photographs, the southern portion of building B1 was visible here.

Near the shed, located in the northeast section of the site, is a thin mound of light-toned material (LTMM). Adjacent to the mound are a ground scar, likely caused by scraping or heavy equipment, and a small irregularly-shaped patch of possible saturated material. Immediately to the south is a collection of ground scars, disturbed ground (DG), an unidentified object, and dark-toned material. A grouping of ground scars is located where in previous photographs vertical storage tanks were visible.

Near buildings B2 and B4 are possible stained ground, the possible horizontal storage tank seen in 1965, light-toned mounded material, two square-shaped (SQ) objects, and a probable loading platform which is adjacent to the railroad spur (not annotated) seen on previous photographs. Several freight cars are visible on this railroad spur, but no railroad tankers are observed. Immediately west of the freight cars are ground scars and disturbed ground at the location of former building B3.

In the railroad marshalling yard adjacent to the Androscoggin River, there are a rectangular-shaped object and numerous railroad freight cars. No railroad tankers are visible on this photograph. Bordering the river are two large swathes of disturbed ground. Within the area of disturbed ground closest to the railroad marshalling yard there are cylindrical-shaped (CYL) objects and

possible dumping activity. The second area of disturbed ground just to the north includes possible ground stains. Part of this area of disturbed ground was formerly occupied by a section of building B2.

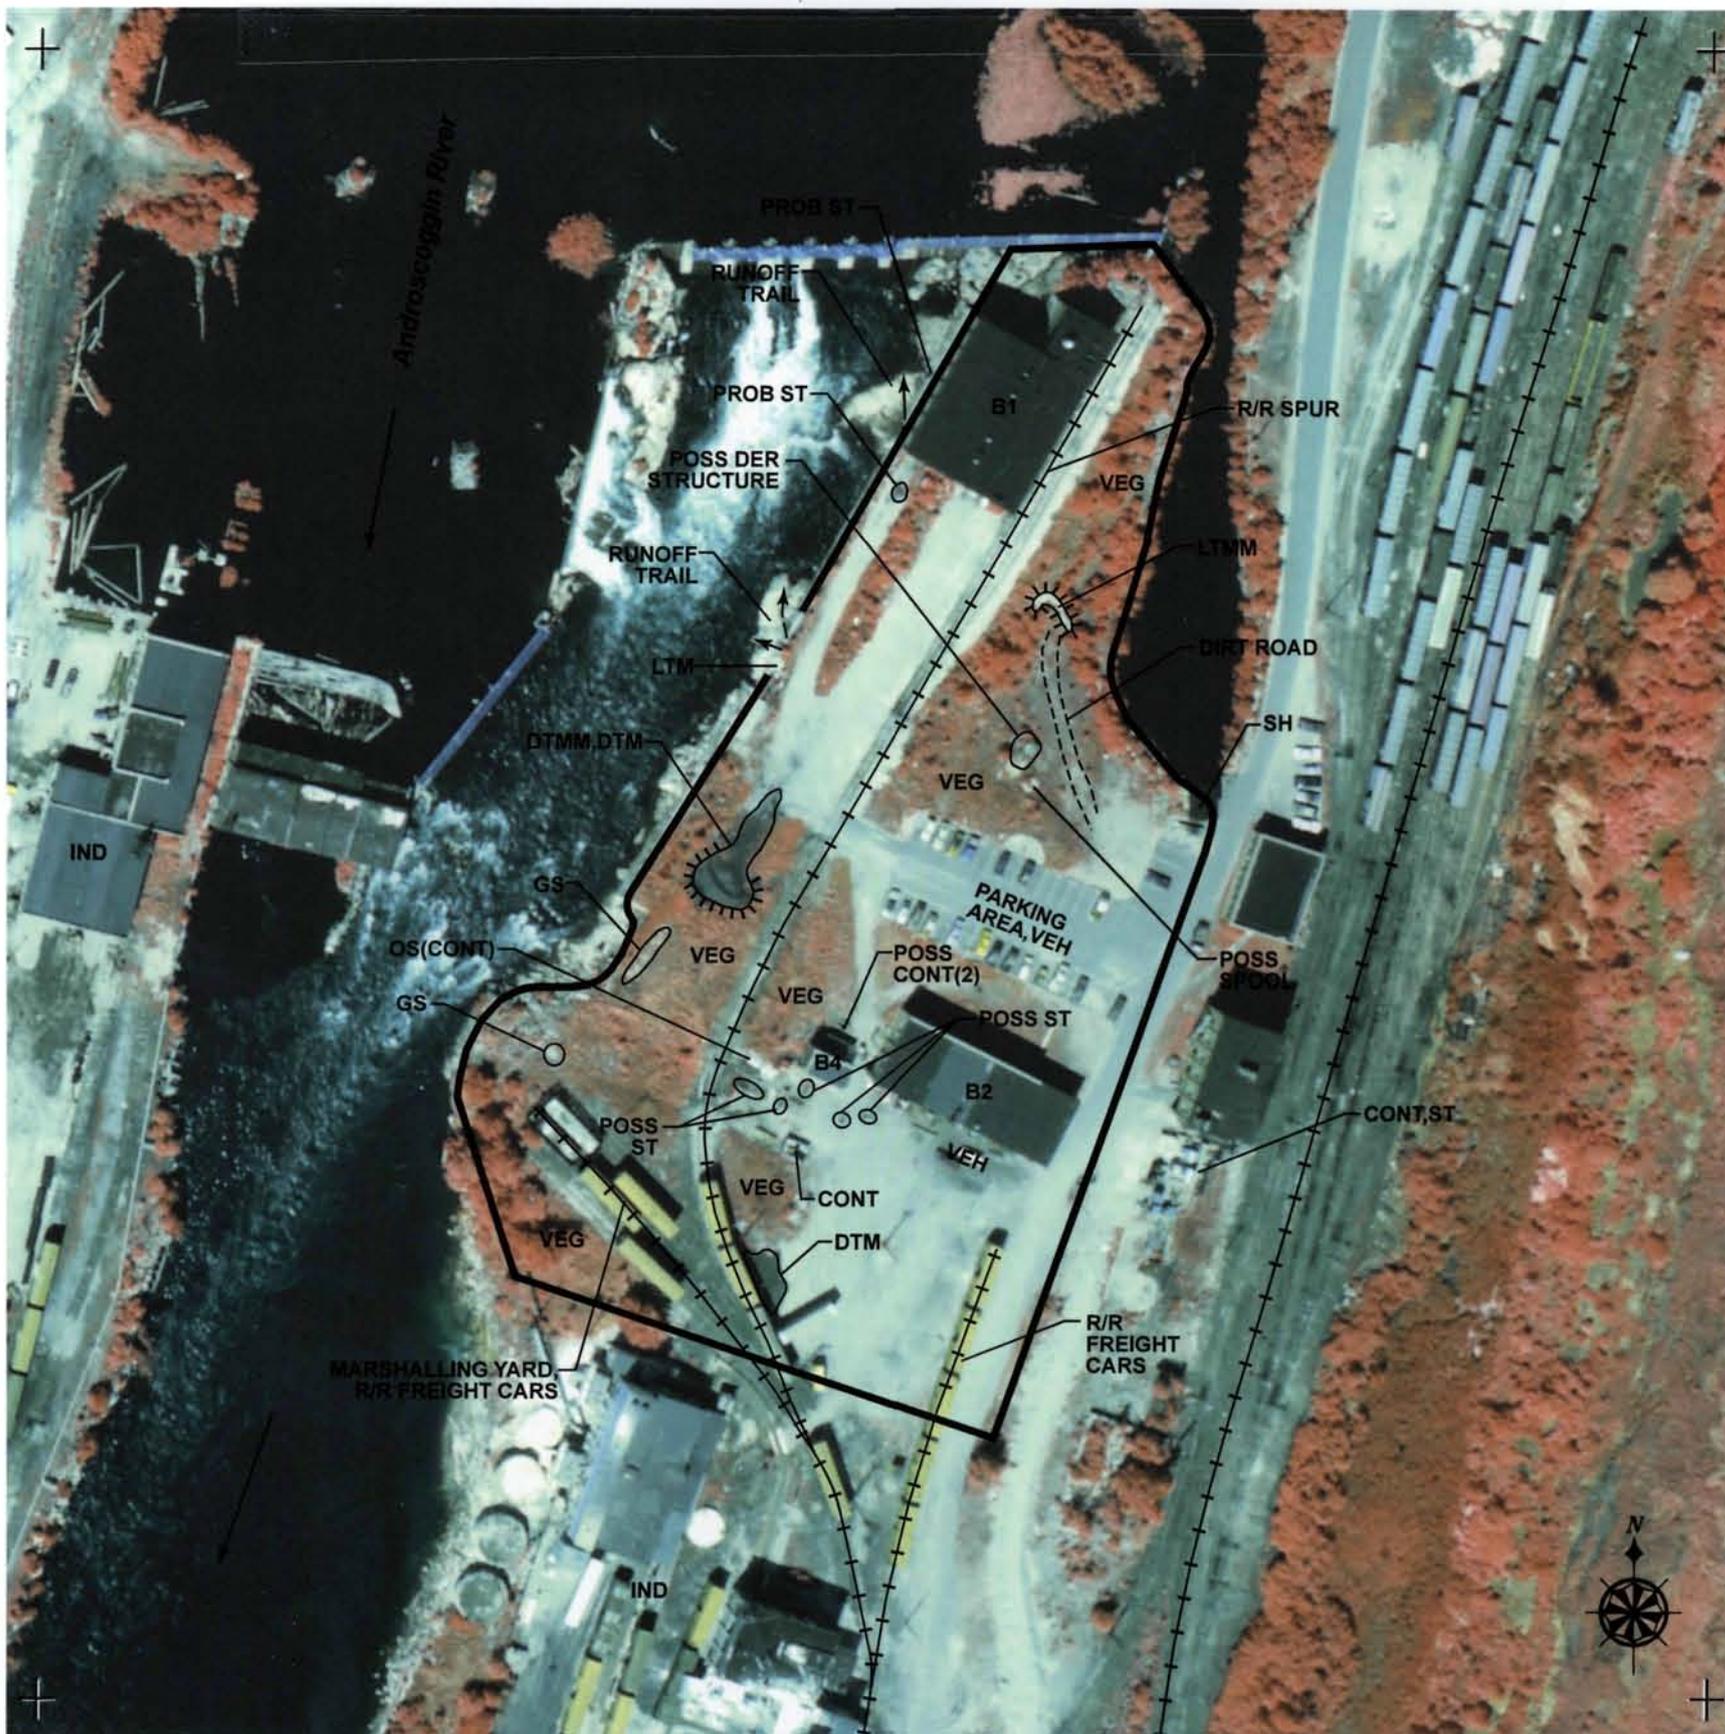
Figure 9. Chlor-Alkali Facility, August 19, 1976. Approximate scale 1:1,485.

There are no changes noted to buildings B1, B2, B4 or the shed, but the walking bridge has been removed. Near building B1 there is a probable ground stain on an entrance road (not annotated) into the building. On the retaining wall of the building just above the Androscoggin River, there are two probable stained areas (annotated as one feature due to scale) that appear to emanate from the retaining wall. On two rock outcrops (not annotated) in the river there are darkened runoff trails. One of these runoff trails appears to originate alongside the building. West of the railroad spur there are uniform light-toned material, a combination of uniform dark-toned material and dark-toned mounded material (DTMM), and ground scars. Numerous freight cars are visible in the railroad marshalling yard.

East of the railroad spur there is a narrow dirt road that extends to a mound of light-toned material which was also noted in 1969. Most of the material seen in this area in 1969 has either been removed or cannot be discerned due to vegetation cover. Adjacent to the dirt road are a possible derelict (DER) structure, possibly part of a loading platform, and a large diameter spool likely used for cable. Numerous vehicles (VEH) are located near building B2, indicating activity at the site.

Near buildings B2 and B4 are patches of possible stained ground and an open storage area where light-toned containers are visible. A large, square-shaped container and two possible containers are also observed near these buildings. Near the railroad spur is a patch of dark-toned material.

At an offsite location there are numerous containers and stained ground.

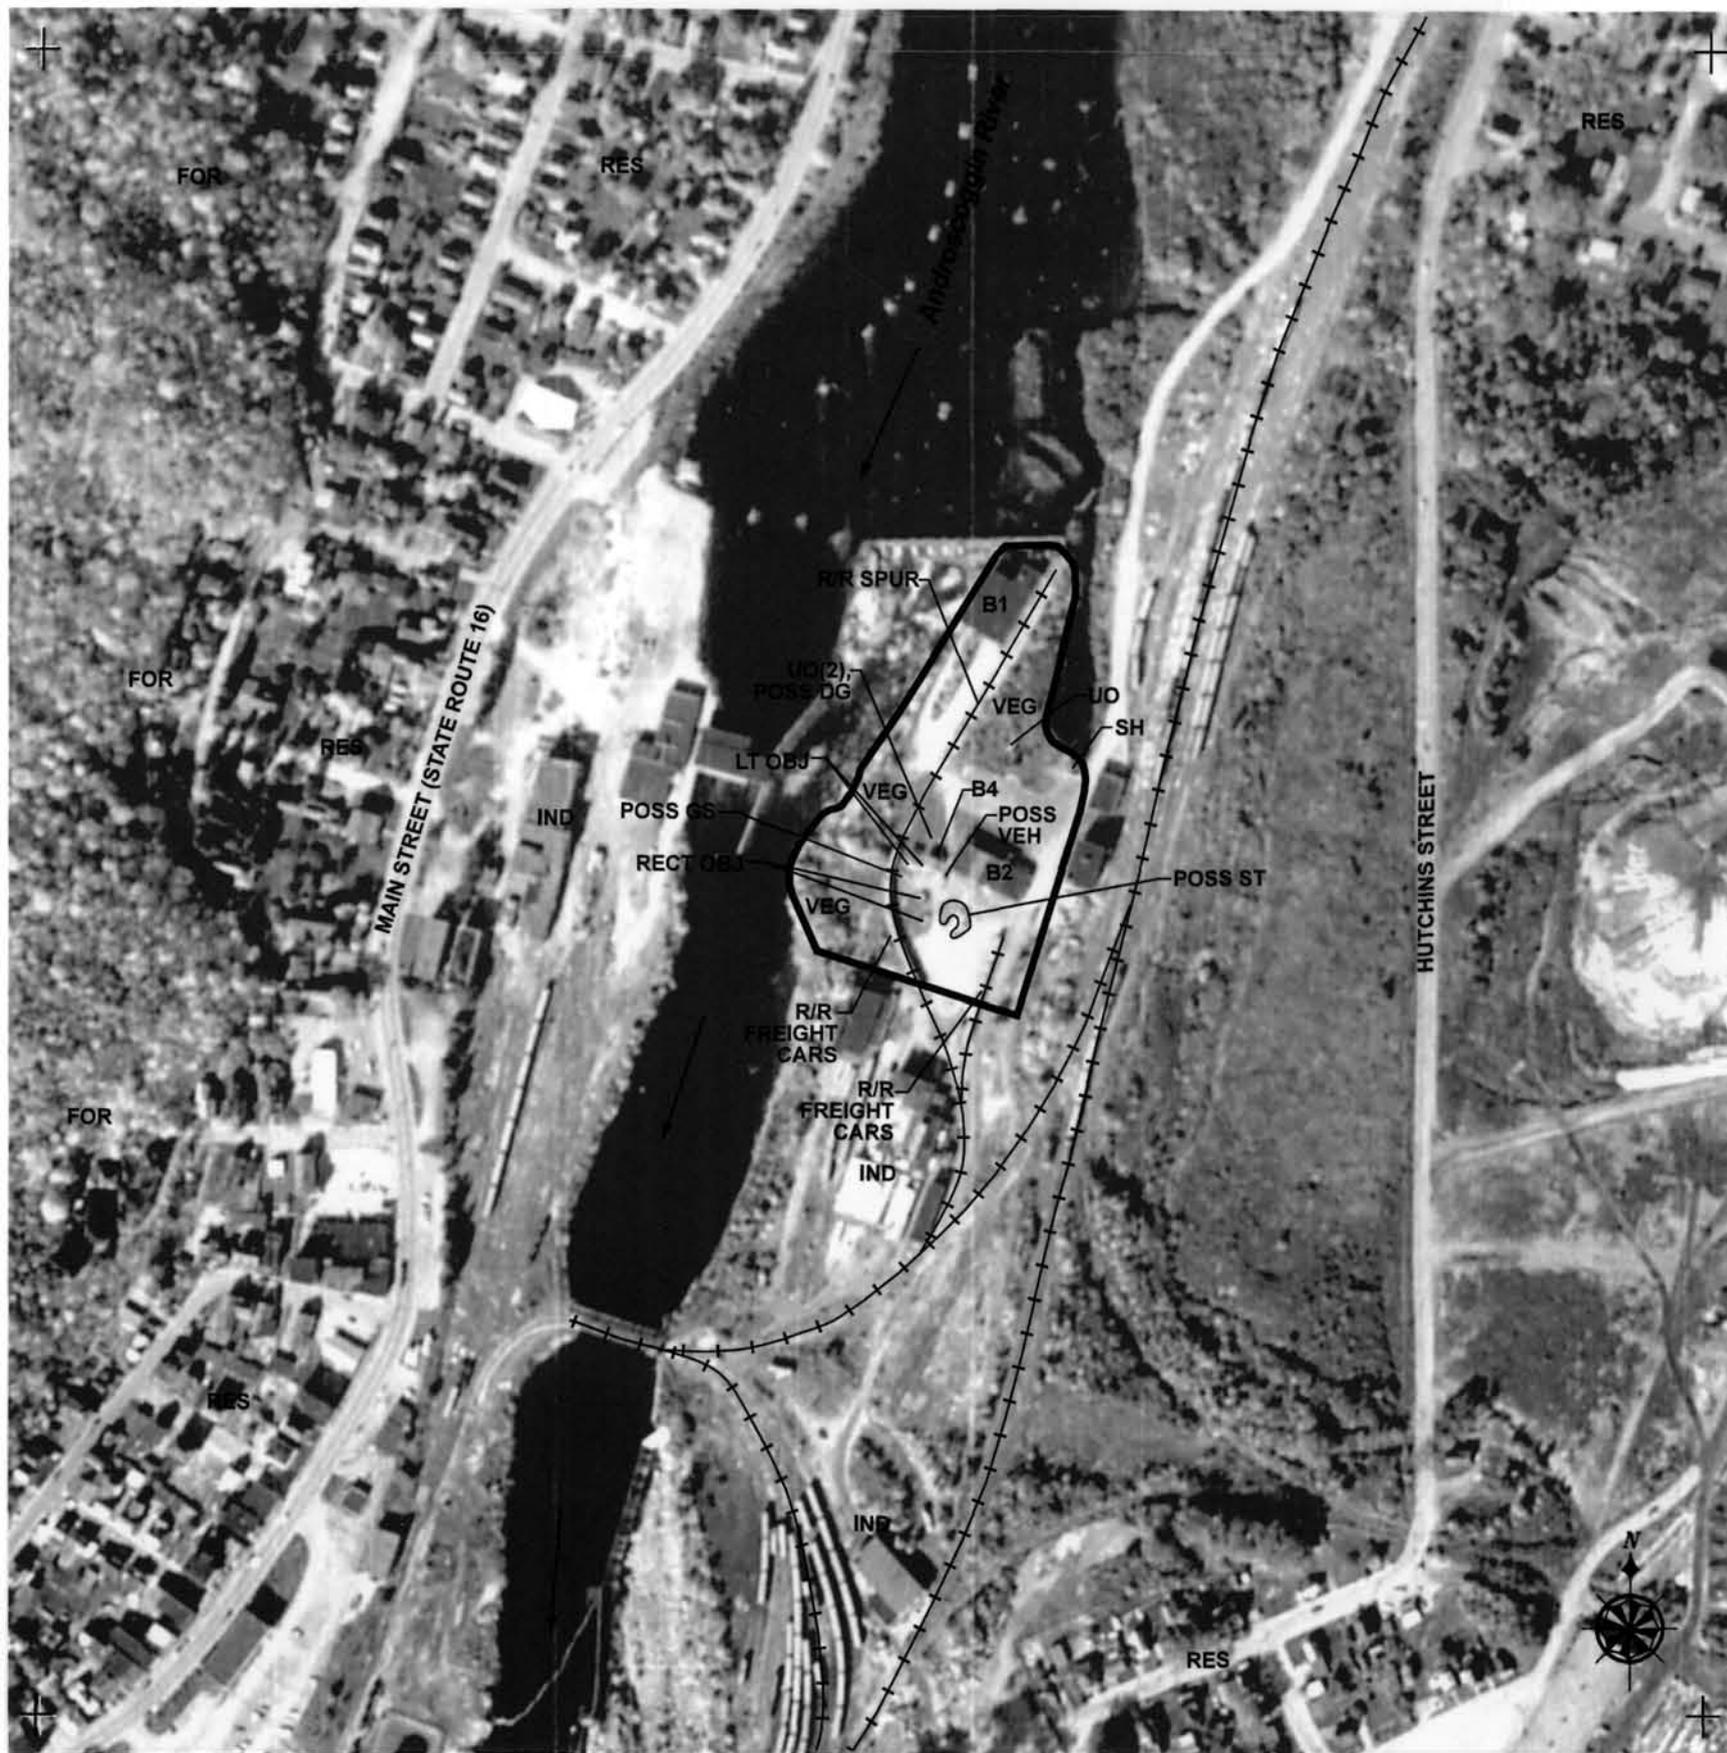
Figure 10. Chlor-Alkali Facility, October 11, 1982. Approximate scale 1:3,600.

There are no changes noted to buildings B1, B2, B4 or the shed. Railroad freight cars have been removed from the marshalling yard and this yard (railroad ties) has been dismantled. Vegetation areas throughout the site appear unkempt and one possible vehicle is present but the facility is no longer active.

No significant environmental activity is noted west of the railroad spur. East of the railroad spur are several unidentified objects, light-toned objects, and rectangular-shaped objects. These objects range in size from a large truck to approximately one-half an automobile. Possible ground scars, possible disturbed ground, and possible stained ground are also noted.
