AERIAL PHOTOGRAPHIC AND FRACTURE TRACE ANALYSES OF CHLOR-ALKALI FACILITY Berlin, New Hampshire

TS-PIC-20801101S
February 2008

AERIAL PHOTOGRAPHIC AND FRACTURE TRACE ANALYSES OF
CHLOR-ALKALI FACILITY

Berlin, New Hampshire

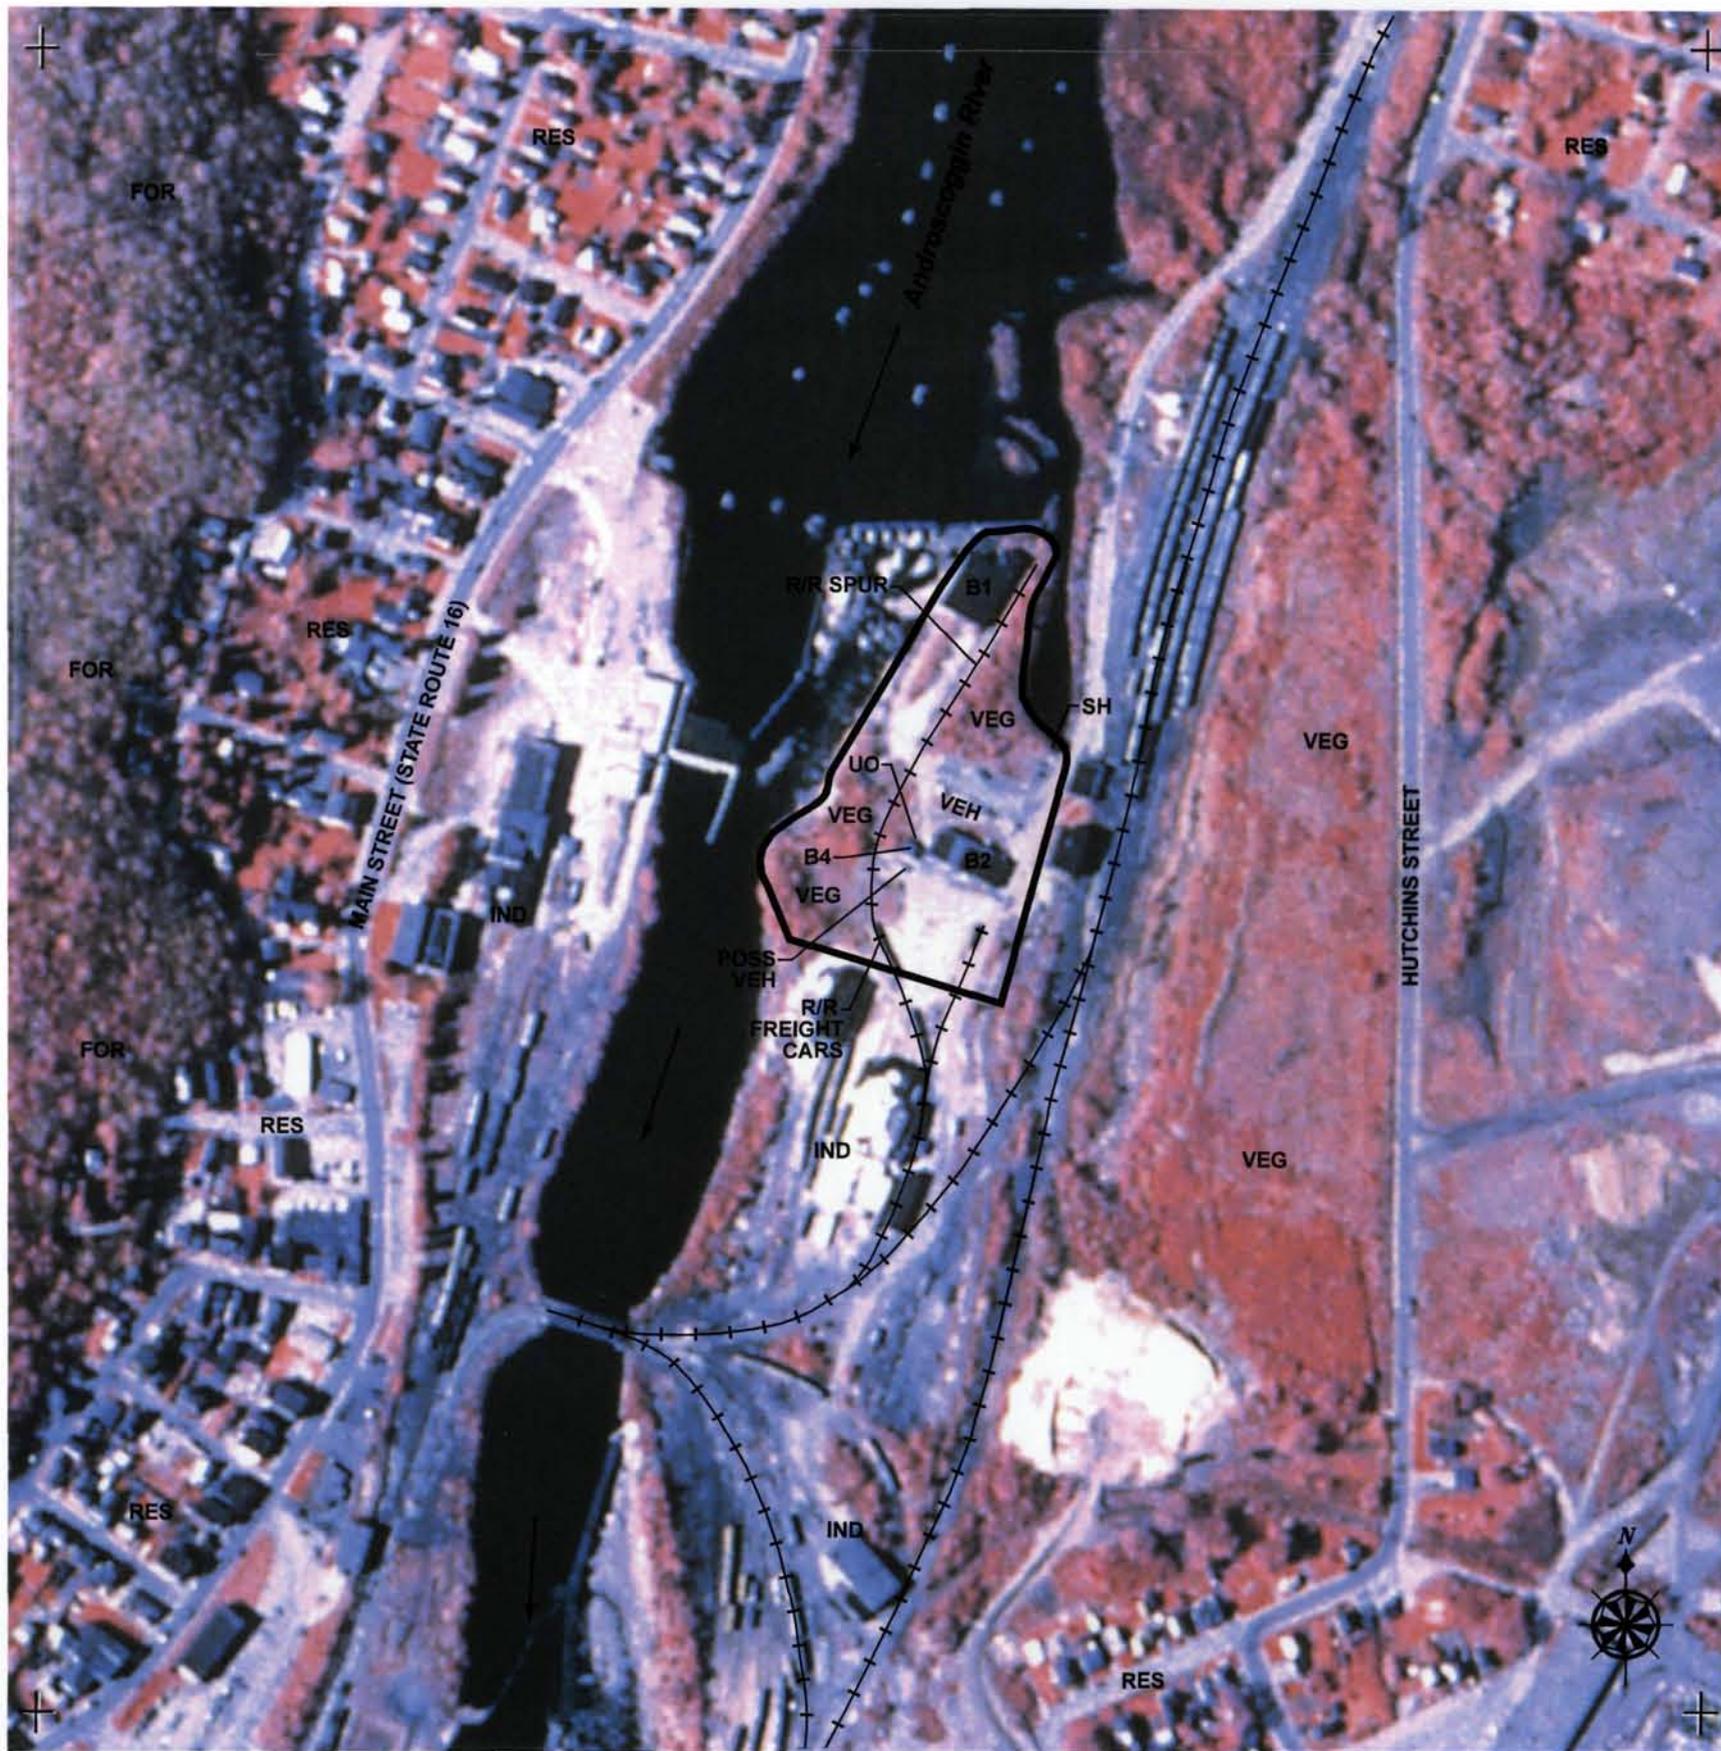
Figure 11. Chlor-Alkali Facility, May 13, 1986. Approximate scale 1:3,560.

There are no changes noted to buildings B1, B2, B4 or the shed. Vegetation areas throughout the site appear unkempt. Several vehicles, a possible vehicle, and railroad freight cars are visible on the railroad spur but the facility is no longer active.

No significant environmental activity is noted west of the railroad spur. East of the railroad spur is an unidentified object approximately one-half the size of an automobile.

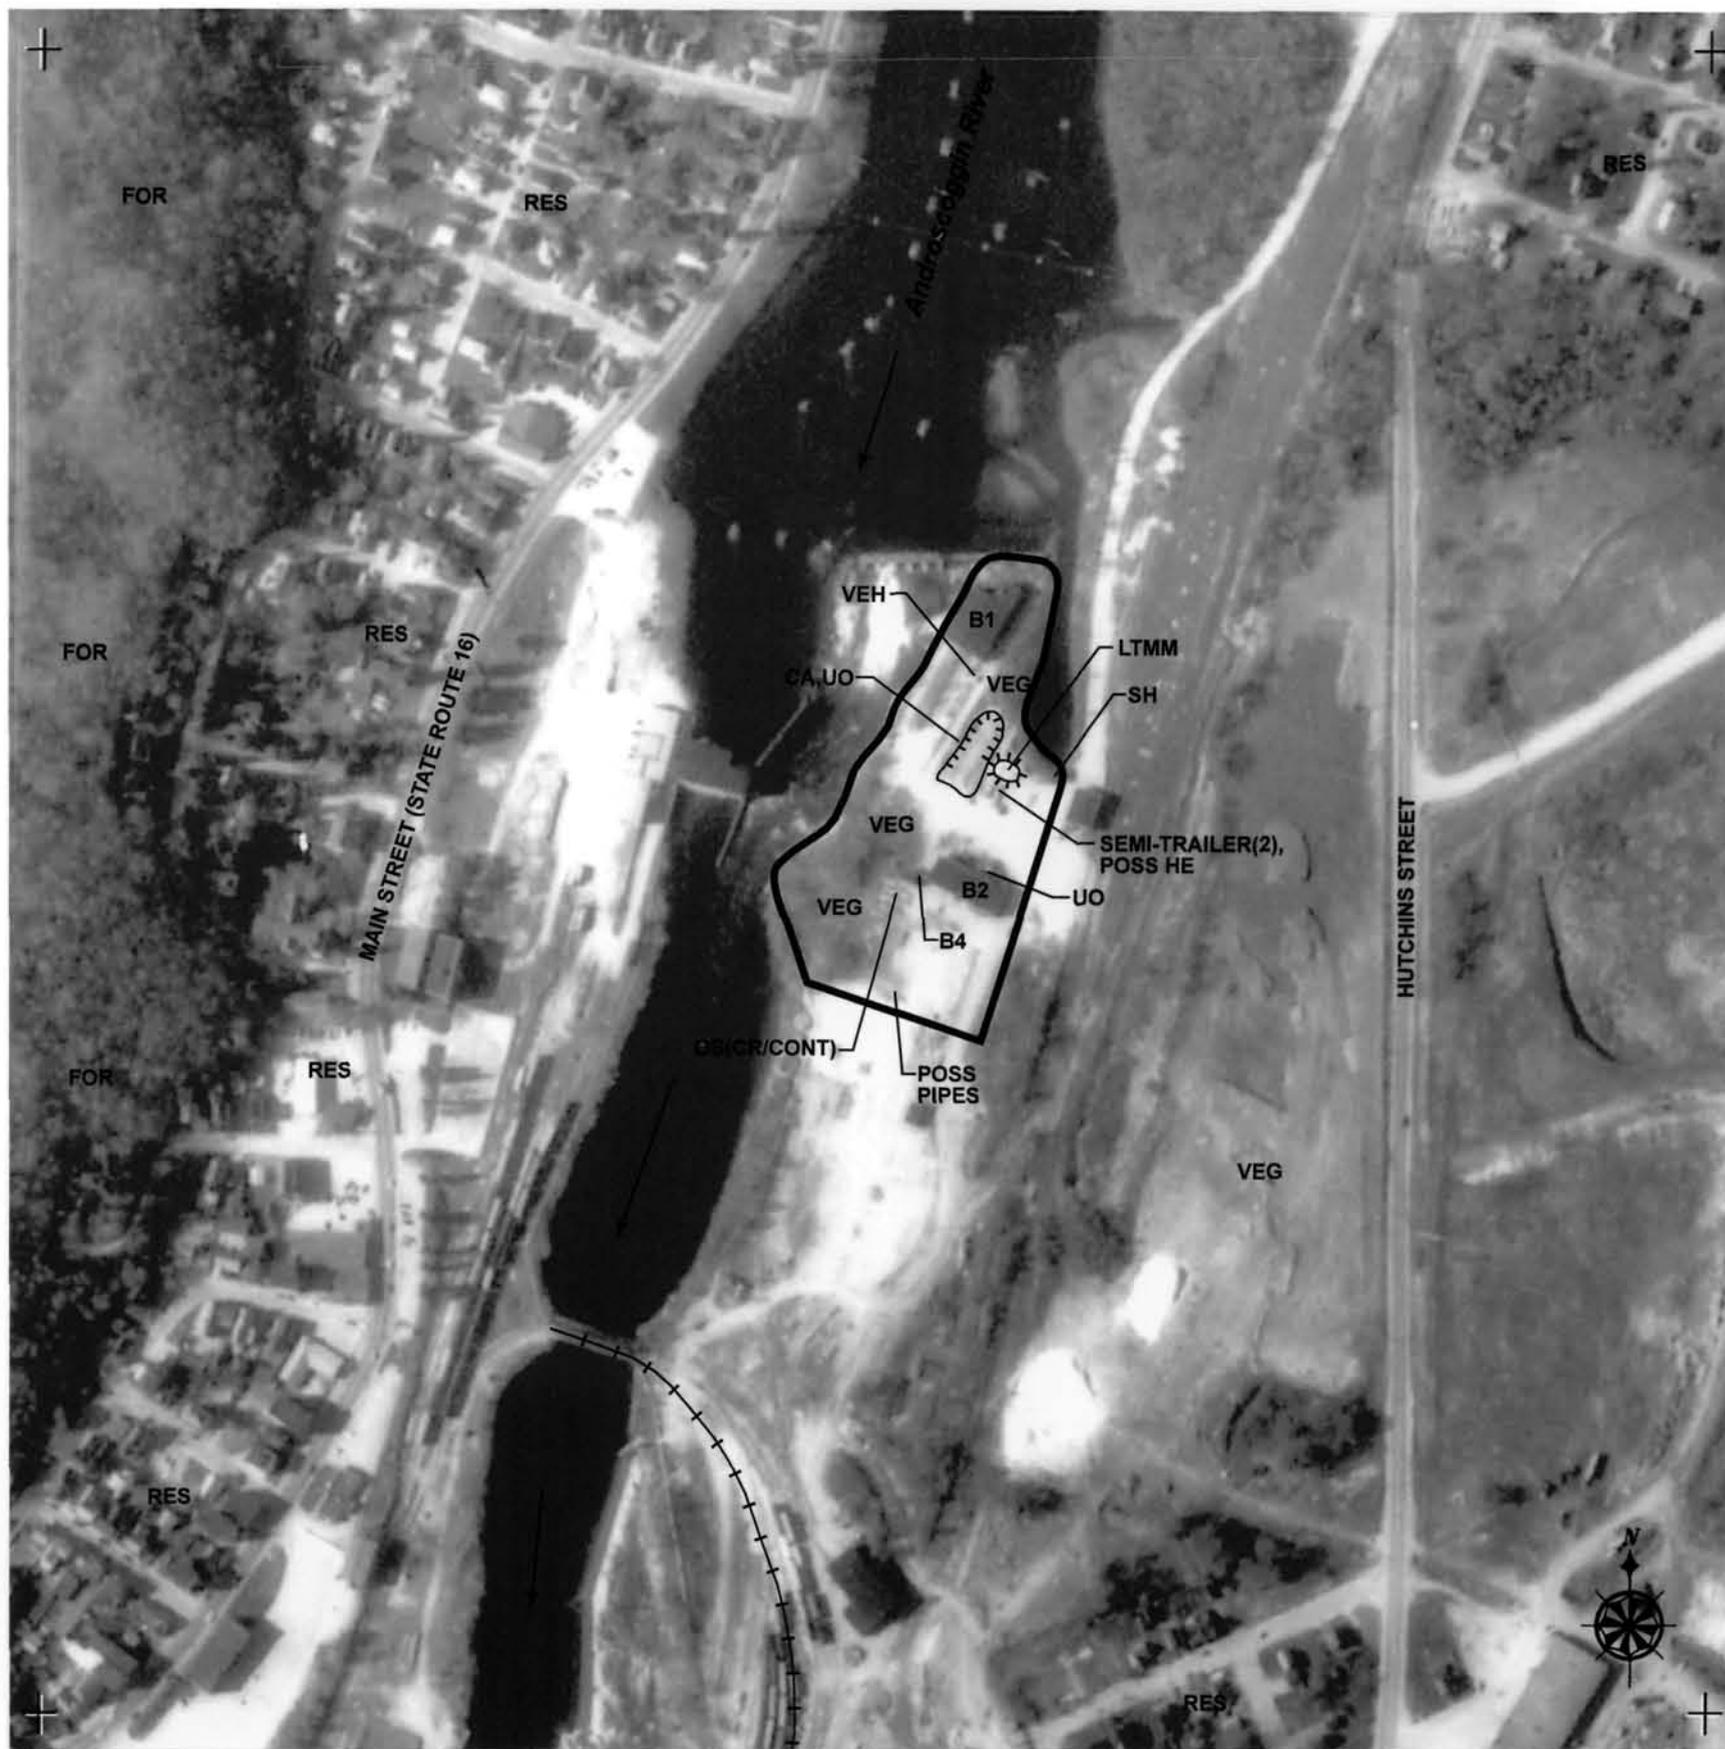
Figure 12. Chlor-Alkali Facility, May 14, 1994. Approximate scale 1:3,600.

There are no changes noted to buildings B1, B2, B4 or the shed; however, all railroad lines have been removed from the site. Vegetation areas throughout the site appear unkempt. Two semi-trailers, possible heavy equipment (HE), and a vehicle are noted at the site. Near the trailers are light-toned mounded material and a large cleared area (CA) which forms a depression. Several small, unidentified objects are noted within this cleared depression. Near buildings B2 and B4 are a larger unidentified object and an open storage area where crates or containers are neatly arranged in three evenly spaced rows.

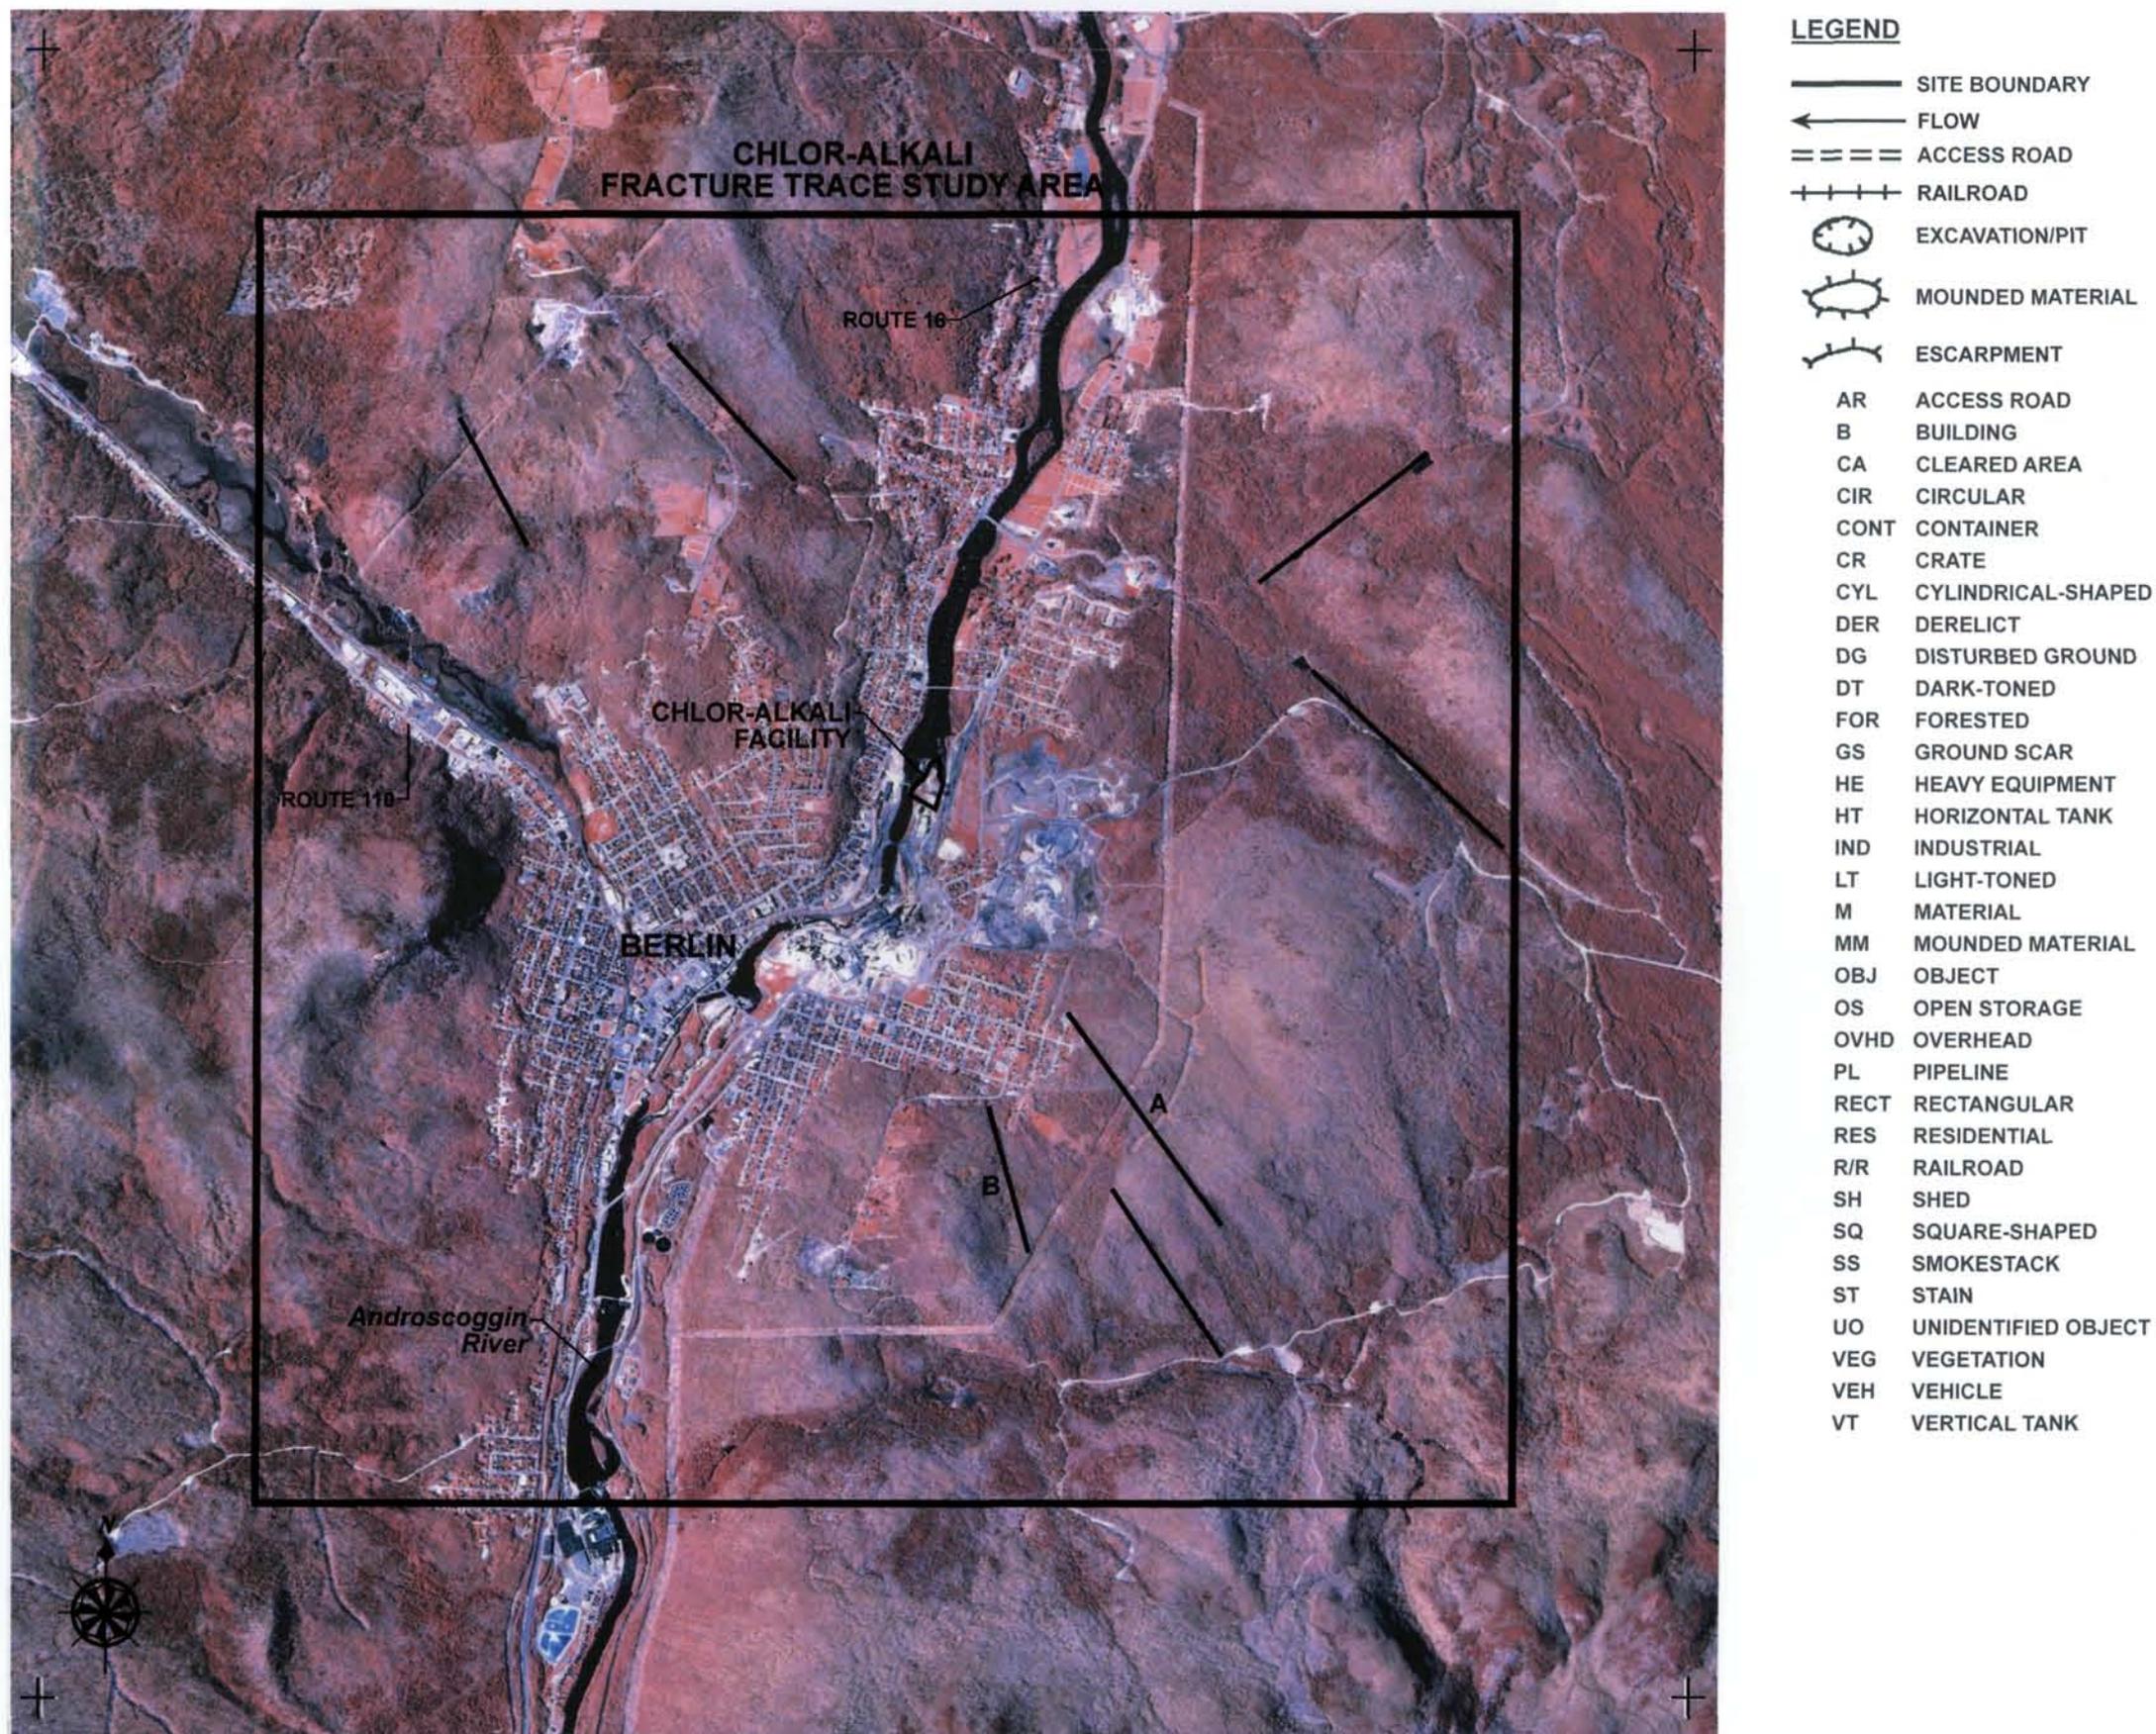
Figure 13. Chlor-Alkali Facility, fracture trace analysis, May 13, 1986.
Approximate scale 1:35,110.

The fracture trace analysis was conducted using 1964 large-scale photographs (1:18,000 scale), 1982 medium-scale photographs (1:40,000 scale), and geologic literature describing the area. A total of seven (7) fracture traces were identified and are presented on an overlay to a print produced from a 1986 photograph (see Figure 13). Two lineaments are presented in a study by Degnan, J.R., et al., (2005). One lineament is located north of the Chlor-Alkali Facility along the east bank of the Androscoggin River and the other in the upland area southeast of the facility. These two lineaments were identified using high altitude aerial photography with an approximate scale of 1:80,000 (Degnan, J.R. et al., 2005). An unsuccessful effort was made to corroborate the location of these two lineaments on the medium- to large-scale photographs used in this report. The lack of success may be attributable to the differences in the scale of photography used in the separate studies.

All of the seven fracture traces identified in this fracture trace analysis are situated in the upland portion of the study area and are underlain by Ammonoosuc Volcanics. Urban development along the Androscoggin River valley has obscured or destroyed any evidence of fracture traces in the area underlain by the Oliverian Plutonics. None of the seven fracture traces were identified extending across the interface between the two bedrock units (Oliverian Plutonics and Ammonoosuc Volcanics) underlying the study area. Therefore no fracture trace induced hydrologic connectivity between the bedrock units can be inferred from this analysis. However, if fracture traces "A" and "B" (see Figure 13) are extended to the northwest into the Oliverian Plutonics of the urban developed lowland area, the two extended traces intersect at the Androscoggin River near the southwest corner of the Chlor-Alkali Facility. This intersection point may possibly identify a zone of fractured bedrock that preferentially directs ground-water flow toward the facility.

Caution, however, should be exercised if the fracture traces identified in this analysis and annotated on Figure 13 are to be used for determining the placement of groundwater monitoring wells. Differences of a few meters can determine whether or not a well is located on a given fracture trace. Thus, it is recommended that the geologic field personnel tasked with determining the placement of the wells utilize stereo diapositives and photographic interpretive equipment as part of their field operations.
