**FIVE-YEAR REVIEW REPORT FOR
KEARSARGE METALLURGICAL CORPORATION SUPERFUND SITE
CARROLL COUNTY, NEW HAMPSHIRE**

**U.S. Environmental Protection Agency
Region I
Boston, Massachusetts**

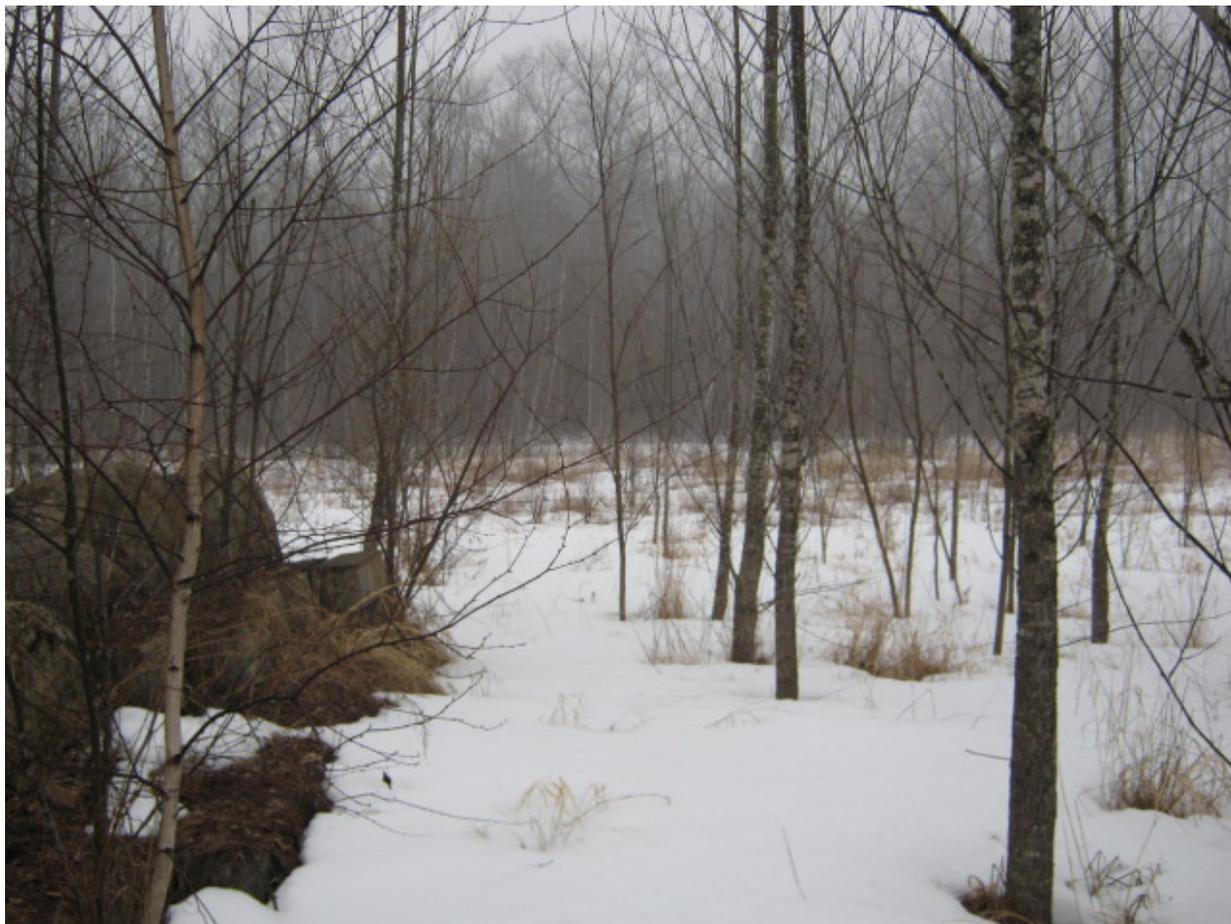
SCENE: View is looking eastward from the southeast corner of the Groundwater Pump-and-Treat system building. The area shown is a wetland and just inside the far wood-line is the most contaminated wells, MW-3010 and MW-3008.

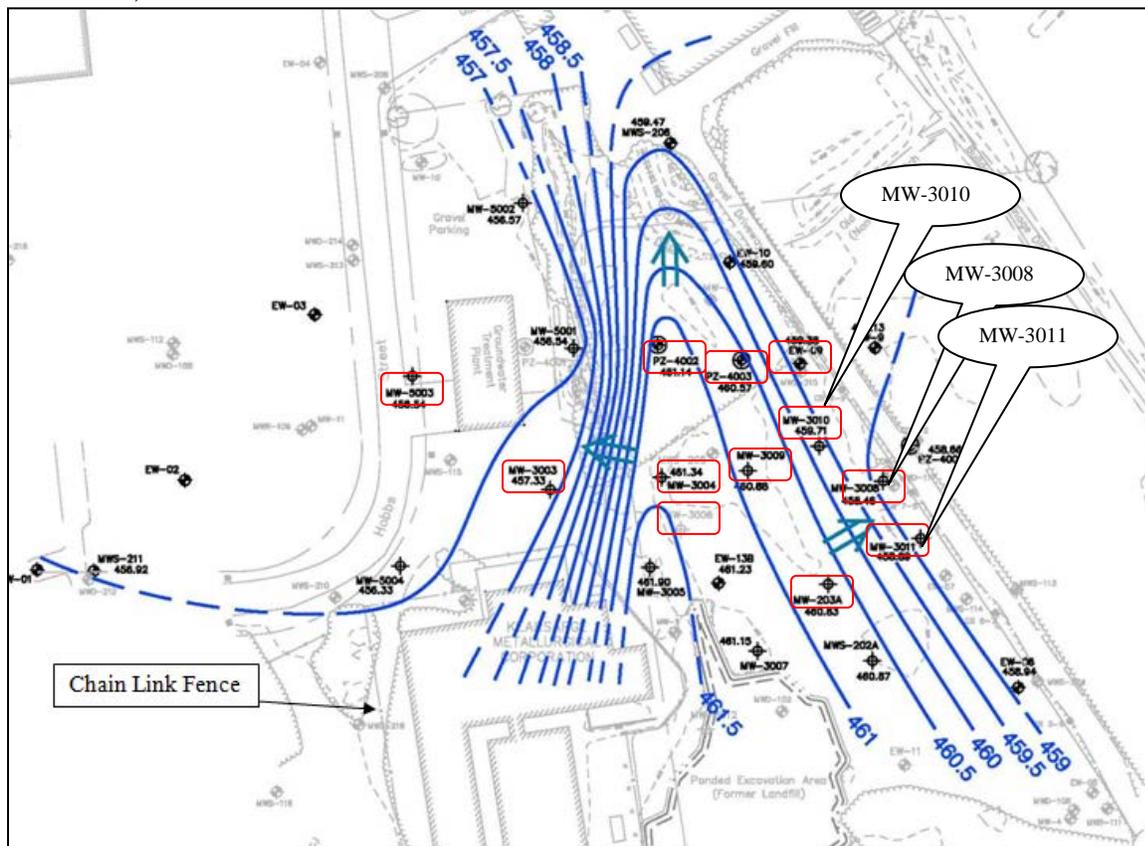
Figure D1. The Site, groundwater monitoring network, and typical late-November groundwater contours. Monitoring wells are outlined in red. The three problematic wells, MW-3010, -3008, and -3011, are labeled for easier identification.

- 1. Water from the Drainage Culvert influences the closer wells.** One confounding issue at the Site is that the groundwater along the eastern edge of the Site is highly influenced by the water level in Pequawket Pond. The level in the pond is controlled by boards and the pond level is lowered significantly prior to winter to minimize damage to docks. The storm drain that runs north-south through the Site, immediately adjacent to wells MW-3010, -3008, and -3011, transmits the effect of the pond water lowering instantly along the length of the drain. This generates the groundwater contours seen on Figure D1.

Criterion #1 and #2 of the 2012 Amended ROD contingency trigger were violated in wells MW-3010 and MW-3011. However, contaminant concentrations in these two wells remain low, do not appear to be migrating, and are likely to be heavily influenced by the surface water management in Pequawket Pond. All other monitoring wells are declining in concentration or are below ICLs.

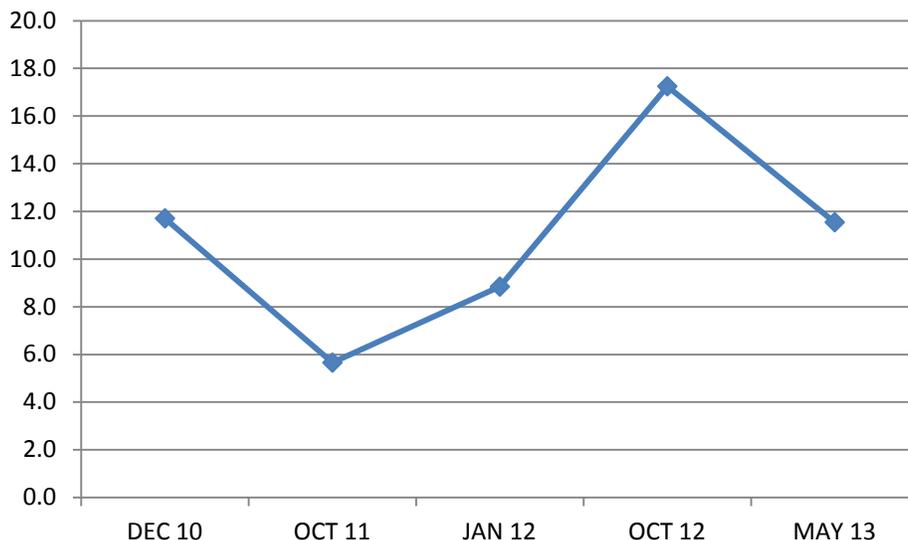
Figure D2. Weighted Total ICL for all contaminants in groundwater at the KMC Site.

Figure D2 shows that the overall concentrations have fluctuated around a central value of about 12 times the ICL and that there is no clear upward trend.

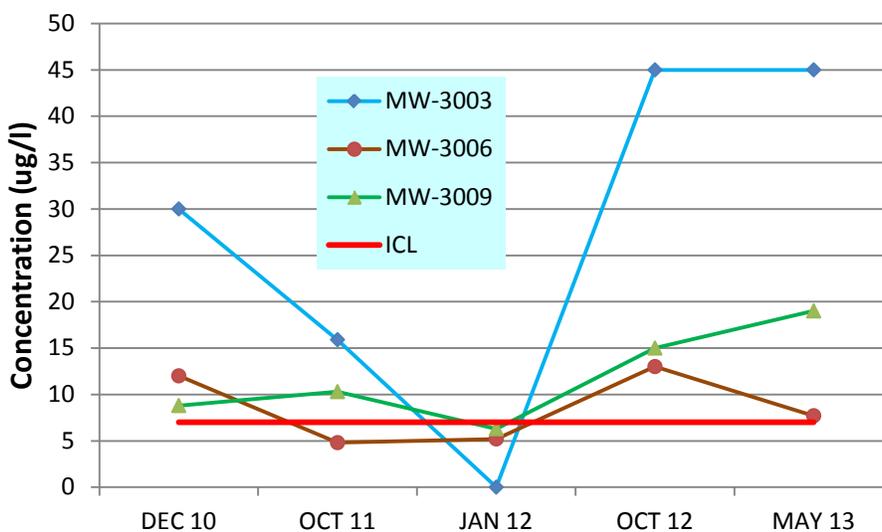
Figure D3. 1,1-DCE in Monitoring wells MW-3003, MW-3006 and MW-3009.

- The remaining wells are either clean or stable in concentration:** Wells EW-3 and MW-3004 have been below detection limits for virtually all sampling rounds. The remaining wells: MW-3003, MW-3006 and MW-3009 are only contaminated by 1,1-DCE which is relatively low in concentration and not generally increasing as shown below in Figure D3.
