AERIAL PHOTOGRAPHIC ANALYSIS OF LEEDS METAL SITE

Leeds, Maine

EPA Region 1

TS-OEI-21101007S
June 2012

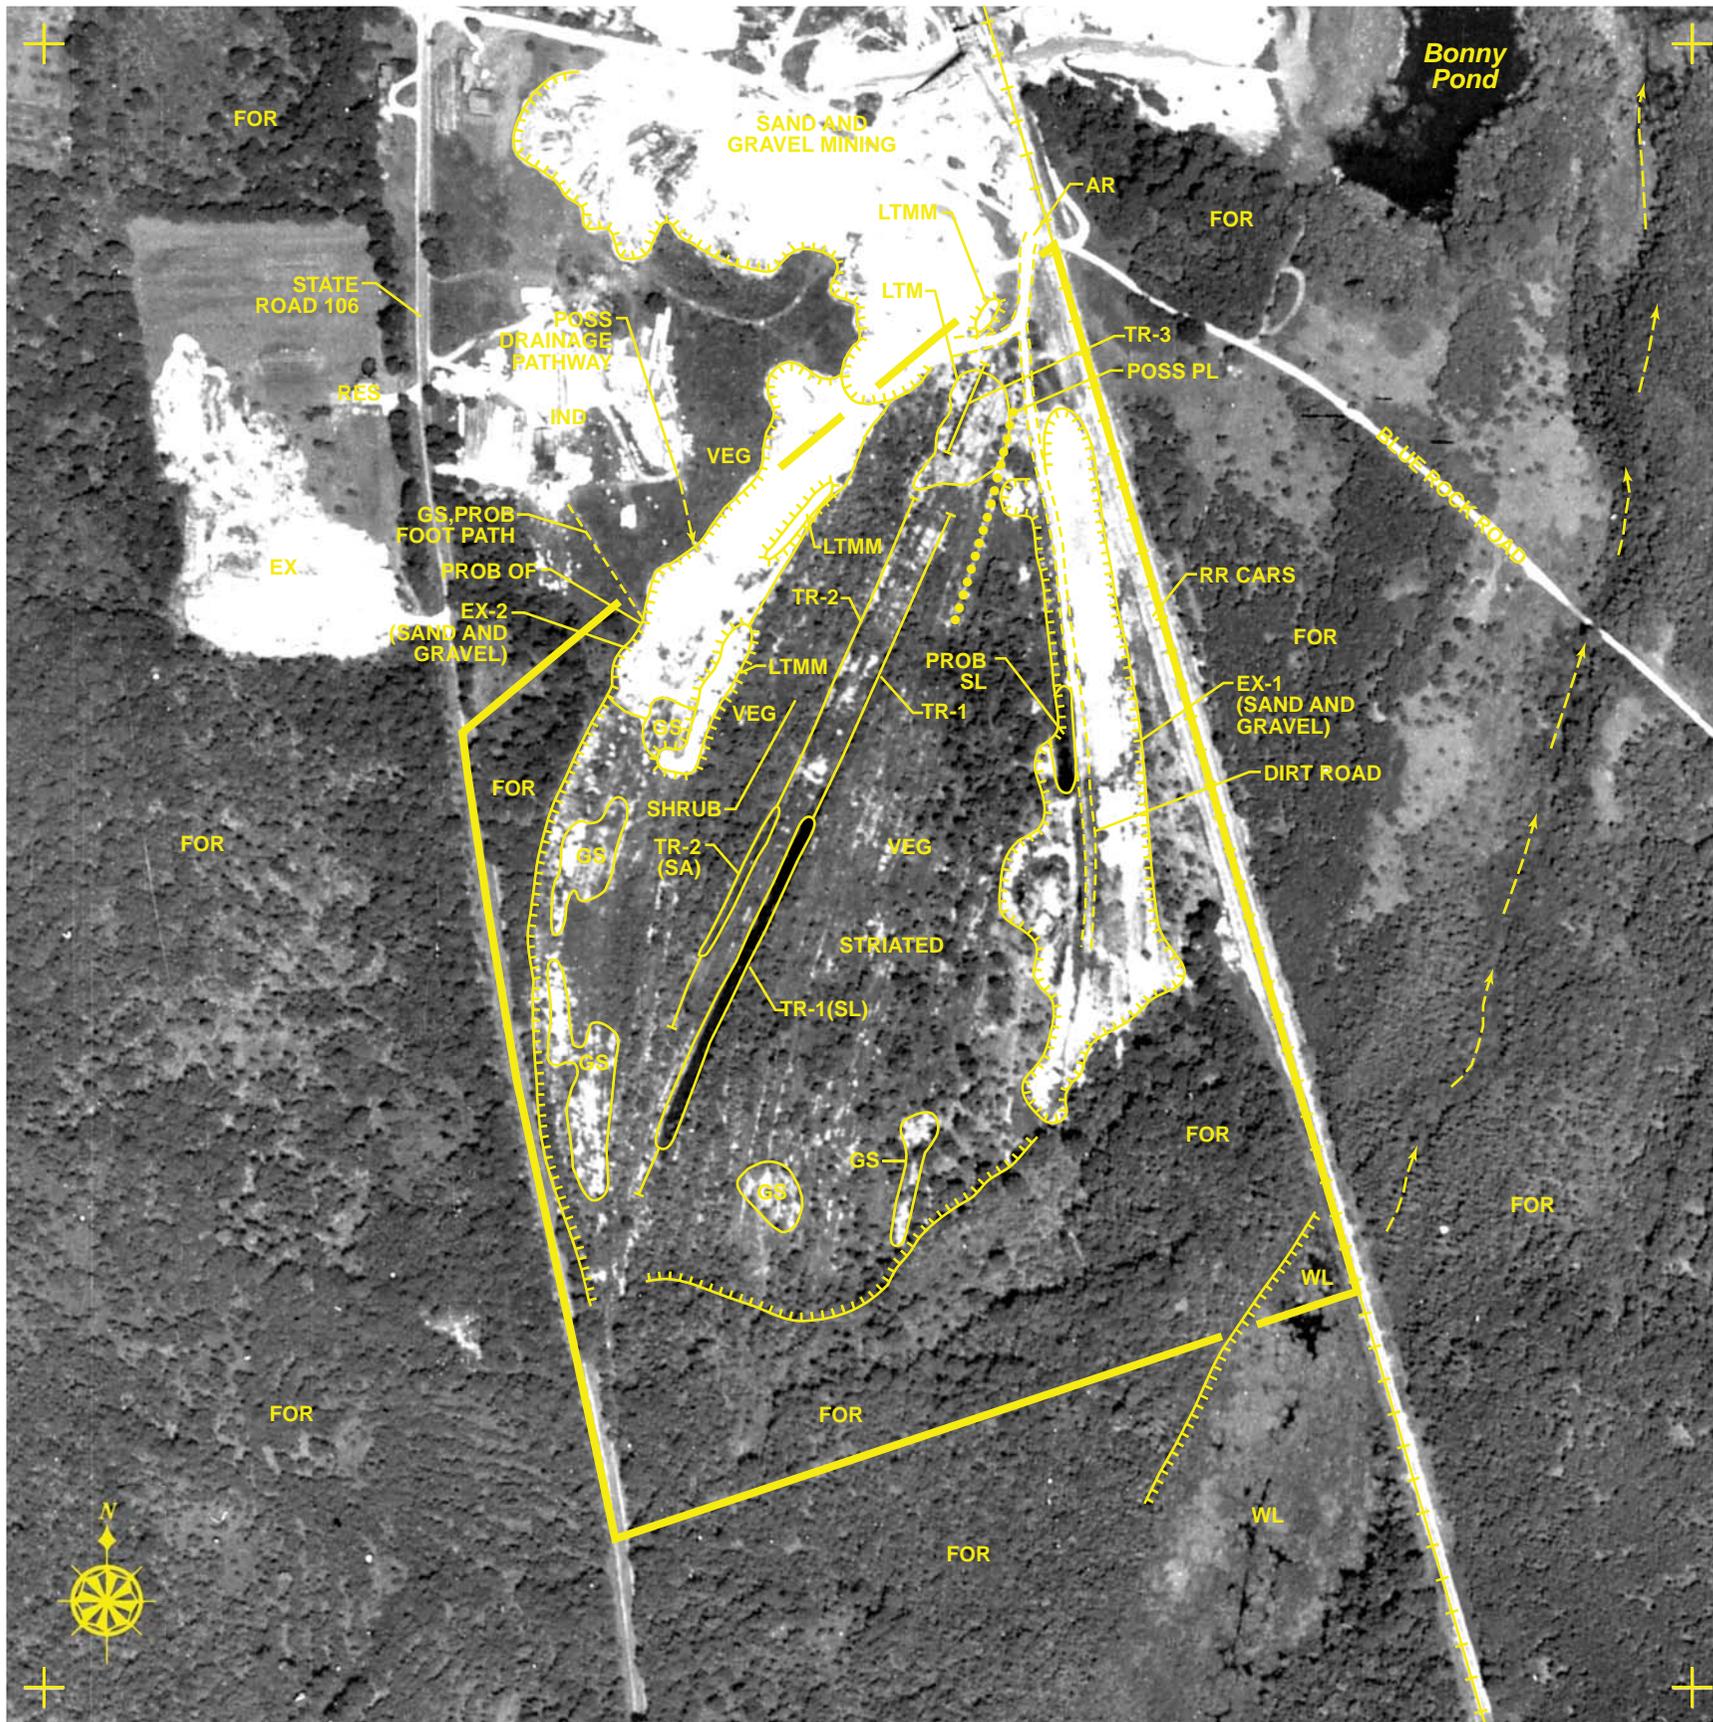
Figure 4. Leeds Metal site, July 24, 1943. Approximate scale 1:3,810.

Two mining excavations (EX-1 and EX-2) are present on the site. Excavation EX-1 is linked, via the access road, to an established sand and gravel mining operation to the north of the Leeds Metal site. Excavation EX-1 is located alongside the railroad, where several open-bed railroad cars (RR CARS) are parked. The railroad cars are filled with light-toned material. The depth of excavation EX-1 is at least 4.6 meters (15 feet). Shallower depths are located in the northern part of the excavation and the deepest sections are located in the central and southern part of excavation EX-1, where surface runoff collects. The northern part of excavation EX-1 is actively being mined. Mining activity has slowed or ceased in the southern part of excavation EX-1. At this location, areas of vegetation (not annotated) are present atop the sand and gravel, and vegetation is present on parts of the dirt road. Probable standing liquid (SL) is present in the western part of the excavation.

Excavation EX-2, located along the northern site boundary, is likely being mined. Excavation EX-2 appears to be a component of the established mining operation located north of the Leeds Metal site. The depth of excavation EX-2 is at least 4.6 meters (15 feet) below grade of the area immediately to the north. Light-toned mounded material (LTMM; likely sand or gravel) has been deposited at two locations.

On the ground surface immediately northwest of excavation EX-2 is a near-linear ground scar (possible subsurface pipeline) or probable foot path, which extends from near the offsite industrial facility (IND) to the ledge of the excavation. At the ledge of excavation EX-2, the ground scar/probable foot path, terminates at a probable outfall (OF). Beneath the location of the probable outfall, a relatively small area on the northwestern face of excavation EX-2 is darkened (not annotated). Just to the northeast is a possible drainage pathway. The possible drainage pathway extends from an offsite open storage area (not annotated) affiliated with the offsite industrial facility, to the ledge of excavation EX-2. A relatively small area on the northwestern face of excavation EX-2, beneath the possible drainage pathway, is darkened (not annotated).

Numerous areas containing ground scars and striations (grooves) are present on the ground surface of the Leeds Metal site (not all areas annotated). The striated ground surface extends east-west, from excavation EX-1 to excavation EX-2, and south, to near the southern site boundary. The ground scars and striations have likely resulted from the use of mining equipment. The striated area had been clear-cut as well. Mining operations have ceased in the central part of the site, allowing for the growth of grass, shrubs, and small trees (VEG). The striations are not nearly as deep as the trenches.

A wetland (WL) is located in the extreme southeastern portion of the site. The wetland drains beneath the railroad and into an offsite drainage channel which empties into Bonny Pond. No activity of environmental significance is observed on the wetland.

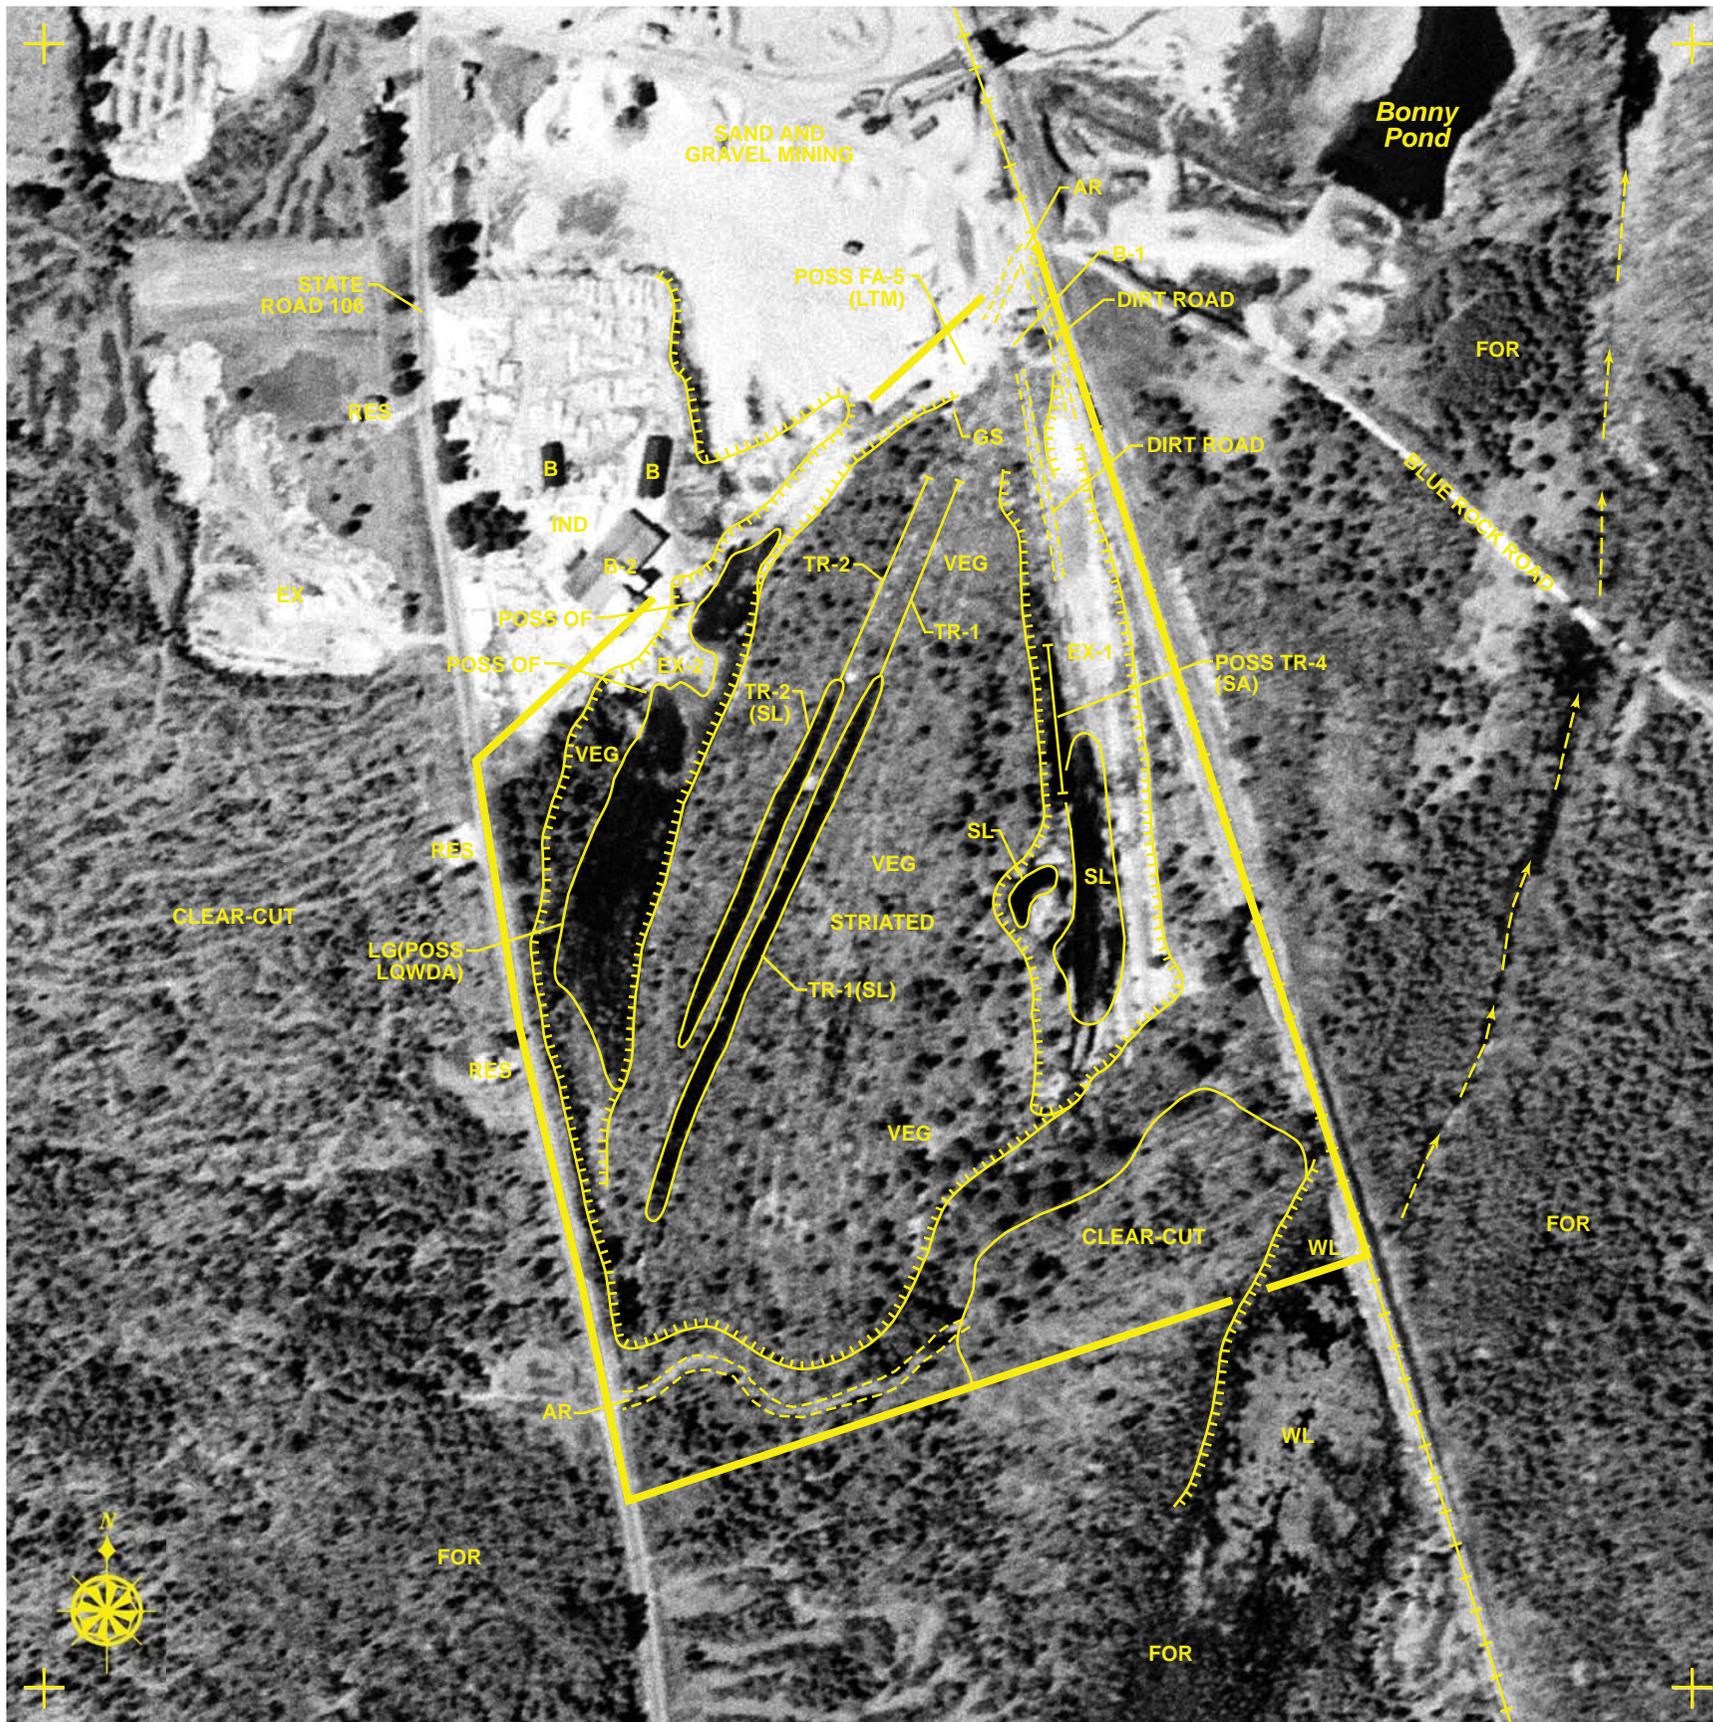
Figure 5. Leeds Metal site, April 24, 1953. Approximate scale 1:3,800.

A lagoon (LG) containing possible liquid waste (LQWDA) is now present in excavation EX-2. Two possible outfalls, located near the base of the excavation, are likely discharging probable liquid waste into the lagoon. The possible liquid waste is likely associated with the offsite industrial facility, which has expanded since 1943. Building B-2 and other structures (not all structures are annotated) have been constructed at the offsite facility since 1943. The probable outfall and possible drainage pathway seen in 1943 are no longer observed due to expansion of the industrial facility. However, relatively small areas on the northwestern face of excavation EX-2 remain darkened (not annotated).

Trench TR-3 is no longer visible. A relatively small ground scar and vegetation (not annotated) are located near to where the southern portion of trench TR-3 was observed in 1943. The location of the northern portion of trench TR-3 has likely been filled (possible fill area FA-5) with light-toned material and graded since 1943.

The possible aboveground pipeline, in place in 1943 between the trenches and excavation EX-1, is no longer observed. The location of the possible pipeline may now be obscured by vegetation, or the possible pipeline has been removed.

A section of the forest in the southern portion of the site, near the wetland, has been clear-cut since 1943. An access road, extending east from State Road 106, leads to the clear-cut area.

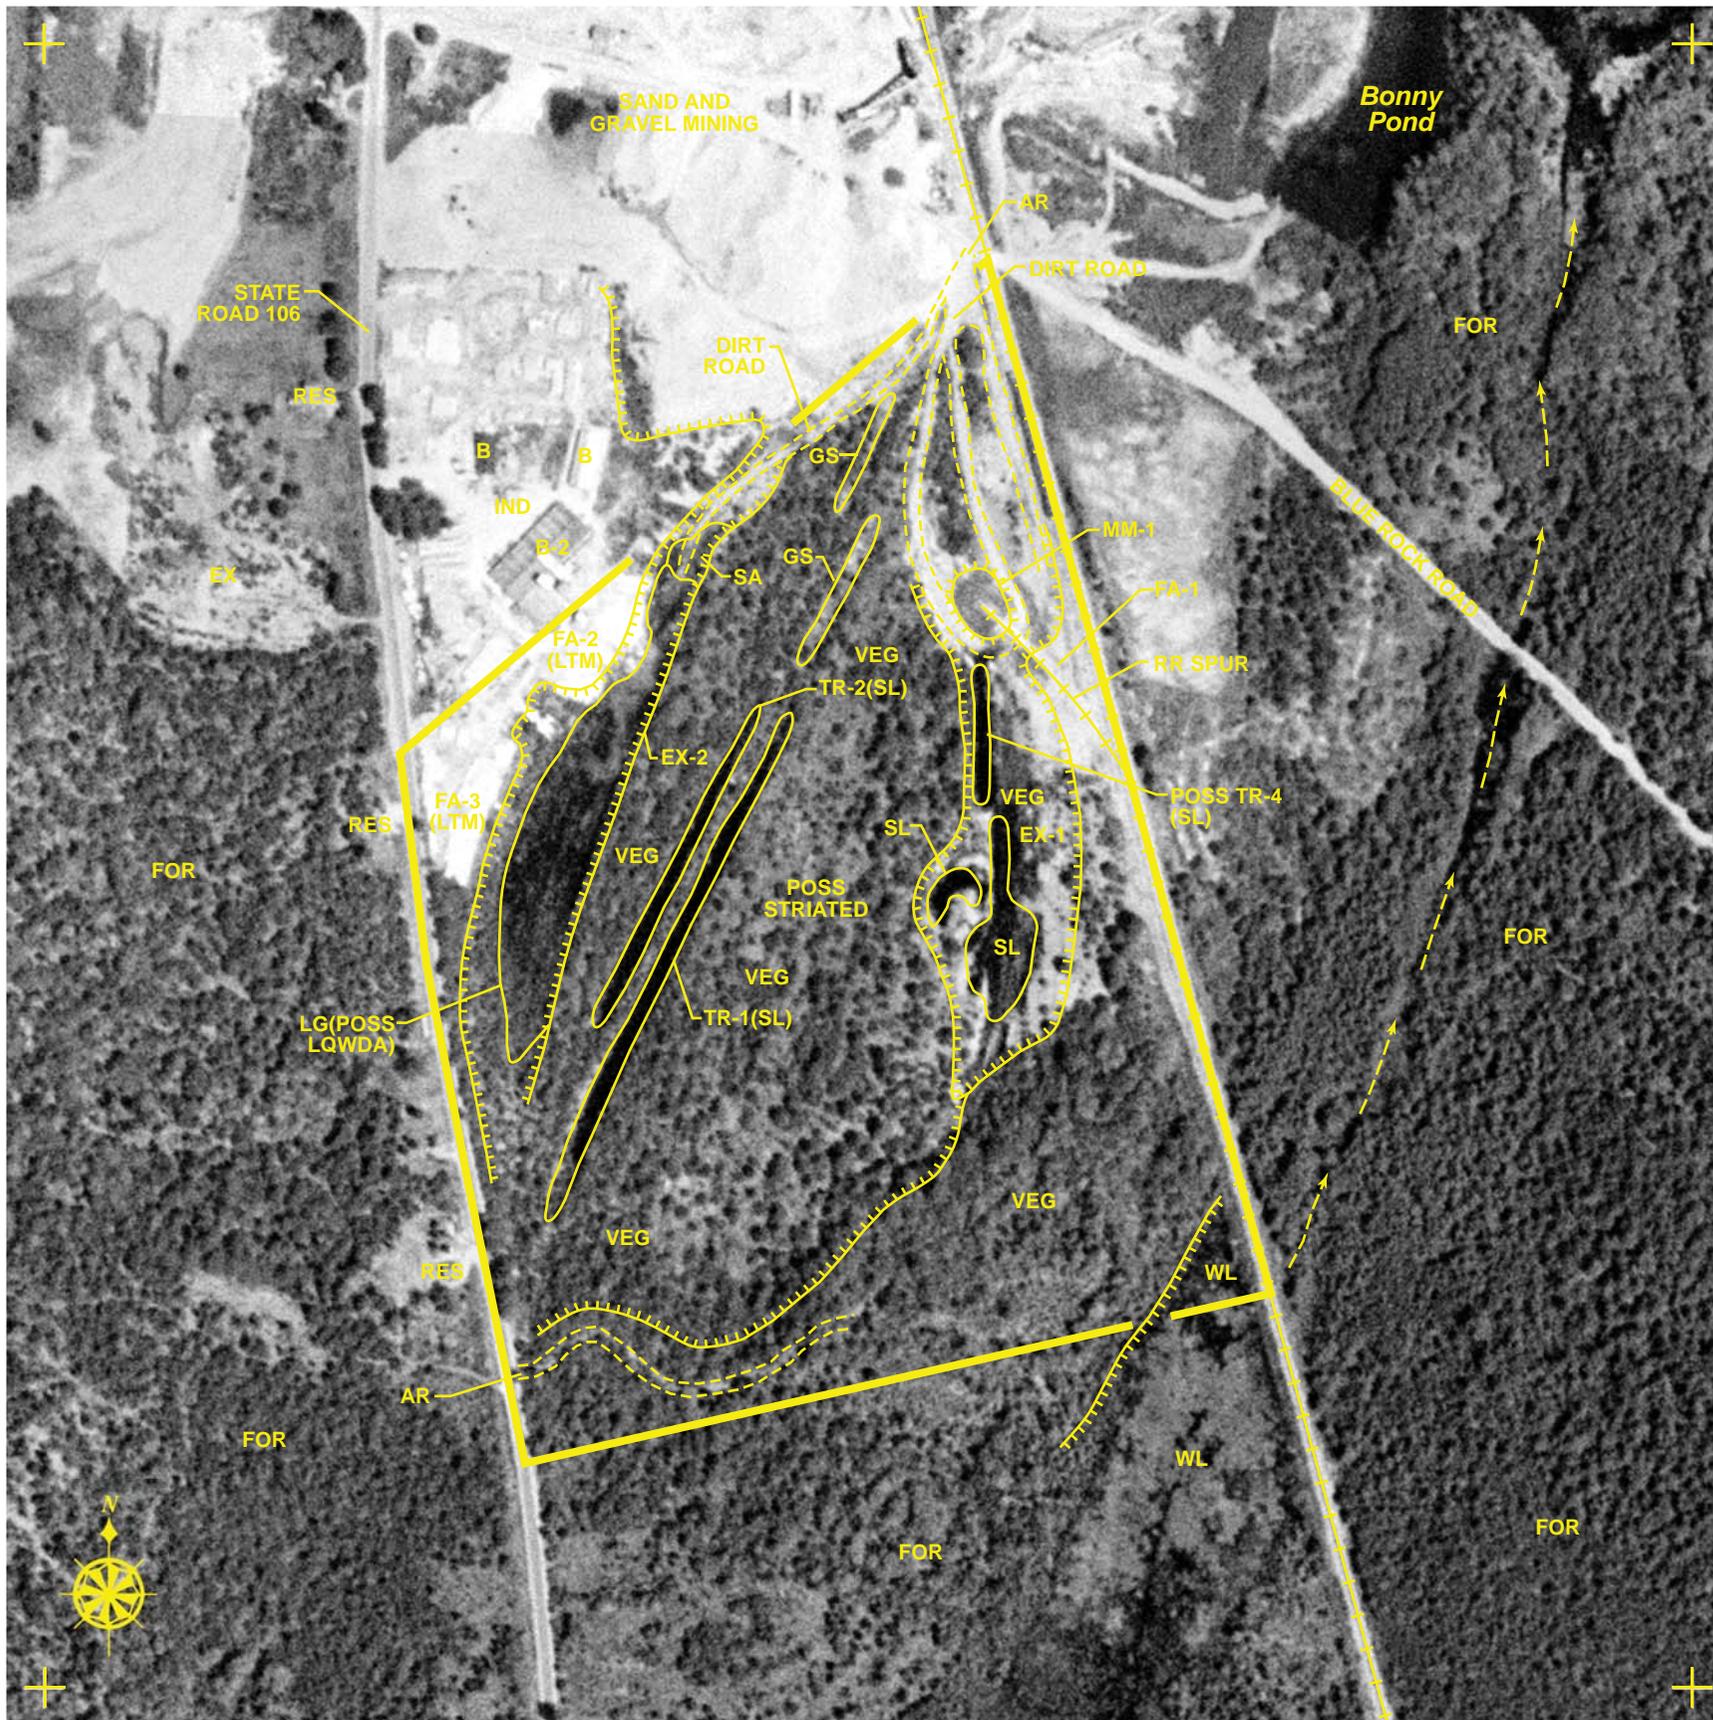
The lagoon containing possible liquid waste is present in excavation EX-2. The areal extent of the possible liquid waste has decreased slightly since 1953. The two possible outfalls, seen in 1953, are no longer observed.

A dirt road, connecting with the access road, extends into the northern section of excavation EX-2. The dirt road terminates at a saturated area adjacent to the lagoon.

Trenches TR-1 and TR-2 remain filled with standing liquid. The northern parts of the trenches are no longer observed. Linear-shaped ground scars are located where, earlier in the analysis, the northern part of trench TR-1 and trench TR-3 were identified.

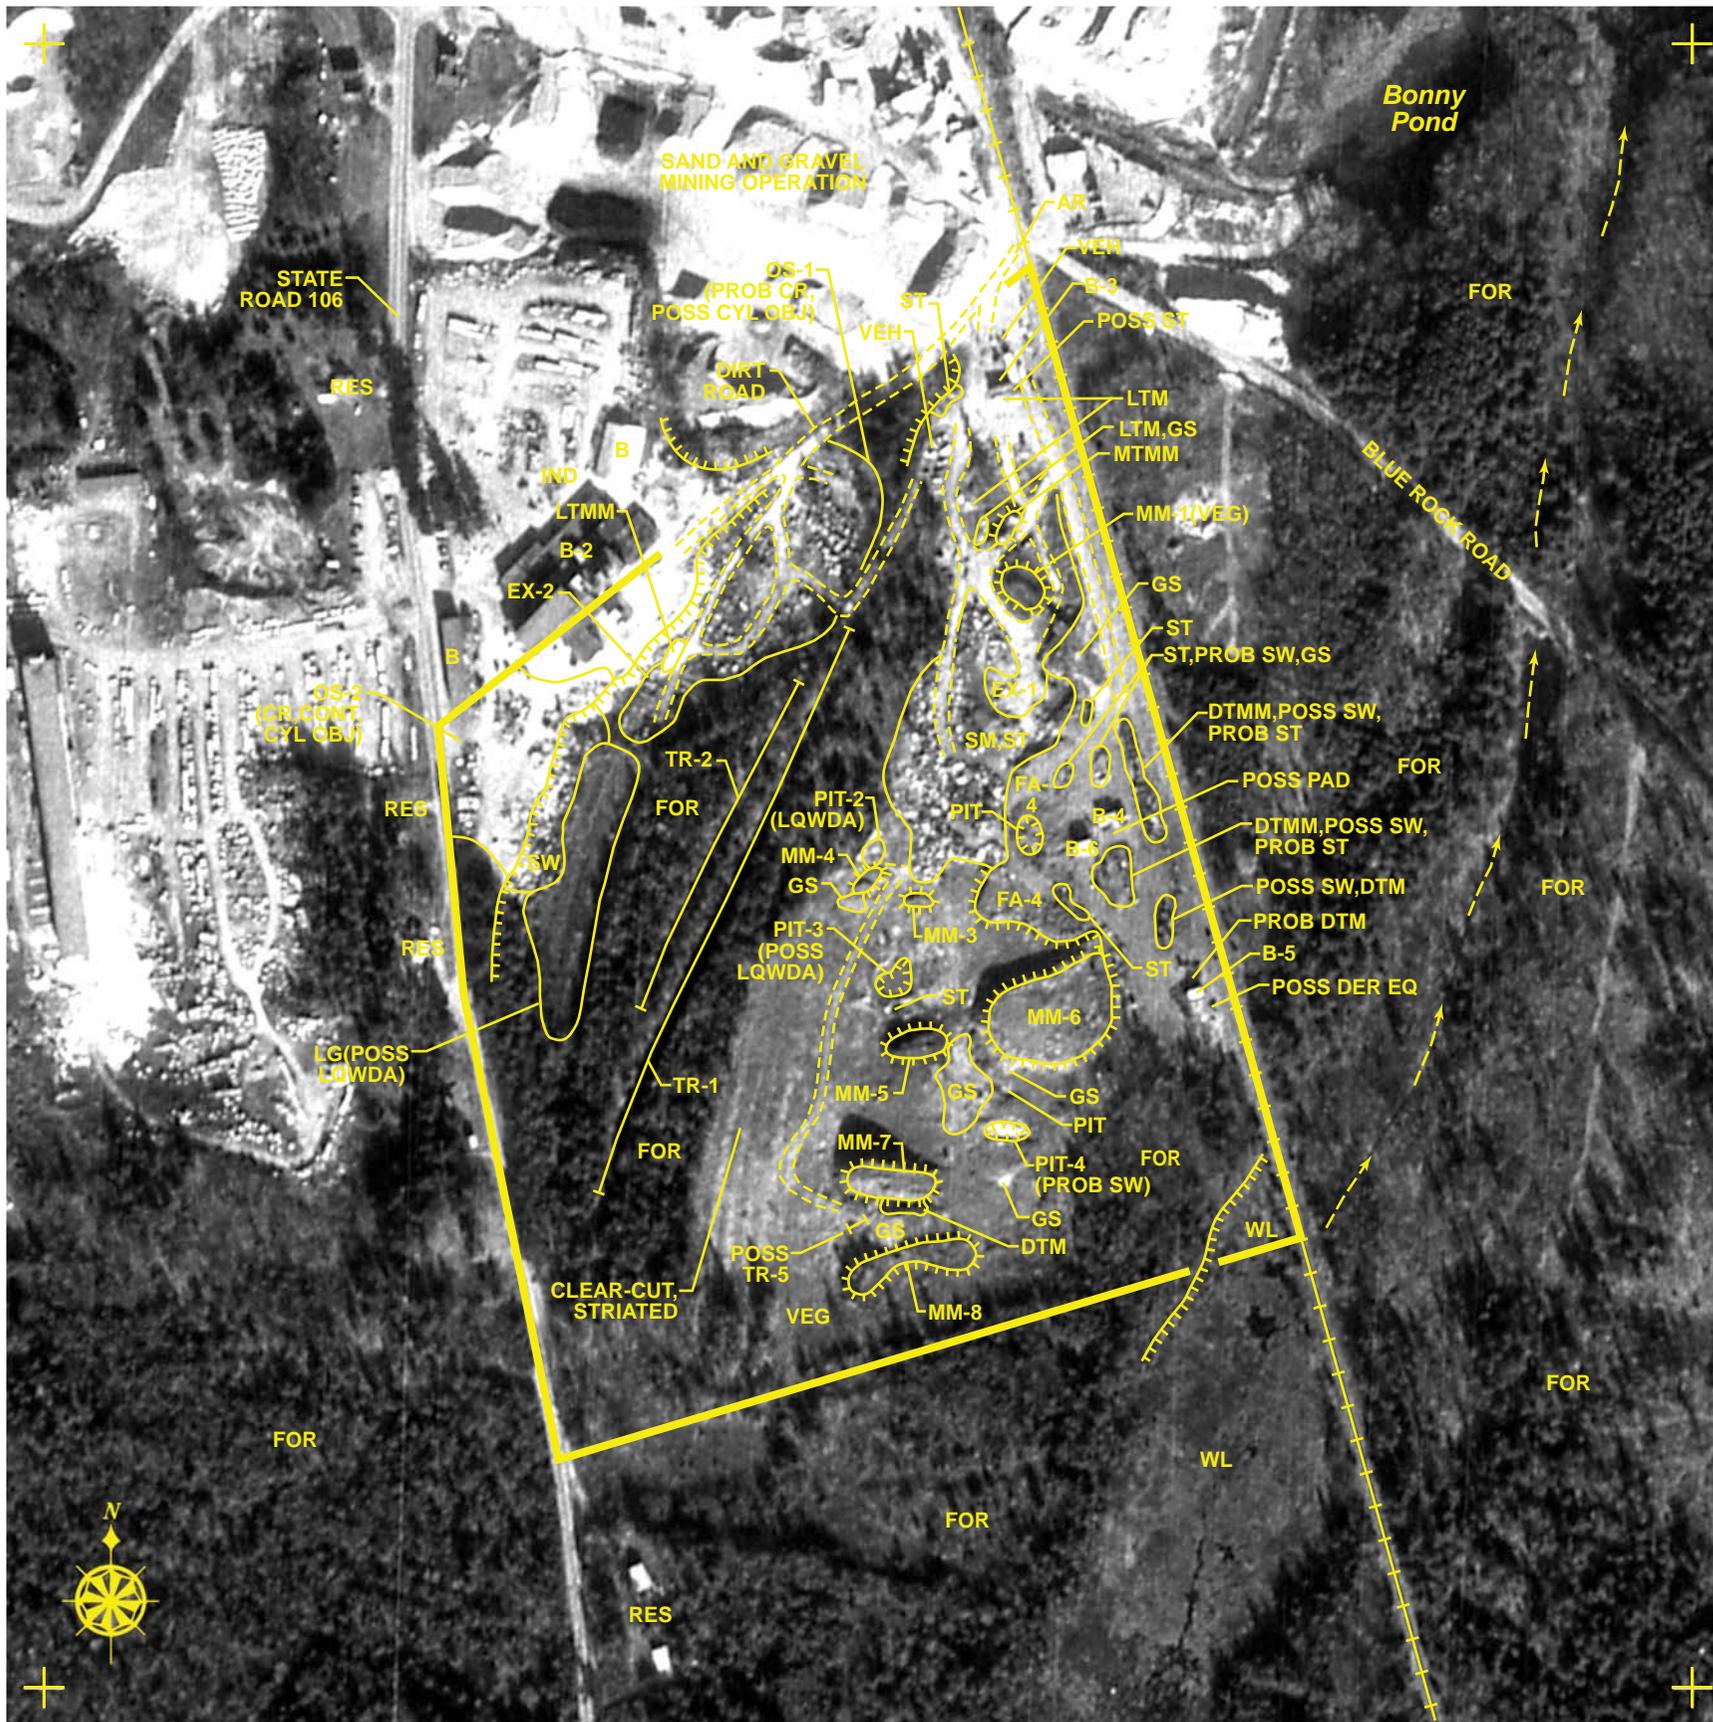
Scrap metal processing is ongoing at Leeds Metal site. Near building B-3, part of the metal processing facility, are stained ground, possible stained ground, and a small area of light-toned material. Several parked vehicles are present nearby. A new dirt road, established since 1973, now connects the scrap metal processing facility to open storage area OS-1. A portion of the dirt road appears to traverse over the northern section of trench TR-2. A probable light-toned object (not annotated), approximately one-fourth the size of an automobile, is present on the "elbow-shaped" turn of the dirt road.

The railroad spur that extended from the railroad to mound MM-1 has been removed since 1973. North of mound MM-1 are light-toned material, ground scars, and medium-toned mounded material. Immediately to the southwest of mound MM-1 is the large area of scrap metal. Areas of stained ground are also observed. The areal extent of the scrap metal stock-piled on the metal processing facility has decreased since 1973.

Since 1973, scrap metal processing building B-6 has been constructed near building B-4. A possible building pad (PAD) is also present, buildings B-4 and B-6 are on the possible pad. The cranes and conveyor system seen in 1973 have been removed from the Leeds Metal site. Near the buildings, located atop fill area FA-4, are areas of stained ground and probable stained ground, probable and possible solid waste, and dark-toned mounded material.

and stained ground (features are not annotated) are present on the base of liquid waste disposal pit PIT-2. A ground scar is adjacent to the southern face of mound MM-4.

Southeast of mound MM-4, in the central part of the site, possible liquid waste is located in PIT-3, a possible disposal pit. Mound MM-5, composed of dark-toned probable solid waste (not annotated), is located just south of PIT-3. The areal extent of mound MM-5 is approximately 350 square meters (3,767 square feet) and the mound is approximately 2.5 meters (8.2 feet) tall. Mound MM-5 has been placed near to where, in 1973, PIT-1 was located. PIT-1 is no longer observed and has been covered by mound MM-5. Mound MM-6, deposited since 1973, is composed of fine-textured probable solid waste (not annotated). The areal extent of mound MM-6 is approximately 3,300 square meters (35,521 square feet) and it is nearly 2.5 meters (8.2 feet) tall along the western face. The surface of the mound gradually slopes to grade at the eastern extent of the mound. Atop mound MM-6 are several widely-spaced pieces of probable scrap metal (not annotated), very similar in appearance to the scrap metal present in and around excavation EX-1. South of mound MM-6, probable solid waste is present in PIT-4, a probable disposal pit.

Open storage area OS-1 remains in use. The areal extent of the open storage area has remained approximately the same since 1973; however, the quantity of stored material has decreased and is now widely-spaced. Numerous, neatly arranged, different-sized probable crates and possible cylinder-shaped objects (each no larger than one-half the size of an automobile) remain housed at the open storage area. Much of the ground surface on the open storage area is now saturated and vegetation is present (features are not annotated).

Open storage area OS-2 remains in use; however, the areal extent of the open storage area has decreased slightly since 1973. The quantity of stored material has also decreased and the material is now widely dispersed. Open storage area OS-2 consists of neatly-arranged crates and containers and cylinder-shaped objects. The size and dimensions of the stored material is very similar to the material stored in 1973.

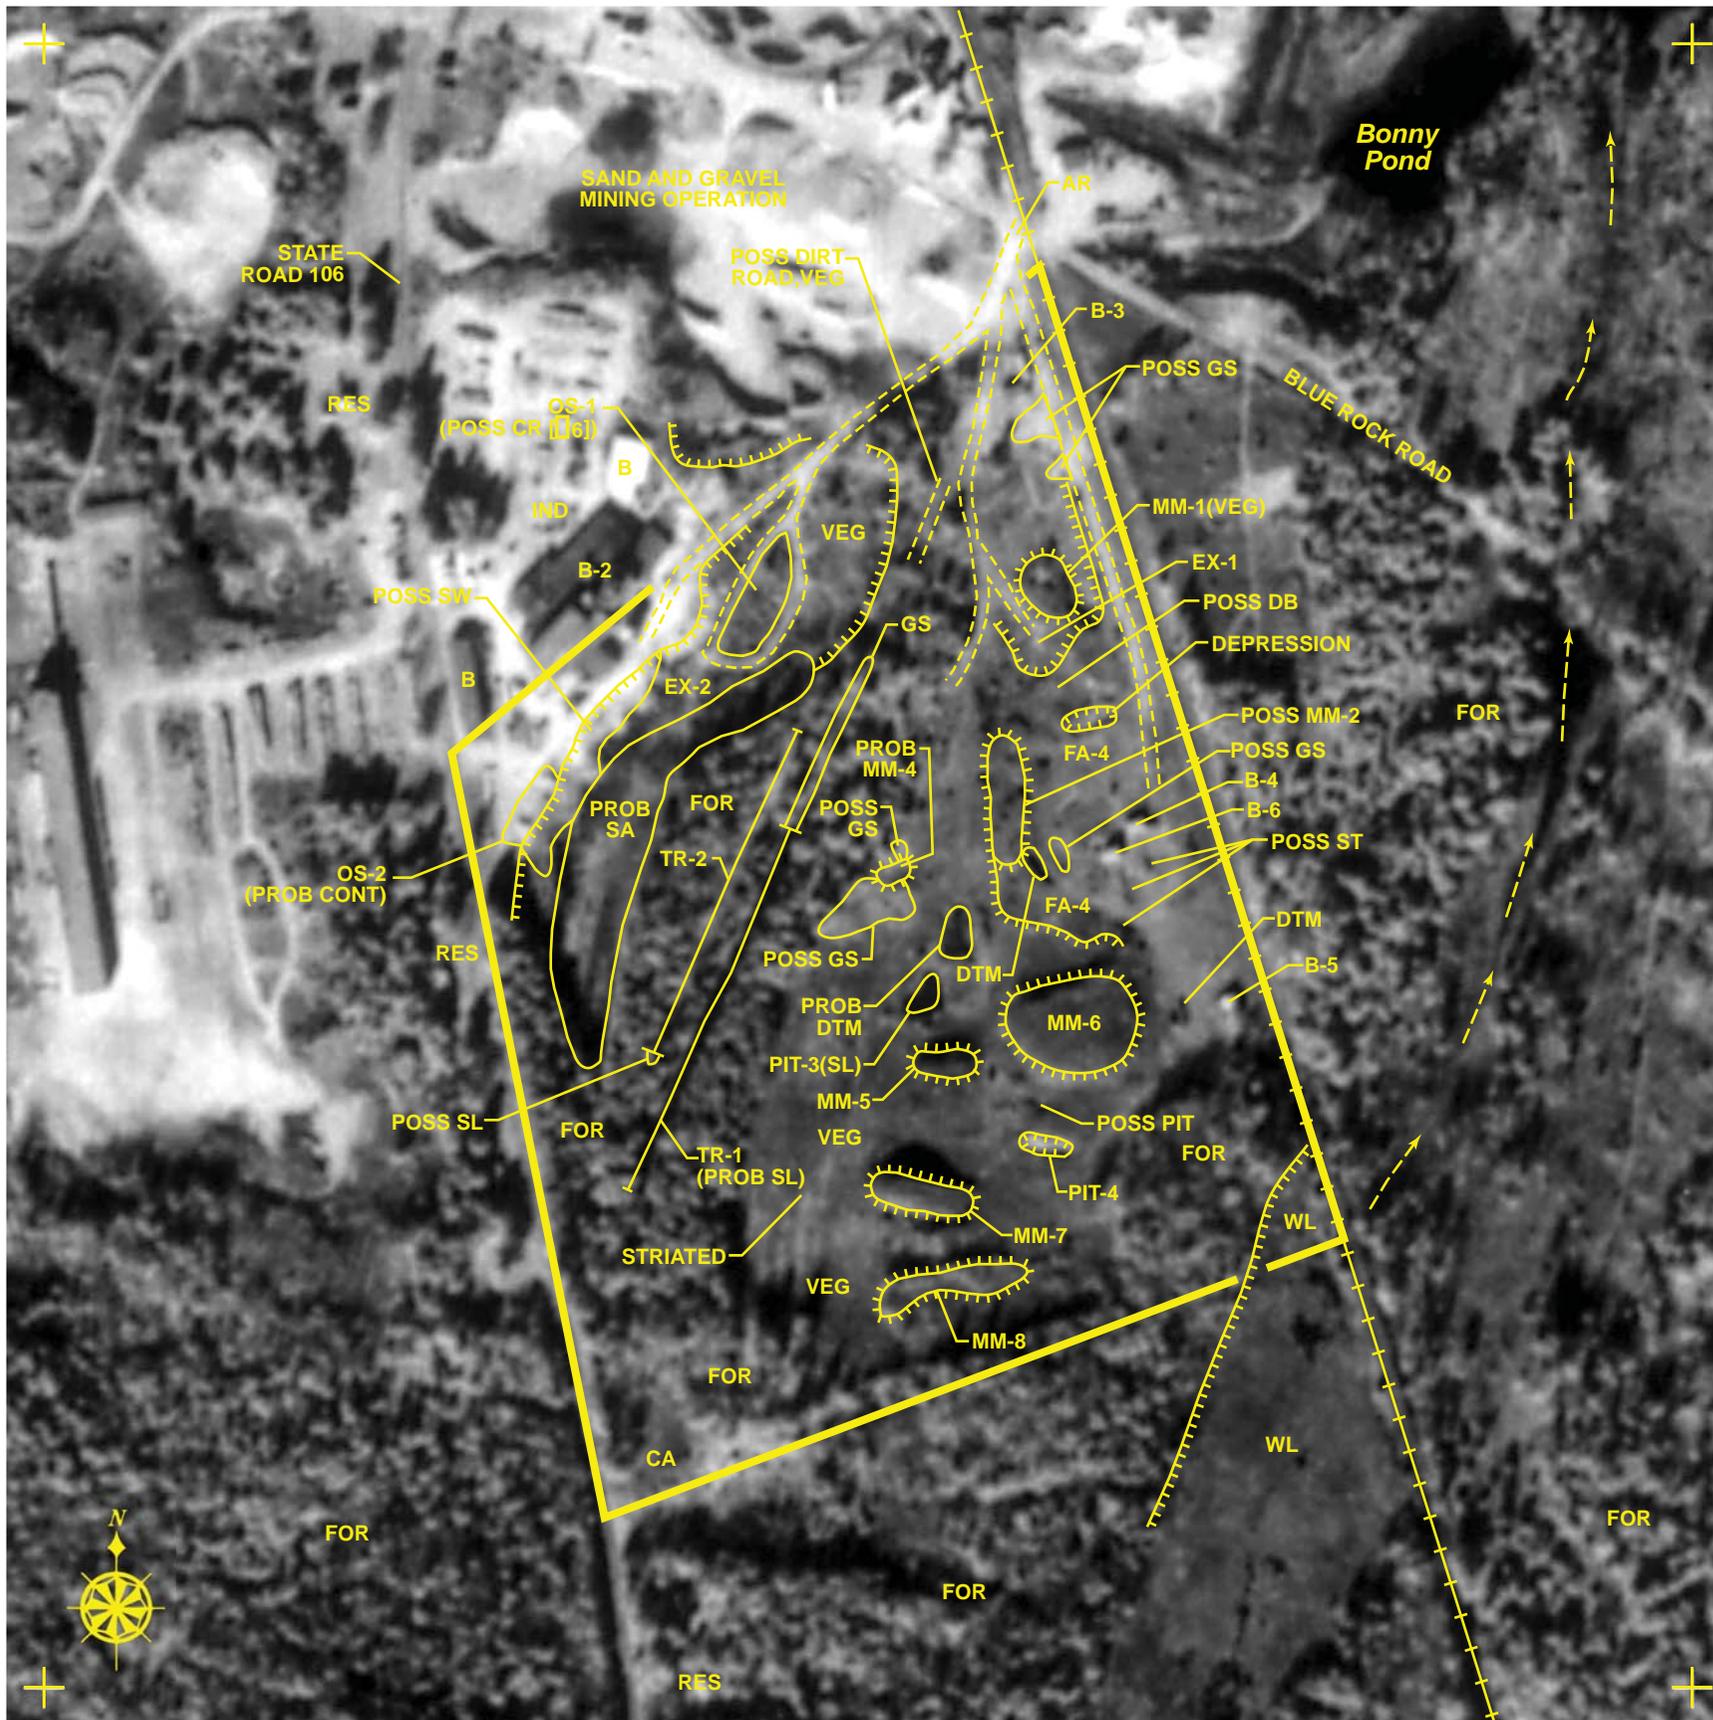
Several dirt roads remain in and near excavation EX-1; however, portions of the roads are now covered with vegetation (not annotated). A dirt road west of building B-3, connecting the former scrap metal processing facility to open storage area OS-1, is no longer discerned. The location of the road is now vegetated and a portion of a possible dirt road is noted at this location.

Probable mound MM-4, composed of medium-toned material (not annotated), has not changed significantly since 1980. A possible ground scar is located immediately north of mound MM-4 where, in 1980, liquid waste disposal pit PIT-2 was identified. PIT-2 is no longer visible. Deposits of medium-toned material (not annotated) appear to have been added to mound MM-6 since 1980. The areal extent and height of mound MM-6 may have increased slightly. Solid waste noted on mound MM-6 in 1980 cannot be identified. The dark-toned material adjacent to mound MM-7 is no longer observed.

Mound MM-3 is not discerned. Possible vegetation (not annotated) is located where, in 1980, mound MM-3 was observed. The possible vegetation may be obscuring the mound or the mound has been removed. Possible trench TR-5 is no longer observed. Possible vegetation (not annotated) covers the area where, in 1980, the possible trench was noted.

Open storage area OS-2 remains in use; however, the areal extent of the open storage area has decreased since 1980. The quantity of stored material has significantly decreased; several probable containers are now present at the open storage area. Industrial activity at the facility just north of the Leeds Metal site appears to have slowed since 1980.

A cleared area is located in the extreme southwestern corner of the site.

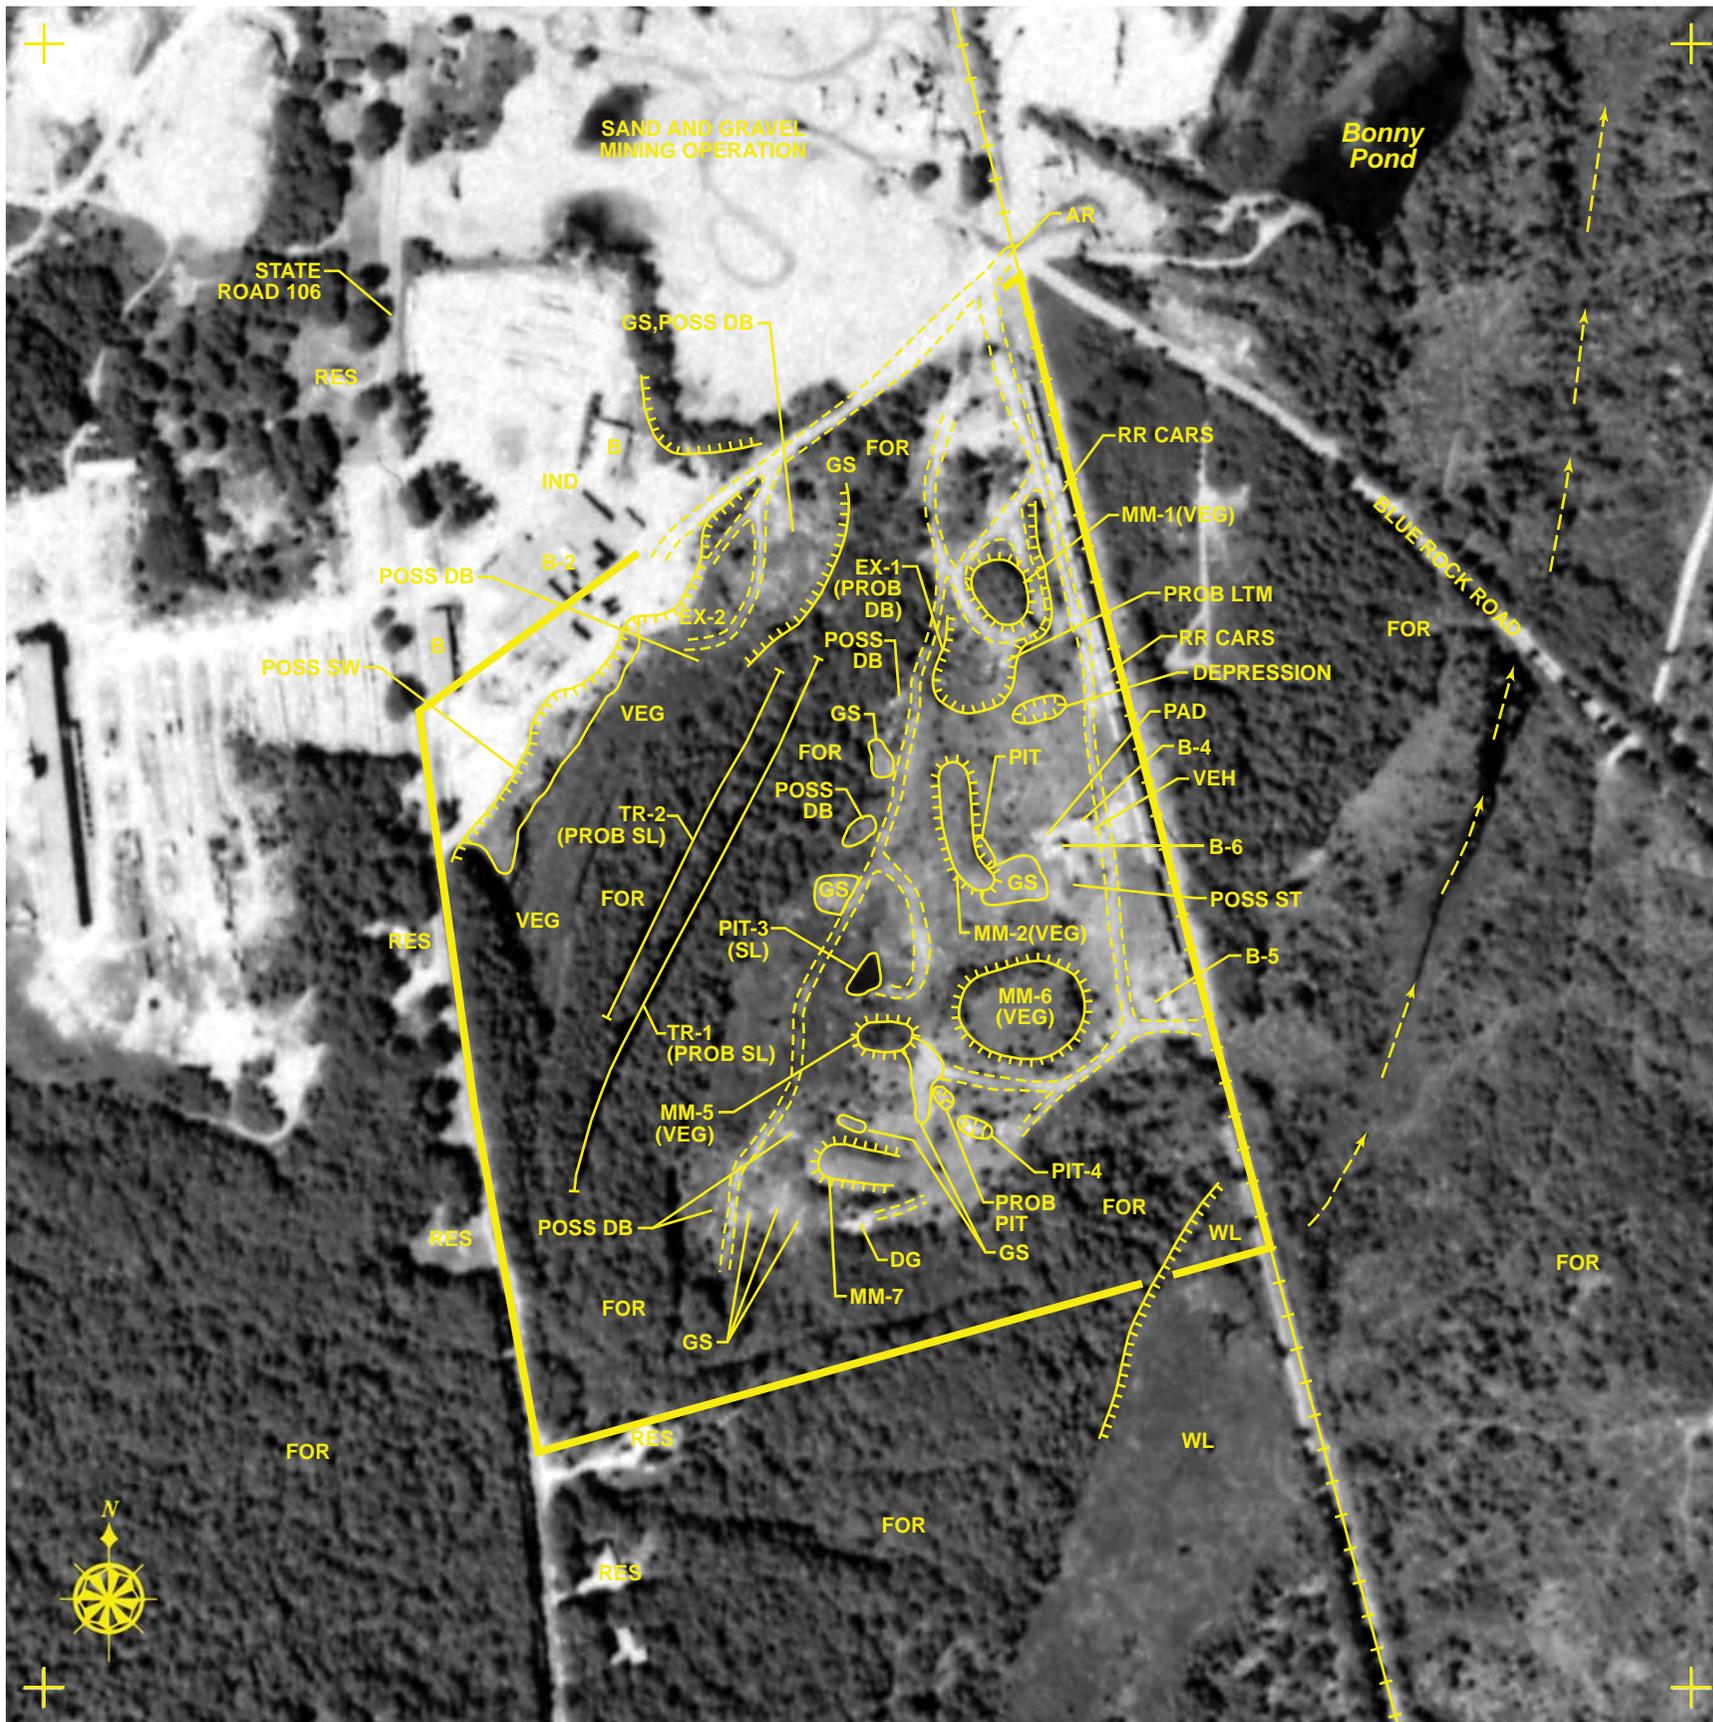
Figure 11. Leeds Metal site, July 22, 1991. Approximate scale 1:3,930.

Widely scatter probable debris, and probable light-toned material are noted within excavation EX-1.

Probable mound MM-4 and mound MM-8, seen in 1985, are no longer observed. A ground scar is located near to where, earlier in the analysis, probable mound MM-4 was identified. Material from mound MM-4 may have been spread around the area. Vegetation is now present where, earlier in the analysis, mound MM-8 was identified.

The industrial facility, north of the Leeds Metal site, has ceased operating since 1985. Open storage areas OS-1 and OS-2, utilized by the industrial facility, are no longer in use. All housed material at the open storage areas has been removed.

A residence (RES) has been constructed on the cleared area located in the extreme southwestern corner of the site Leeds Metal site.
