AERIAL PHOTOGRAPHIC ANALYSIS OF LEEDS METAL SITE

Leeds, Maine

EPA Region 1

TS-OEI-21101007S
June 2012

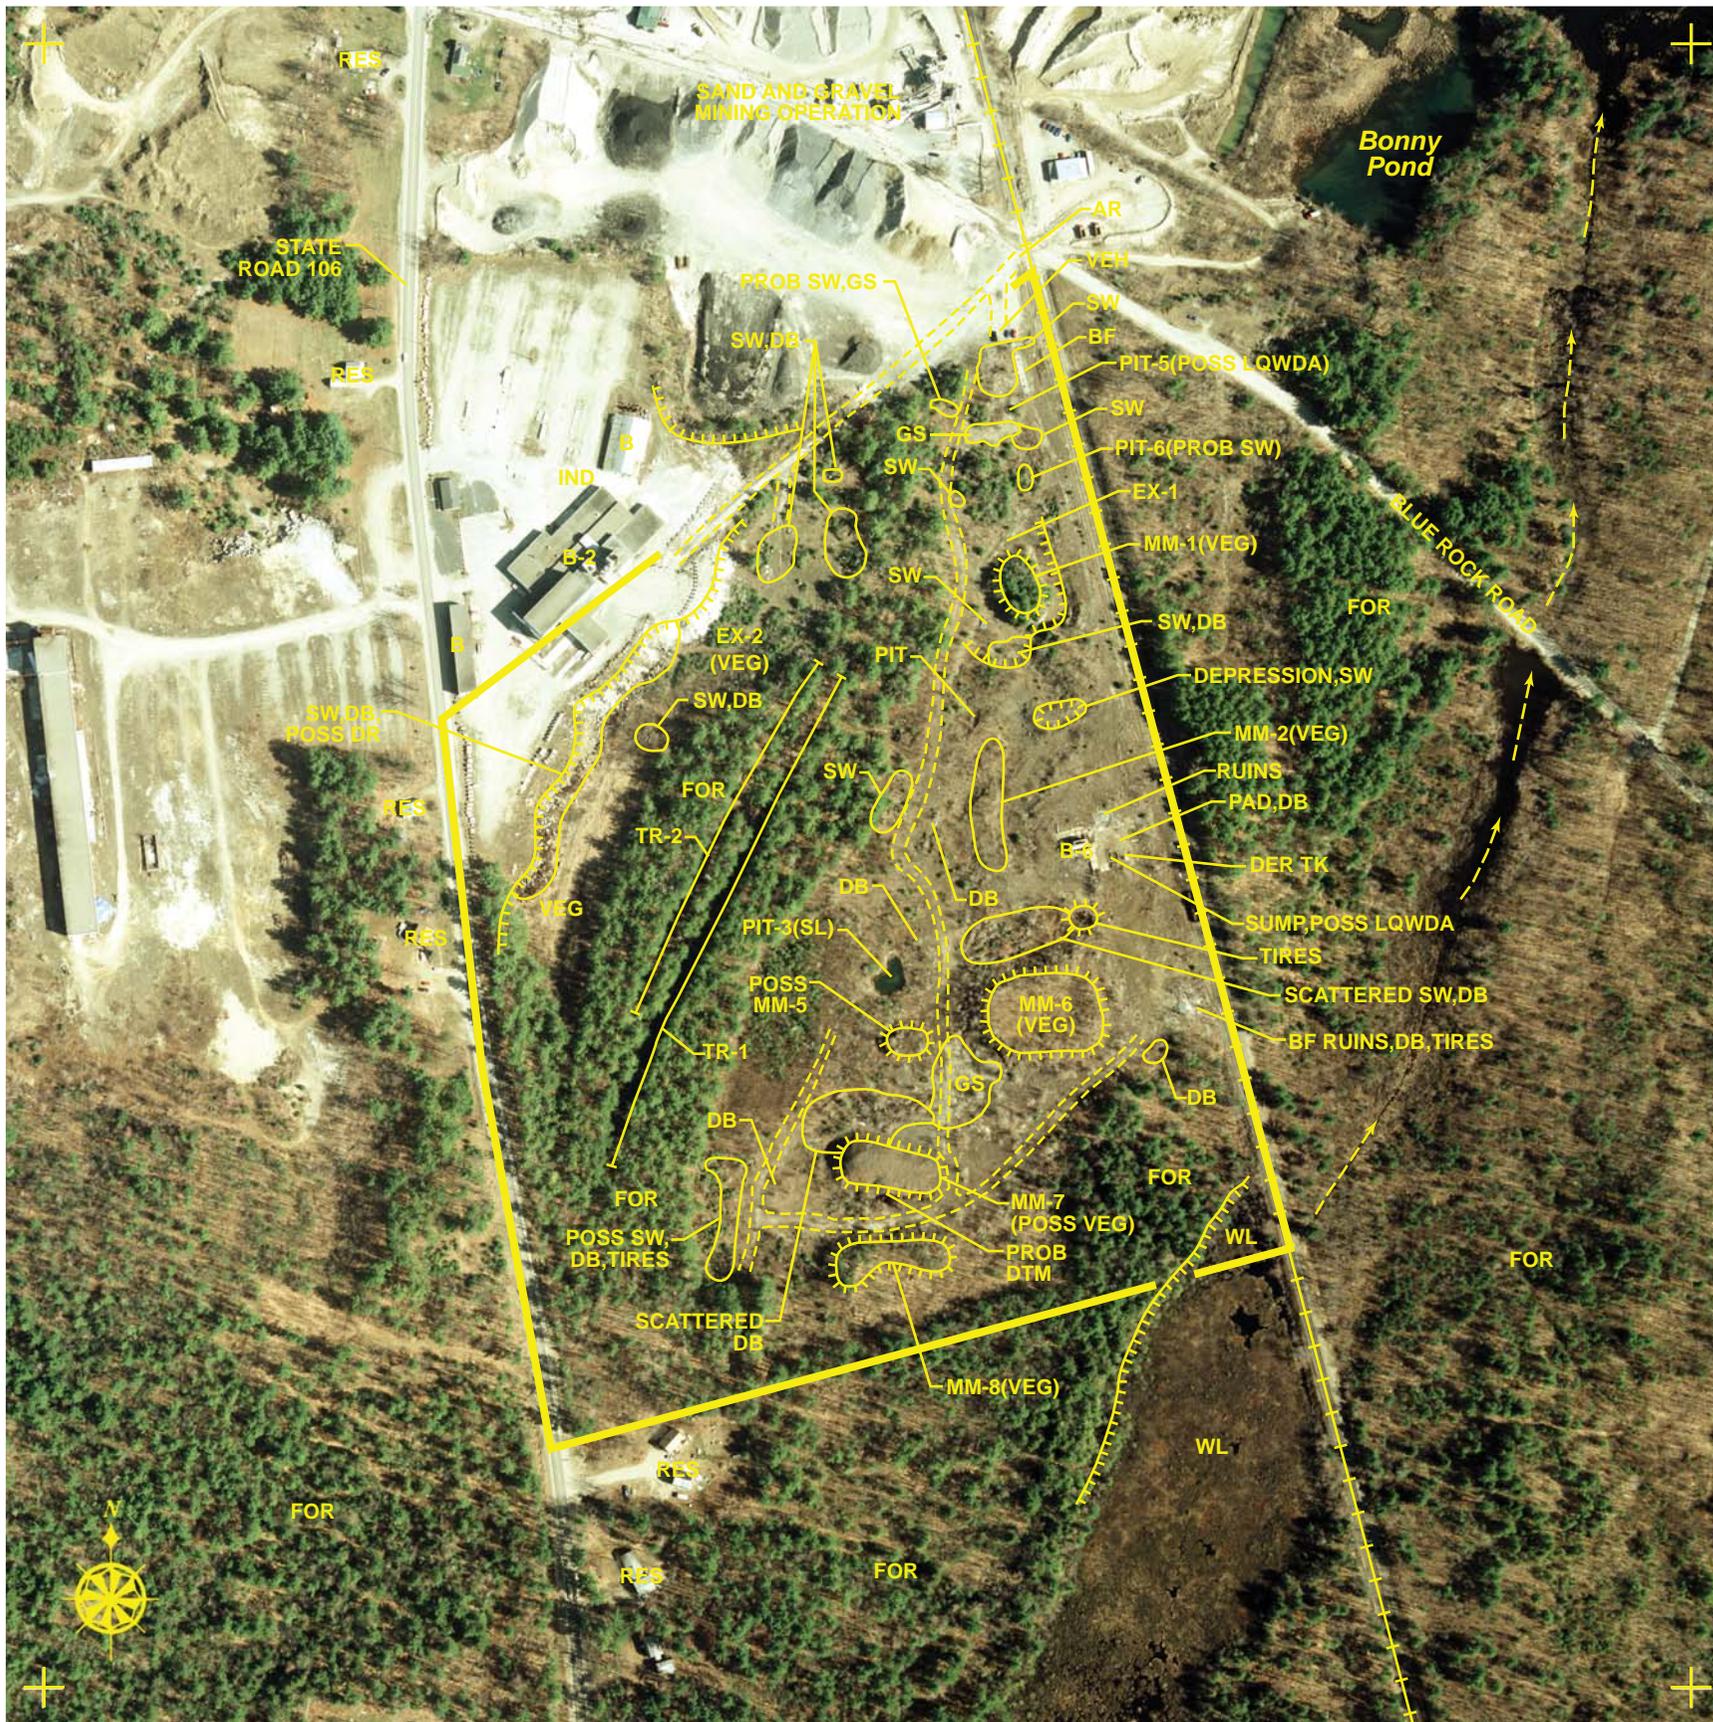
Figure 12. Leeds Metal site, April 30, 2003. Approximate scale 1:3,850.

In the extreme northeastern portion of the site, several vehicles are parked near the access road. Solid waste is located adjacent to the building foundation (BF; former location of building B-3).

Building B-4, onsite since 1973, is in ruins. Debris, likely remnants of the building, is scattered on and near the building pad. A derelict storage tank and a sump filled with possible liquid are located on the building pad. A tire pile and a collection of scattered solid waste and debris are located southwest of the building pad. Building B-5, onsite since 1973, is in ruins. On and near the building foundation are scattered debris and tires.

Widely scattered solid waste and debris has been deposited within the northern portion of excavation EX-2 since 1991. Solid waste, debris, and possible drums (DR) remain at the base of excavation EX-2, adjacent to the northwestern face of the excavation.

No features or conditions of environmental significance are observed at the industrial facility north of the Leeds Metal site. The facility remains inactive.

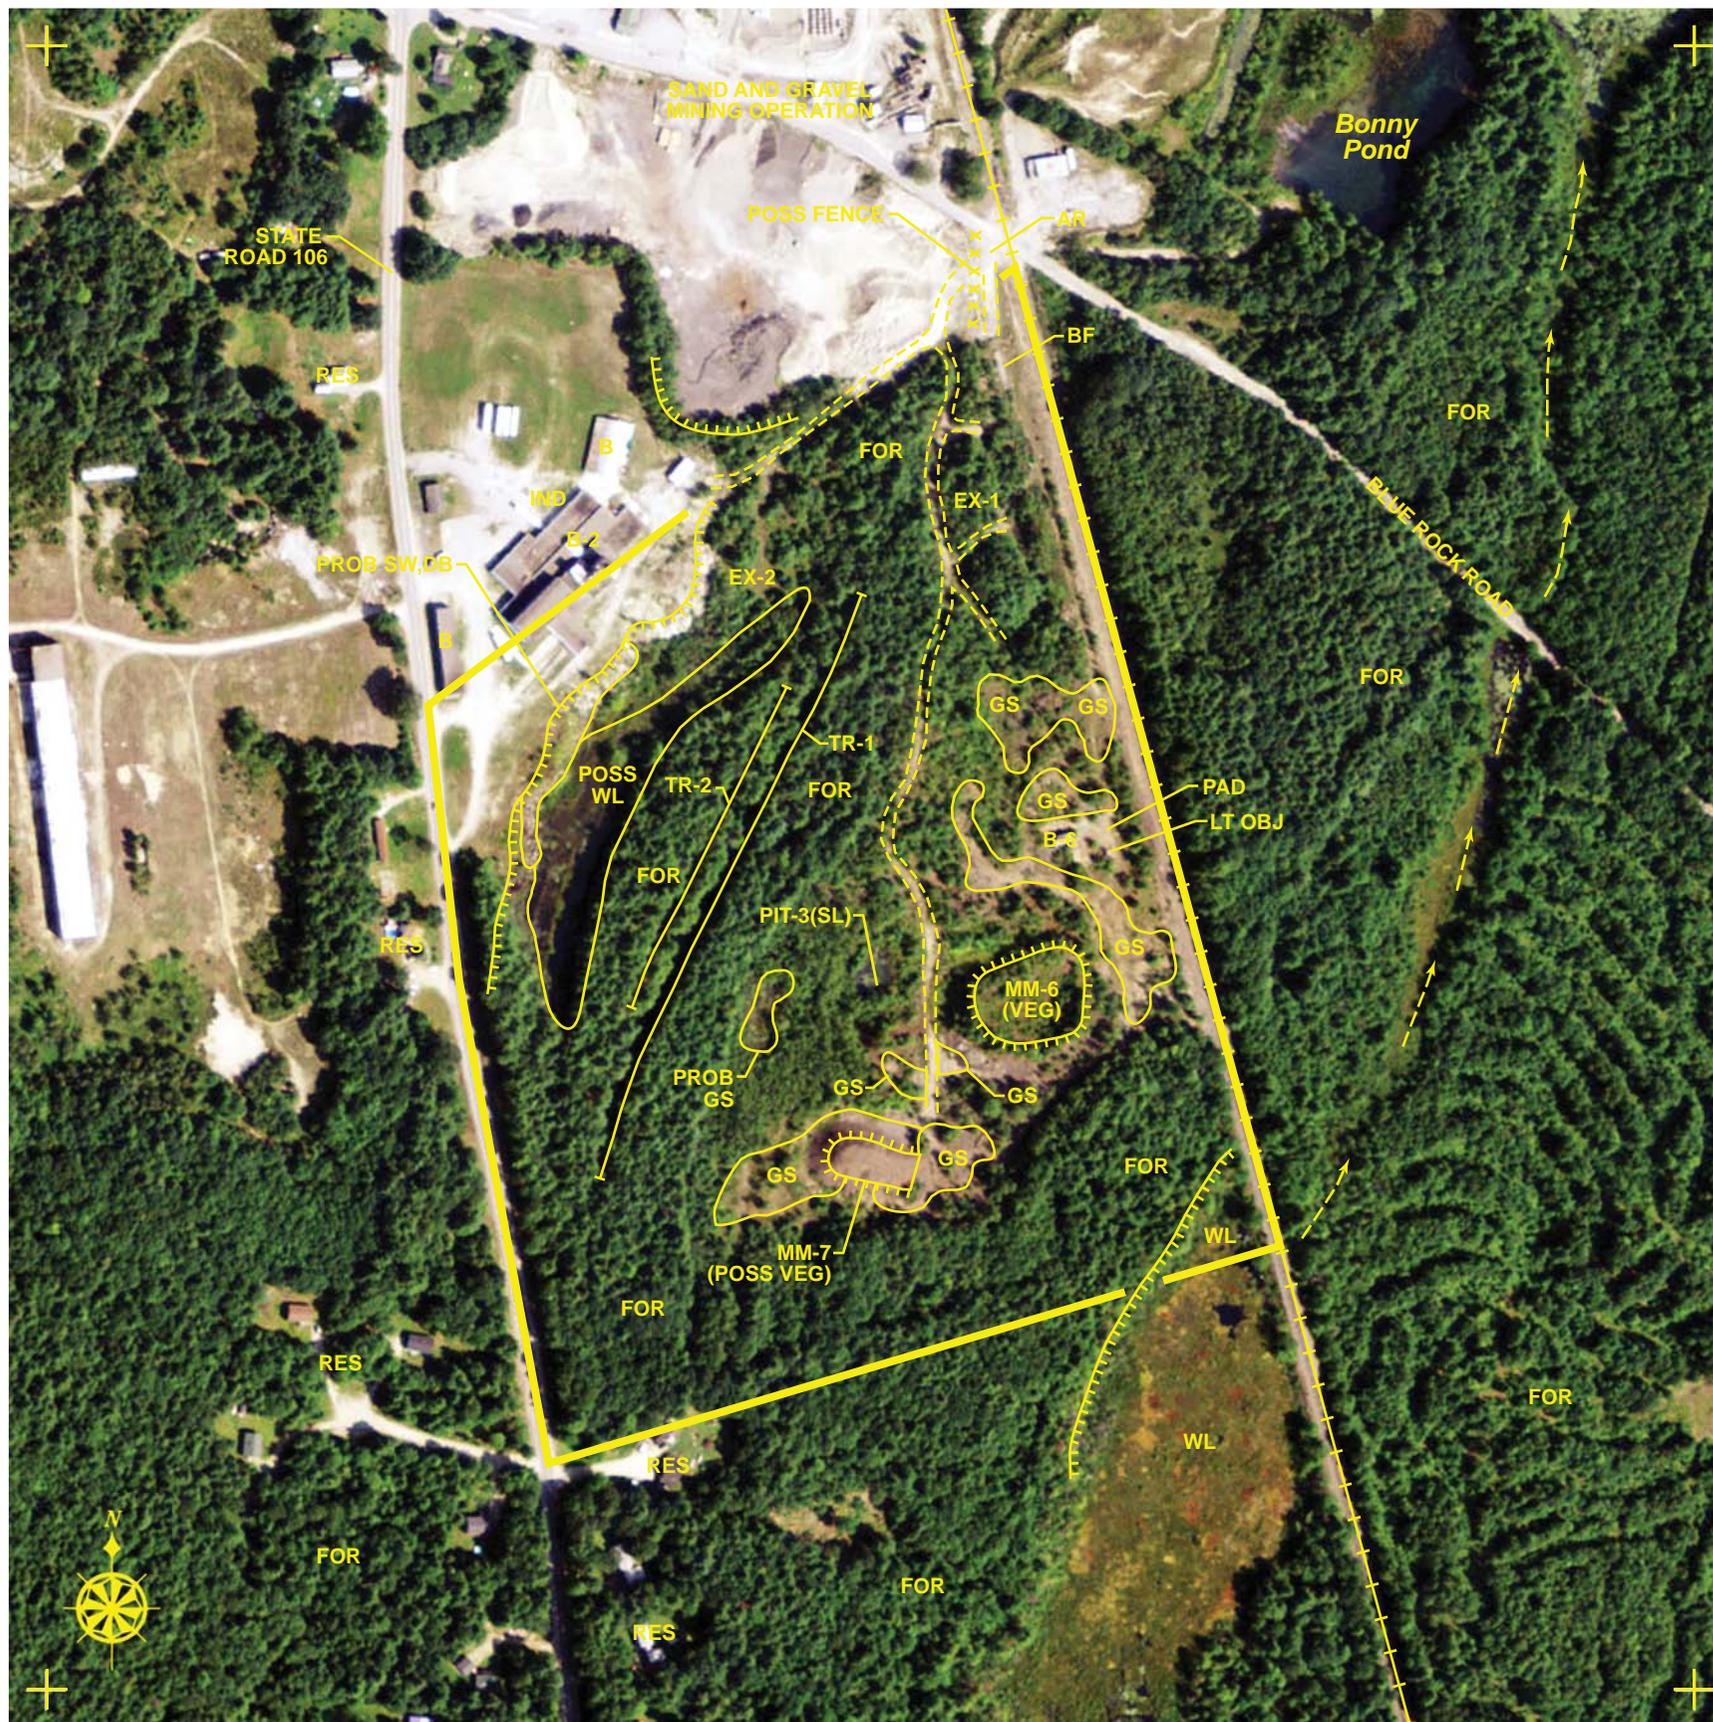
Monoscopic photographic coverage was used to perform the 2011 analysis. Because stereoscopic coverage was not used, the features and conditions visible on photographs from other years of analysis may not be discerned on the 2011 photograph, and the following analysis may not be as detailed.

A light-toned object is located where, in 2003, a derelict storage tank was identified. Tree shadows obscure the area where, in 2003, a sump filled with possible liquid was identified. Numerous ground scars are present near the building foundation. A ground scar is present near to where, in earlier years of the analysis, mound MM-2 was observed.

Two mounds of material remain on the Leeds Metal site. Mound MM-6 is covered with vegetation. Mound MM-7 is covered with possible vegetation. Vegetation is located where, in 2003, possible mound MM-5, and mounds MM-1 and MM-8 were observed.

A possible wetland is now located at the base of excavation EX-2.

No activity or conditions of environmental significance are observed at the industrial facility north of the Leeds Metal site.
