TS-PIC-83015  
February 1983

# Photographic Analysis of Suspected PCB Dump Site Marsh Island, Massachusetts

prepared for  
EPA Region 1  
and OERR

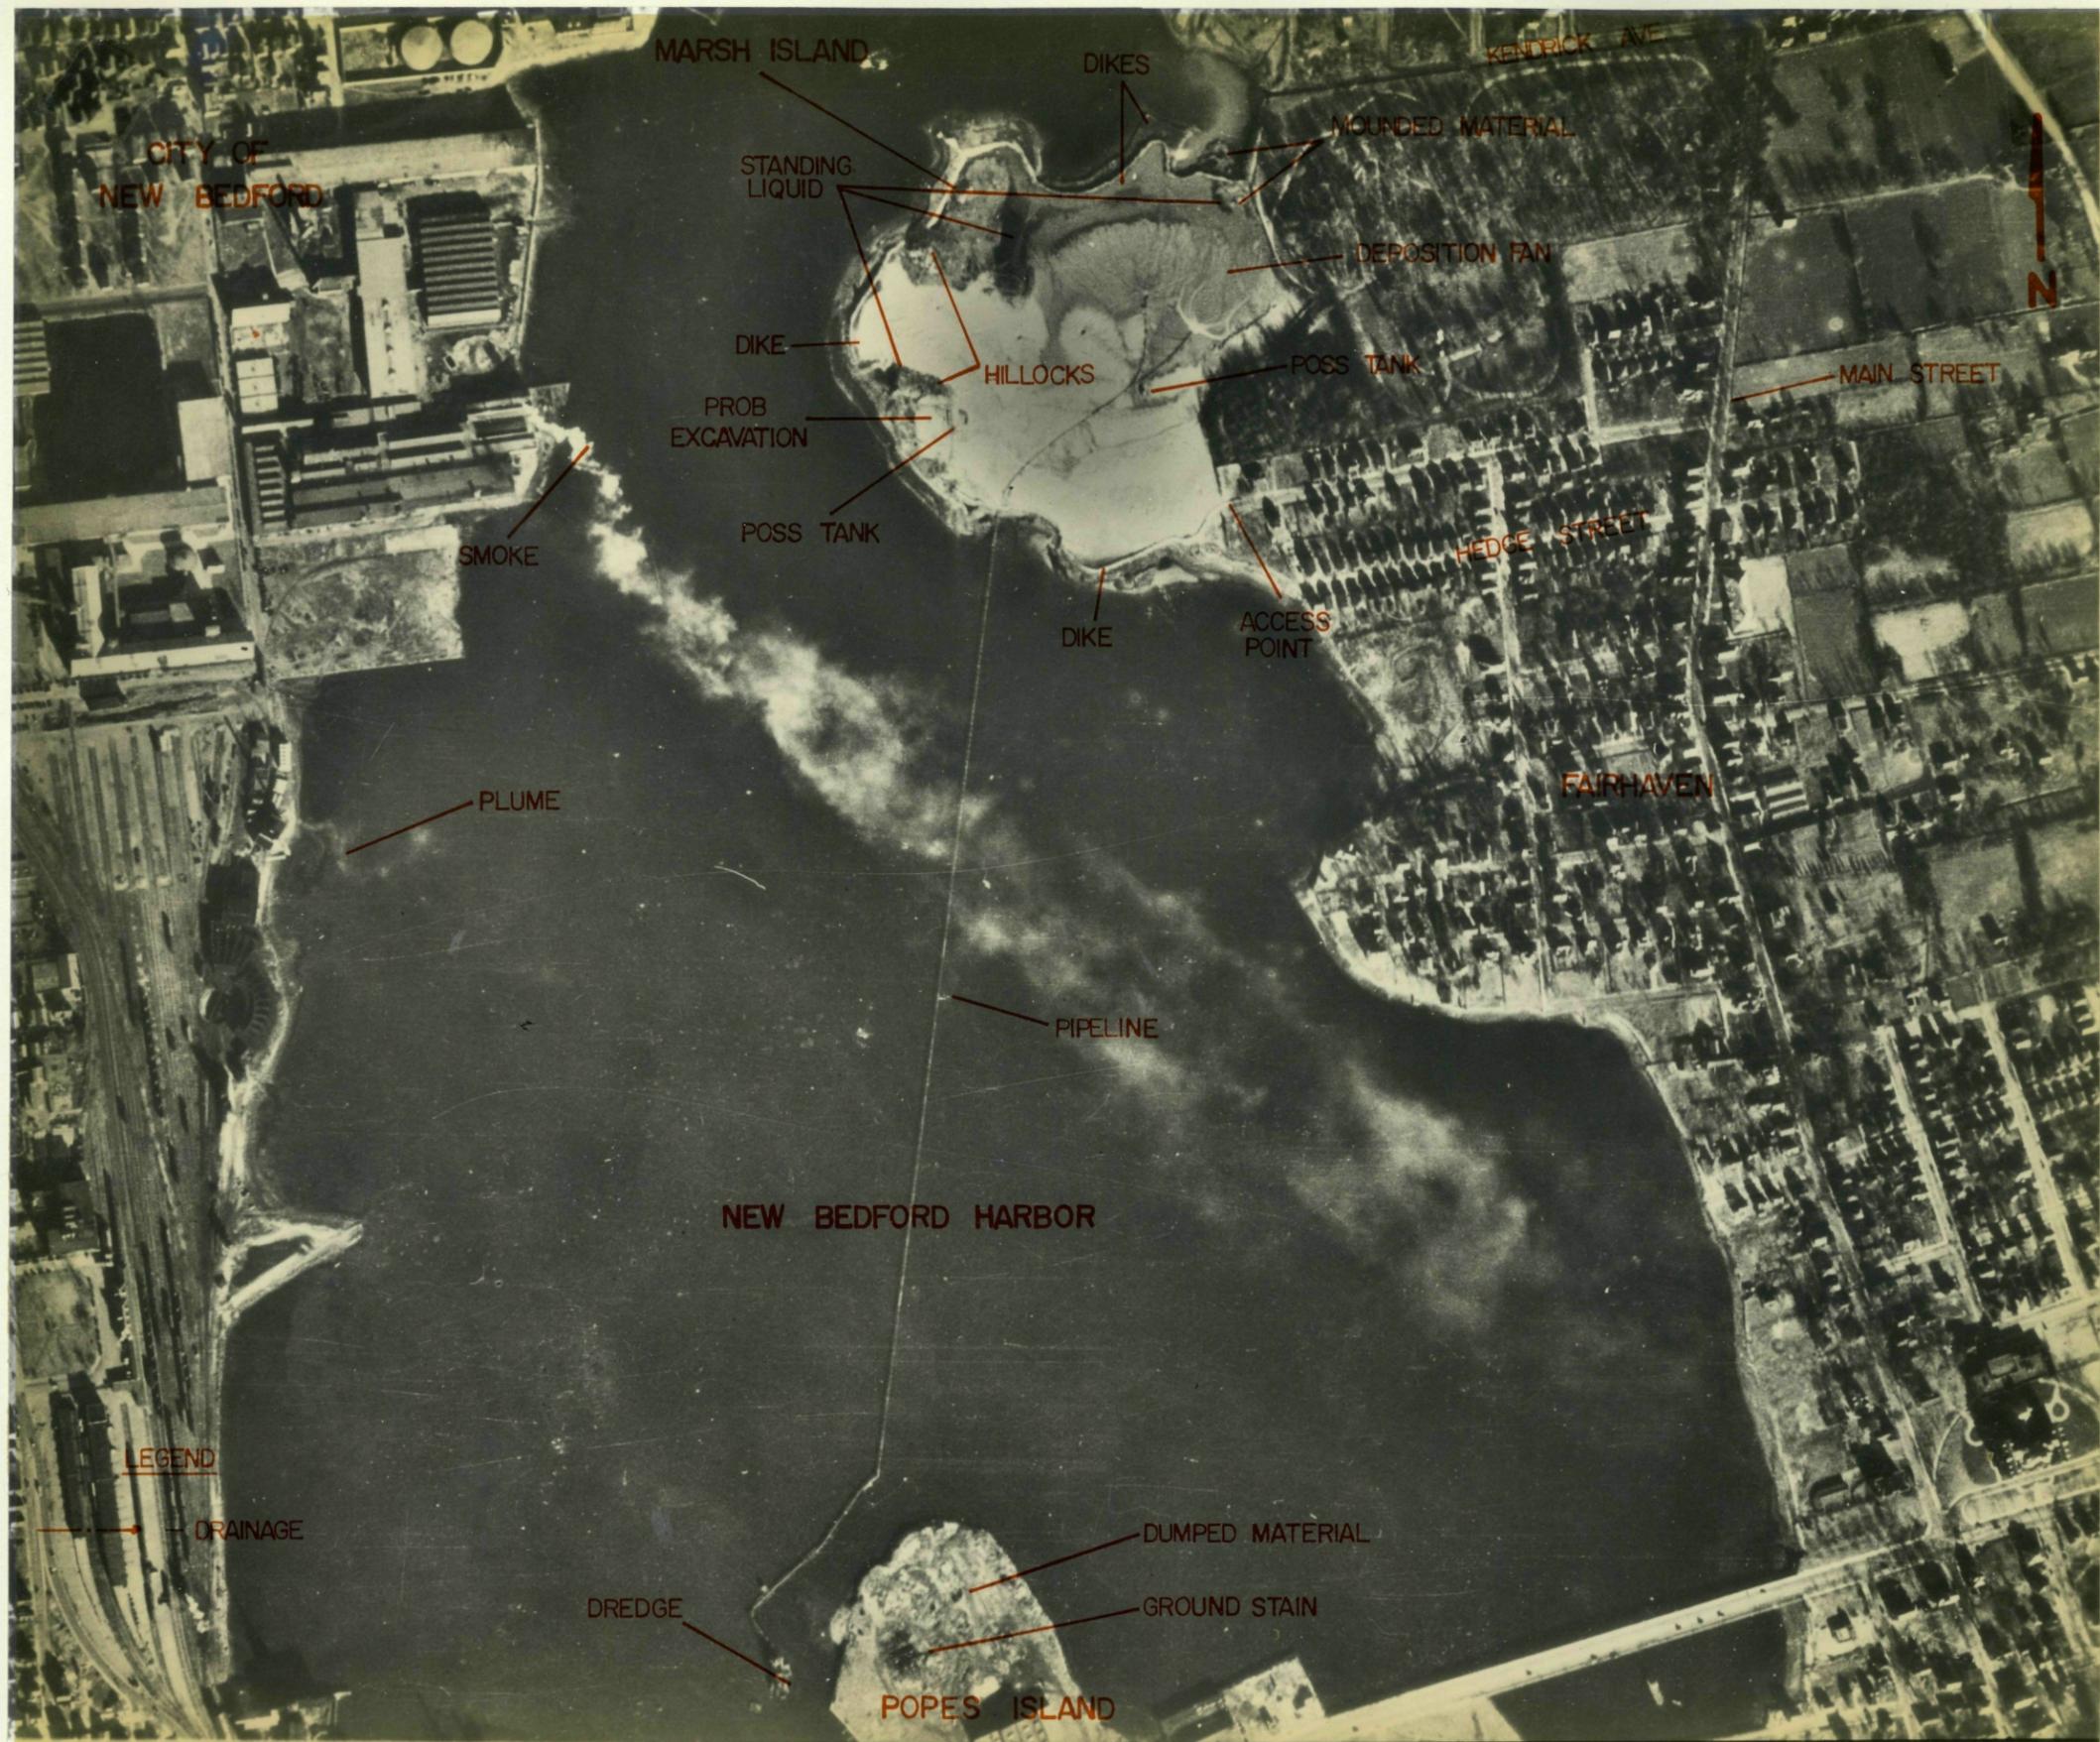
DECEMBER 13, 1938

A dredge west of Popes Island is pumping material onto Marsh Island peninsula via a large pipeline which crosses New Bedford Harbor. Ground stains and dumped material are visible on Popes Island. On the Marsh Island peninsula the pipeline branches into two lines, and white material is flowing from the eastern branch.

The Marsh Island peninsula is diked along its entire coastline and along portions of its landward side. Another small section of dike is located in the water outside the main dike on the north side of the peninsula.

The southern half of the peninsula is covered with a thick layer of light-toned, fine-textured material (probably sand). This layer extends out to the dikes on the west, south and east sides and terminates in a well-defined sloping edge on the north. A slightly lower medium-toned fan of depositional material has built up north of the pipeline termini. The northernmost side of the peninsula is the area of lowest elevation. Pools of standing liquid are visible in this area.

Two hillocks are present on the west side of the peninsula. The southern one exhibits signs of probable excavation along its south side.

Vehicle access to the site appears possible only in the southeast corner of the site. Two long, light-toned objects, possibly tanks, are present on site.

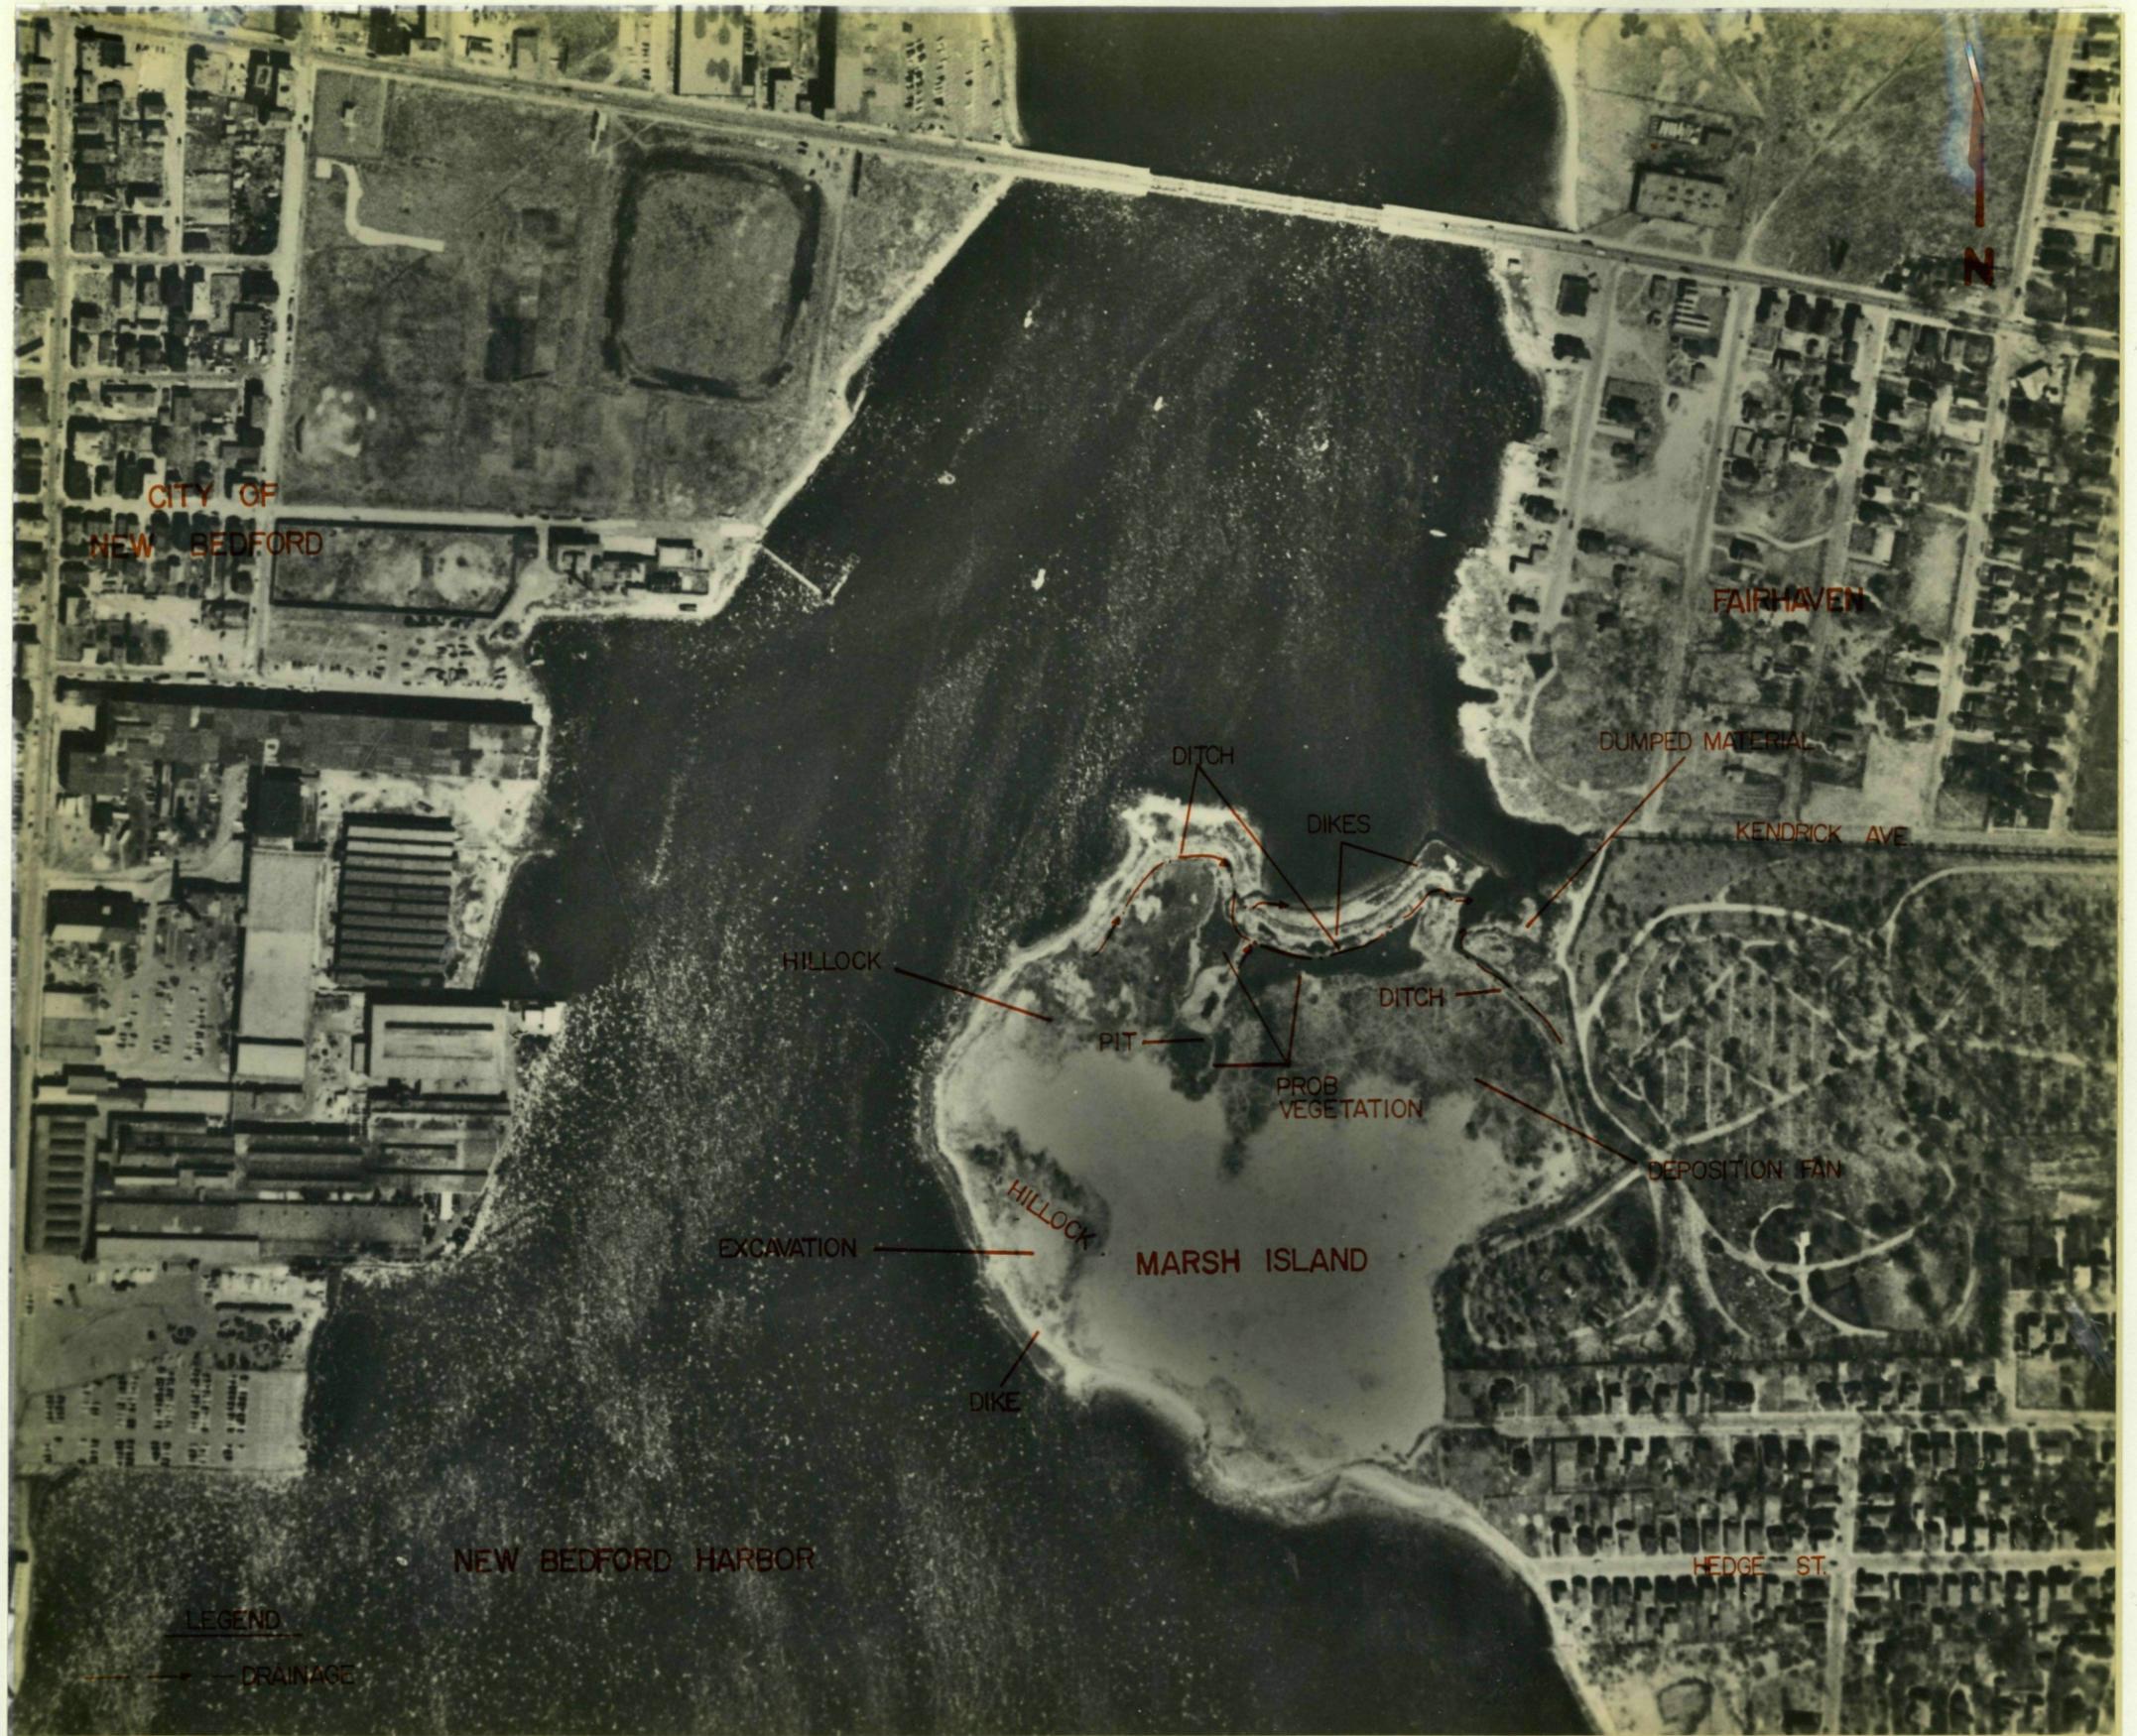
MAY 1, 1956

Little change has occurred on the site since 1938.

The layer of fine-textured white material still covers the south end of the peninsula. It has changed only slightly since 1938. The fan of darker material on the northeast edge of the light-toned material is slightly larger than it was in 1938. No signs of recent dumping of dredge spoils remain in this area. The area appears to have a thin cover of vegetation. The low area on the north side of the peninsula is very dark in tone, probably due to thicker vegetation cover and, possibly, higher soil moisture content.

A drainage ditch, which contains liquid, has been dug inside the dike on the northern edge of the site. A pit is connected to this ditch via a small channel. Standing liquid is visible in the pit. In 1938 this pit may have been present under a pool of standing liquid.

Additional material has been dumped outside the dike on the northeast corner of the site. A new man-made ditch now extends along the west side of this fill area.

Distinct signs of excavation are visible on the south side of the southern hillock. It does not appear as if additional material has been removed since 1938.

The dike still extends around the entire perimeter of the site, broken only by two new drainage outlets on the north side. Additional filling has occurred between the main dike and the smaller dike on the north side of the peninsula.

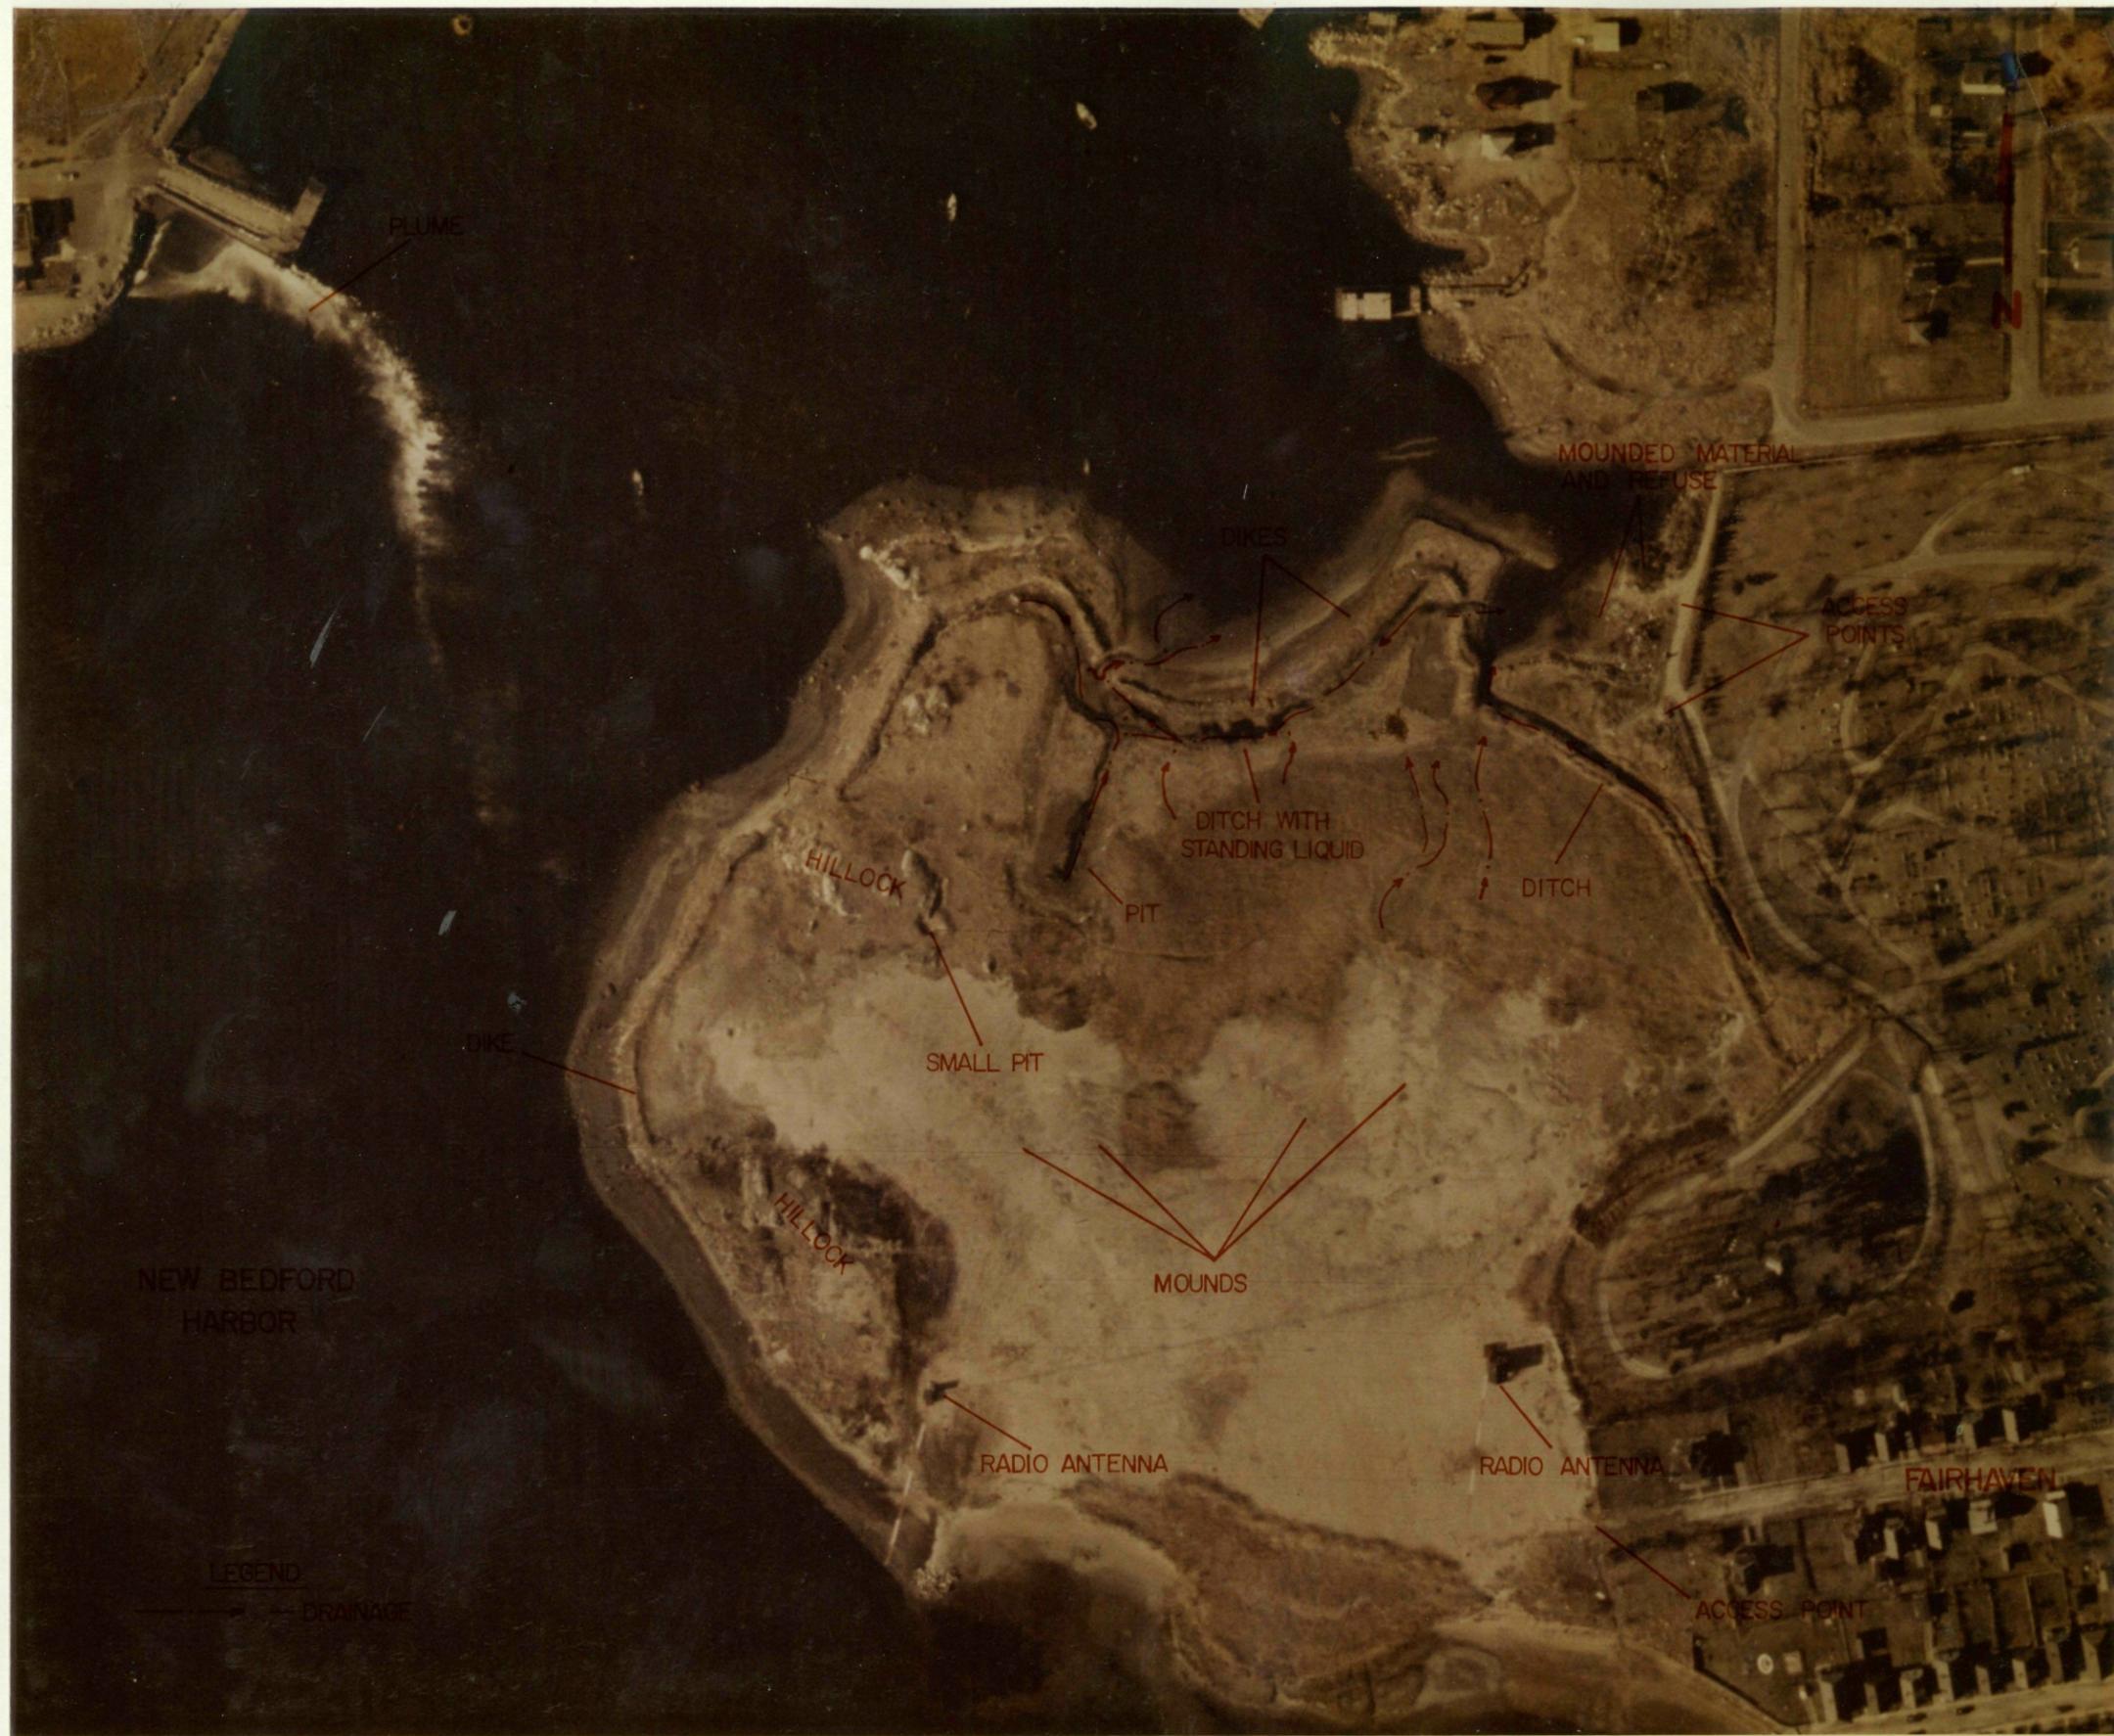
APRIL 10, 1962

No signs of additional dumping of dredge spoils are present on Marsh Island peninsula.

Linear ridges of mounds are now visible in the light-toned layer of fill. These were present in 1938 and 1956, but they were less noticeable on the earlier, small-scale photographs.

Additional fill has been added to the area between the two dikes on the north side of the site. Additional filling has also occurred in the northeast corner of the site, where mounded material and refuse are visible.

The drainage ditches present in 1956 are visible in more detail on the 1962 photograph, but they appear essentially unchanged.

The dike no longer extends virtually unbroken around the entire peninsula; portions of it are still present.

Two radio antennas and their associated small buildings are now present on site.

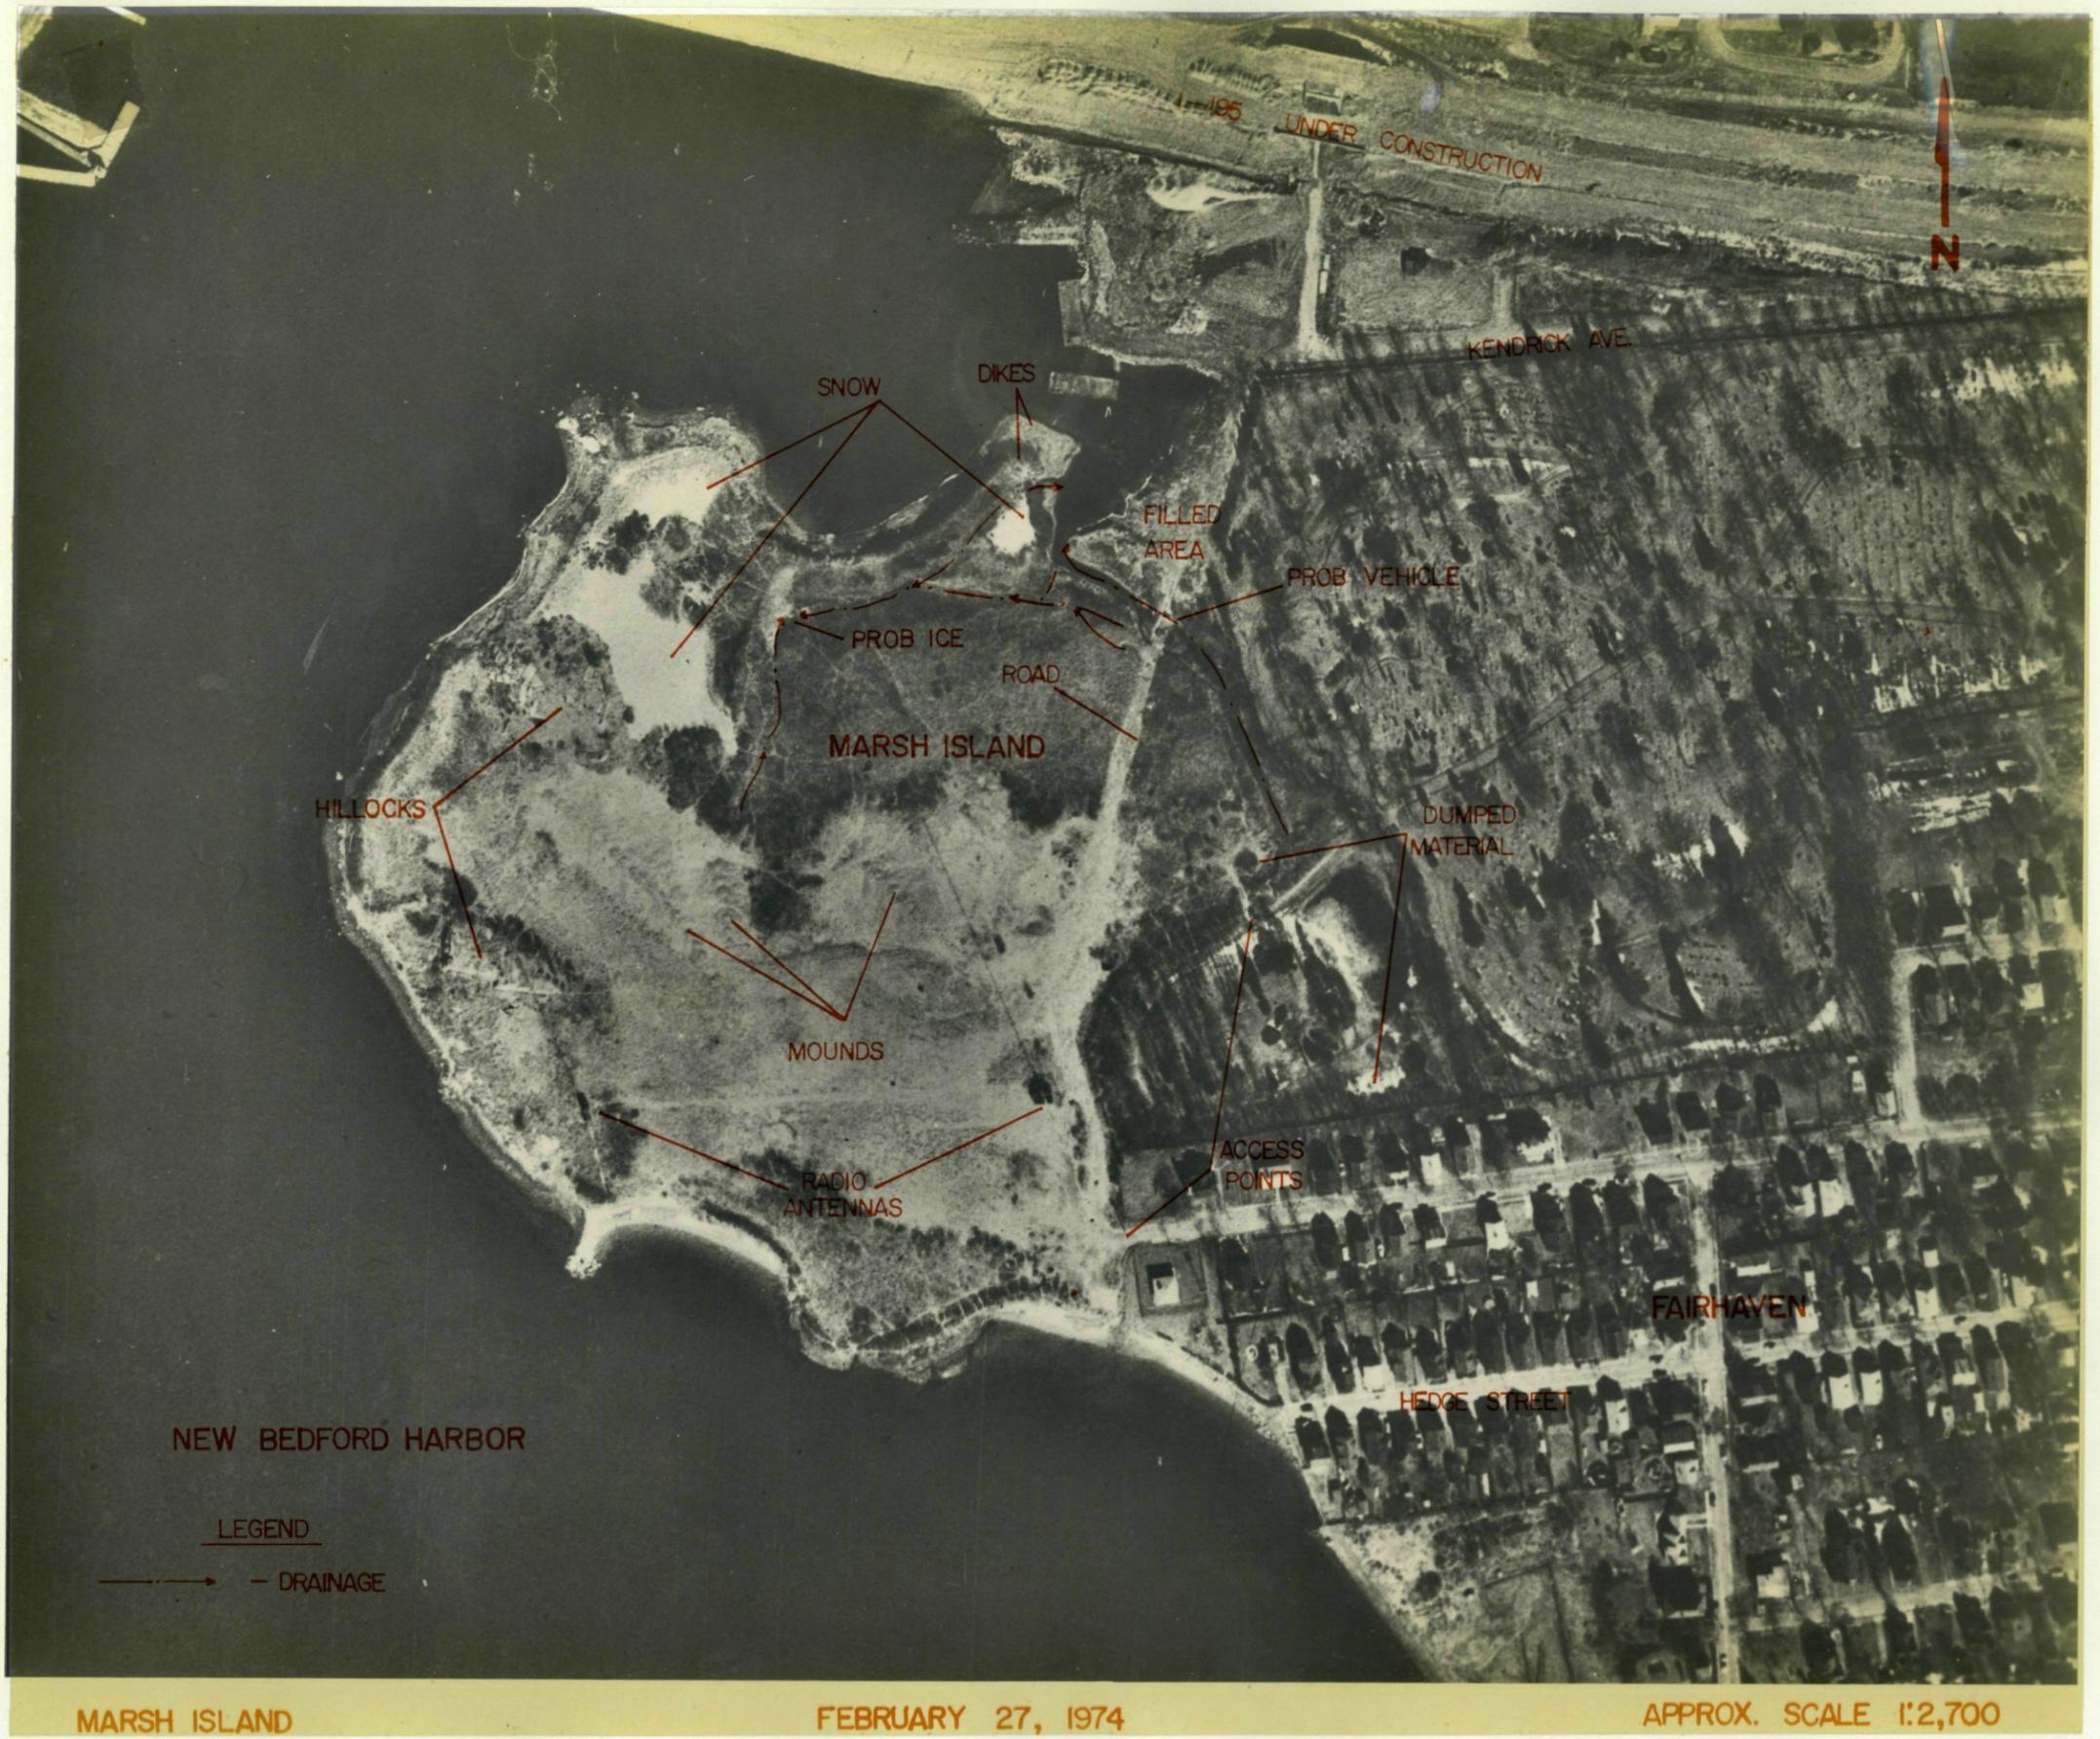
FEBRUARY 27, 1974

No signs of additional dumping of dredge spoils are present on Marsh Island peninsula.

The linear ridges of mounds are still visible in the fine-textured fill on the south side of the site. No additional filling has occurred between the two dikes on the north side of the site. Little, if any, additional material has been added to the filled area in the northeast corner of the site. A small amount of dumped material is now present near a new access point on the east side of the site. Dumped material is also visible in the woods east of the site.

The drainage ditches on the north side of the site are not as well-defined on the 1974 photograph as they were on the 1962 photograph. Patches of snow are present on the north side of the site.

Some additional revegetation has occurred since 1962 along the north and far south sides of the peninsula.

The two radio antennas are still present. A probable vehicle is visible on the new road that connects the southern part of the site with the filled area in the northeast corner of the site.
