APPENDIX A

SITE PHOTOGRAPHS

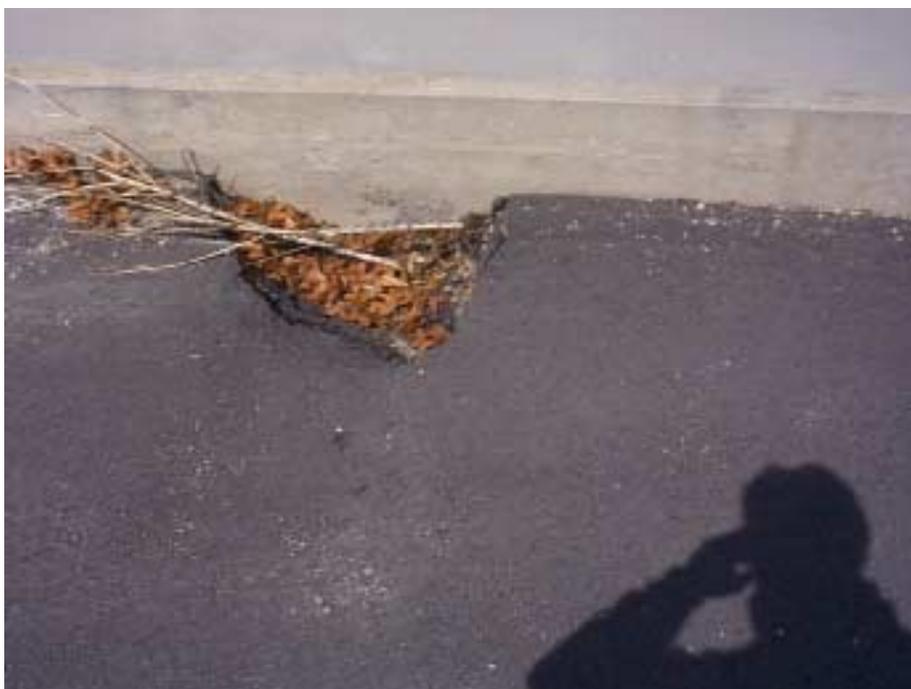
SITE 2 – AREA A LANDFILL AND WETLAND
VIEW OF A DEPRESSION IN THE ASPHALT ABOVE THE NORTHERN CULVERT'S
HEADWALL.
APRIL 10, 2001
NSB-NLON, GROTON, CONNECTICUT. CTO 0816

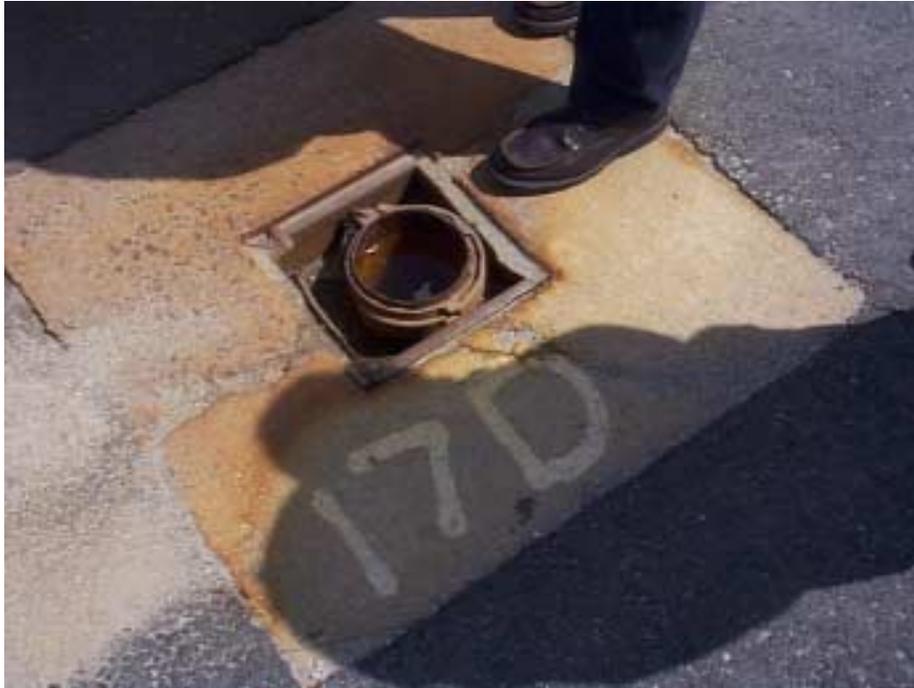
SITE 2 – AREA A LANDFILL AND WETLAND
VIEW OF MONITORING WELL 2LMW17D. THE WELL WAS MISSING A COVER AND LID.
APRIL 10, 2001
NSB-NLON, GROTON, CONNECTICUT. CTO 0816

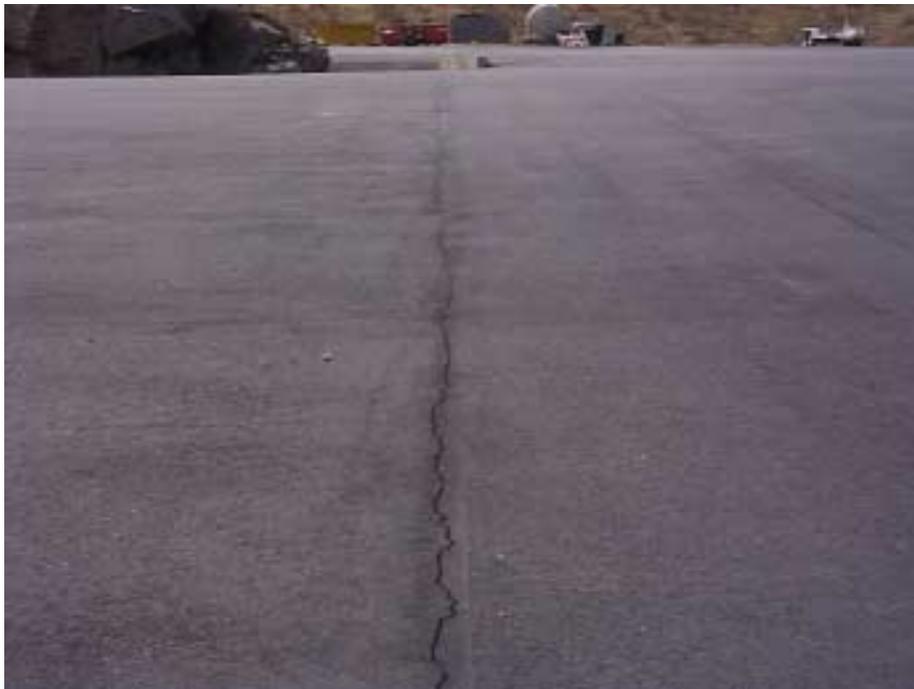
SITE 2 – AREA A LANDFILL AND WETLAND
VIEW OF A LONGITUDINAL (NORTH-SOUTH) CRACK IN THE ASPHALT AT
APPROXIMATELY THE MIDDLE OF THE COVER AREA.
APRIL 10, 2001
NSB-NLON, GROTON, CONNECTICUT. CTO 0816

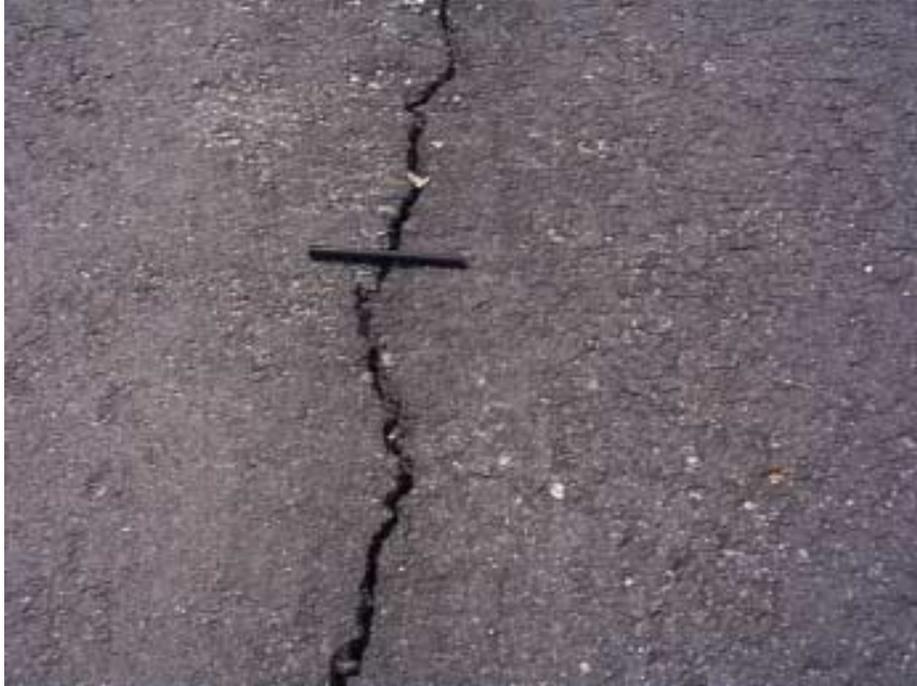
SITE 2 – AREA A LANDFILL AND WETLAND
CLOSE UP VIEW OF THE LONGITUDINAL CRACK IN THE ASPHALT LAYER.
APRIL 10, 2001
NSB-NLON, GROTON, CONNECTICUT. CTO 0816

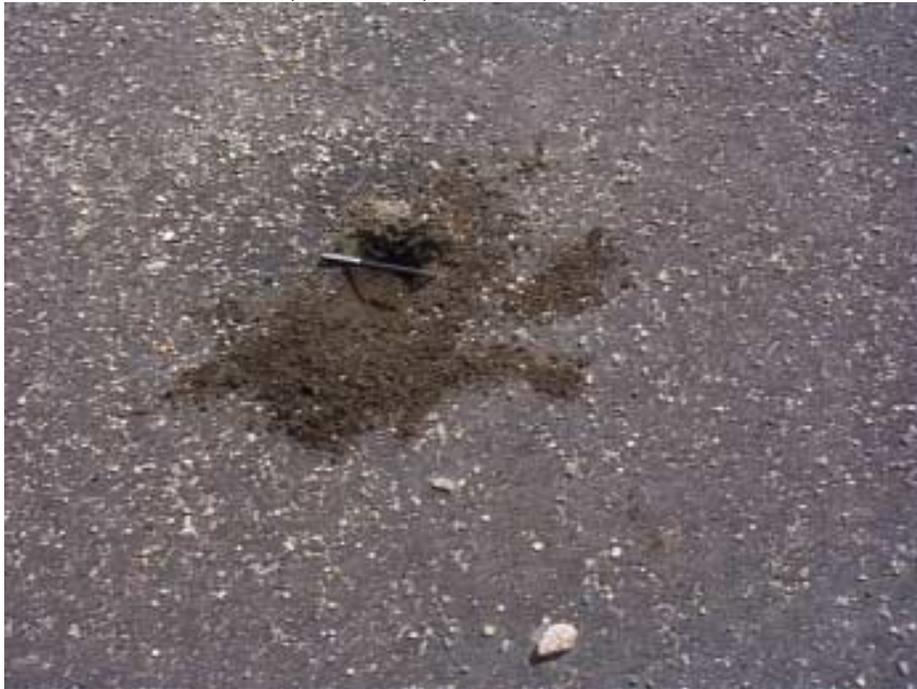
SITE 2 – AREA A LANDFILL AND WETLAND
VIEW OF A HOLE IN THE ASPHALT LAYER FROM THE FIRST QUARTER AREA OF THE
COVER. BELIEVED TO BE CAUSED FROM HEAVY EQUIPMENT PARKED ON ASPHALT.
APRIL 10, 2001
NSB-NLON, GROTON, CONNECTICUT. CTO 0816

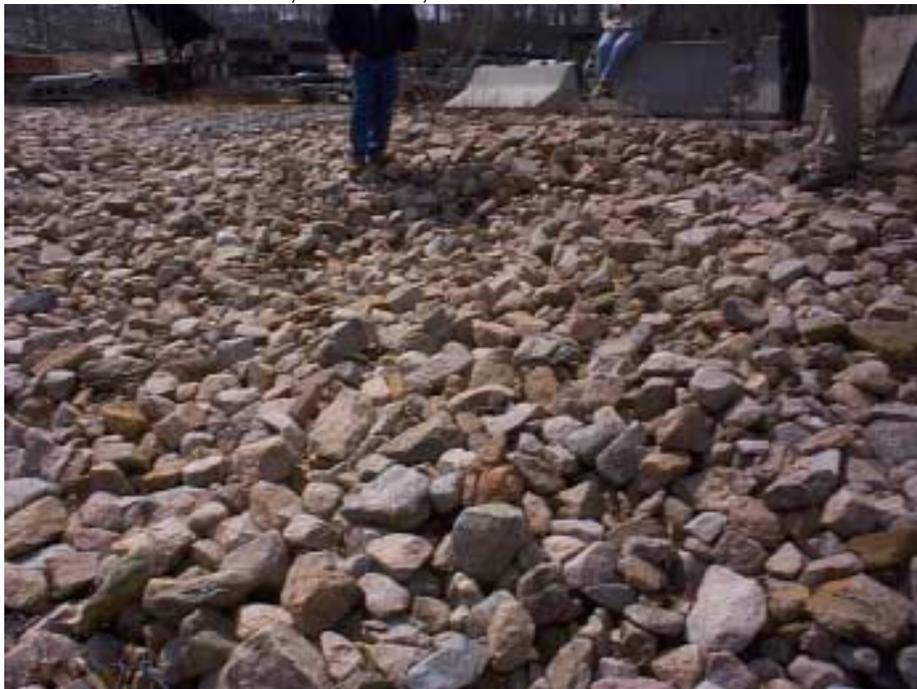
SITE 2 – AREA A LANDFILL AND WETLAND
VIEW OF DEPRESSION IN RIP RAP AT TOE OF LANDFILL AT NORTHEASTERN END OF
CAP. POSSIBLE LOCATION OF PIPING OF FINES FROM BENEATH RIP RAP.
APRIL 10, 2001
NSB-NLON, GROTON, CONNECTICUT. CTO 0816

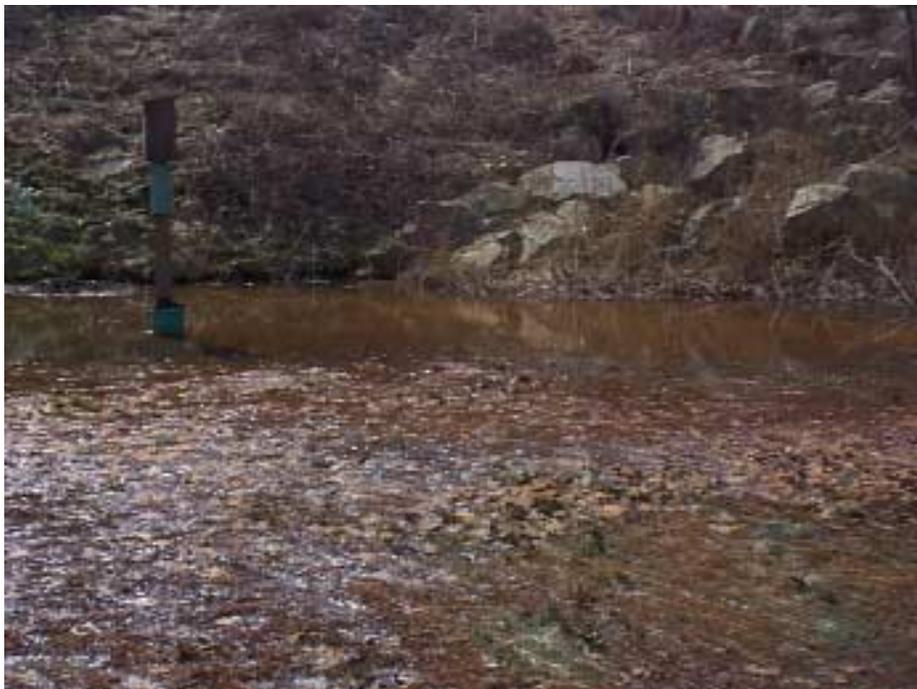
SITE 3 – AREA A DOWNSTREAM/OBDA
VIEW OF SEEP ON SOUTHERN BANK OF OBDA POND.
APRIL 10, 2001
NSB-NLON, GROTON, CONNECTICUT. CTO 0816

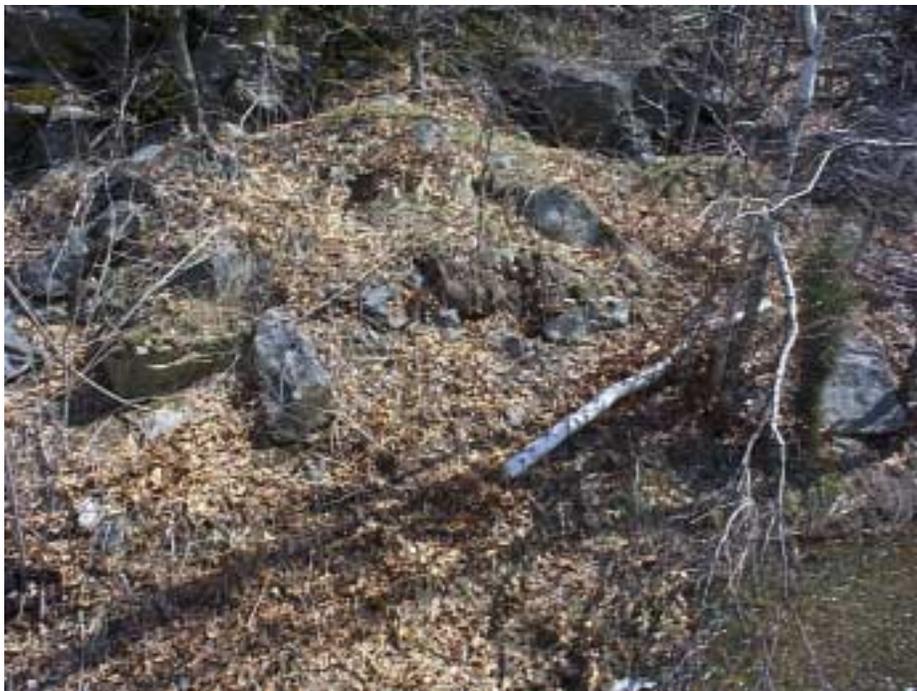
SITE 3 – AREA A DOWNSTREAM/OBDA
VIEW OF NEWLY DISCOVERED DISPOSAL AREA ON HILLSIDE TO THE NORTH OF
STREAM 5.
APRIL 10, 2001
NSB-NLON, GROTON, CONNECTICUT. CTO 0816

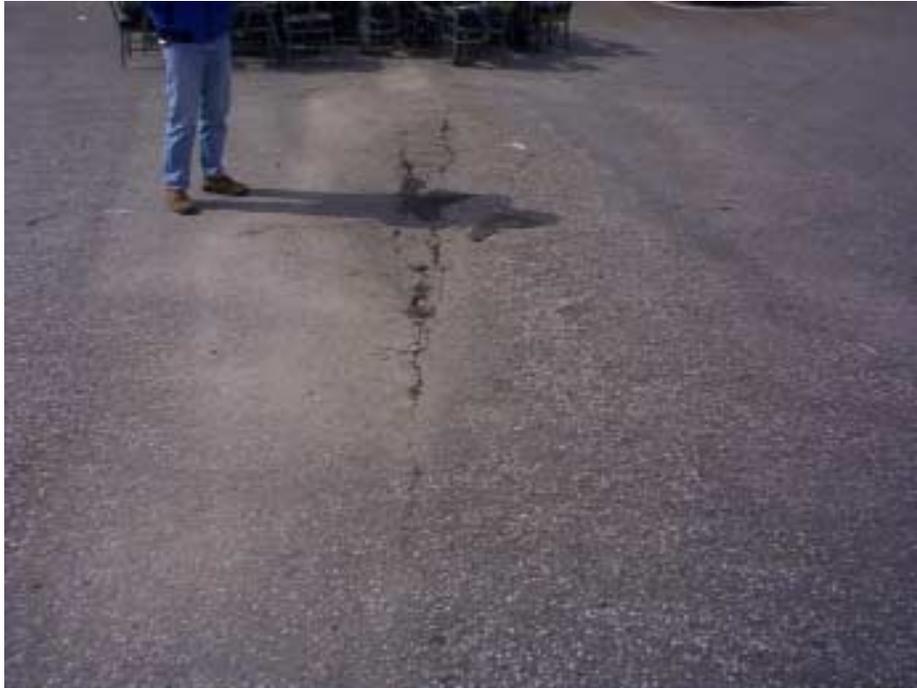
SITE 6 – DRMO
AREA OF SETTLEMENT APPROXIMATELY 50 FEET SOUTHWEST OF THE SOUTHWEST
CORNER OF BUILDING 491.
APRIL 11, 2001
NSB-NLON, GROTON, CONNECTICUT. CTO 0816

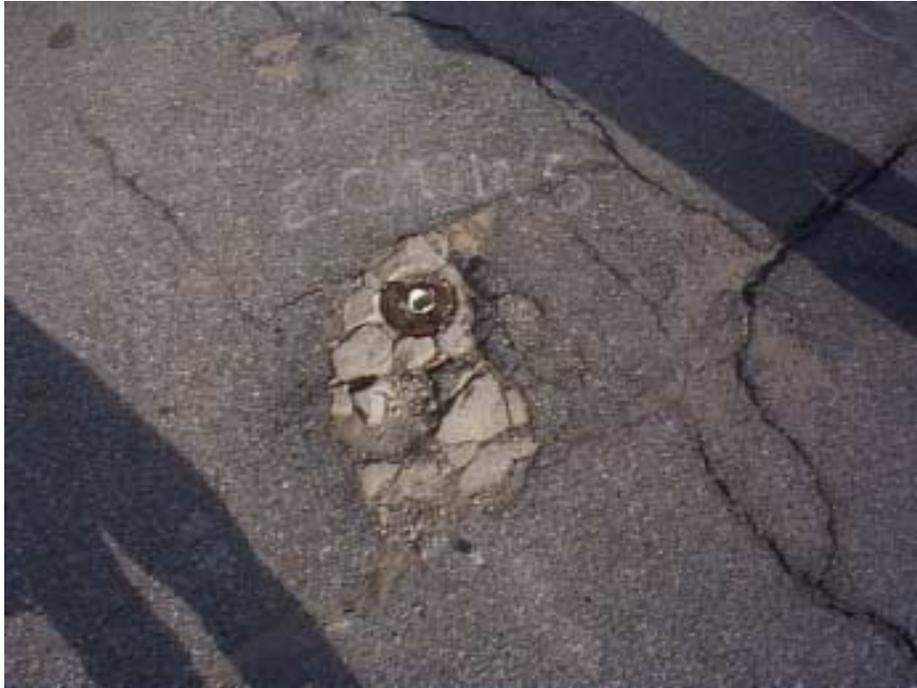
SITE 21 – BERTH 16
CLOSE UP VIEW OF DAMAGED MONITORING WELL 20MW5.
APRIL 10, 2001
NSB-NLON, GROTON, CONNECTICUT. CTO 0816
