Re Third Five-Year Review for the Naval Submarine Base New London Superfund Site

Thank you for the opportunity to review the *Third Five-Year Review for CERCLA Sites at Naval Submarine Base New London, Groton, CT*, dated December 2011. EPA reviewed this document in light of its compliance with the *Comprehensive Five-Year Review Guidance* (OSWER No 9355 7-03B-P dated June 2001). This statutory review is consistent with the guidance provided in the OSWER directives. Upon review, EPA concurs with the findings that the remedies that have been implemented at the Area A Landfill, the Goss Cove Landfill, the Defense Reutilization and Marketing Office, the Area A Downstream/Over Bank Disposal Area, the Area A Weapons Center, the Torpedo Shops, and Basewide Groundwater are protective of human health and the environment.

During EPA's site walkover on April 6, 2011, numerous issues were identified with respect to the on-going maintenance of several remedies currently in place. These issues are summarized appropriately in Table 18-2 of the *Third Five-Year Review* report along with corresponding recommendations to address them. EPA is pleased that the Navy has already put in place plans to

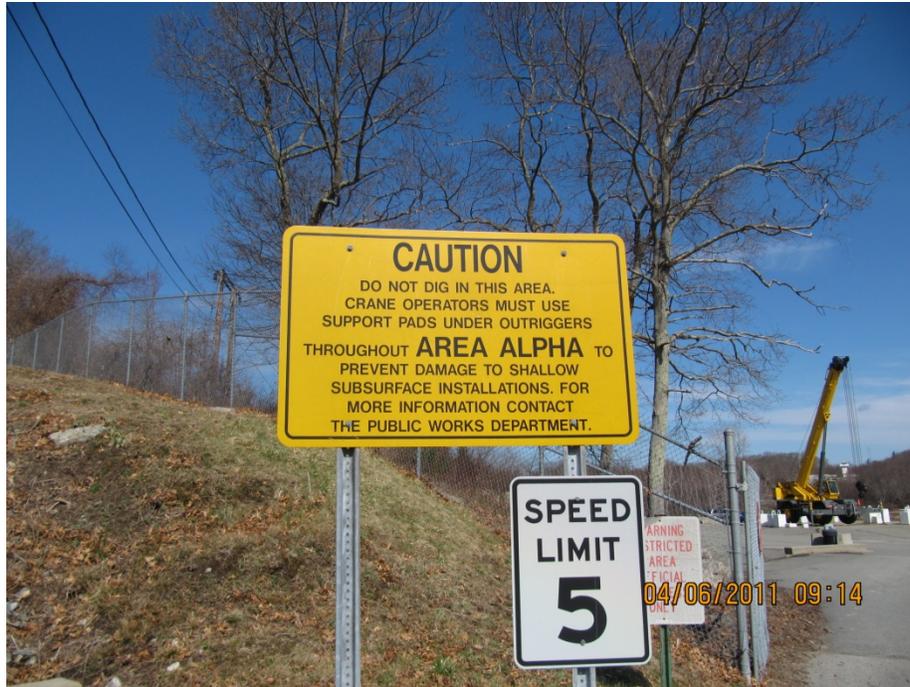
SITE 2A – AREA A LANDFILL  
SIGN AT SALT STORAGE AREA COVERED BY TREE  
APRIL 6, 2011  
NSB-NLON, GROTON, CONNECTICUT. CTO WE33

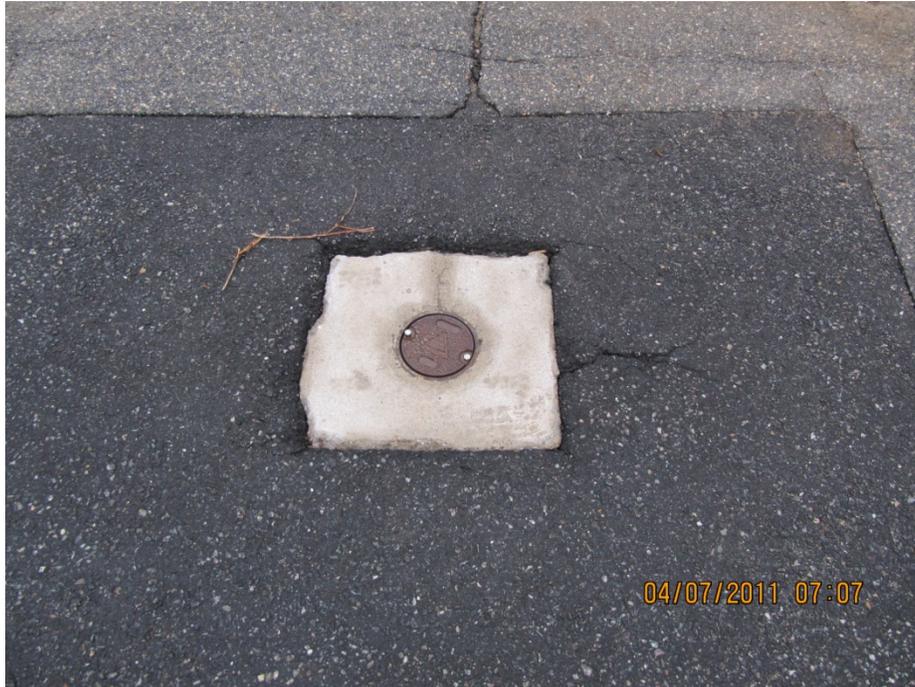
(9) The cover of monitoring well 4MW1S is broken and the riser is bent, which could lead to the integrity of the well being compromised.

SITE 2A – AREA A LANDFILL  
DAMAGED MONITORING WELL 4MW1S  
APRIL 6, 2011  
NSB-NLON, GROTON, CONNECTICUT. CTO WE33

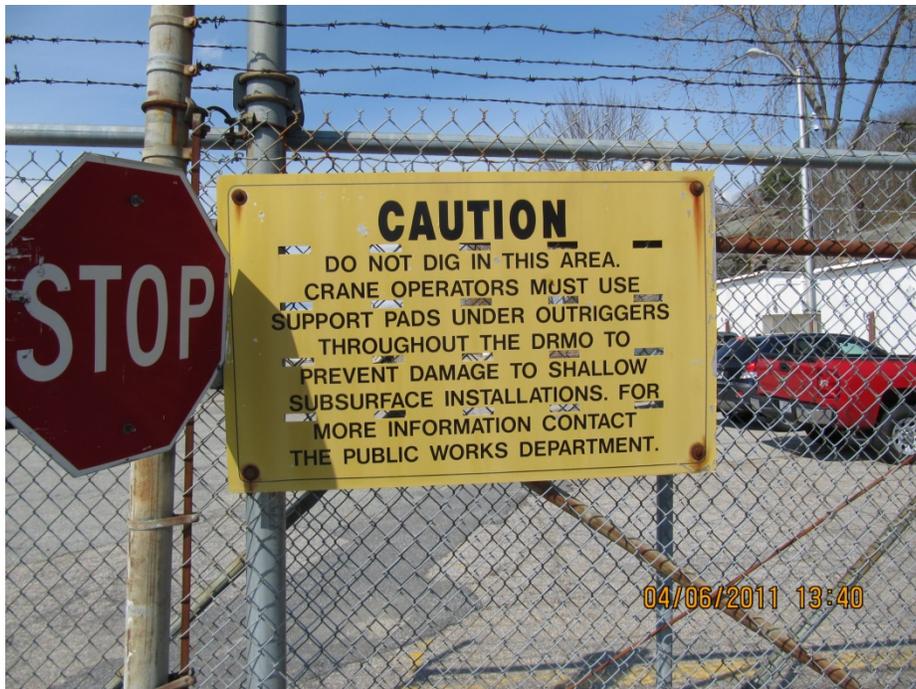
(7) A sign was missing Public Works contact information. Until a LUC RD for Site 6 is completed and implemented, LUCs are being enforced under the NSB-NLON Instruction and the O&M program.

SITE 6 – DRMO  
SIGN MISSING PUBLIC WORKS DEPARTMENT PHONE NUMBER  
APRIL 6, 2011  
NSB-NLON, GROTON, CONNECTICUT. CTO WE33

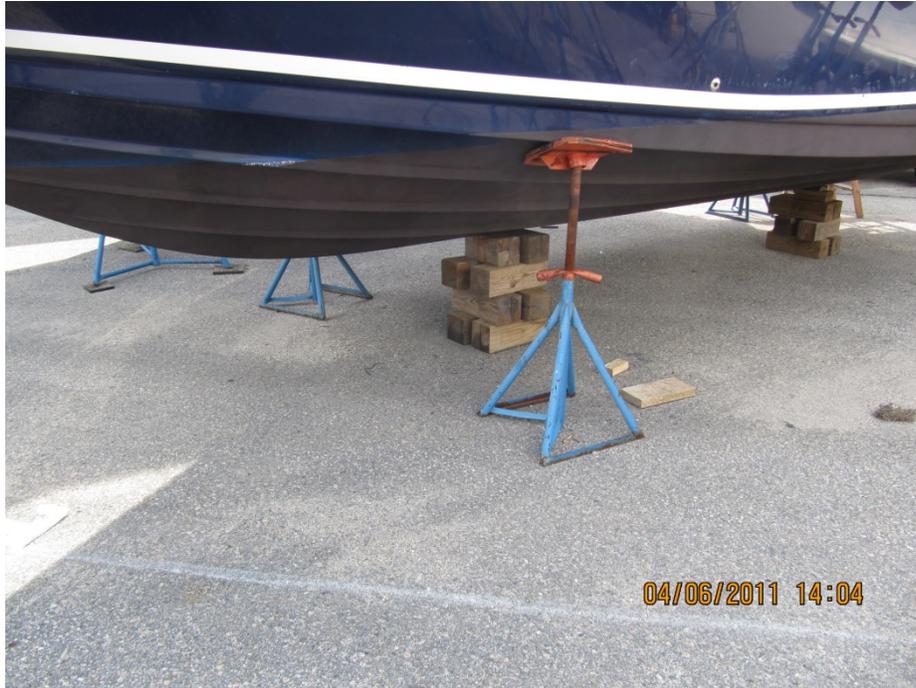
During the review process for Site 6 (OU2), one deficiency and several O&M issues were identified that, if not addressed, could negatively affect the long-term performance of the cap system. The deficiency was that boats are being stored on the cap without blocking to prevent point-load damage to the asphalt. The O&M issues included the following:

SITE 6 – DRMO  
IMPROPER BOAT STORAGE ON CAP  
APRIL 6, 2011  
NSB-NLON, GROTON, CONNECTICUT. CTO WE33

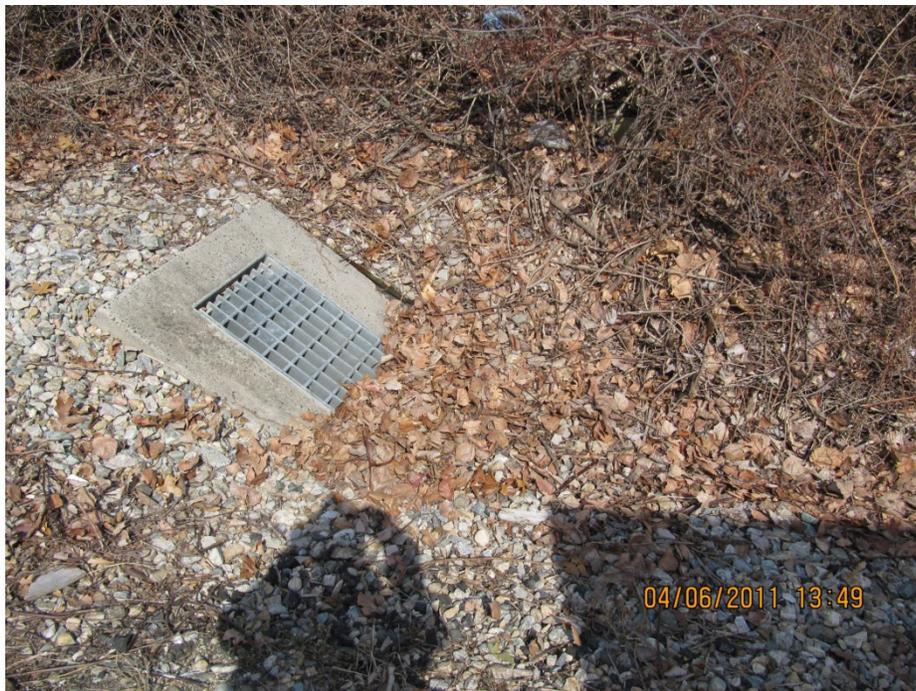
SITE 6 – DRMO  
LEAF LITTER ACCUMULATION IN DROP INLET  
APRIL 6, 2011  
NSB-NLON, GROTON, CONNECTICUT. CTO WE33

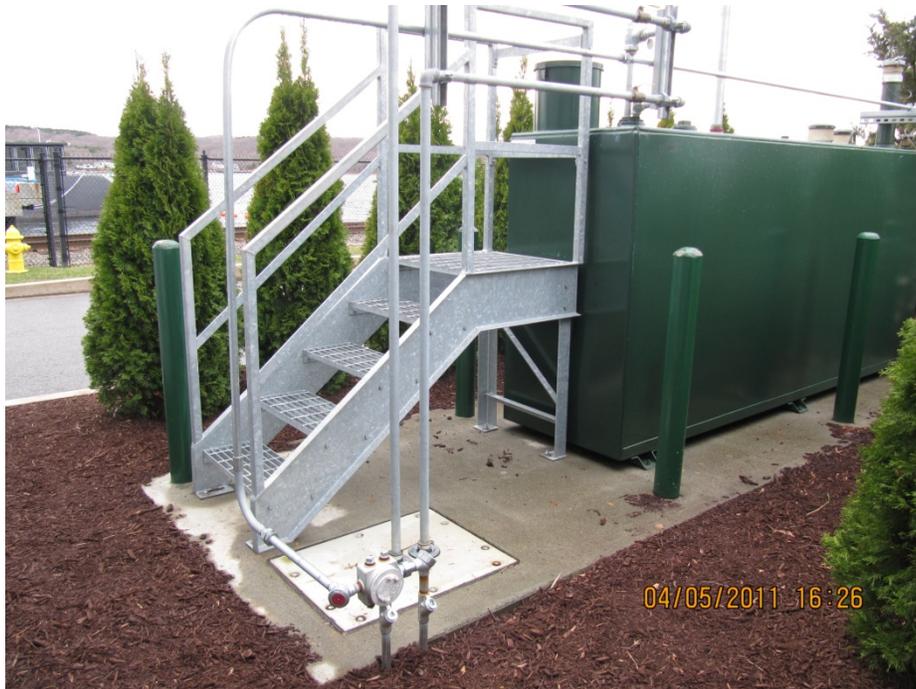
One deficiency and a number of O&M issues were identified at Site 8 (OU5) through the review process. Most of the issues were minor and overall the site is in good condition. The one deficiency identified had the potential to impact the long-term performance of the cap. An above-ground storage tank (AST), its foundation (concrete pad), and associated piping were installed on the cap without prior knowledge or permission from the Installation Restoration Program (IRP) Manager. The pad and piping for the AST were subsequently investigated for possible major impacts to the cap system. An investigation was planned and executed in October 2011 to determine if the cap was damaged, or a portion of the cap removed during the AST installation, allowing infiltrating surface water to flow through the waste material in the landfill and promoting contaminant migration to groundwater. The investigation determined that the liner system was not compromised. Therefore, the Navy did not need to remediate any damage to the cap. Additionally, a subsequent investigation is being completed to determine whether the AST pad can be enlarged without impacting the cap. The O&M issues are summarized as follows:

SITE 8 – GOSS COVE LANDFILL  
AST FOUNDATION THAT MAY HAVE DAMAGED CAP  
LOOKING NORTHWEST  
APRIL 6, 2011  
NSB-NLON, GROTON, CONNECTICUT. CTO WE33

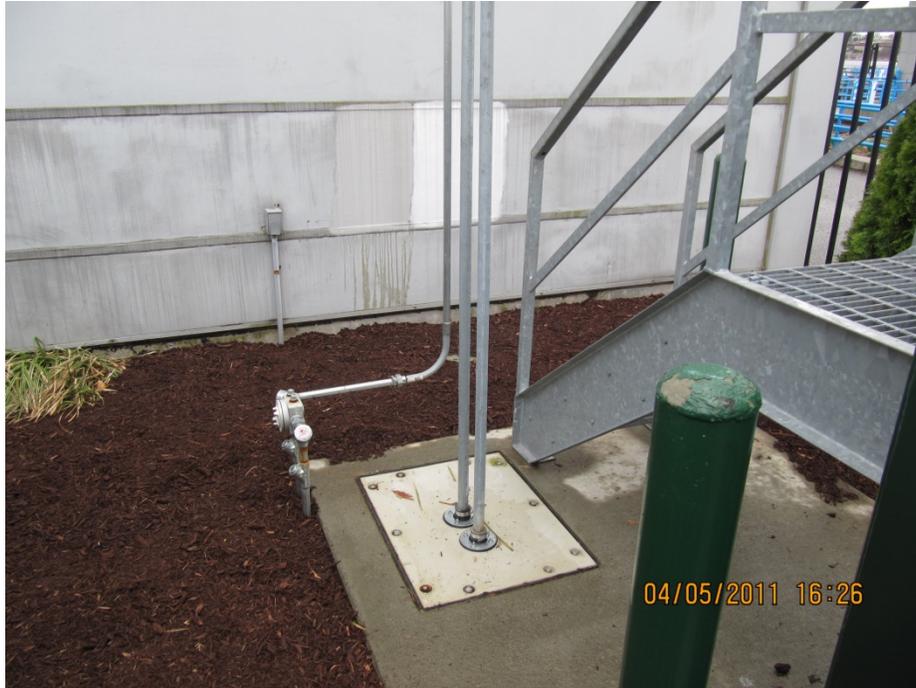
SITE 8 – GOSS COVE LANDFILL  
PROXIMITY OF AST FOUNDATION TO MUSEUM, LOOKING SOUTH  
APRIL 6, 2011  
NSB-NLON, GROTON, CONNECTICUT. CTO WE33

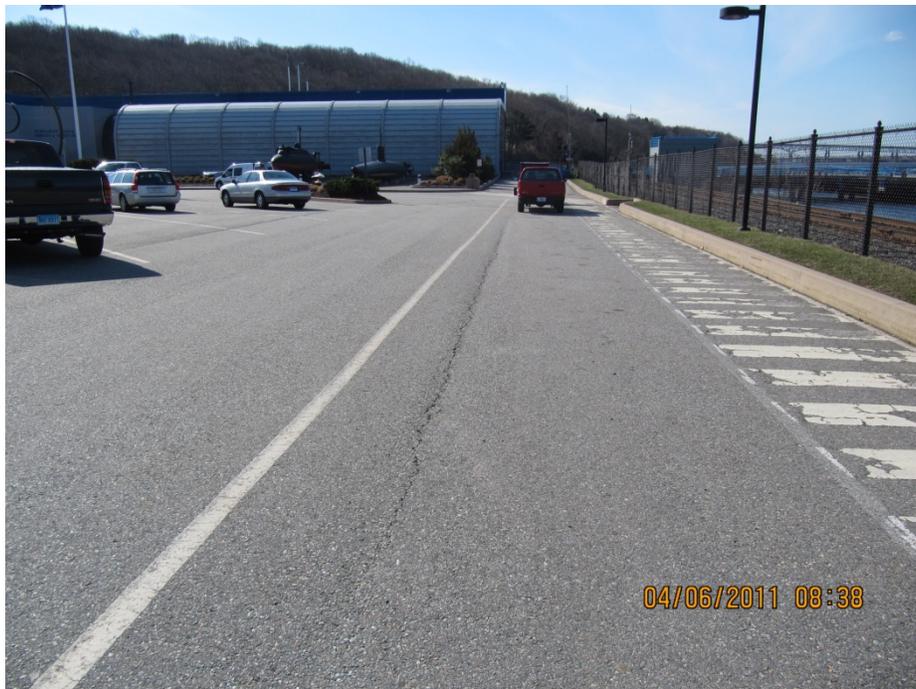
(7) Minor longitudinal cracks in the asphalt were observed during the inspection. These cracks need to be repaired to prevent water from penetrating the asphalt and entering the cap drainage layer.

SITE 8 – GOSS COVE LANDFILL  
MINOR LONGITUDINAL CRACK IN ASPHALT, LOOKING SOUTH  
APRIL 6, 2011  
NSB-NLON, GROTON, CONNECTICUT. CTO WE33

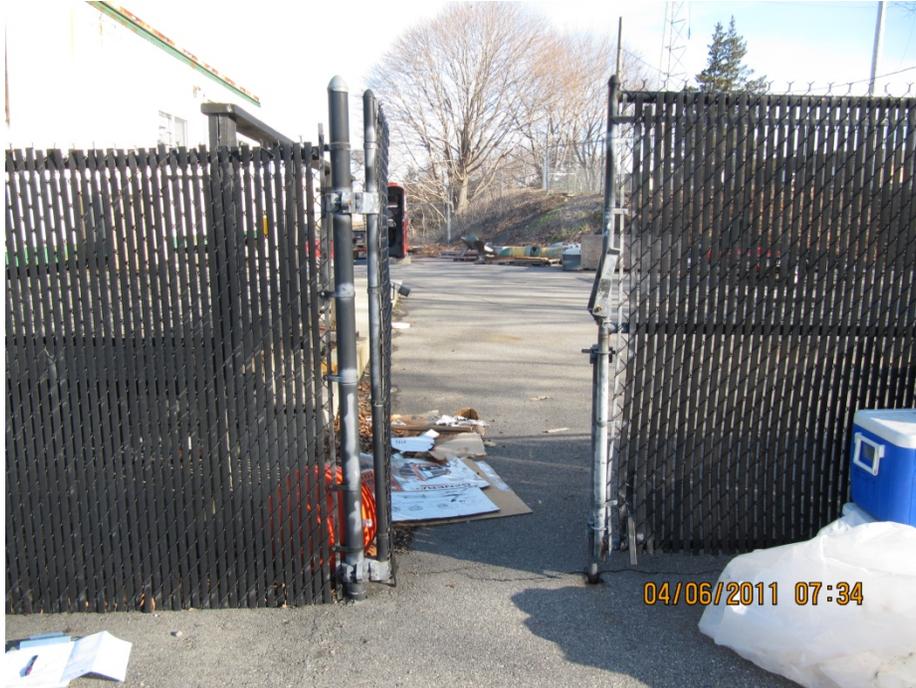
SITE 8 – GOSS COVE LANDFILL  
UNLOCKED GATE ON THE NORTHERN END OF CAP, LOOKING NORTH  
APRIL 6, 2011  
NSB-NLON, GROTON, CONNECTICUT. CTO WE33

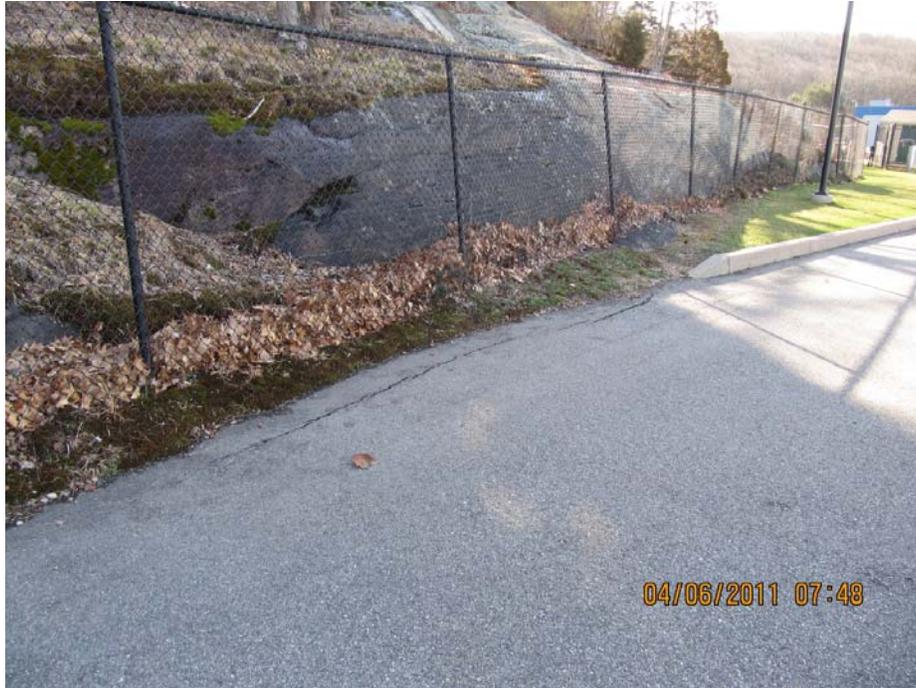
(6) Minor settling of the asphalt around Light Pole 11 was observed during the inspection. The asphalt should be repaired to prevent water from penetrating the asphalt and entering the cap drainage layer.

SITE 8 – GOSS COVE LANDFILL  
MINOR LONGITUDINAL CRACK BETWEEN LIGHT POLES 11 AND 9, LOOKING SOUTHEAST  
APRIL 6, 2011  
NSB-NLON, GROTON, CONNECTICUT. CTO WE33

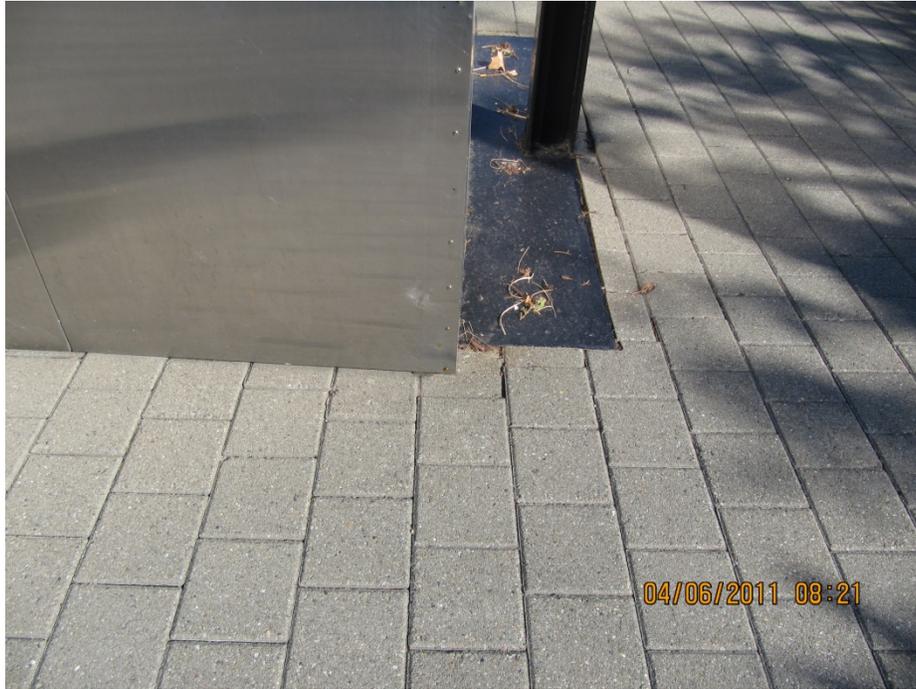
(2) There has been some apparent settling of the pavers beneath the gun and missile hatch displays. The displays should be monitored to detect any additional settling that potentially could lead to future cap damage.

SITE 8 – GOSS COVE LANDFILL  
SLIGHT SAGGING OF PAVERS AROUND MISSILE HATCH DISPLAY, LOOKING NORTH  
APRIL 6, 2011  
NSB-NLON, GROTON, CONNECTICUT. CTO WE33

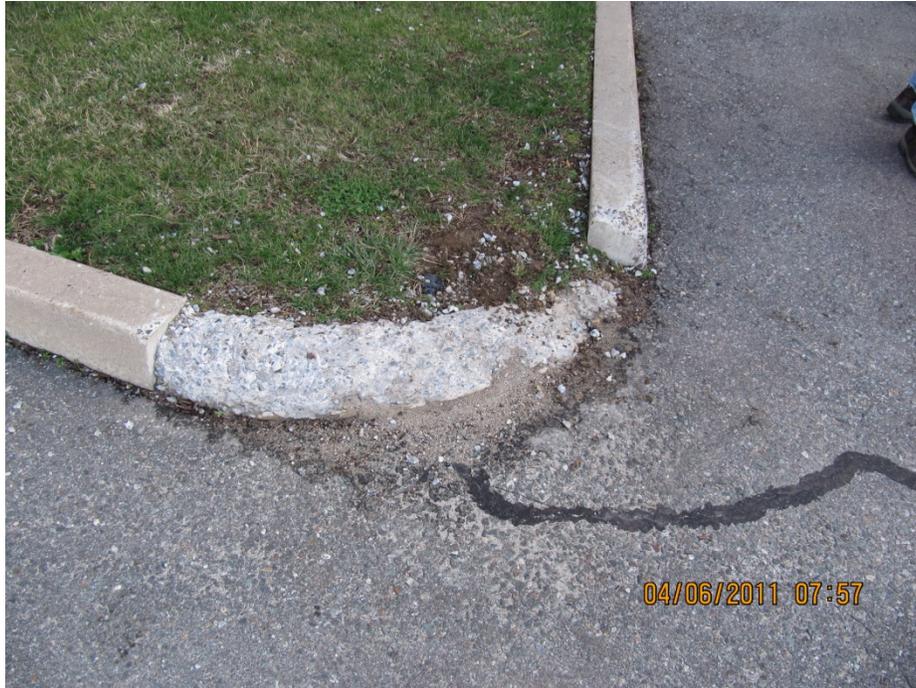
(4) The sprinkler head near Gas Vent M, adjacent to the damaged curb, is damaged, a condition that could lead to pooling of surface water. A follow-up inspection of the area by Sovereign Consulting Inc., the O&M contractor, noted that the head was bent at an angle and missing part of its cap, and recommended that the sprinkler head be replaced and the angle adjusted to provide proper irrigation of the area.

SITE 8 – GOSS COVE LANDFILL  
DAMAGED CURB AND SPRINKLER HEAD NEAR GAS VENT M, LOOKING EAST  
APRIL 6, 2011  
NSB-NLON, GROTON, CONNECTICUT. CTO WE33

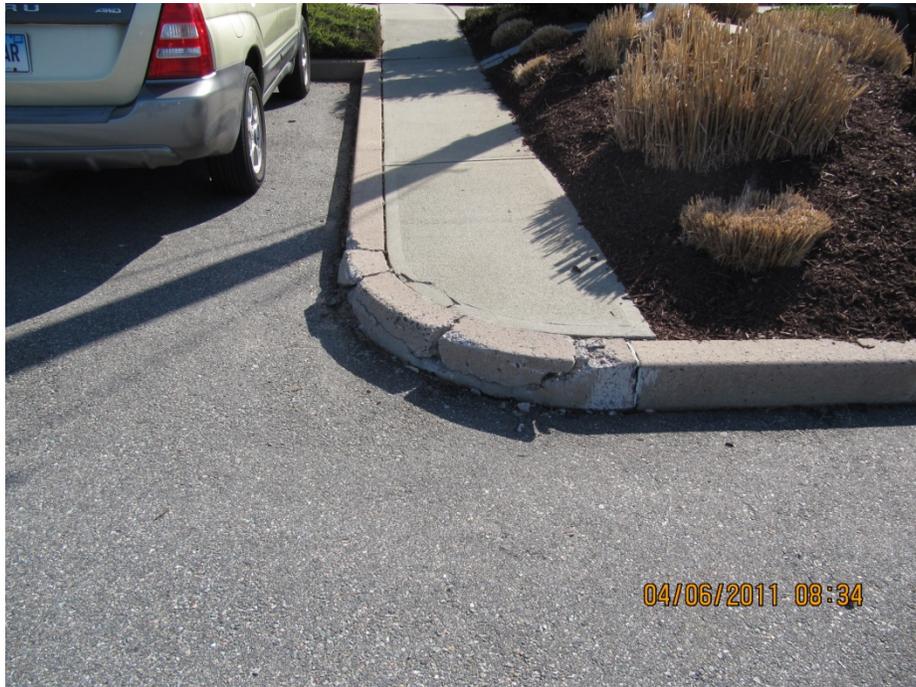
SITE 8 – GOSS COVE LANDFILL  
DAMAGED CURB NEAR FLAGPOLE B, LOOKING EAST  
APRIL 6, 2011  
NSB-NLON, GROTON, CONNECTICUT. CTO WE33
