SDMS DocID 494738

**ADDENDUM TO FOURTH FIVE-YEAR REVIEW. NYANZA CHEMICAL WASTE DUMP
SUPERFUND SITE, DATED MAY 13, 2009**

US Army Corps of Engineers New England District	
NYANZA CHEMICAL WASTE DUMP SUPERFUND SITE ASHLAND, MASSACHUSETTS PROPERTY LOCATIONS	
FIGURE

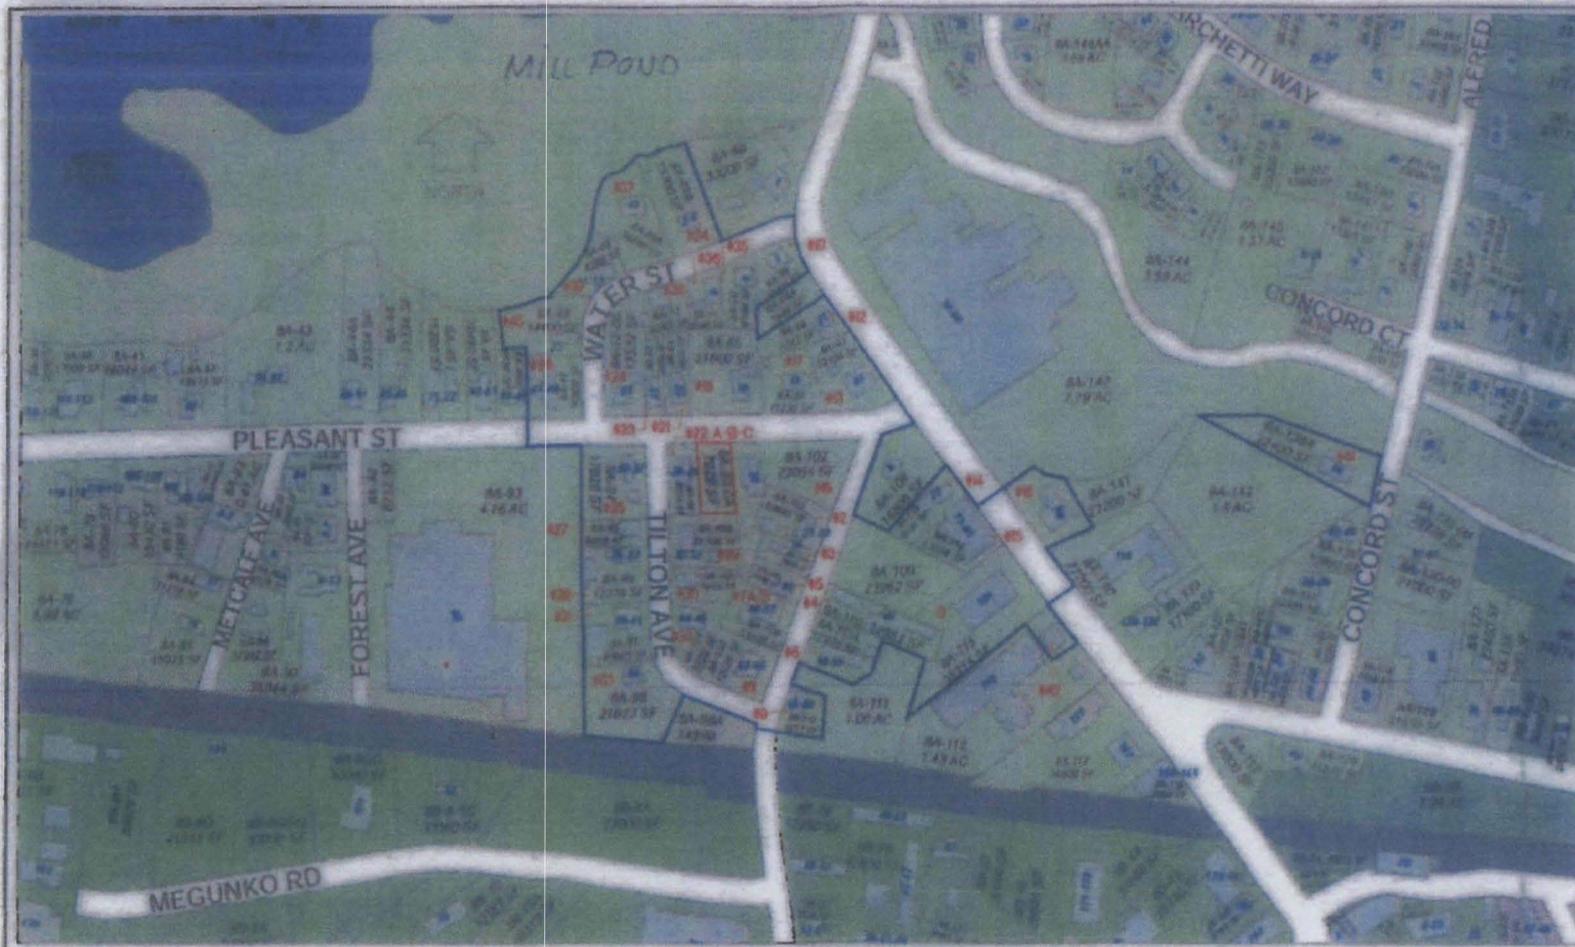
FIGURE 1

MassDEP has since completed inspections (referred to by MassDEP as baseline maintenance and monitoring activities) for all forty-three (43) VMS units. The attached Figure 1 shows VMS property locations. Thirty-three (33) of the VMS units had no significant performance issues. A total of ten (10) VMS units did not achieve the minimum pressure-based performance standard at one of more pressure monitoring points. In an effort to achieve compliance, MassDEP performed numerous diagnostic and maintenance activities at these ten properties. These efforts generally included activities such as:

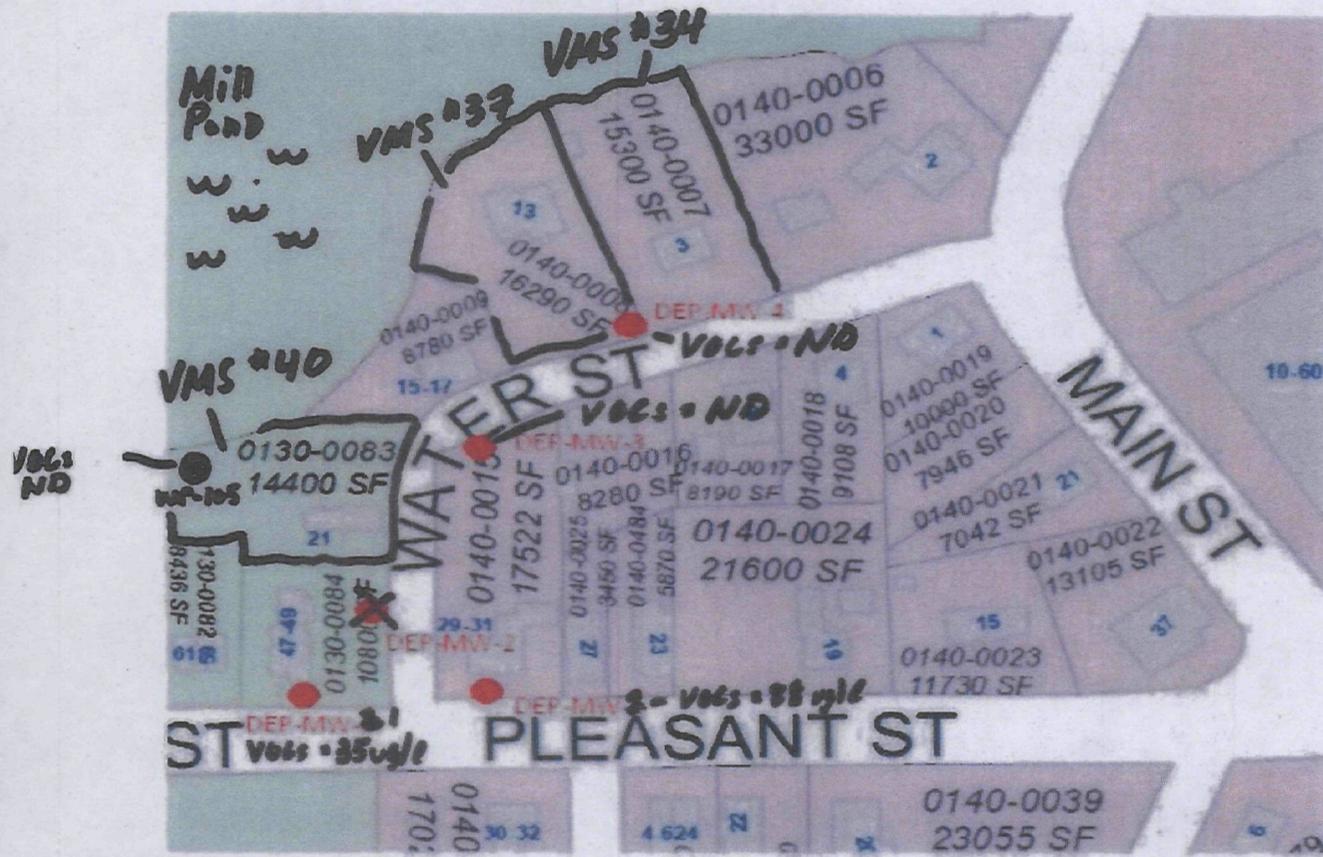
FIGURE 2

The three remaining properties are all located on Water Street and directly abut Mill Pond (VMS Property nos. 34, 37 and 40). Standing water was observed in the pressure monitoring points on numerous occasions. This confirms that an elevated water table condition exists underneath these homes as a result of influence from the pond. The water table rises to the bottom of the slab, circumventing the pressure field. There is no obvious method to lower the regional water table. Locally, sump pumps are present at

each of these properties. To better evaluate groundwater conditions in this area, MassDEP installed two piezometers screened across the shallow water table to measure VOC concentrations in the immediate vicinity of these properties (See attached Figure 2). Both wells were non-detect for VOCs. All the VMS units along Water Street had been installed as a pre-emptive mitigation measure based on groundwater VOC results available in 2006. The recent groundwater data from the new piezometers concludes that the shallow VOC plume does not extend under the Water Street properties and therefore mitigation of these three Water Street properties is no longer required. Notwithstanding, MassDEP will continue to monitor and maintain the VMS units along Water Street, and EPA will continue to sample the piezometers and area monitoring wells.

- WP 105 - TCE = ND
- DEP MW 3 - TCE = ND
- DEP MW 4 - TCE = ND
- DEP MW 1 - TCE = 35 ugle
- DEP MW 2 - TCE = 88 ugle
