**FIVE-YEAR REVIEW REPORT FOR  
F. O'CONNOR COMPANY SUPERFUND SITE  
KENNEBEC COUNTY, MAINE**

U.S. Environmental Protection Agency  
Region 1  
Boston, Massachusetts

09/26/12  
Date

## 2012 Five-Year Review Site Inspection Photographic Record

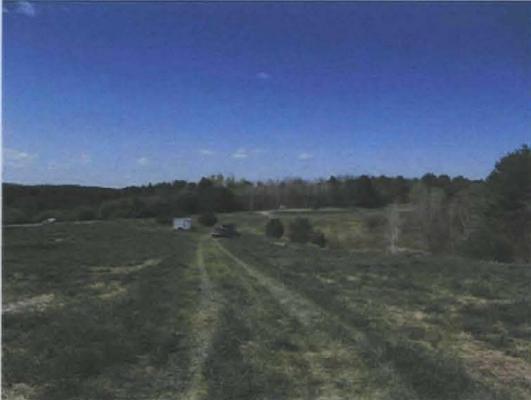
**Photo No: 1**  
**Date:** 4/26/2012  
**Comments:** At the high point of the Site at the TWA III area, on the access road, looking toward Route 17.

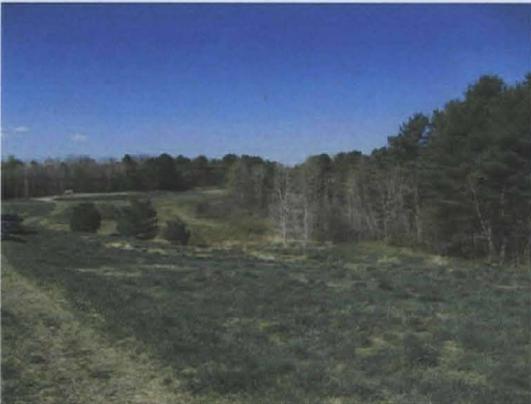
**Photo No: 2**  
**Date:** 4/26/2012  
**Comments:** Toward the wetland area west of the access road.

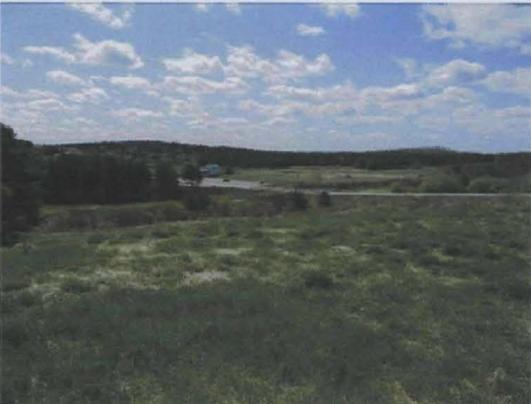
**Photo No: 3**  
**Date:** 4/26/2012  
**Comments:** From the TWA II area toward the lower lagoon.

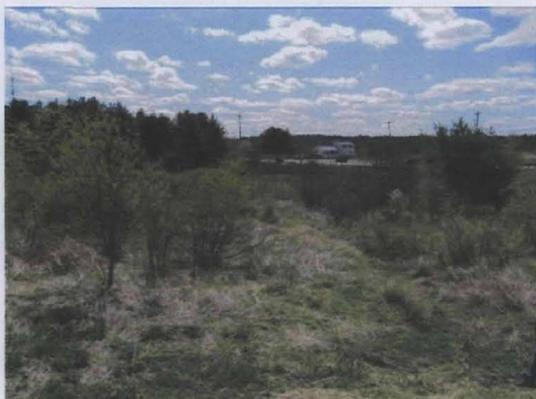
**Photo No: 4**

**Comments:** From the lower lagoon area looking toward Riggs Brook and its wetlands.

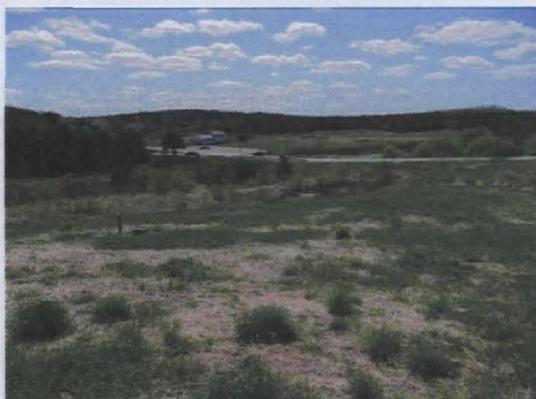
**Photo No: 5**

**Comments:** Standing near upper lagoon looking southeast toward the lower lagoon and Riggs Brook.

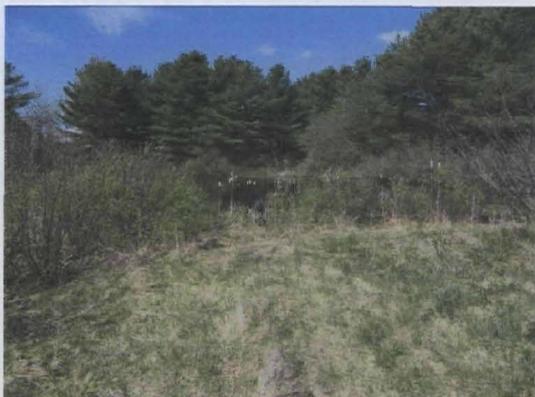
**Photo No: 7**  
**Date: 4/26/2012**  
**Comments: Upland wet area.**

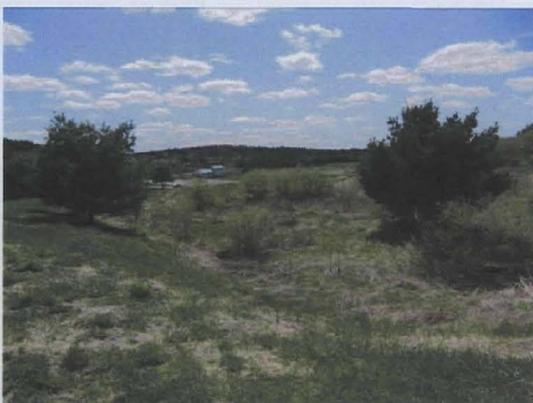
**Photo No: 8**  
**Date: 4/26/2012**  
**Comments: Upper lagoon/wetland.**

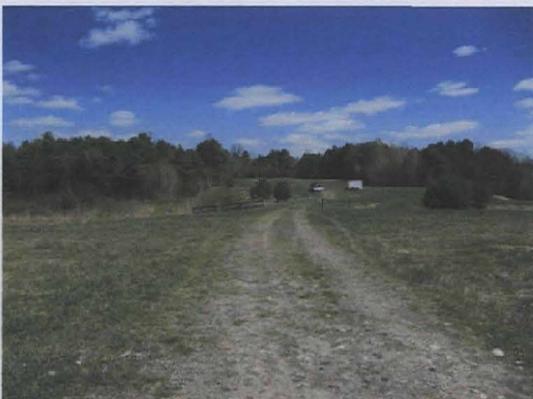
**Photo No: 9**  
**Date: 4/26/2012**  
**Comments: Near Route 17 and end  
of access road, facing uphill.**
