MAY 2003 SUPPLEMENTAL

SEEP SAMPLING RESULTS

Re: Additional Seep Sampling
Old Springfield Landfill
DH 4030002

OLD SPRINGFIELD LANDFILL

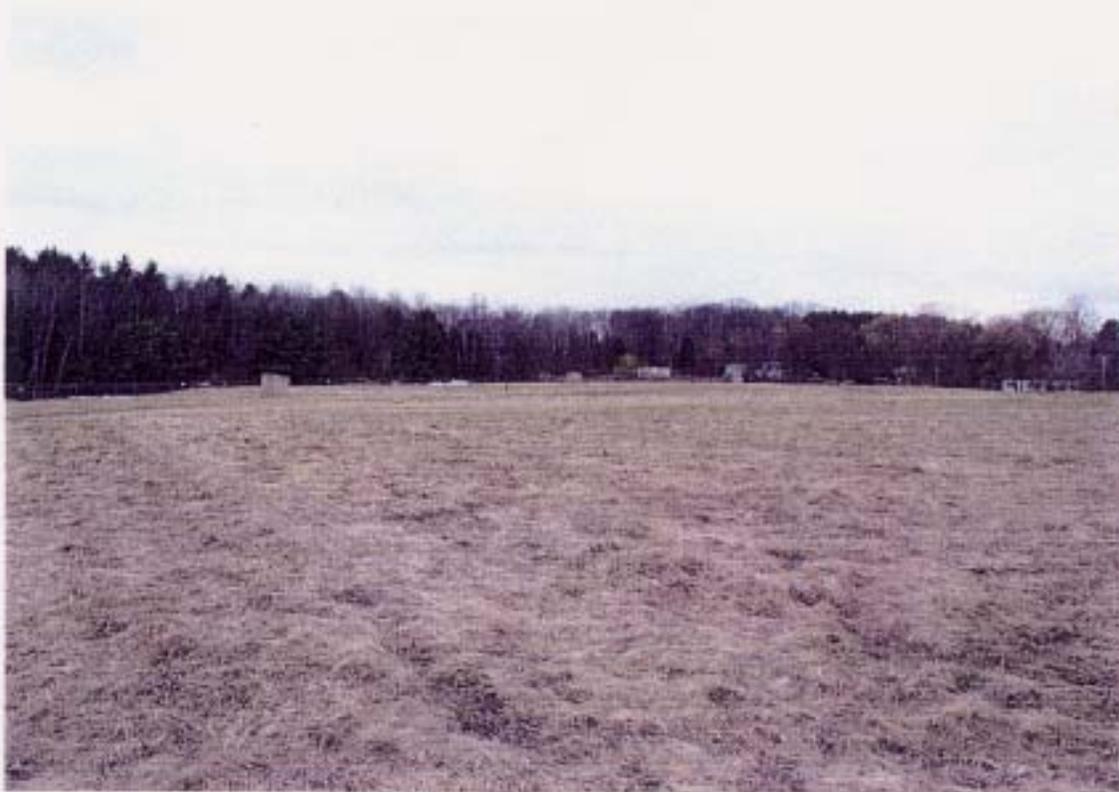
The surface of the landfill was generally in good condition with no obvious signs of settlement, erosion, or cracks (see Photos 1 and 2). The surface of the cover system appeared to be firm and stable on the day of inspection. The vegetative cover was in good condition. During the inspection, a 2-foot wide depression caused by animal burrows was observed on the northern portion of waste area No. 4 (Photo 9). Gopher and mole holes were also observed in the northeast portion of waste area No. 3, near the lower bench on the slope and near the center of waste area No. 2.

Photo 1: Landfill cover over waste area No. 4, facing south.

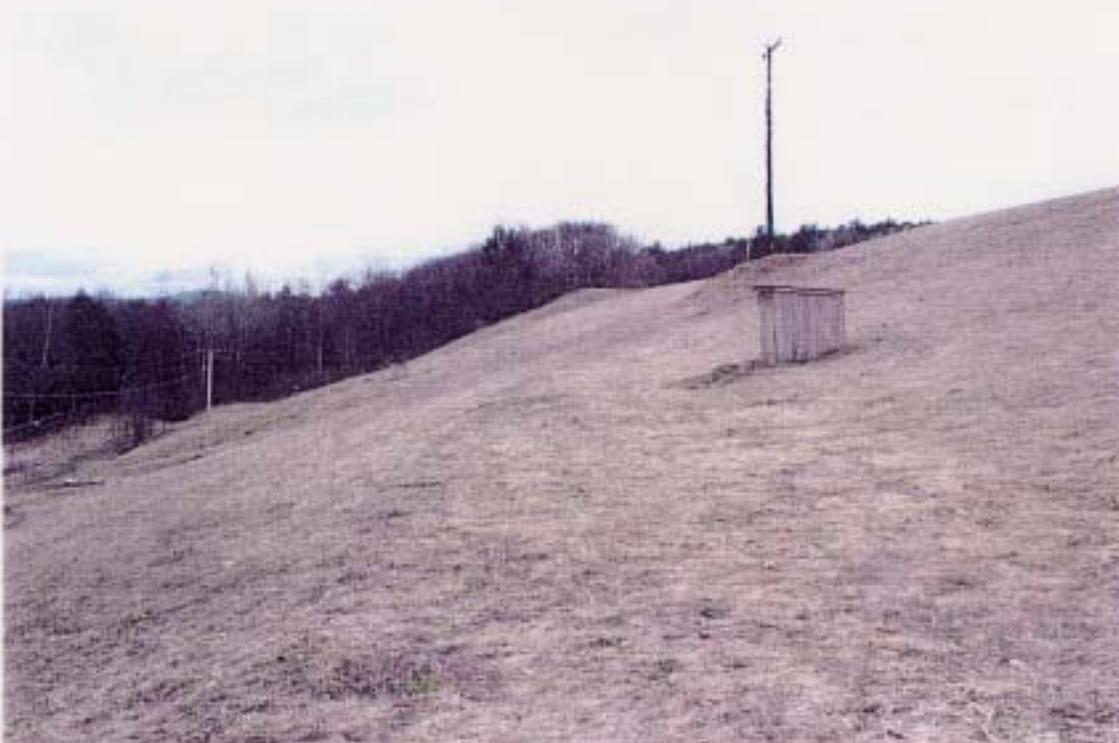
Photo 2: Landfill slope on east side of waste area No. 2, facing southeast.

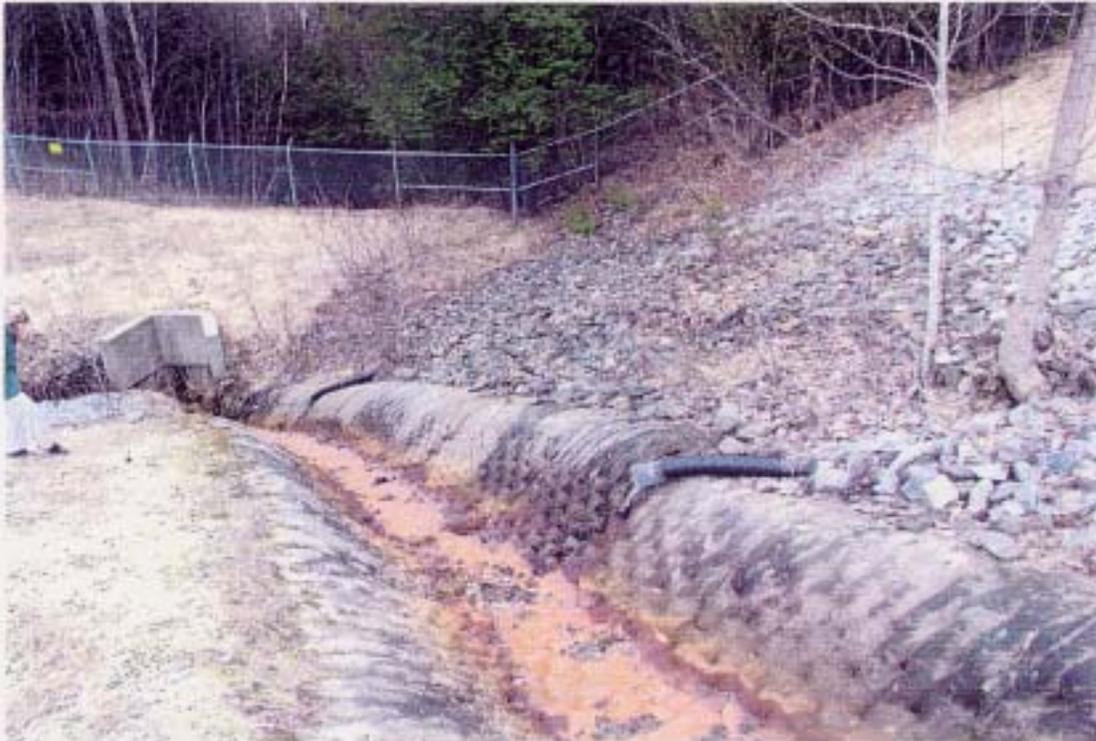
TRC engineers inspected the steep slope that was repaired and stabilized using a French drain system in November 2001. The area appeared to be stable, and the vegetation at the top of the slope repair area was in good condition (see Photo 3). Water was flowing from the upper French drain outlet pipe in the slope repair area. However, there was no water flowing from the lower slope repair French drain pipe, which appeared to be raised above the slope and covered with a mound of riprap, rather than situated flush with the slope surface below the riprap like the upper French drain pipe in this area.

Photo 3: South Fabri-Form ditch at slope repair area.

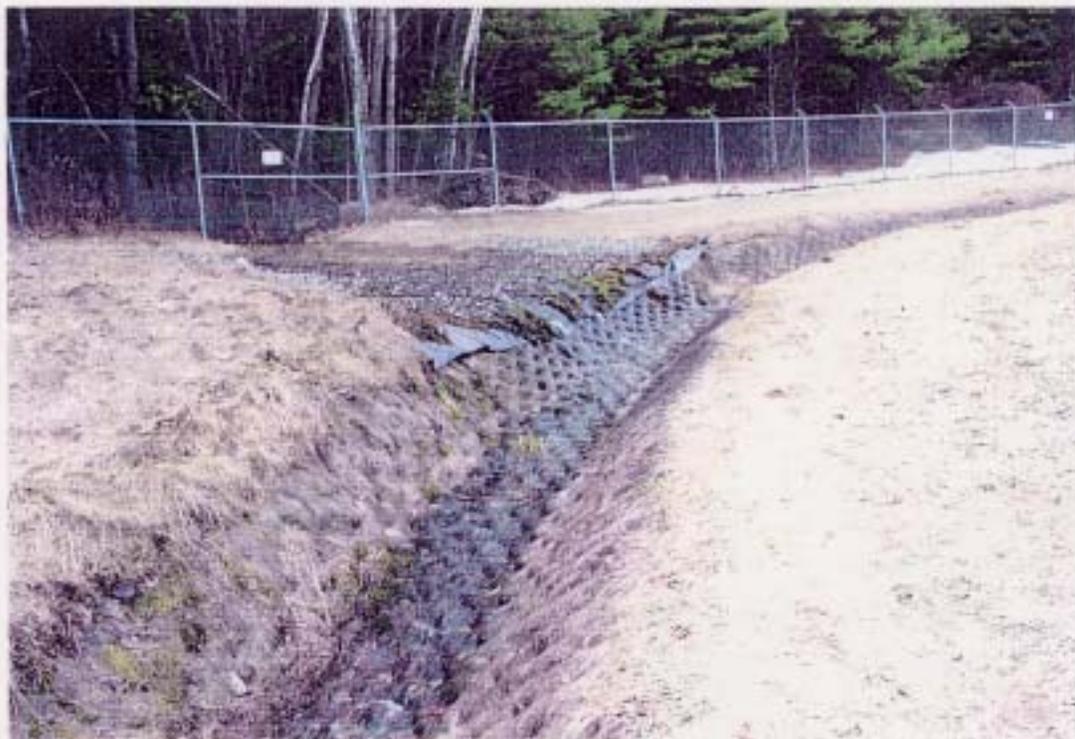
In general the channels were in fair to good condition (see Photos 3, 4 and 5). However, in the southern Fabri-Form ditch a slight split was observed at a seam in the Fabri-Form material, and water flowing in the channel was seeping into this split (see Photo 6). Adjacent to the split Fabri-Form material, a cavity was present in the soil on the outer edge of the concrete (outside

Photo 4: South Fabri-Form ditch at top of landfill/south end of waste area No. 4.

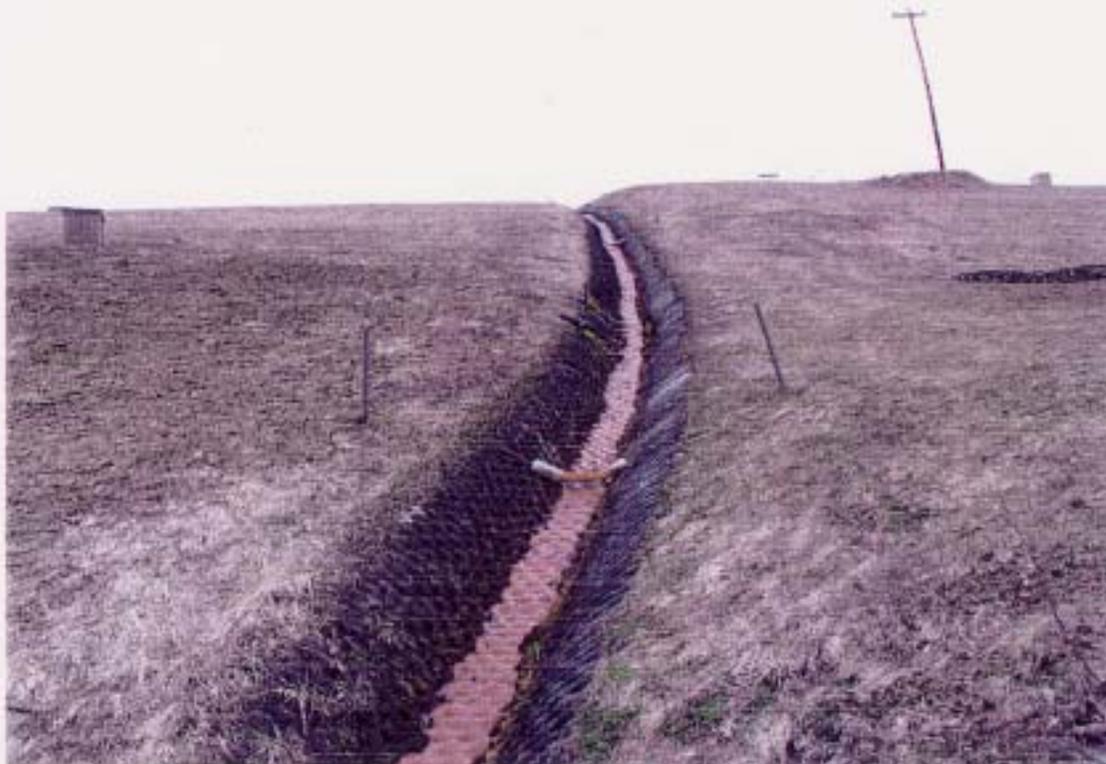
Photo 5: Middle Fabri-Form ditch, facing west.

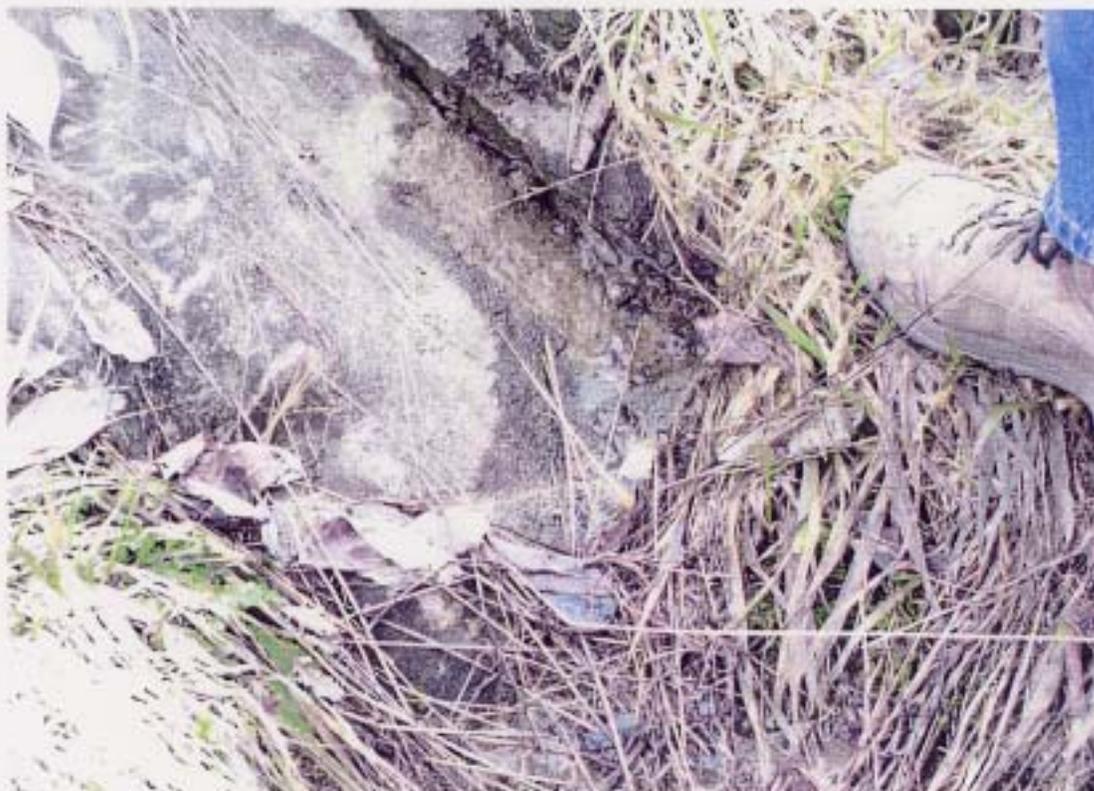
| | Remarks <u>Seam in FabriForm in south letdown channel at west end - channel is cracked above det. pond.</u> | | |

Photo 6: Crack at seam in south Fabri-Form ditch above detention basin.

- The cause of the seep and related erosion on the western sidewall of the sedimentation basin should be investigated and permanent repairs should be undertaken. As noted in TRC's previous inspection reports, consideration should be given to replacing the GCL lining below the detention basin in the future to prevent further erosion and limit the infiltration of water at the top of the steep slope. An alternative to GCL, such as HDPE geomembrane, is recommended.
- The split in the southern Fabri-Form ditch should be repaired to prevent further damage to the concrete lining and to prevent infiltration and further undermining of the drainage ditch. The related soil erosion area on the south side of the Fabri-Form ditch, adjacent to the cracked Fabri-Form, should be filled or repaired.

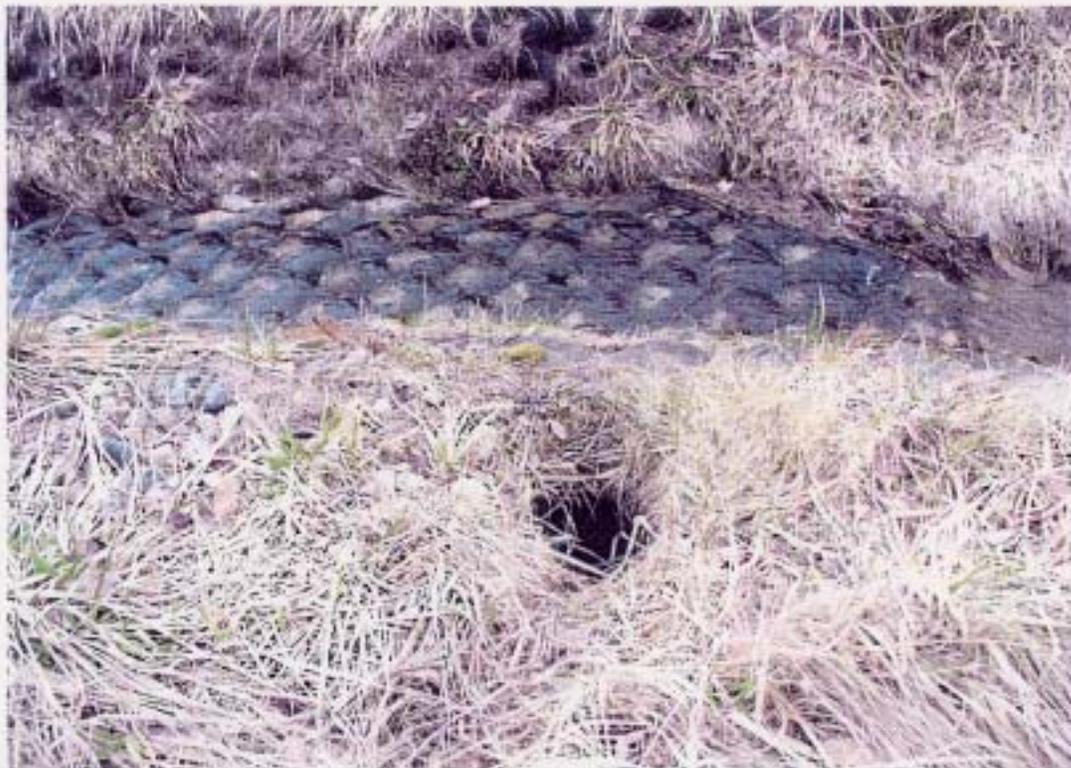
| Outstanding Deficiencies/Defects | Status | Corrective Action Adequate? | Recommendation |
|--|--|---|---|
| Holes along edges of Fabri-Form ditches | Hole observed on southern ditch adjacent to split in Fabri-Form. | No. Runoff flowing in hole and undermining ditch. | Capture/divert flow, if necessary. Repair hole. |

Photo 7: Cavity next to south Fabri-Form ditch near crack in ditch.

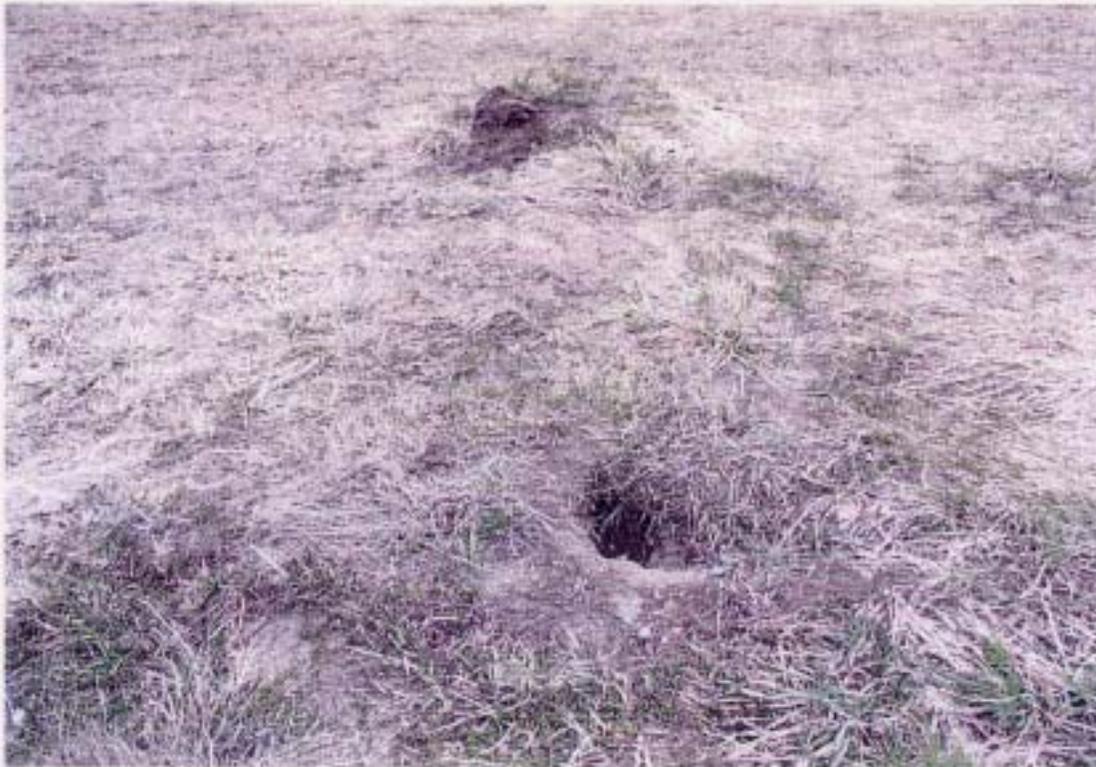
Photo 9: Animal burrow in northwest portion of waste area No. 4.

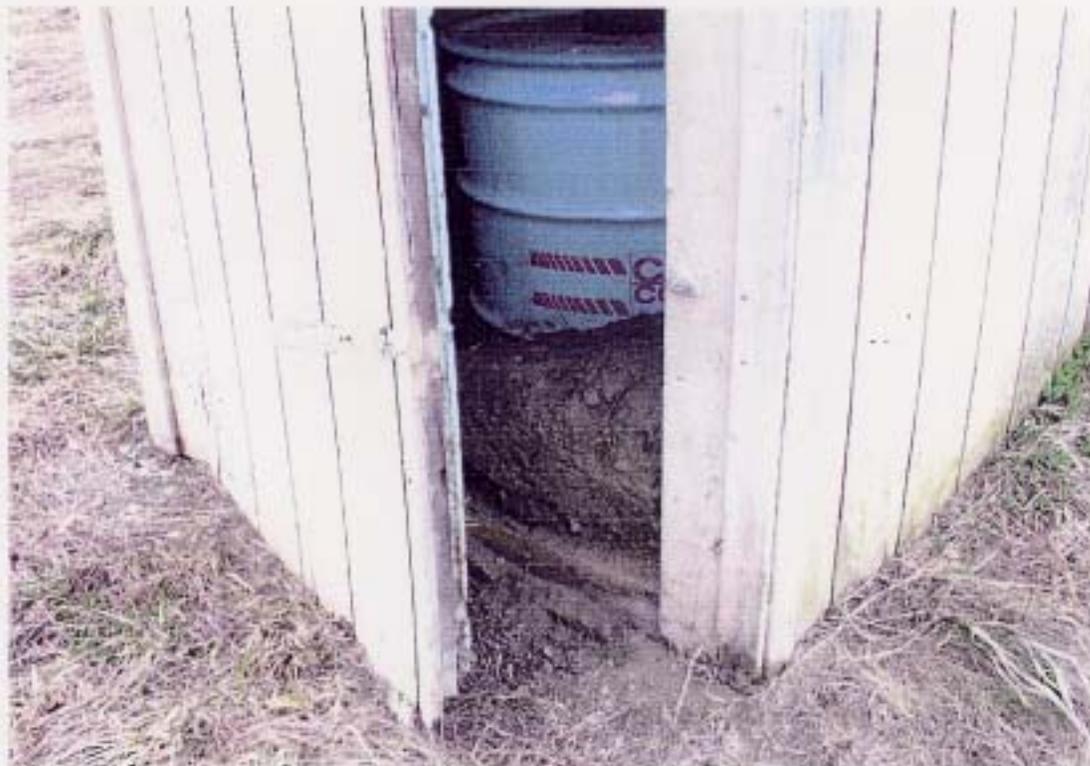
Penetrations through the landfill cover system include ten passive gas vent structures, three piezometers, and one source control extraction well. The above ground portions of the gas vent sheds were opened and inspected for damage. Although the gas vent sheds generally appear to be in good condition, rodent holes were observed at the base of several of the sheds. Rodent damage, including displaced insulation and/or mounded soils, was also observed inside some of the sheds (see Photo 10). Mounded soil up to 1-foot deep was observed inside the middle shed on waste area No. 2 and the southern shed on waste area No. 2. The accumulated sediments should be removed from these gas vent sheds. The rodent activity does not appear to be affecting the operation of the gas vent structures. TRC understands that the POTW plans to improve the gas vent sheds with concrete floors sometime this year.

Photo 10: Gas vent shed with 1-foot deep soil inside (from gopher) on waste area No. 2.

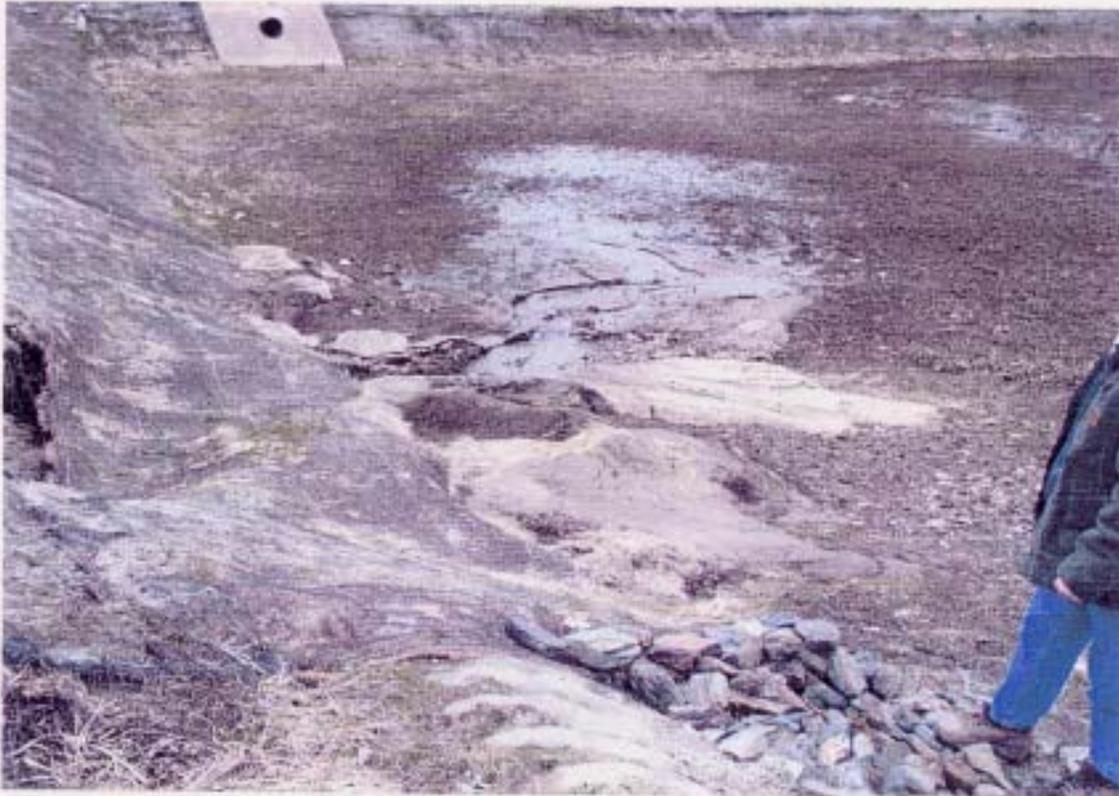
During the April 2003 snowmelt, a seep developed on the western sidewall at the southwest corner of the sedimentation basin (see Photo 11). The location of the slope failure was consistent with the location where a seep was observed during TRC's November 2001 inspection. At the time of TRC's April 18, 2003 inspection, the slope failure spanned approximately ten feet across the western sidewall of the basin, beginning at the southwest corner near the outlet of the southern Fabri-Form channel into the basin. As discussed in the Fall 2002 inspection report, the walls of the sedimentation basin were previously stabilized and regraded in the fall of 2002. The existing geosynthetic clay layer (GCL) lining underlying the detention basin was not replaced as part of the recent repairs. During previous inspections, TRC noted that this GCL was severely degraded and was promoting the infiltration of water into the soils below the basin. In the area of the recent slope failure, a portion of the soils underlying the erosion control mat on the basin wall had eroded and was deposited on the floor of the basin, and an opening was present in the sidewall down to the GCL. Water was flowing in a northeasterly direction across the bottom of the opening in sidewall, but it was not clear whether water was infiltrating the GCL in the slope failure area (see Photo 12).

| Outstanding Deficiencies/Defects | Status | Corrective Action Adequate? | Recommendation |
|--|--|---|---|
| Erosion of detention basin sidewalls | New slope failure in western sidewall at southwest corner of basin. | No. | Cause of slope failure should be investigated and permanent repair of basin should be undertaken. |

Photo 11: Seep/erosion problem on western sidewall of detention basin, facing north.

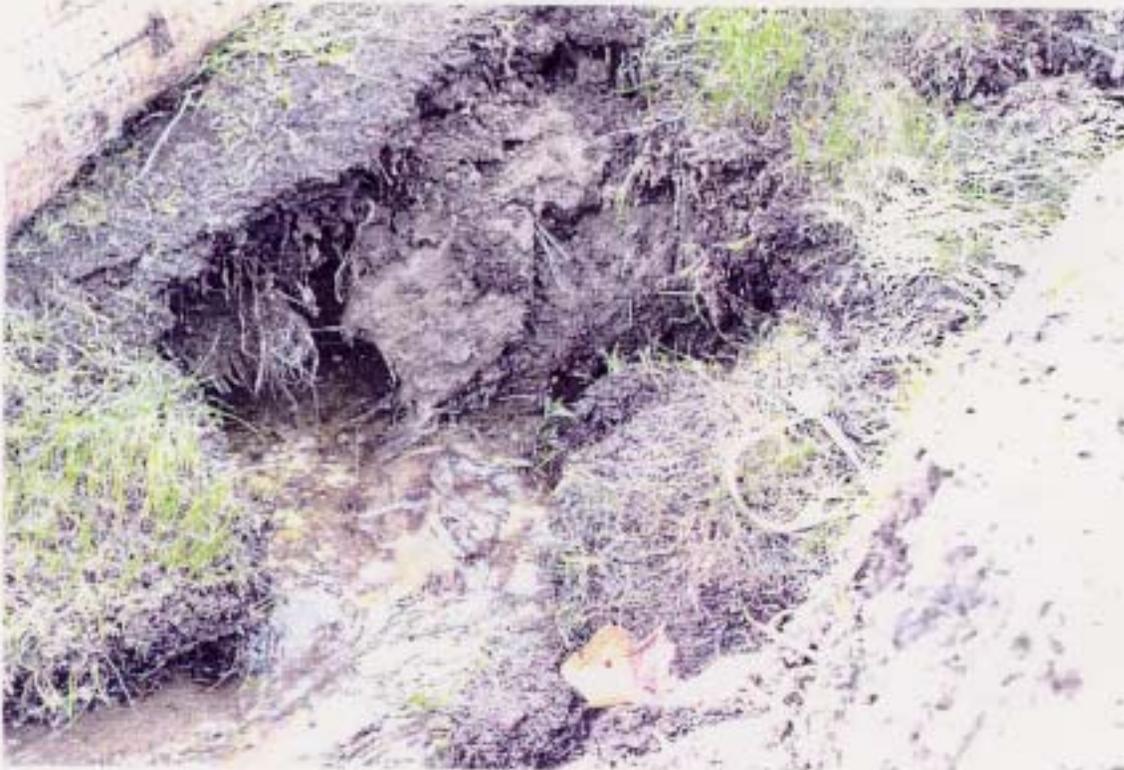
Photo 12: Close-up of water flowing north through eroded detention basin sidewall.

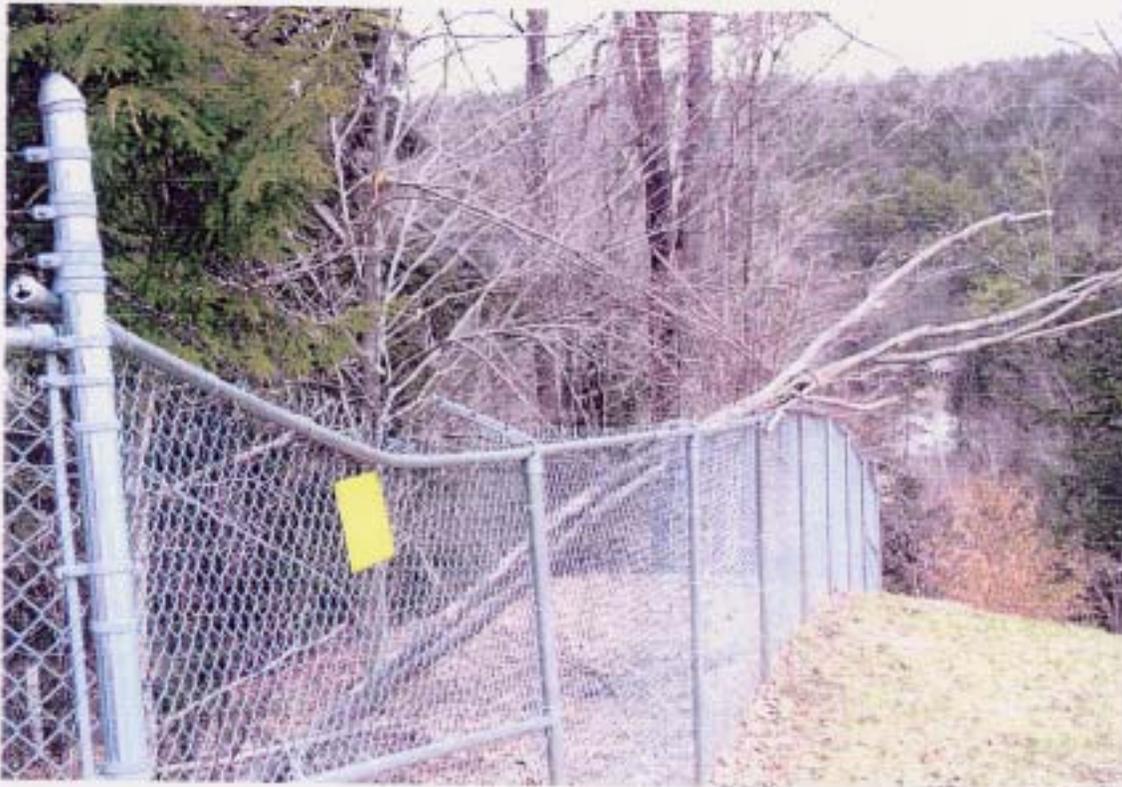
The majority of fencing was in good condition. However, slight damage (i.e., collapsed barbed-wires) was observed on the perimeter fence located northeast of waste area No. 2 and down-slope of Gate C, apparently as a result of fallen trees outside the cap (see Photo 13). The fence below the bent barbed wire was in tact.

Photo 13: Damaged barbed wire fence near north Fabri-Form ditch, east of Gate C.

- The damage to the barbed wire on the top of the fence northeast of waste area No. 2 should be repaired and downed trees should be moved away from the fence to prevent further damage.

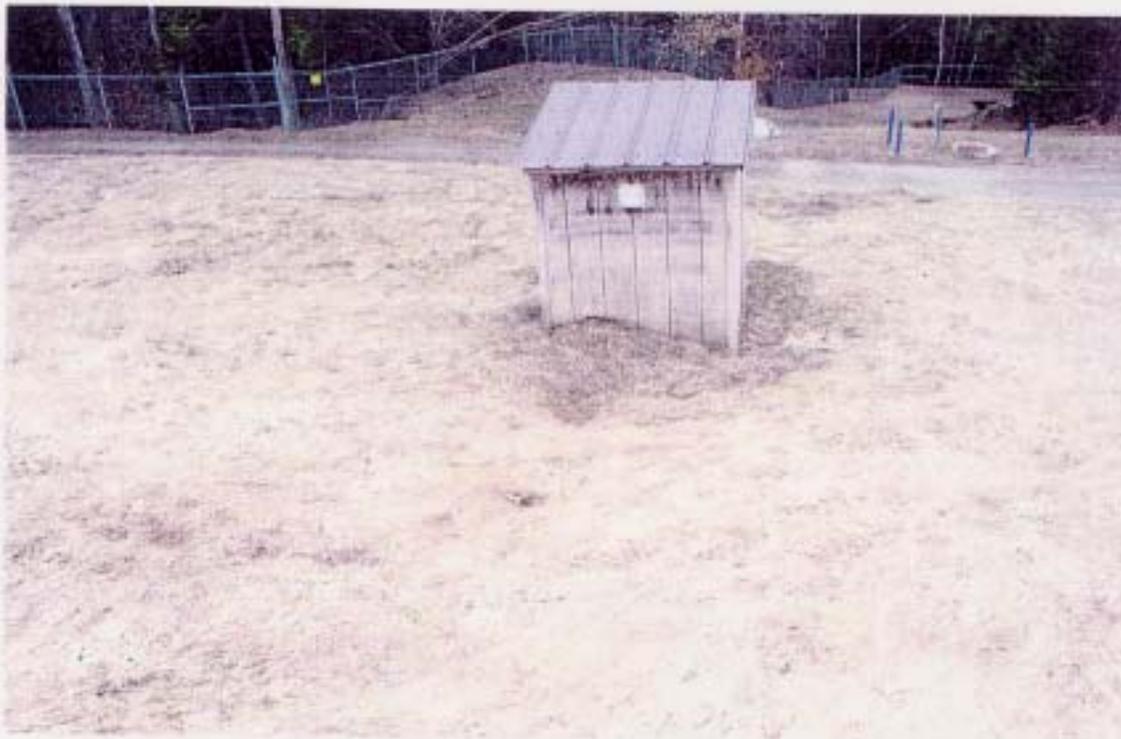
The perimeter roads were in good condition with no erosion, rutting, or potholes (see Photo 14).

Photo 14: Access road and gas vent shed near north end of waste area No. 2.
