2.3 ZONE 3, SITES 32/36

2.3.1.1 Site Location and Description

2.4 ZONE 3, SITES 34/39

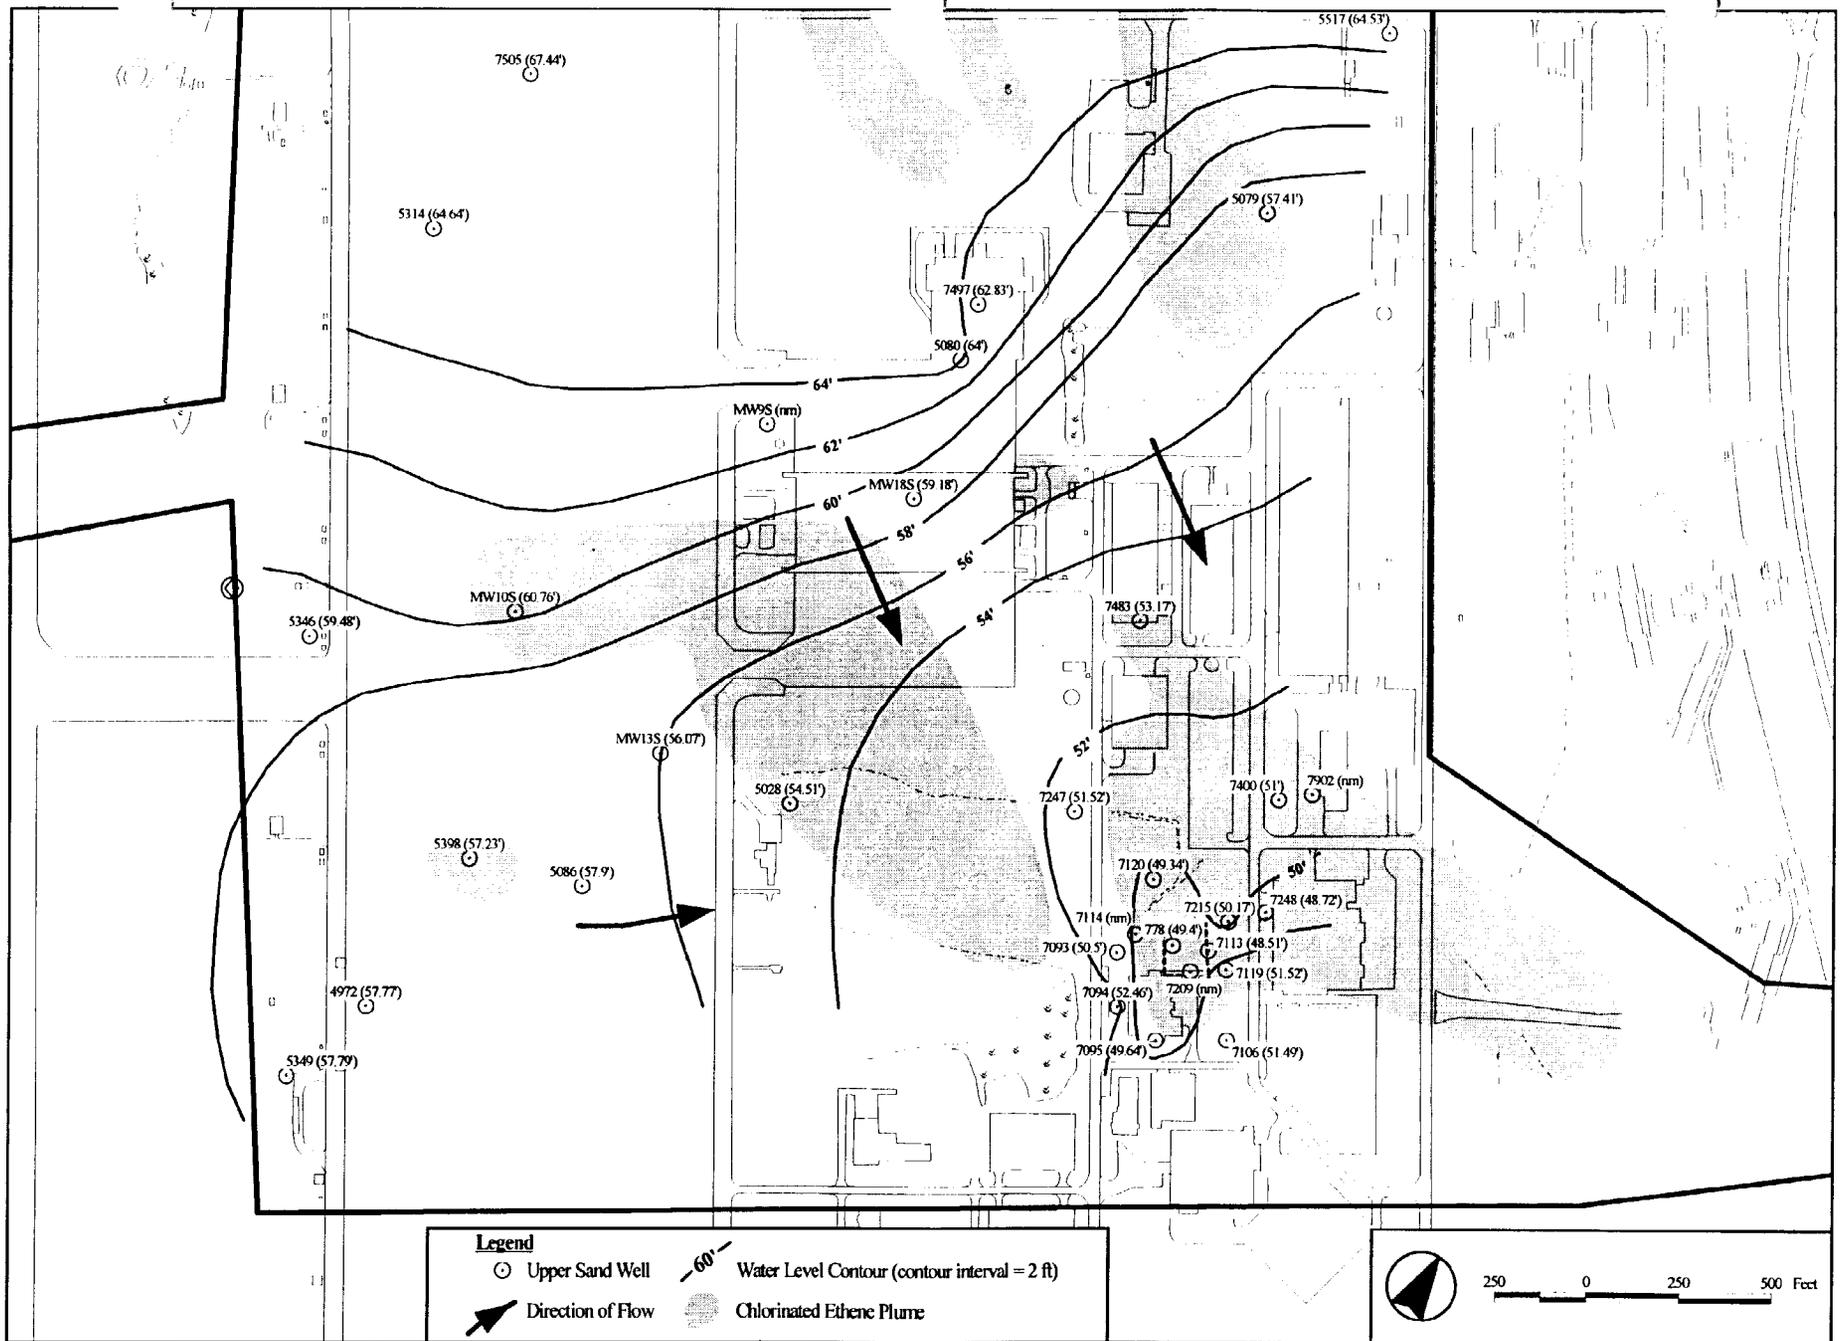
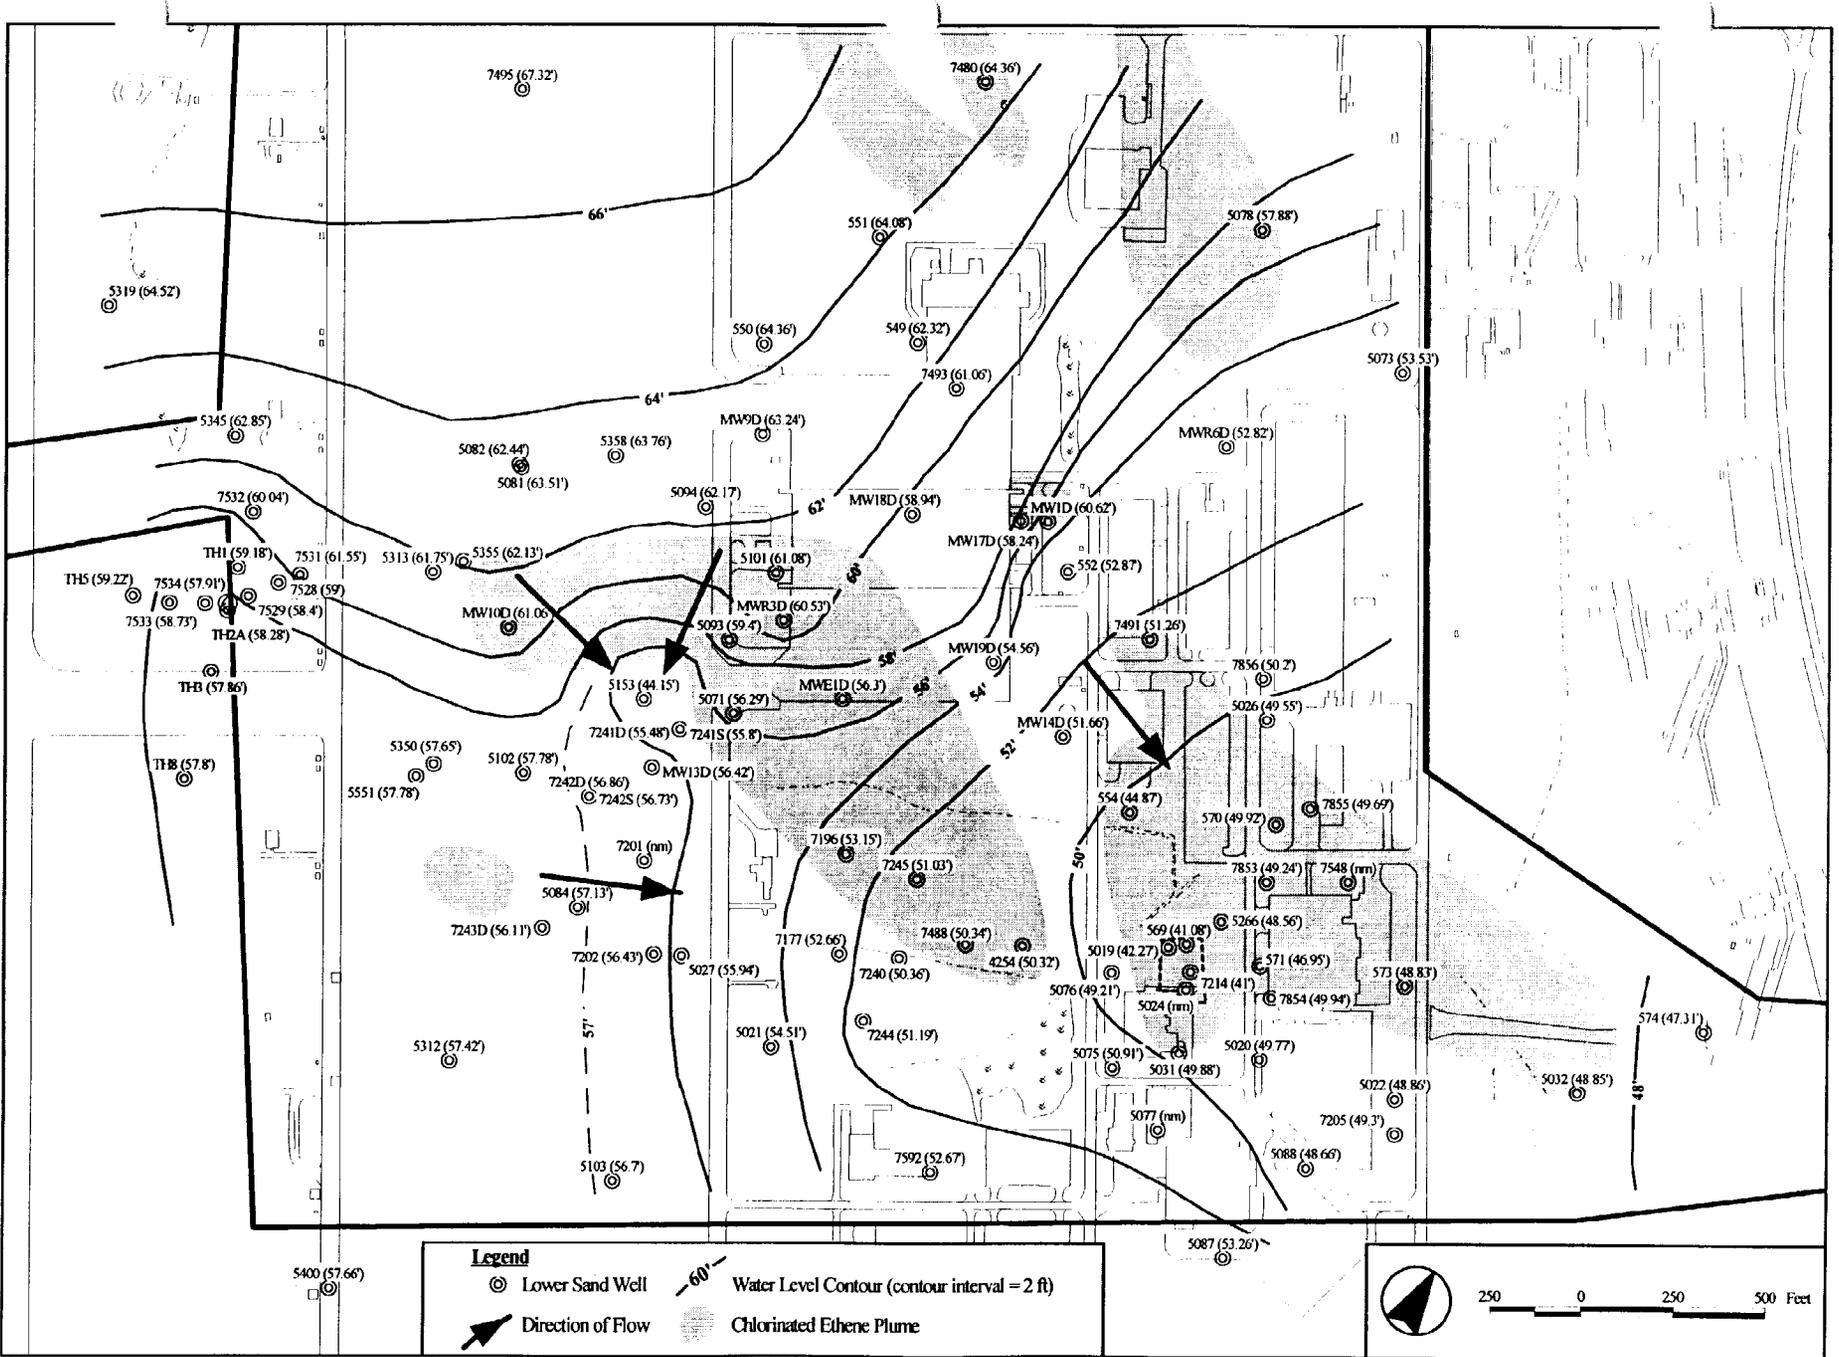
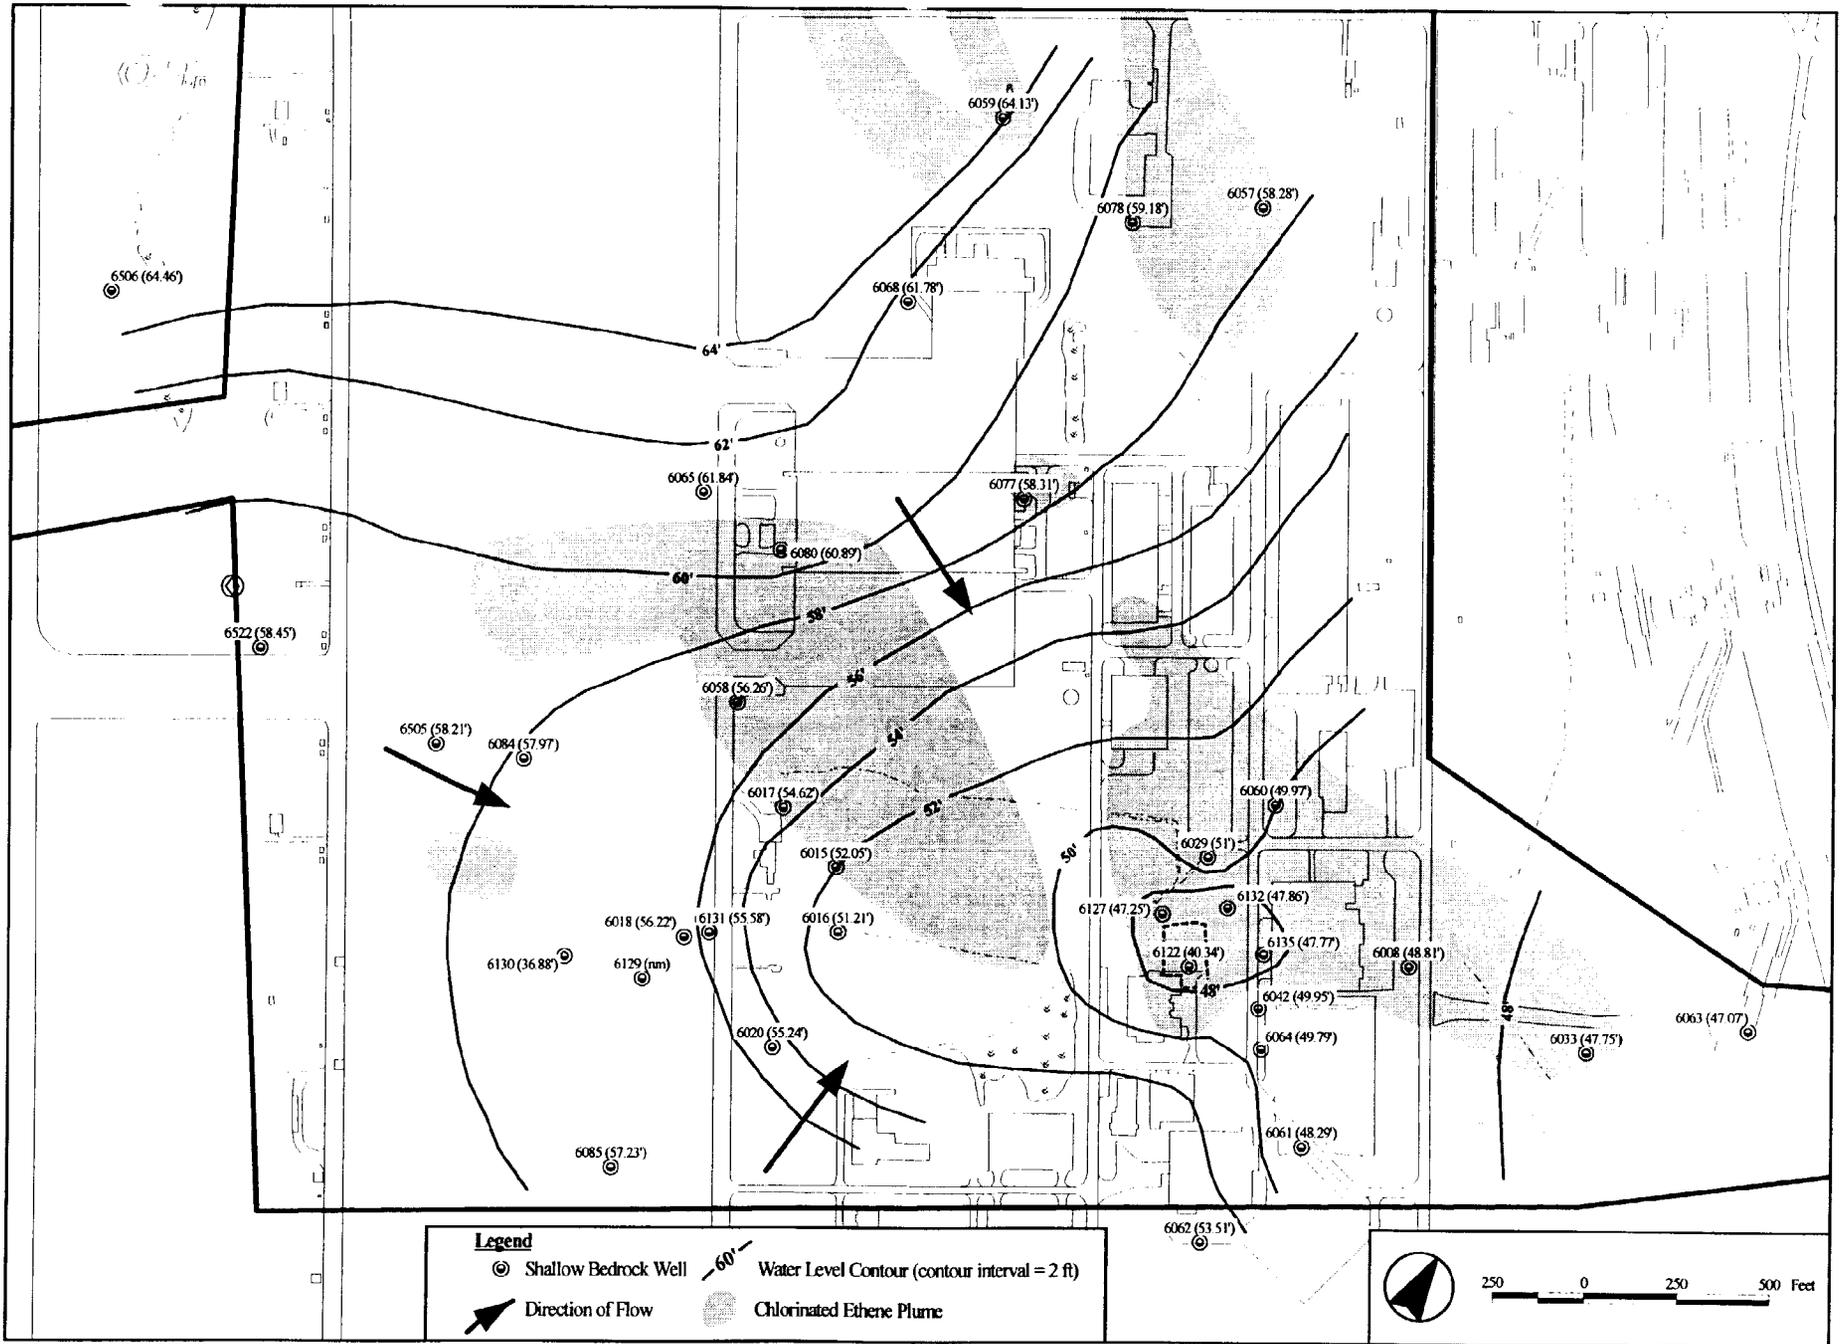
The predominant groundwater flow is southeast to east for overburden groundwater units, east to southeast for shallow bedrock groundwater units, and southeast for the deep bedrock. Groundwater contours for the upper sand, lower sand/glacial till, and shallow bedrock in Zone 3 (including the Site 32/36 area) are shown in Figures 2.3-2 through 2.3-4 respectively.

The treatment goals for the Site 32 groundwater are being met. The goal of hydraulically containing the source area is being met (see Figures 2.3-2 through 2.3-4). There are no known areas of noncompliance.

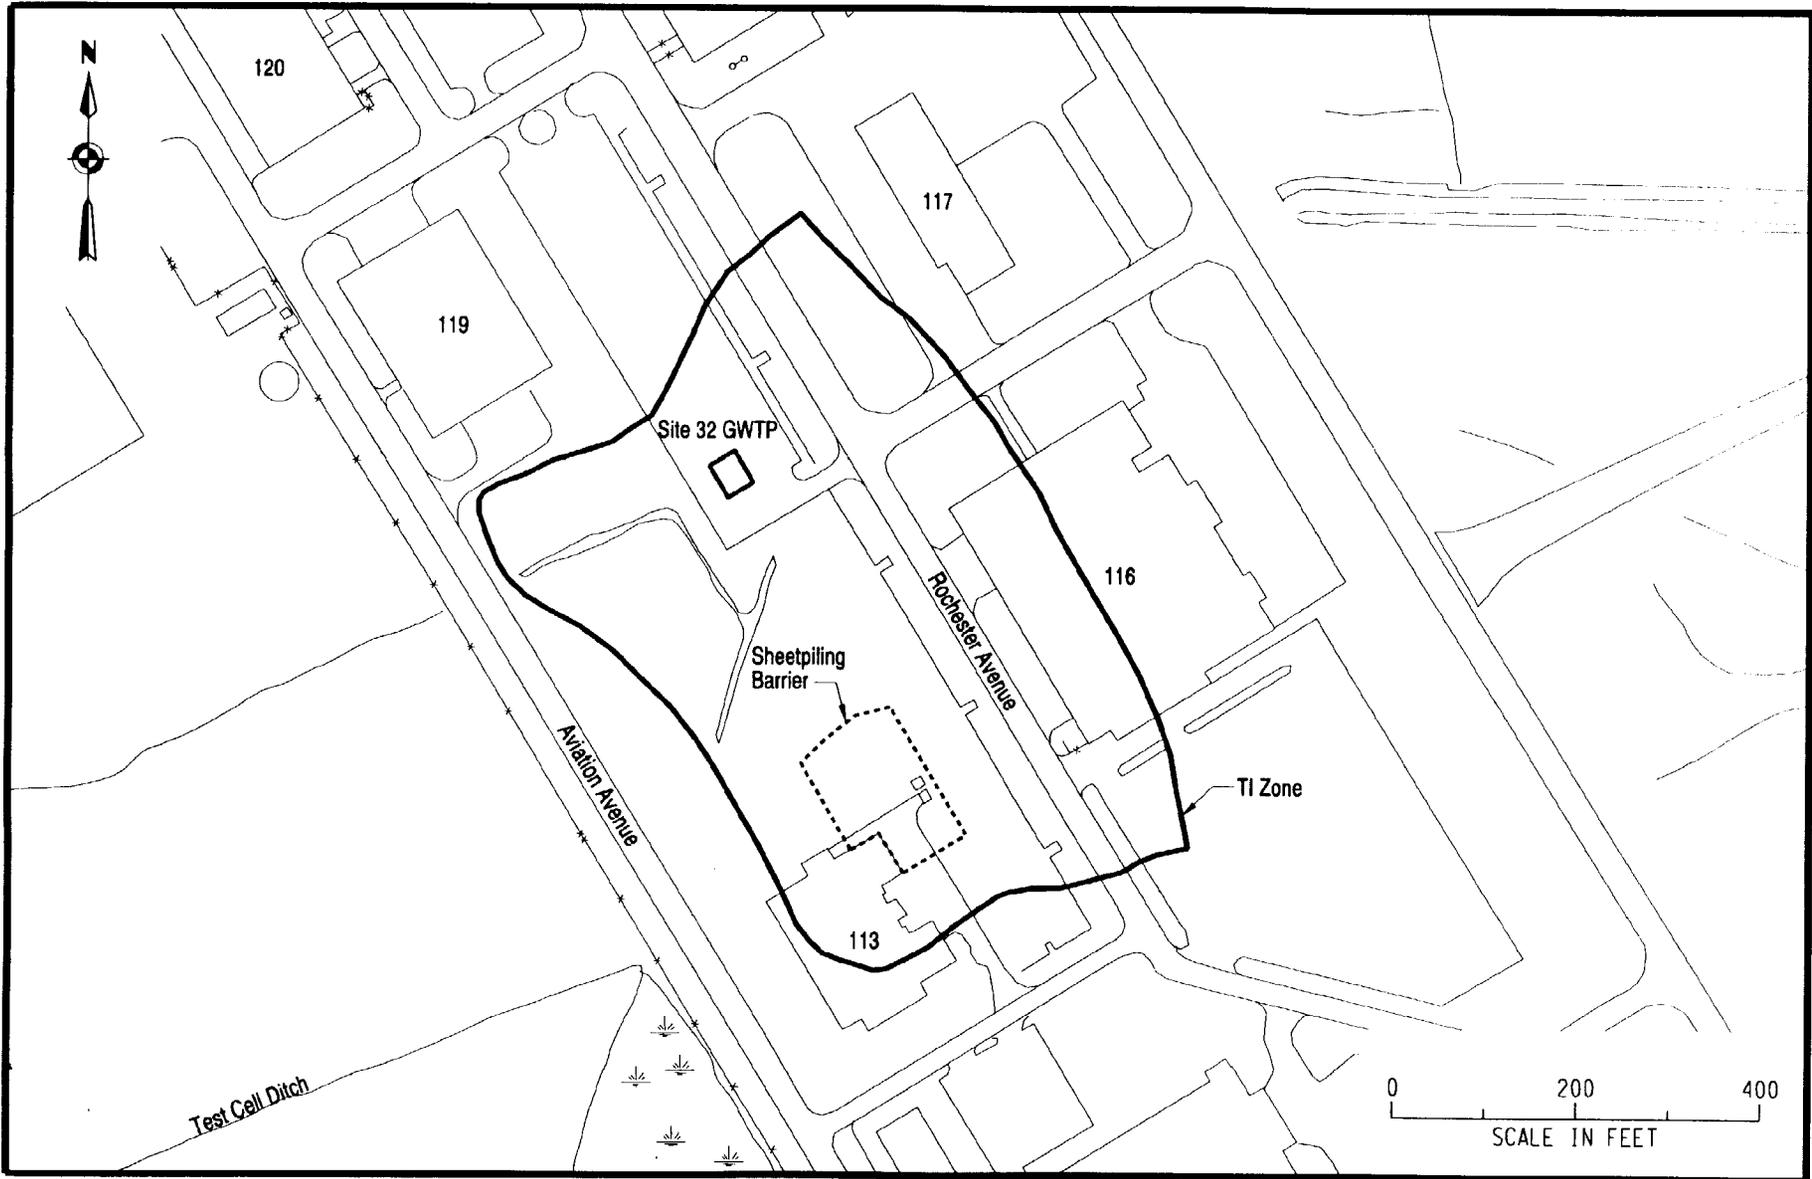
Figure 2.3-5
Site 32 TI Zone
Pease AFB, New Hampshire

The first draft of the Site 32 Technical Impracticability (TI) Evaluation Report was completed in March 1994 and finalized in July 1995. The objective of that report was to provide the technical basis for the TI determination at Site 32/36. The TI Evaluation Report concluded that complete groundwater restoration to applicable or relevant and appropriate standards at Site 32 in a reasonable time frame was not feasible under any remedial scenario. It recommended isolation of the Site 32 source area to prevent continued migration of contaminated groundwater. In addition, it defined the TI Zone as the spatial extent of groundwater to be captured by the hydraulic containment system at Site 32. The boundary of the TI Zone is shown in Figure 2.3-5.

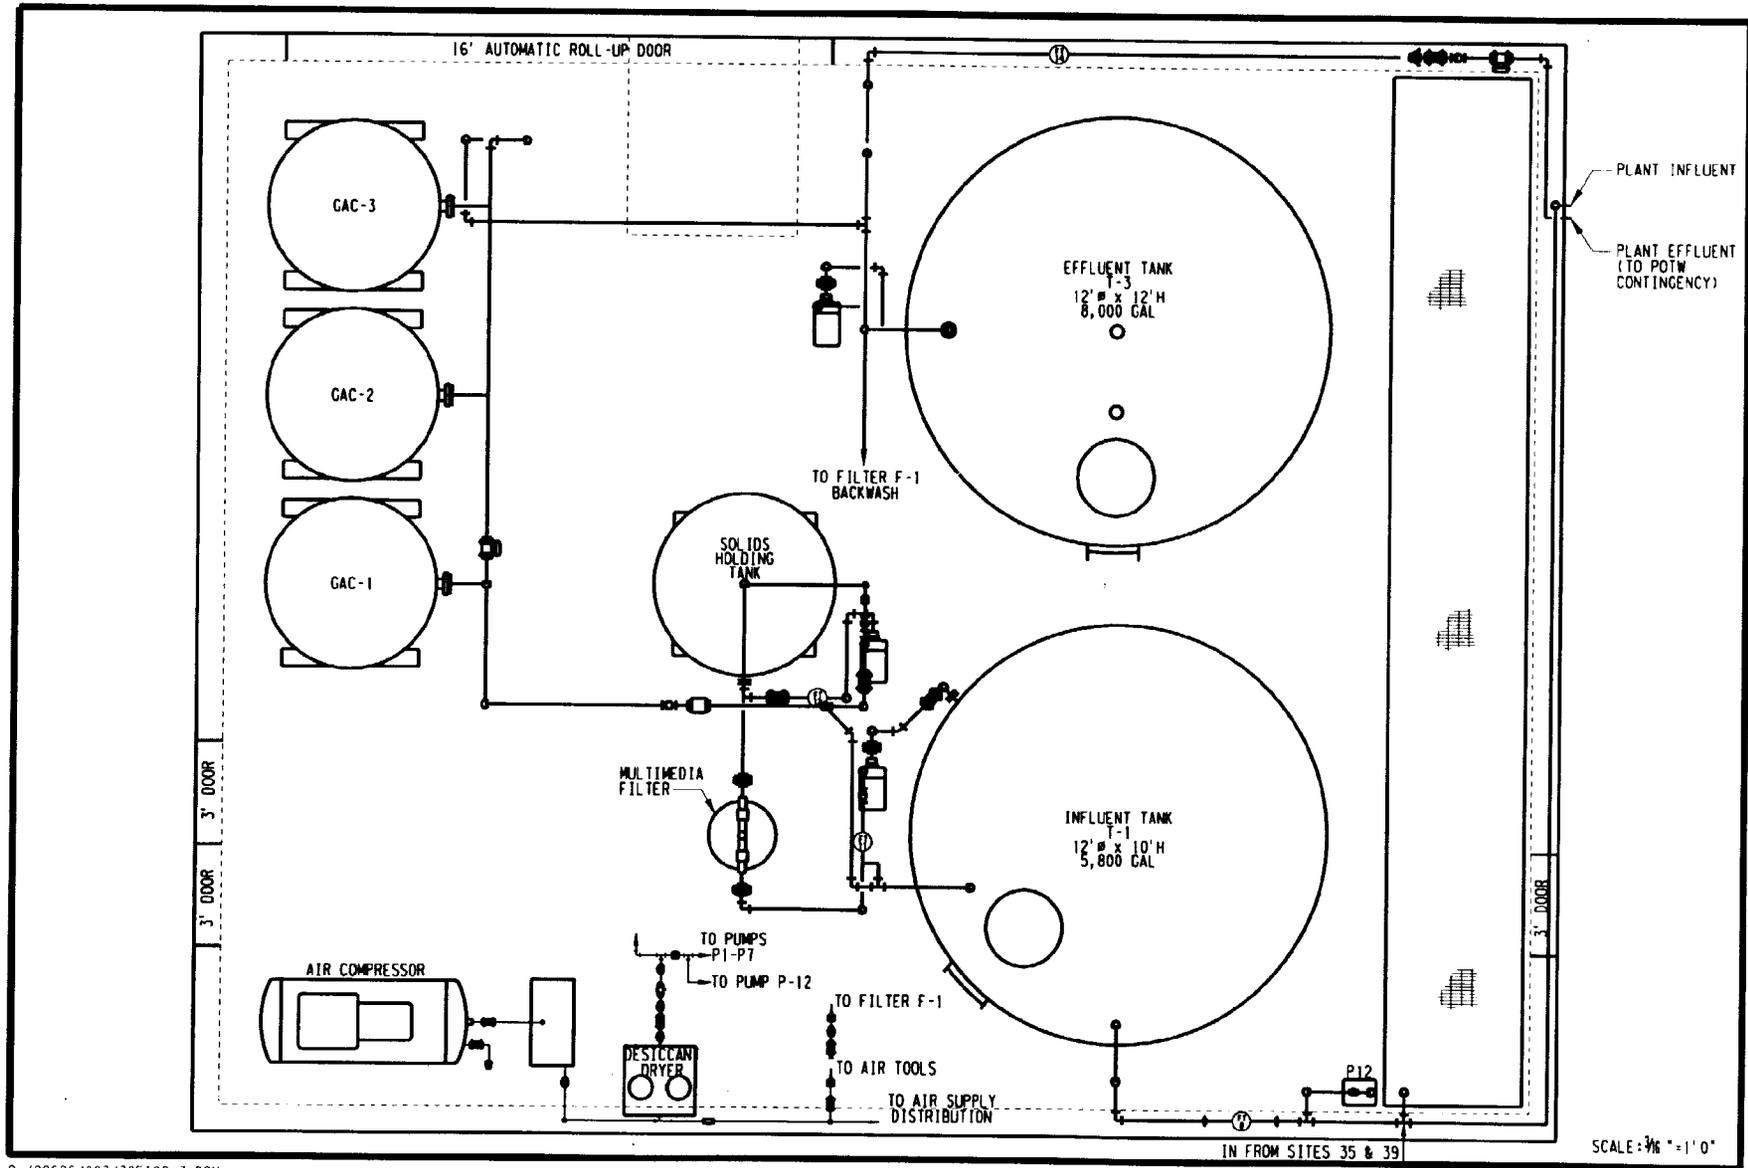
Figure 2.3-8
 Site 32 Groundwater Treatment System
 Pease AFB, NH

The Site 32 GWTP has two granular-activated carbon (GAC) units operating in series (Figure 2.3-8). The systems are operated in a manner so that if any of the treatment goals are exceeded in the monthly samples collected from the primary GAC unit, the primary unit will be taken off line, and the carbon will be replaced. The secondary unit will become the primary unit, and a reserve clean unit will become the secondary unit.

The primary GAC unit at Site 32 had breakthrough four times during the first year of operation: March 1997, June 1997, October 1997, and February 1998. The secondary GAC unit prevented release of contaminants in excess of treatment standards. As the contaminant concentration in the plant influent has decreased, the length of the time to breakthrough of the primary GAC unit increases. The average time to breakthrough of the primary GAC unit is approximately 100 days.
