Pinette's Salvage Yard Superfund Site - Five Year Review
 EPA Contract Number 68-W6-0042
 Work Assignment Number 054-FRFE-0134
 PHOTOGRAPHIC RECORD

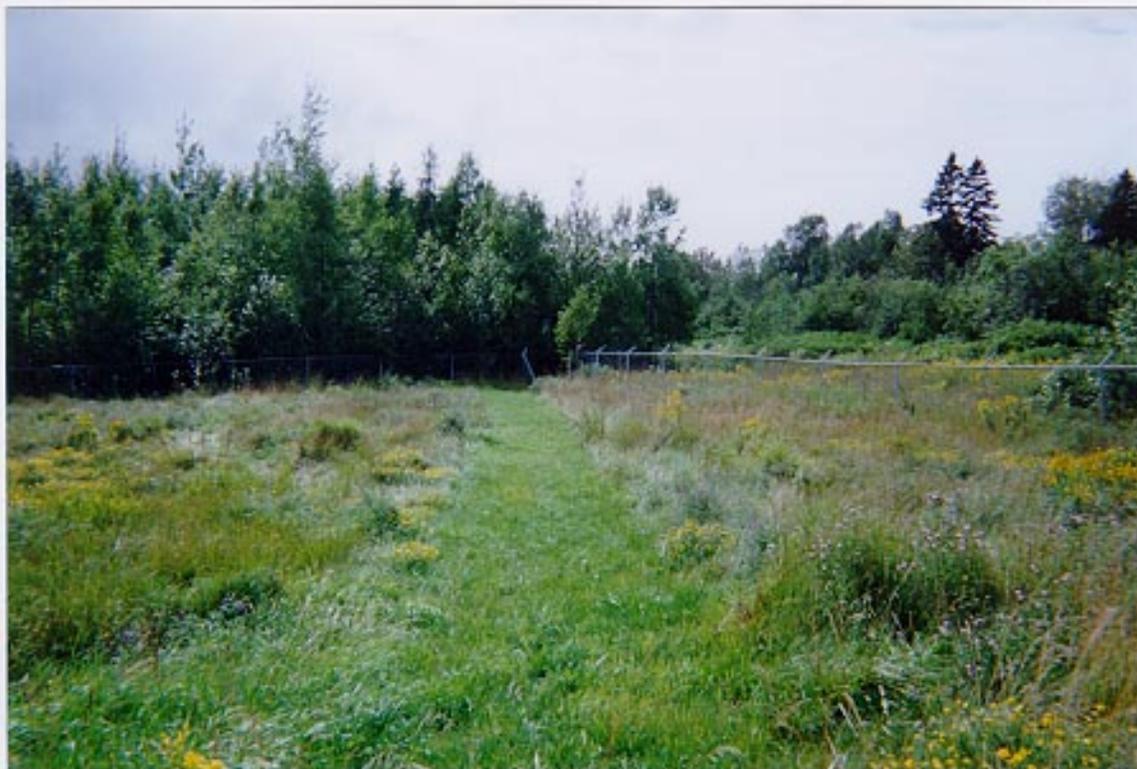
Frame No: 1

Hole in fence looking towards site.

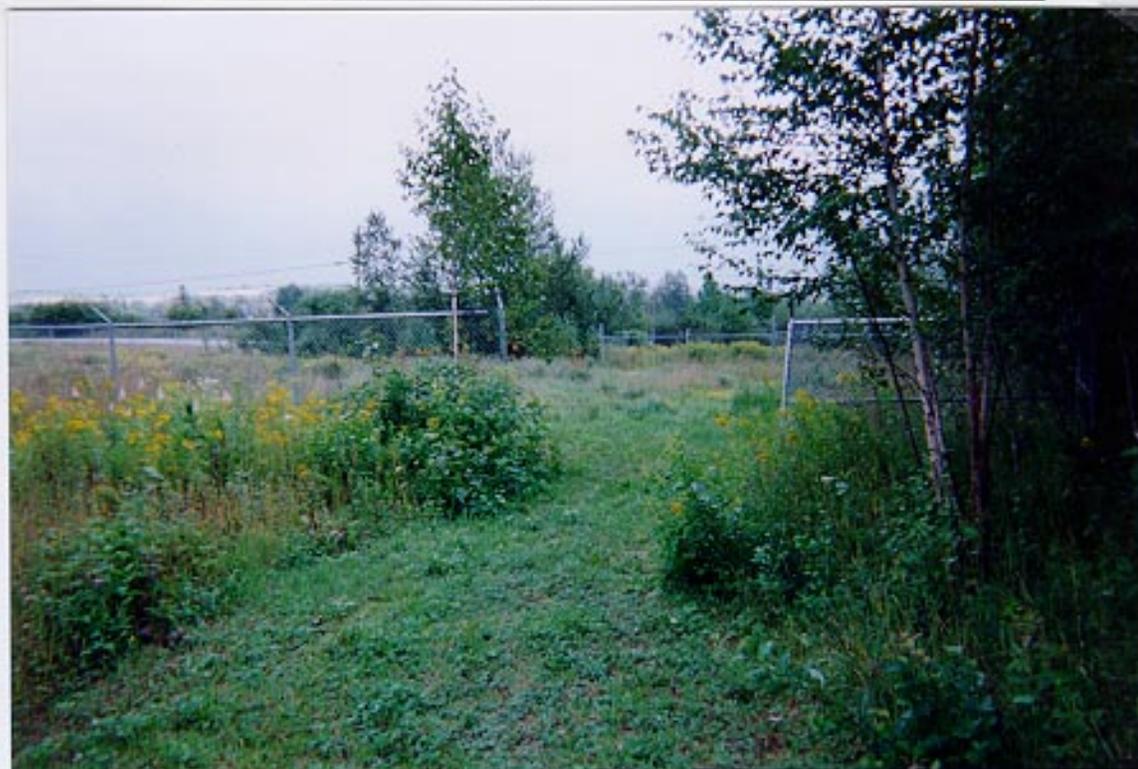
Frame No: 2

Hole in fence from concrete pad.

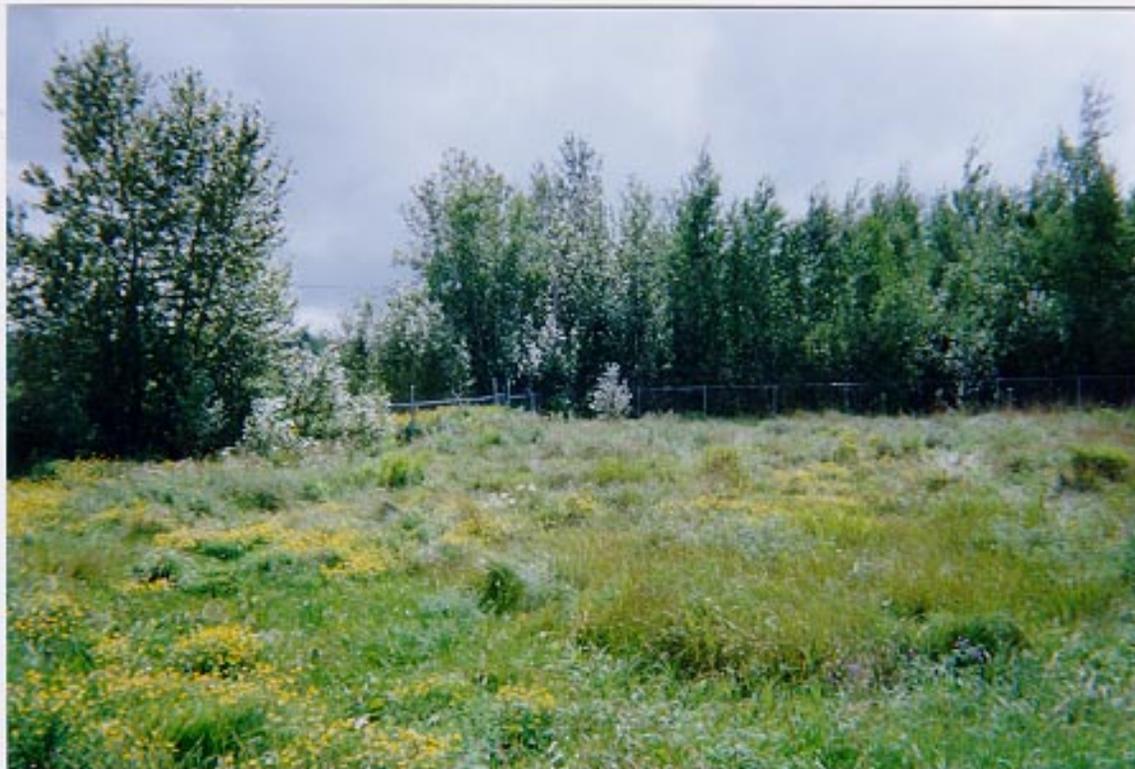
Frame No: 3

Southwest corner of site.

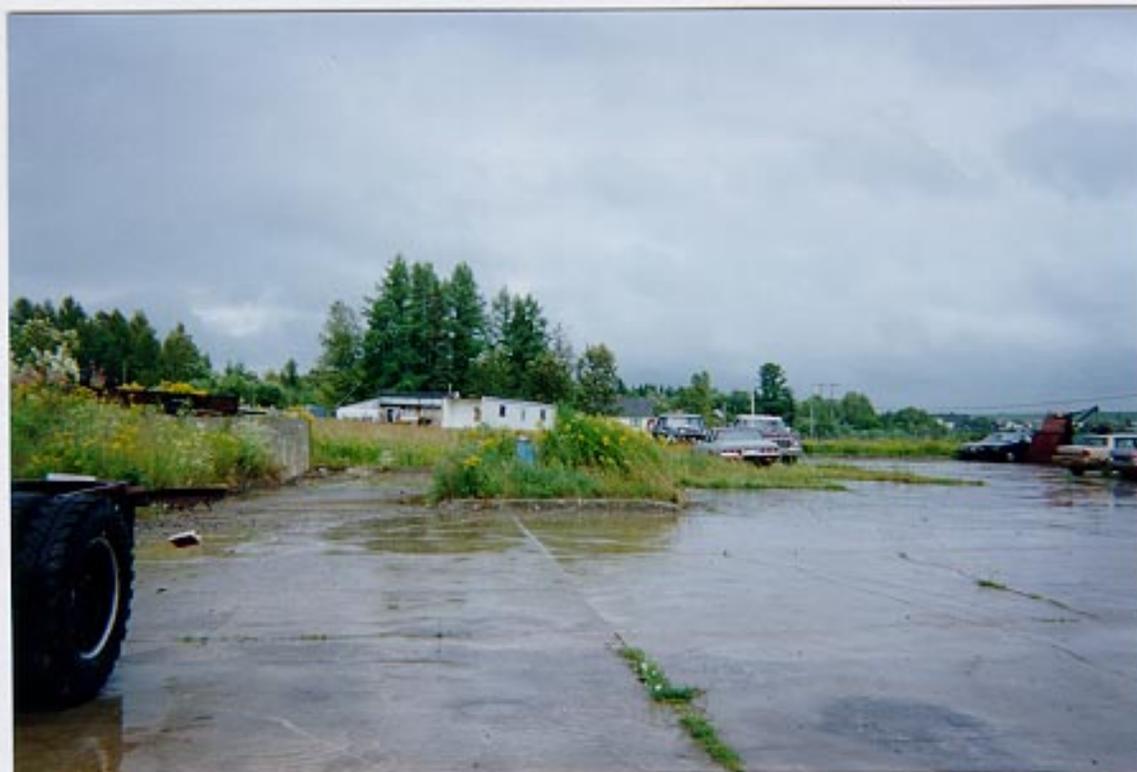
Frame No: 4

Northeast side of site with MW 8 cluster in foreground. B. Pinette's garage in background

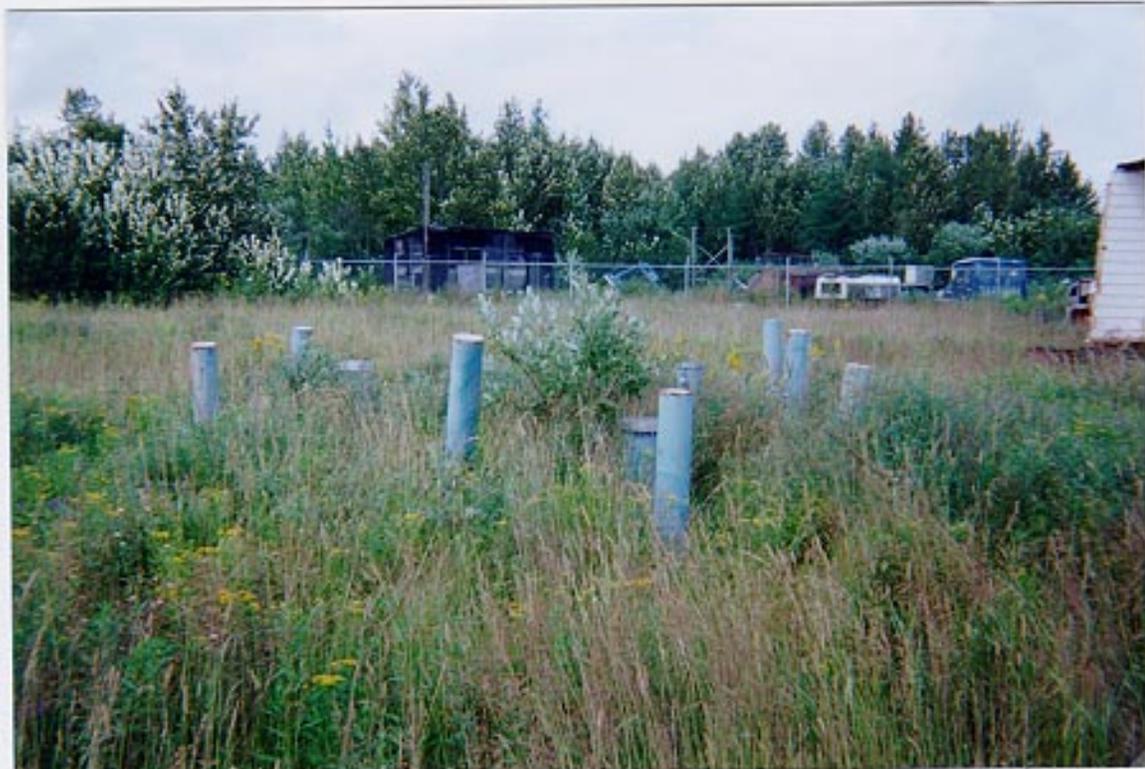
Frame No: 5

MW-5 cluster with northern fence line in background.

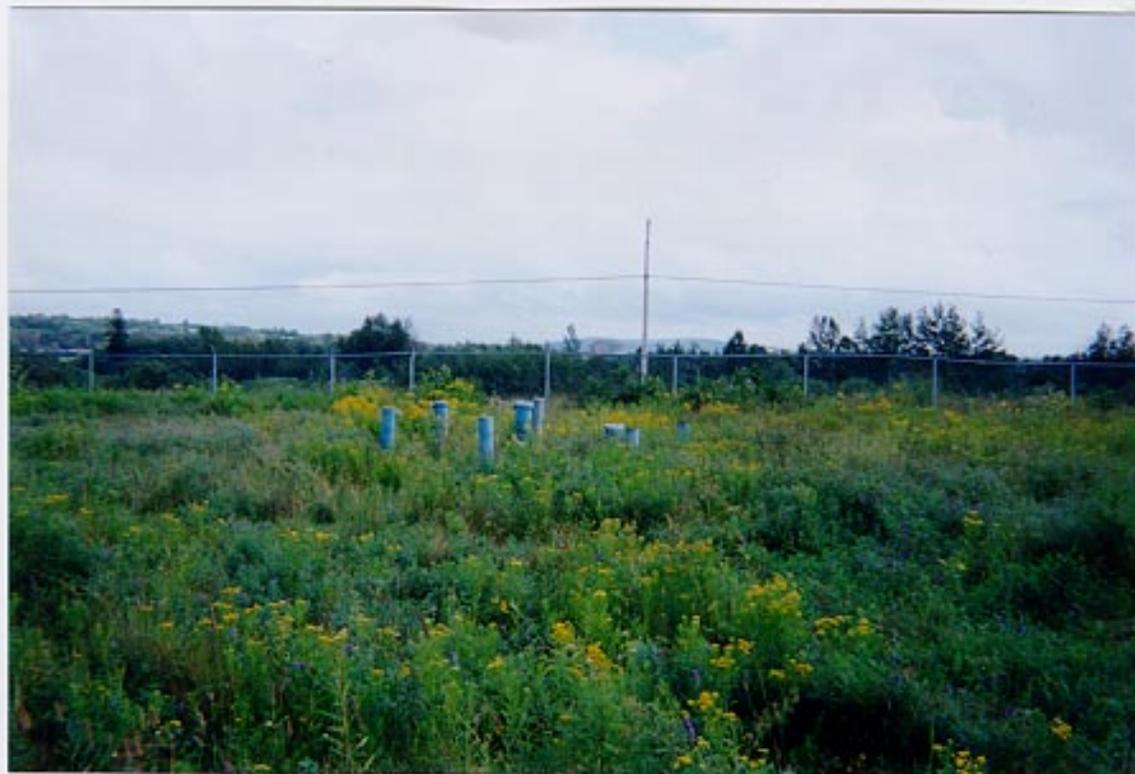
Frame No: 6

MW-7 cluster.

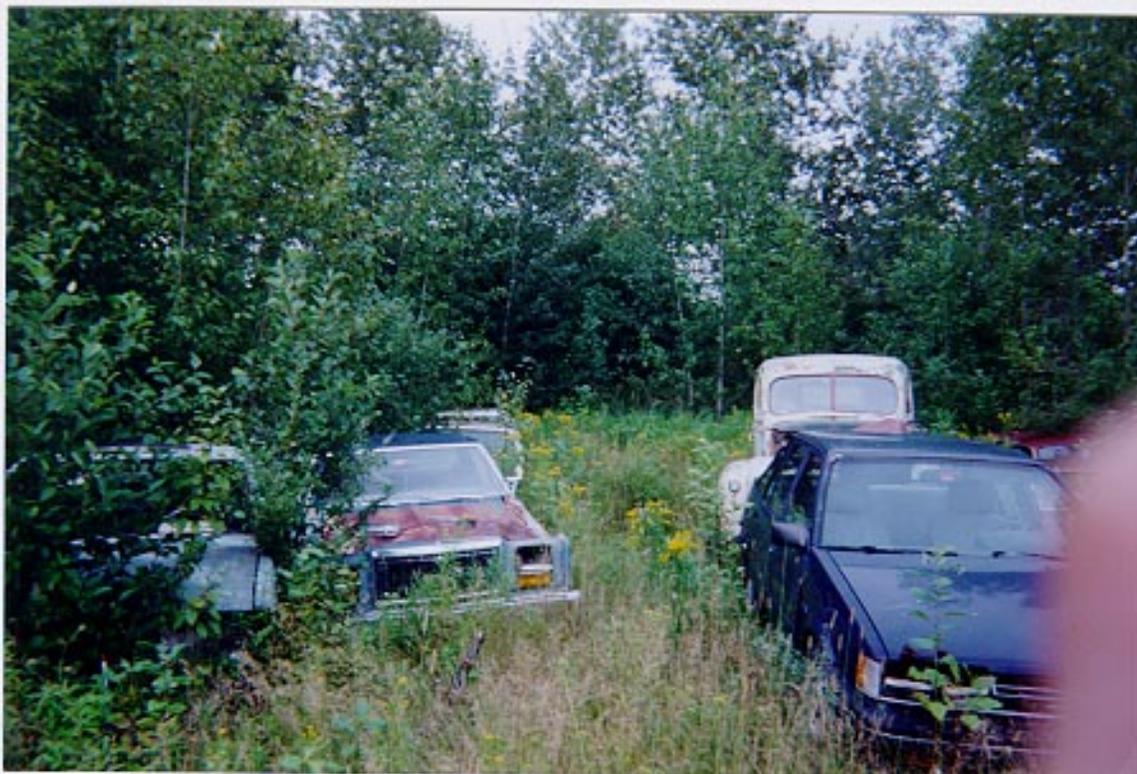
Frame No: 7

MW-1 cluster area (wells obscured by tall grass).

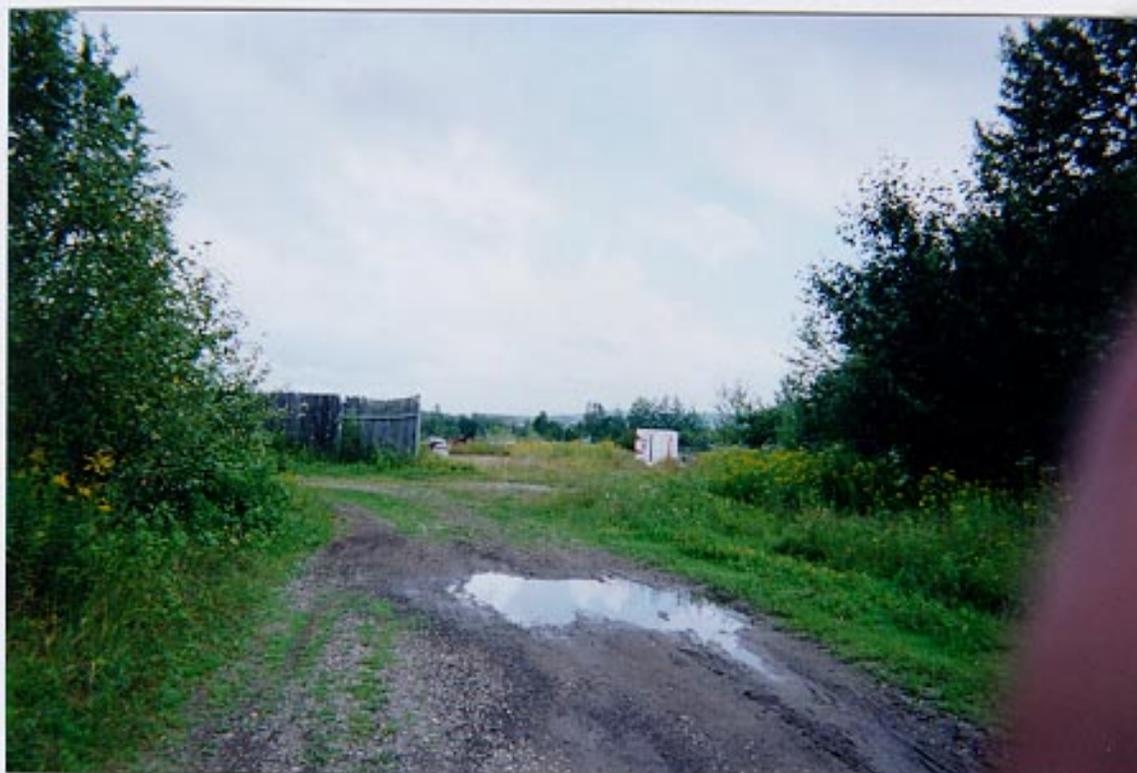
Frame No: 8

Looking toward the site through large (~30') break in northwest corner of fence

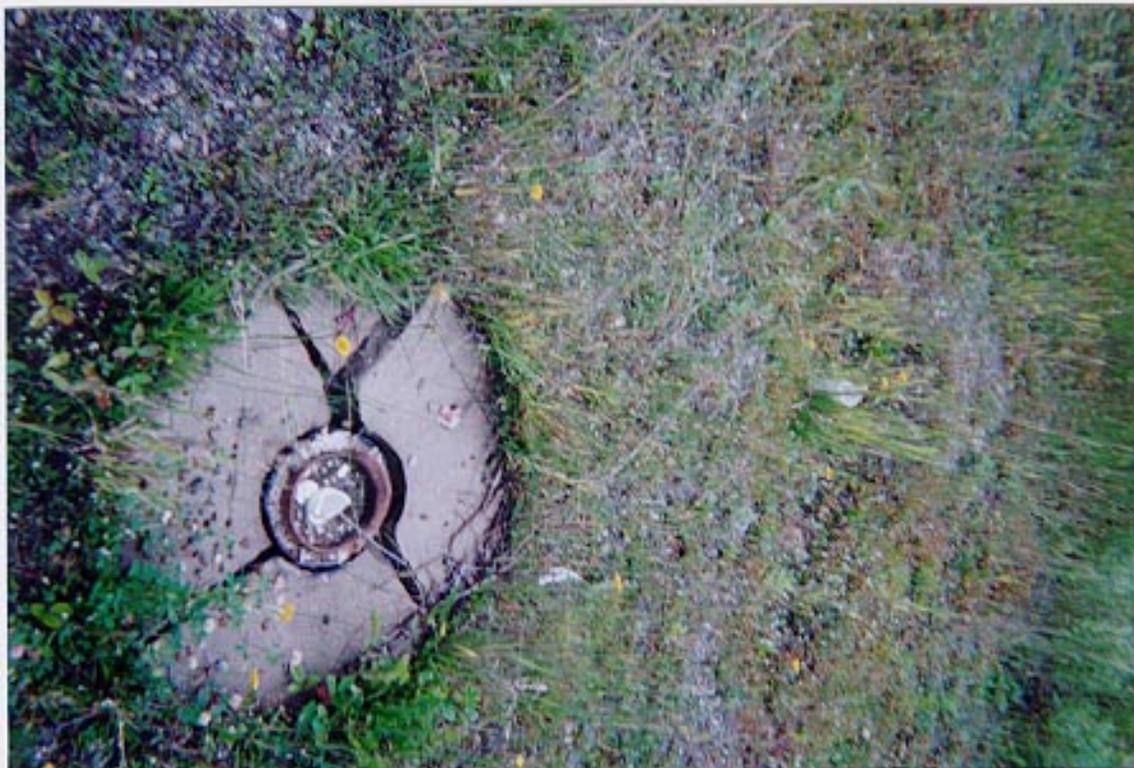
Frame No: 9

MW-9 cluster, wells broken at grade.

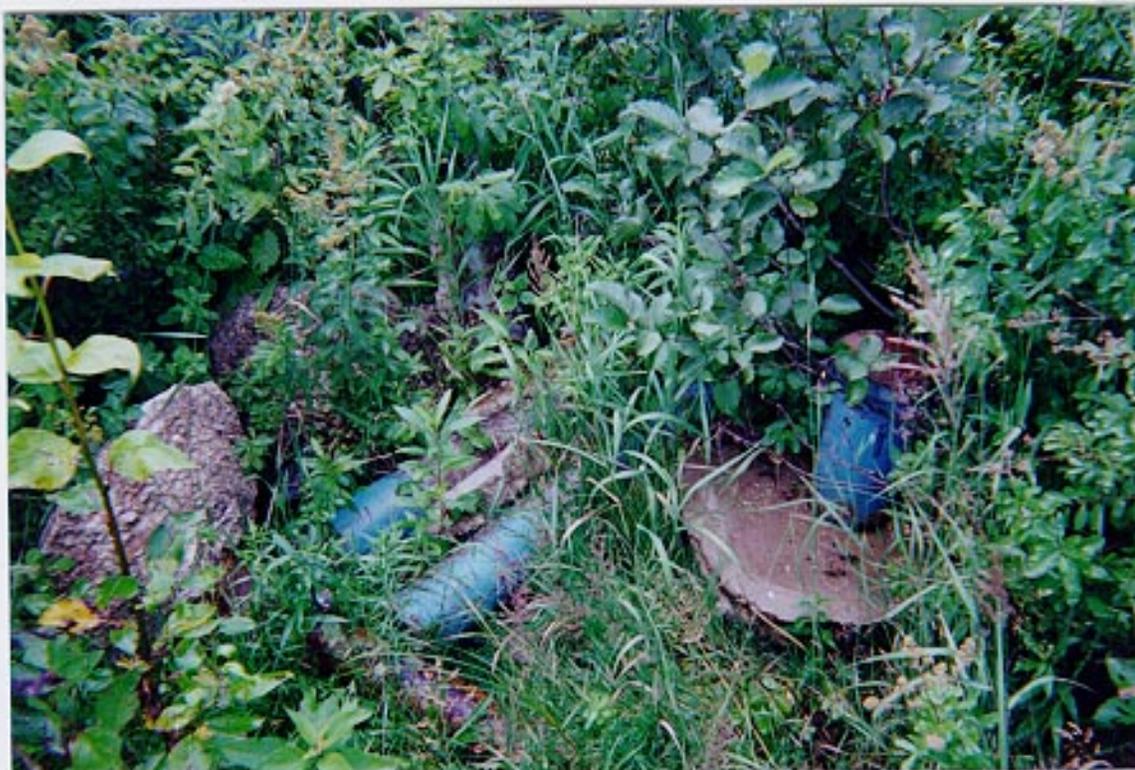
Frame No: 10

Well risers and surface seals stockpiled by Roger Pinetta

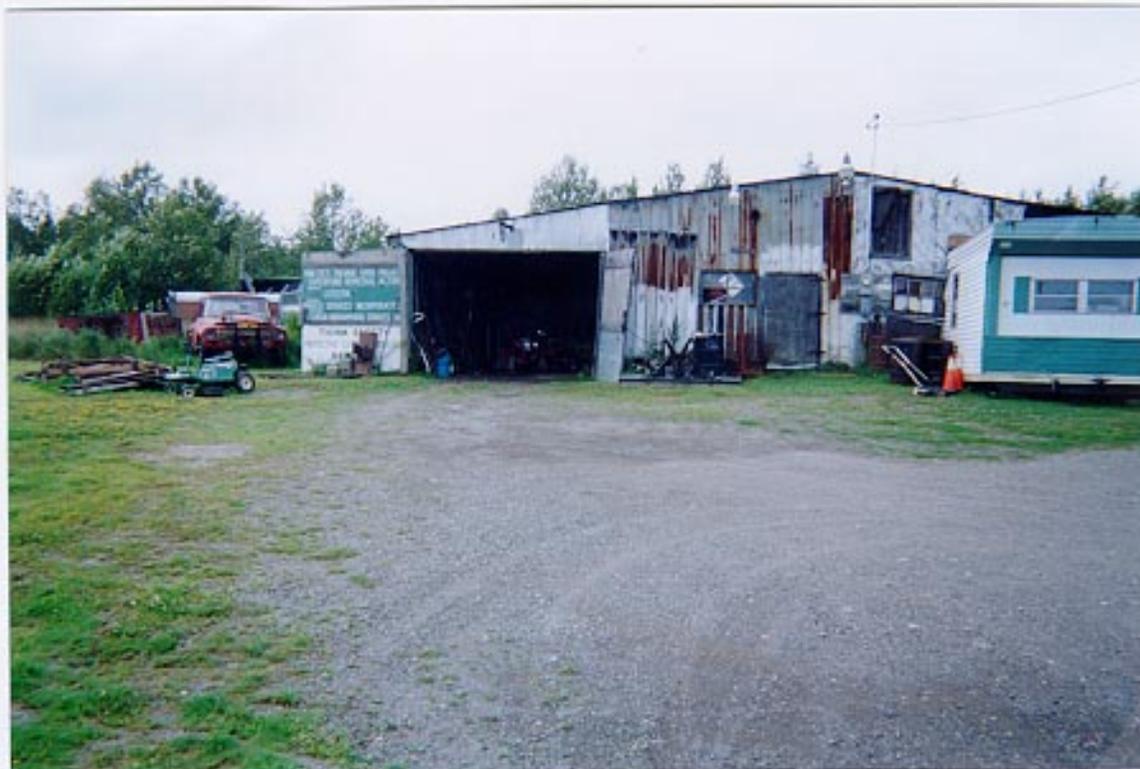
Frame No: 11

Roger Pinette's garage with old site sign used as siding.

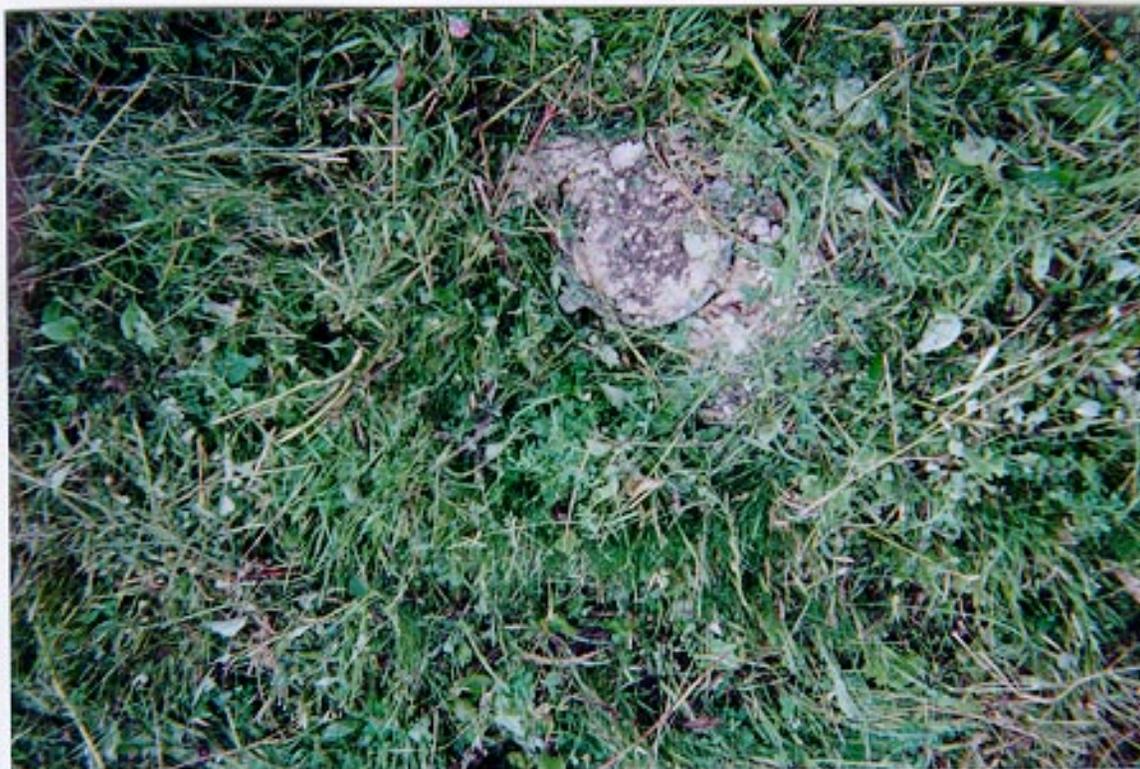
Frame No: 12

DMW-4 destroyed.

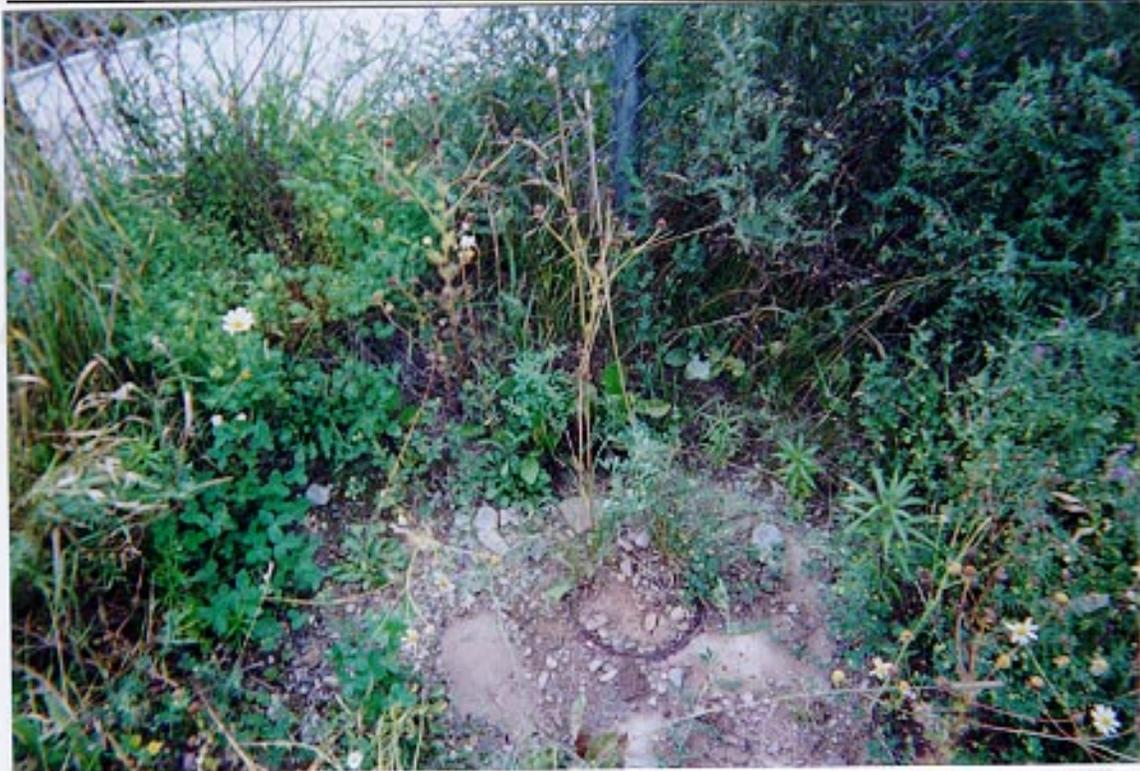
Frame No: 13

MW-3 cluster well destroyed.

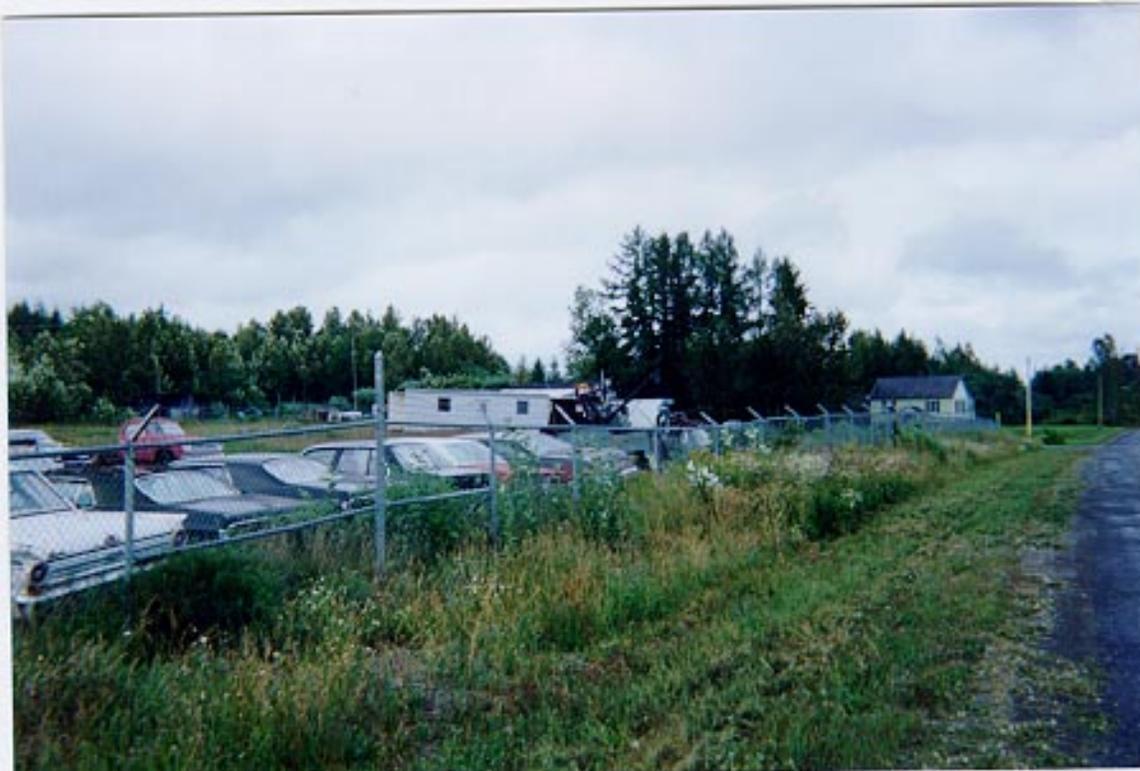
Frame No: 14

Site fence from main gate looking down Gardner Creek road, Rita Pinette's residence in background.

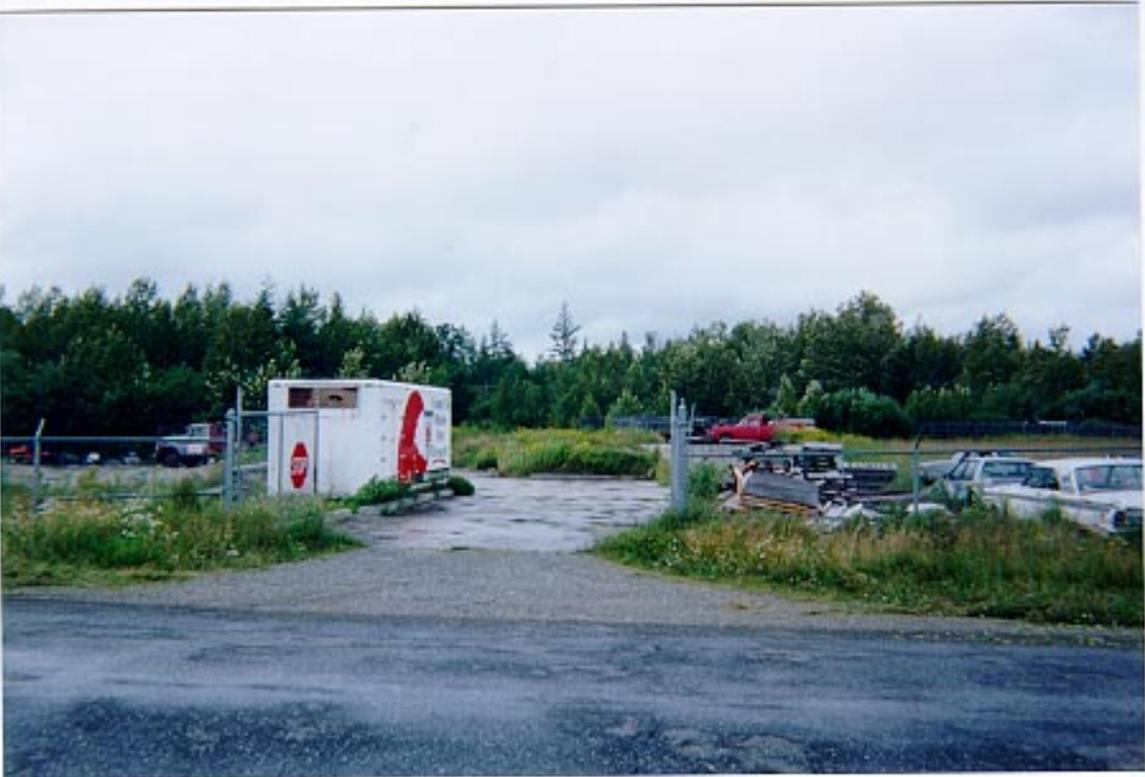
Frame No: 15

Main site gate.
