## **FIVE-YEAR REVIEW REPORT**

**Pinette's Salvage Yard Superfund Site  
Washburn, Maine**

September 2000

Prepared by  
Foster Wheeler Environmental Corporation  
133 Federal Street  
Boston, MA 02110

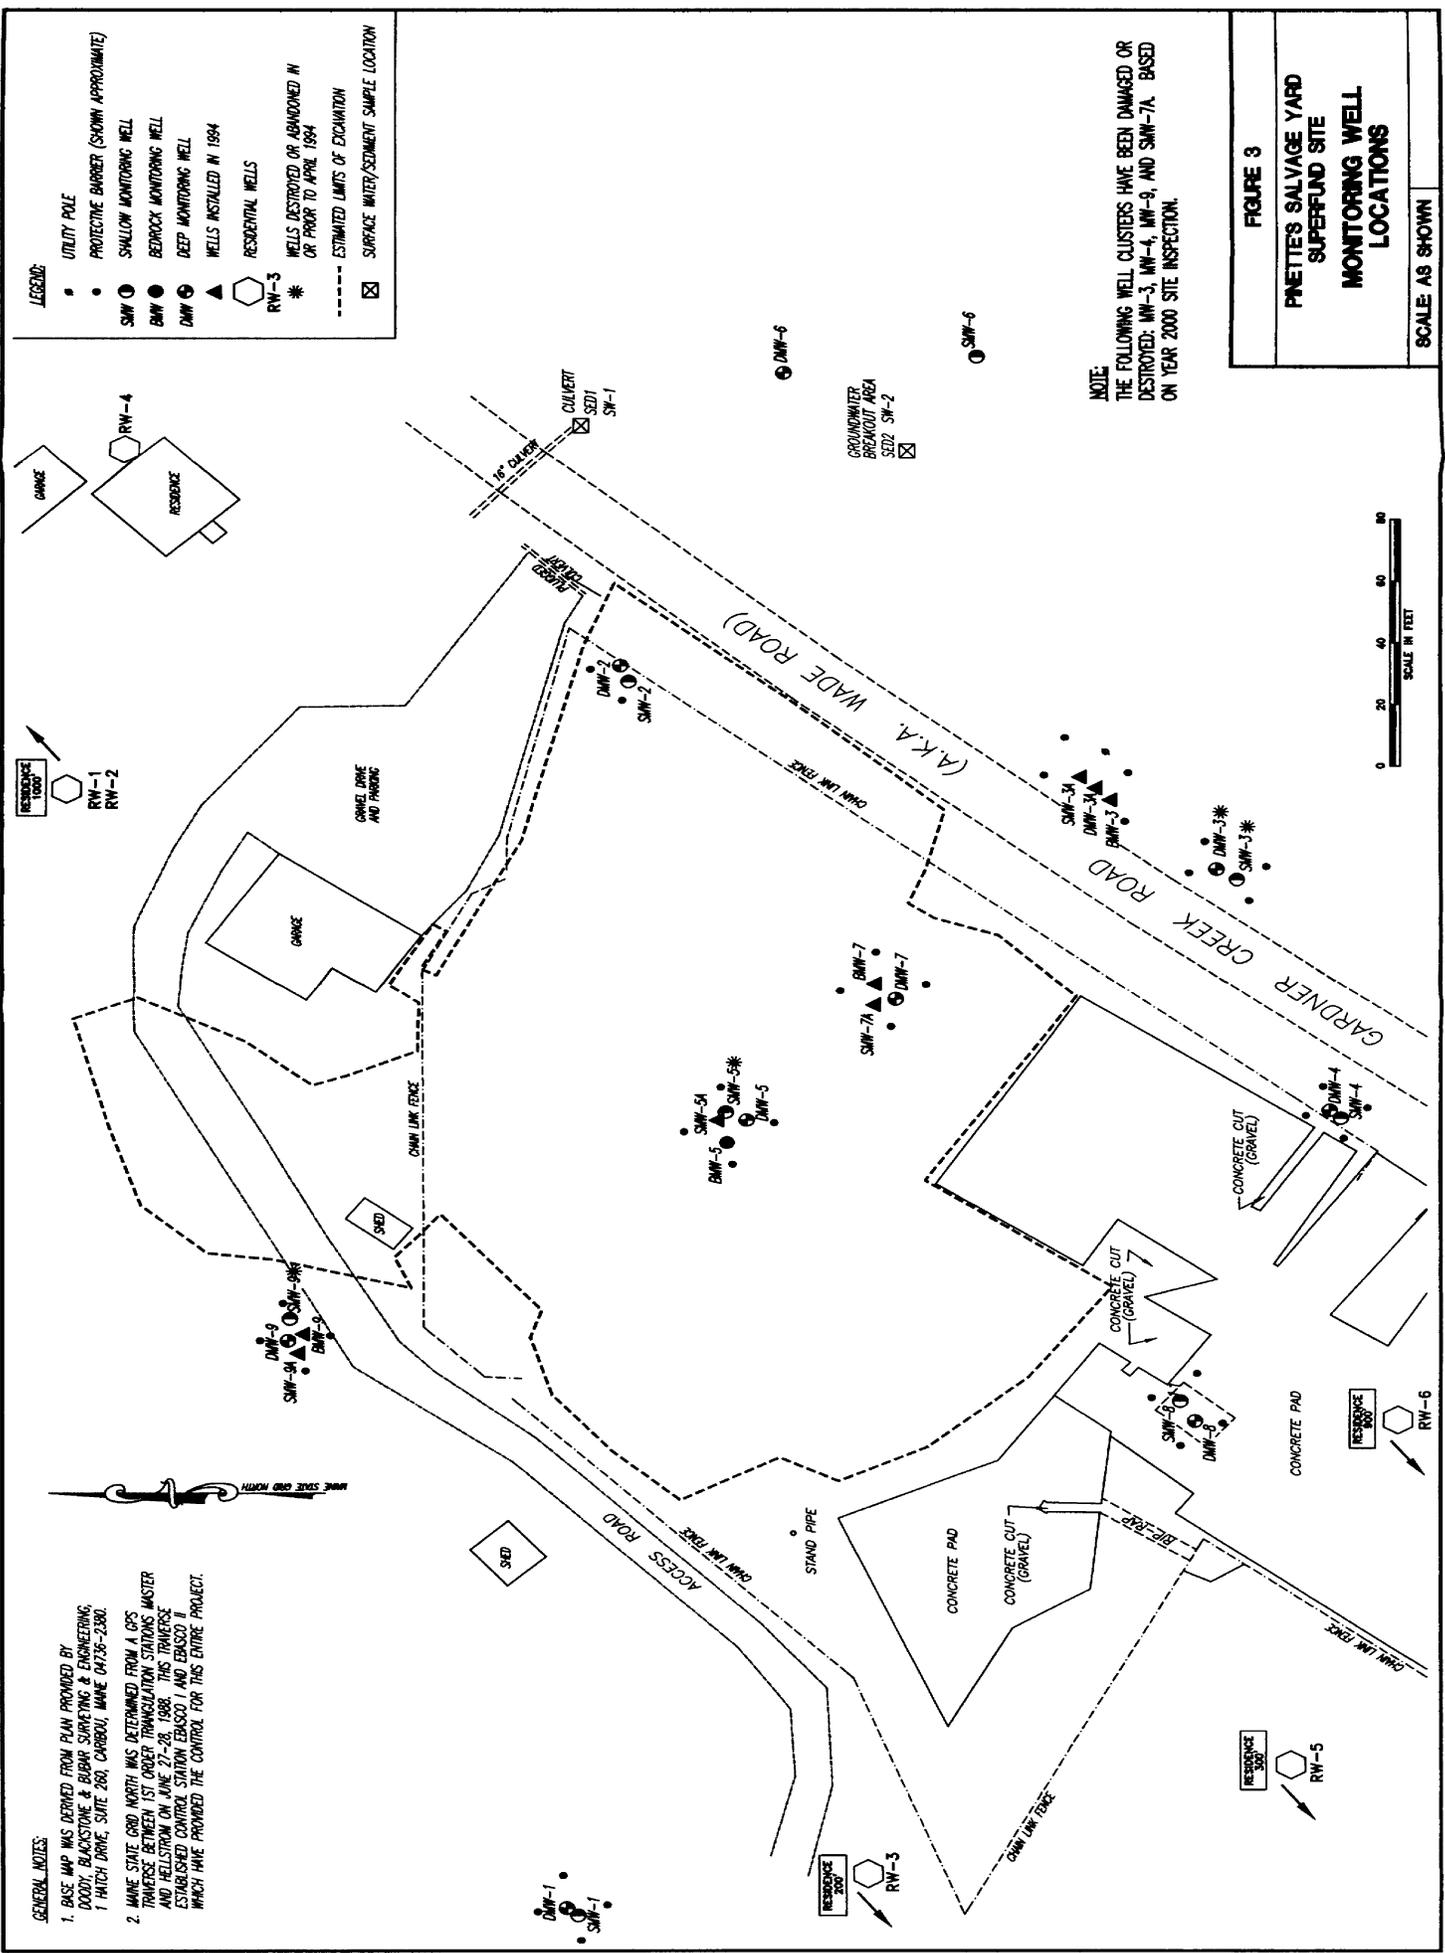
**FIGURE 3**  
**PRETTE'S SALVAGE YARD SUPERFUND SITE**  
**MONITORING WELL LOCATIONS**

All site monitoring wells were visually inspected. The MW-3 and MW-4 well clusters have been destroyed. The protective risers of the MW-9 cluster have been removed and the integrity of this cluster has likely been compromised. Well SMW-7A has a loose surface seal and may also be compromised. All other site monitoring wells appear to be in good condition. Overall deficiencies are summarized in Section VIII.

**NOTE:**  
THE FOLLOWING WELL CLUSTERS HAVE BEEN DAMAGED OR DESTROYED: MW-3, MW-4, MW-9, AND SMW-7A. BASED ON YEAR 2000 SITE INSPECTION.

Based upon the results of the site inspection, EPA is evaluating the need to repair and/or upgrade site fencing to minimize trespassing. EPA is also evaluating measures to repair certain site monitoring wells and possible abandonment of damaged wells. It is not anticipated that all wells will be repaired since the site inspection indicated that some of the principal monitoring wells needed to monitor groundwater contamination remain intact. Finally, EPA recognizes the need for institutional controls through deed restrictions and/or easements prohibiting the construction of domestic wells on-site and is in the process of putting these controls in place. The recommendations and follow-up actions are as outlined in Table 5.
