September 2002 Site Inspection Report

WESTERN SAND AND GRAVEL

SITE INSPECTION REPORT

**MARCH 2003 SUPPLEMENTAL PHOTOGRAPHIC DOCUMENTATION
WESTERN SAND AND GRAVEL
BURRILLVILLE, RHODE ISLAND**

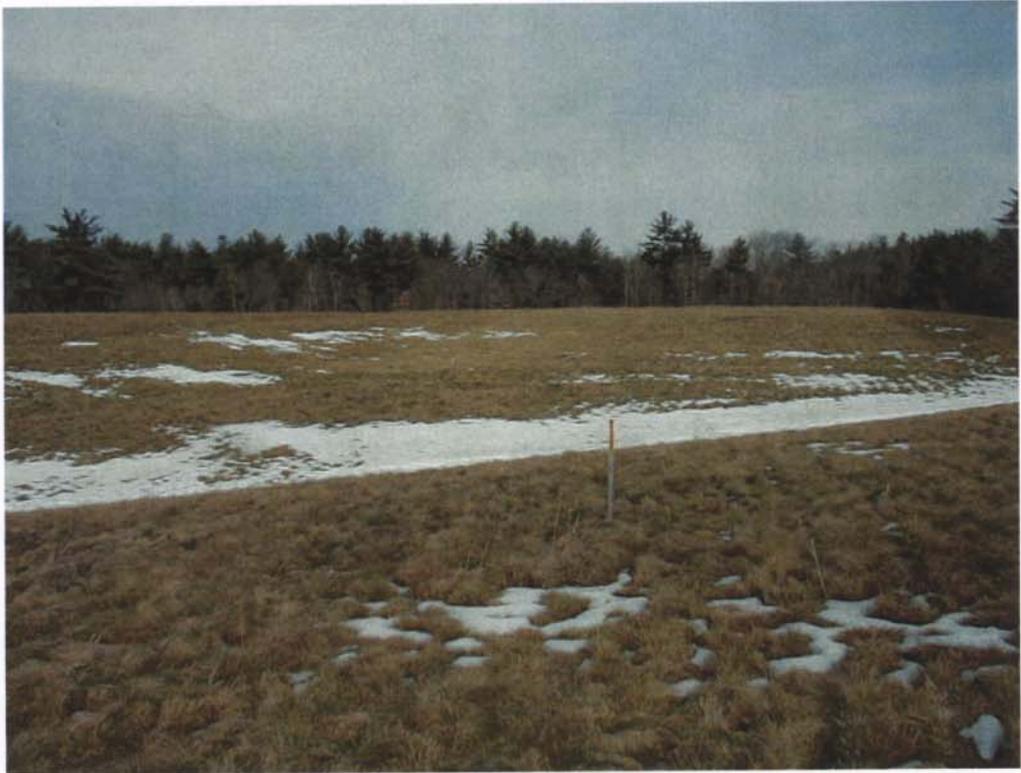
Photograph No. 1: Looking north at the cap (northern) area of the landfill.

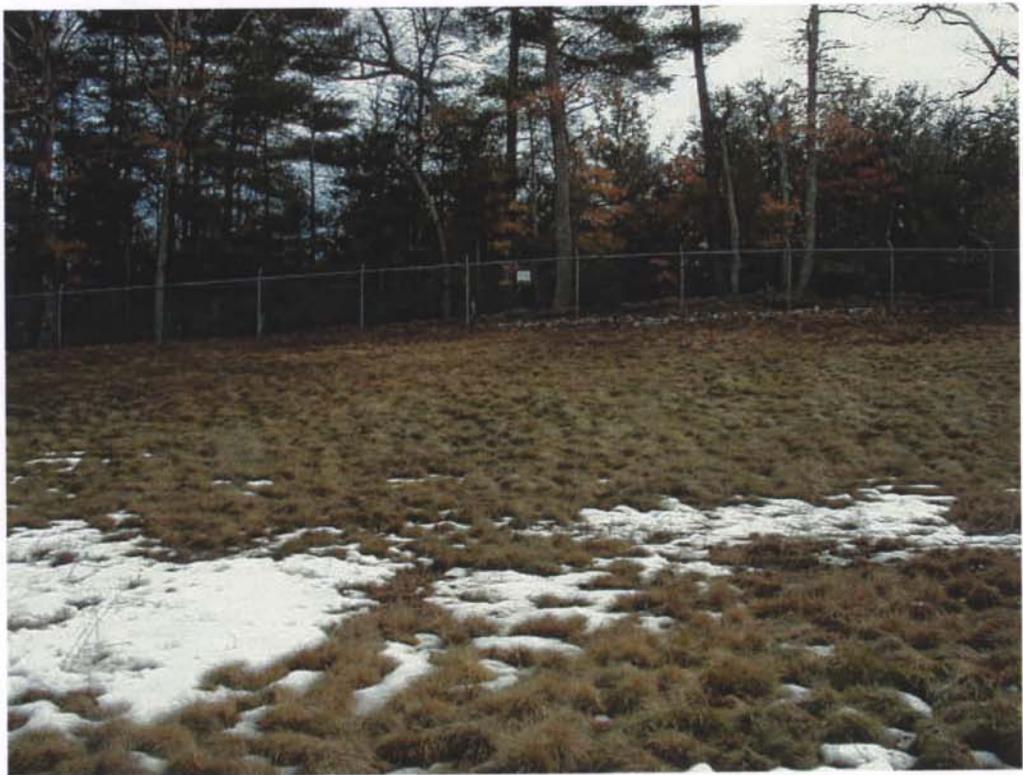
Photograph No. 2: Looking east at the eastern portion of the landfill area.

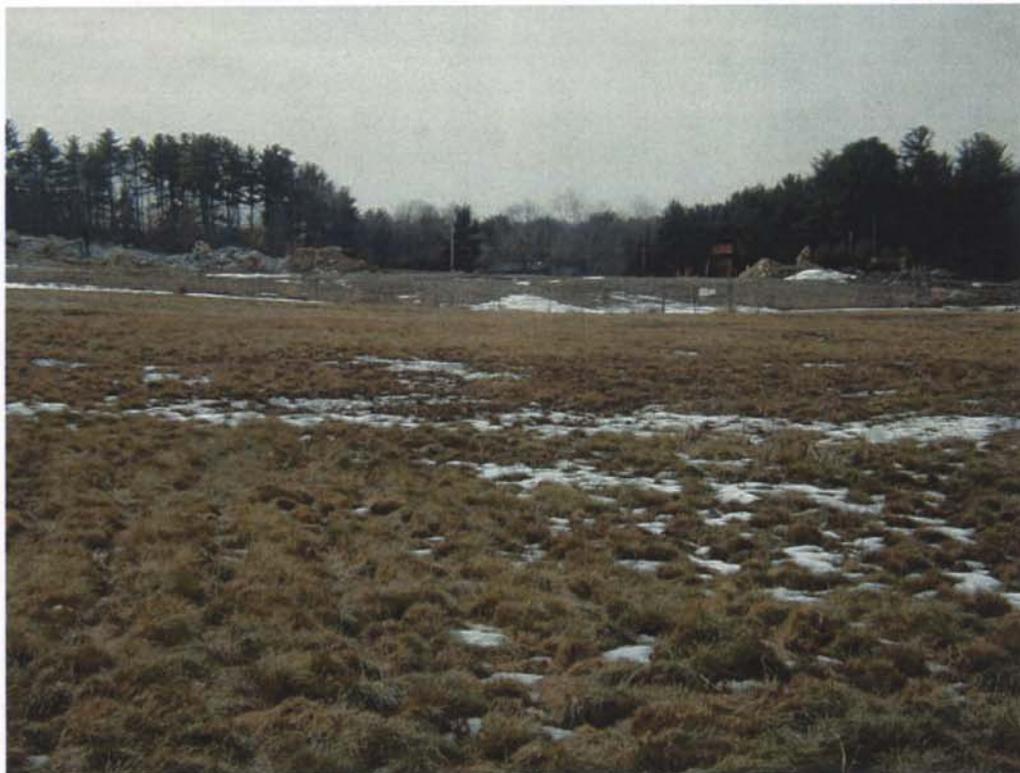
Photograph No. 3: Looking south at the southern portion of the landfill. Note construction activities to the south of the landfill.

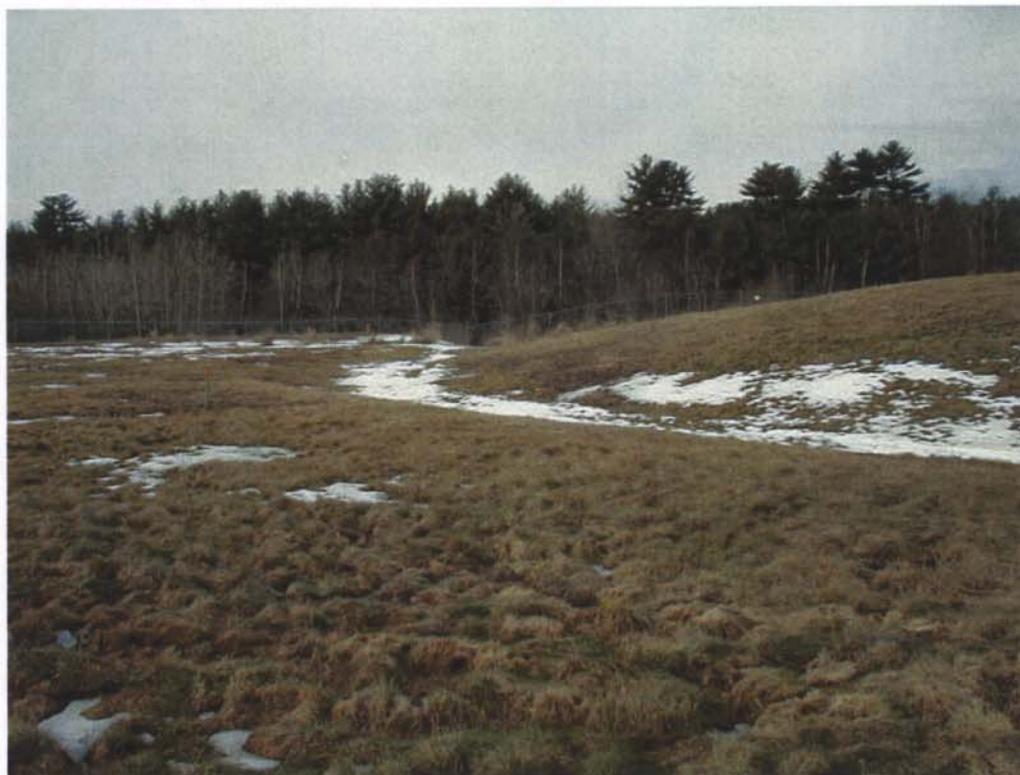
Photograph No. 4: Looking west at the western portion of the landfill.

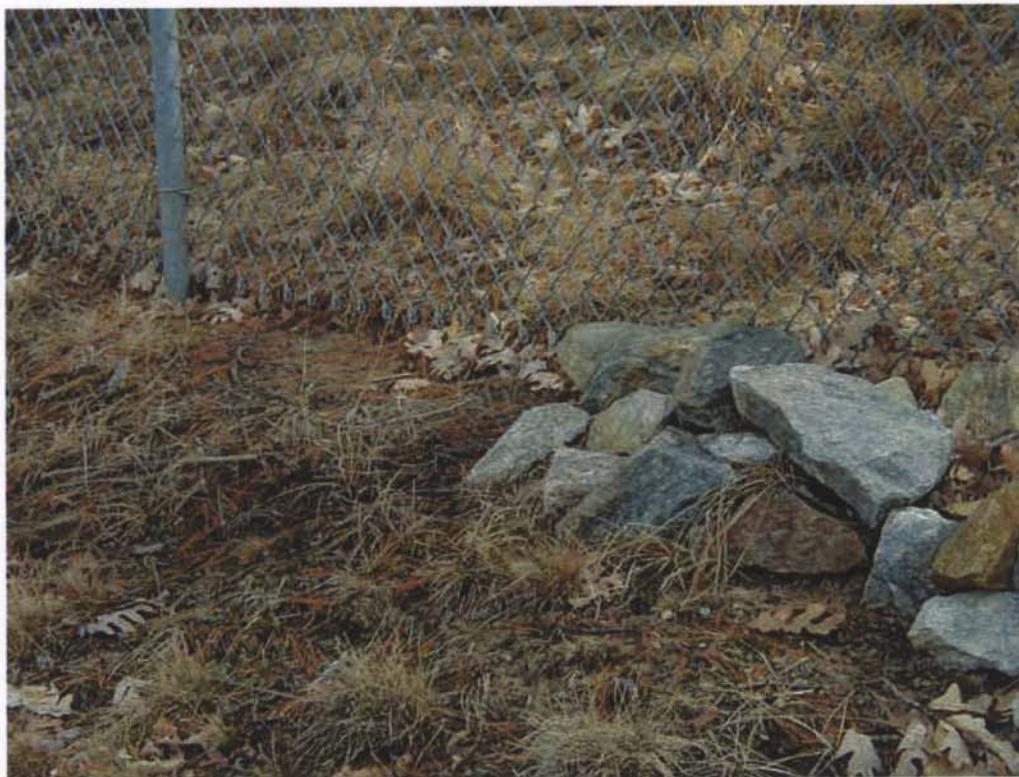
- An animal burrow was observed underneath the east side fencing. ATC filled in the hole with rocks.
- An animal burrow was observed underneath the north side fencing. ATC filled in the hole with rocks.

Photograph No. 5: Typical fenceline gap area along perimeter of landfill.

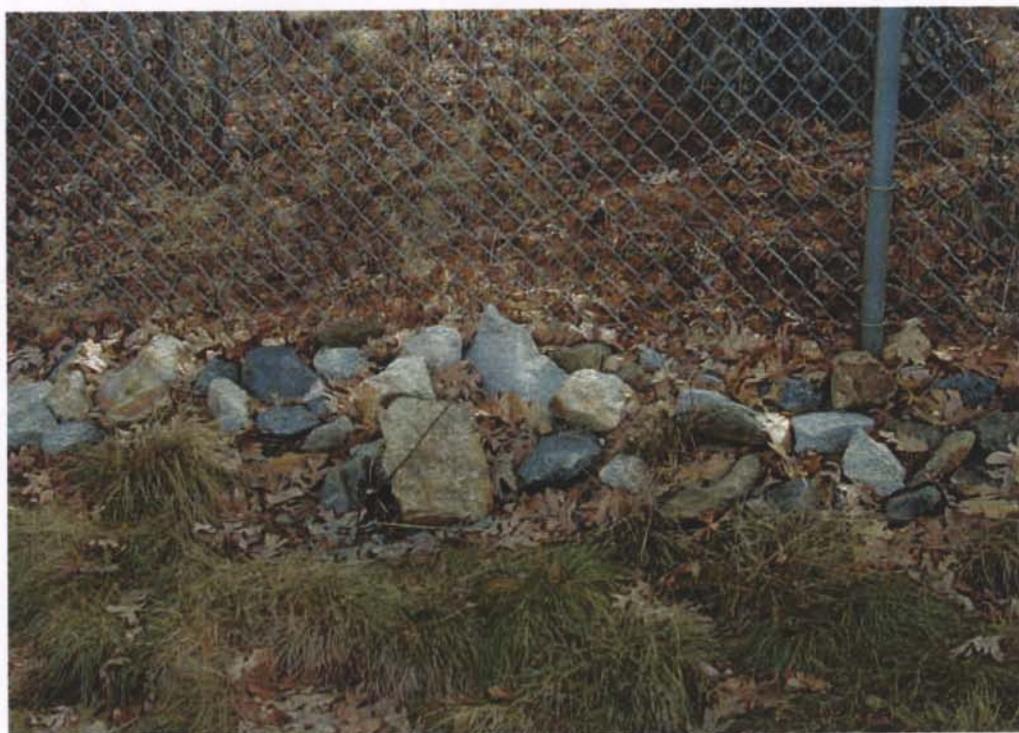
Photograph No. 6: Typical fenceline gap filled/secured with rocks.

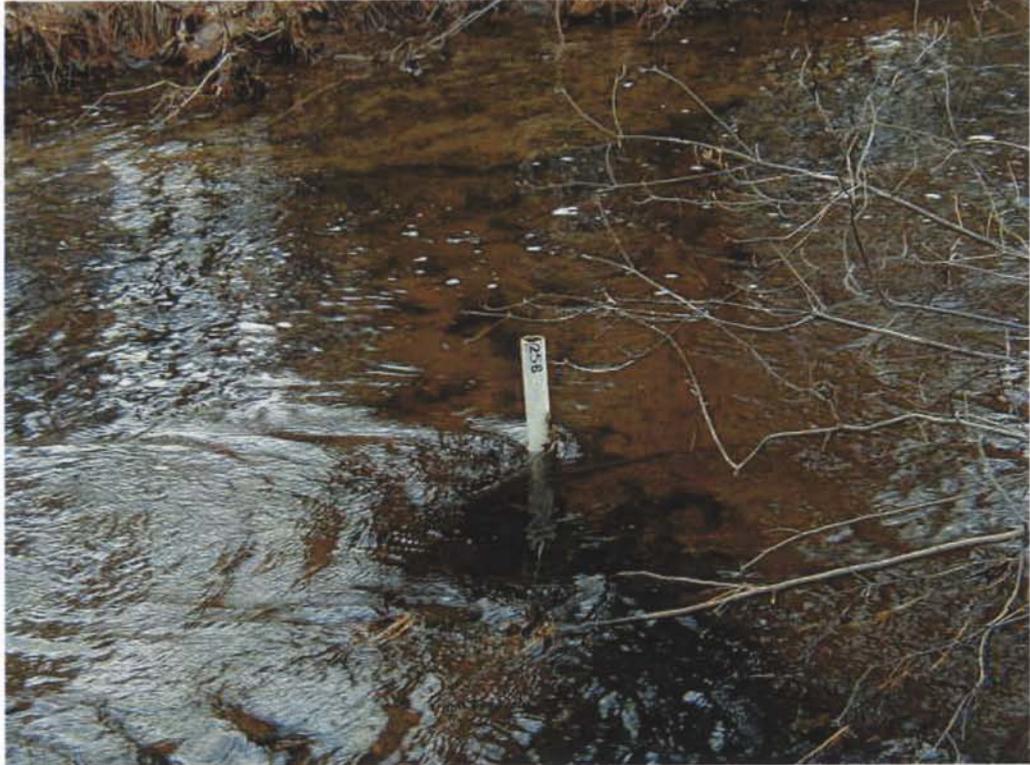
Photograph No. 7: Stream gauge SG-1 as observed on March 20, 2003.

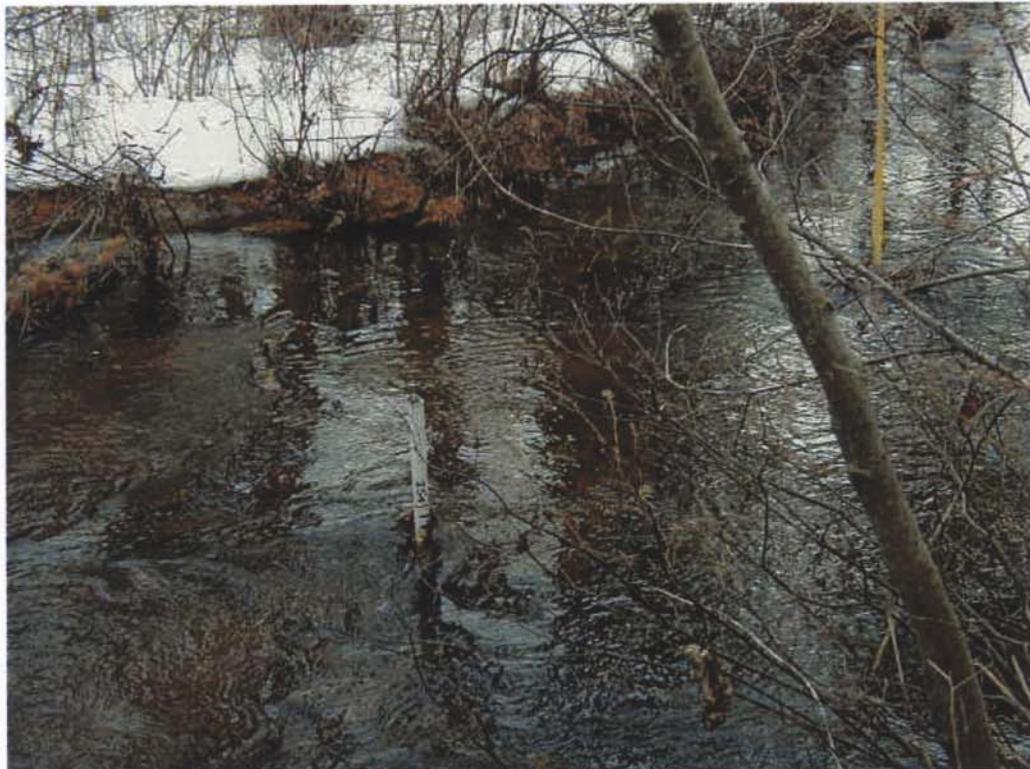
Photograph No. 8: Stream gauge SG-2 as observed on March 20, 2003.

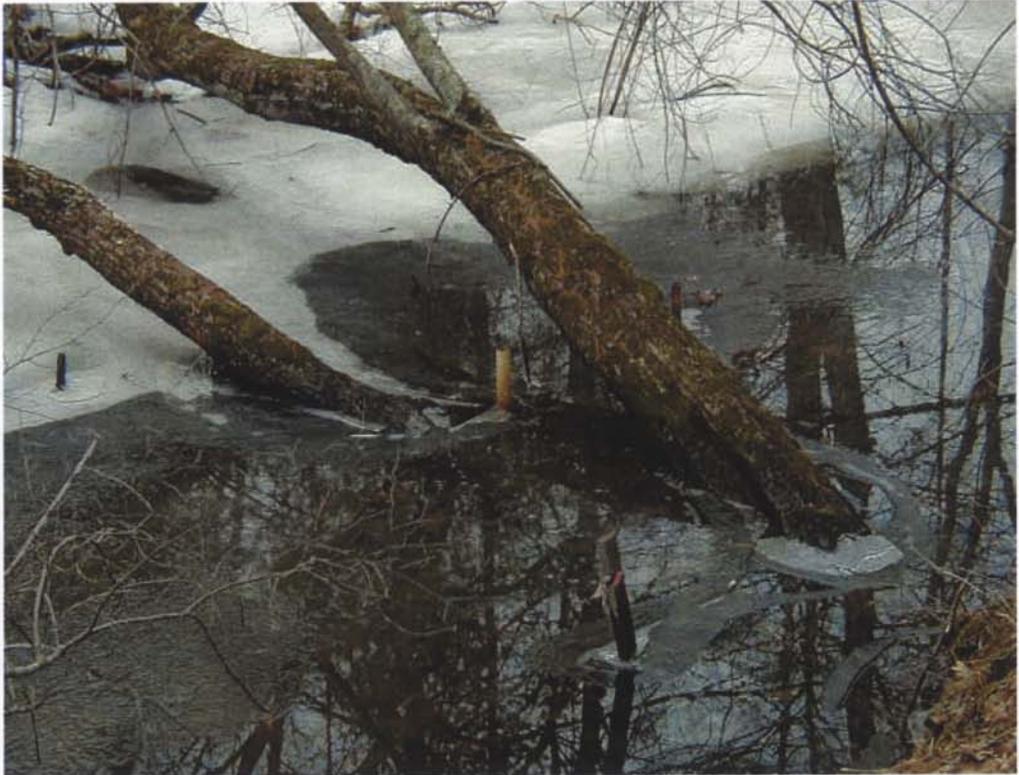
Photograph No. 9: Stream gauge SG-2A as observed on March 20, 2003.

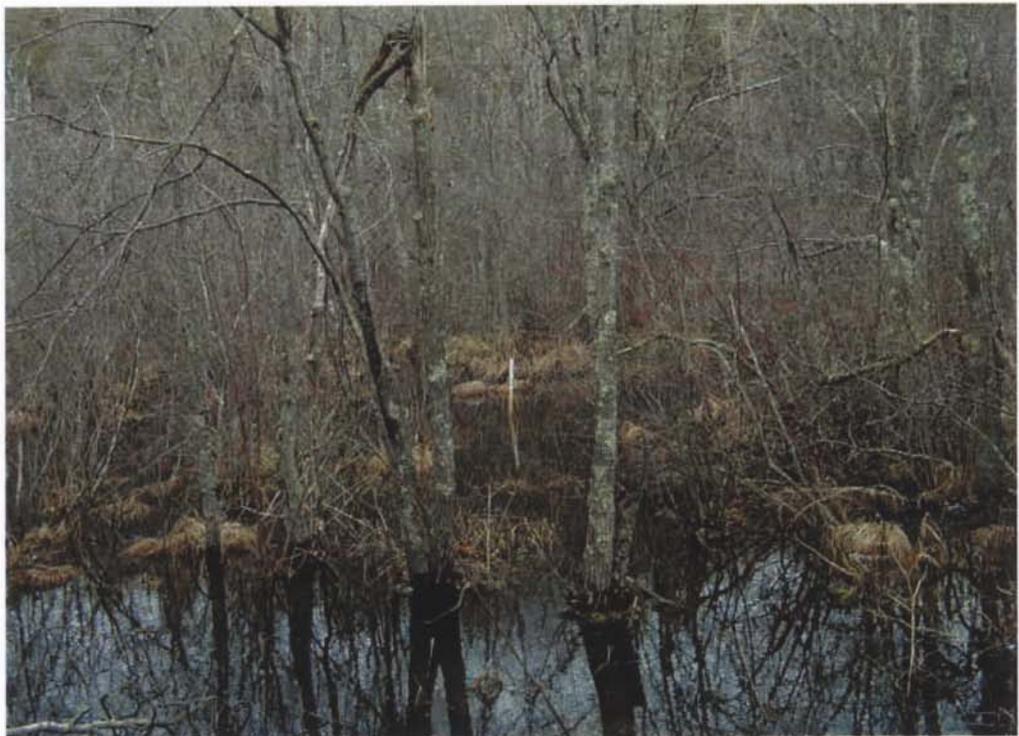
Photograph No. 10: Close-up photograph of stream gauge SG-3 as observed on March 20, 2003.

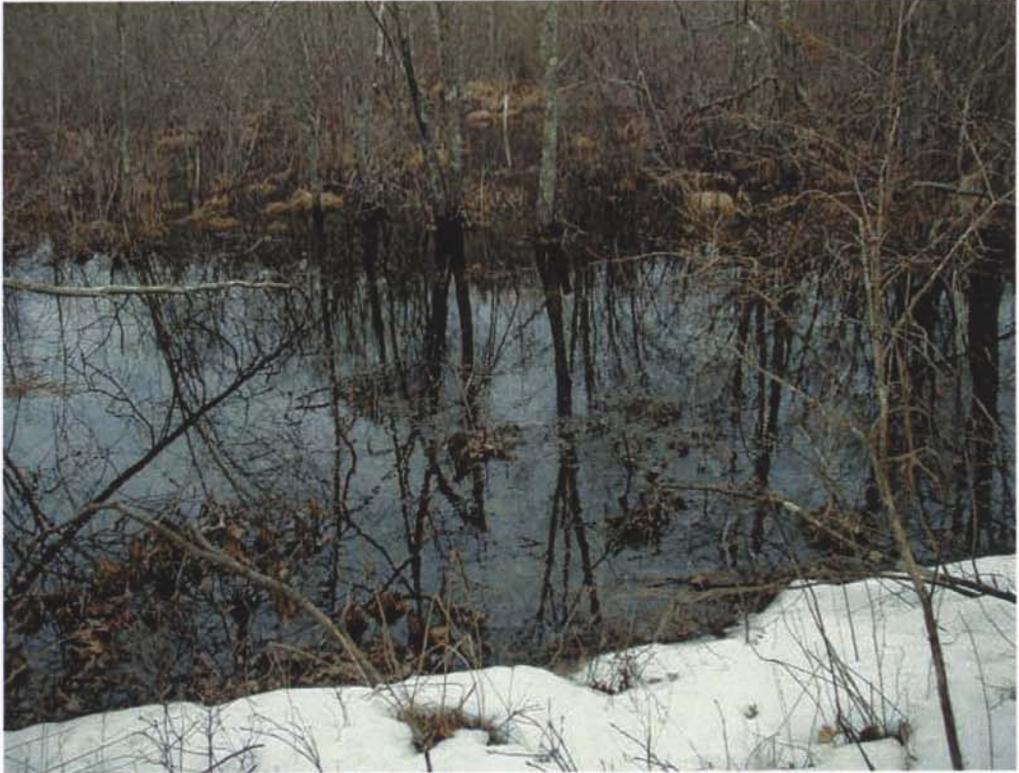
Photograph No. 11: Area photograph of stream gauge SG-3 as observed on March 20, 2003.

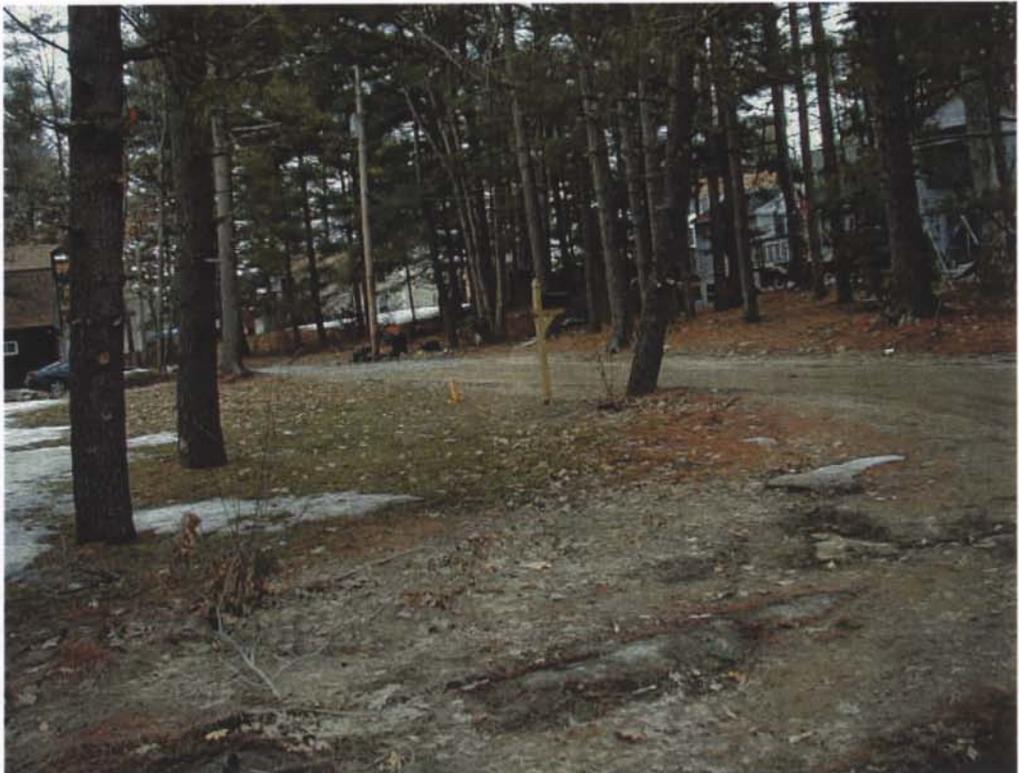
Photograph No. 12: Area of former well cluster II-4.

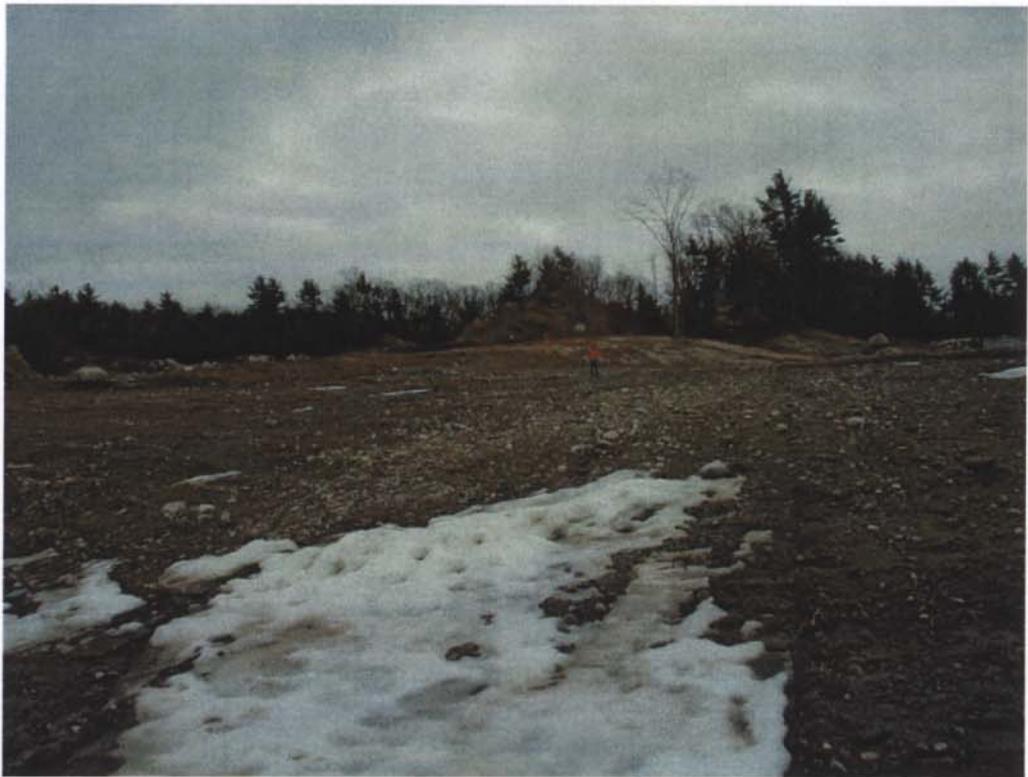
Photograph No. 13: Looking southeast from near the southern landfill perimeter fence towards the former hillside area and former location of monitoring well C-1-D.

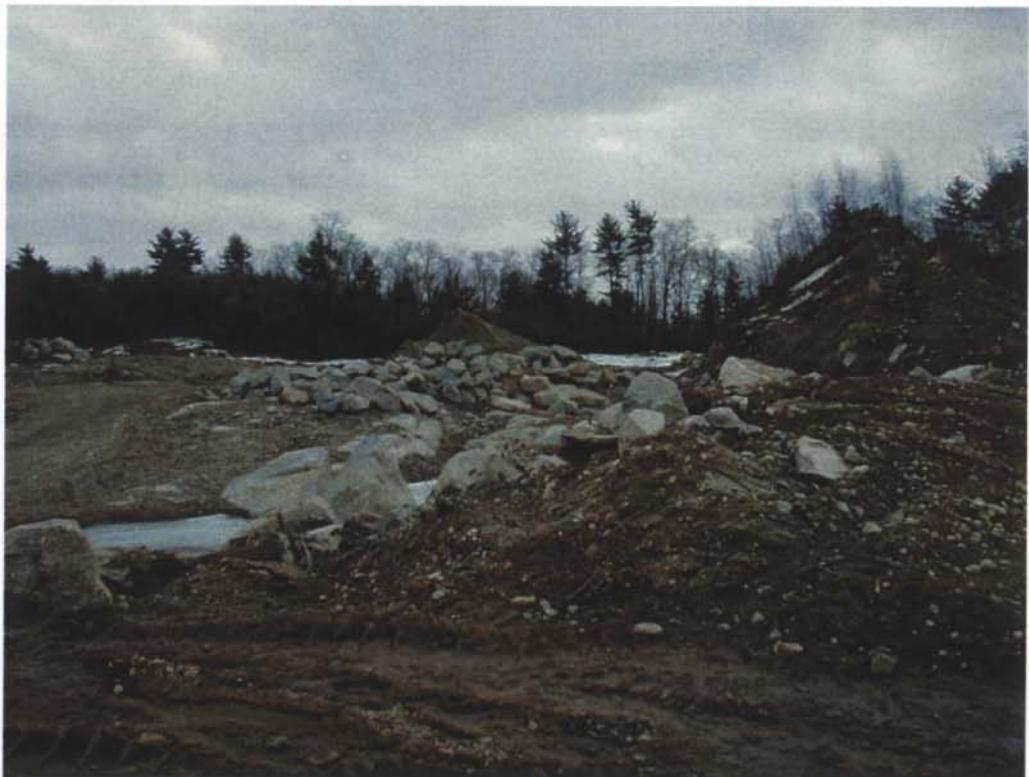
Photograph No. 14: Looking southeast from the estimated location of monitoring well C-1-D and former hillside area.
