DRAFT  
YEAR 5 INTERIM MONITORING REPORT—  
TERMINAL 4 PHASE I REMOVAL ACTION  
PORT OF PORTLAND, PORTLAND, OREGON

Port of Portland  
Portland, Oregon

Anchor QEA, LLC  
421 SW Sixth Avenue, Suite 750  
Portland, Oregon 97204

**January 2014**

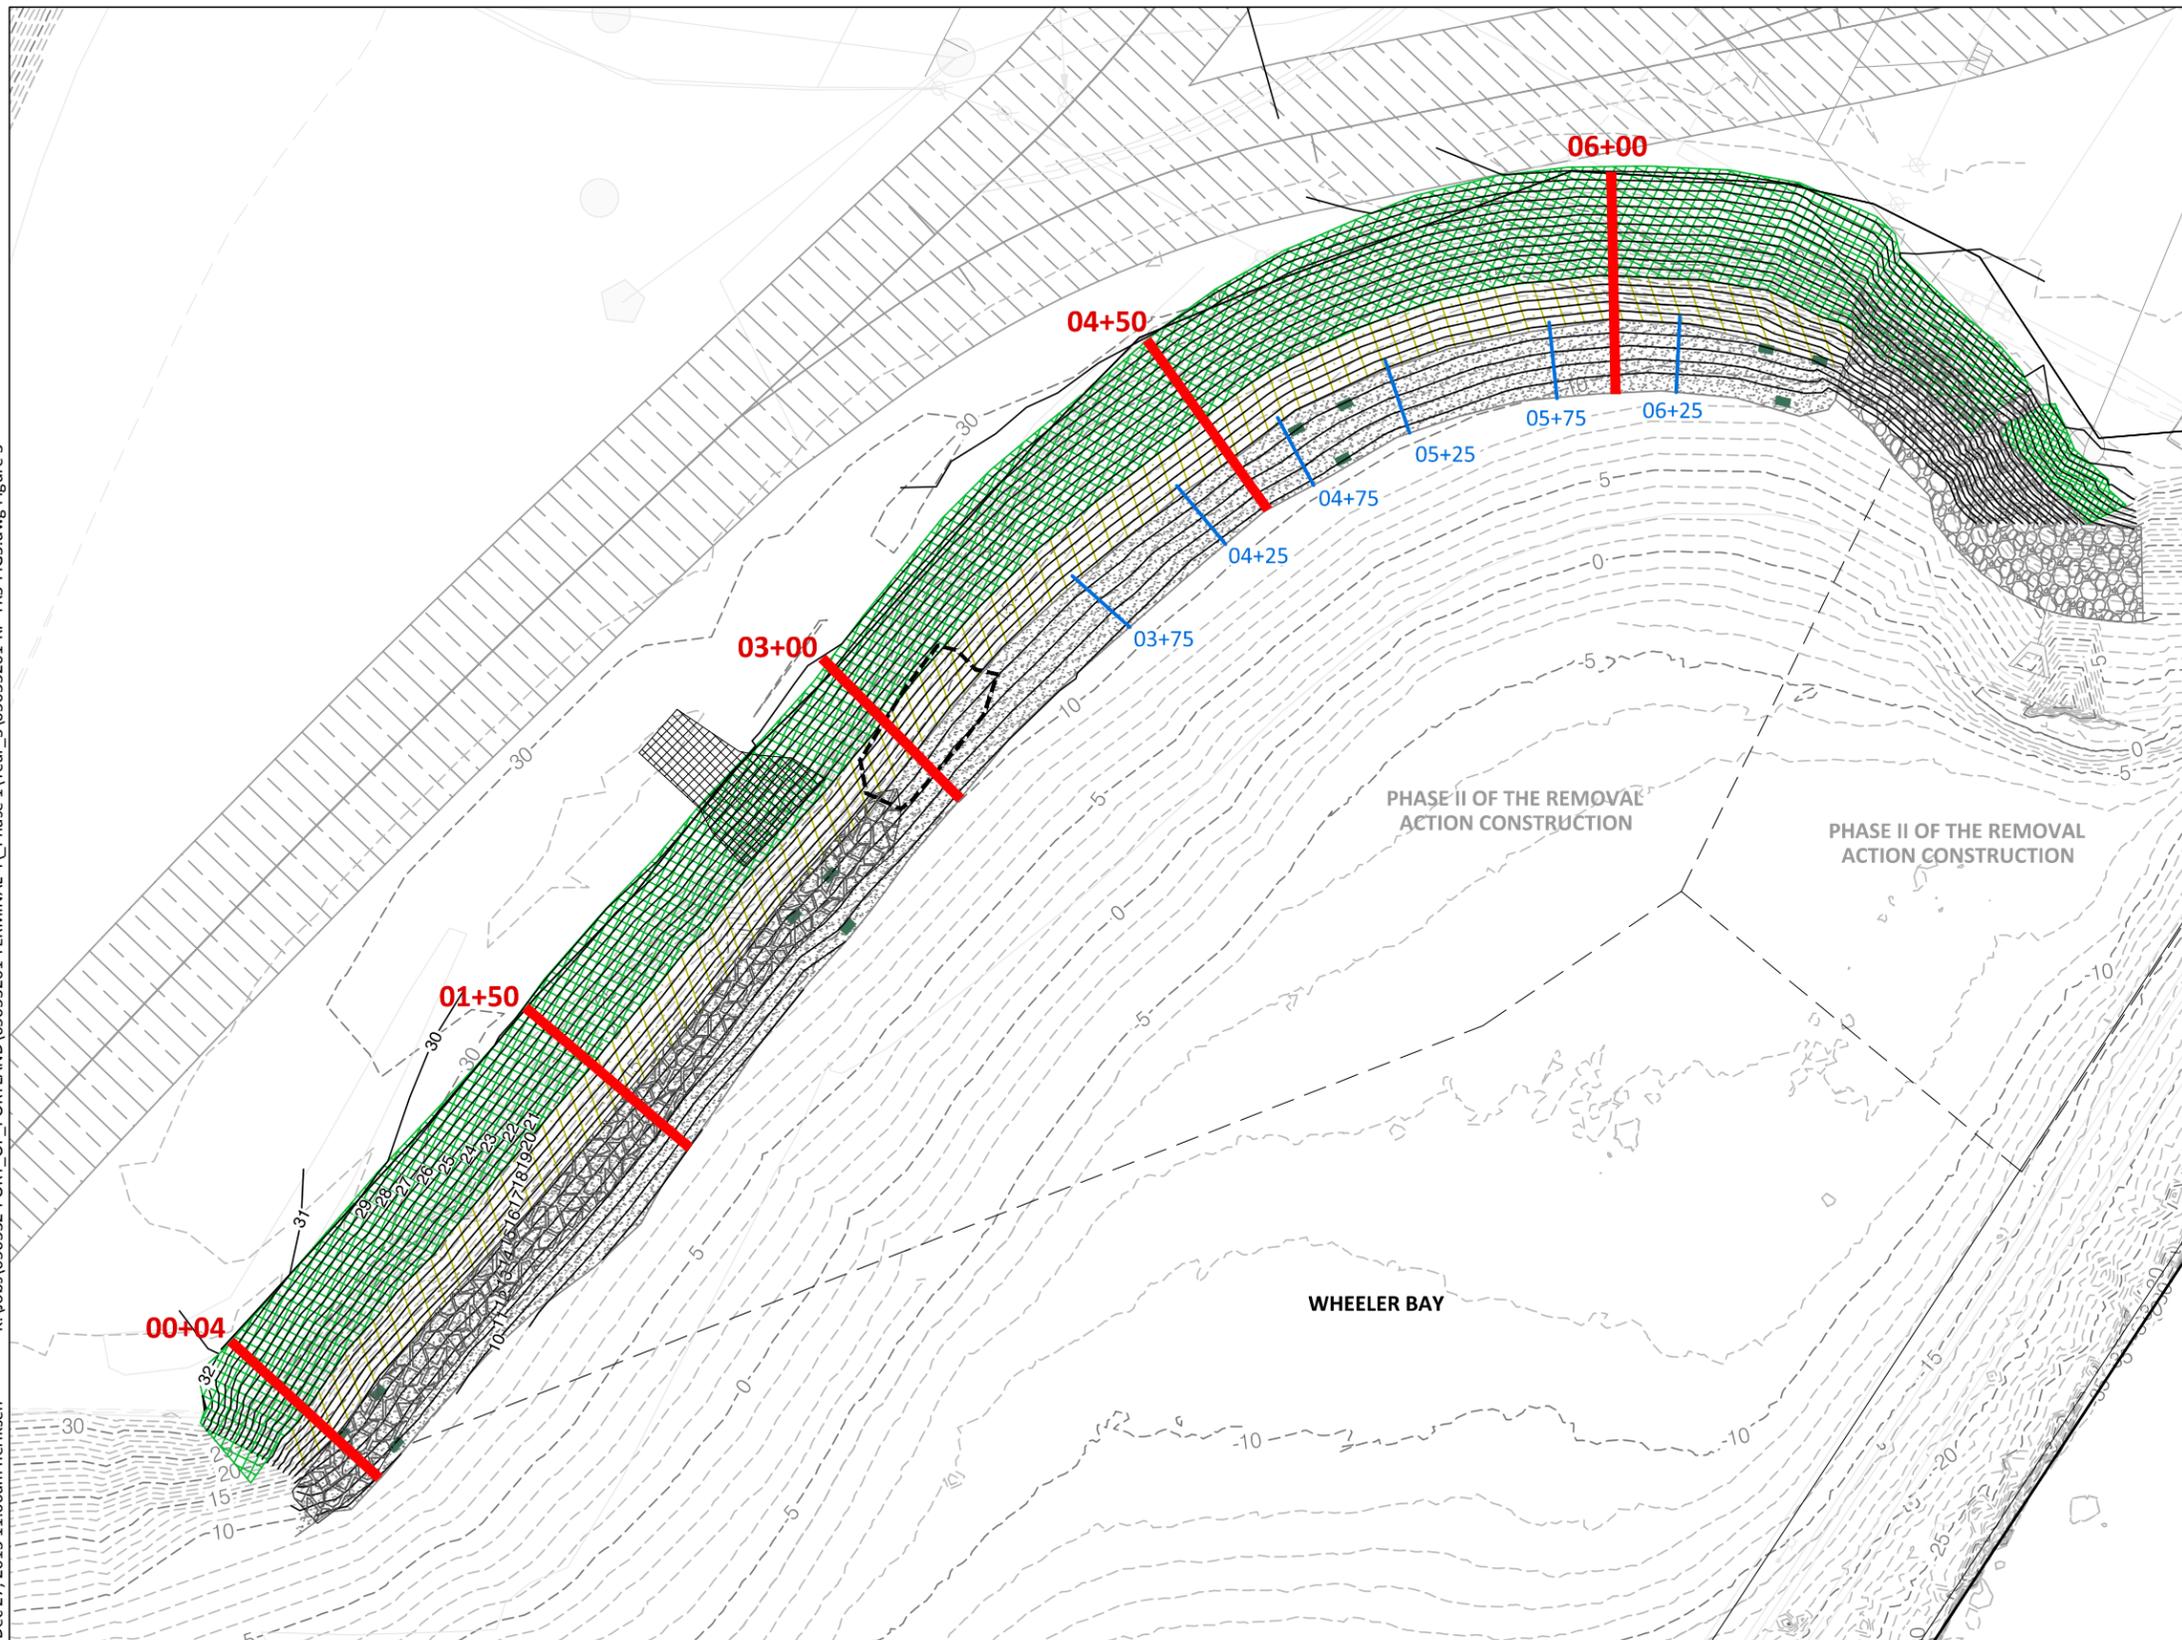
K:\Jobs\050332-PORT\_OF\_PORTLAND\05033201\_TERMINAL\_4\_Phase 1\Year\_5\05033201-RP-YR5-FIG3.dwg Figure 3  
Dec 27, 2013 11:06am heriksen

Transects were established perpendicular to the shoreline at 150-foot centers, as described in Section 3.1 and depicted in Figure 3. Monitoring staff walked along the transects looking for evidence of erosion within the armor layer. Notes and photographs were taken of the armor layer at each transect (see Appendix A: Attachments A-1 [field data sheets] and A-2 [photographs]). The armor layer showed no signs of instability, sloughing, or erosion. All woody debris installed as part of the original design and repair activities was in place, stable, and in good condition.

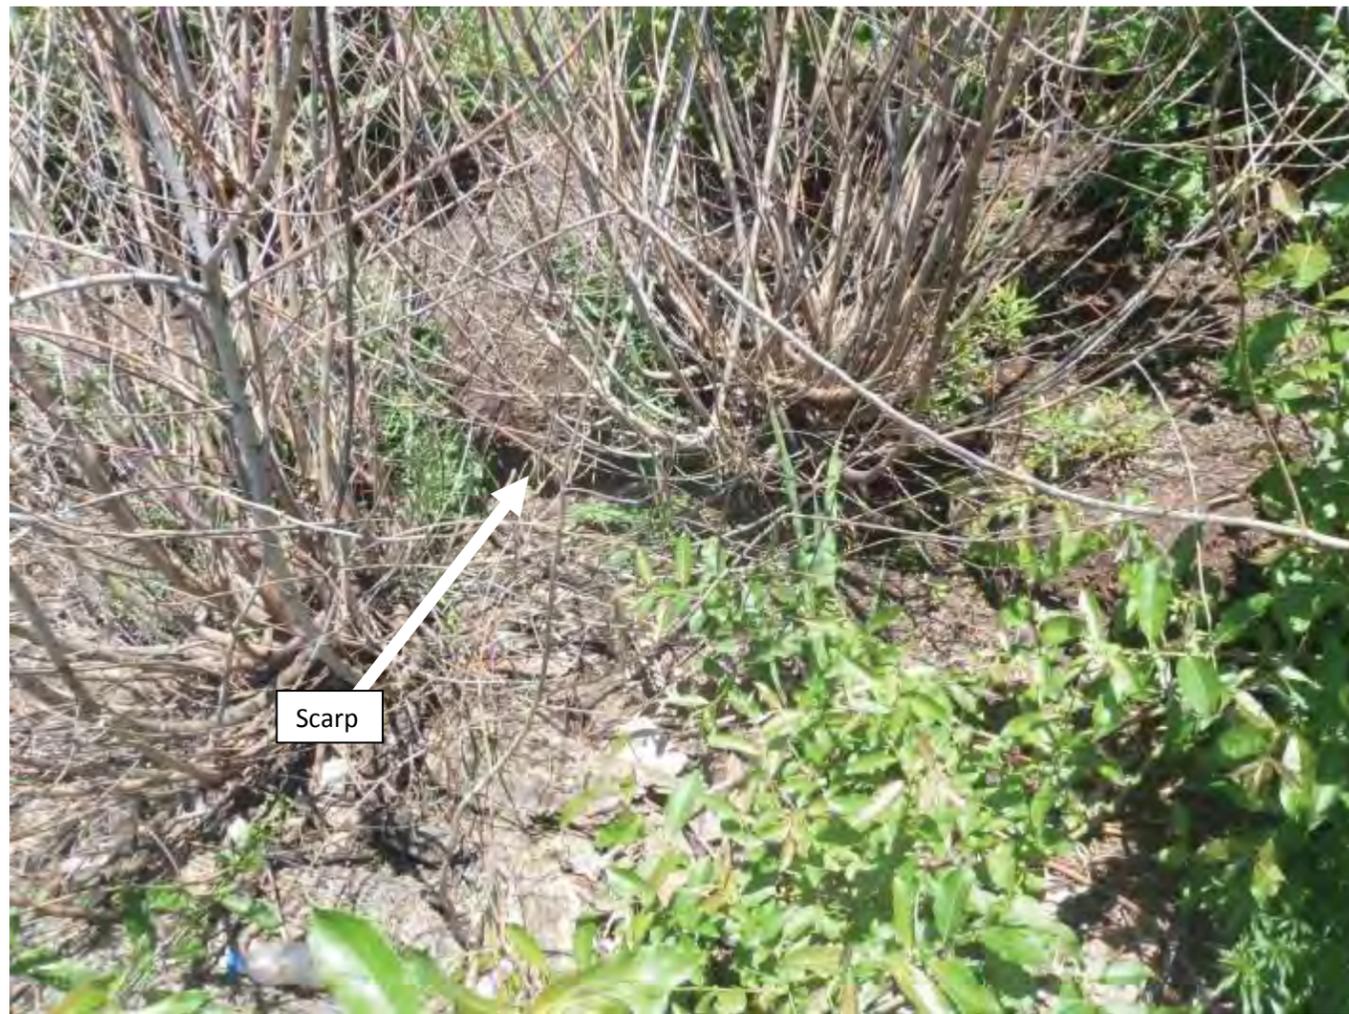
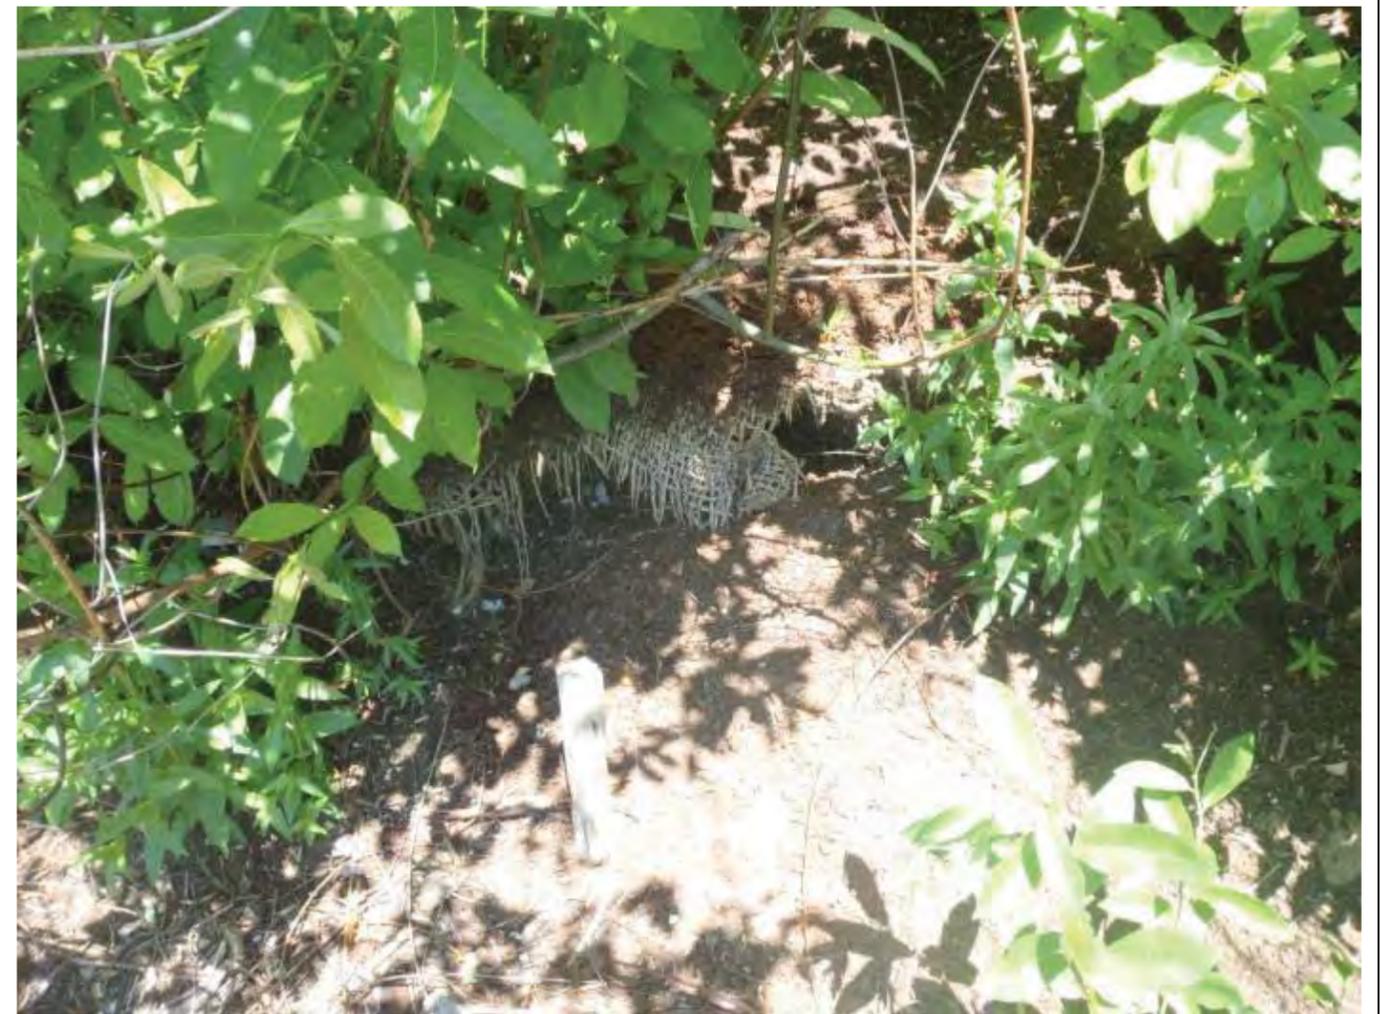
- A 1-foot scarp was observed in the willow planting area between Stations 00+00 and 01+60 during the Year 4 first quarter monitoring event of the repaired area. During Year 5, this erosional area remained unchanged from the scarp documented in the Repair Memo.
- A 1-foot scarp was observed in the willow planting area between Stations 03+40 and 06+70 during the Year 4 second, third, and fourth quarter monitoring events. During Year 5, this erosional area remained unchanged from the scarp documented in the Repair Memo.

- A 1-foot scarp was observed in the willow planting area between Stations 00+00 and 01+60 during the Year 4 first quarter monitoring event. The Year 5 monitoring results indicate this scarp area was unchanged from monitoring activities conducted in the previous year.
  - A 1-foot scarp was observed in the willow planting area between Stations 03+40 and 06+70 during the Year 4 second, third, and fourth quarter monitoring events. The Year 5 monitoring results indicate this scarp area was unchanged from monitoring activities conducted in the previous year.
-

1-foot scarp in the willow planting area between Stations 00+00 and 01+60 (Photo Date: 6/4/2013).

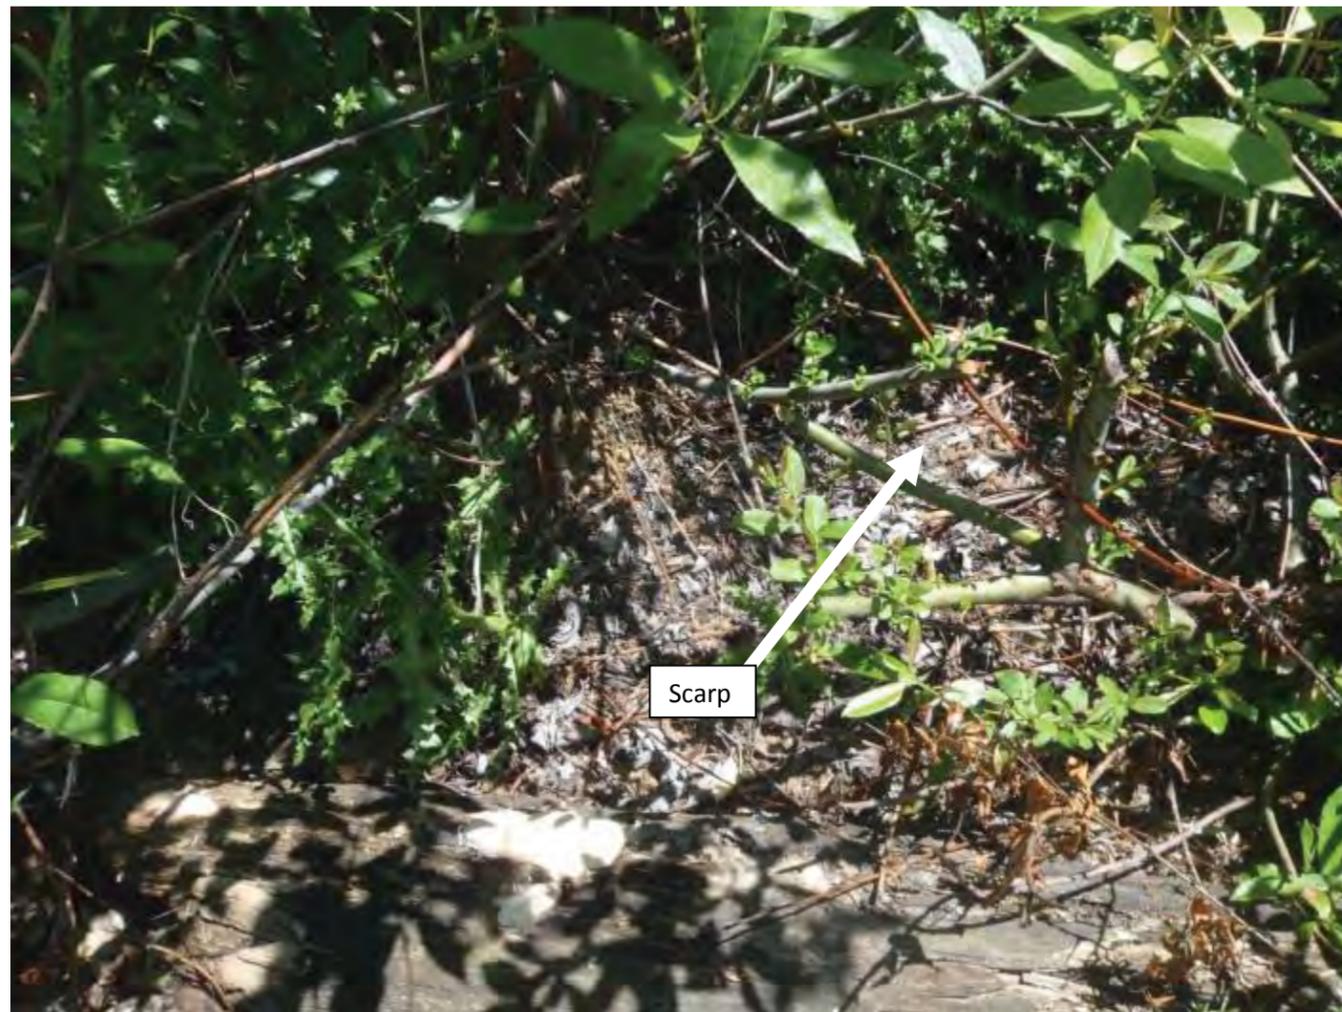
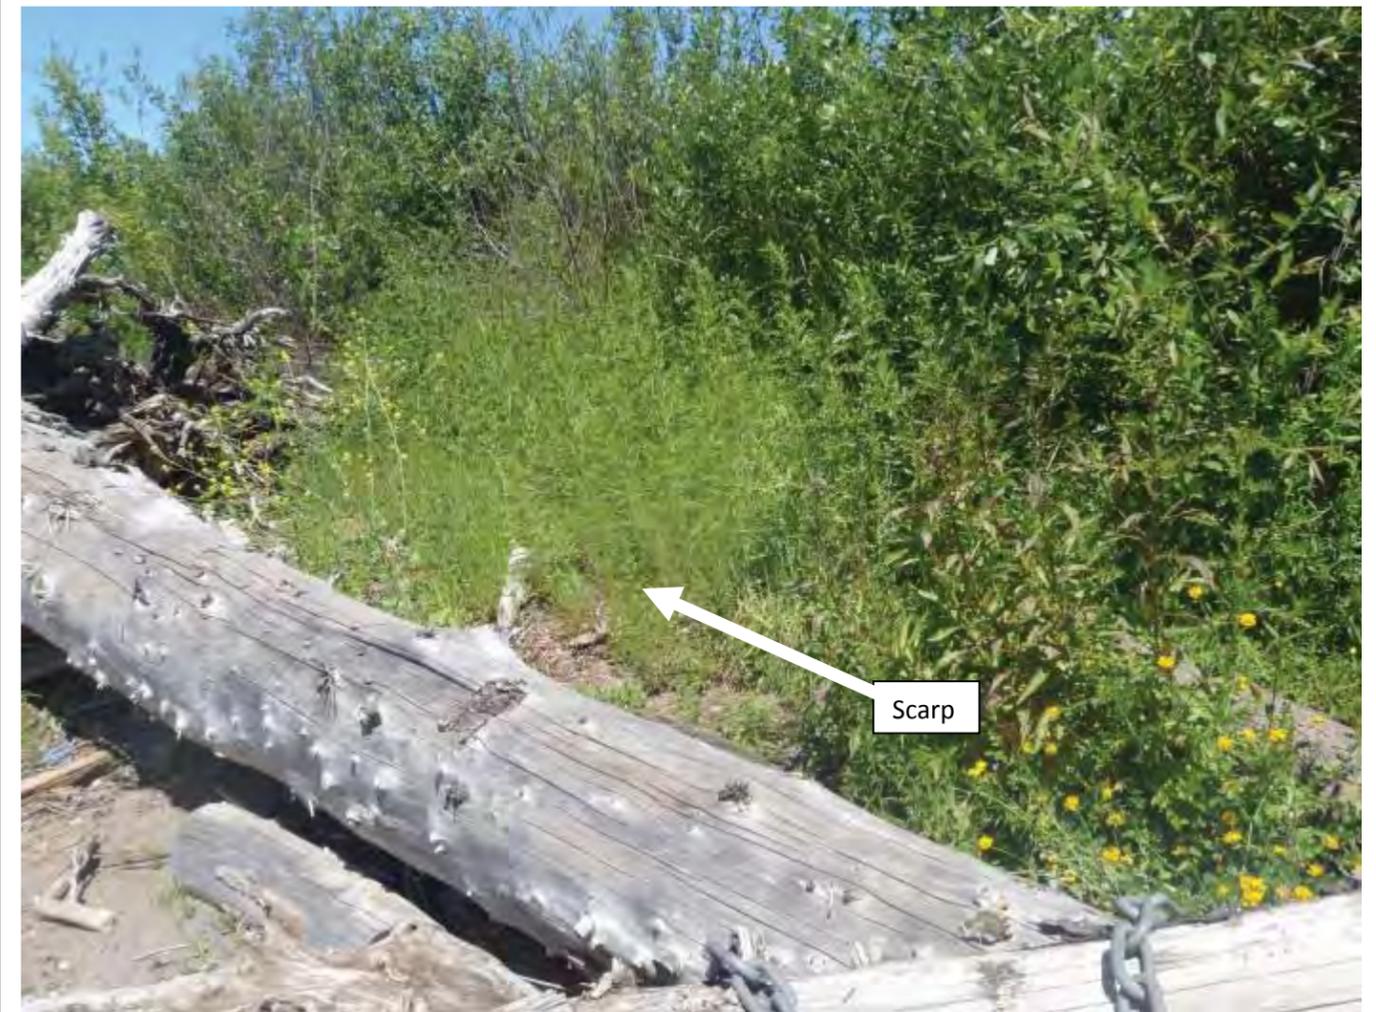
1-foot scarp in the willow planting area between Stations 3+40 and 6+70. (Photo Dates: 6/4/2013)

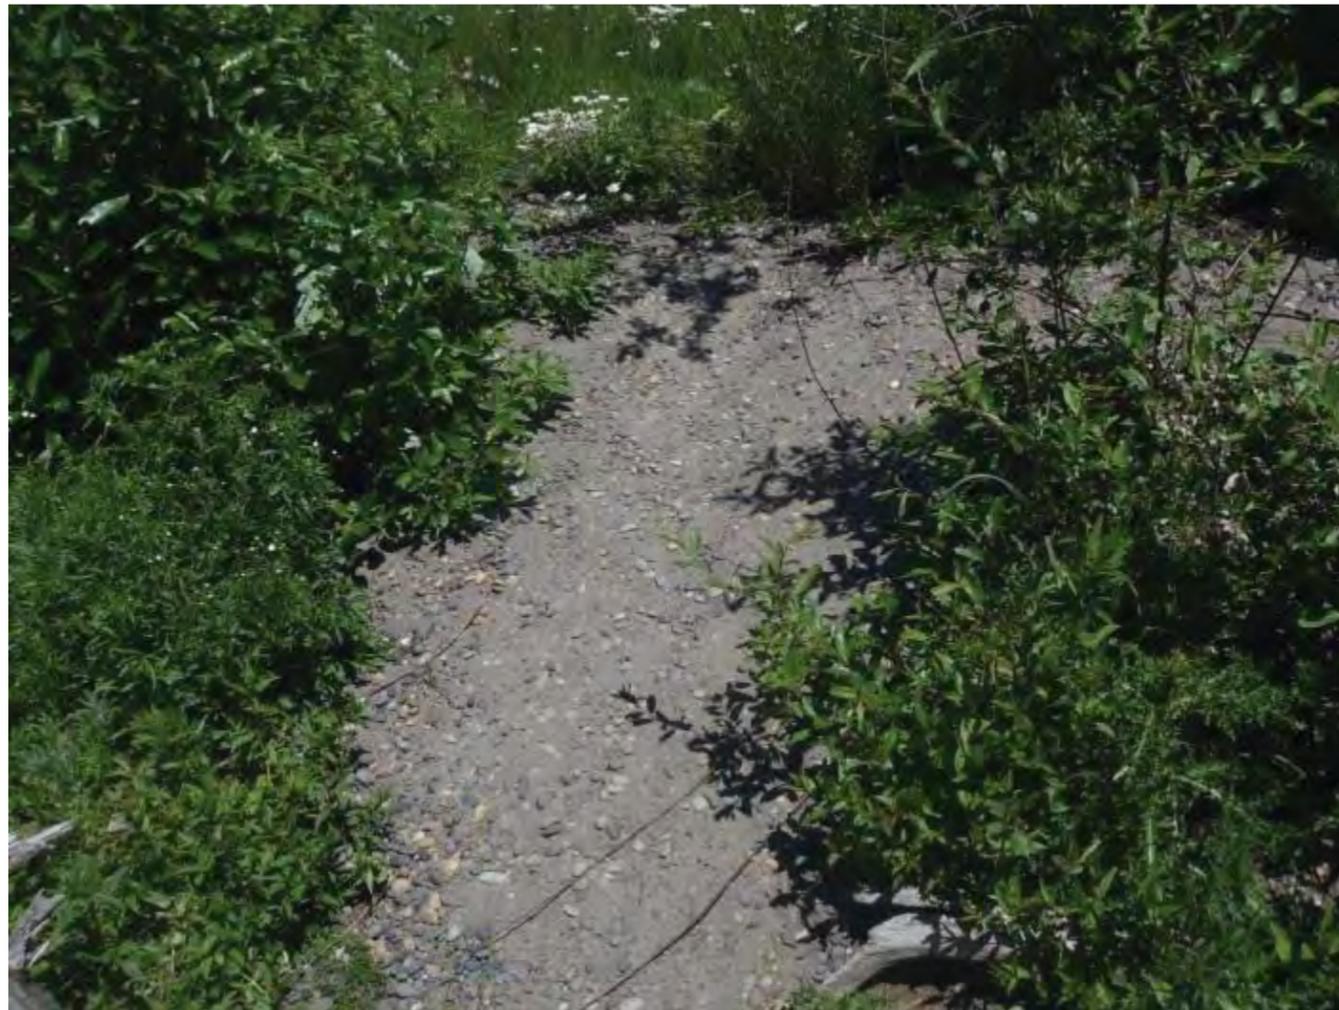
Surplus, on-site habitat material was placed above the large woody debris (LWD) between stations 03+40 and 03+90 during the 2011 repair. A 1-foot scarp in the surplus habitat material was observed at Stations 03+50 and 03+90 during the Year 4 second quarter monitoring event. Year 5 monitoring activities indicate no significant change in the scarp areas. Photographs of the scarps are provided in Attachment A-3 to Appendix A.

No orange demarcation layer material was exposed by any of the scarps, and the scarps did not appear to impact slope stability.

- A 1-foot scarp in the habitat material placed above the woody debris as part of the 2011 repair was observed at Stations 03+50 and 03+90 during the second quarter monitoring event. Year 5 monitoring activities indicate this scarp area was unchanged from monitoring activities conducted in the previous year.

1-foot scarp in the habitat material placed above the woody debris at Station 03+50 as part of the 2011 Repair (Photo Date: 6/4/2013).

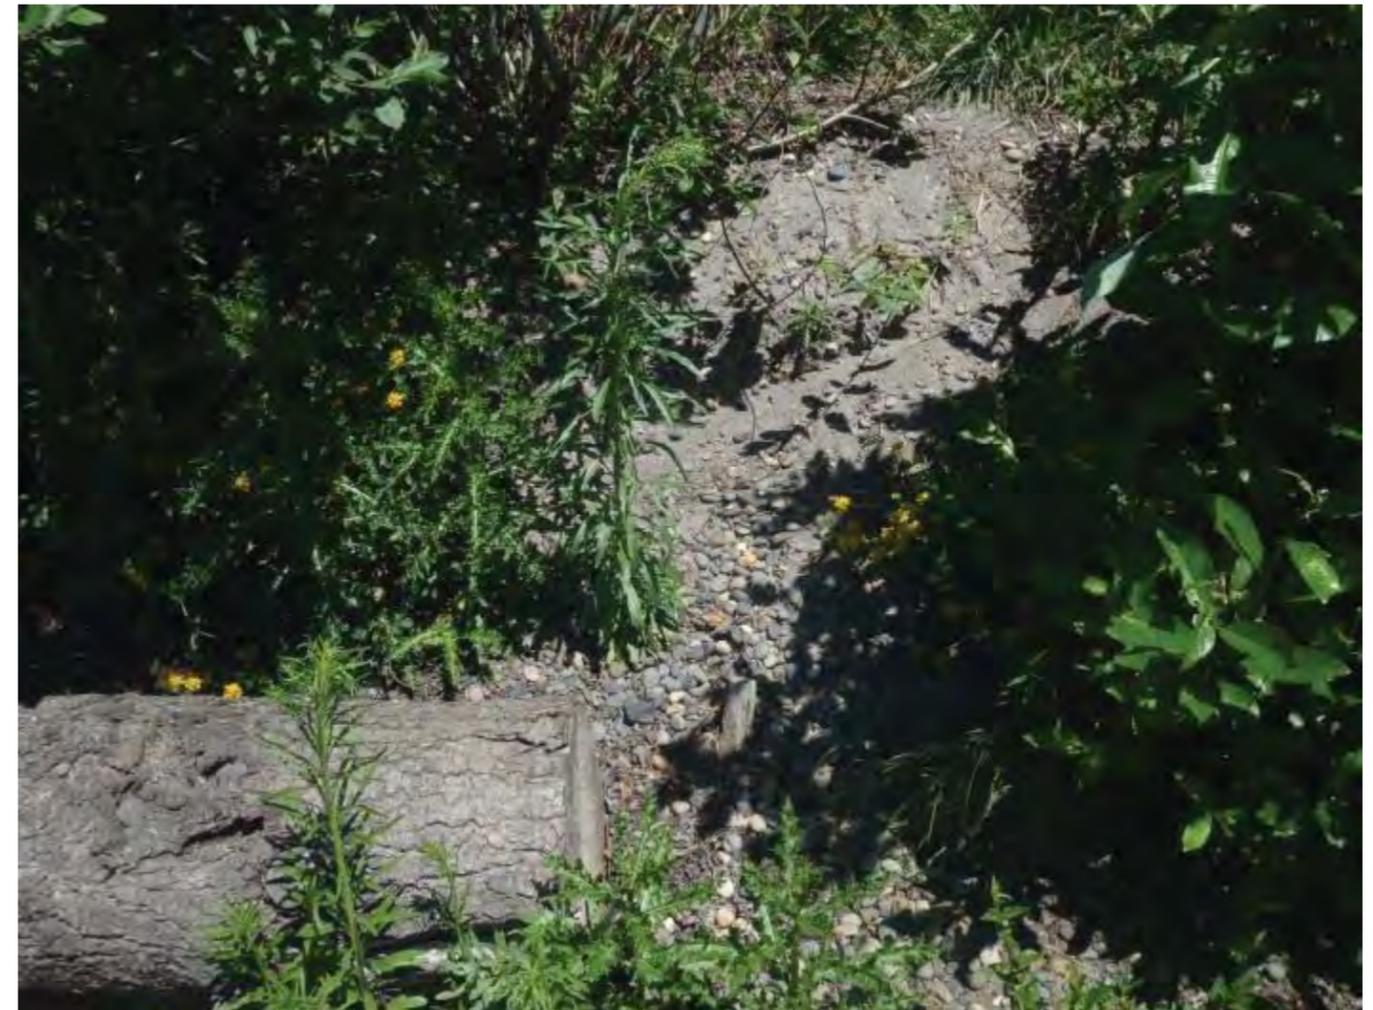
1-foot scarp in the habitat material placed above the woody debris at Station 03+90 as part of the 2011 Repair (Photo Date: 6/4/2013).

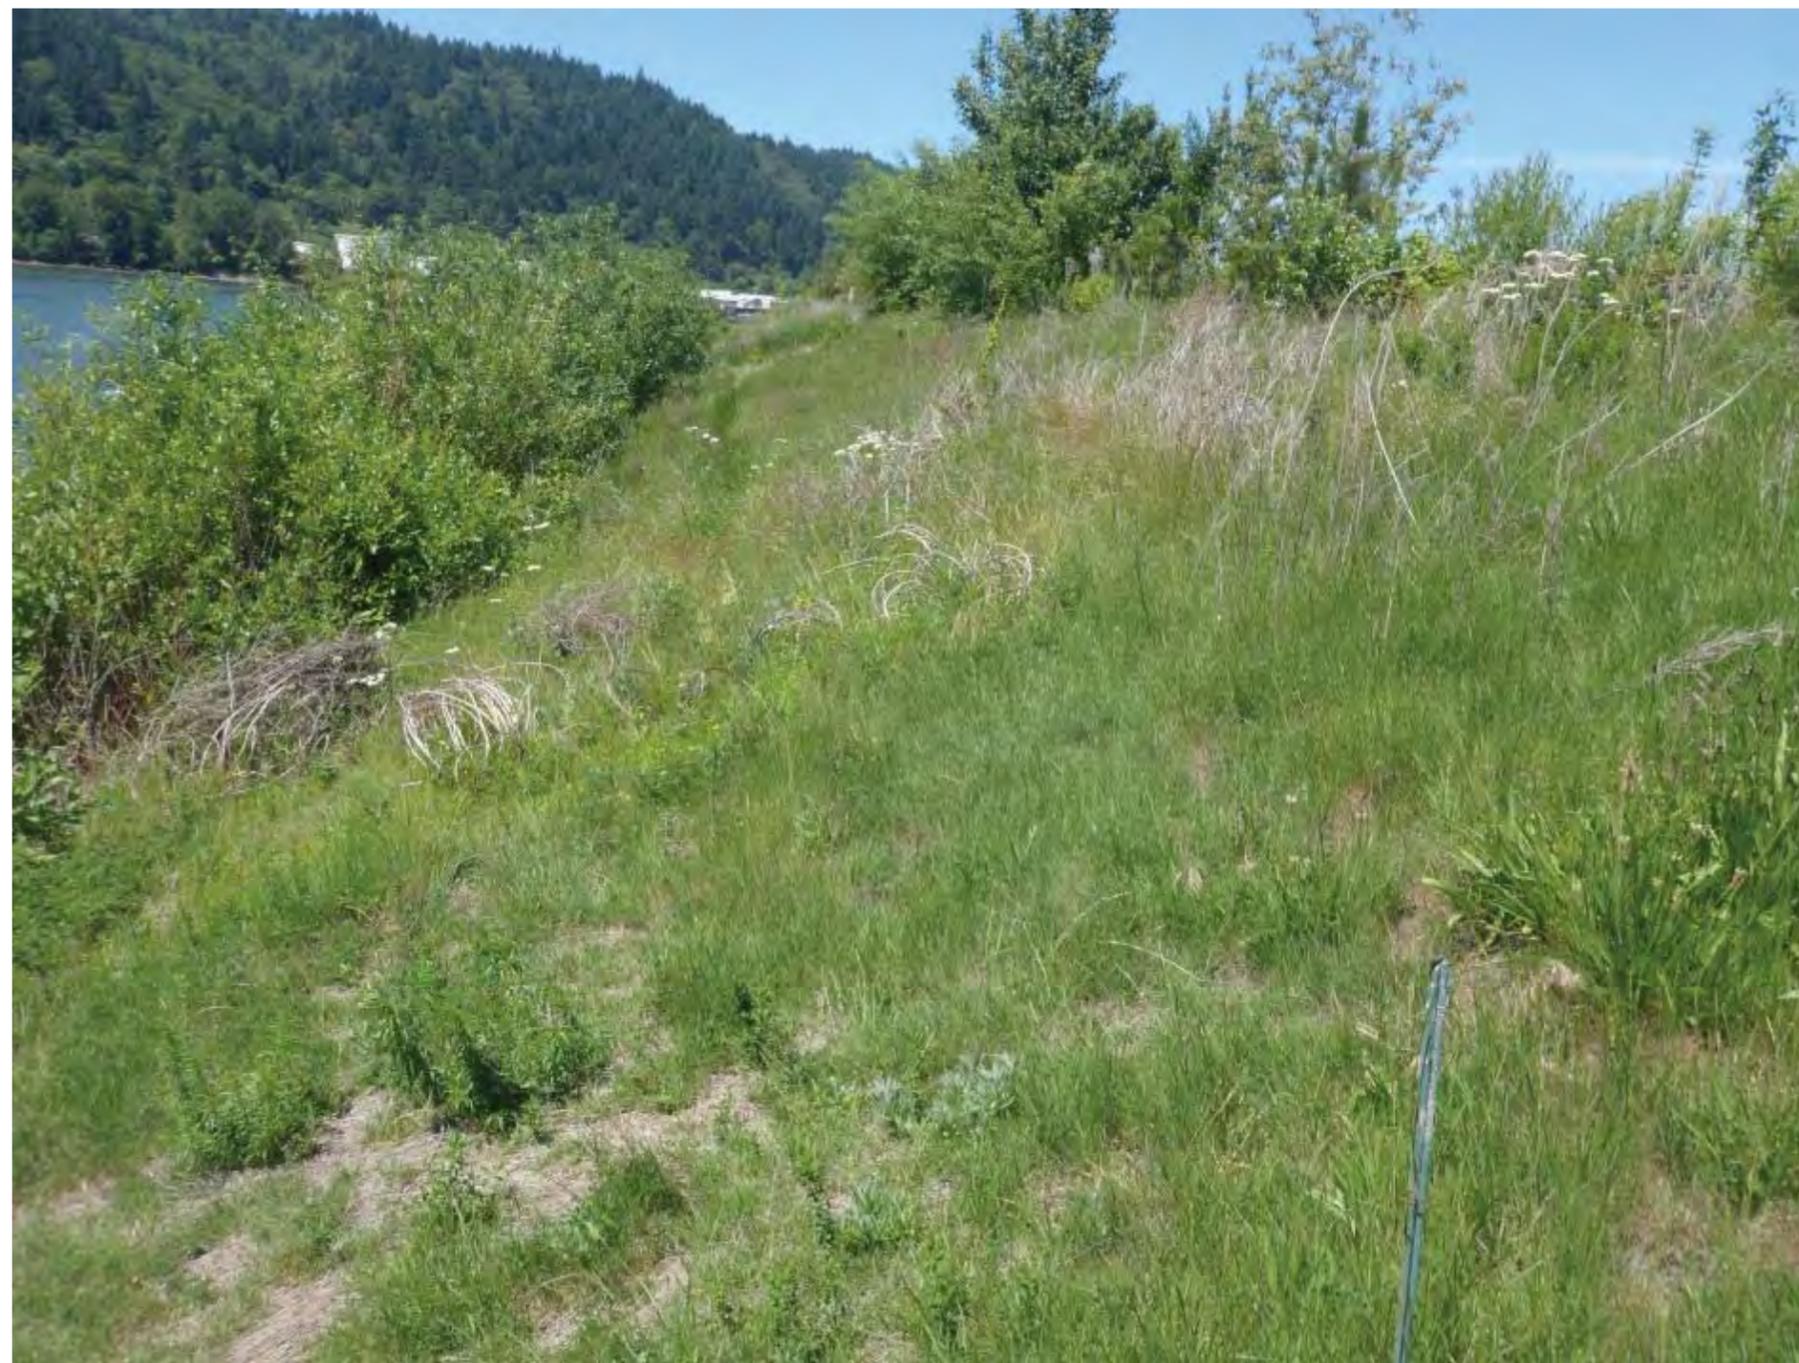
At the time of the Year 4 first quarter monitoring event, the surficial layer of grass in the grass planting area between Stations 01+70 and 02+90 was observed to have sloughed downslope approximately 4 inches following a heavy rain event. This area encompasses the former material transfer zone between Stations 02+35 and 02+70 used to transfer materials downslope as part of the 2011 repair. No additional sloughing was observed during any subsequent monitoring events in Year 5, and the area showed improvement during Year 5 monitoring events due to increased grass coverage and growth.

No orange demarcation layer material was exposed by any of the scarps, and the scarps did not appear to impact slope stability. At the time of the Year 4 first quarter monitoring event, the surficial layer of grass in the grass planting area between Stations 01+70 and 02+90 was observed to have sloughed downslope approximately 4 inches following a heavy rain event. No additional sloughing was observed during the monitoring events in Year 5, and the area showed increased grass coverage and growth compared to last year.

Improvement in 4-inch sloughing of surficial layer along bottom of grass planting area between Stations 01+70 and 02+90 (Photo Date: 6/4/2013).

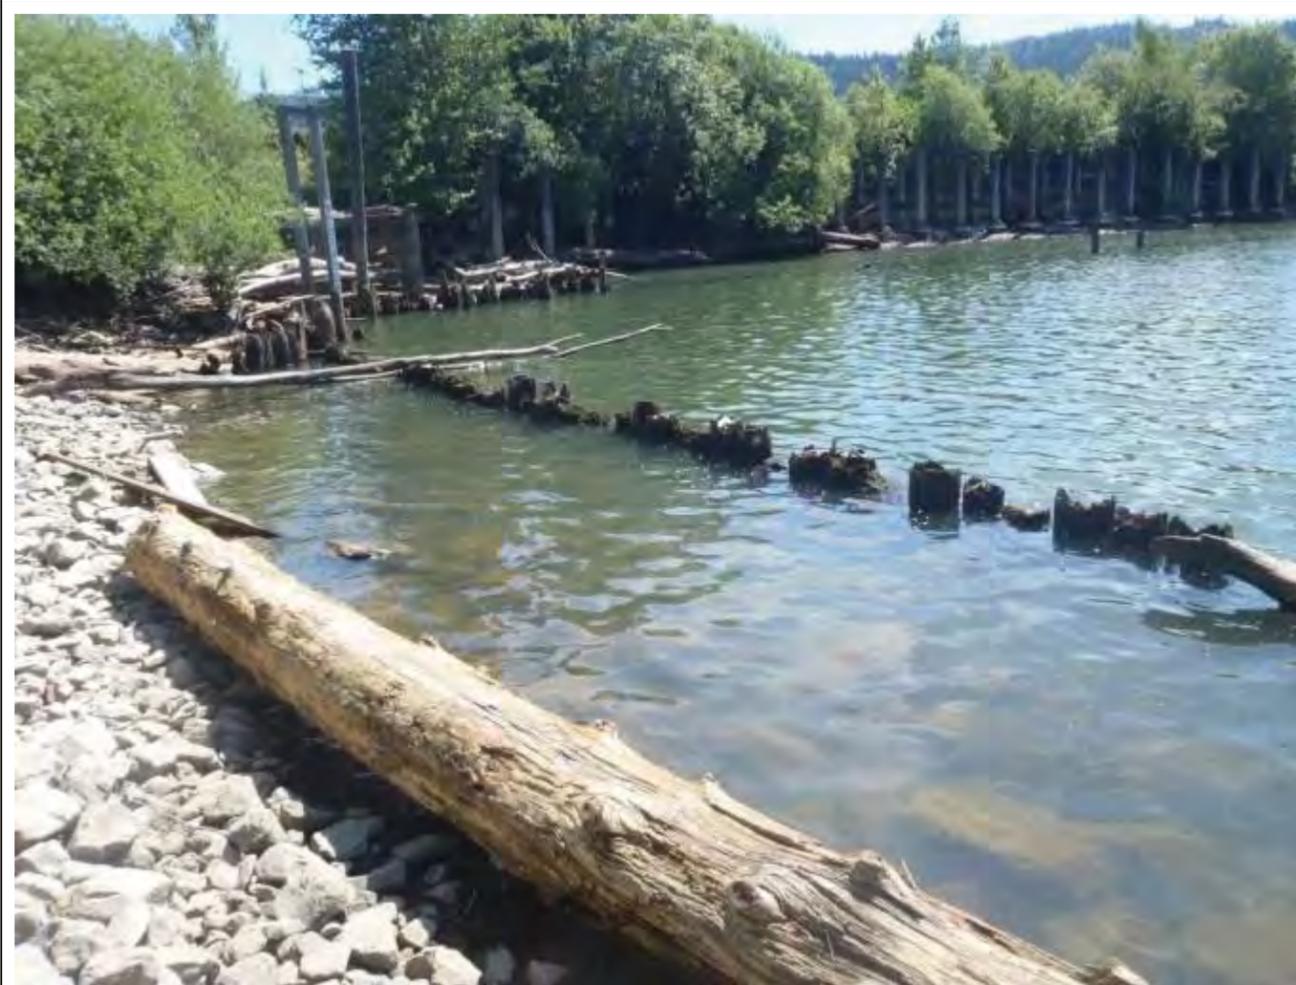
High Water Observation on 6/4/2013: No Sheen

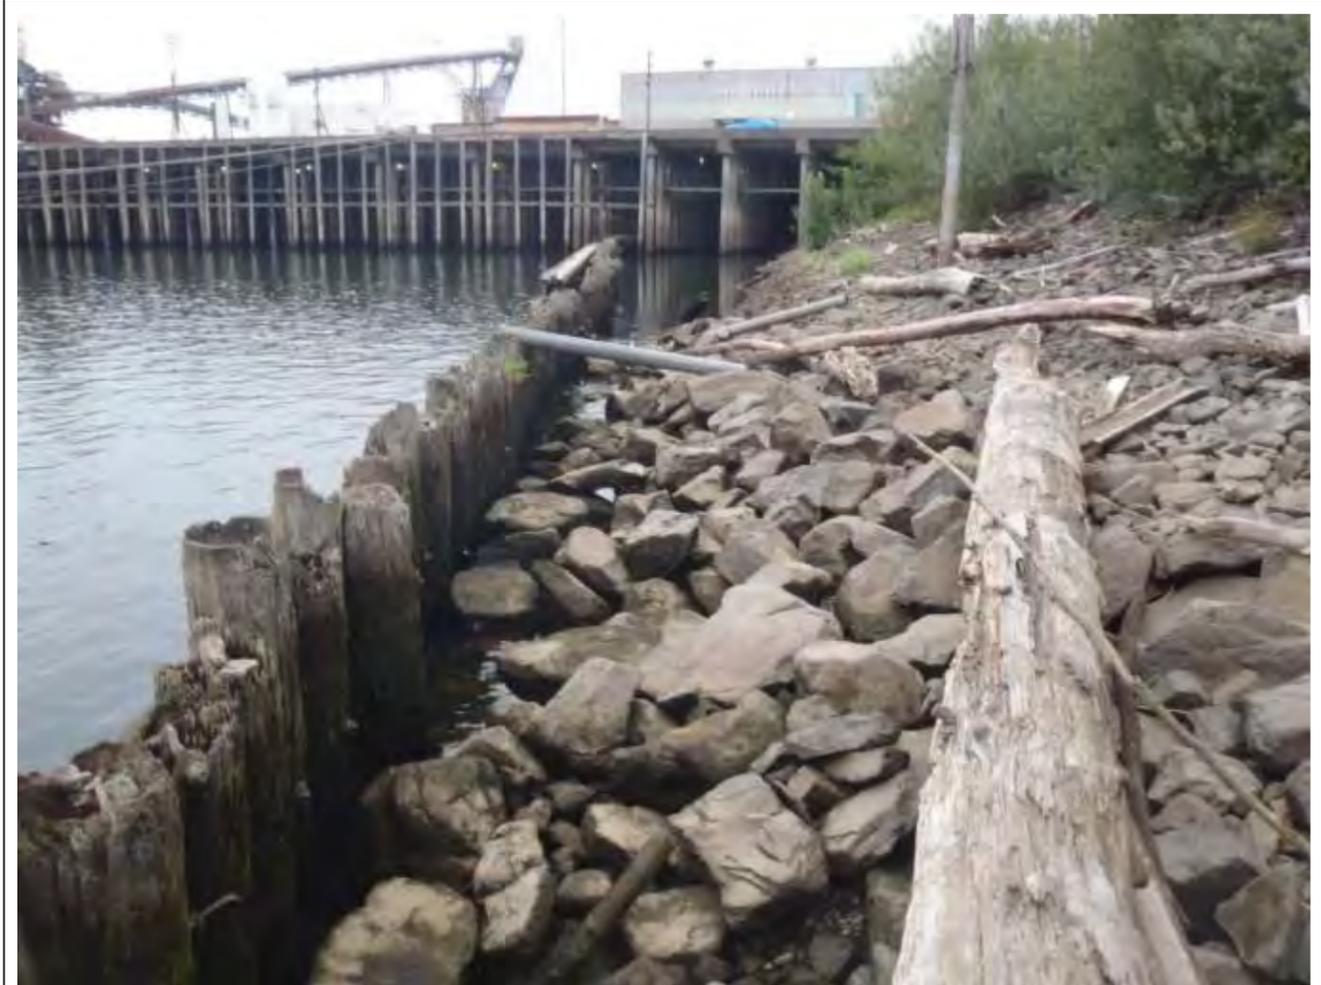
Low Water Observation on 09/12/2013: No Sheen
