**Field Oversight Report  
For Wheeler Bay Repair  
October 2011**

**Work Assignment No.: 343-VOBB-10BC  
Terminal 4  
EPA RPM: Sean Sheldrake  
CDM Project Manager: Lance Peterson**

**December 16, 2011**

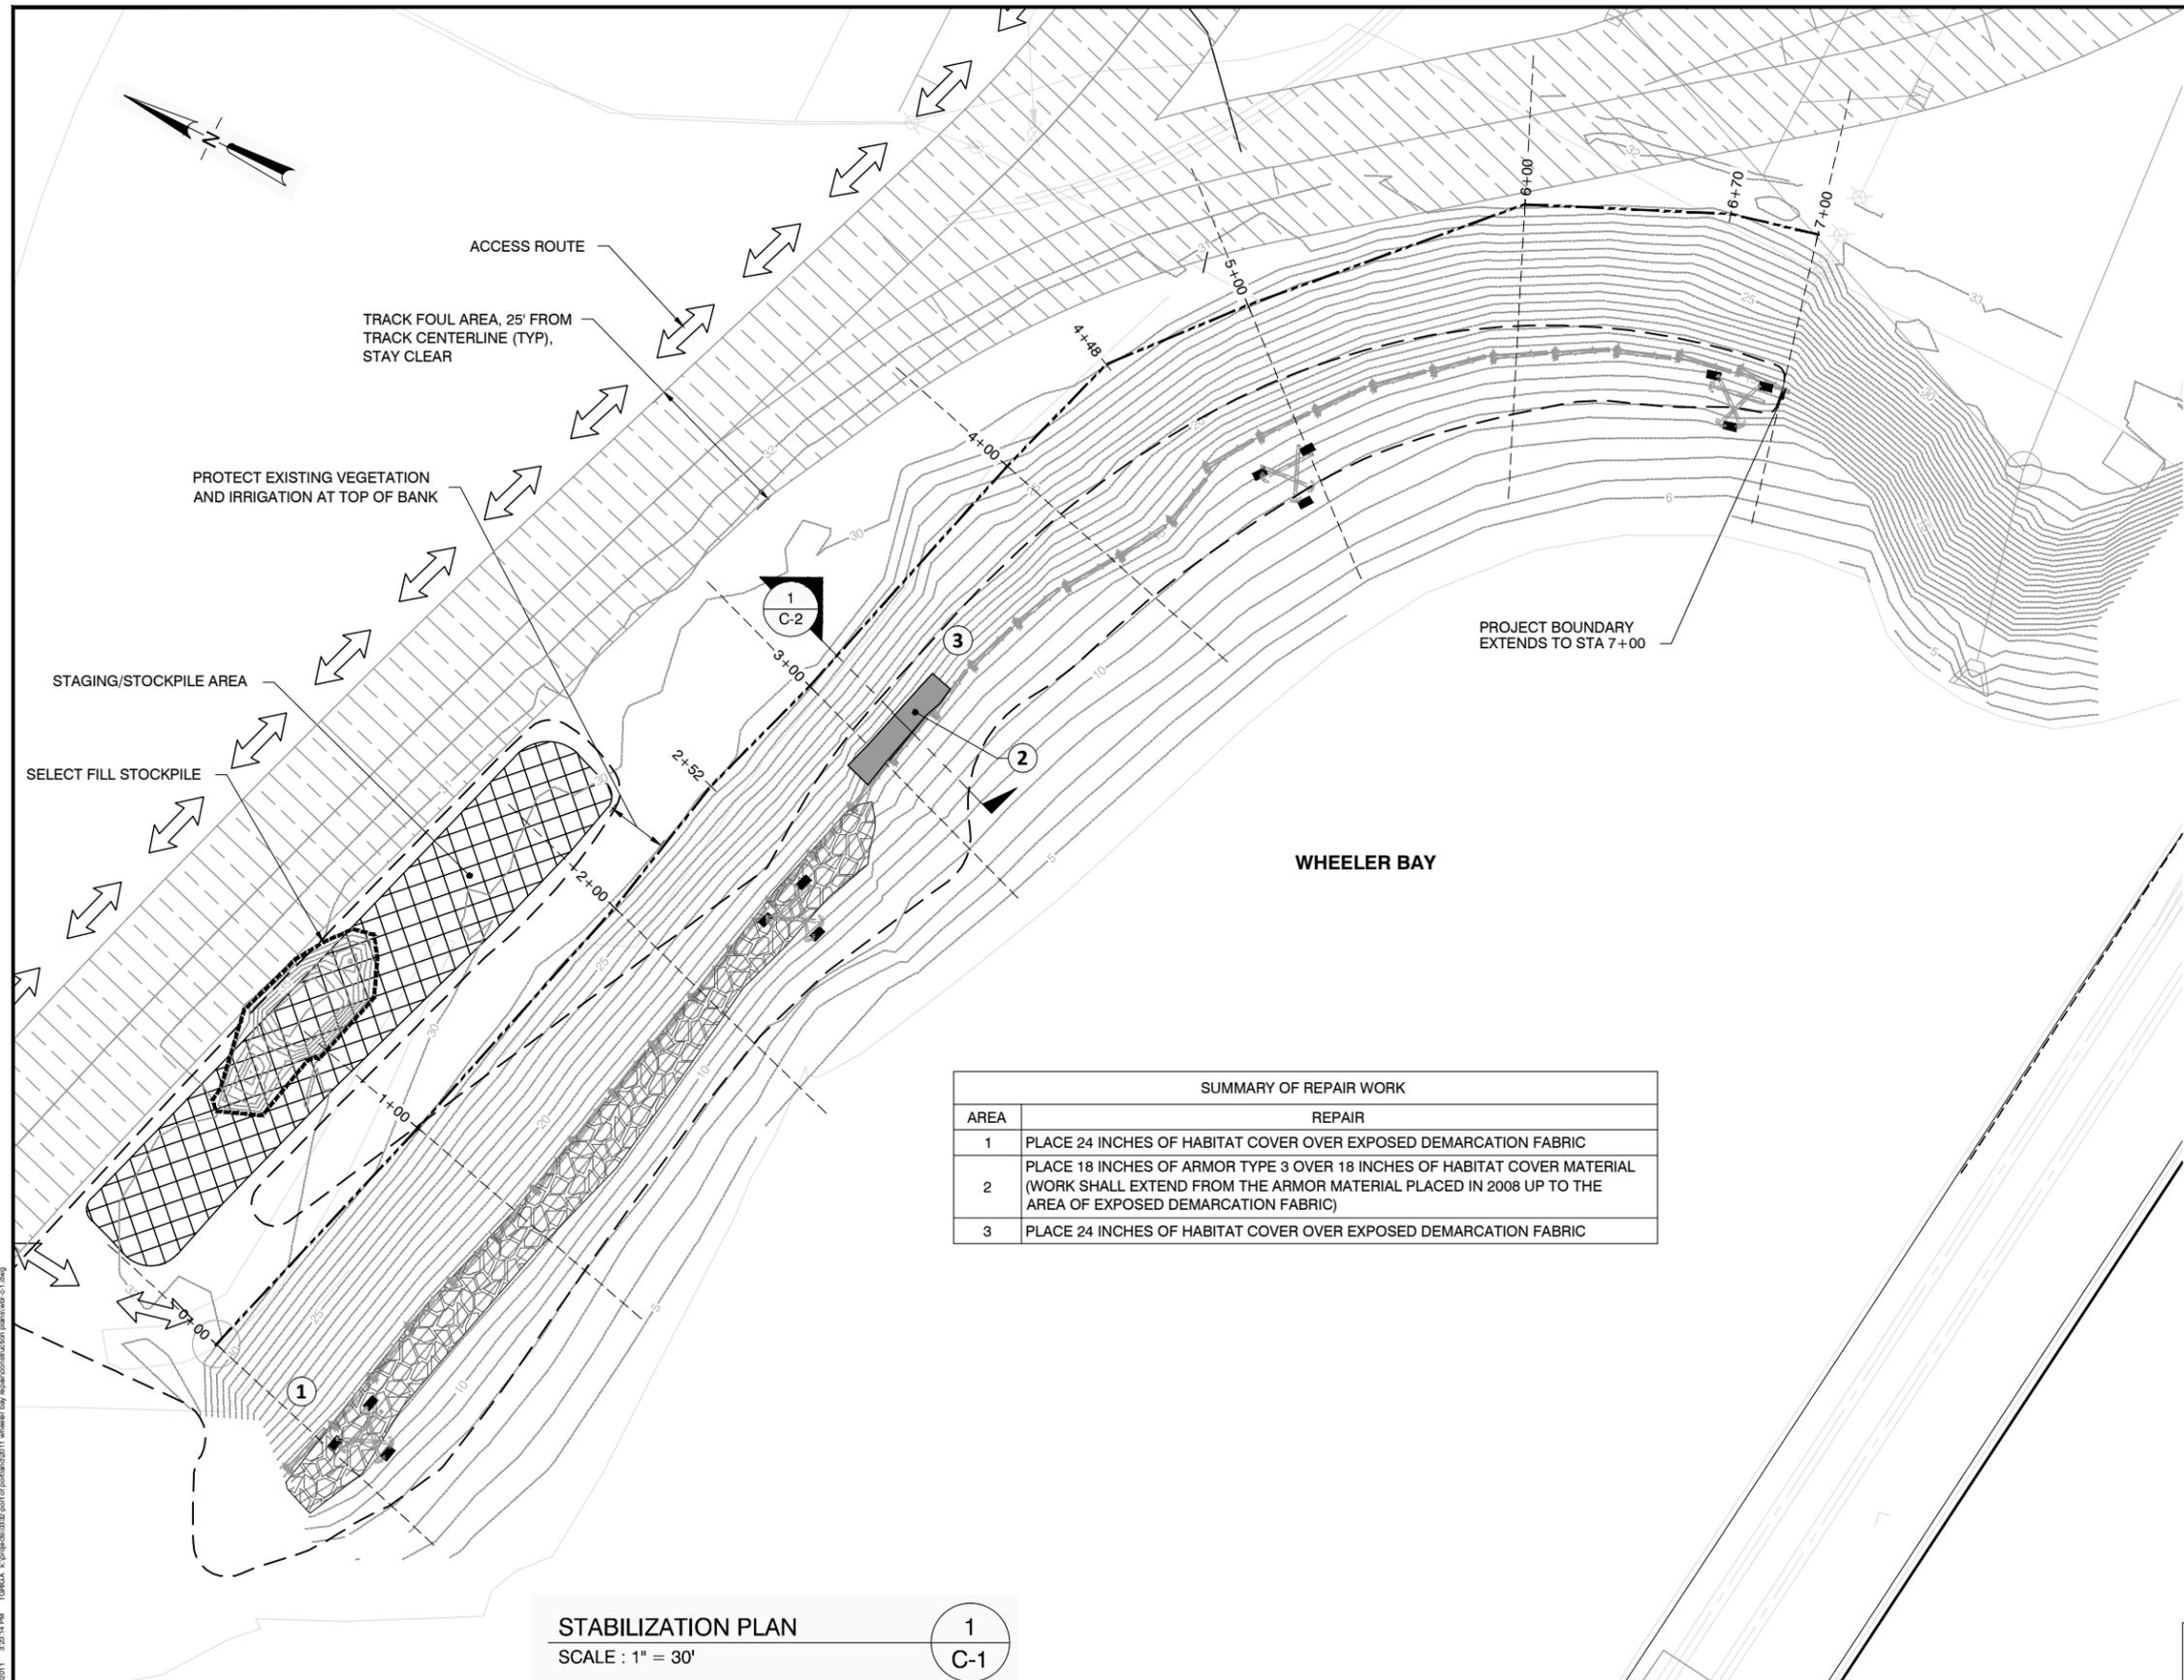
**WHEELER BAY BANK REPAIRS 2011  
STABILIZATION REPAIR PLAN**

SUMMARY OF REPAIR WORK	
AREA	REPAIR
1	PLACE 24 INCHES OF HABITAT COVER OVER EXPOSED DEMARCATION FABRIC
2	PLACE 18 INCHES OF ARMOR TYPE 3 OVER 18 INCHES OF HABITAT COVER MATERIAL (WORK SHALL EXTEND FROM THE ARMOR MATERIAL PLACED IN 2008 UP TO THE AREA OF EXPOSED DEMARCATION FABRIC)
3	PLACE 24 INCHES OF HABITAT COVER OVER EXPOSED DEMARCATION FABRIC
