FINAL
YEAR 3 INTERIM MONITORING REPORT –
TERMINAL 4 PHASE I REMOVAL ACTION
PORT OF PORTLAND, PORTLAND, OREGON

Port of Portland
Portland, Oregon

Anchor QEA, LLC
6650 SW Redwood Lane, Suite 333
Portland, Oregon 97224

May 2012

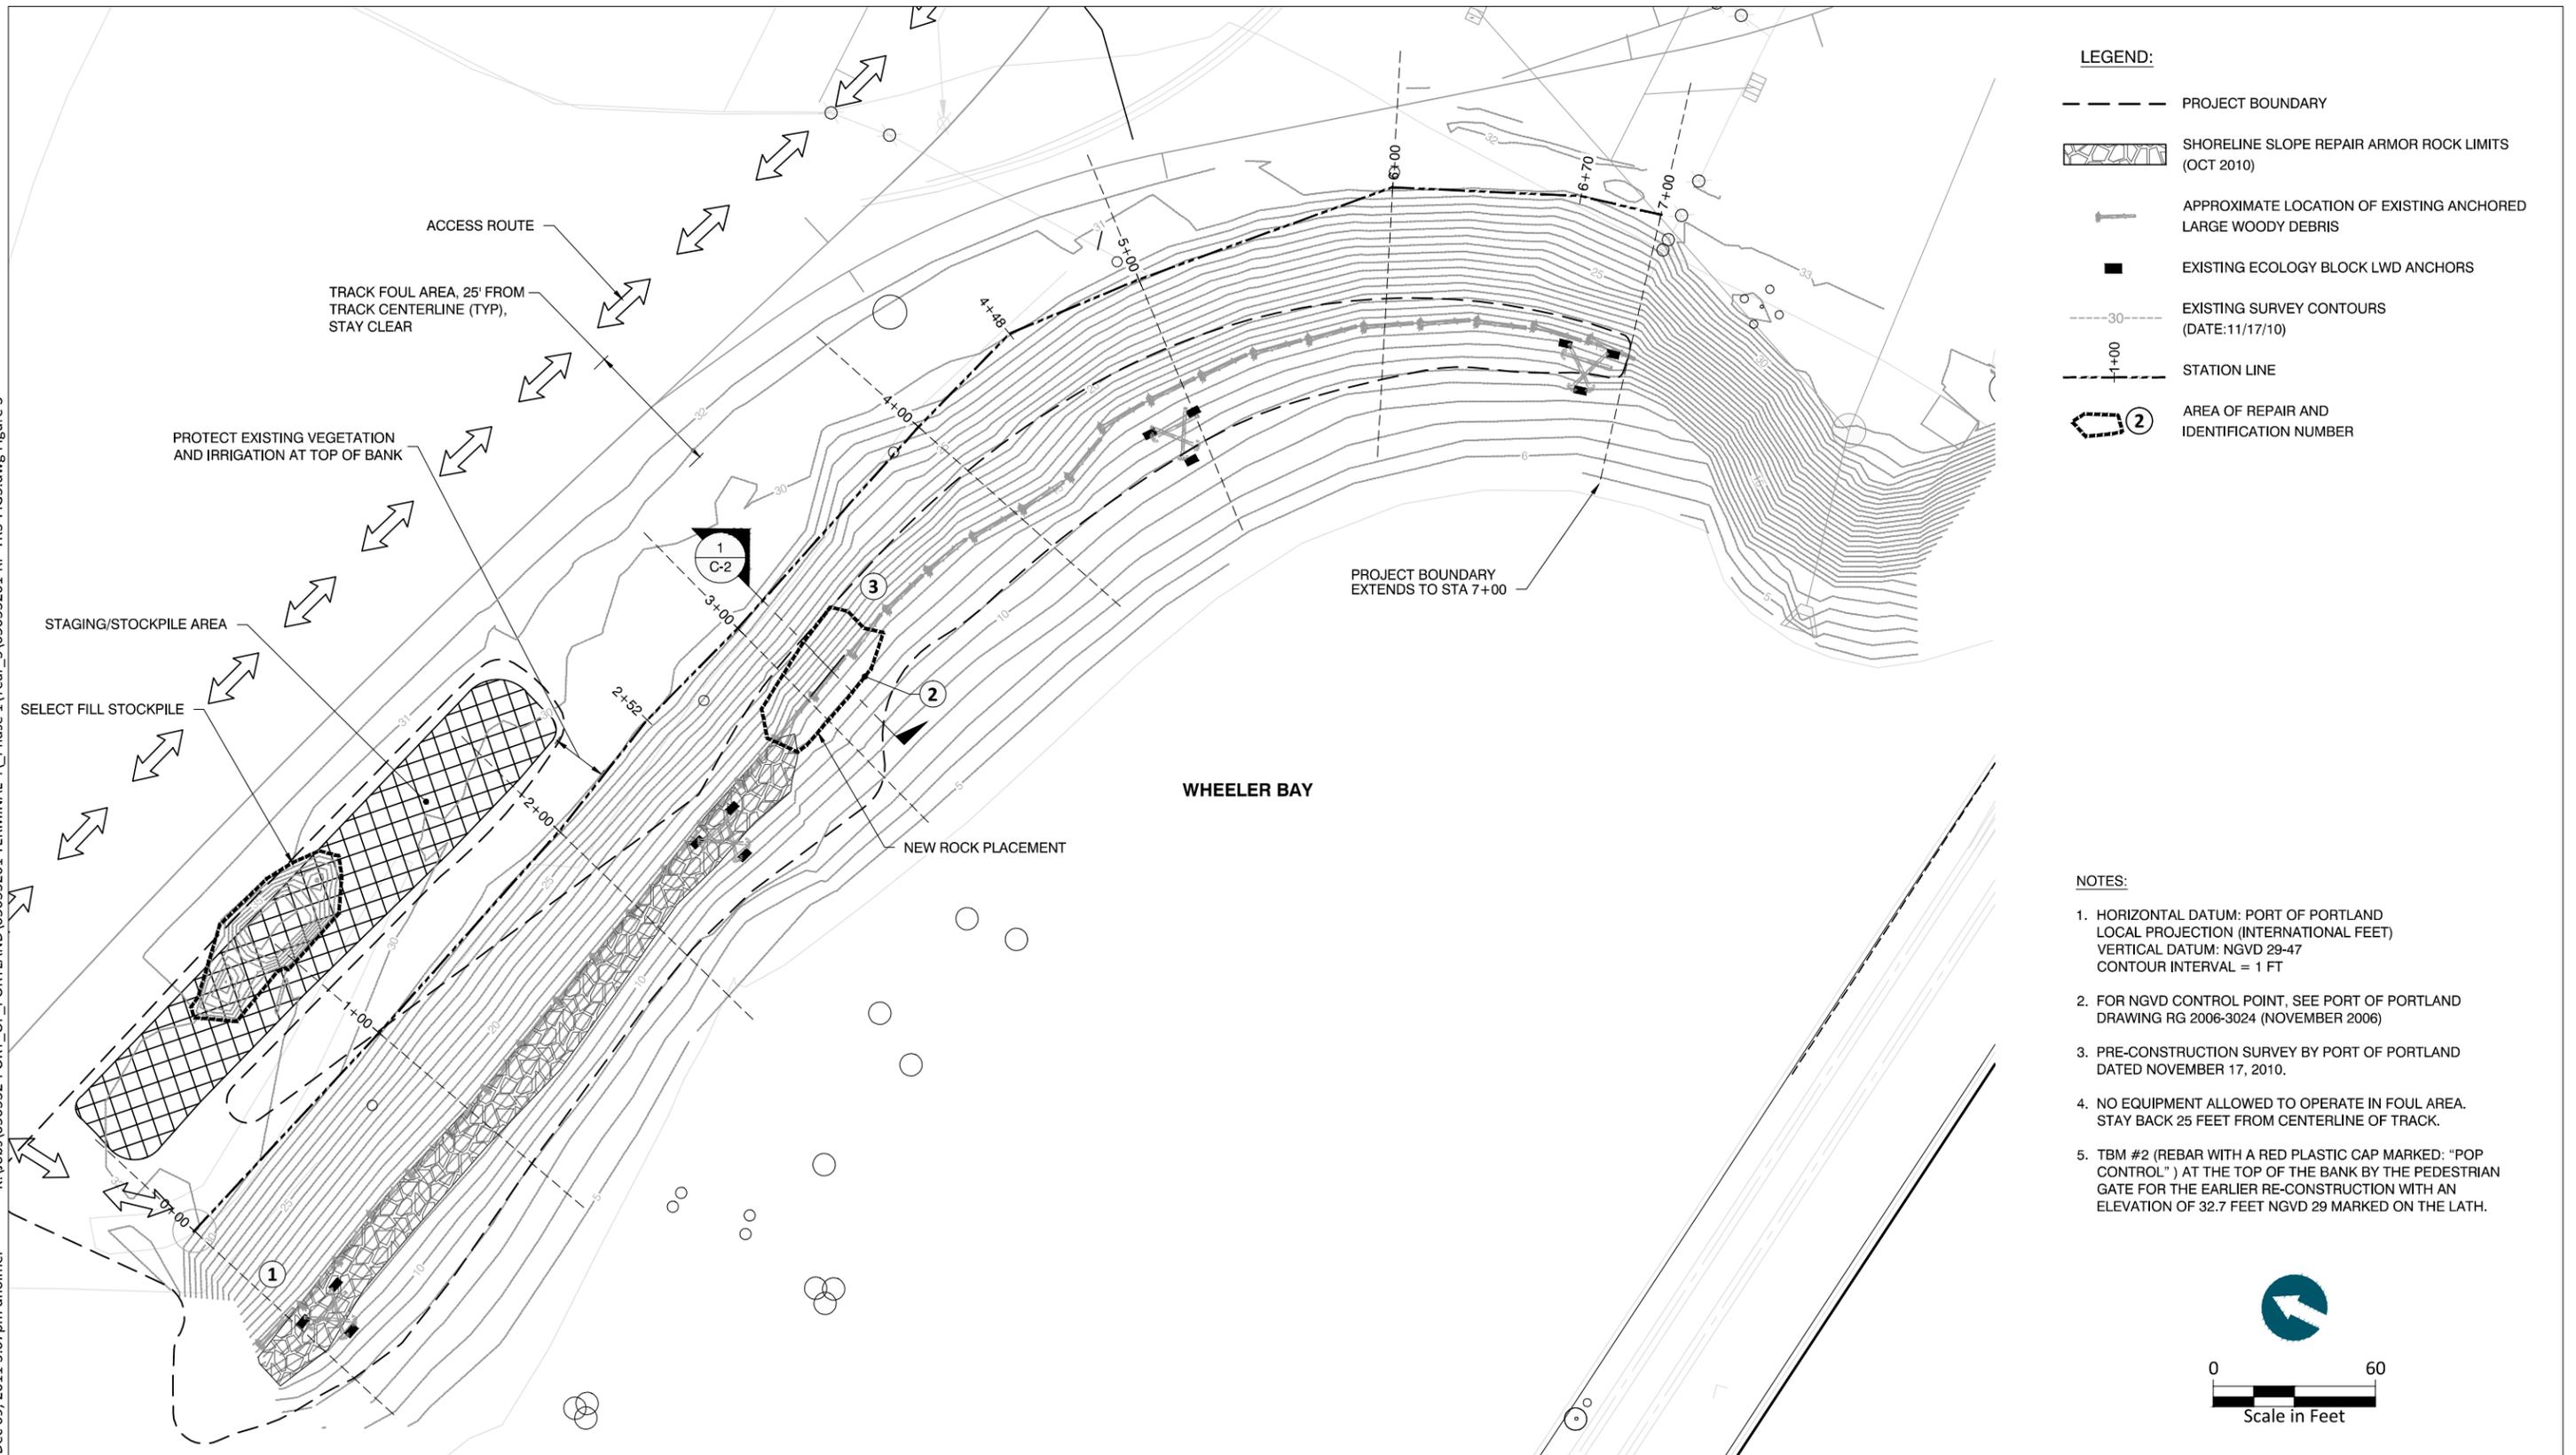
Figure 3
2011 Shoreline Stabilization Slope Repair Plan
Year 3 Interim Monitoring Report - Terminal 4 Phase I Removal Action
Portland, Oregon

This section provides a brief summary of the 2011 repair work performed at WB. A Closure Report with a detailed description of construction activity was submitted to USEPA on December 12, 2011 (Anchor QEA 2011b). The repair work included placing armor in the main area of erosion and additional select fill over the two small isolated areas of exposed demarcation fabric at Stations 0+08 and 3+49. The armor placement occurred between Stations 2+90 to 3+38, as shown on Figure 3. The upslope extent of the armor placement was to the scarp with the downslope edge to the existing armor layer. This design modification is intended to better protect the shoreline based on the causes of the current erosion.

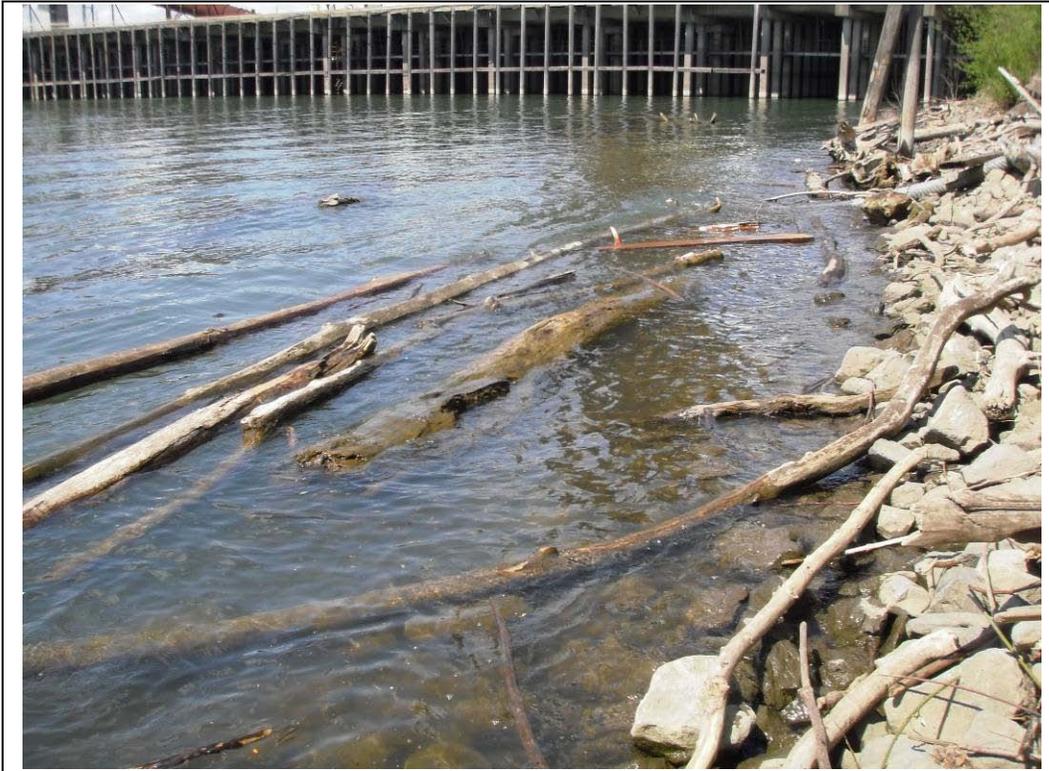
High water observation 5/19/2011: No sheen

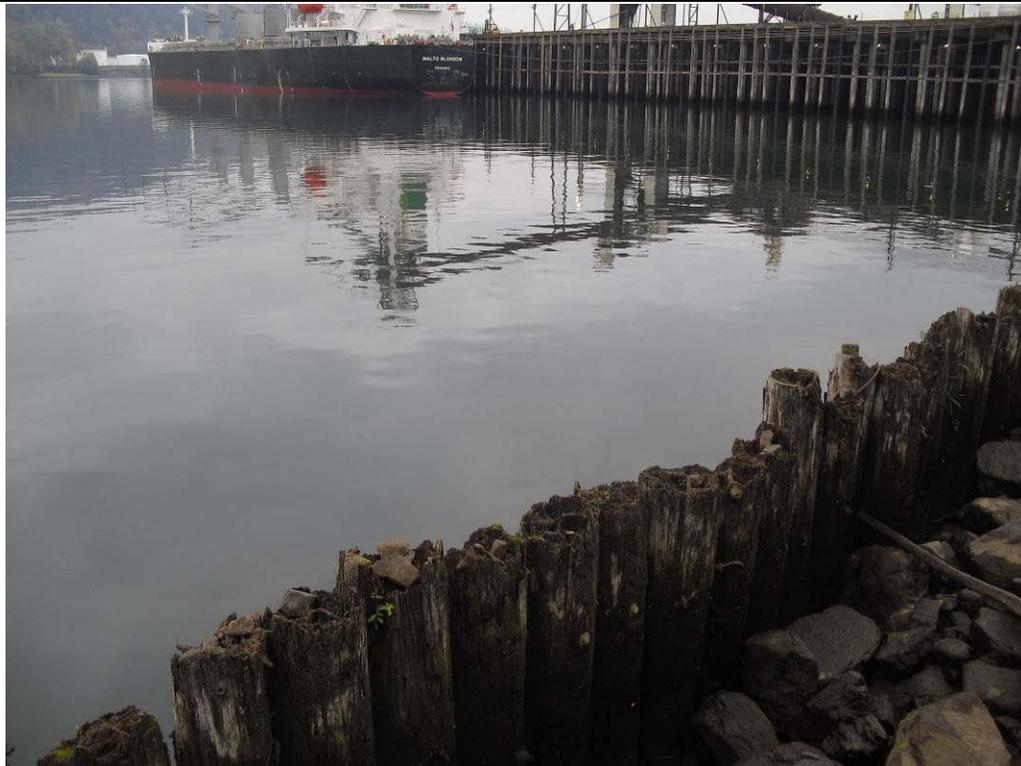
Low water observation 10/27/2011: No sheen

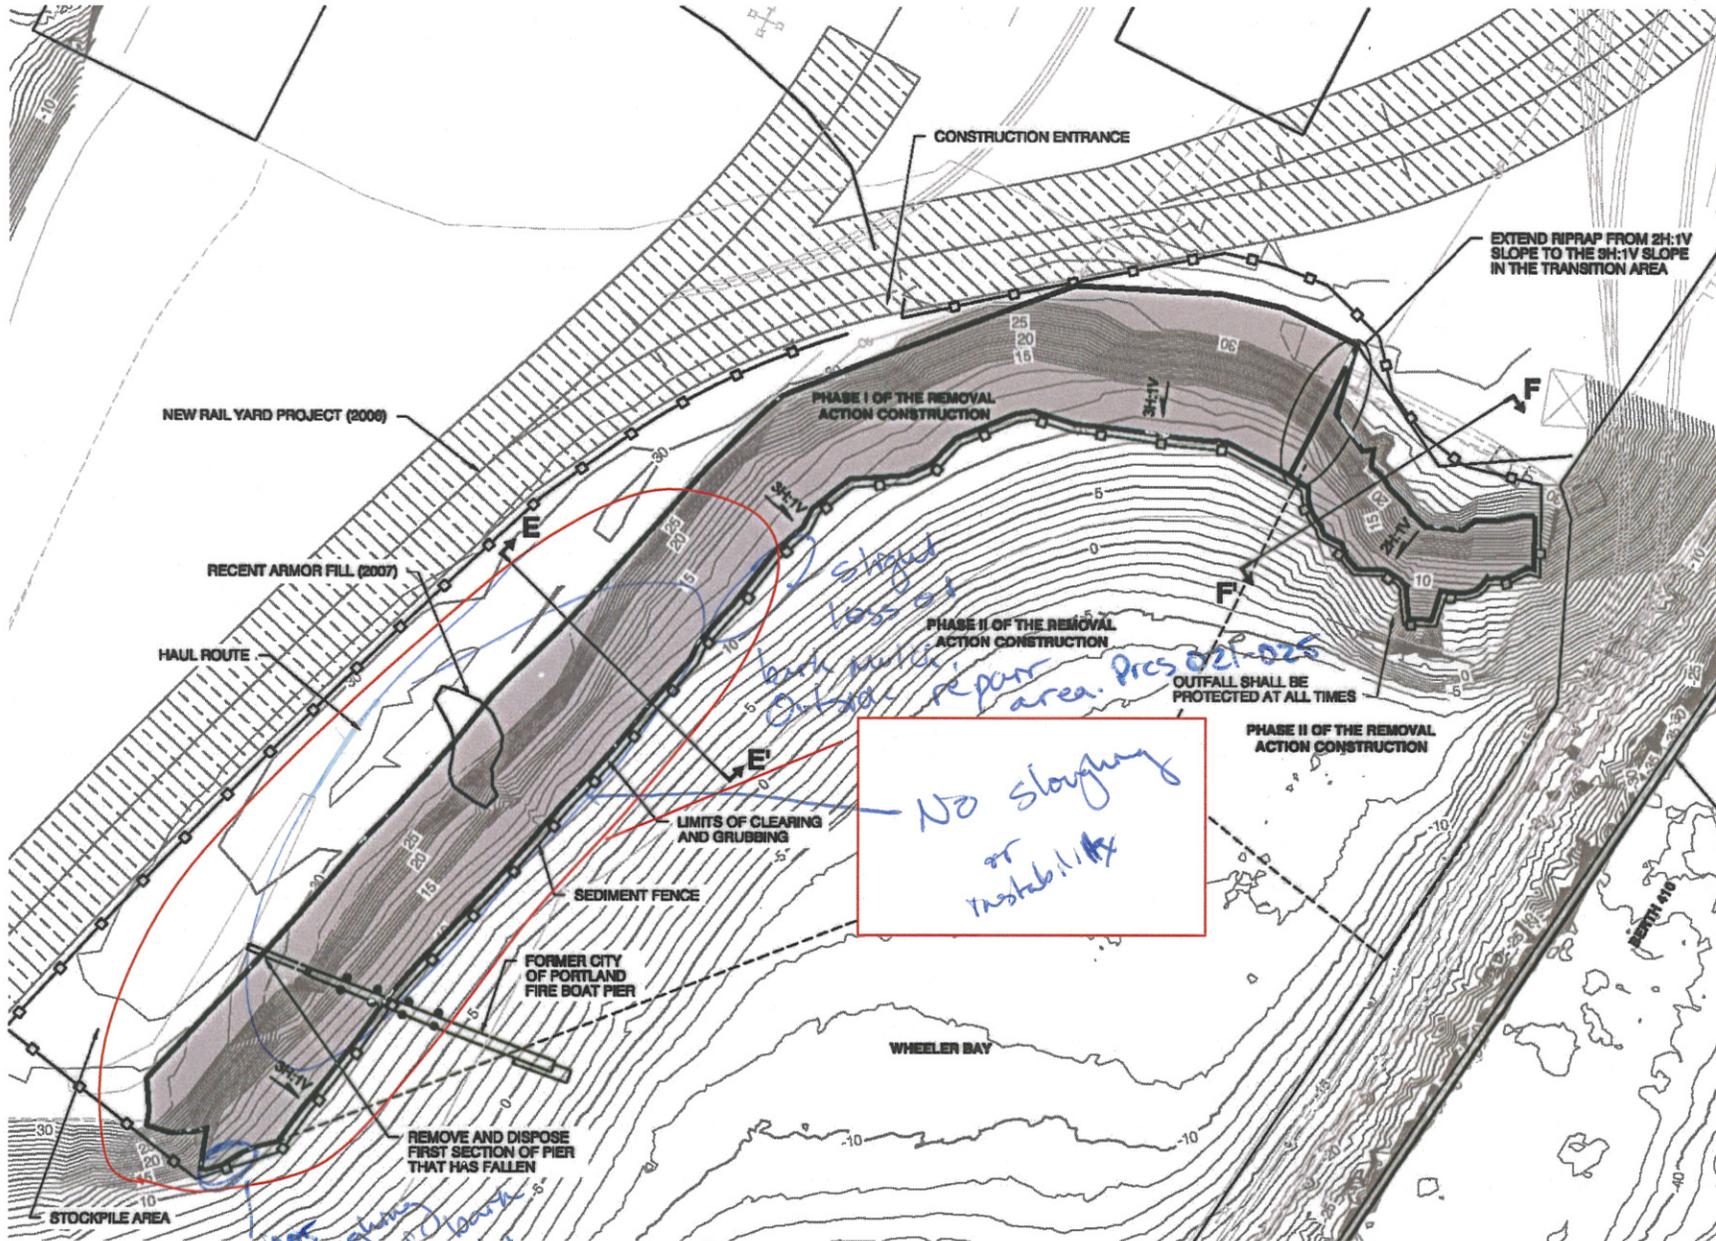
2 staged loss of bank mulch. Outside repair area. Pres 021-025

No sloping or instability

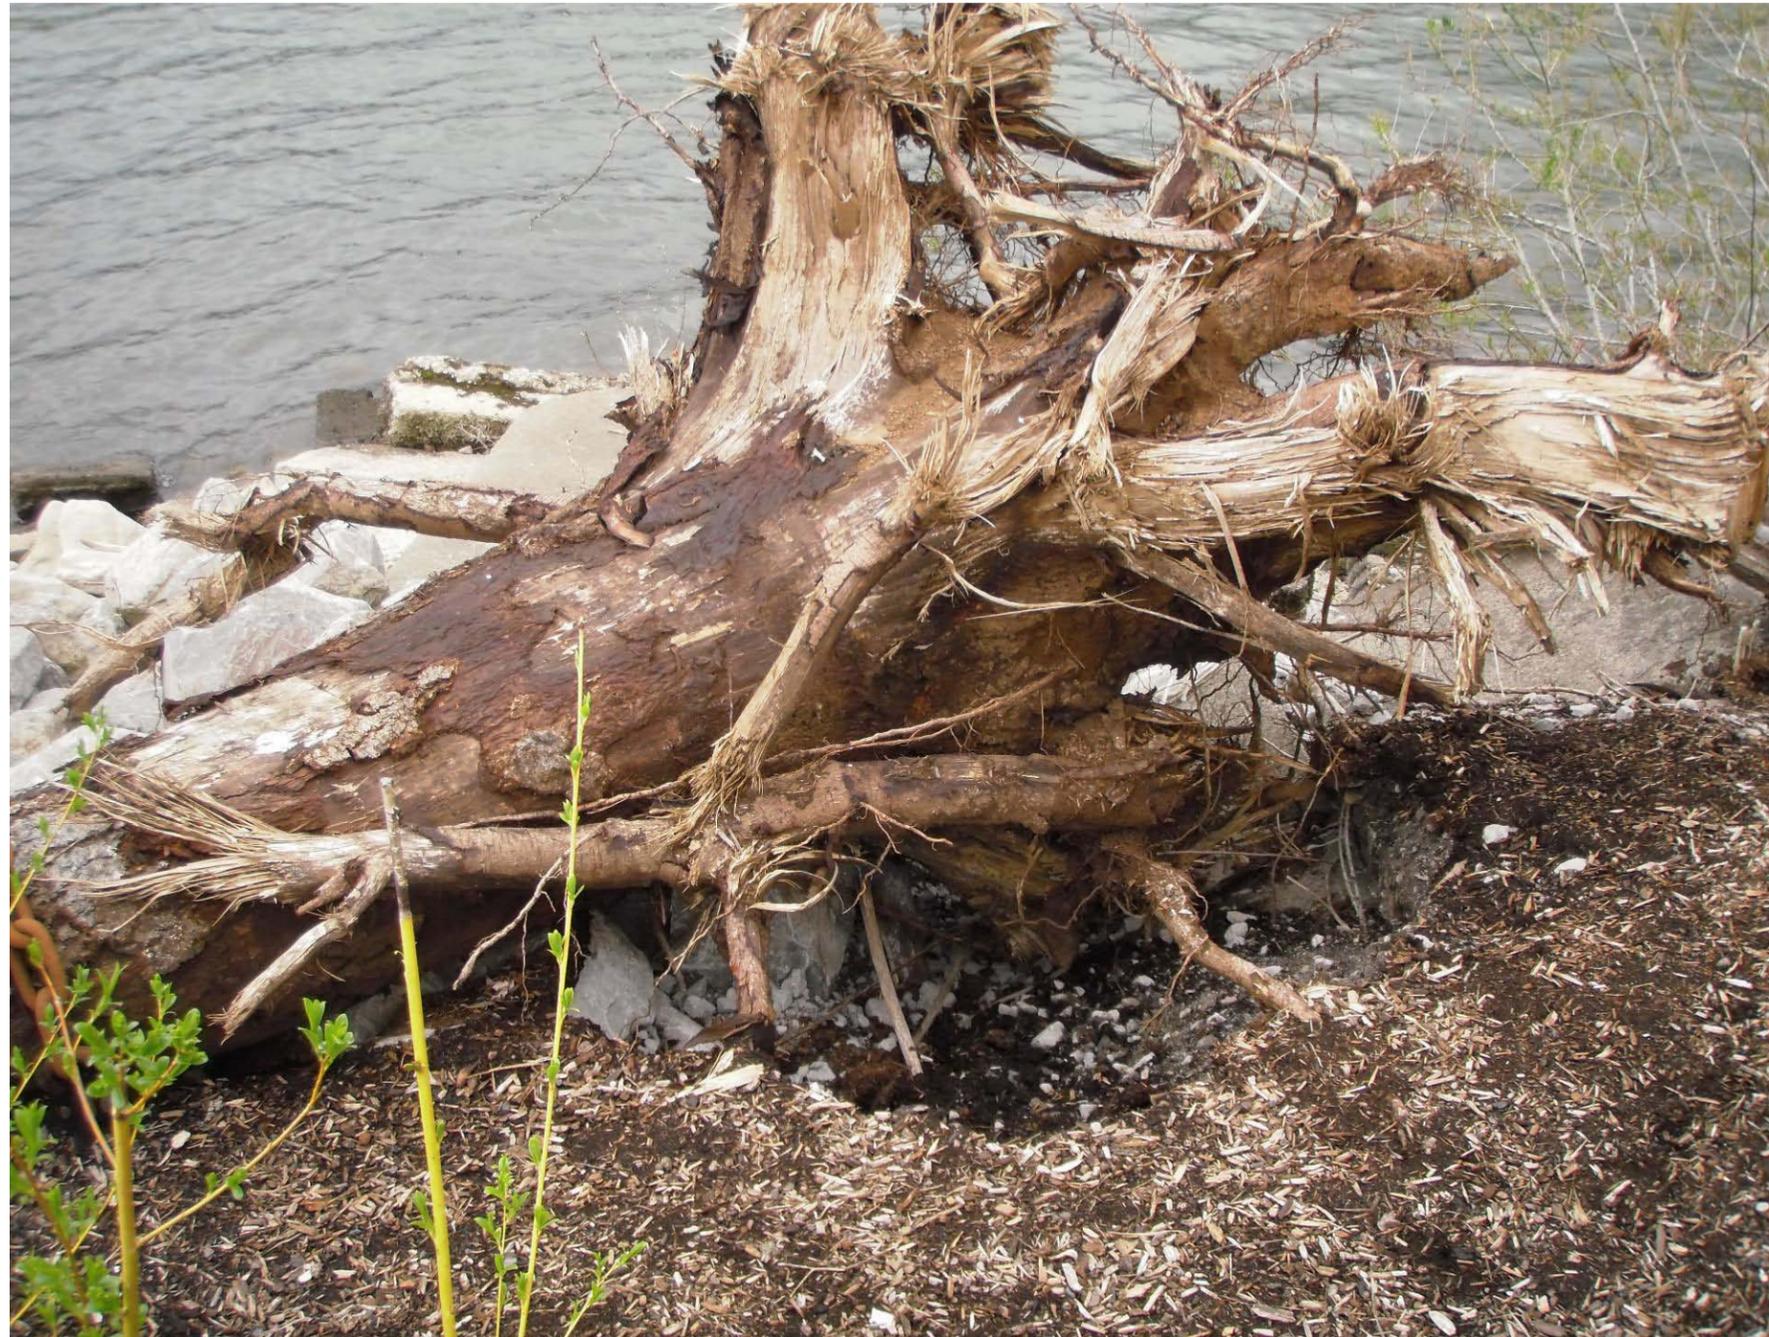
Area of settling behind LWD at Station 00+05

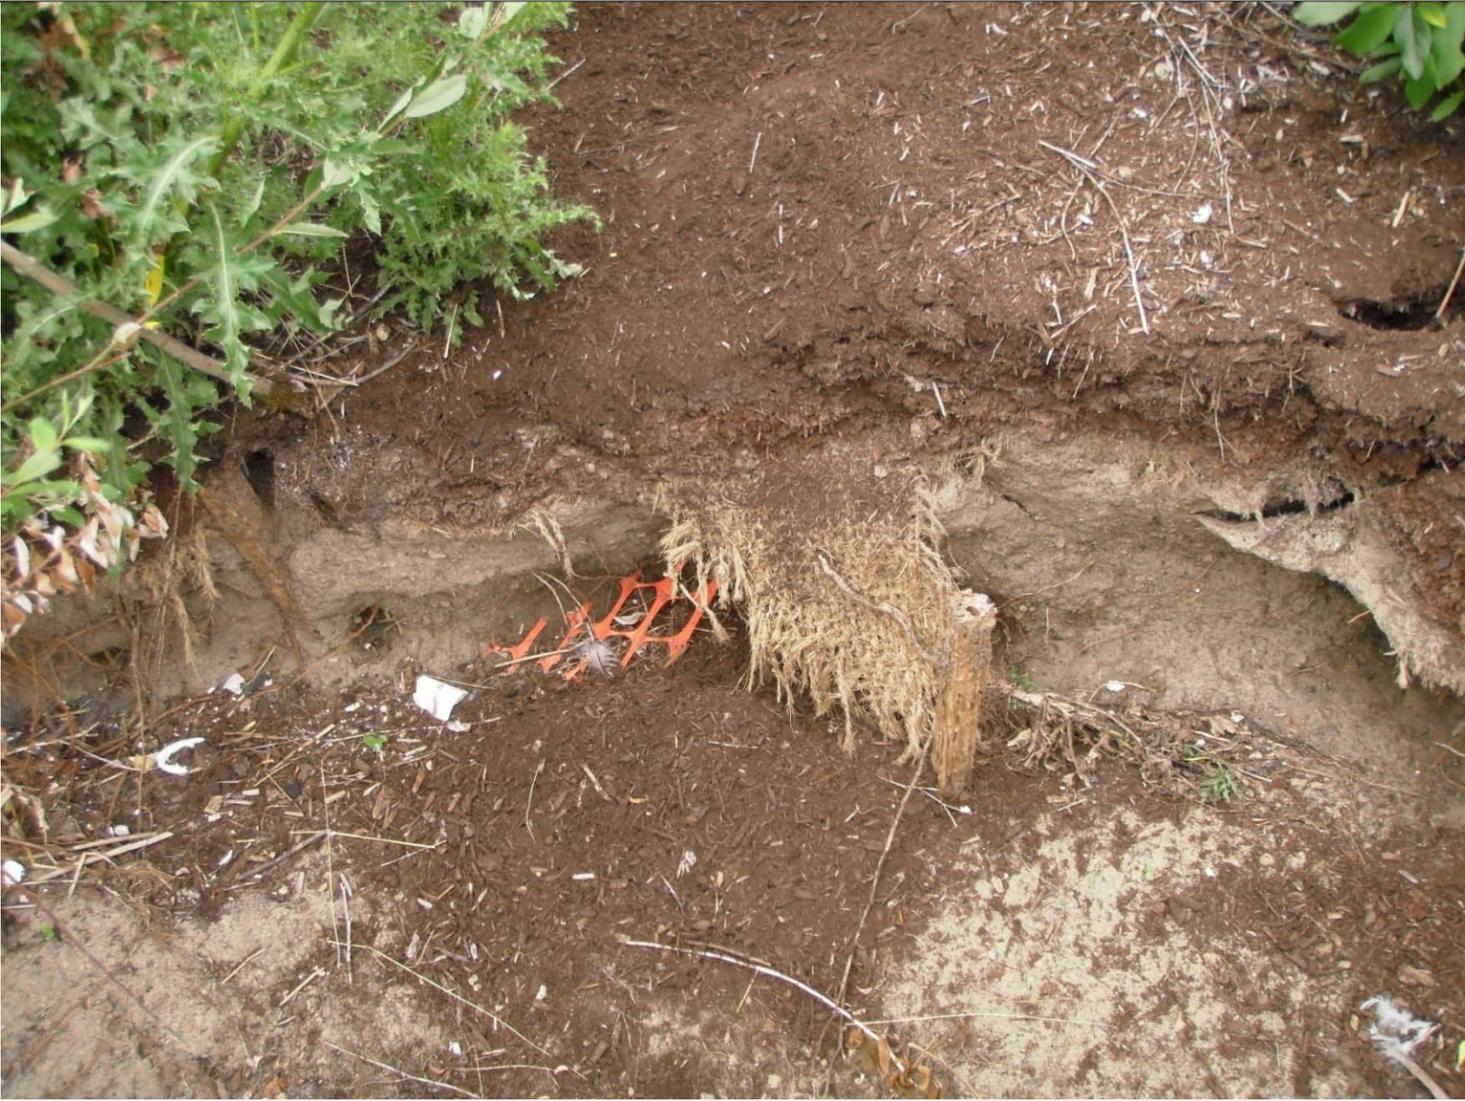
Demarcation fabric observed at Station 0+00

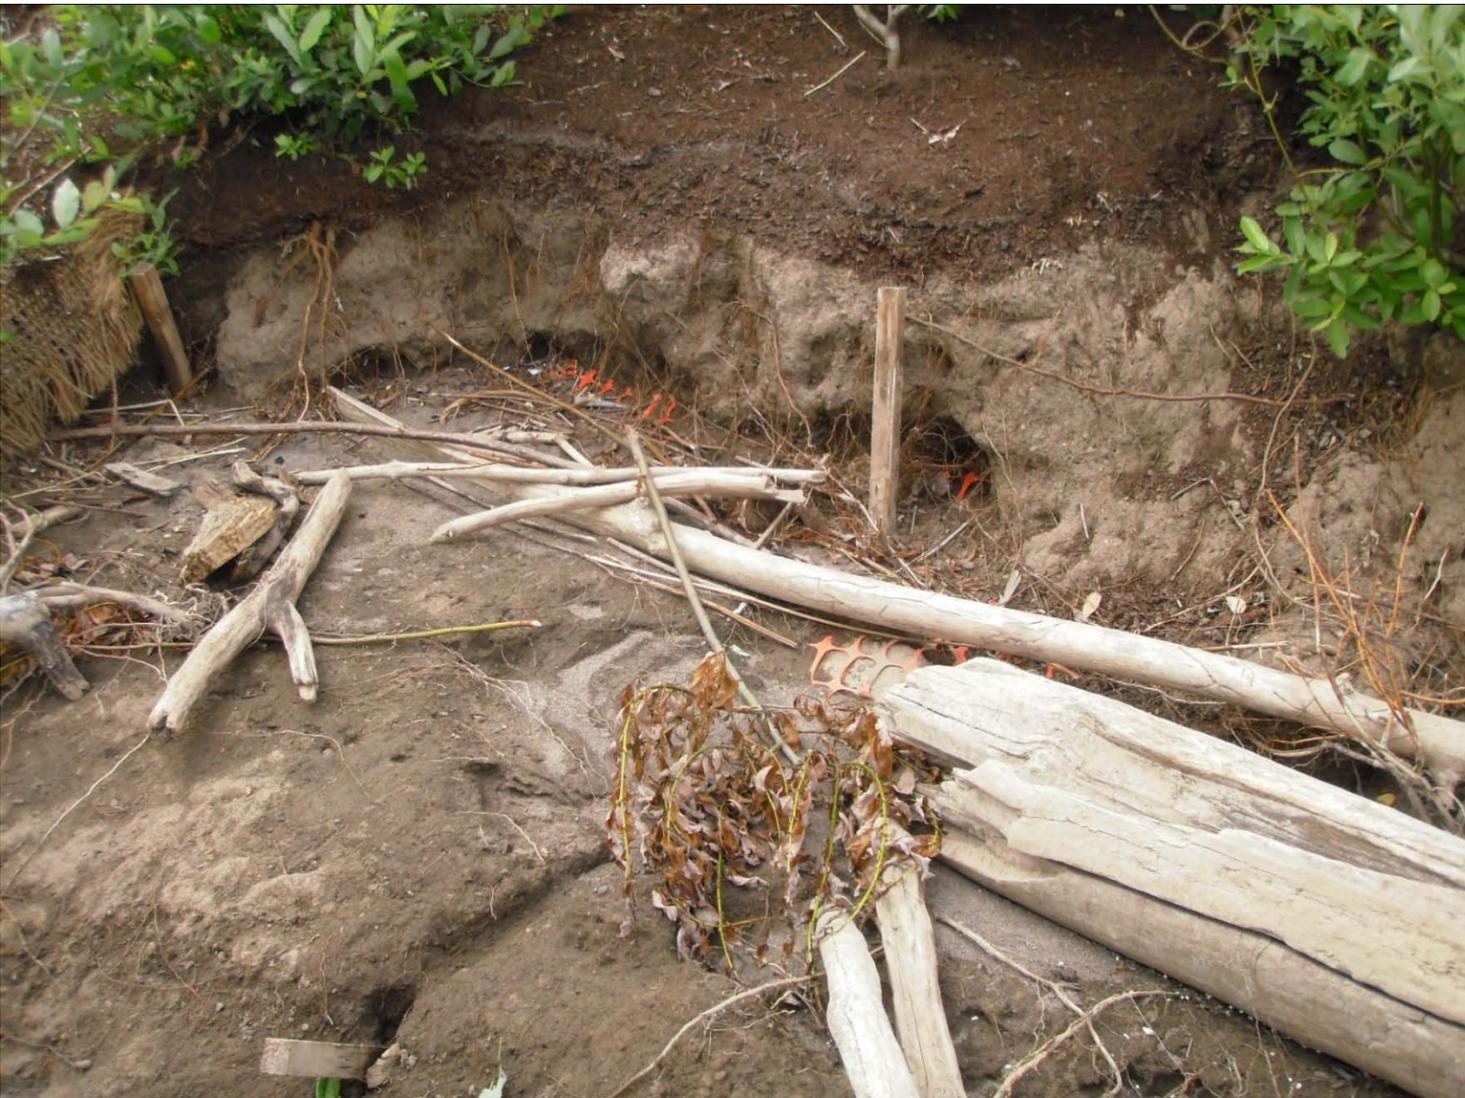
Demarcation fabric observed at Station 2+90

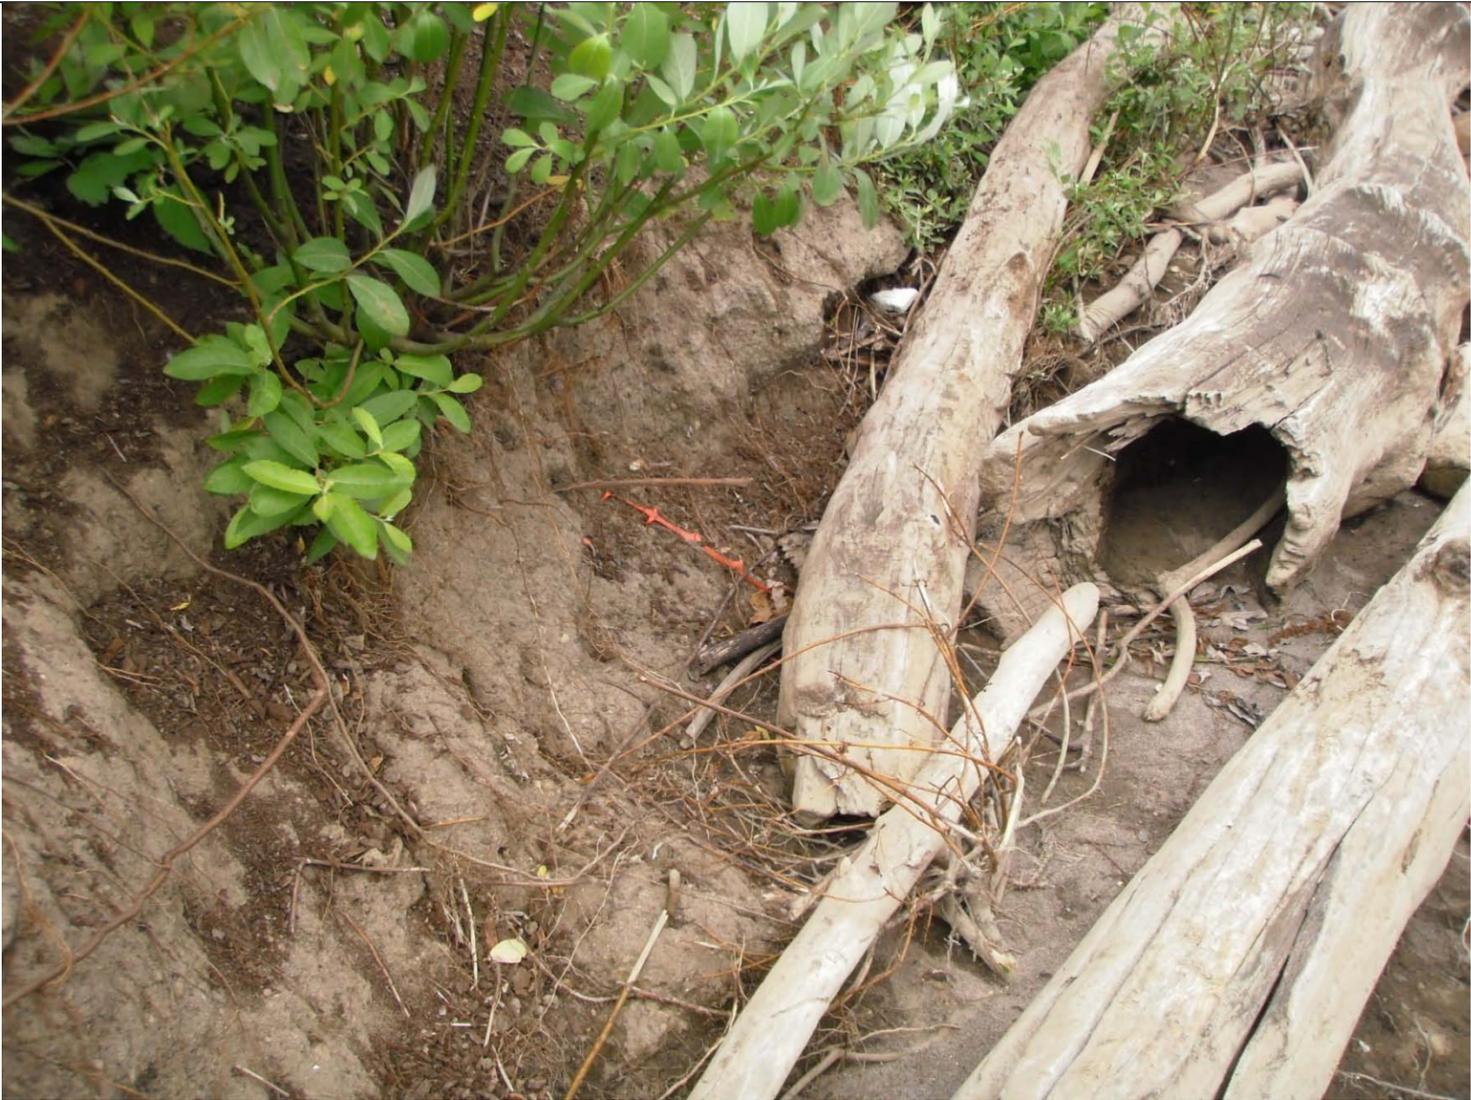
Demarcation fabric observed at Station 2+90

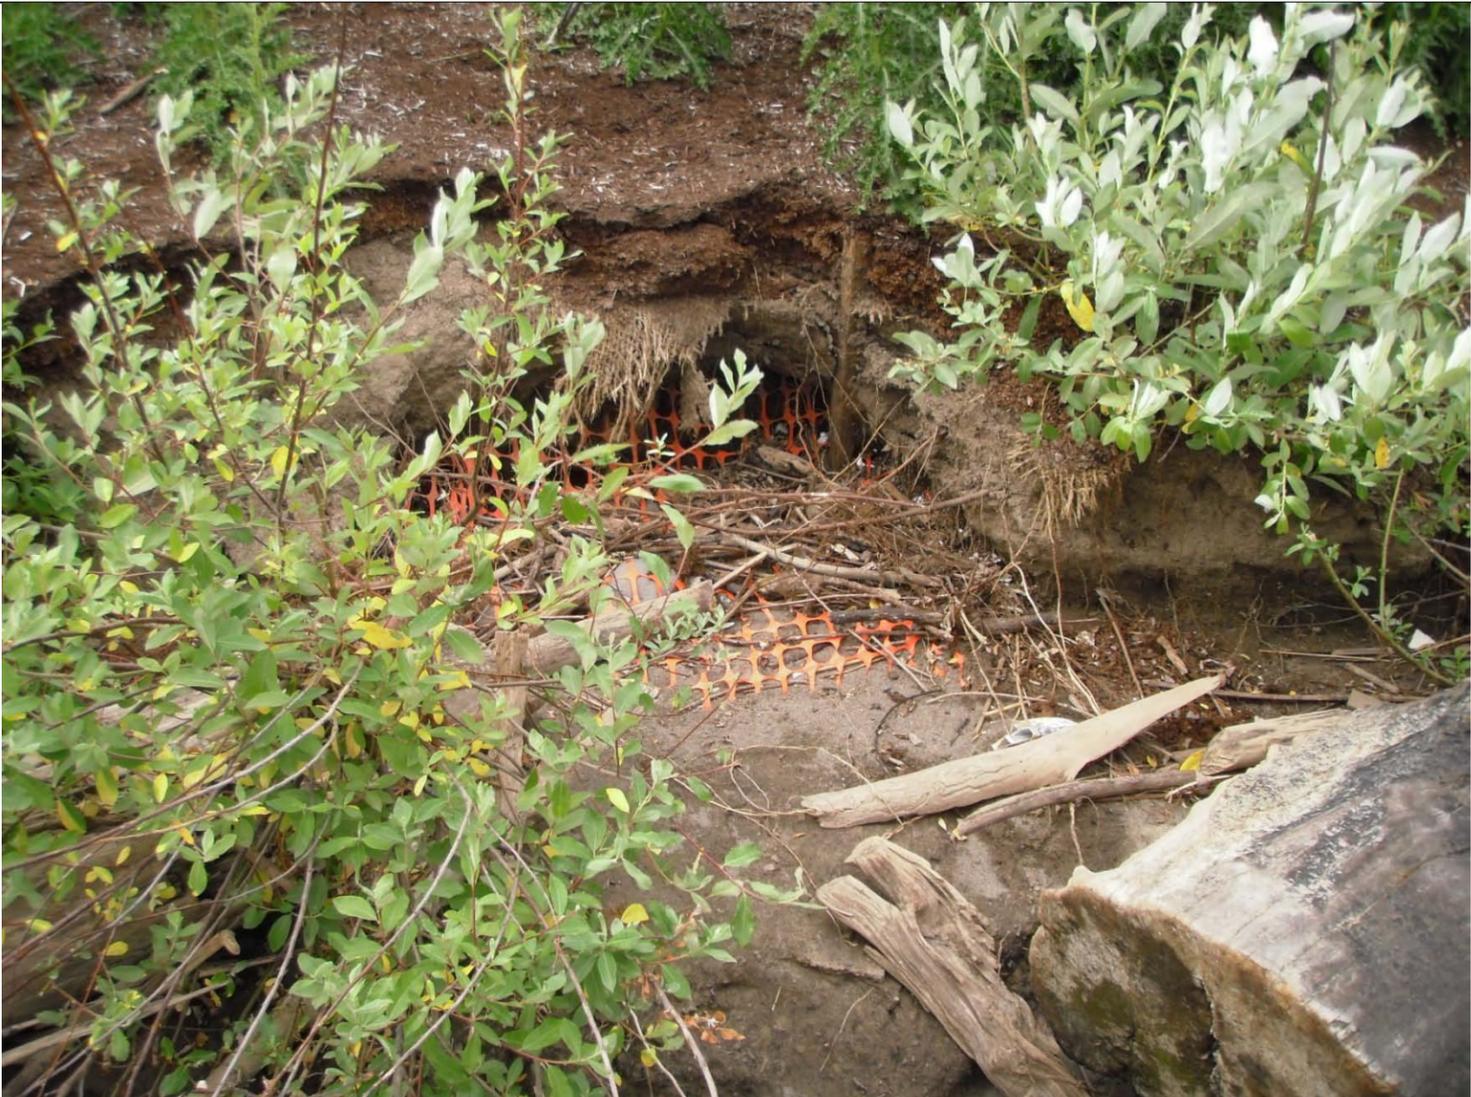
Demarcation fabric observed at Station 3+20

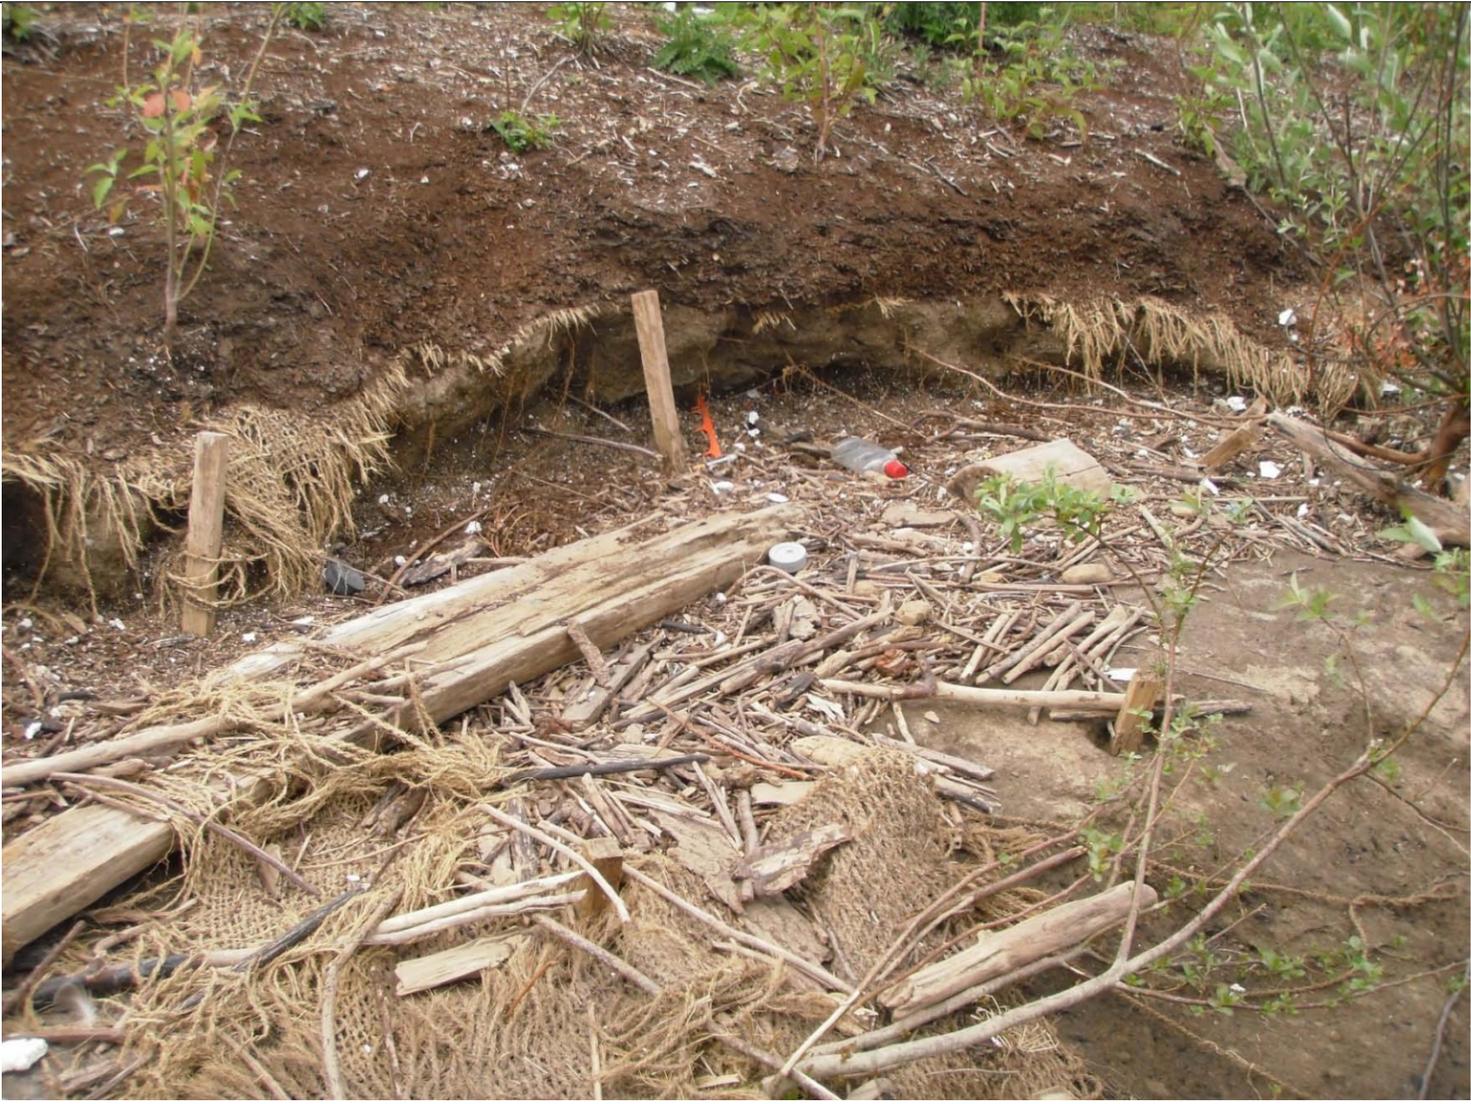
Demarcation fabric observed at Station 3+49
