**YEAR 5 INTERIM MONITORING REPORT—
TERMINAL 4 PHASE I REMOVAL ACTION
PORT OF PORTLAND, PORTLAND, OREGON**

Port of Portland
7200 Northeast Airport Way
Portland, Oregon 97218

Anchor QEA, LLC
421 Southwest Sixth Avenue, Suite 750
Portland, Oregon 97204

March 2014

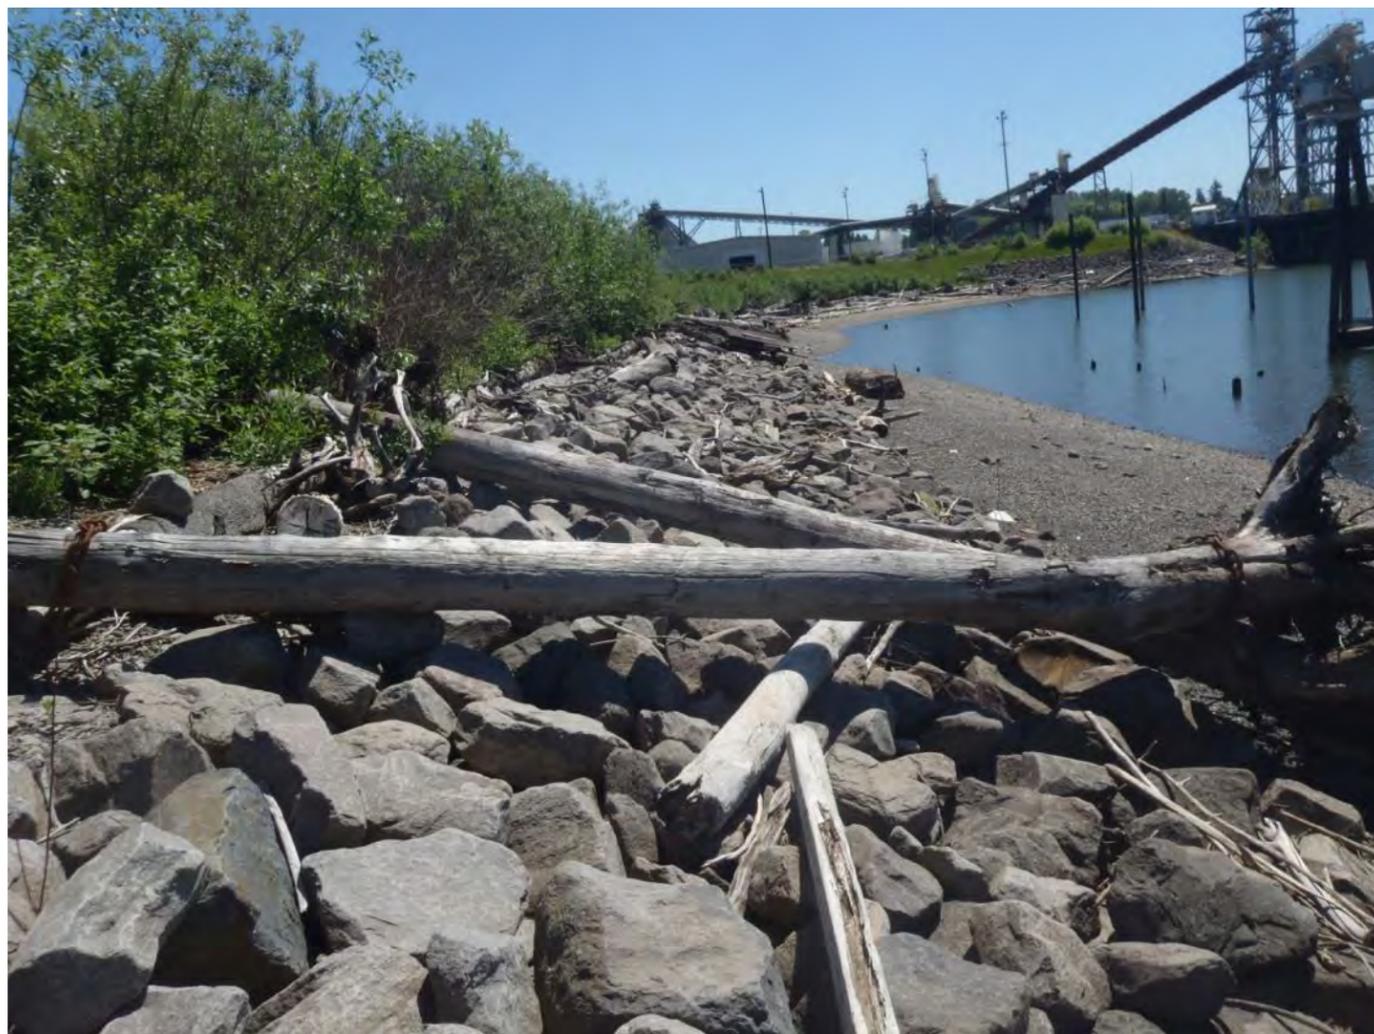
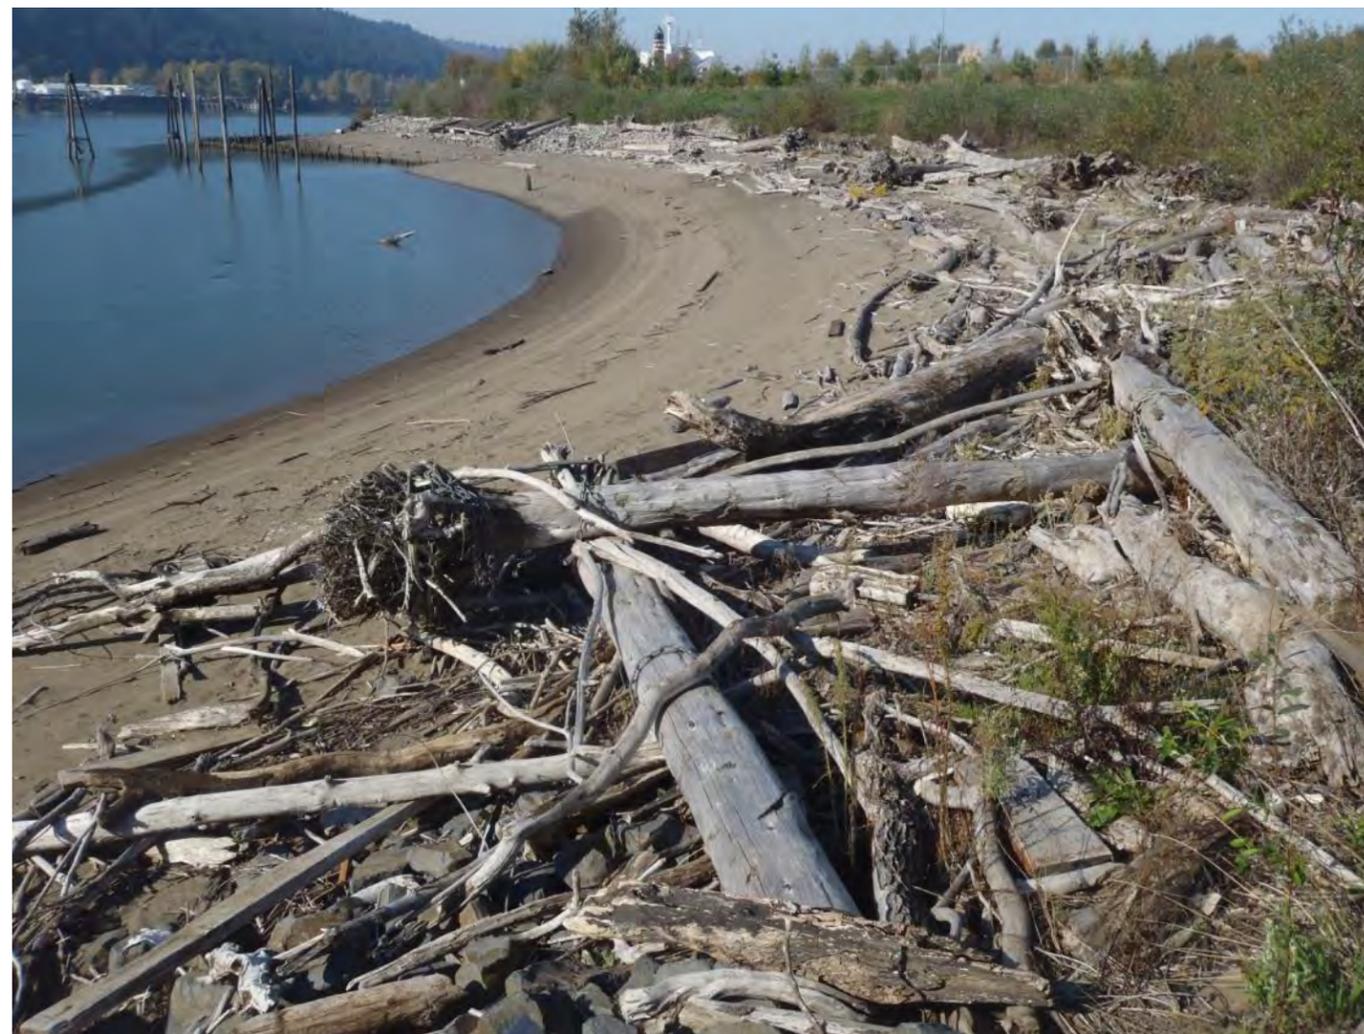
Overall, the WB shoreline is developing as expected into high quality habitat (see Figure 2). The willows have grown to a height of 2 to 4 meters and seem to be stabilizing the shoreline. The habitat material has remained over the placed riprap outside of the repaired area, and sand is depositing on top of the habitat material, especially at the middle and lower elevations. Woody debris continues to accumulate in the bay in and around the placed large woody debris, adding complexity to the system.

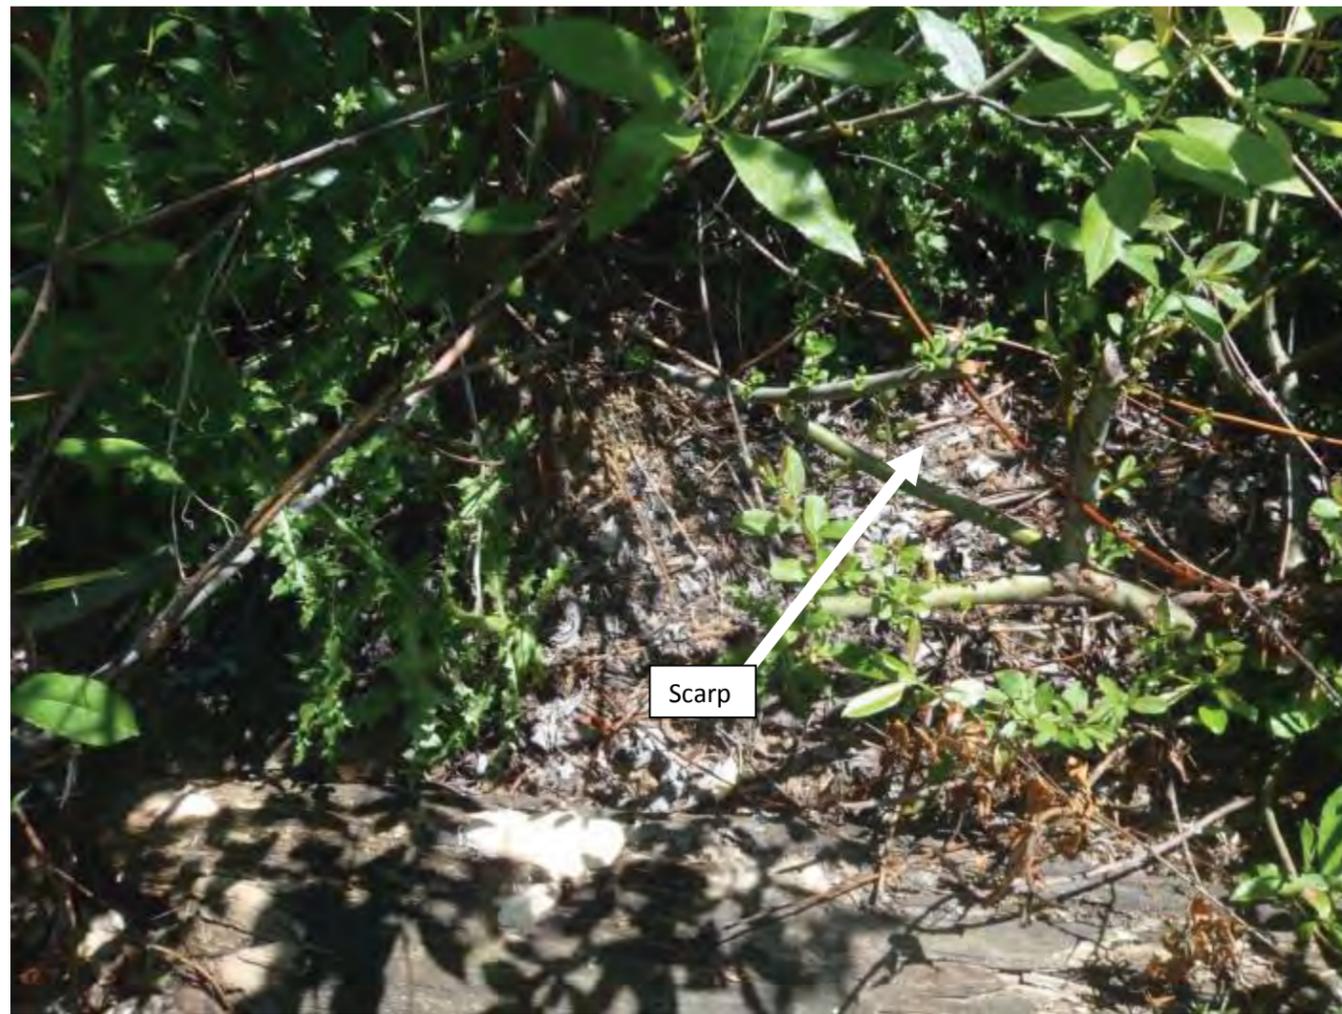
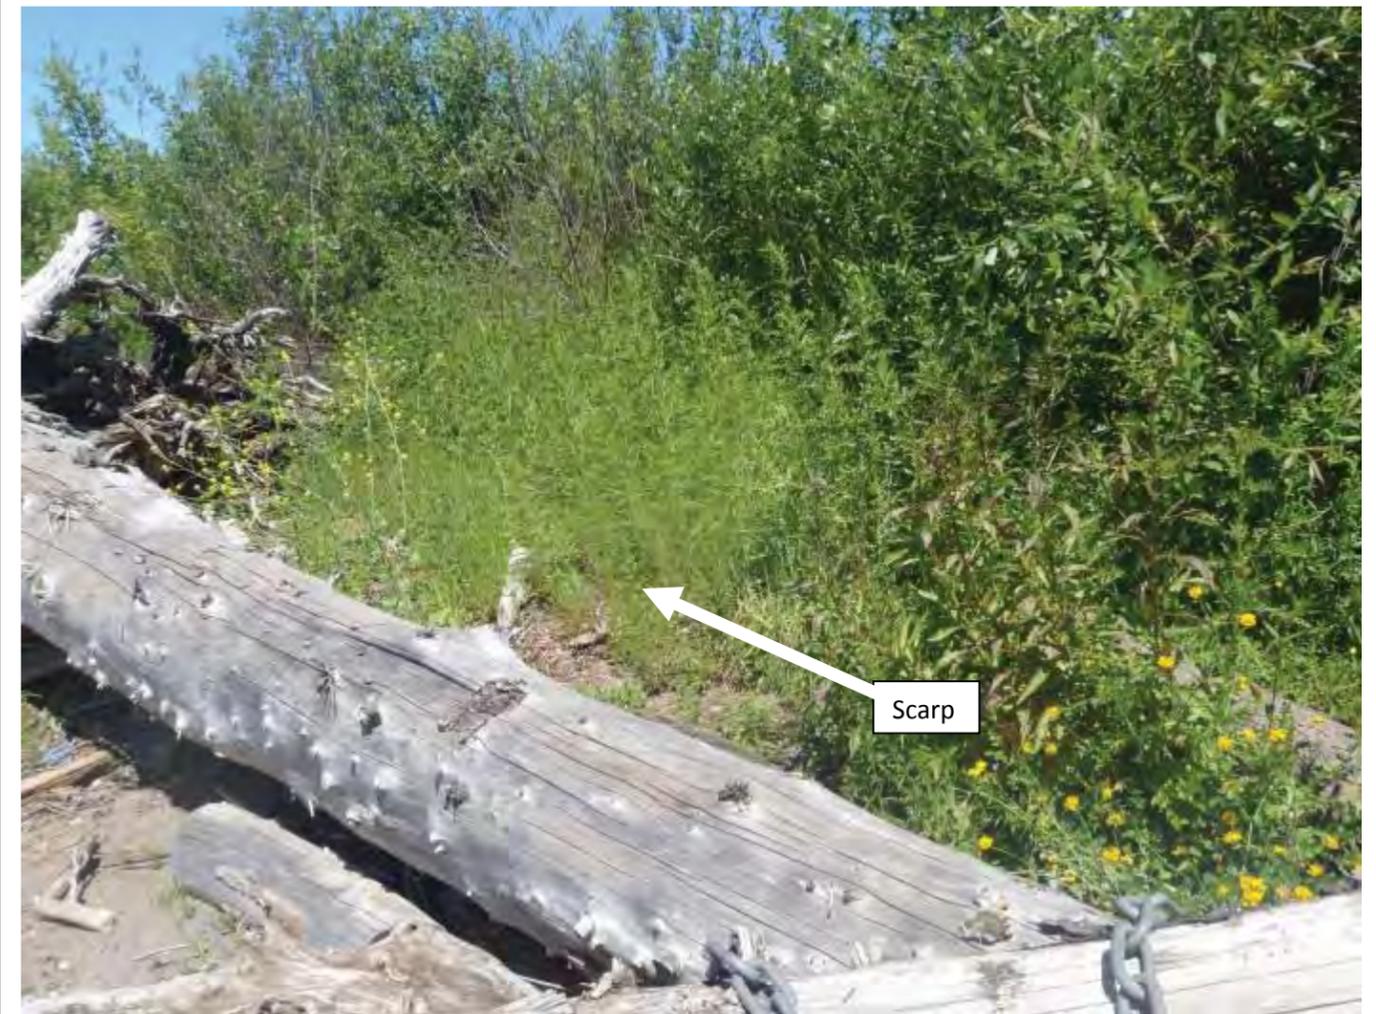
1-foot scarp in the willow planting area between Stations 3+40 and 6+70. (Photo Dates: 6/4/2013)

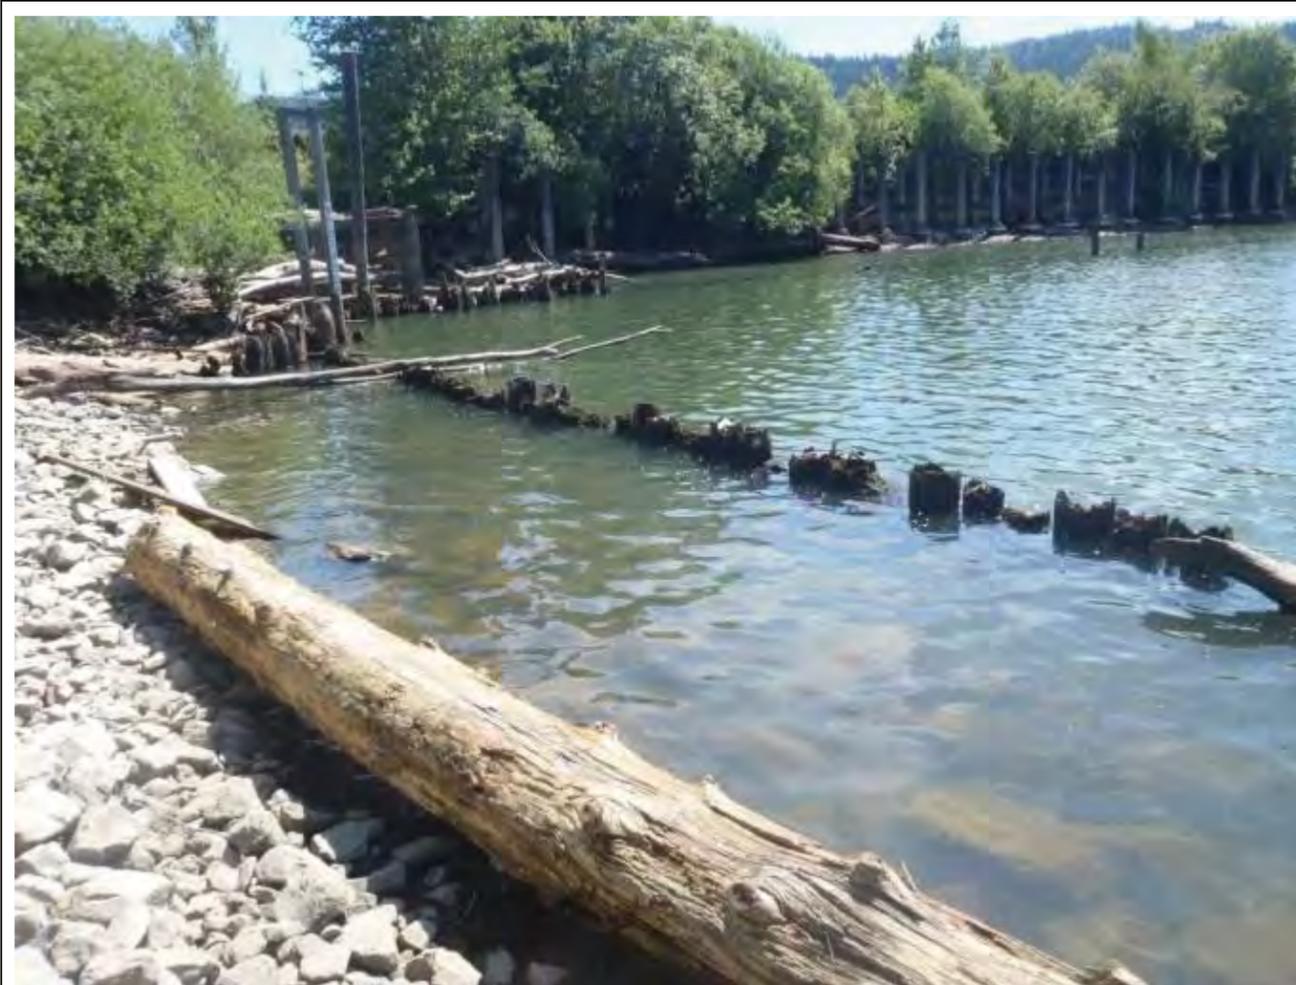
High Water Observation on 6/4/2013: No Sheen

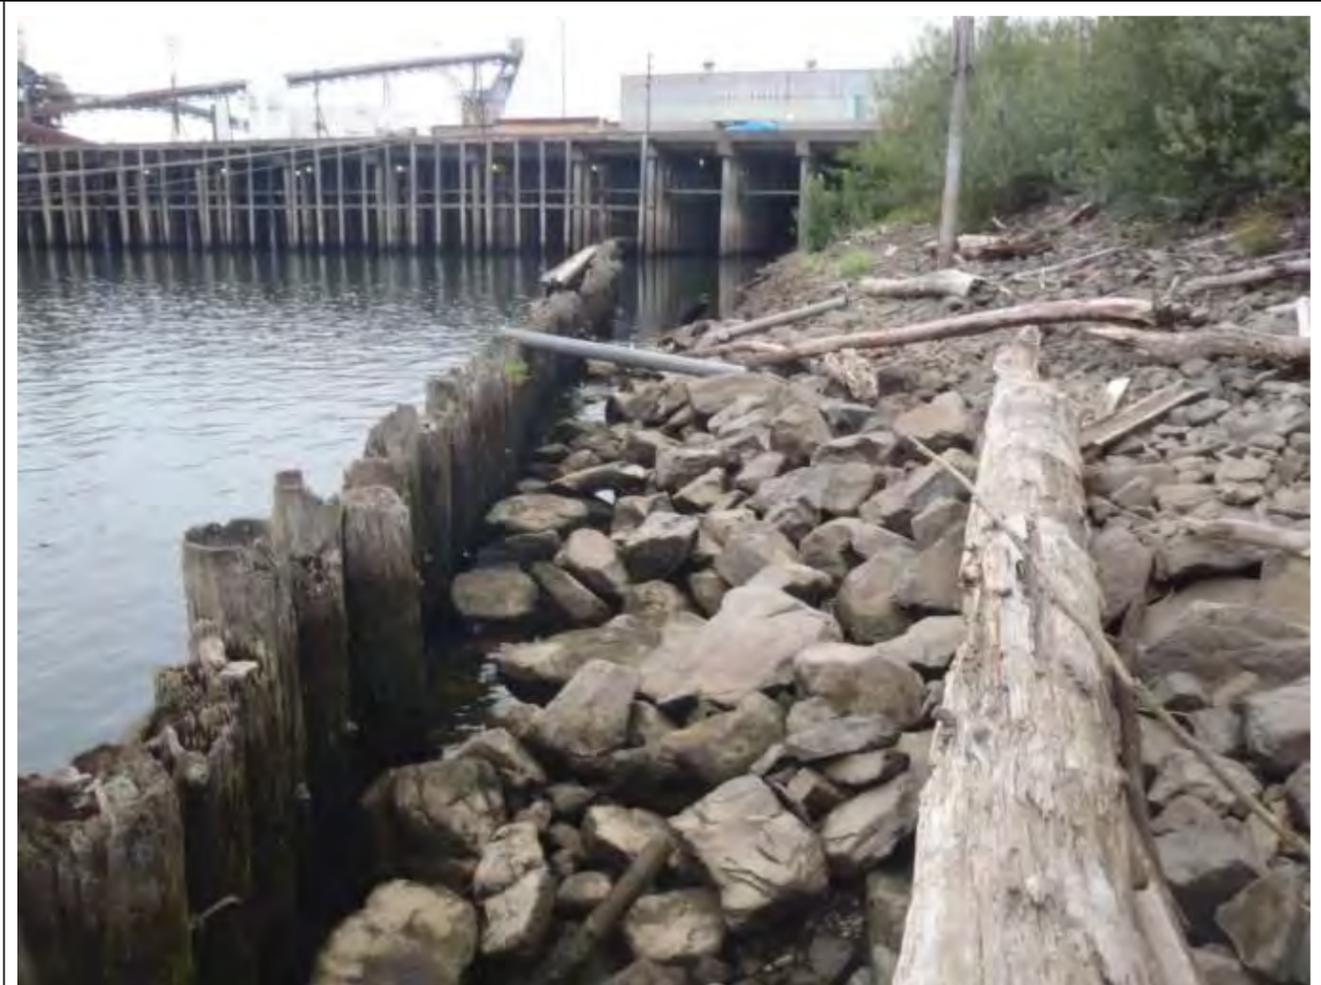
Low Water Observation on 09/12/2013: No Sheen
