**Subject: Terminal 4 Removal Action – Wheeler Bay Bank Repairs
Construction Weekly Progress Report for October 11 through 15, 2010**

PROJECT	Terminal 4, Wheeler Bay Bank Repairs	CONTRACT NO.	10D015/820027
CONTRACTOR	Northwest Earthmovers	SUPERINTENDENT	Carl Johnson (NEI)
DAY OF WEEK & DATE:	Wednesday, October 13, 2010	REPORT NO.	6
WEATHER	Clear, Southeast wind 5-15 mph	TEMPERATURE	L:59 H:74 degrees F

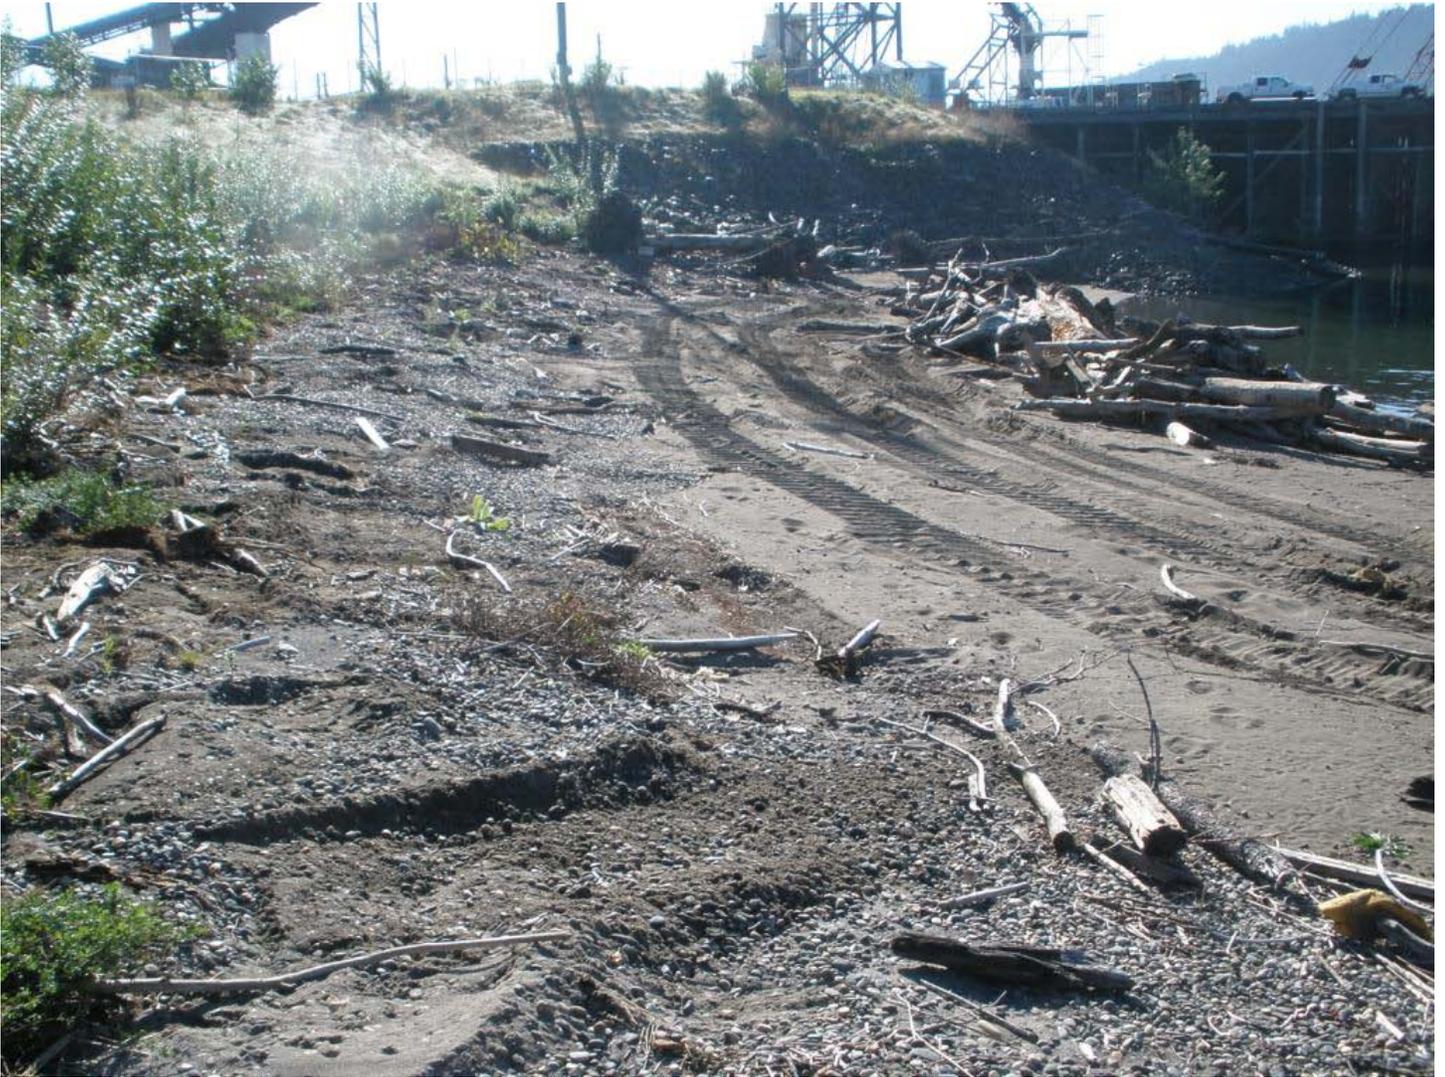
PHOTO 1

<p>1- naturally occurring LWD cleared from approximately 2+81 to 7+00</p> <p>2- delivery of LWD (4 pieces)</p> <p>3- delivery of LWD (6 pieces)</p> <p>*other photos of construction activities available but not attached to this document. Photos will be transmitted to Mary Green and she will make them available on the Port system.</p>	None
--	------

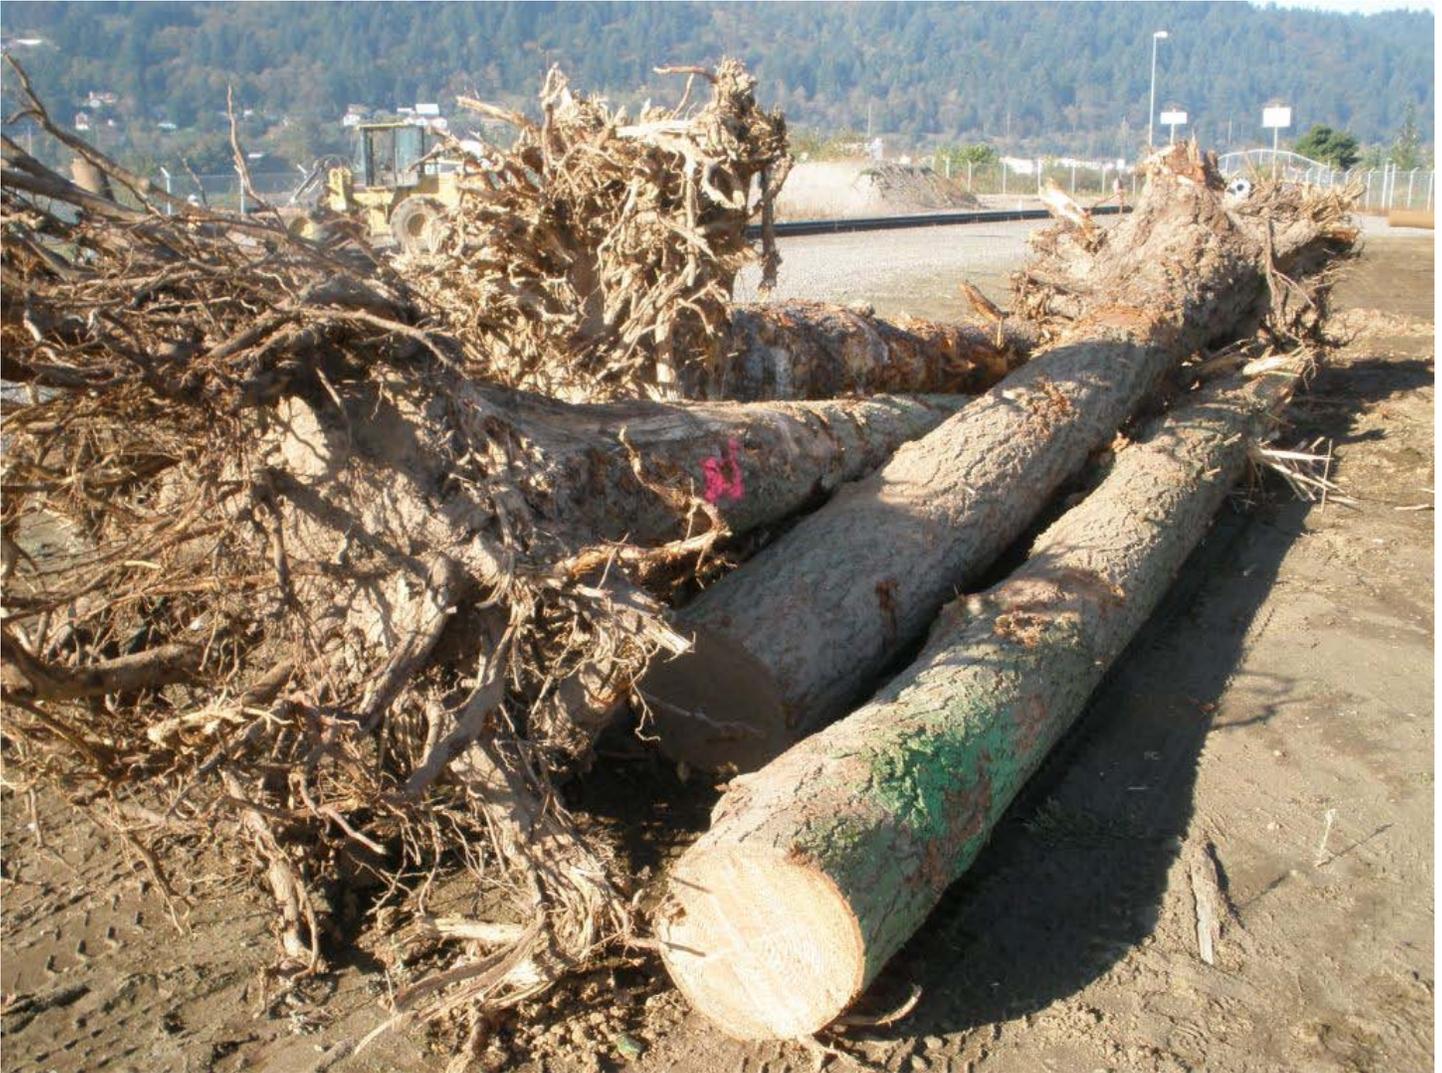
PHOTO 1

08:00 NEI receiving coir fabric (3 rolls x 1079 sq.ft. = 3237 sq.ft.), 10"x10"x1" fabric staples (1000 pcs.)
 NEI removes excavator N833 from site
 NEI delivers replacement 160LC equipped with hoe compactor for driving anchors
 NEI delivers LWD (4 pcs.)—confirmed compliance with spec by measurement (Photo 1)

- 1- LWD delivery #1 (4 pieces)
 - 2- fabricated anchor-driver assembly
 - 3- delivery of LWD (4 pieces)
 - 4- attempt to drive anchor with threaded anchor rod
- *other photos of construction activities available but not attached to this document. Photos will be

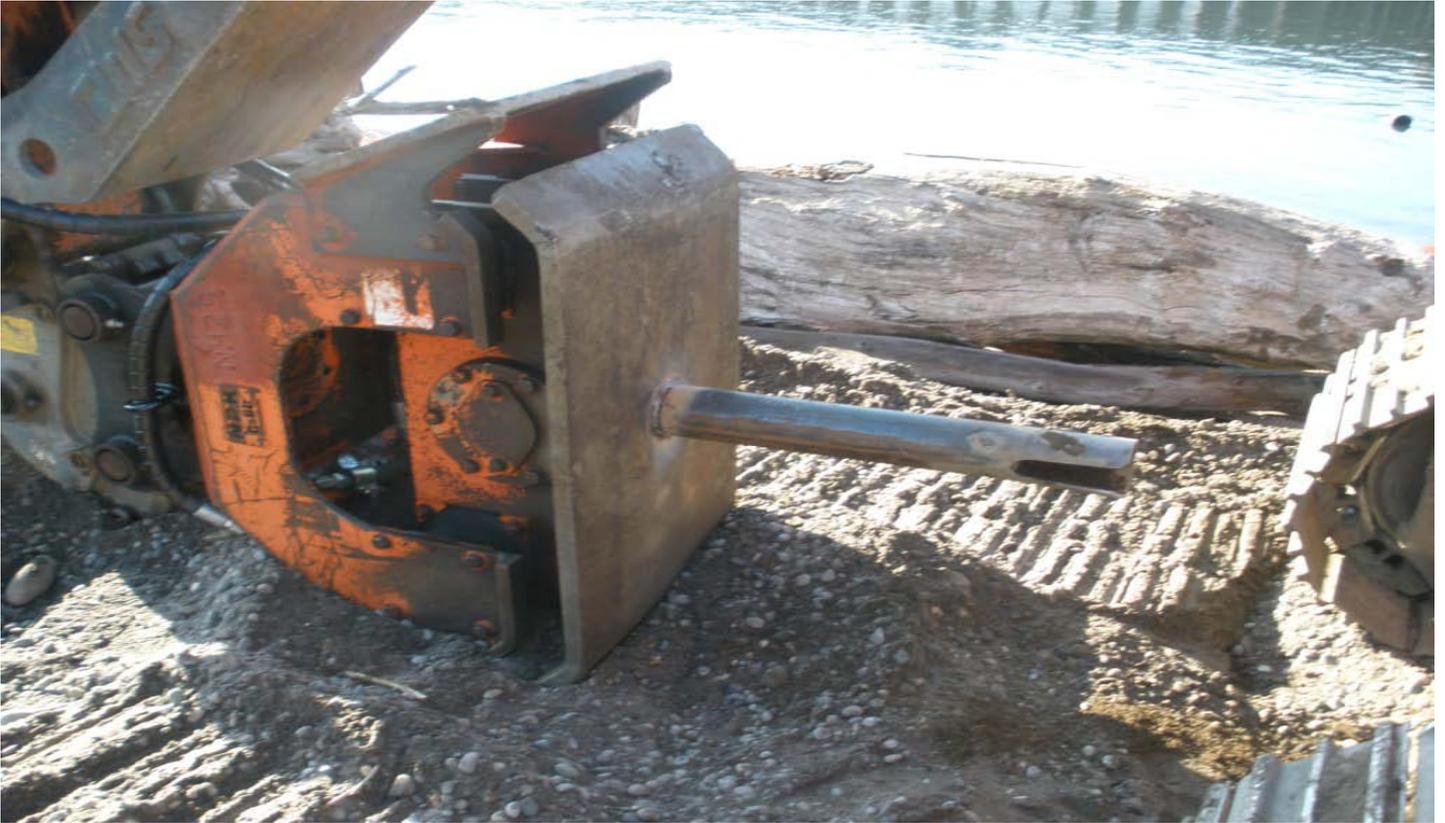
PHOTO 2

09:00 NEI assembling tooling and configuring 160LC excavator and hoe compactor for driving anchor systems (Photo 2)

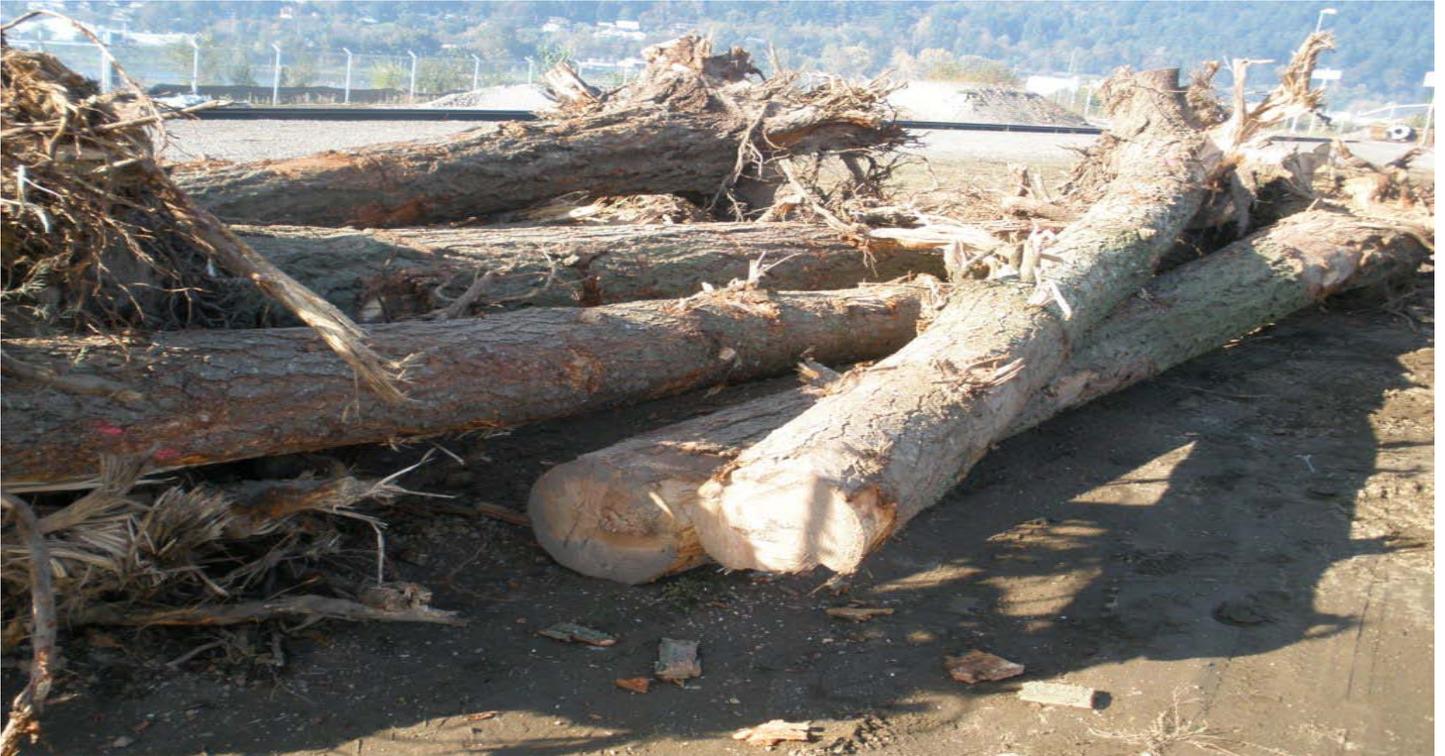
PHOTO 3

10:00 NEI preparing to test-drive manta ray anchors
 NEI delivers LWD (4 pcs.)—confirmed compliance with spec by measurement

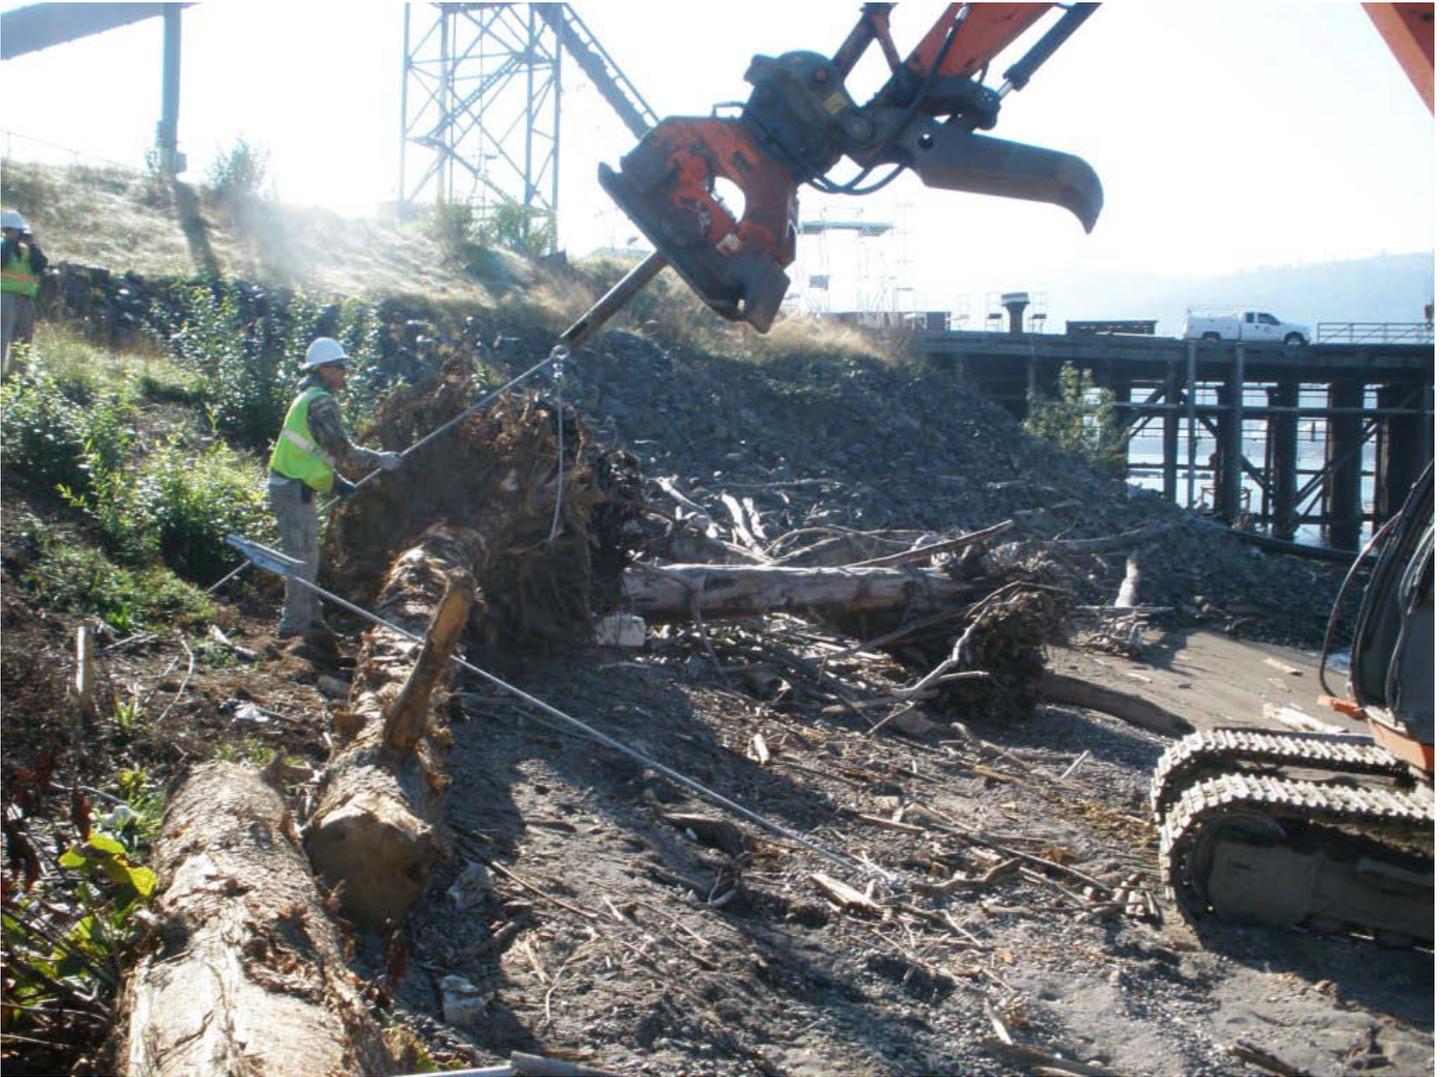
PHOTO 4

11:00 NEI attempts to drive anchor at approximately station 6+80 by pushing on threaded anchor rod and vibrating with hoe compactor
 Threaded anchor rod is too flexible for driving anchor, and anchor could not be driven beyond 3 ft below ground surface.
 Anchors will need to be driven by independent heavy rod (approximately 1-3/8" diameter) inserted into drive hole provided in anchor foot.

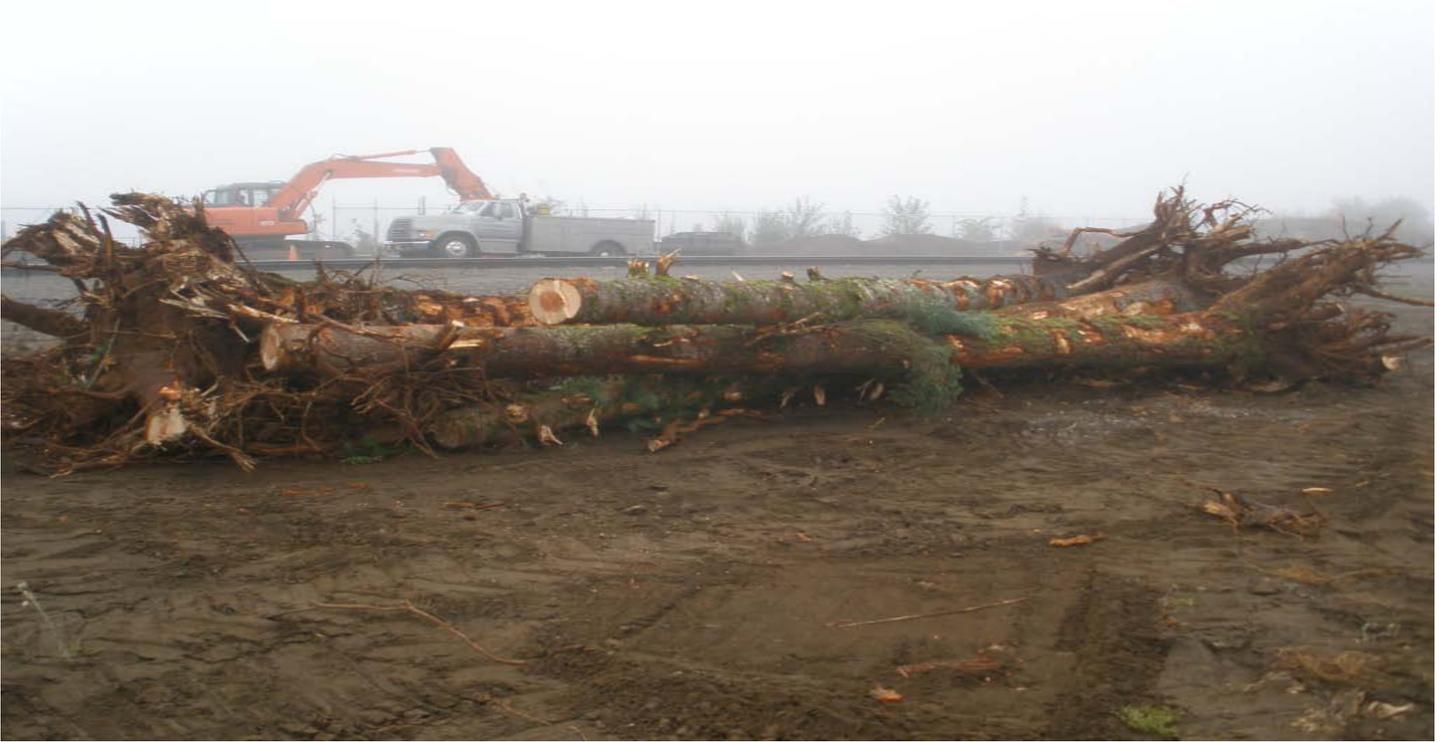
PHOTO 1

<p><u>CHRONOLOGICAL ACCOUNT OF DAY'S WORK:</u></p> <p>07:00 PMX(1), and AQ/POP(1) staff on site NEI delivers LWD (5 pieces)—visually observed and measured for specification compliance (PHOTO 1)</p> <p>08:00 Carl Johnson (NEI) on site NEI begins fabricating reconfigured anchor-driving rod</p> <p>09:15 NEI assembling tooling and configuring 160LC excavator and hoe compactor for driving anchor systems and mobilizing down slope to approximately station 6+80</p> <p>09:15-10:00 NEI preparing to test-drive manta ray anchor at 6+80 Anchor driven to approximately 6.5 feet bgs at which point driving rod bent and was retracted from ground (PHOTO 2) NEI attempts to recover anchor from ground by pulling with excavator; however anchor sets at approx. 5.5 feet bgs and could not be removed—spec requires driving 7-10 feet bgs (PHOTO 3)</p> <p>10:15 NEI delivers LWD (6 pieces)—NEI will import additional logs if needed AQ/POP visually observes and measures LWD for specification compliance</p> <p>10:30 NEI obtaining materials to reconfigure anchor-driving system NEI moving LWD from drop area to stockpile across tracks to project stockpile area outside of fence</p> <p>11:30 NEI begins fabrication of pilot push rod constructed of 3.5-inch O.D. SCH80 steel pipe</p> <p>12:15 NEI moves to approximately 6+65 to attempt driving pilot hole with new assembly Pilot hole driving was successful to depth, but weld broke away at hoe compactor attachment point</p> <p>12:30 NEI receives 300' x 3/4" long-link lash chain—non-galvanized</p> <p>12:40 NEI lunch break</p> <p>13:10 NEI demobilizes and prepares for end of day</p> <p>14:00 NEI traveling to shop to complete fabrication of driving rod and pilot driver assembly NEI, PMX, and AQ/POP off site</p> <p><u>Summary of contractor progress (reflects revised stationing layout by contractor):</u> Rip rap base layer completed from approximately station 0-20 to 2+50</p>

- 1- LWD delivery #1 (5 pieces)
- 2- attempt to drive anchor at 6+80 with 1-1/2" drive rod
- 3- anchor set at 5.5 feet bgs
- 4- attempt to drive pilot hole with 3-inch SCH80 pipe assembly
