**Subject: Terminal 4 Removal Action – Wheeler Bay Bank Repairs
Construction Weekly Progress Report for October 18 through 22, 2010**

PROJECT	Terminal 4, Wheeler Bay Bank Repairs	CONTRACT NO.	10D015/820027
CONTRACTOR	Northwest Earthmovers	SUPERINTENDENT	Carl Johnson (NEI)
DAY OF WEEK & DATE:	Monday October 18, 2010	REPORT NO.	9
WEATHER	Clear, NW wind 0-5 mph	TEMPERATURE	L:42 H:64 degrees F

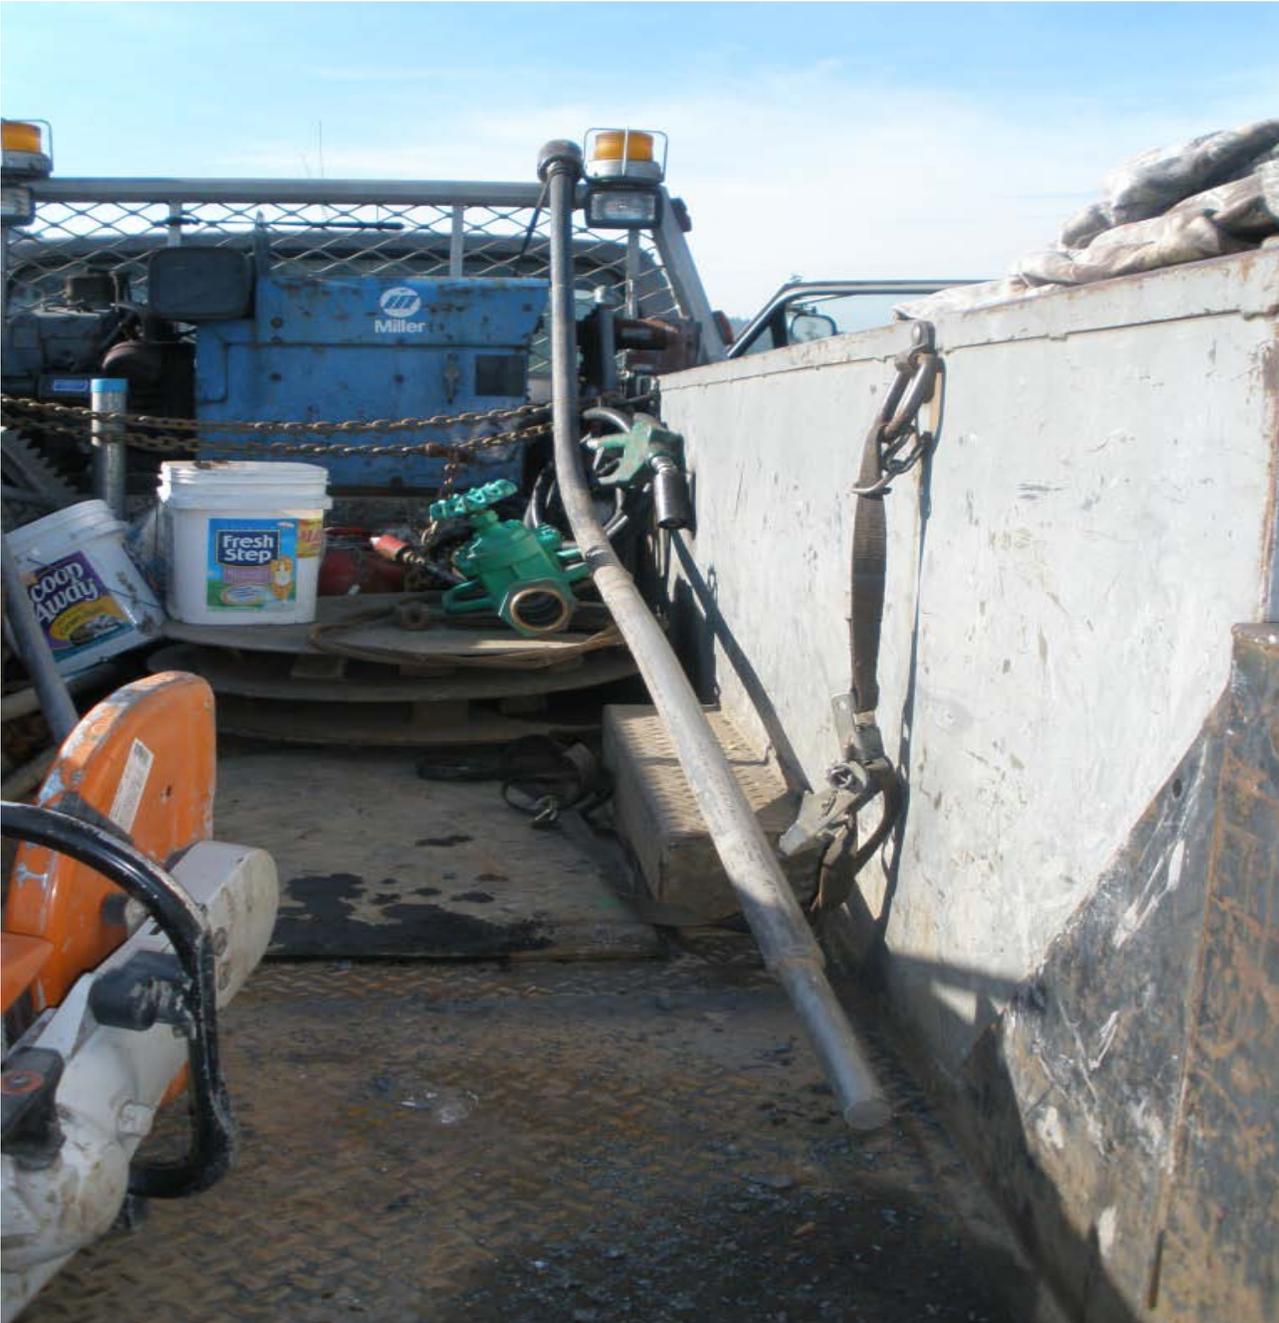
PHOTO 1

13:00 NEI driving anchors nearing stn.5+80
 Drive rod was bent on 10th anchor driven—NEI will fabricate replacement for 10/19/10 (Photo 1)

- 1- bent anchor drive-rod
- 2- completed anchor point attached to log
- 3- anchored logs at overlap point (top end of LWD)

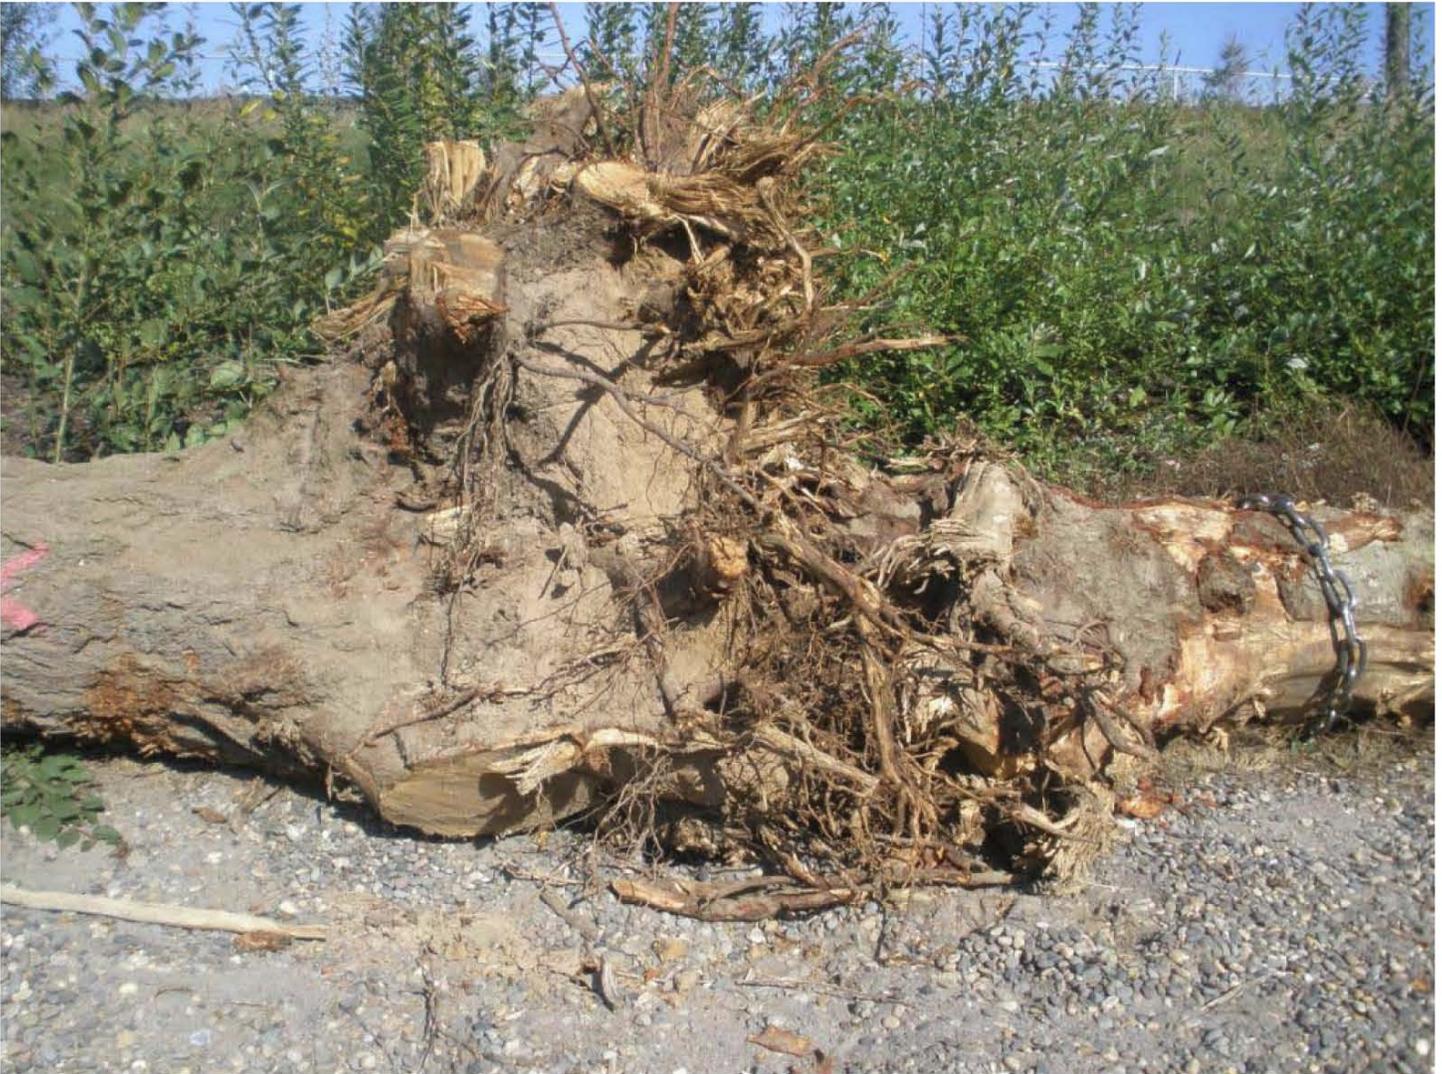
PHOTO 4

4- anchored logs at conneciton of root balls

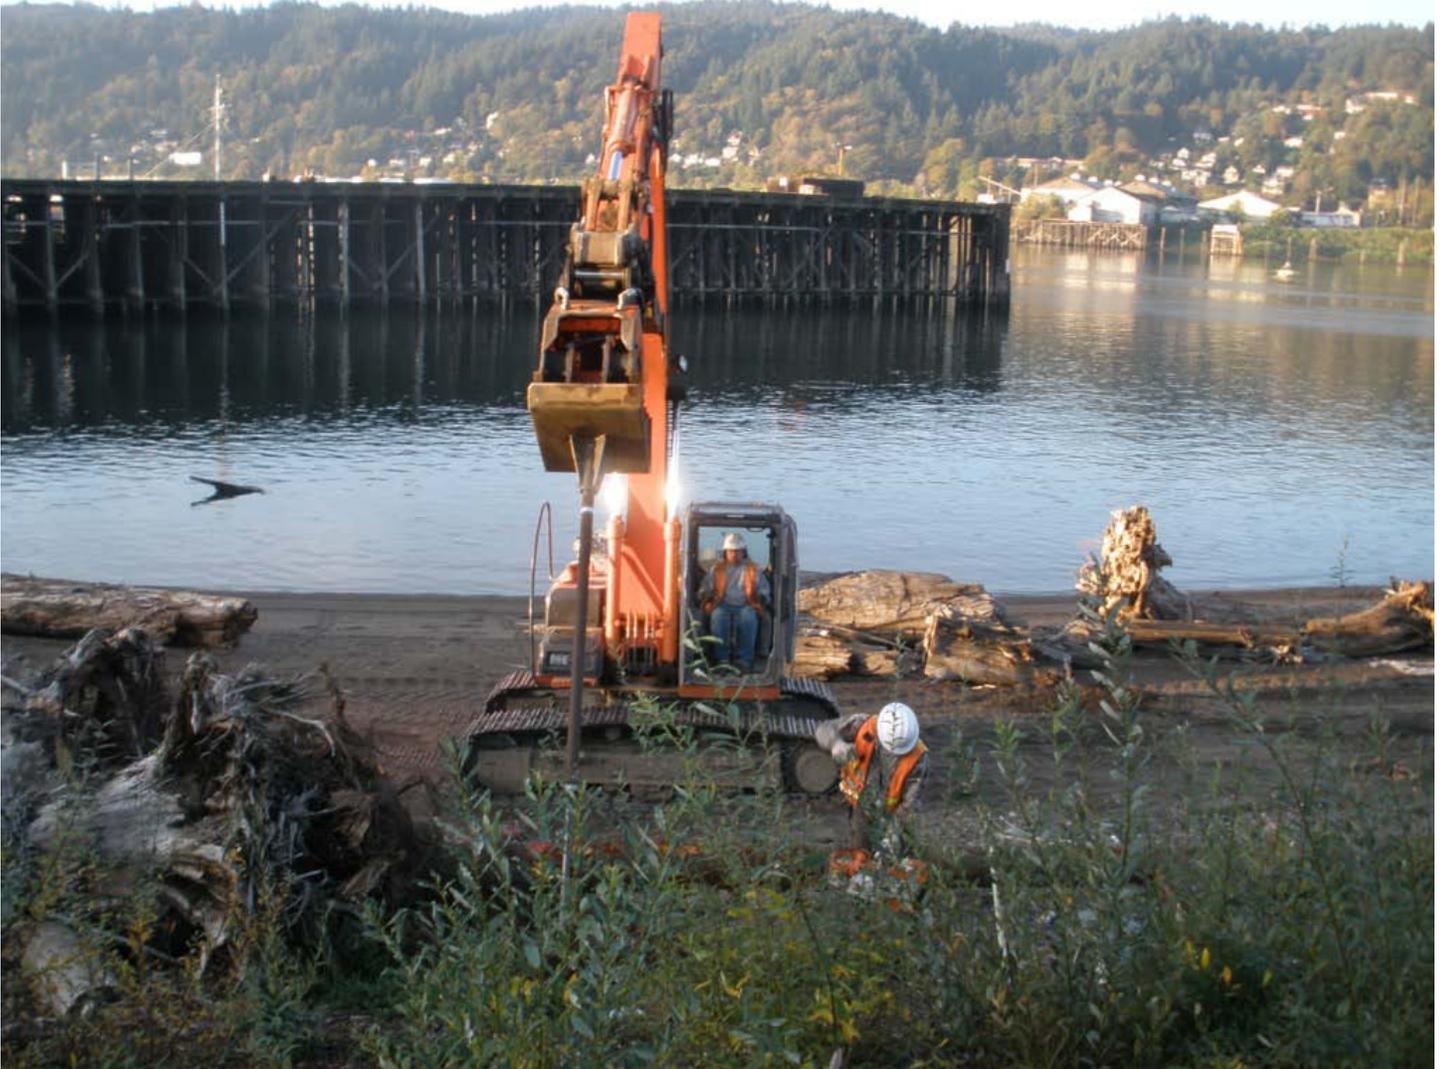
PHOTO 1

- 1- NEI driving anchor points
- 2- NEI securing chains to anchor system
- 3- Wheeler Bay shoreline overview

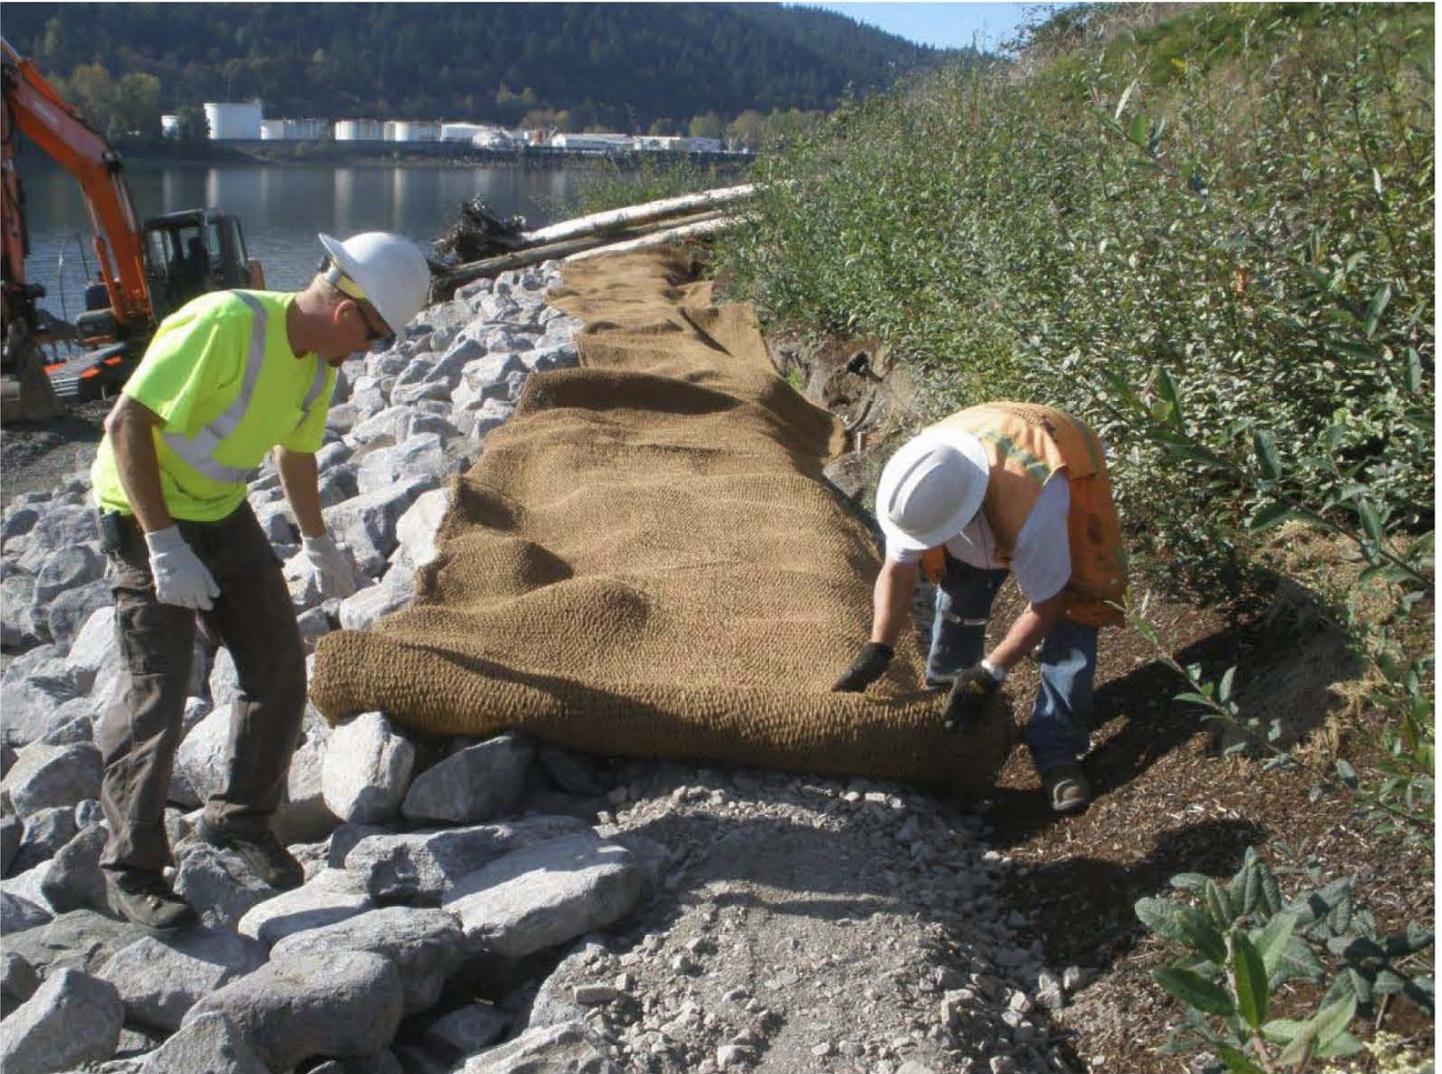
PHOTO 4

4- NEI installing and staking coir fabric in anchor trench

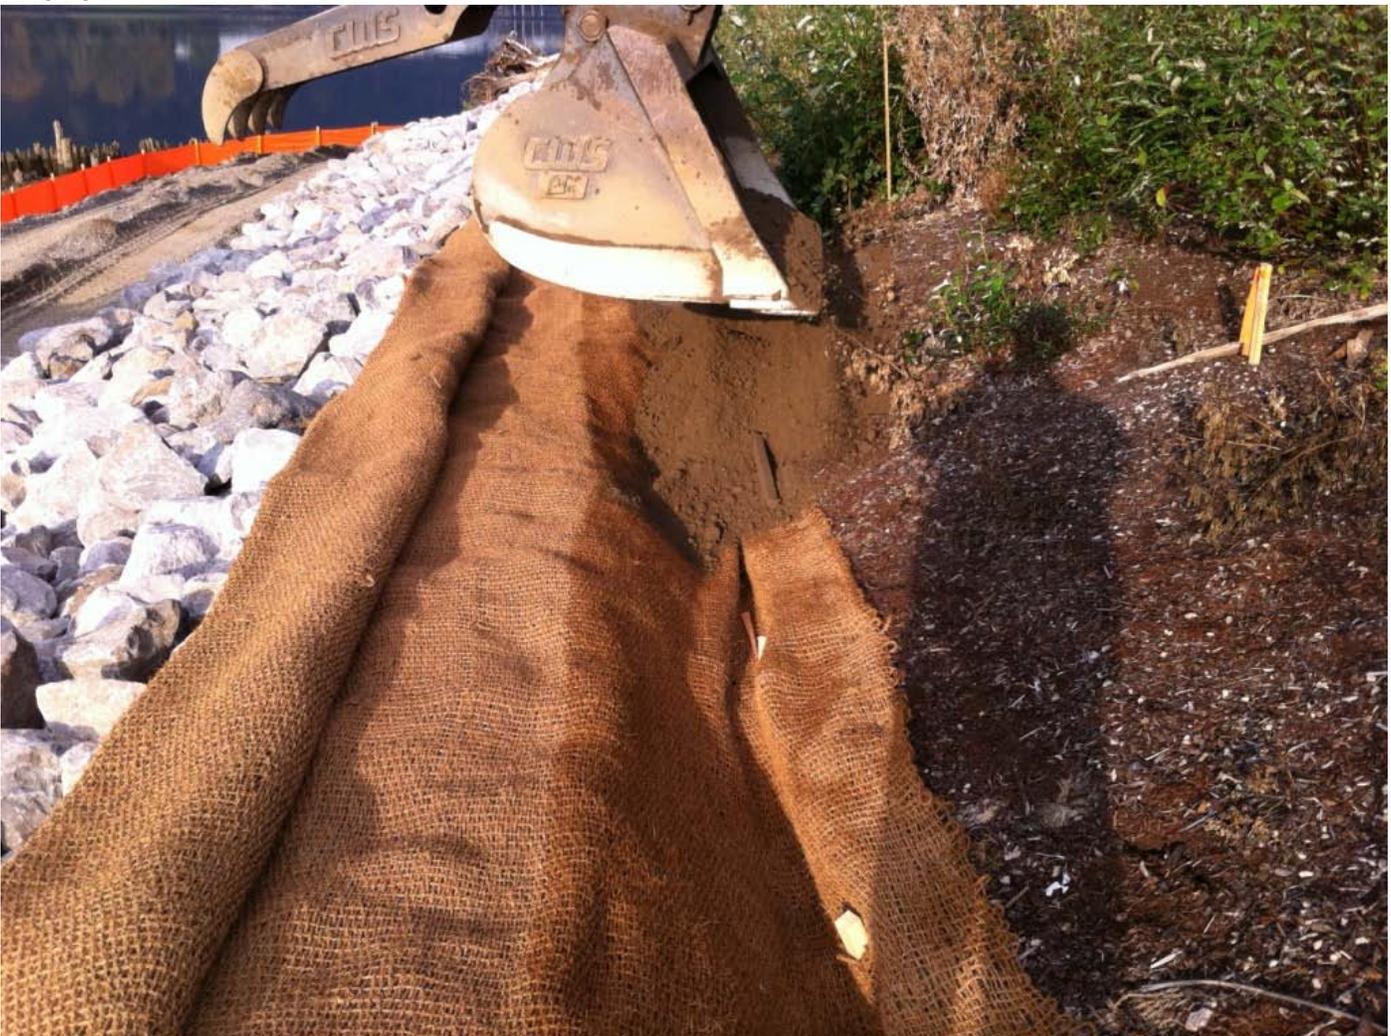
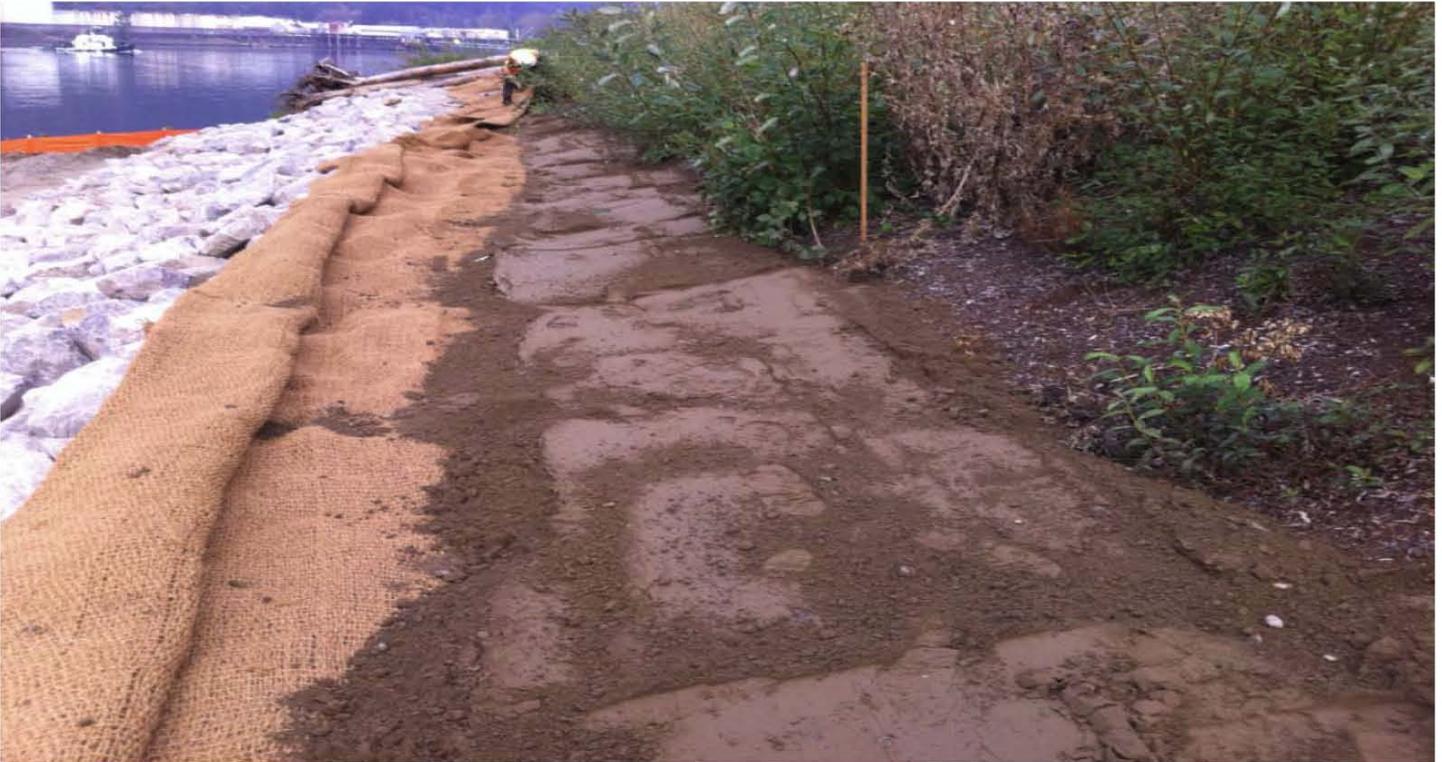
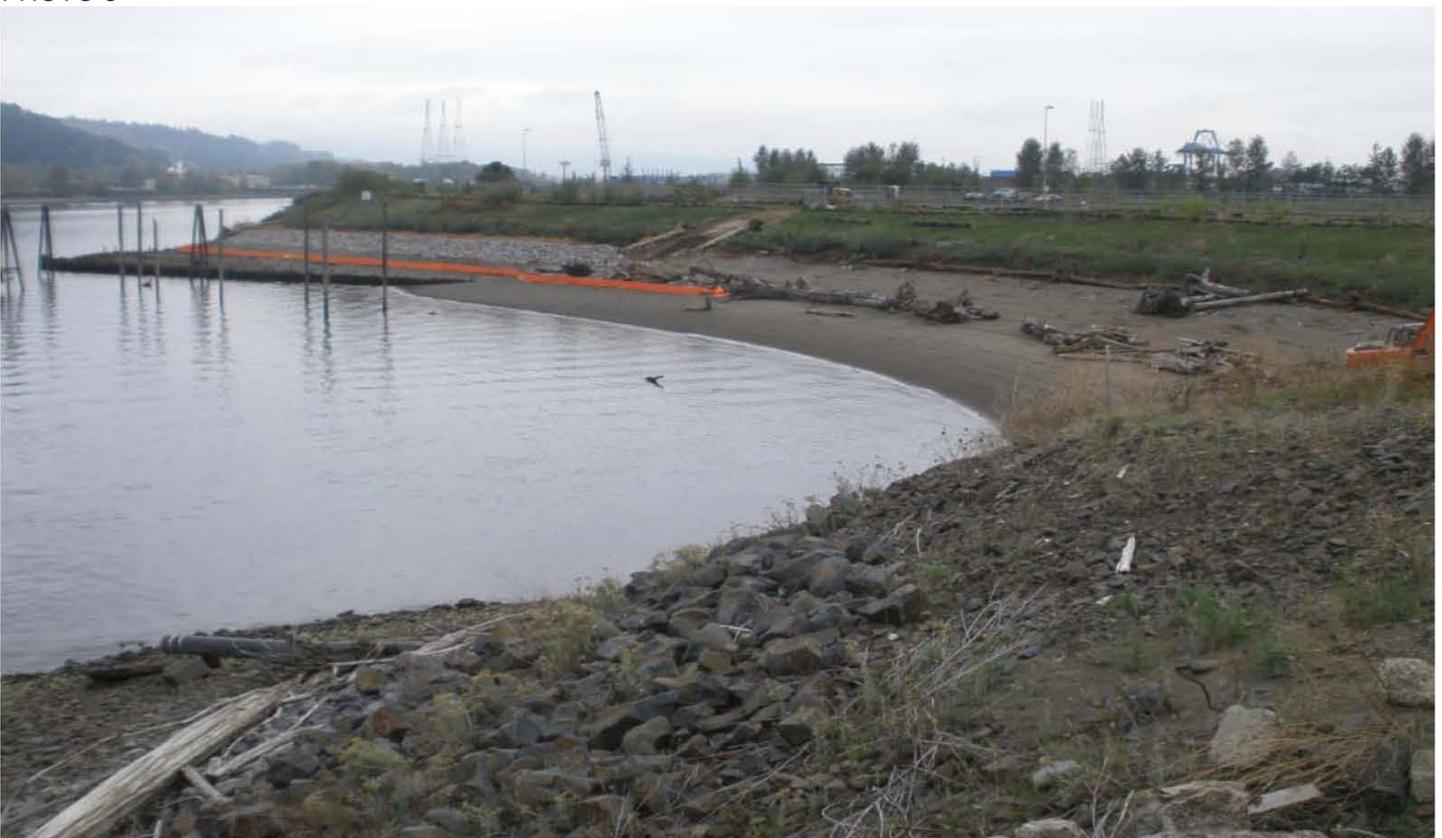
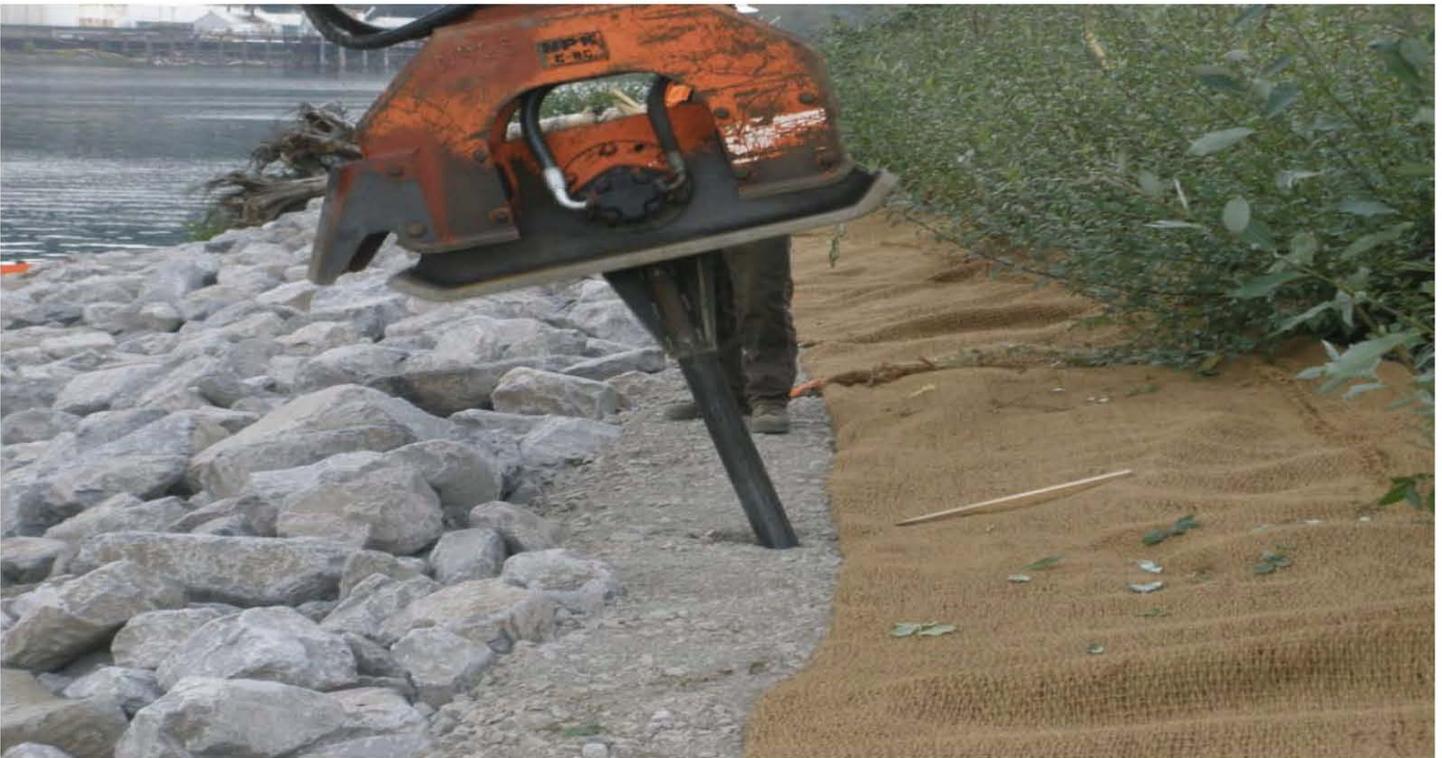
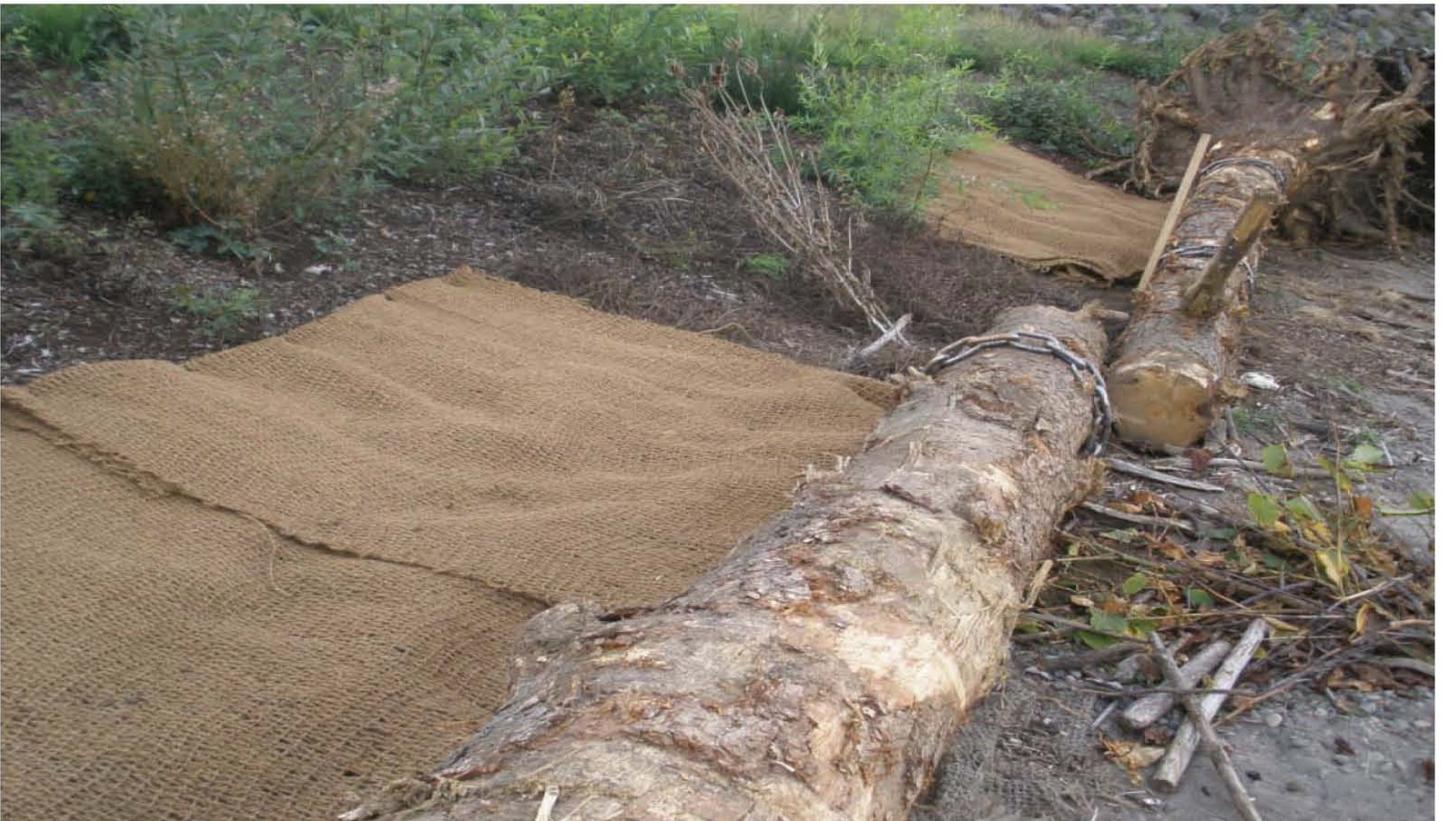
<p>1- NEI installing sandy loam</p> <p>2- NEI shaping and grading sandy loam</p> <p>3- Wheeler Bay shoreline overview</p> <p>4- NEI driving anchor pilot holes between station 0-20 and 0+100</p> <p>5- areas being repaired between station 3+00 and 7+00</p> <p>*other photos of construction activities available but not attached to this document. Photos will be transmitted to Mary Green and she will make them available on the Port system.</p>	<p>None</p>
-----------------------------------------------------------------------------------------------------------------------------------------------------------------------------------------------------------------------------------------------------------------------------------------------------------------------------------------------------------------------------------------------------------------------------------------------------------	-------------

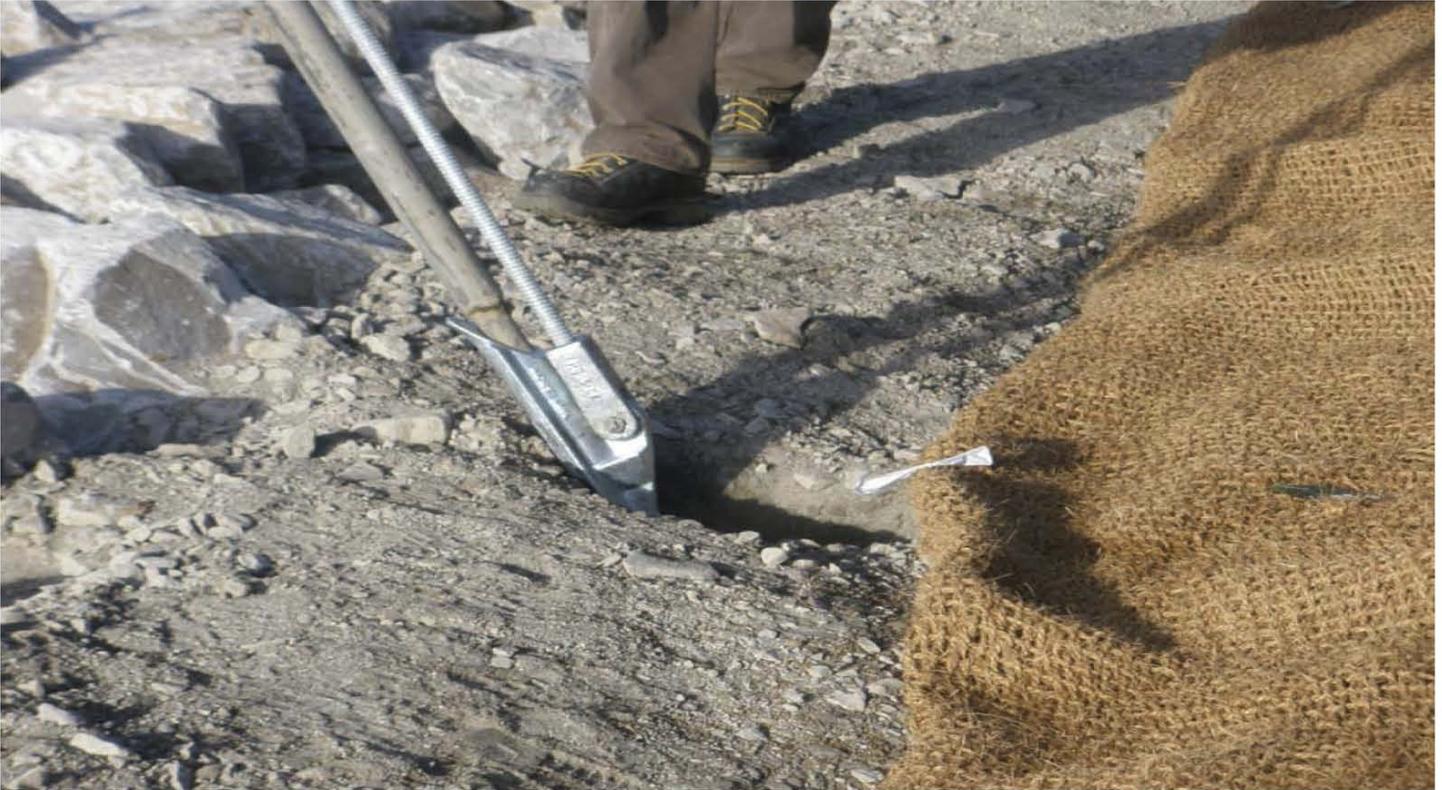
PHOTO 1

- 1- NEI driving anchors through select fill
- 2- NEI setting/pull testing anchor systems
- 3- NEI placing LWD
- 4- logs placed at top of constructed slope
