**Subject: Terminal 4 Removal Action – Wheeler Bay Bank Repairs
Construction Weekly Progress Report for October 25 through 29, 2010**

ATTACHMENT A
PORT OF PORTLAND DAILY CONSTRUCTION REPORTS

PROJECT	Terminal 4, Wheeler Bay Bank Repairs	CONTRACT NO.	10D015/820027
CONTRACTOR	Northwest Earthmovers	SUPERINTENDENT	Carl Johnson (NEI)
DAY OF WEEK & DATE:	Monday October 25, 2010	REPORT NO.	13
WEATHER	Partly Cloudy, NW wind 0-10 mph	TEMPERATURE	L:50 H:60 degrees F

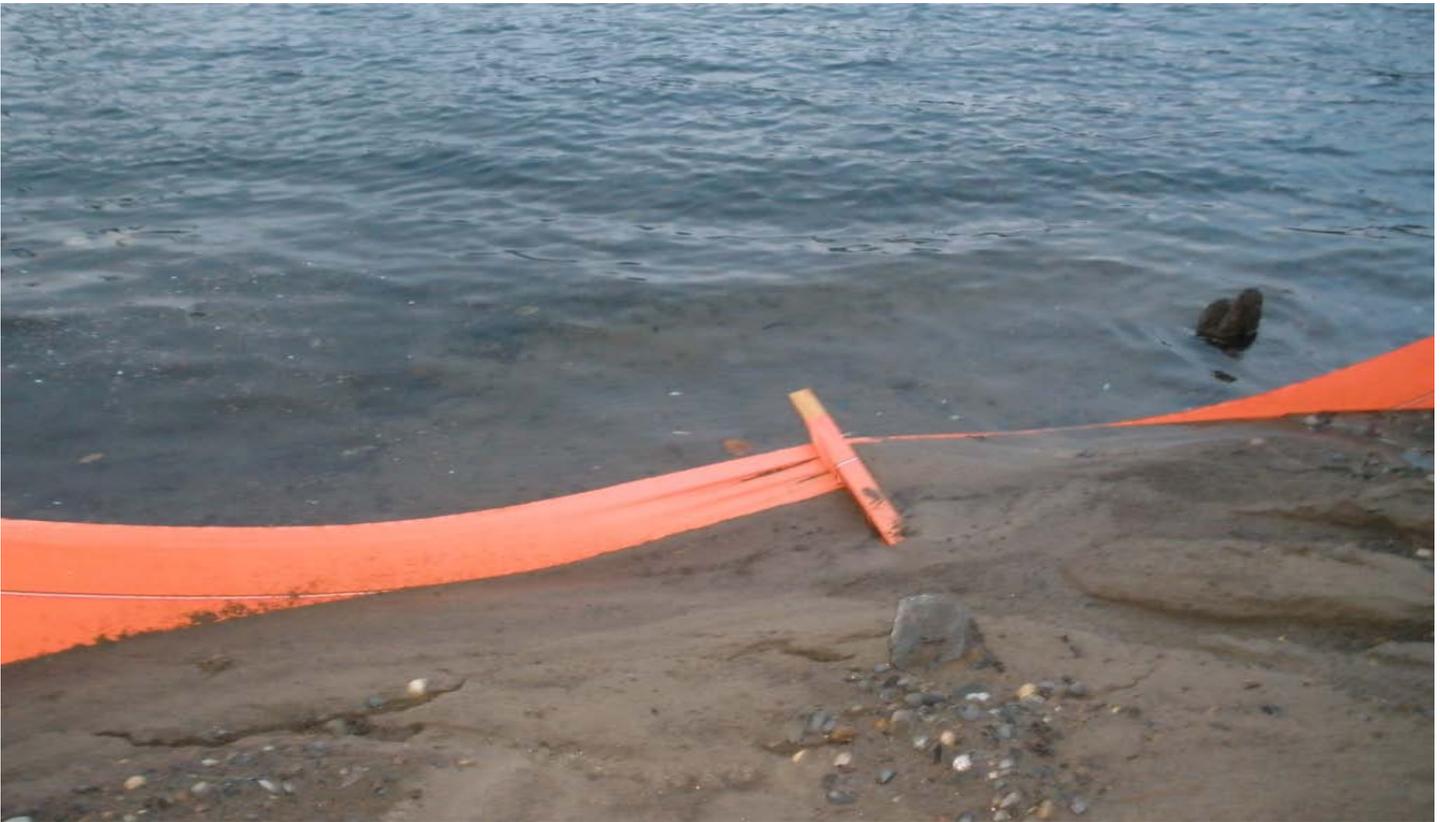
PHOTO 1

- 07:00 NEI (Carl/Mike+2 laborers), AQ/POP (1-Stone) on site
NEI performing equipment inspection and safety checks
- 07:00-
- 07:30 NEI performing repairs to silt fence at base of access ramp
Silt fence damaged during heavy weekend rains
No turbidity observed in river at breached location

<p>1- damage to silt fence near access ramp</p> <p>2- anchored LWD at top of constructed rip rap slope</p> <p>3- NEI subcontractor augering holes for native plantings</p> <p>4- completed native plantings</p> <p>*other photos of construction activities available but not attached to this document. Photos will be transmitted to Mary Green and she will make them available on the Port system.</p>	<p>None</p>
--	-------------

Silt Fence: got washed out just north of our ramp Mike M. reinstalled and added another fence in front of existing one FIXED SAME DAY ✓

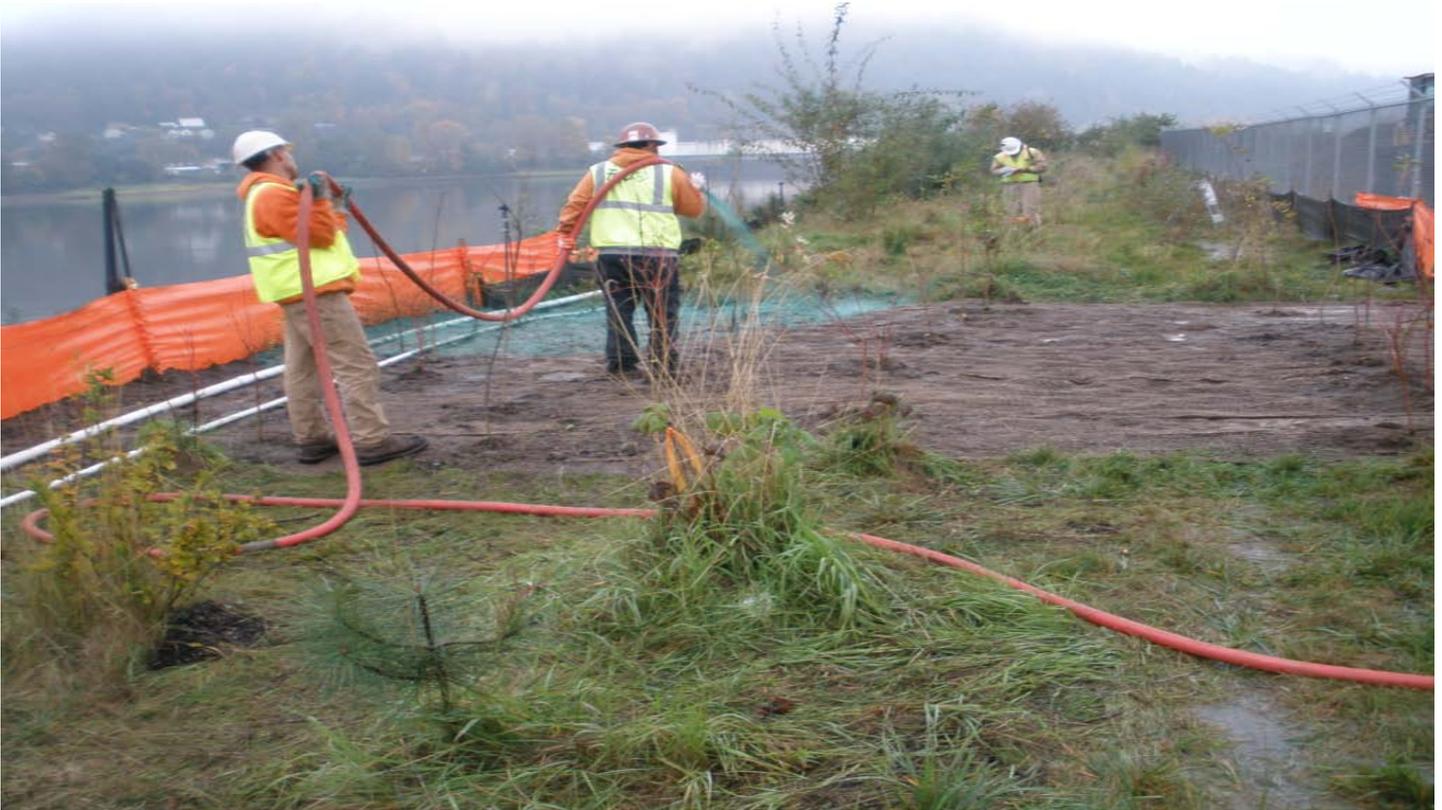
PHOTO 1

10:00 NEI subcontractor on site to perform hydro-seed application in access ramp repair area--above elevation 20 feet (PHOTO 1). NEI subcontractor applied 18 pounds of grass seed to an area of approximately 1800 square feet.

- 1- Hydro seed application in progress
 - 2- Final shoreline condition (from station 3+00 toward station 7+00)
 - 3- Final shoreline condition (from station 3+00 toward station 0+00)
 - 4- treated wood debris removed from shoreline—pressure treated certification stamp
- *other photos of construction activities available but not attached to this document. Photos will be transmitted to Mary Green and she will make them available on the Port system.

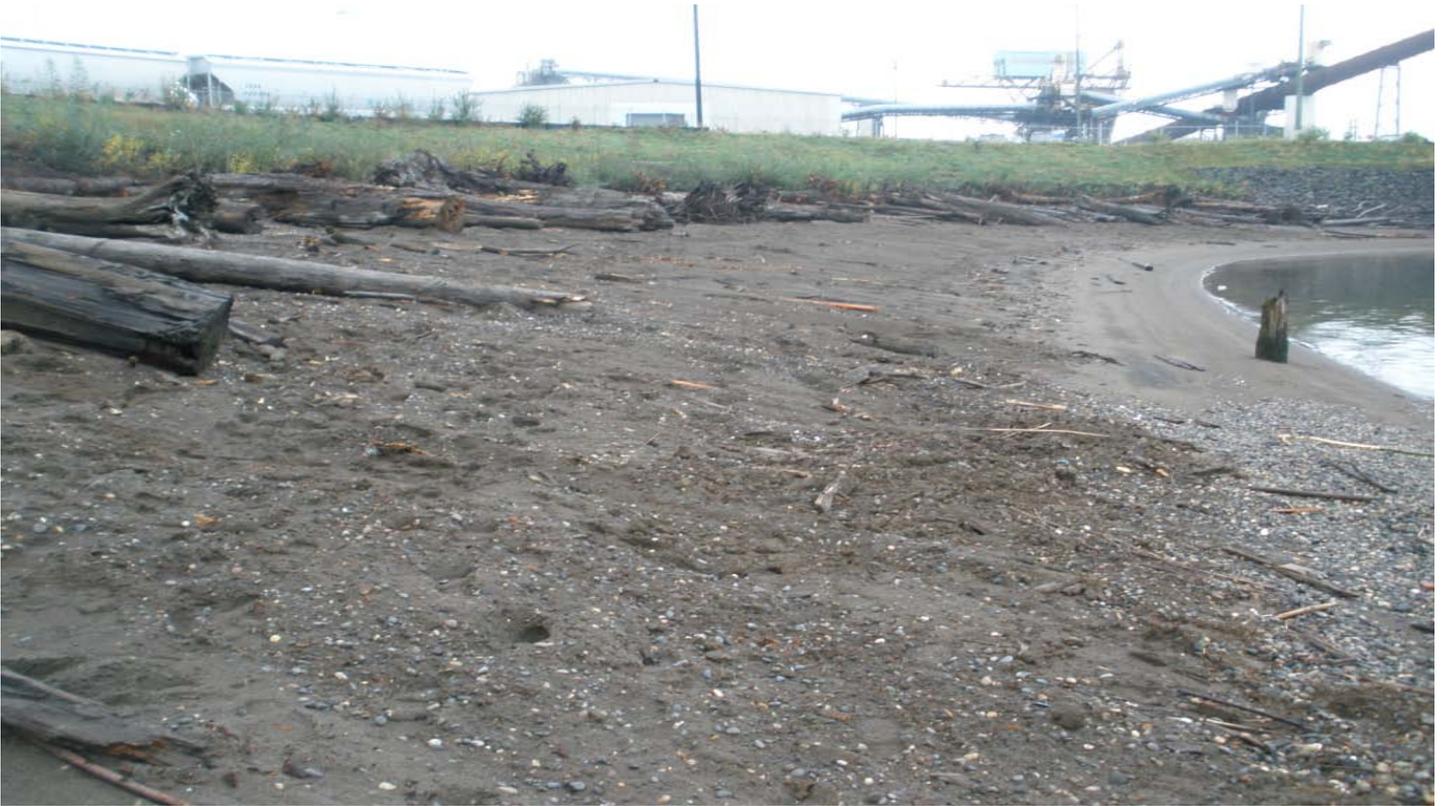
10:15 Kelly Madalinski, Roger Anderson, Lyle Larson (POP); Jeff Hargens, Philip Hansen (NEI); Tim Stone (AQ/POP) on site to perform final construction completion inspection. PHOTO 2 shows the completed conditions looking from station 3+00 toward station 7+00. PHOTO 3 shows the completed conditions looking from station 3+00 toward station 0-20.
NEI removes treated wood from shoreline as indicated by Ken Fellows (PMX) on 10/28. Wood debris was stamped as shown in PHOTO 4. Shoreline is free of incidental garbage and debris.
POP maintenance staff reconnects irrigation control wiring at the point it had been disconnected to construct the construction access ramp.

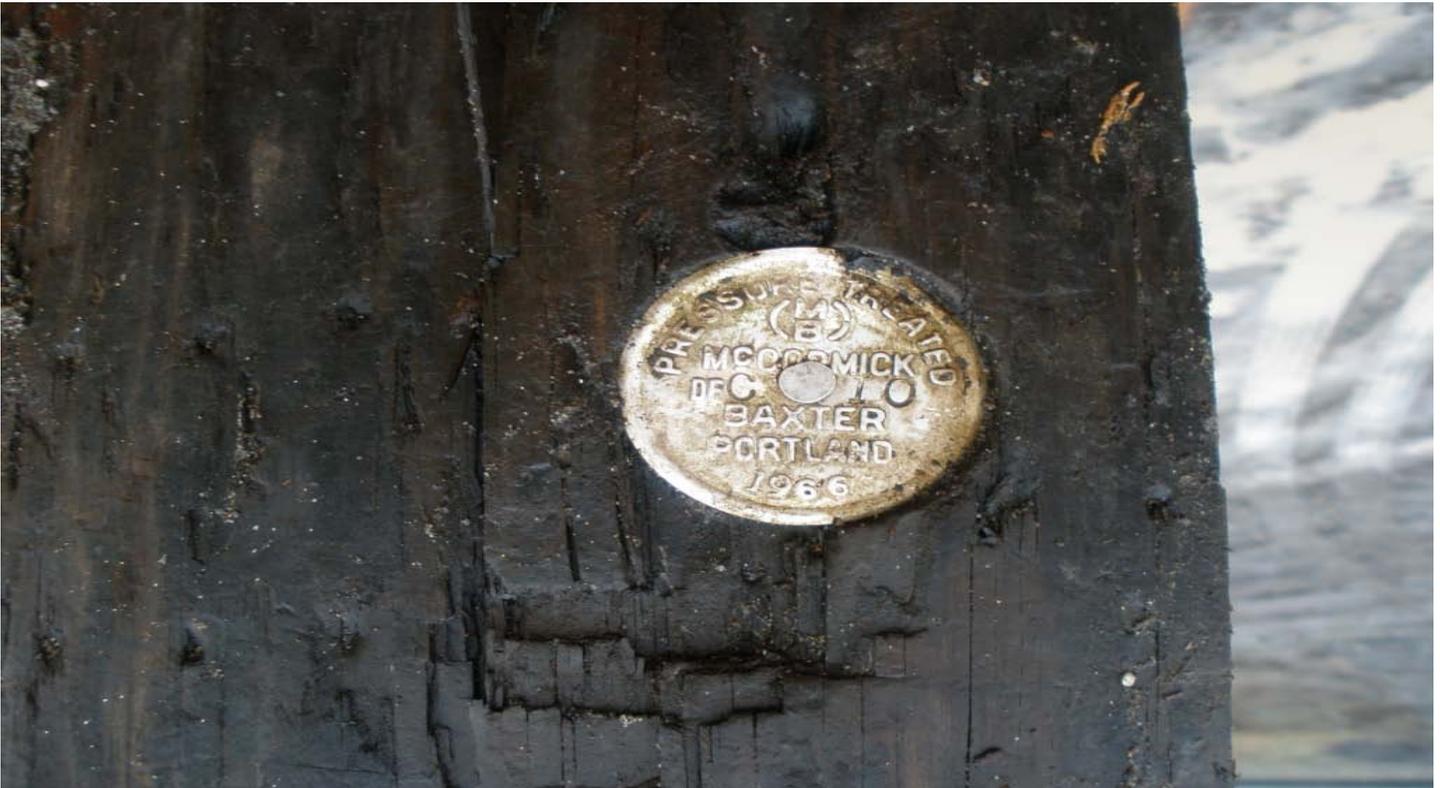
PHOTO 4

1. clean up debris/garbage from shoreline
 2. remove 1 length of pressure treated post (identified by stamp on post—McCormick and Baxter)
- 10:30 Ken Fellows(PMX) and Kelly Madalinski(POP) off site
