FINAL
YEAR 4 INTERIM MONITORING REPORT—
TERMINAL 4 PHASE I REMOVAL ACTION
PORT OF PORTLAND, PORTLAND, OREGON

Port of Portland
Portland, Oregon

Anchor QEA, LLC
421 SW Sixth Avenue, Suite 750
Portland, Oregon 97204

March 2013

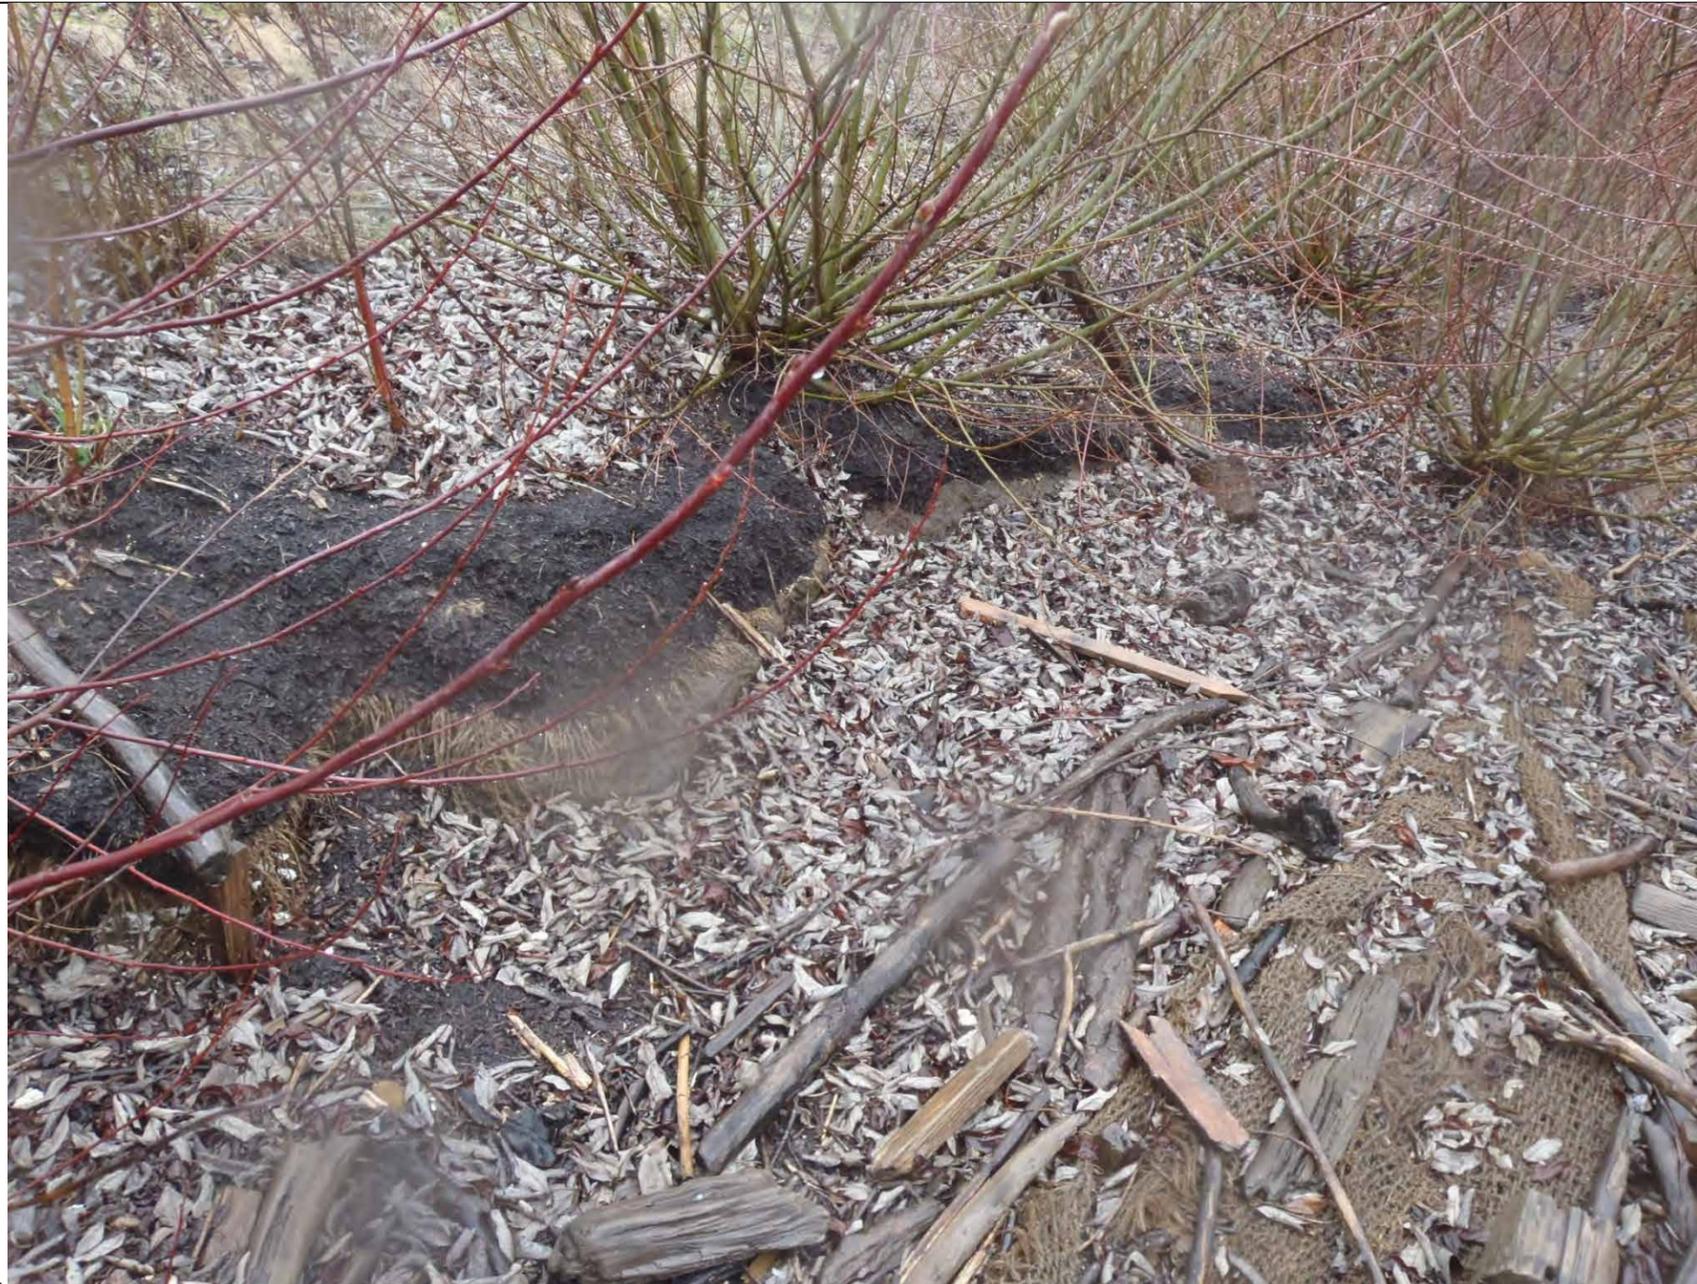
- A 1-foot scarp was observed in the willow planting area between Stations 00+00 and 01+75 during the first quarter monitoring event of the repaired area. This erosional area was unchanged from the scarp documented in the Repair Memo.
- Additionally, a 1-foot scarp was observed in the willow planting area between Stations 03+40 and 06+70 during the second, third, and fourth quarter monitoring events. This erosional area was unchanged from the scarp documented in the Repair Memo.
- Finally, the 0.5-foot scarp between Stations 2+00 and 2+25 documented in the Repair Memo was not observed during Year 4 monitoring activities.

1 foot Scarp in Willow Planting Area between Sta. 00+00 and 01+60

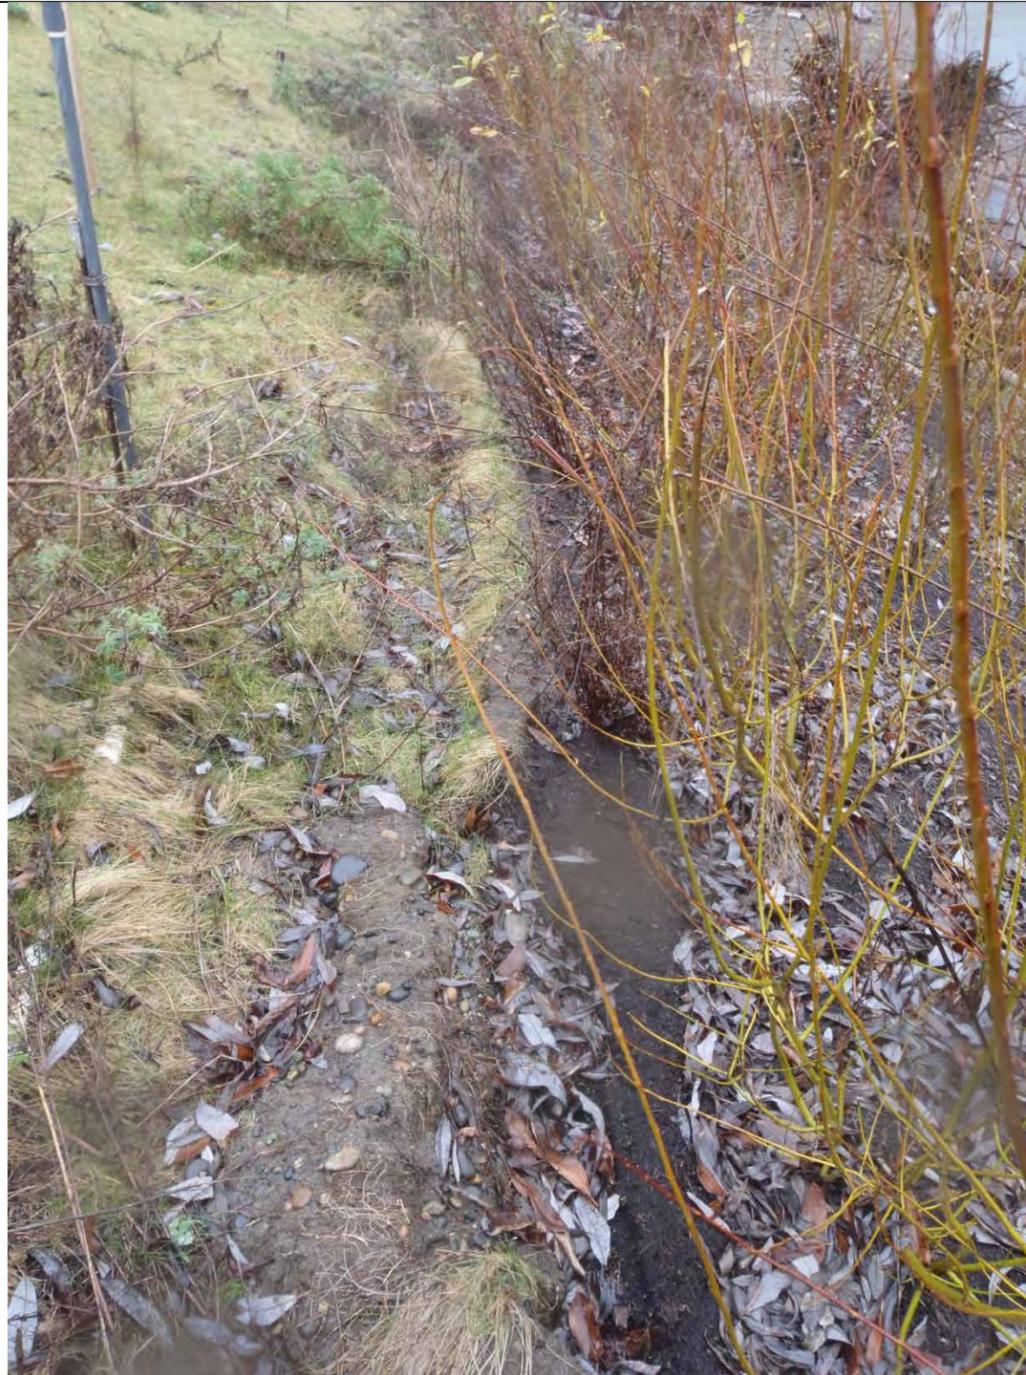
After heavy rain, the surficial layer of grass in the grass planting area between Stations 01+70 and 02+90 was observed to have sloughed downslope approximately 4 inches at the time of the first quarter monitoring event. This area encompasses the former material transfer zone

between Stations 02+35 and 02+70 used to transfer materials downslope as part of the 2011 repair. No additional sloughing was observed during any subsequent monitoring events. The sloughing did not appear to impact slope stability.

Bottom of grass planting area
Minor 4 inch sloughing of grass area between Sta. 01+70 and 02+90

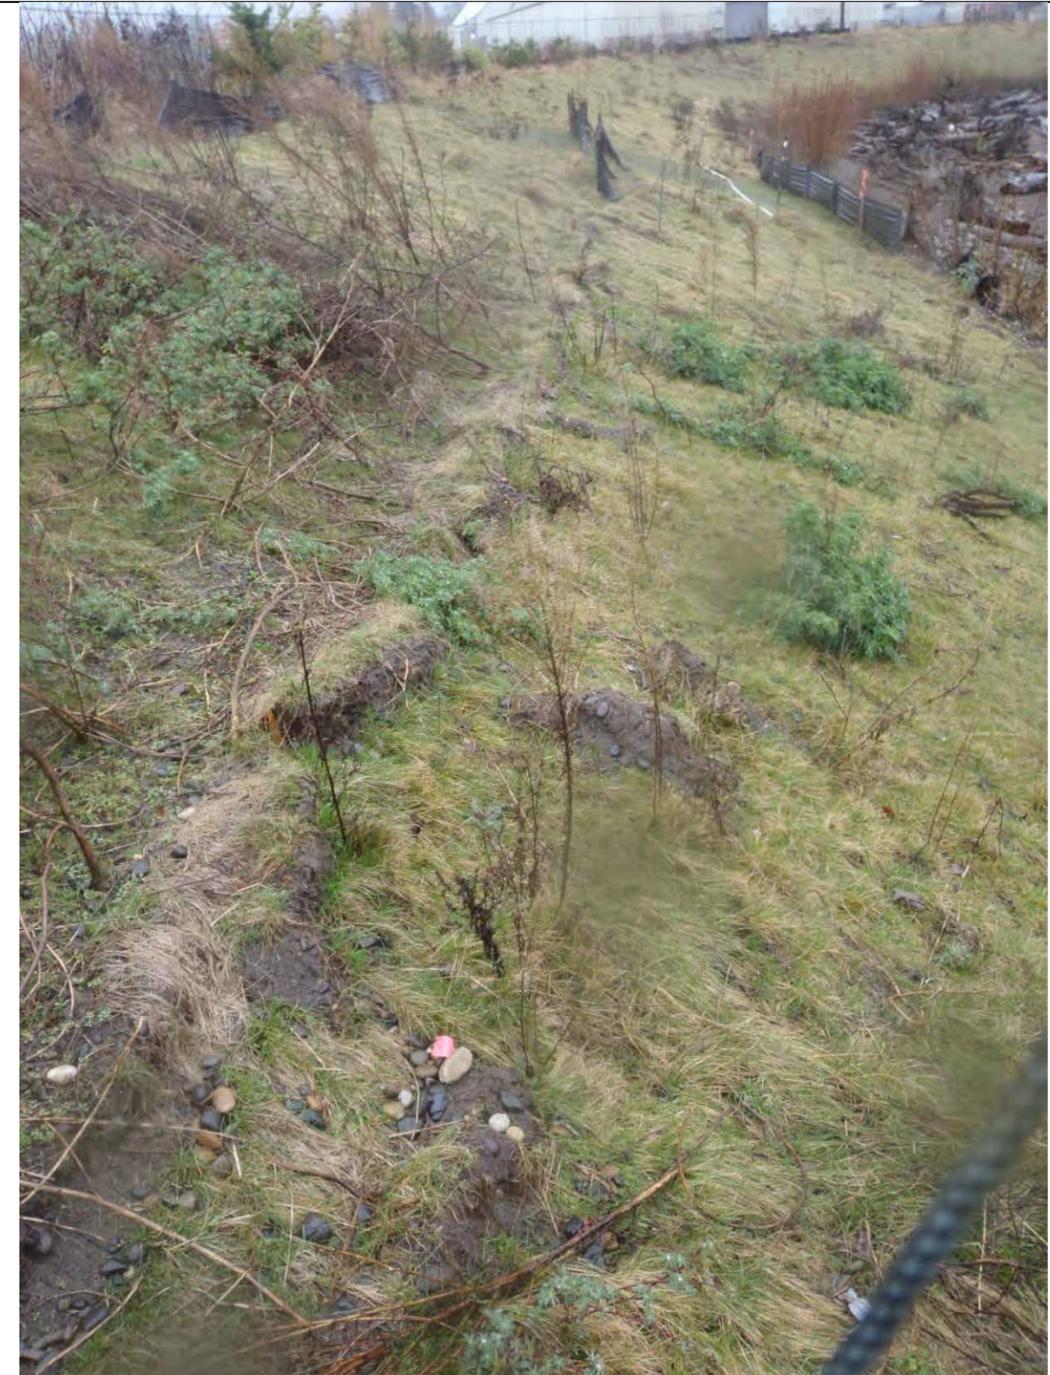
Top of grass planting area
Minor 4 inch sloughing of grass area between Sta. 01+70 and 02+90

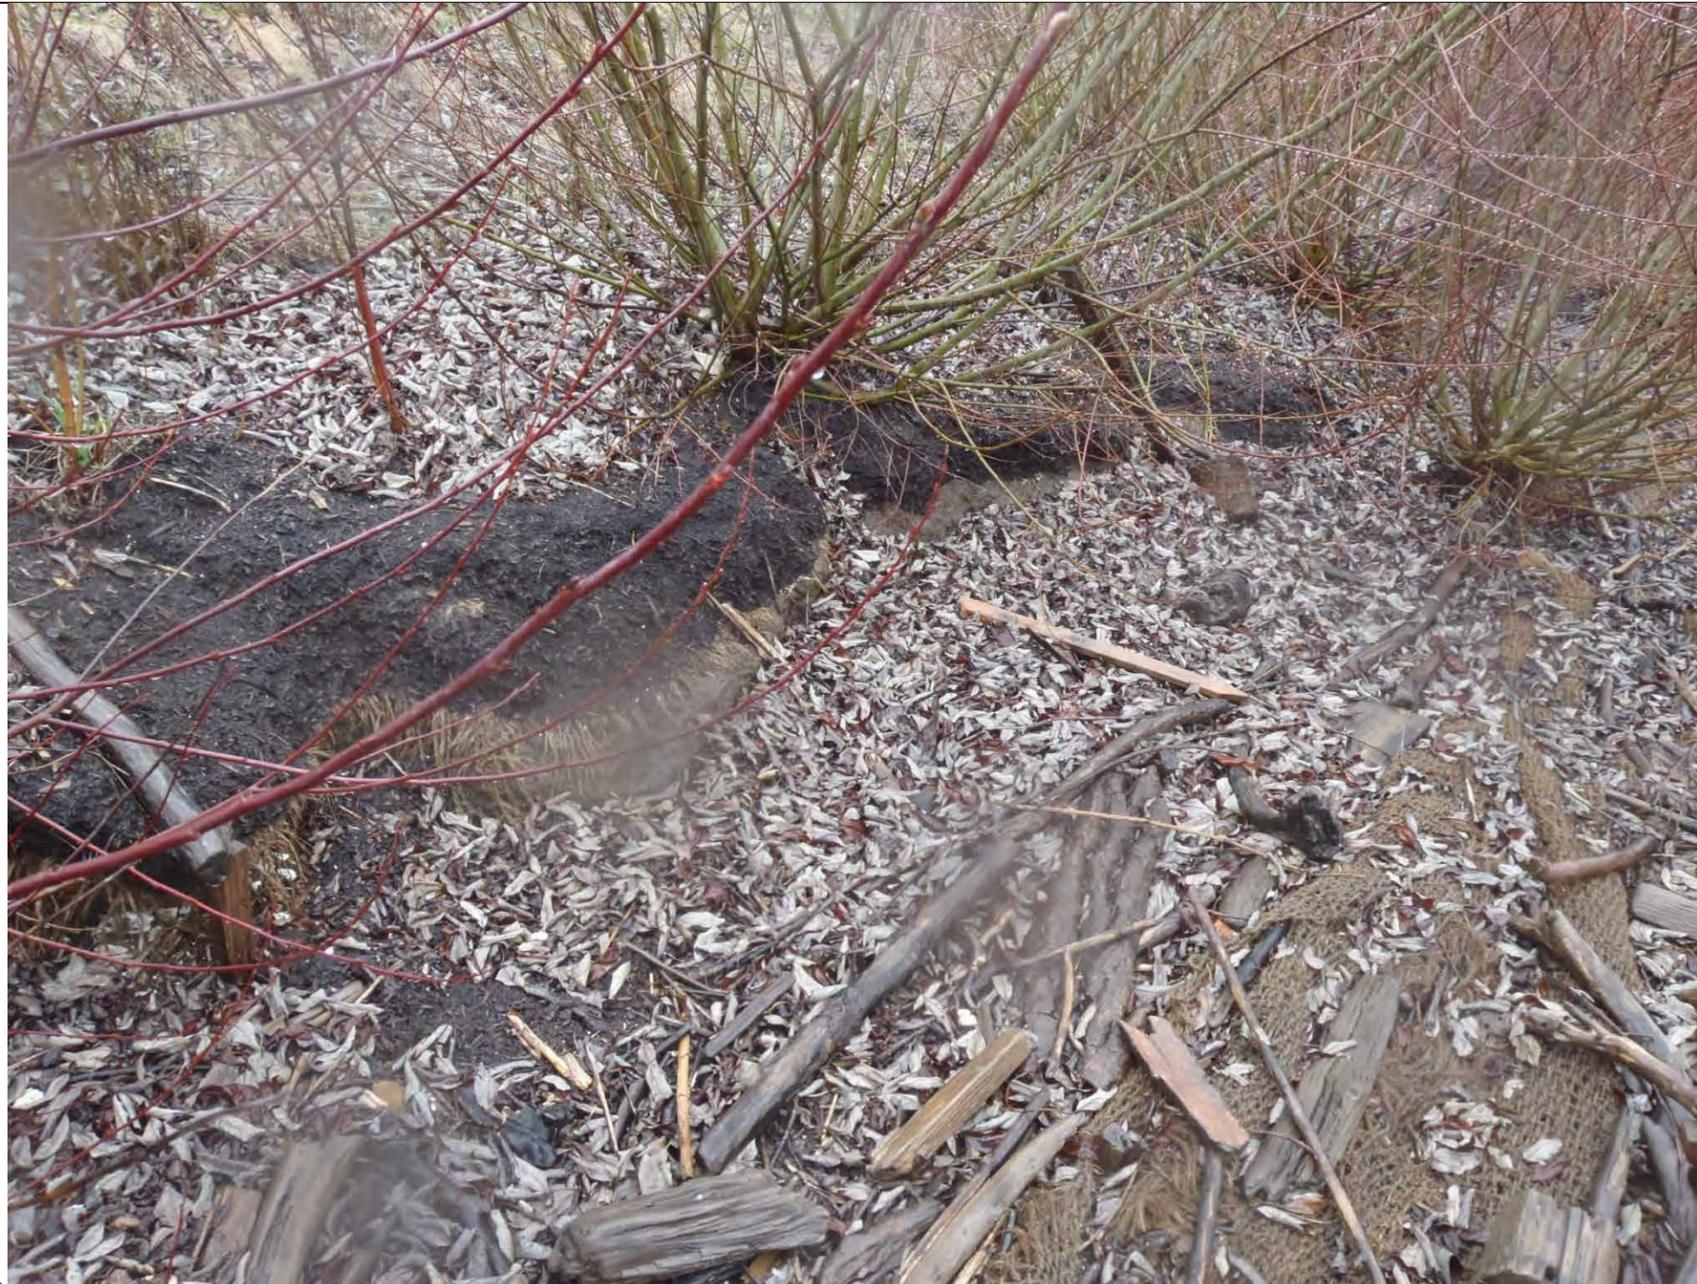
- A 1-foot scarp was observed in the willow planting area between Stations 00+00 and 01+75 during the first quarter monitoring event of the repaired area. This scarp was unchanged from the scarp documented in the Repair Memo.
- Additionally, a 1-foot scarp was observed in the willow planting area between Stations 03+40 and 06+70 during the second, third, and fourth quarter monitoring events. This scarp was unchanged from the scarp documented in the Repair Memo.
- Finally, the 0.5-foot scarp between Stations 2+00 and 2+25 documented in the Repair Memo was not observed during Year 4 monitoring activities.

1 foot Scarp in Willow Planting Area between Sta. 00+00 and 01+60. (Photo: 1st Quarter Monitoring Event)

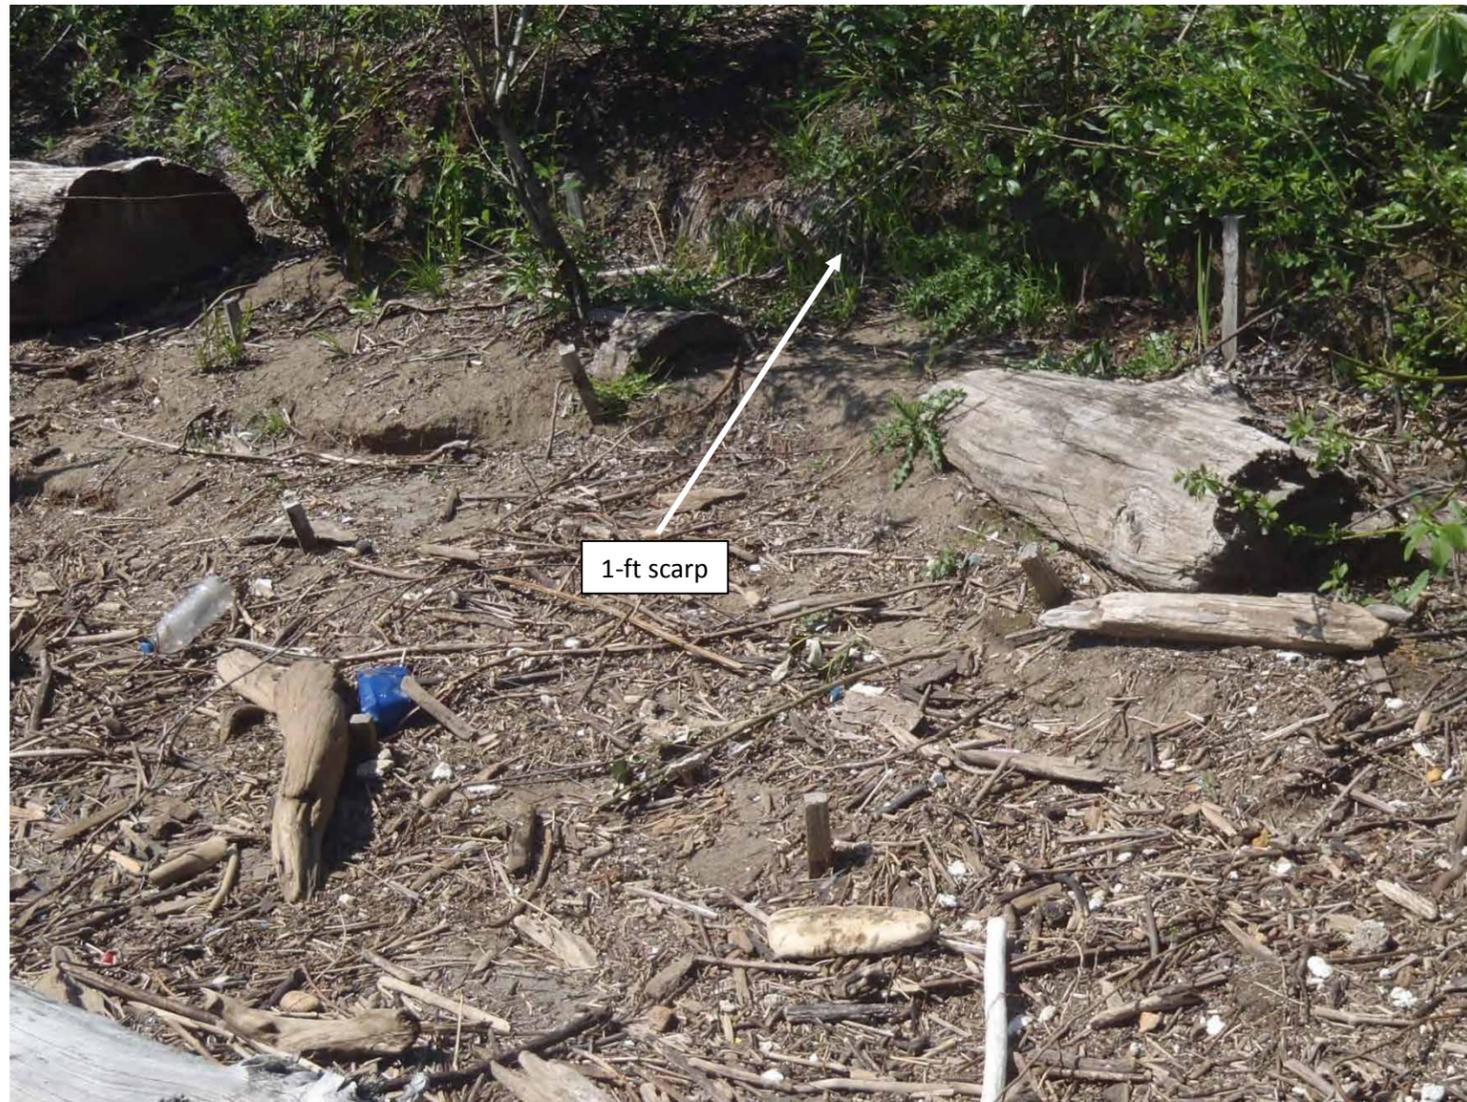
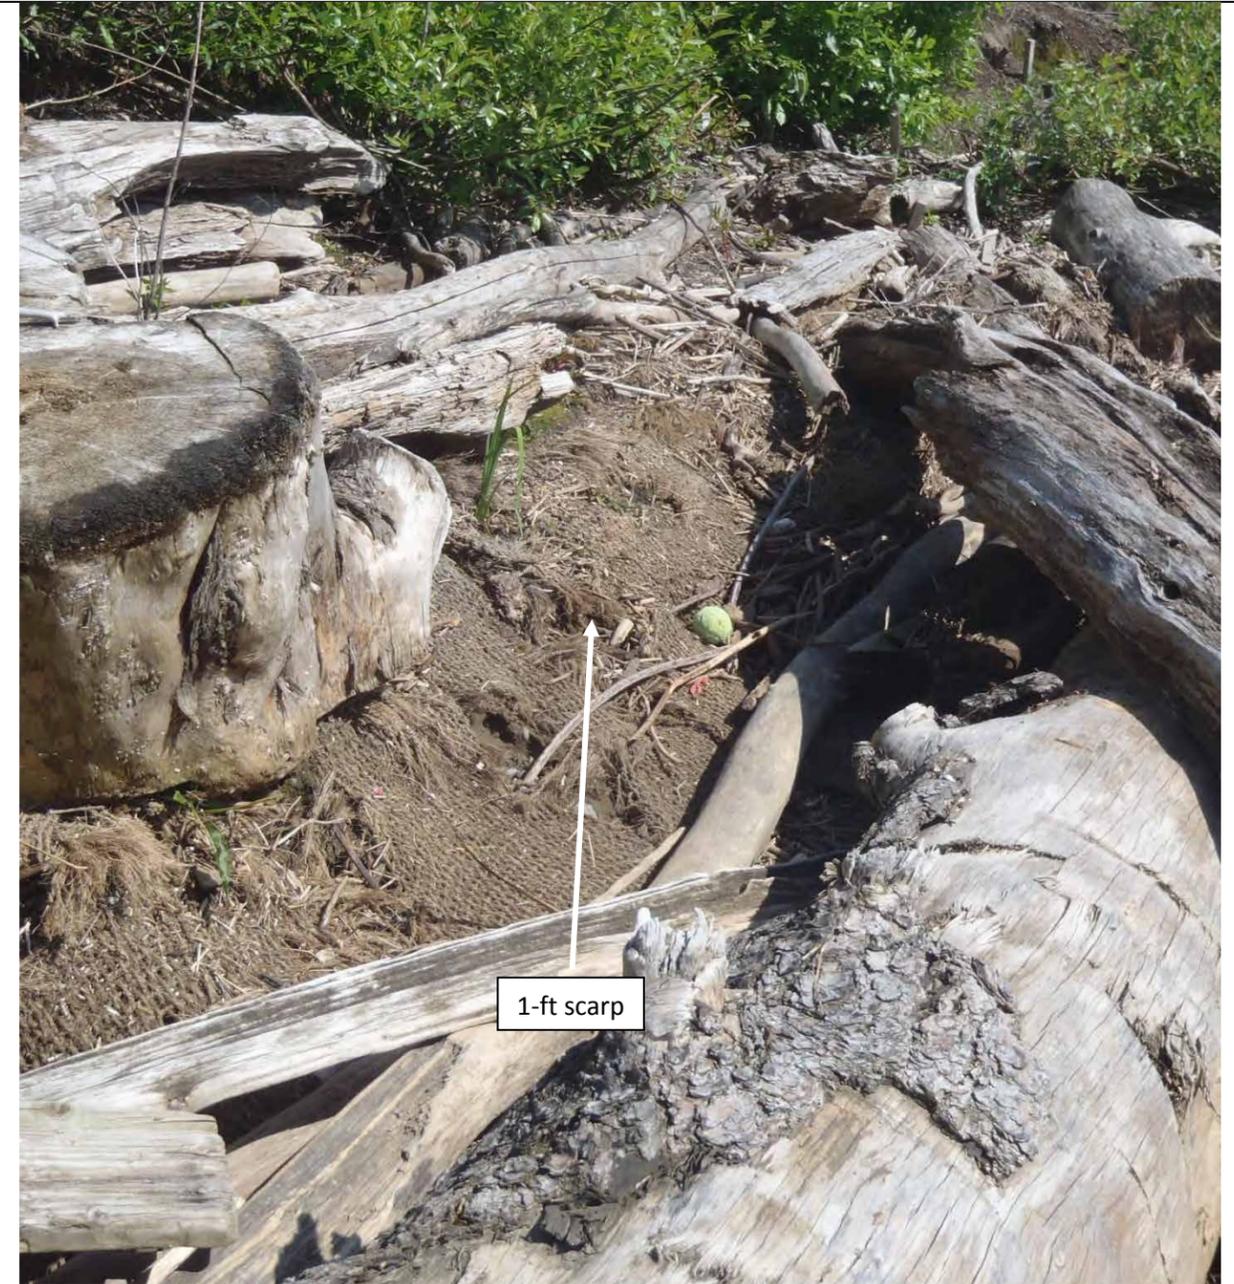
1 foot Scarp in Willow Planting Area between Sta. 3+40 and 6+70. (Photo: 2nd Quarter Monitoring Event)

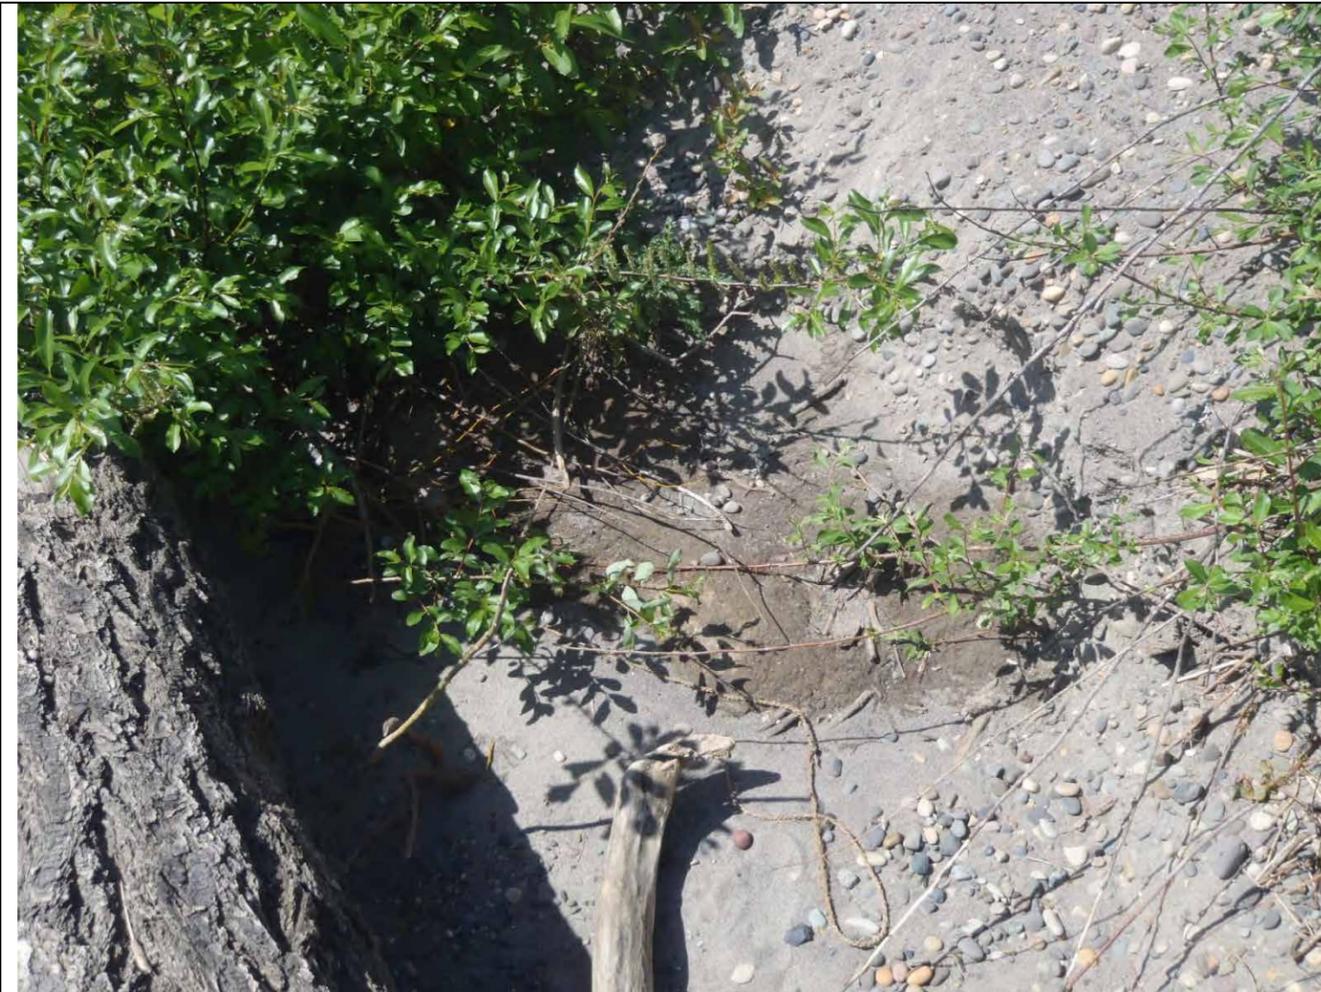
Surplus, on-site habitat material was placed above the woody debris between stations 03+40 and 03+90 during the 2011 repair. A 1-foot scarp in the surplus habitat material was observed at Stations 03+50 and 03+90 during the second quarter monitoring event. Photographs of the scarps are provided in Attachment A-3 to Appendix A.

1-foot Scarp in the Habitat Material Placed Above the Woody Debris as Part of the 2011 Repair. (Photo: 2nd Quarter Monitoring Event @ Sta. 3+50)

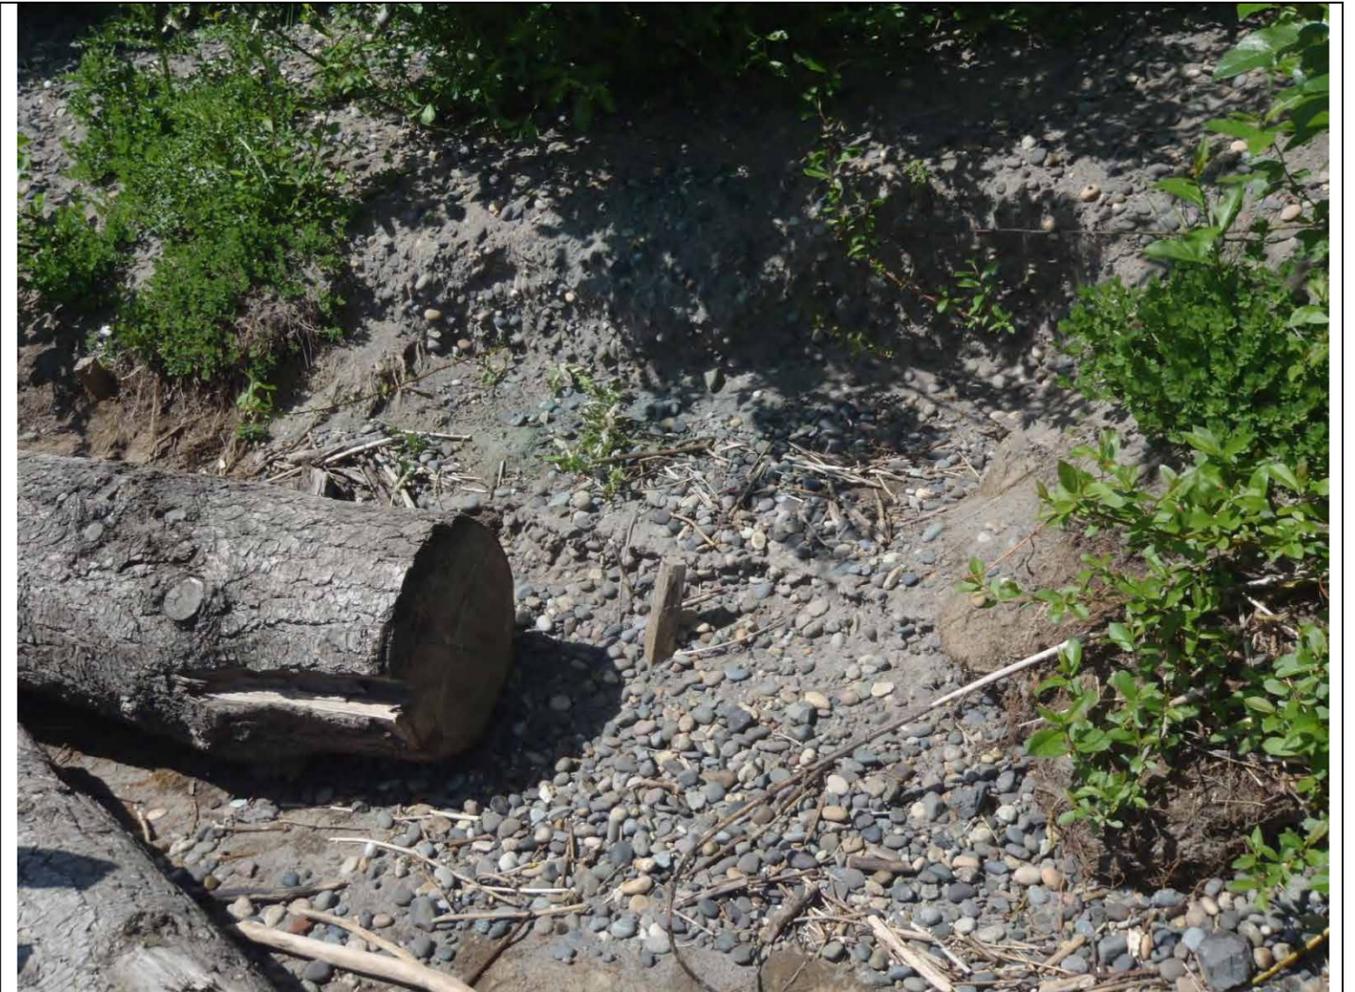
1-foot Scarp in the Habitat Material Placed Above the Woody Debris as Part of the 2011 Repair. (Photo: 2nd Quarter Monitoring Event @ Sta. 3+90)

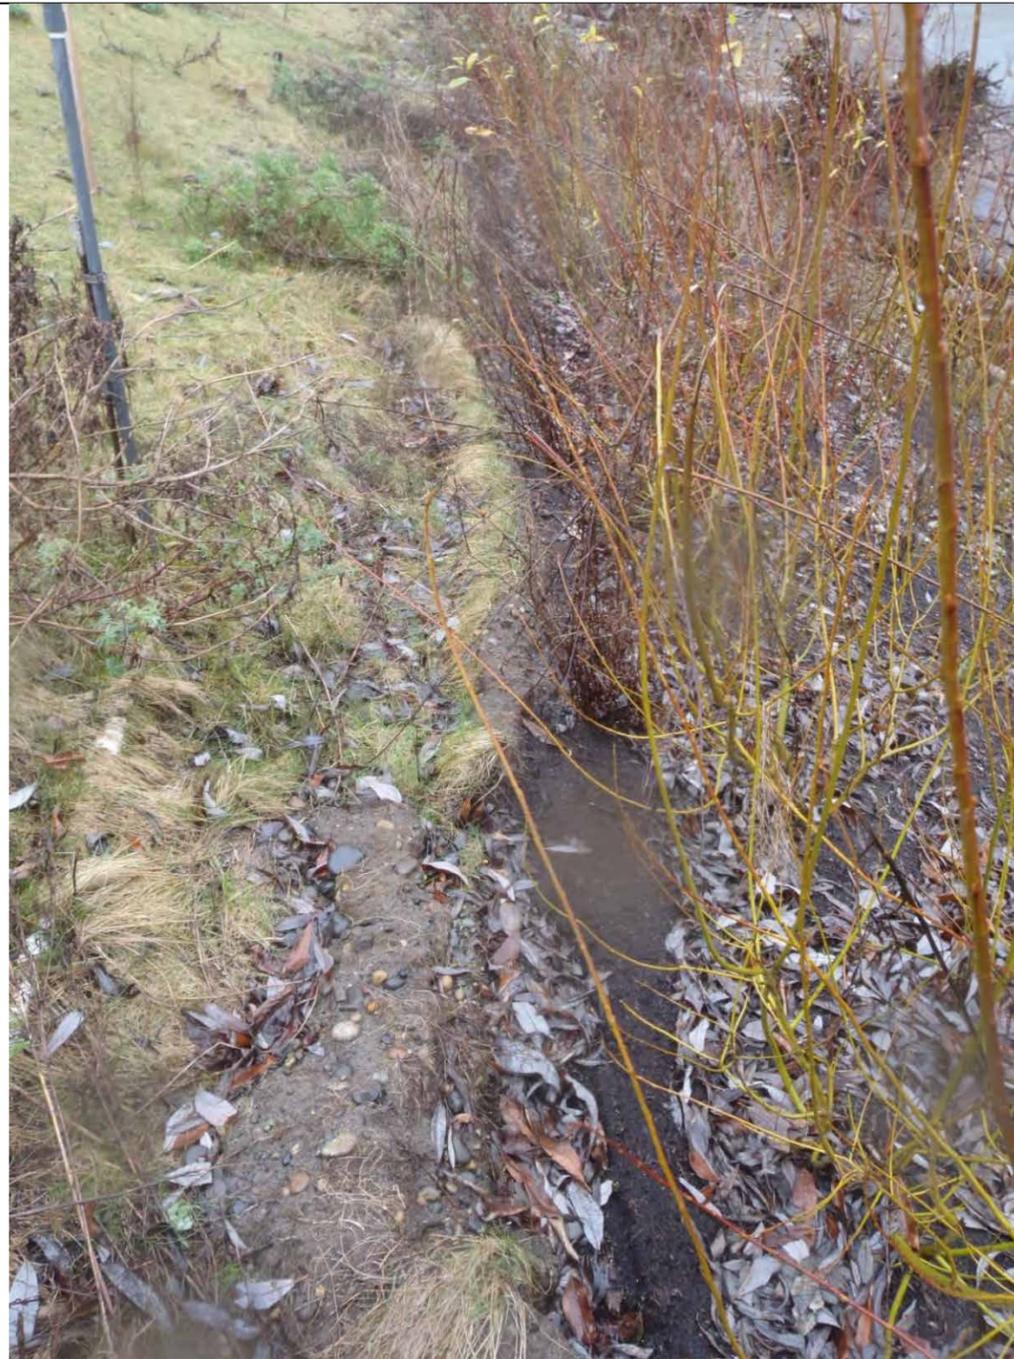
After heavy rain, the surficial layer of grass in the grass planting area between Stations 01+70 and 02+90 was observed to have sloughed downslope approximately 4 inches during the first quarter monitoring event (Attachment 3). This area encompasses the former material transfer zone between Stations 02+35 and 02+70 used to transfer materials downslope as part of the 2011 repair. No additional sloughing was observed during any subsequent monitoring events. The sloughing did not appear to impact slope stability.

Bottom of Grass Planting Area
4 inch Sloughing of Surficial Layer Between Sta. 01+70 and 02+90
(Photo: 1st Quarter Monitoring Event)

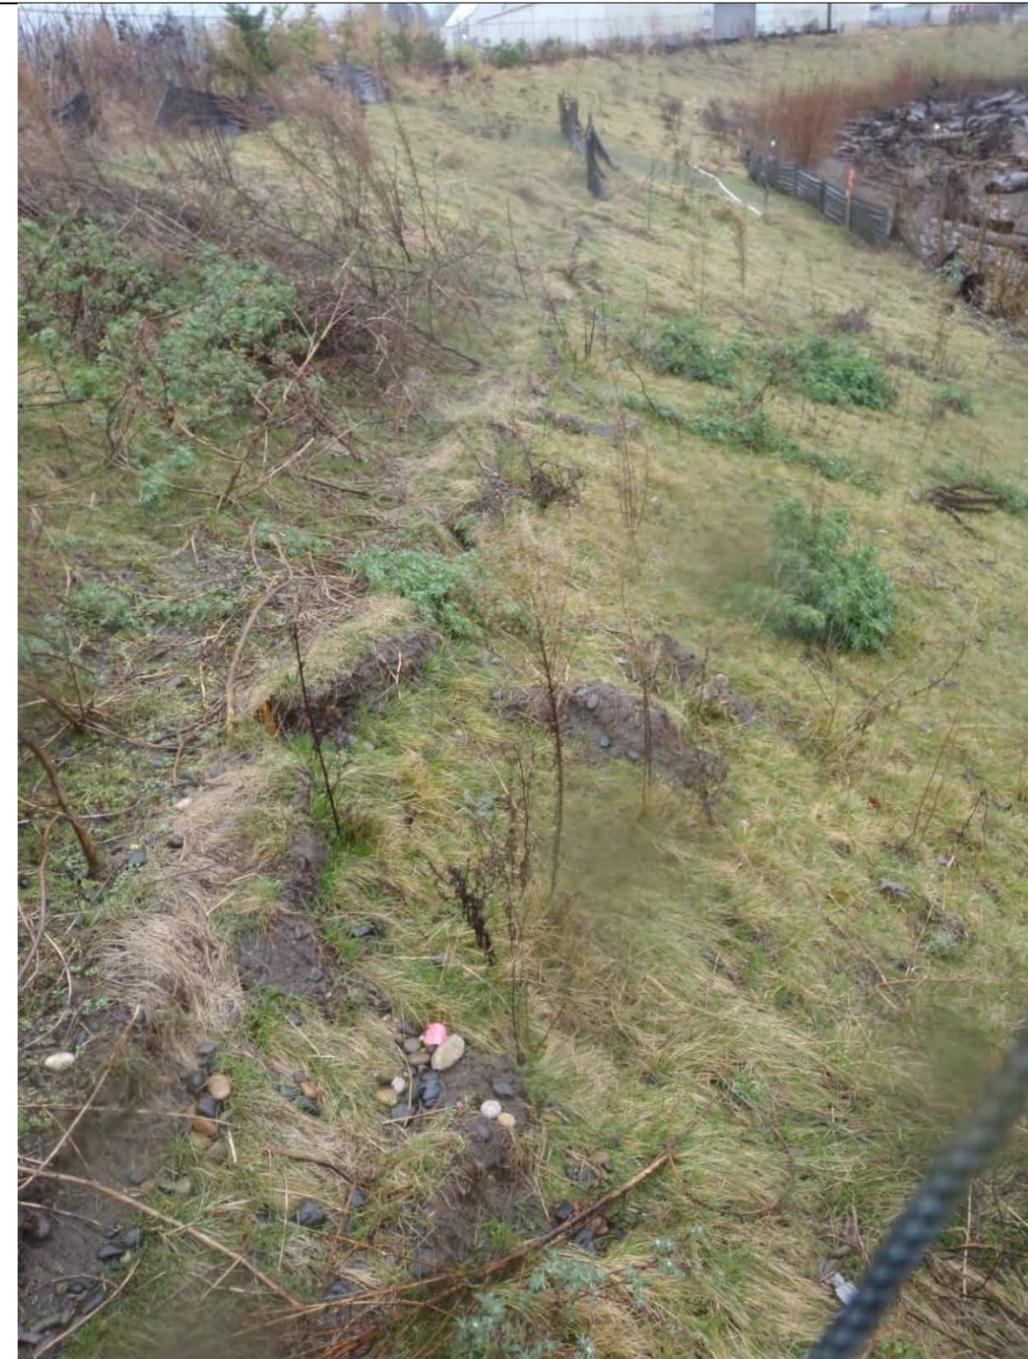
Bottom of Grass Planting Area
4 inch Sloughing of Surficial Layer Between Sta. 01+70 and 02+90
(Photo: 1st Quarter Monitoring Event)

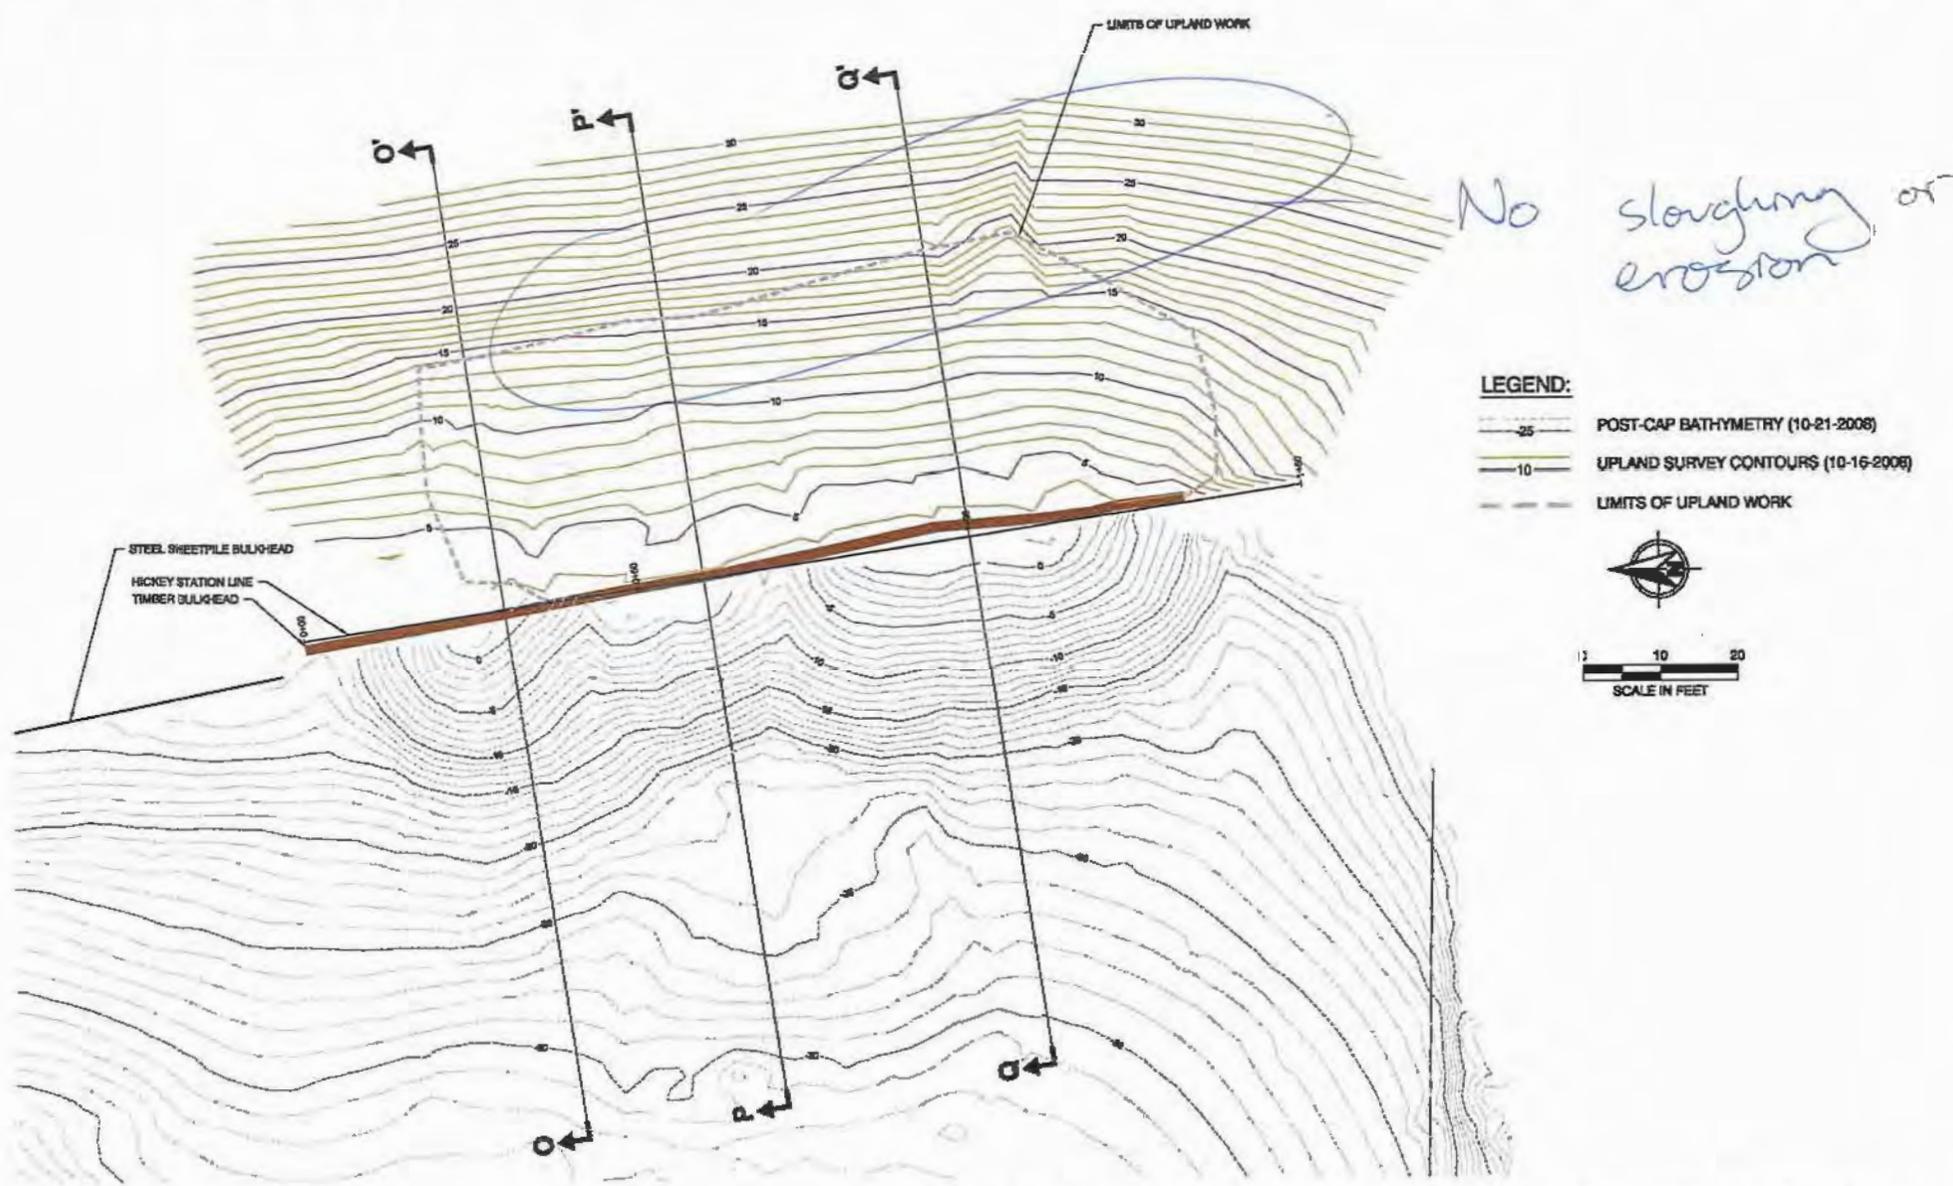
Head of Slip 3 Cap Transects Observation

No sloughing or erosion

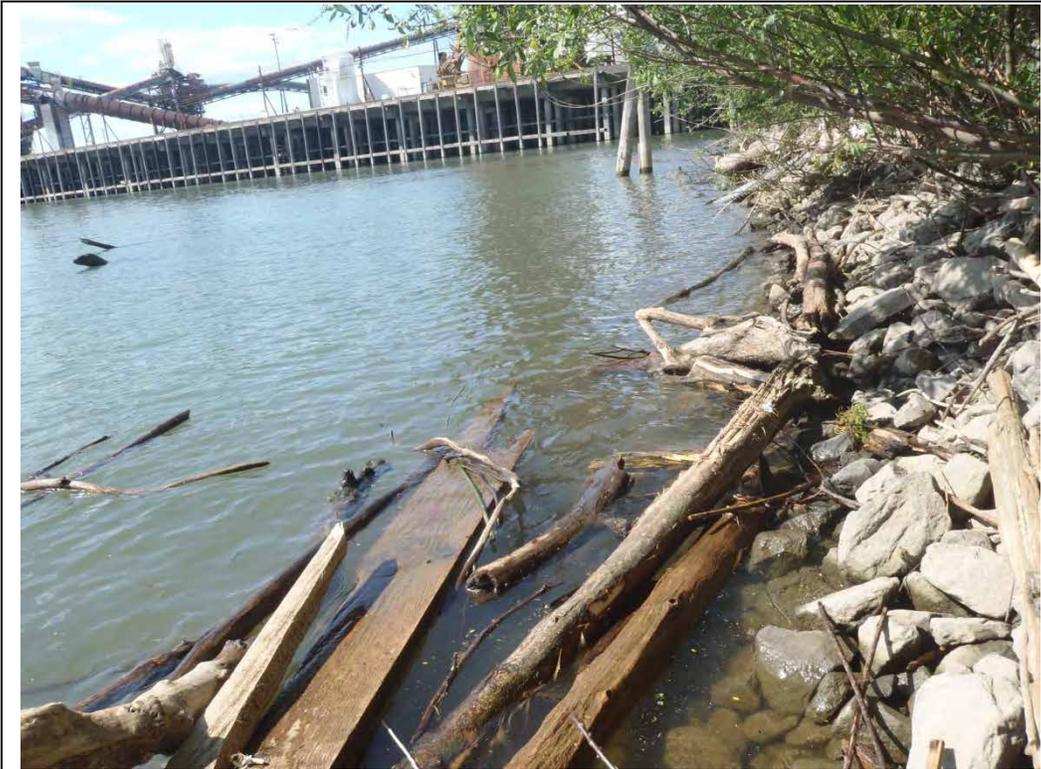
High water observation 5/10/2012: No sheen

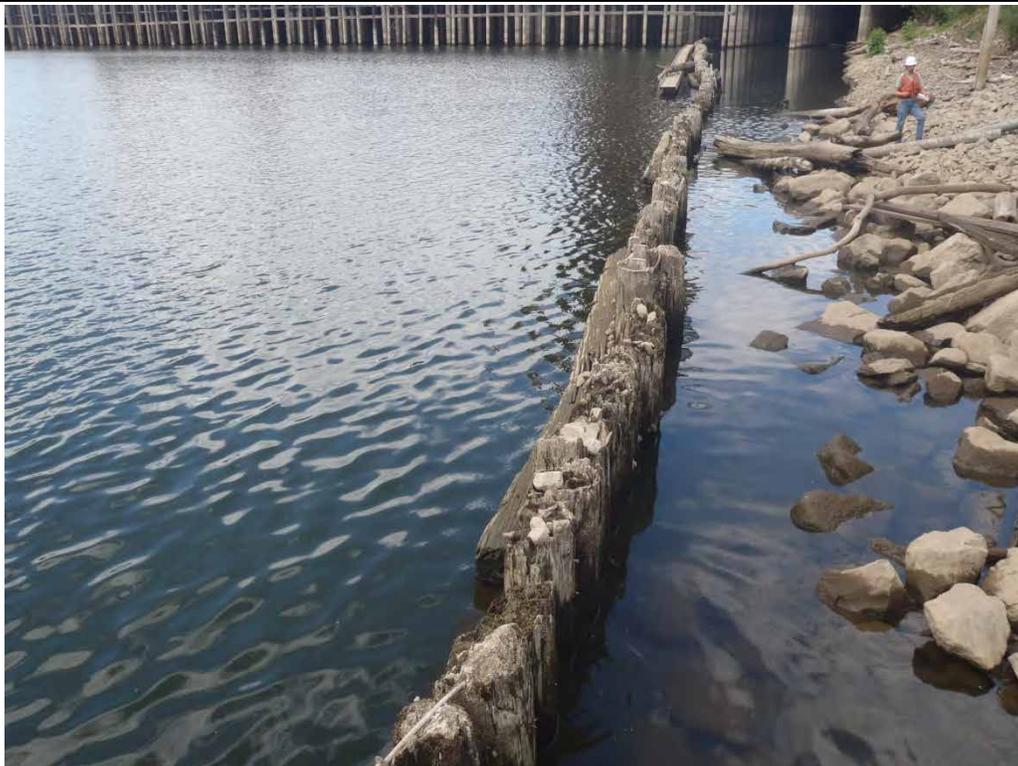
Low water observation 08/23/2012: No sheen
