FINAL  
YEAR 2 INTERIM MONITORING REPORT –  
TERMINAL 4 PHASE I REMOVAL ACTION  
PORT OF PORTLAND, PORTLAND, OREGON

Port of Portland  
Portland, Oregon

Anchor QEA, LLC  
6650 SW Redwood Lane, Suite 333  
Portland, Oregon 97224

**February 2011**

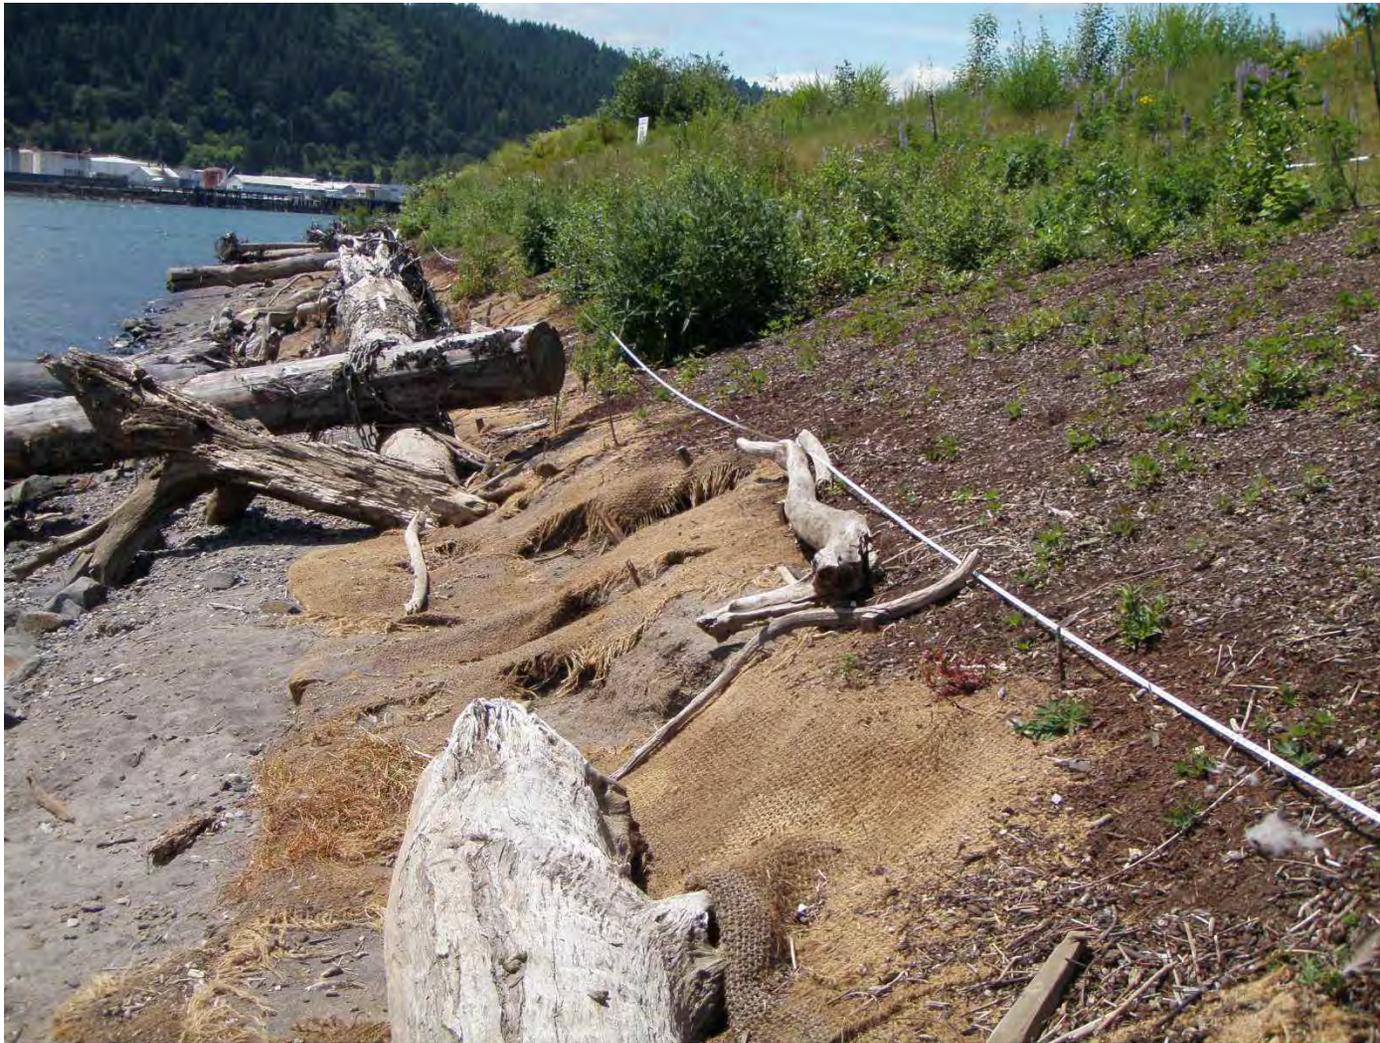
During a site visit conducted on June 21, 2010, a significant erosion scarp was observed at the base of the willow planting area within the first 225 feet from the mouth of the bay. The scarp ranged from 0 to 2 feet in height, and in places extended midway up the willow planting area (Figure 2). A general description of the construction elements of the WB repair are provided in Section 4. Construction of the WB repair work was completed on October 29, 2010.

Willow Scarp Example

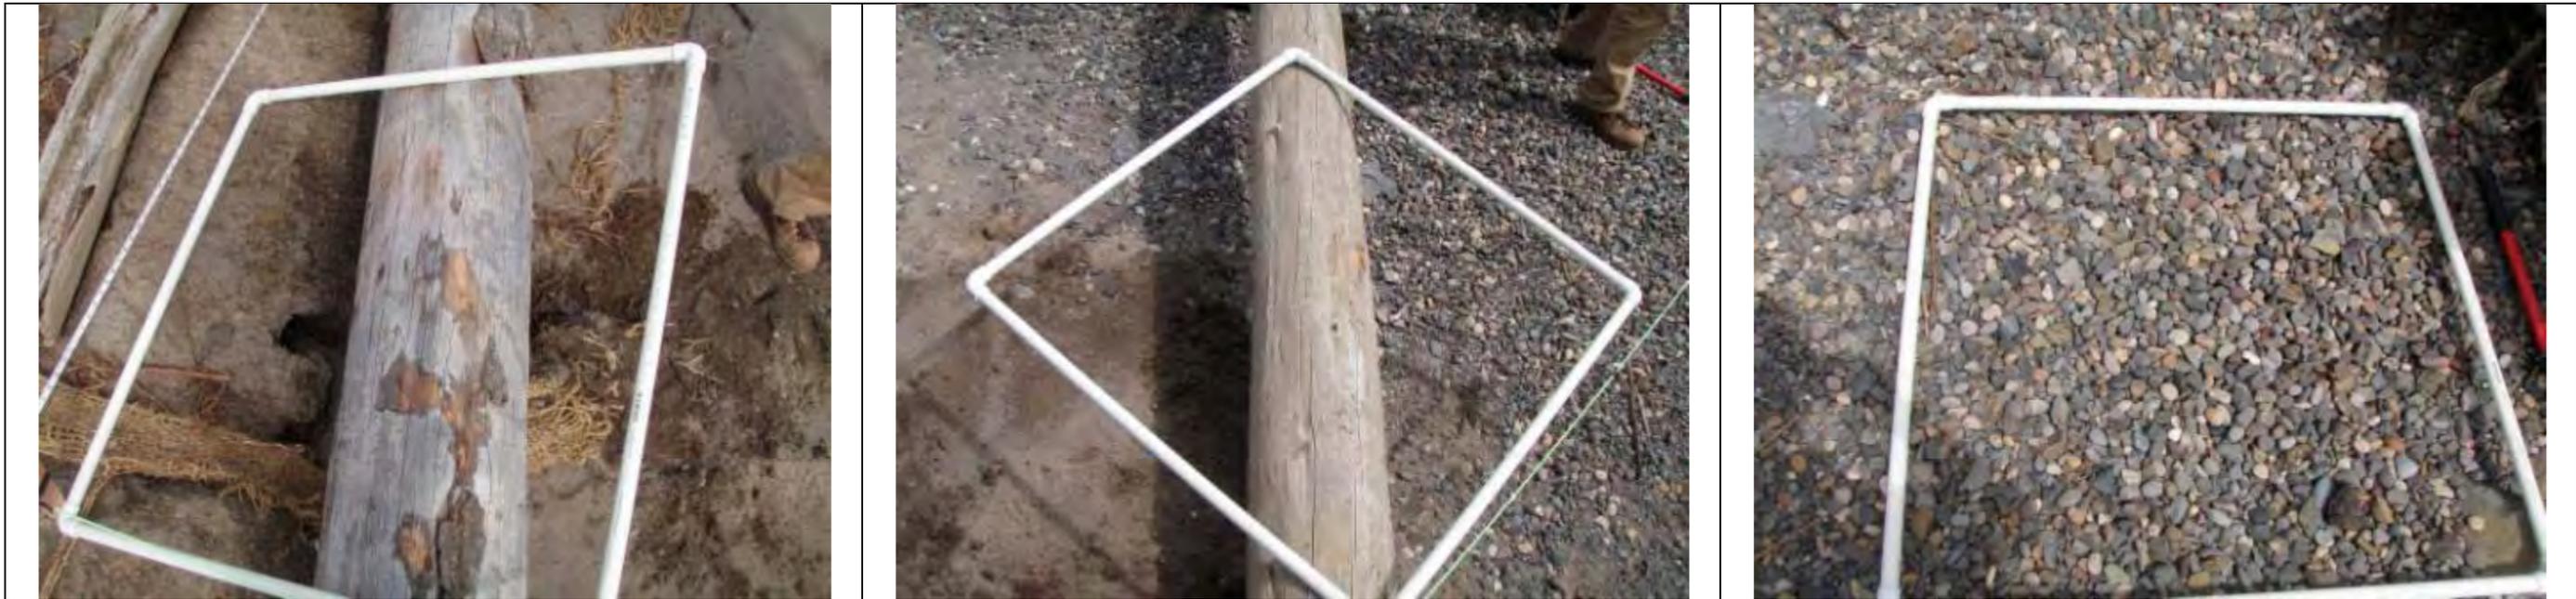
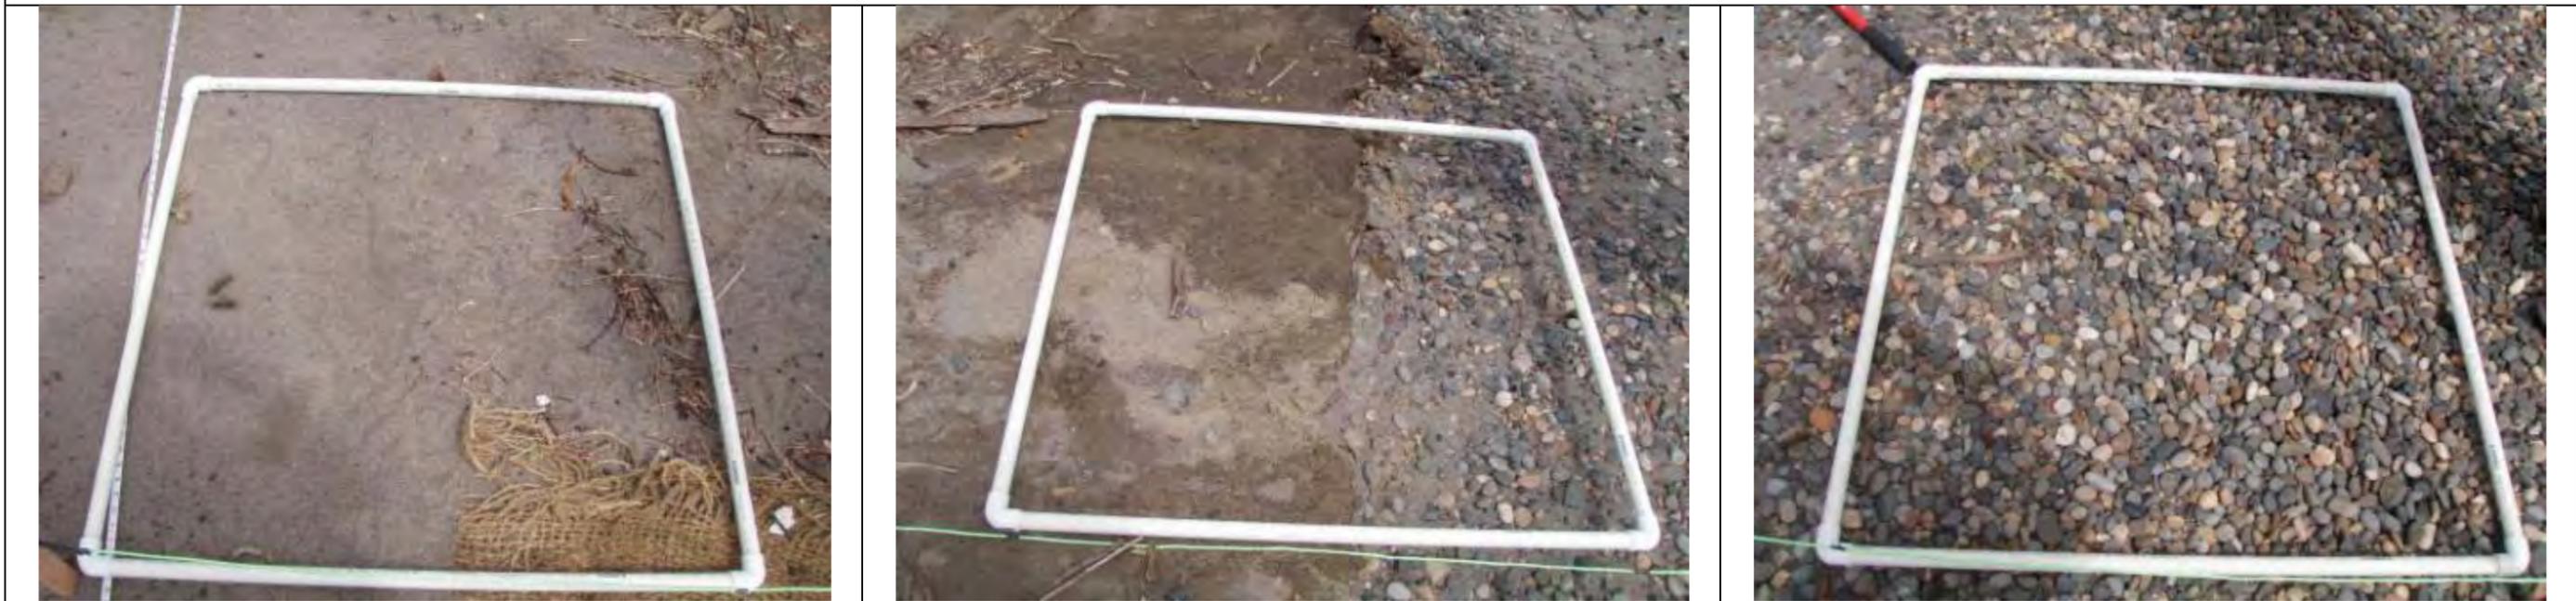
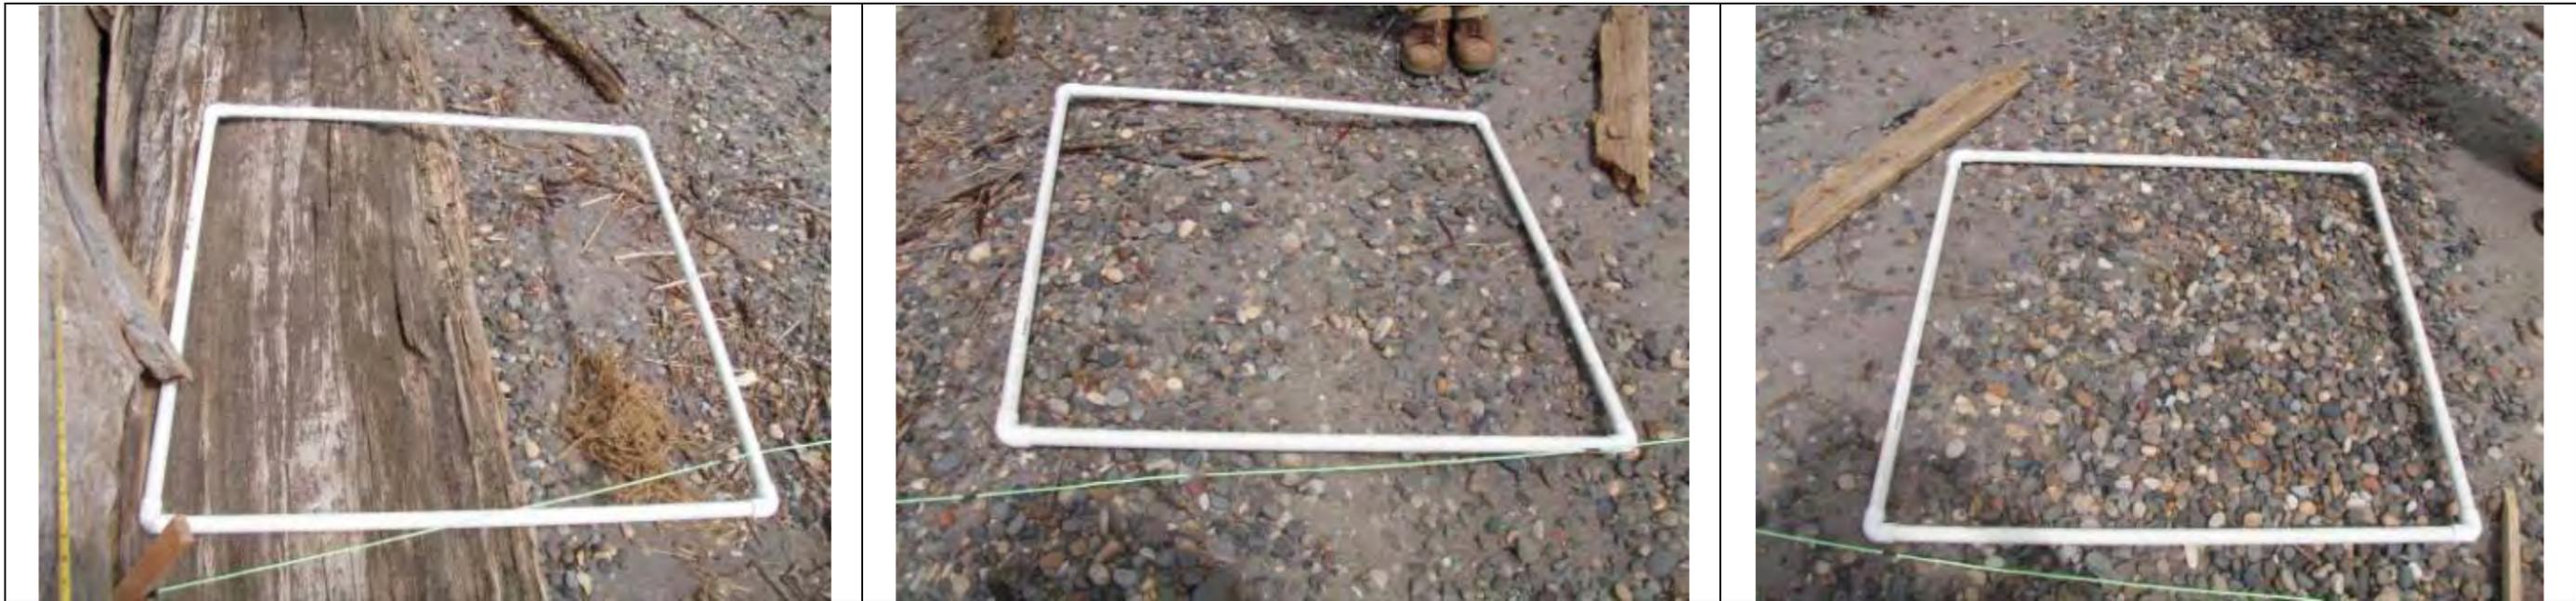
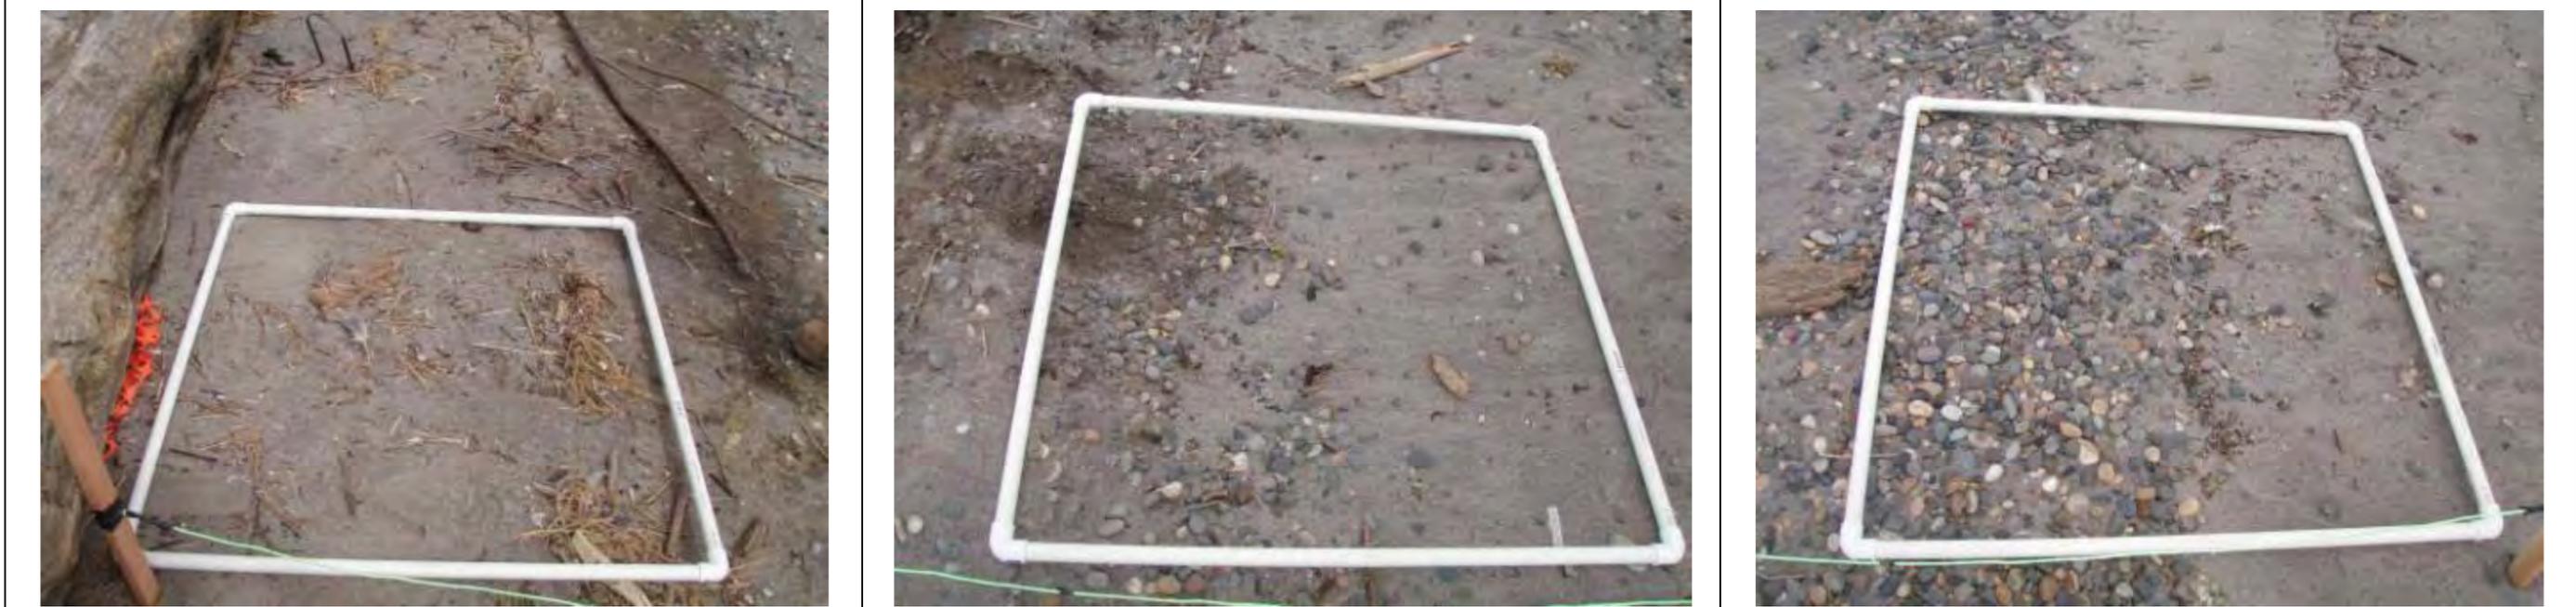
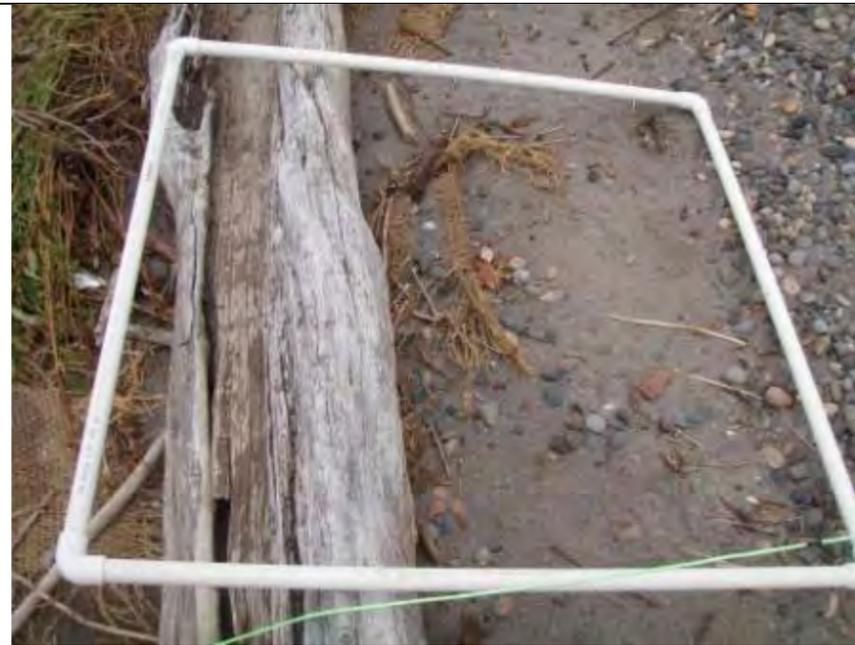
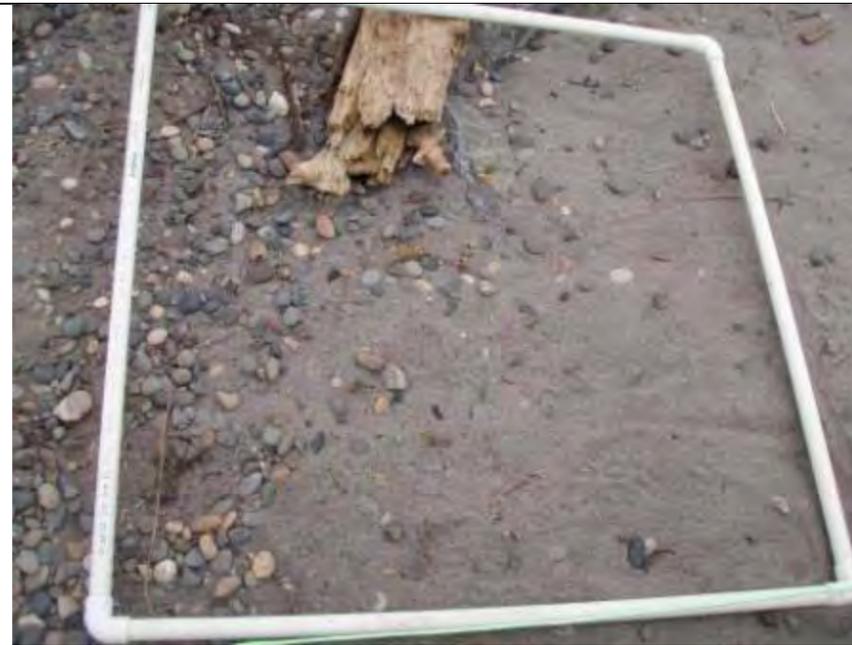
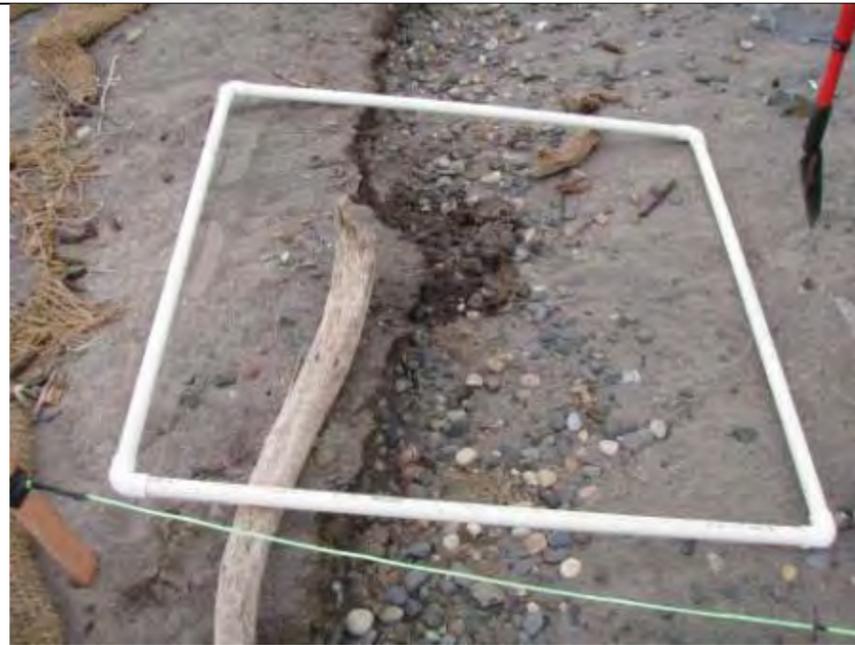
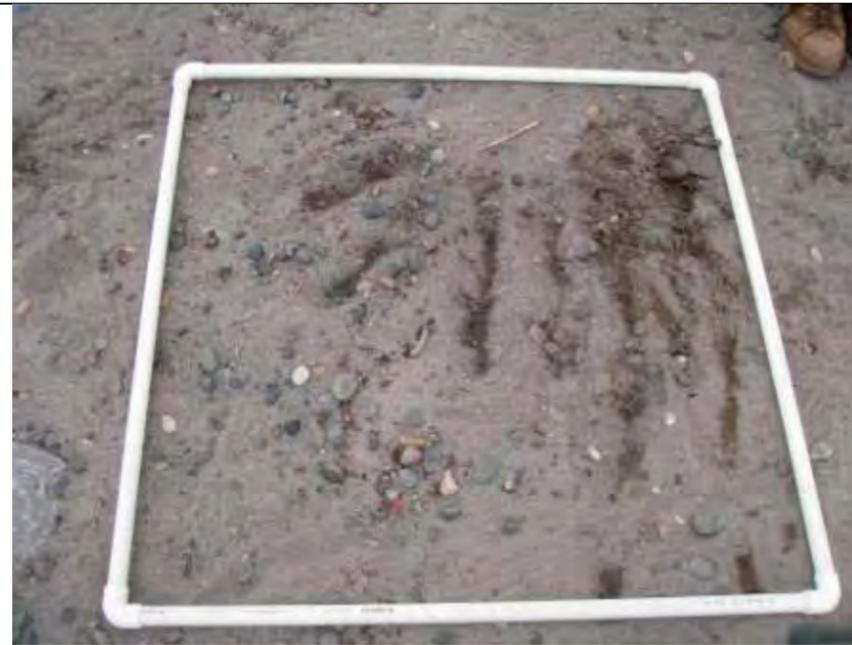
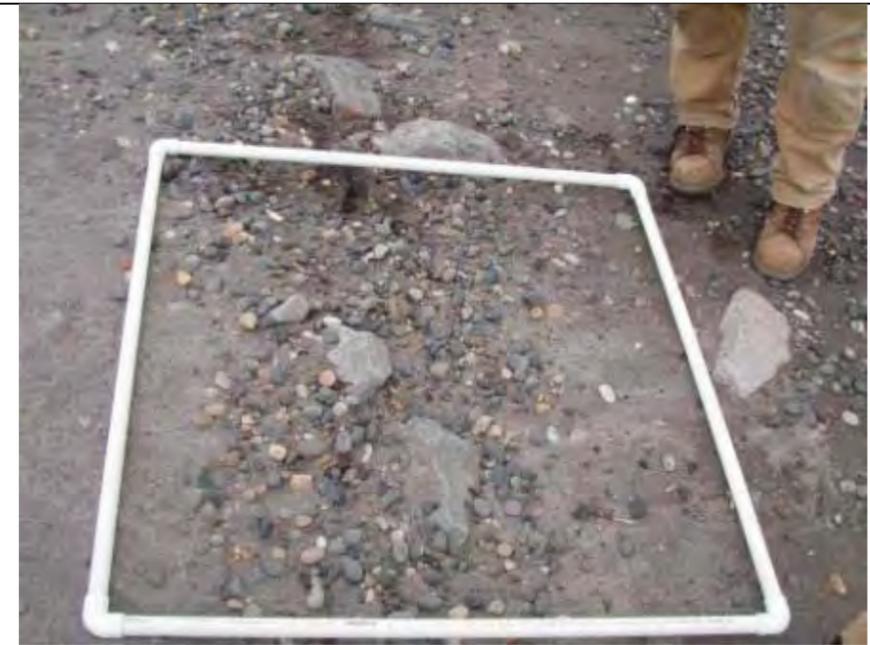
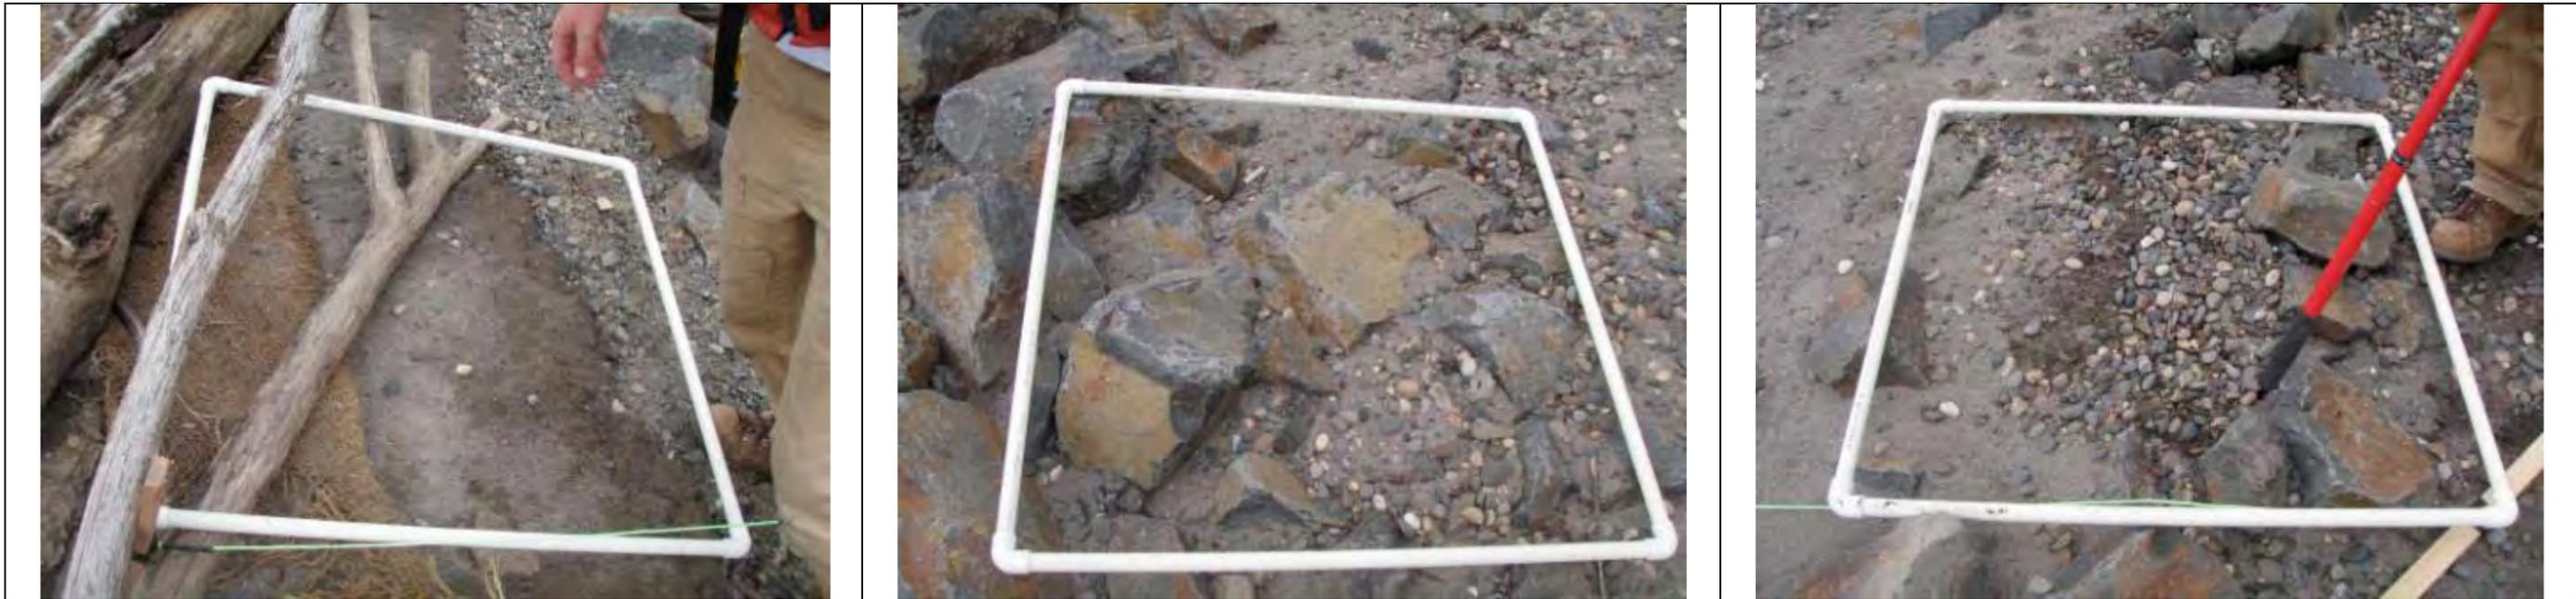
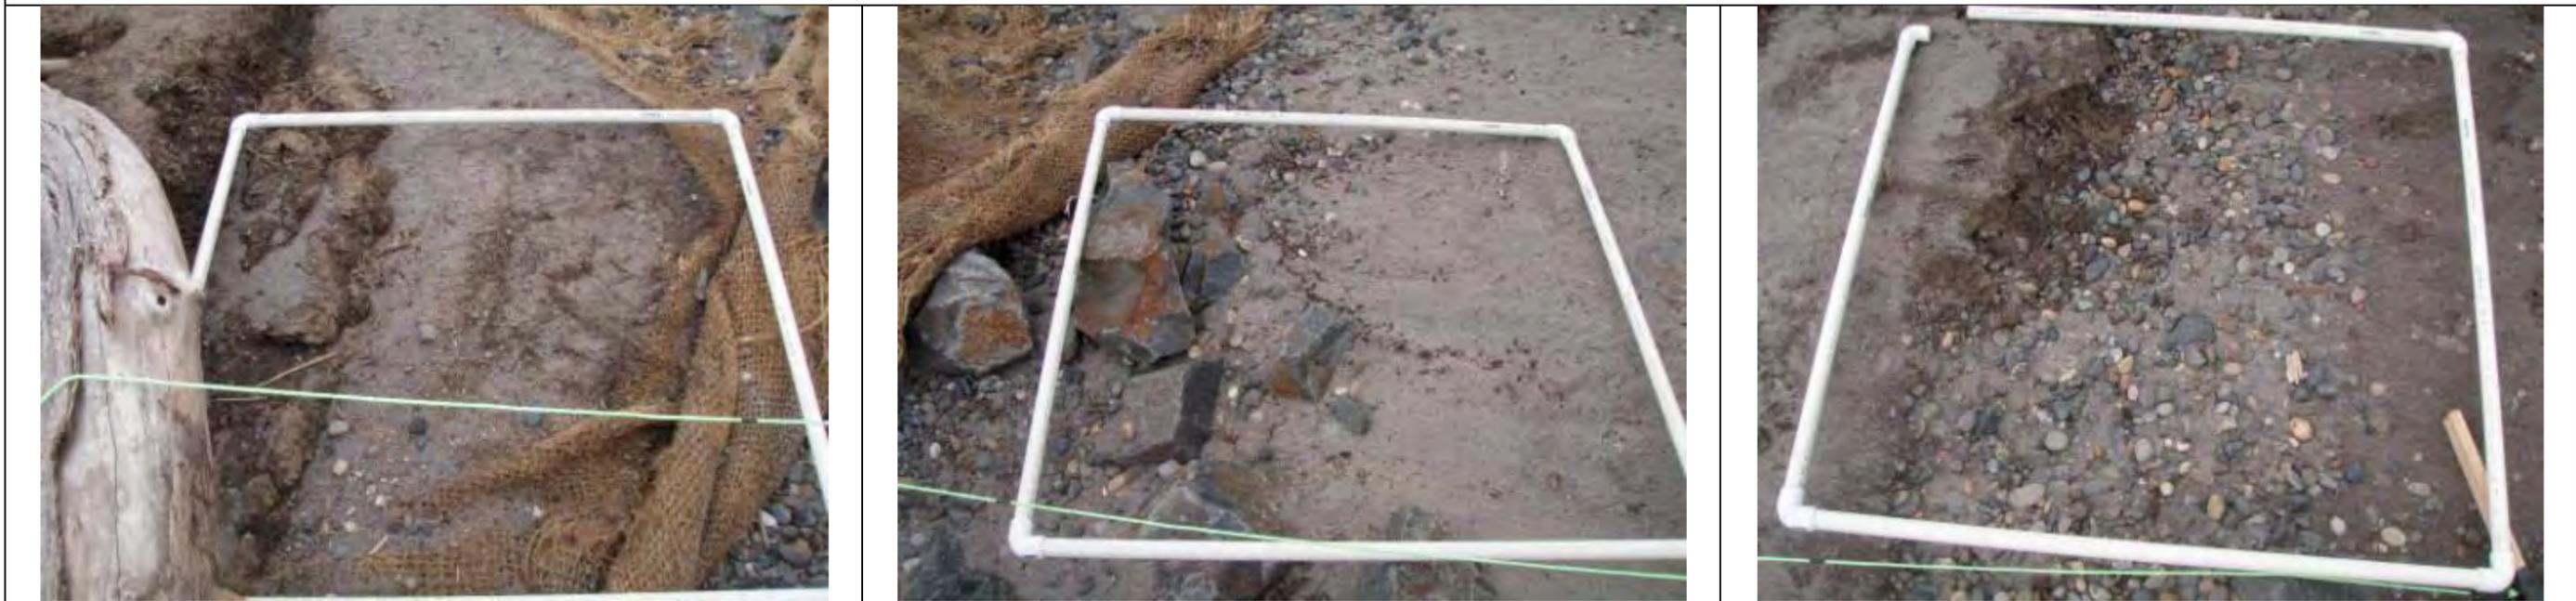
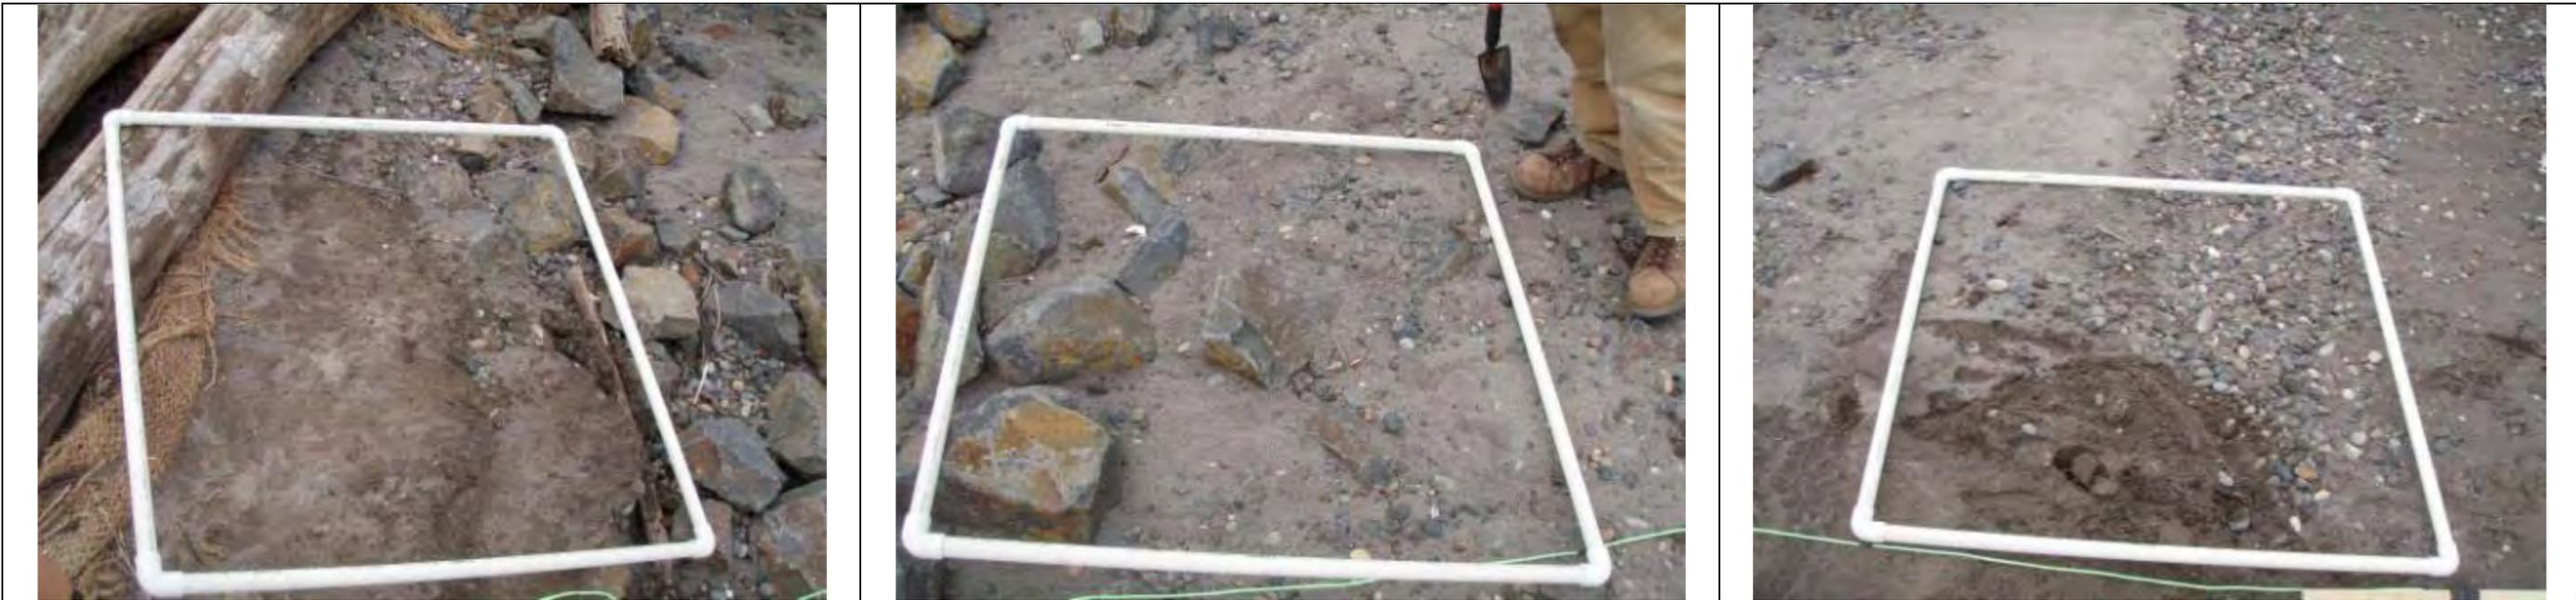
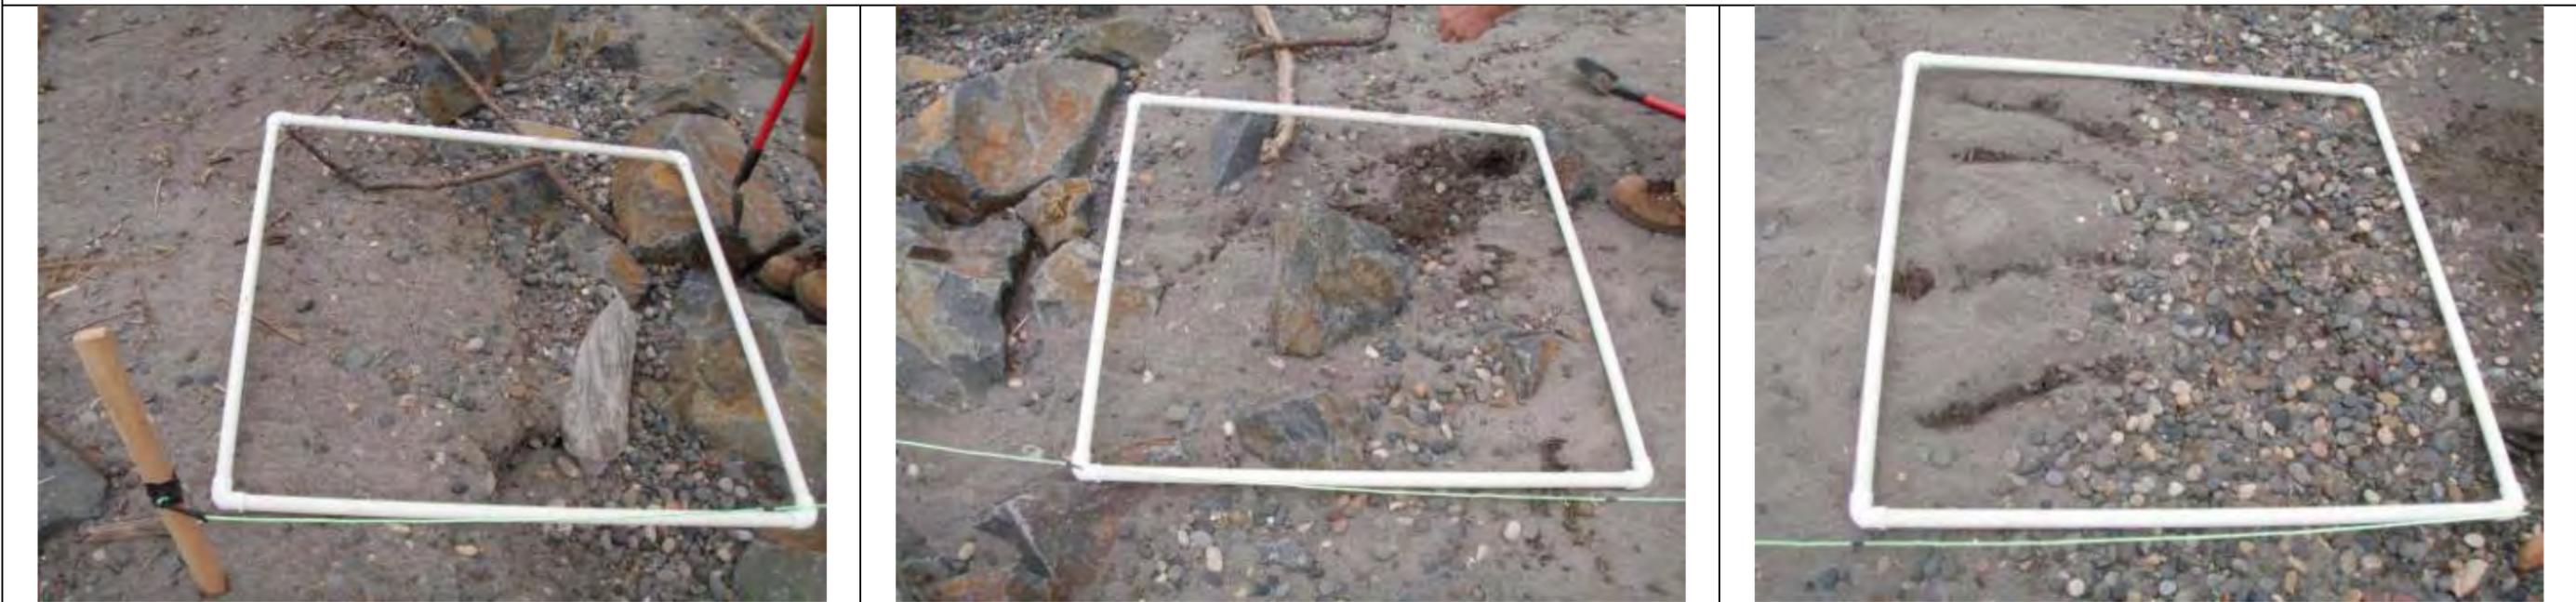
Results of the habitat material layer quantification are summarized below and in Table 2, and photographs from each transect location are shown in Figures 5a-5i. Habitat material and other types of non-armor rock material (i.e., placed material from upslope, depositional sand, or large woody debris [LWD]) covered 97 percent of the slope where habitat material was placed over armor rock. Armor rock was observed on the surface in only 3 percent of the overall area. The exposed armor rock occurred between 0 and 275 feet from the mouth of the bay between approximate elevations +10 and +15 feet NGVD, which generally corresponds to the area of the June 2010 bank erosion located between approximate elevations +15 to +20 feet NGVD that has been repaired (see Section 4). The rest of the area between 275 and 700 feet from the mouth of the bay where new armor rock was placed remains covered with habitat material, logs, and depositional sand. The average thickness of the habitat material (or other material) overlying the armor rock was greater than 6 inches in the area 0 to 275 feet from the mouth of the bay, and was greater than 10 inches in the remainder of the area from 275 to 700 feet. As such, in the area between 275 to 700 feet from the mouth of the bay, the habitat material has remained on the surface with an average thickness of material of greater than 10 inches. As mentioned previously, the intent of the placed habitat material is to allow it to naturally accrete or erode so it is not expected that all 12 inches of placed material would remain completely in place in the short term or the long term.

As part of the WB repair between 0 and 275 feet from the mouth of the bay described in Section 4, habitat material present at the time of construction was moved to the side and subsequently re-used at the toe of the new armor rock slope once placement of the armor rock was complete. No new habitat material was placed. As such, the armor rock is the surface layer in this section of WB, and no further monitoring of habitat material will be conducted in subsequent years in this area of WB. In the remaining area of the bay, which is not as exposed to erosive forces (i.e., between 275 and 700 feet from the mouth of the bay), the material is expected to move around, but generally stay where placed. The remaining area from 700 to 820 feet is armor rock where no habitat material was placed; this area represents an area of pre-existing armor rock.

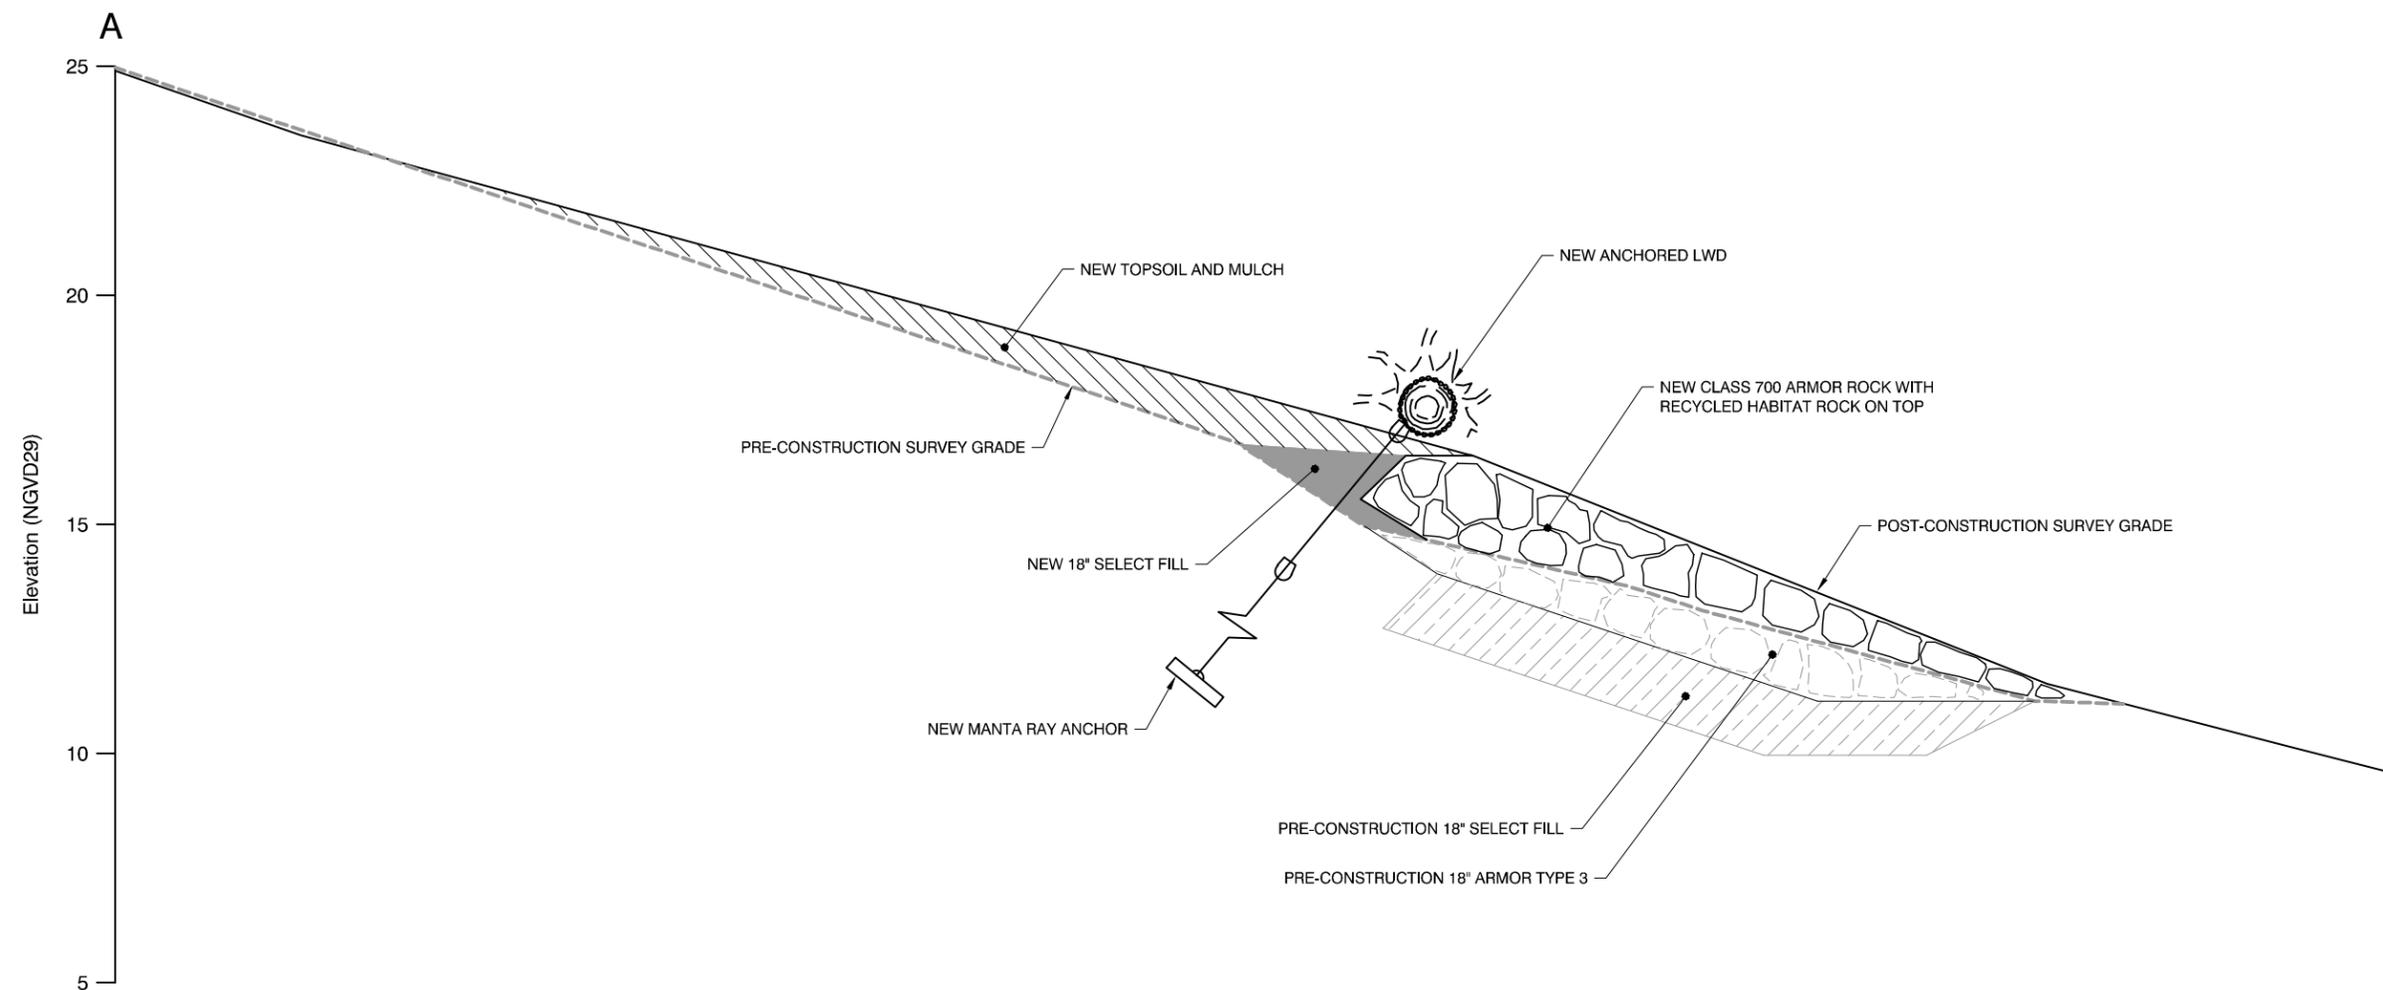
Erosive forces that likely contributed to observed erosion in 2009 and 2010 in the area between 0 and 275 feet from the mouth of the bay, which are expected to continue into the future, are described in the next section.

The hydrodynamic conditions that may affect the shoreline at WB in the future are expected to remain similar to those observed from 2008 to 2010. In those areas being exposed to breaking waves (i.e., between 0 and 275 feet from the mouth of the bay), the erosive forces being exerted on the shoreline appear to be redistributing the placed habitat material, and it is expected that these forces will continue in these areas. It is also expected that the areas protected by the piles underneath Berth 410 will remain protected as long as the piles remain in place. Overall, approximately 0.18 acres of the armor rock that was placed in 2008 are expected to remain covered by habitat material. This assumes that all new armor rock placed in 2010 between 0 and 275 feet from the mouth of the bay is exposed on the surface and not covered by habitat material or other material, and that the armor rock between 275 and 700 feet from the mouth of the bay remains covered with sand and gravel habitat material. The remaining area from 700 to 820 feet is armor rock where no habitat material was placed; this area represents an area of pre-existing armor rock.

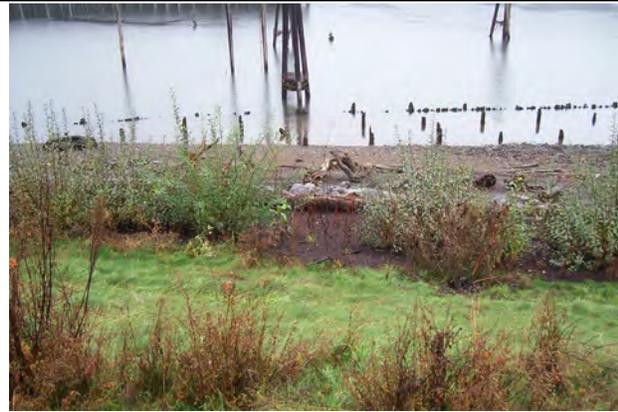
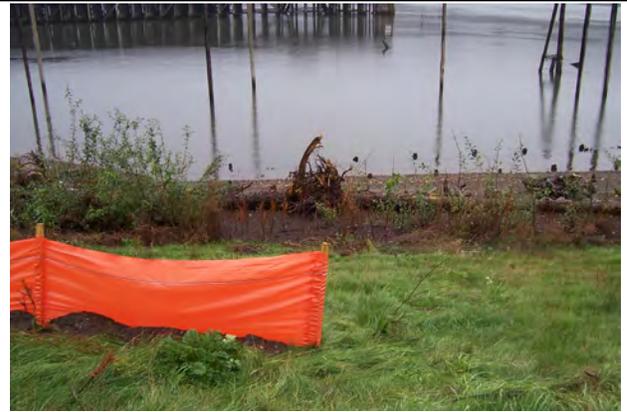
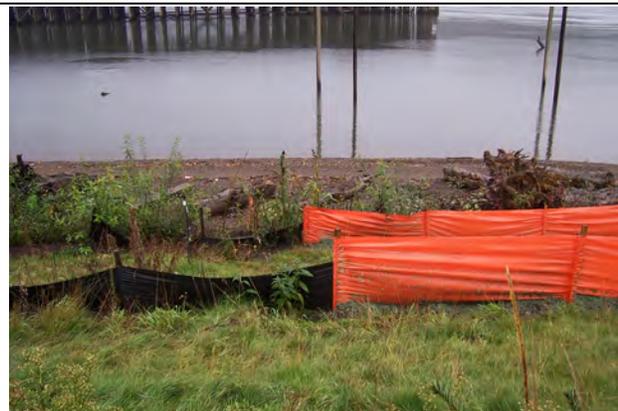
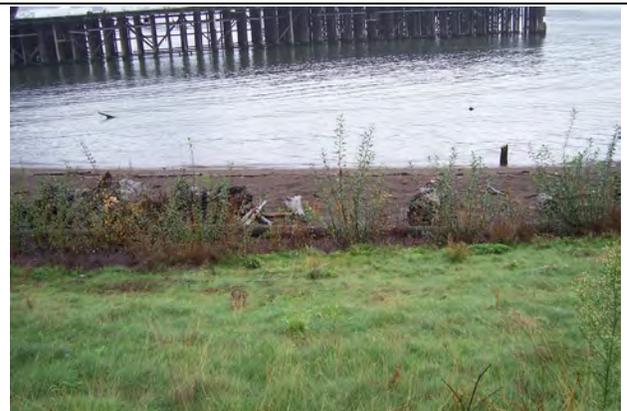
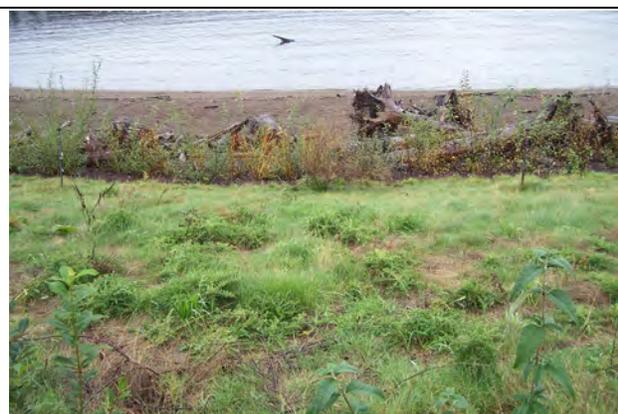
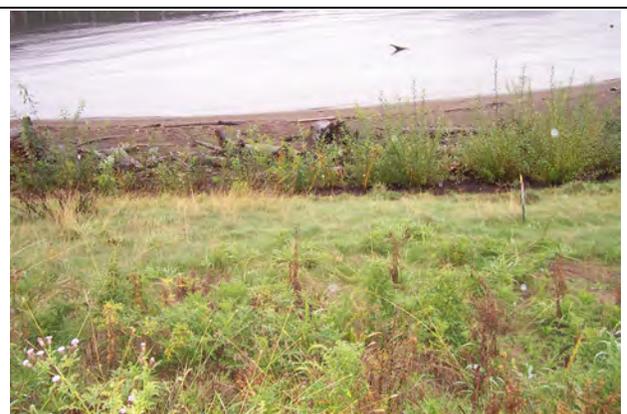
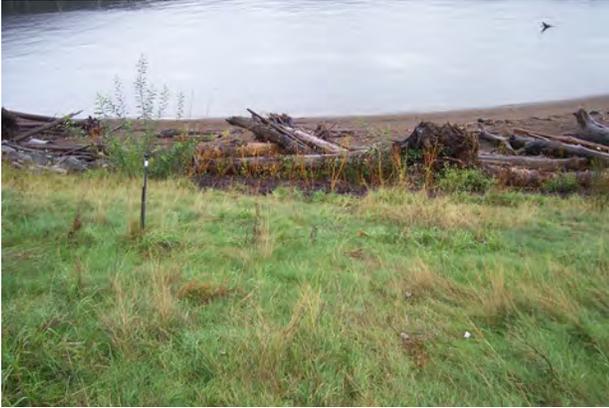
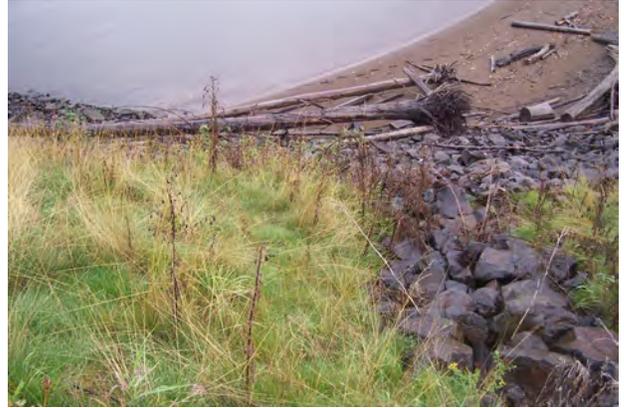
Attachments A-1 and A-2 to Appendix A, respectively) were taken of the armor layer at each transect. The armor layer showed no signs of instability, sloughing, or erosion. All woody debris installed as part of the original and repair design was in place, stable, and in good condition.
