FINAL  
YEAR 2 INTERIM MONITORING REPORT –  
TERMINAL 4 PHASE I REMOVAL ACTION  
PORT OF PORTLAND, PORTLAND, OREGON

Port of Portland  
Portland, Oregon

Anchor QEA, LLC  
6650 SW Redwood Lane, Suite 333  
Portland, Oregon 97224

**February 2011**

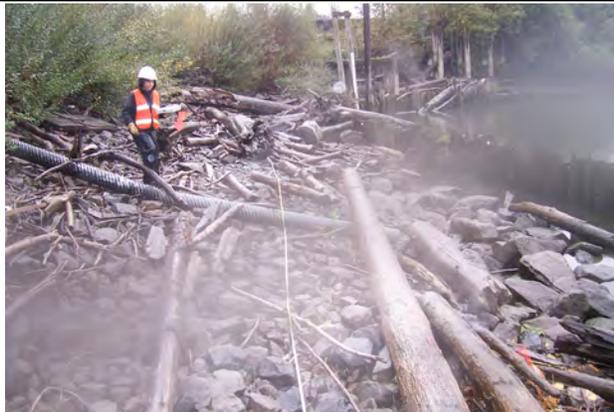
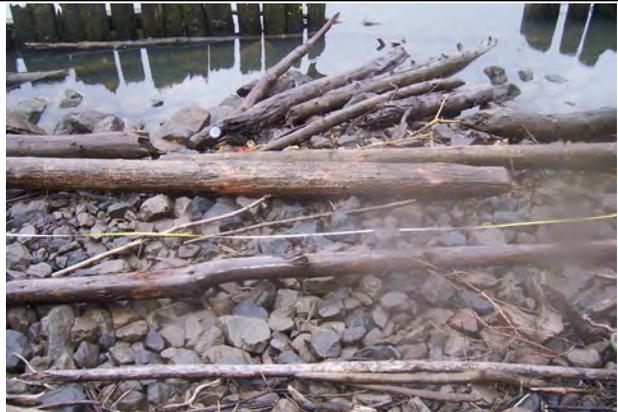
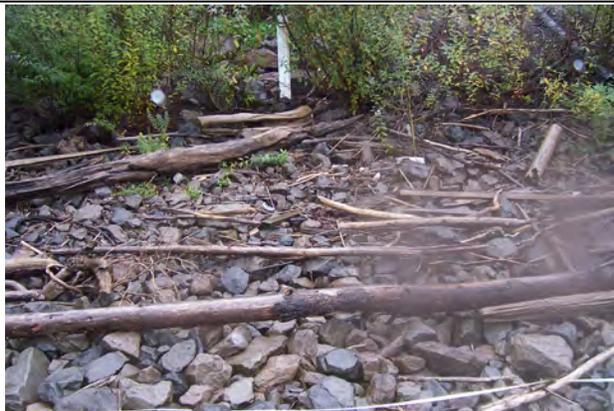
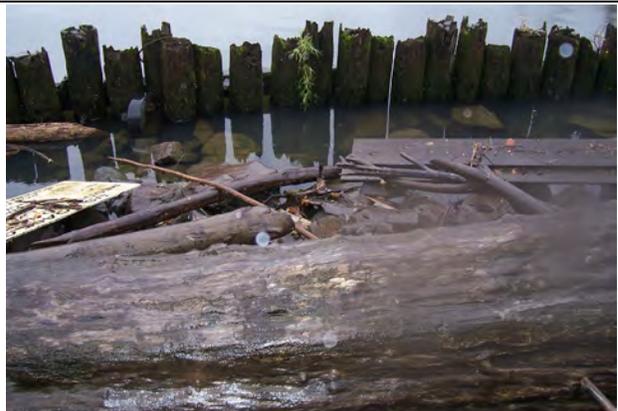
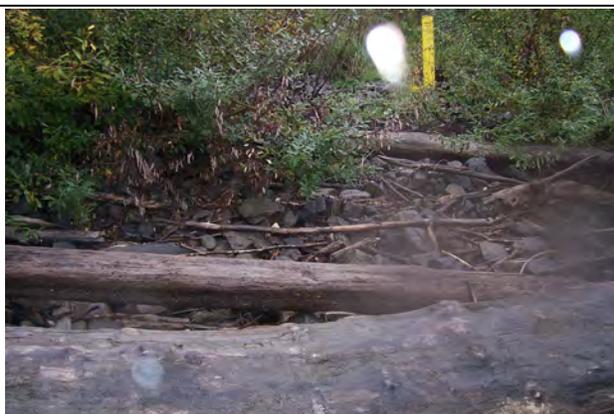
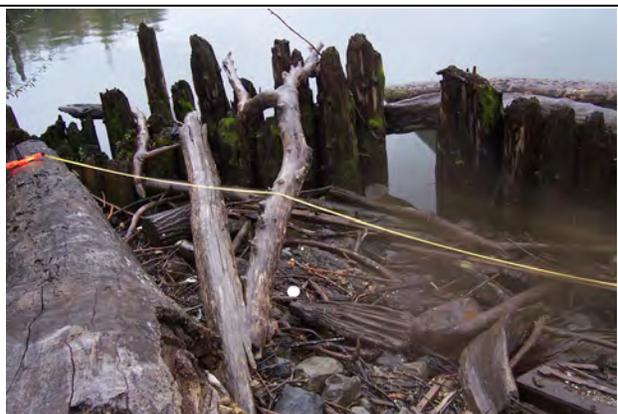
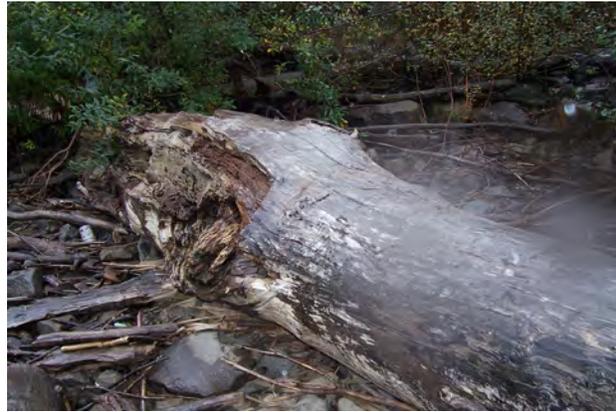
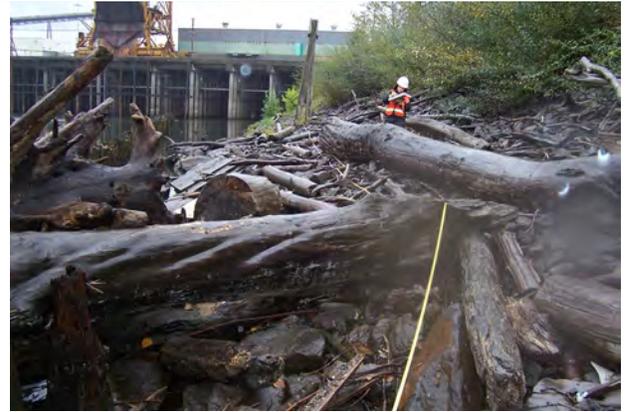
On November 9, 2010, three transects were re-established on 40-foot spacings perpendicular to the shoreline in the same locations as the Year 1 slope observations. Transects were marked with flags and monitoring staff walked from the upslope edge of the stabilization area to the water. Notes and photographs (provided as Attachments A-3 and A-4 to Appendix A, respectively) were taken to document visual slope stability along each transect. In summary, no areas of instability were noted.

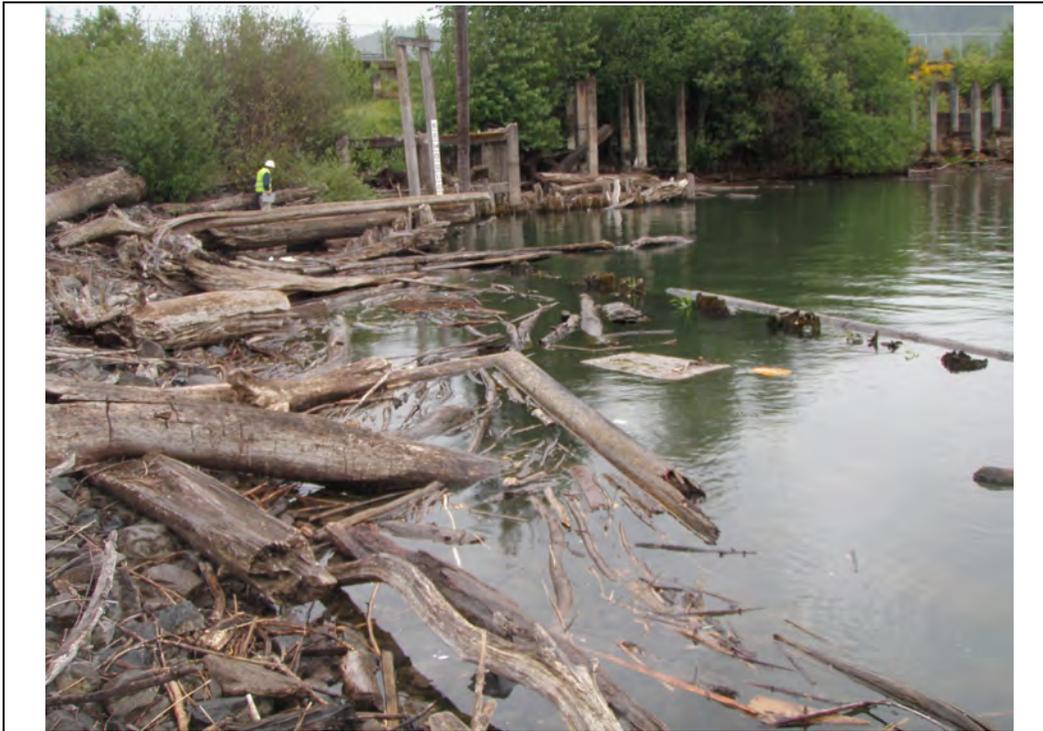
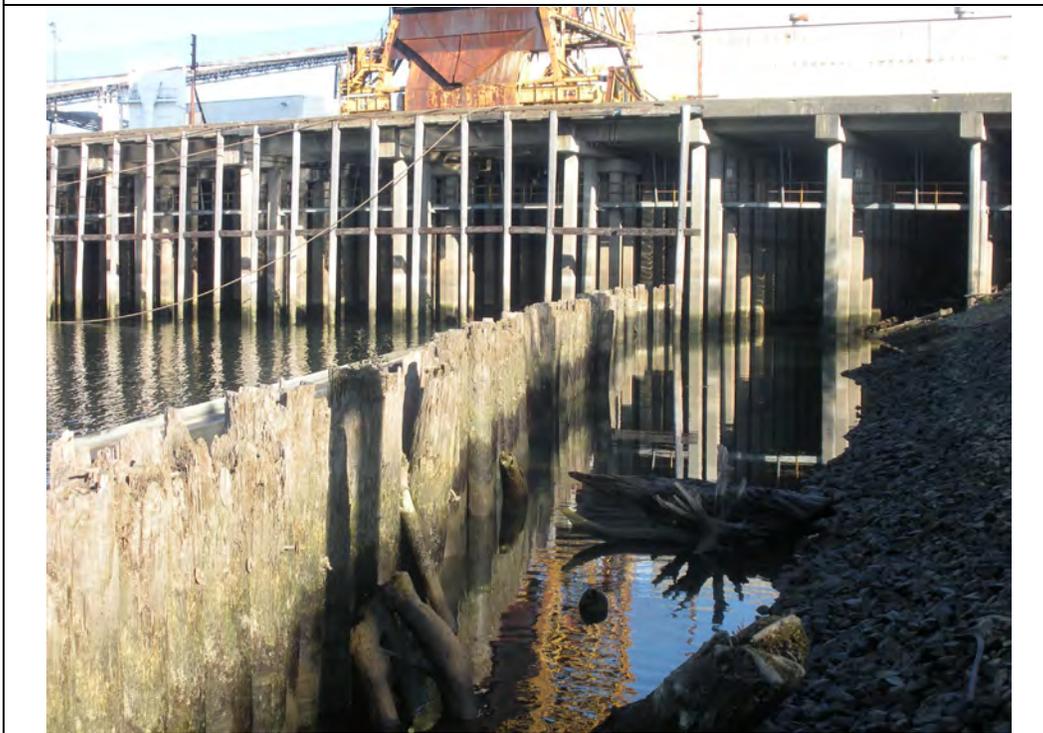
The water level was approximately +6.7 feet NGVD during the May 19, 2010 survey, and approximately +2.0 feet NGVD during the October 18, 2010 survey. Monitoring staff walked along 20-foot transects parallel to the shoreline to observe the presence of sheens. No sheens were observed, as documented in Attachments A-5 and A-6 to Appendix A, respectively.

No areas of instability were observed along any portion of the stabilized slope. Armor rocks were stable and free of erosion and sloughing. No sheens were observed during either of the sheen observation events.
