YEAR 1 INTERIM MONITORING REPORT – PHASE I REMOVAL ACTION  
TERMINAL 4 EARLY ACTION  
PORT OF PORTLAND, PORTLAND, OREGON

Port of Portland  
Portland, Oregon

Anchor QEA, LLC  
6650 SW Redwood Lane, Suite 333  
Portland, Oregon 97224

**February 2010**

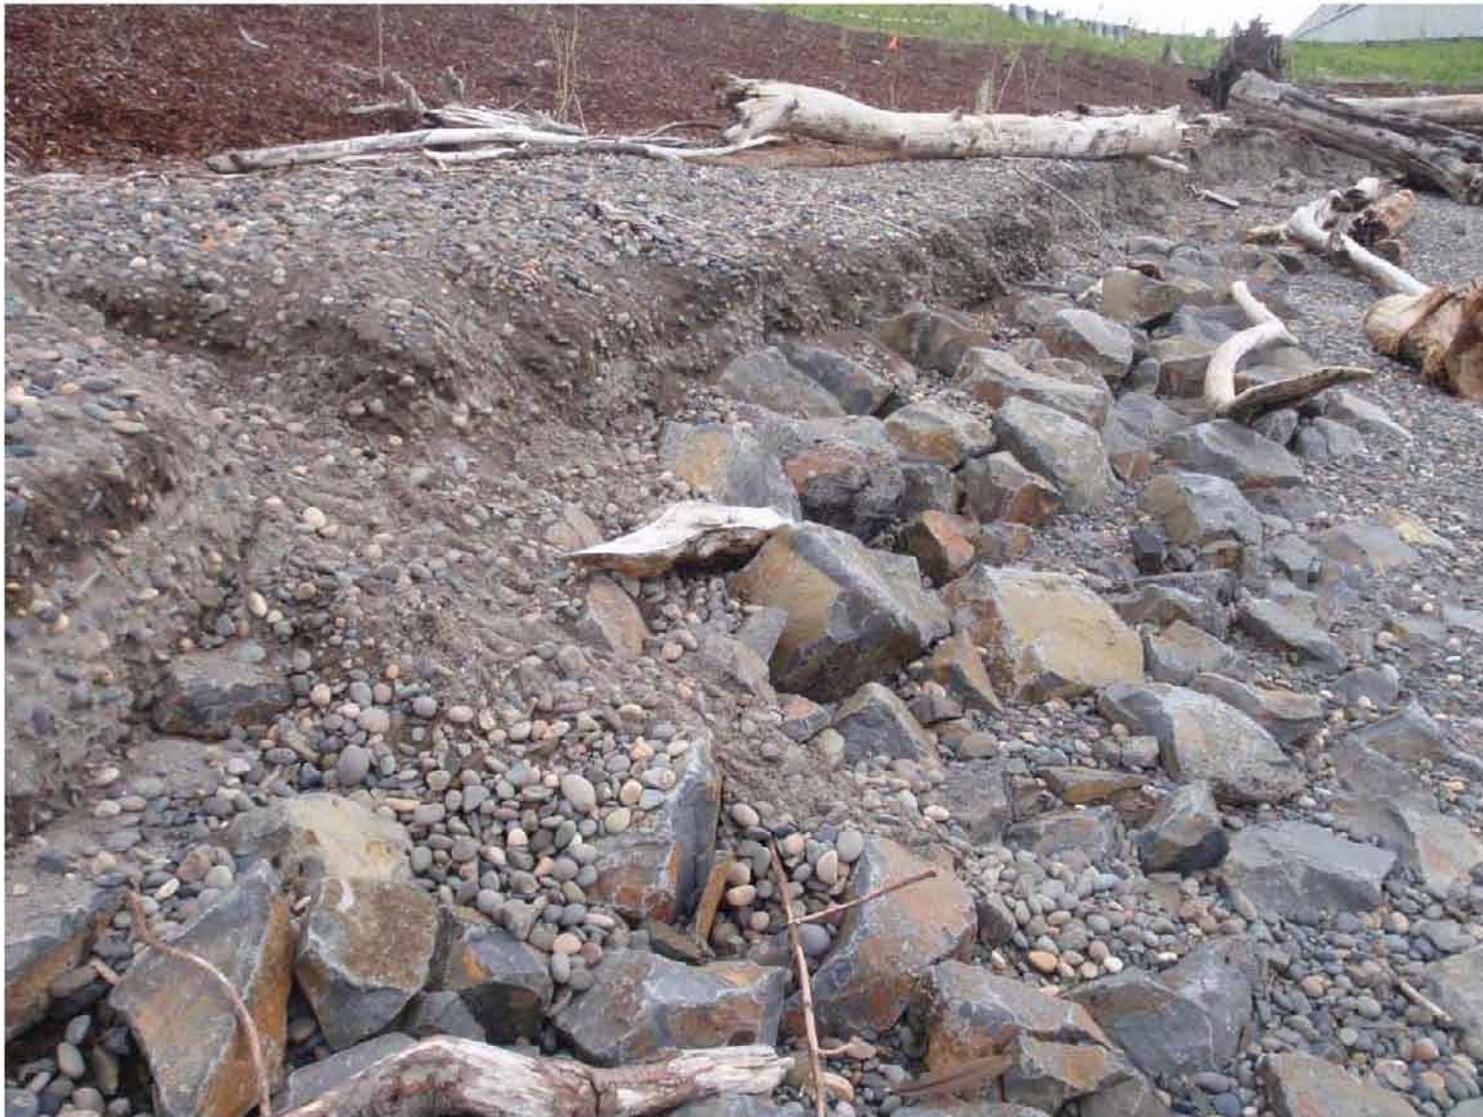
**Figure A-2**  
Habitat Layer Erosion Scarp East of Transect 3  
Wheeler Bay and Head of Slip 3 Cap Year 1 Visual Slope and Armor Survey Monitoring Report  
Portland, Oregon

Beginning 50 feet channel-ward of Transect 1 and extending to Transect 3, a 250-foot erosion scarp in the habitat layer was observed on June 19, 2009 (Figure A-2). The scarp ranged between 0.5 and 2 feet in height, exposing the underlying armor rocks in some spots. The largest erosion scarp was located near Transect 2 and was progressively less severe on either side extending to Transects 1 and 3. The distance between the erosion scarp and the lower edge of the willow planting area and jute mat was greater than 5 feet where the erosion scarp was 1 foot or less. Where the erosion scarp was 2 feet in height, the distance to the jute mat was approximately 2 feet. An additional 1-foot erosion scarp in the habitat rock was observed at Transect 7, where the habitat rock transitions to armor riprap. The erosion scarp was observed to be largely unchanged during the October 22, 2009 site visit.

Based on the observations performed, the habitat layer is still in place (covering the riprap) over approximately 80 percent of the area where it was initially placed. In the areas noted above (representing approximately 20 percent of the total area where the habitat layer was initially placed), the habitat layer has eroded from within the voids in the riprap.

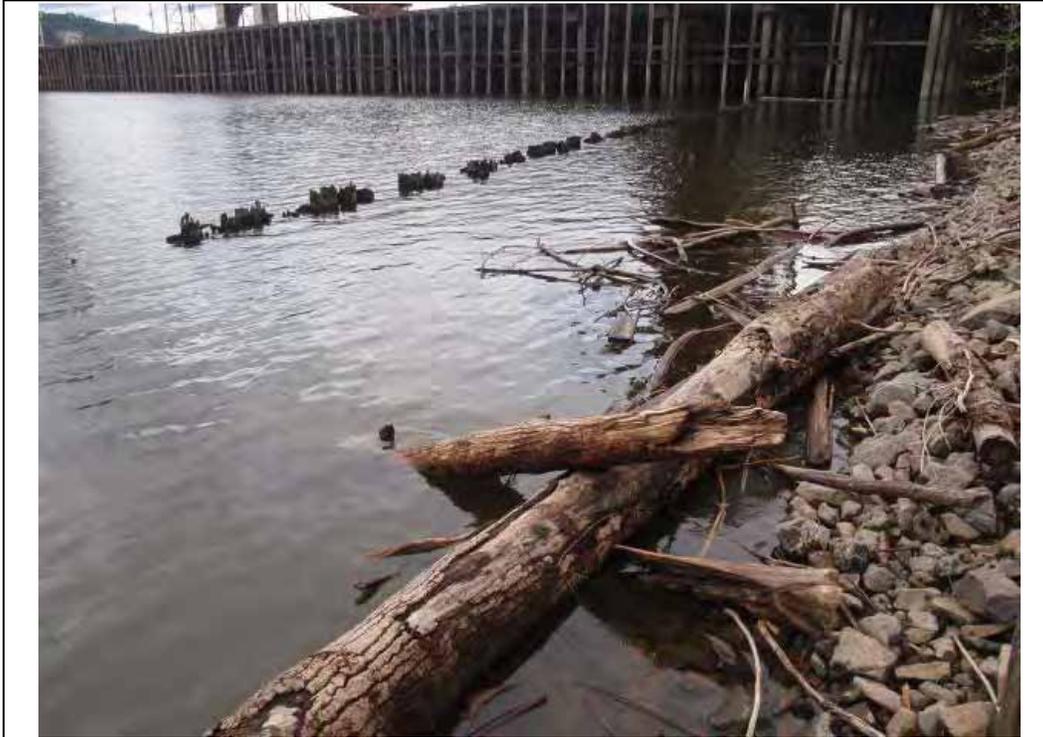
No areas of instability were observed along any portion of the stabilized slope. Armor rocks were stable and free of erosion and sloughing. No sheens were observed during either of the sheen observation events.

High water sheen observation 6/19/2009

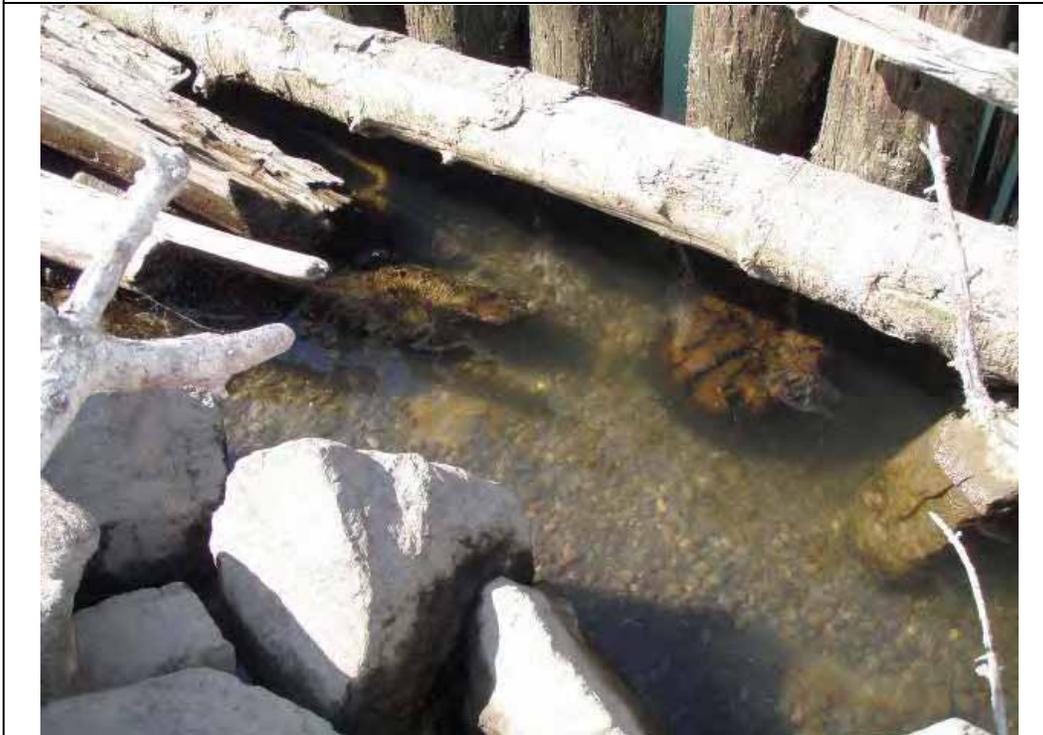
Low water sheen observation 9/22/2009

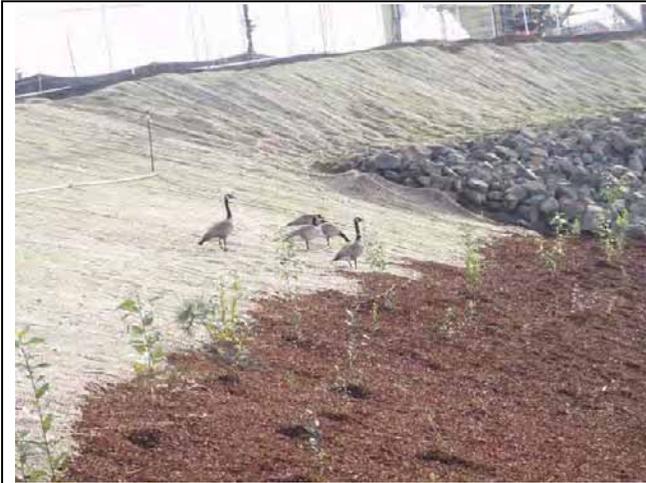
Geese grazing near Stations 11G and 12W

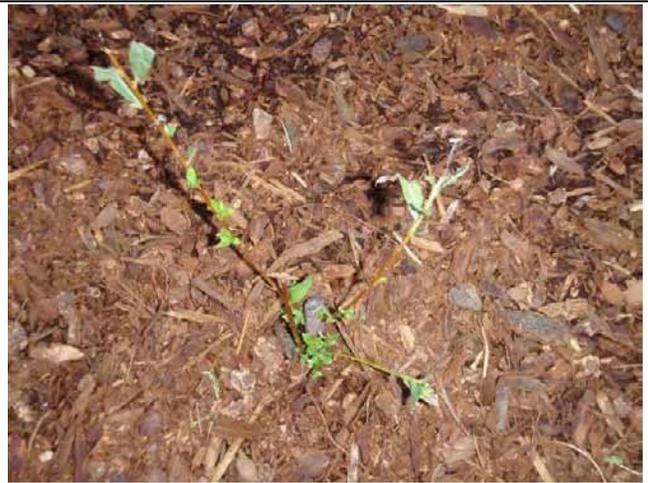
Grazed willow

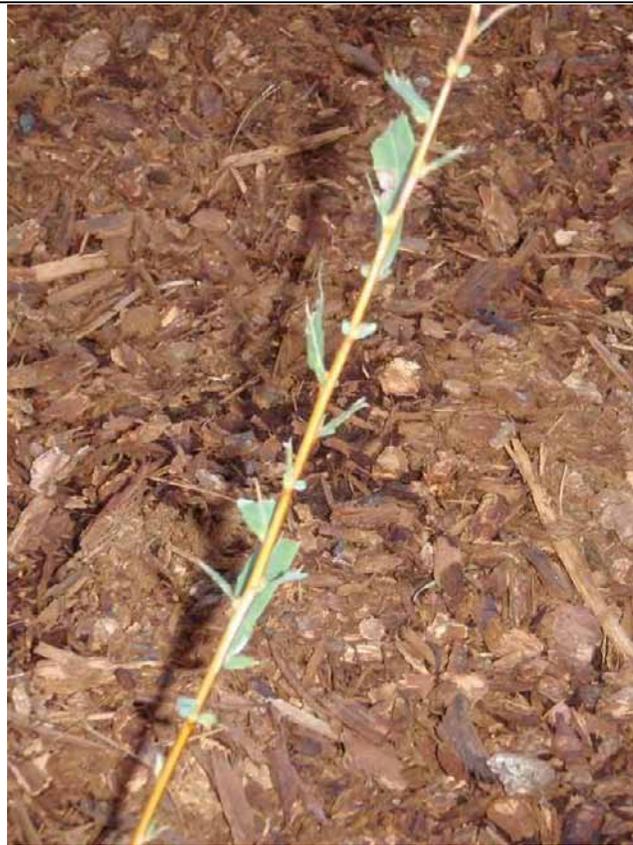
Grazed willow

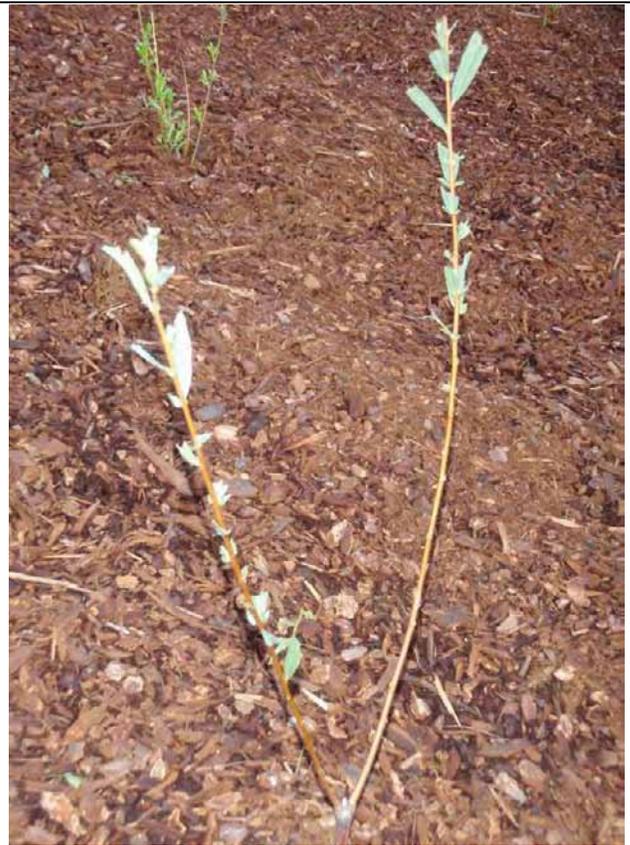
Grazed willow

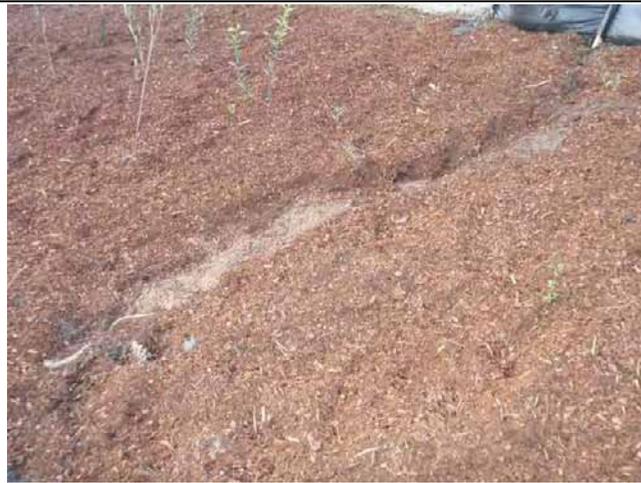
Bark mulch erosion A

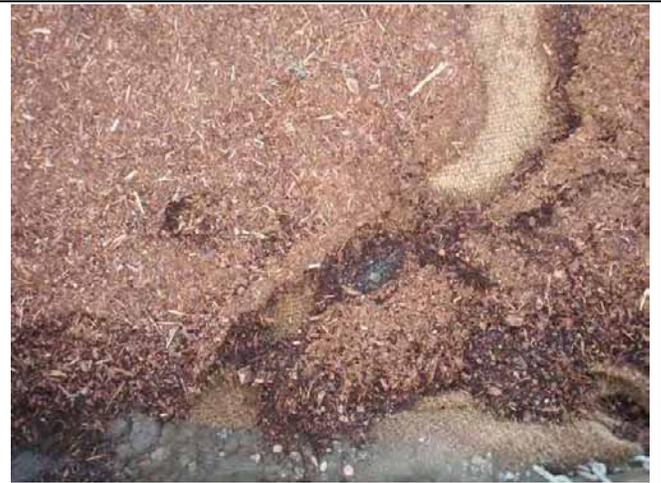
Bark mulch erosion B

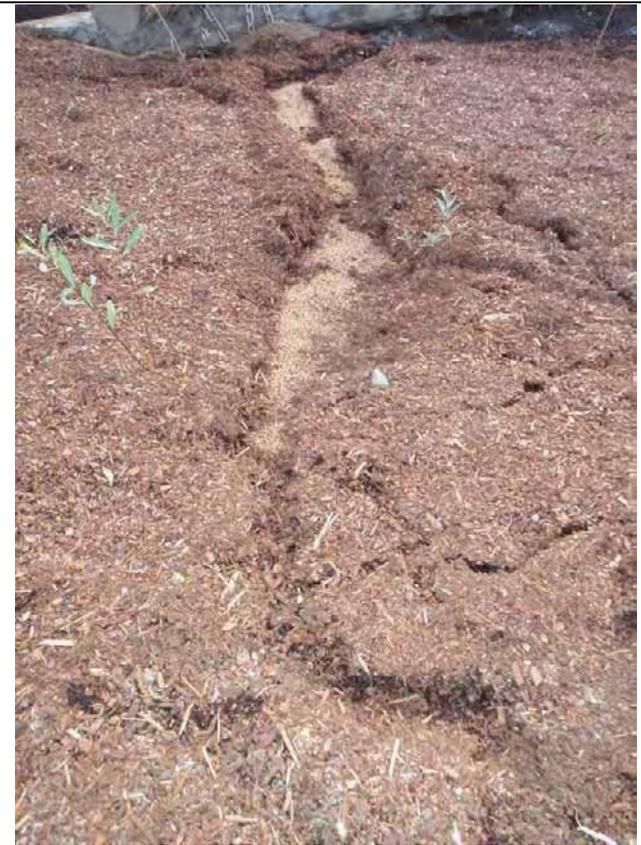
Bark mulch erosion B

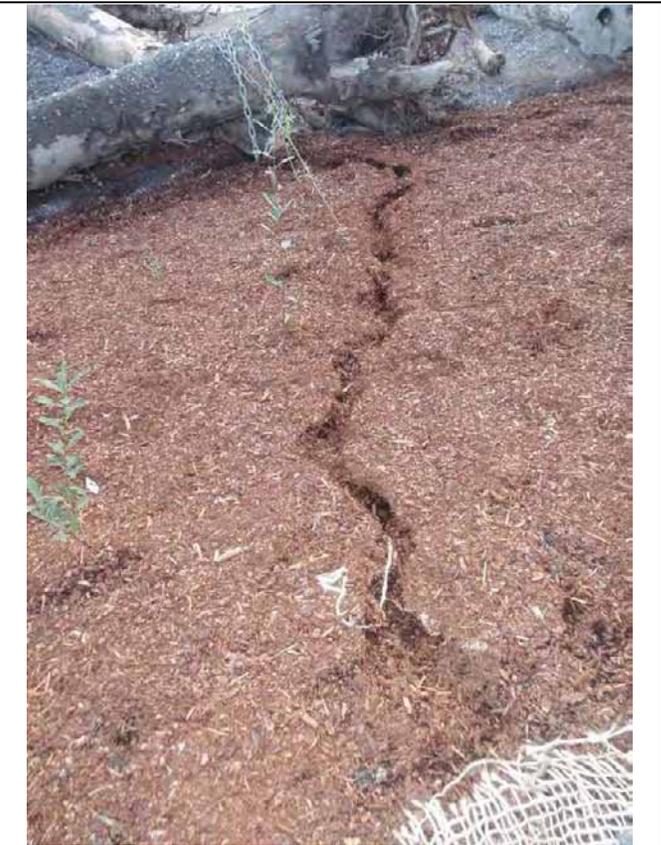
Bark mulch erosion C

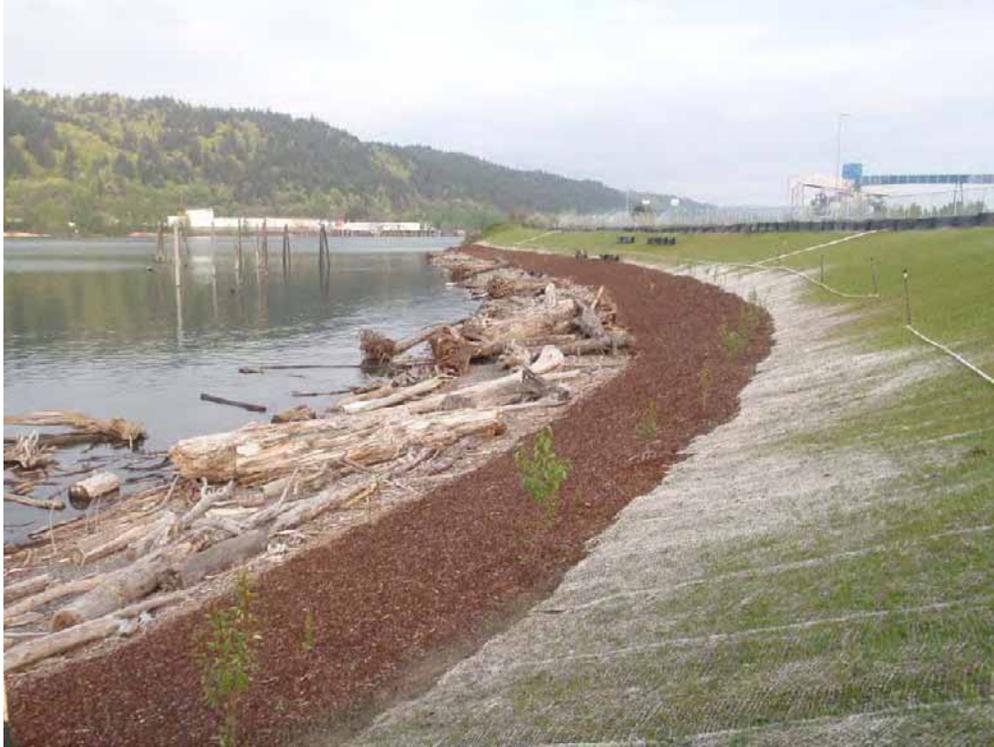
Low-density grass patches

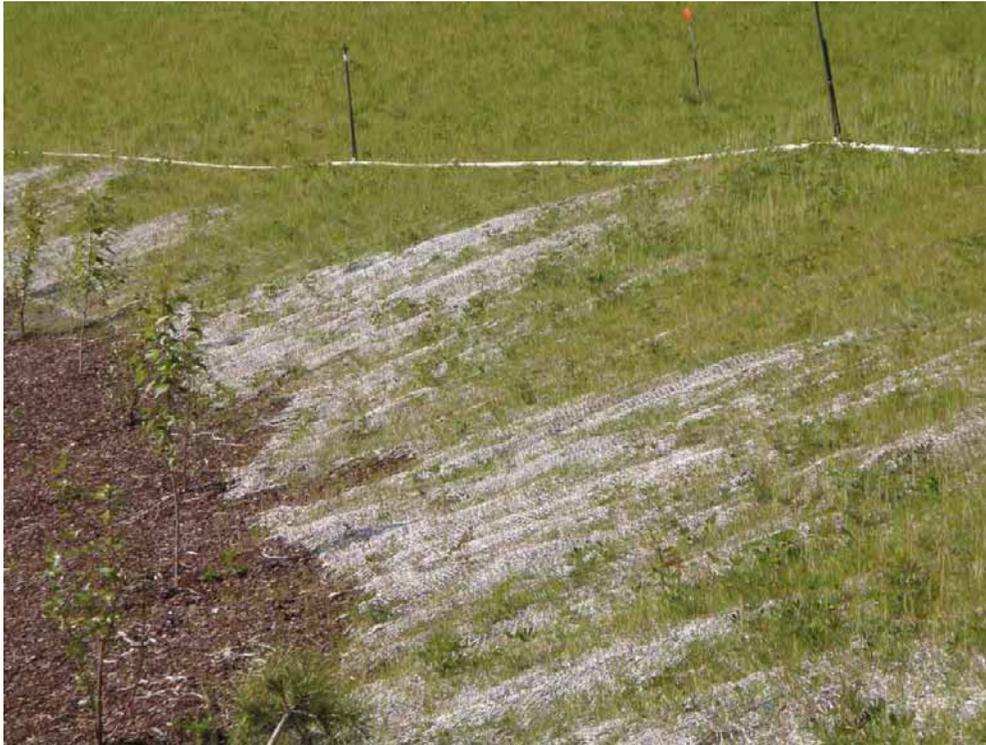
Low-density grass patches

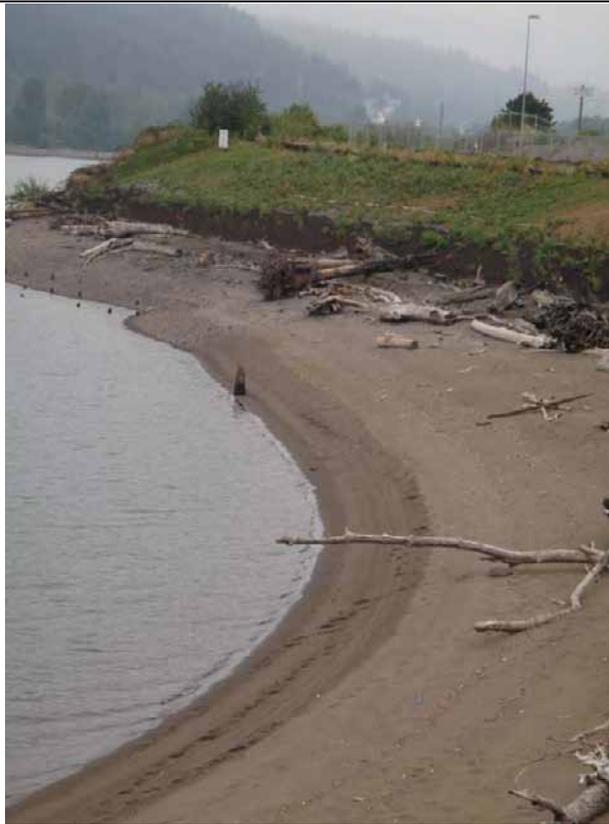
NW view of beach and slope

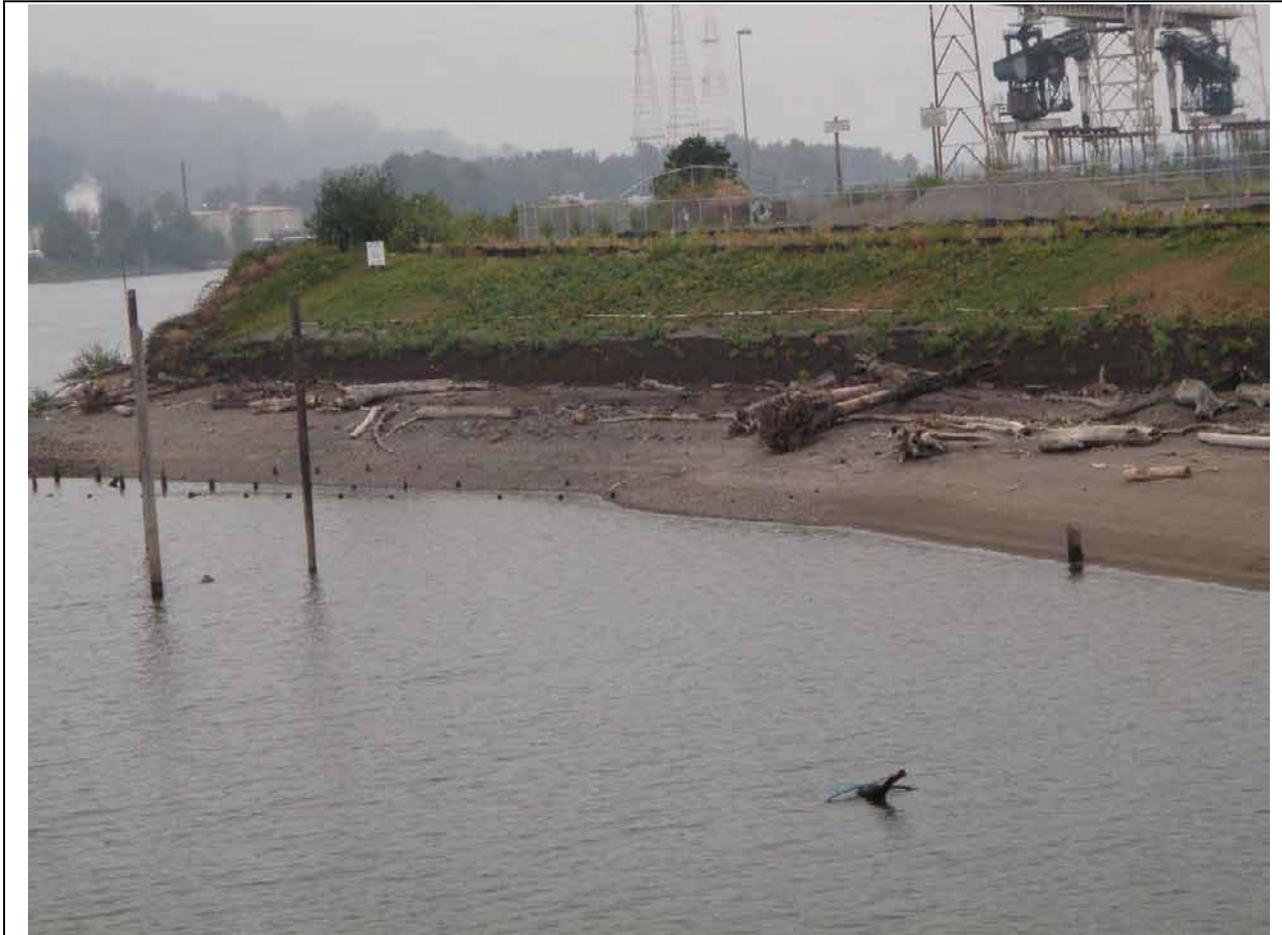
Based on the observations performed, the habitat layer is still in place (covering the riprap) over approximately 80 percent of the area where it was initially placed. In the areas noted above (representing approximately 20 percent of the total area where the habitat layer was initially placed), the habitat layer has eroded from within the voids in the riprap.

Section of slope where part of habitat layer eroded and stabilized to lower grade
