**Fourth Five-Year Review Report  
For**

**Allied Plating, Inc  
Superfund Site  
Portland, Oregon**

September 2013

Prepared by EPA Region 10, Seattle, Washington

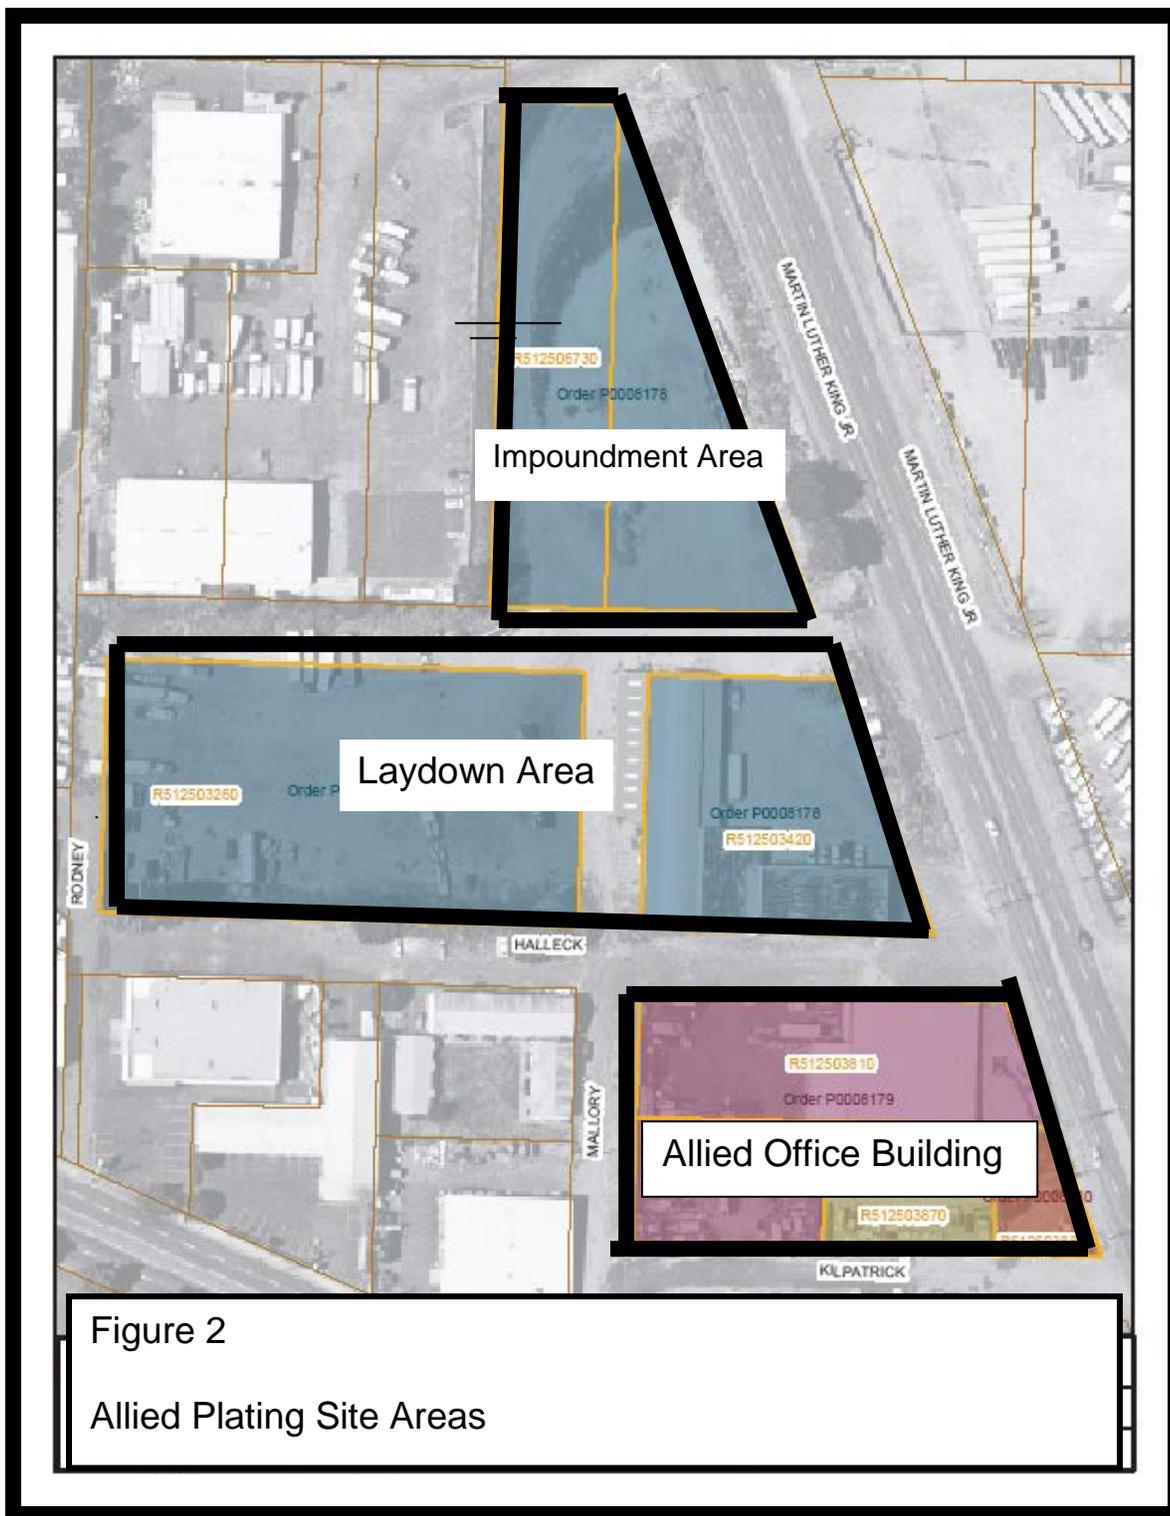
Figure 2: Allied Plating Site Areas

The site covers approximately 12 acres, and for the site investigation and cleanup was divided into three areas based on their historical usage (Figure 2). The southernmost section contained the administrative and storage building for the former Allied Plating business. This area was across the street from the location where plating activities occurred, and was not considered to be contaminated from operations.

EPA signed an Action Memorandum in October 1992 and the impoundment area was remediated by a Removal Action (Removal) (see Figure 2 for the area covered by the Removal). The selected goal of the Removal was to clean the site so that the Hazard Index would be less than or equal to 1, and the excess cancer risk would be less than or equal to  $1 \times 10^{-4}$  for the industrial scenario.

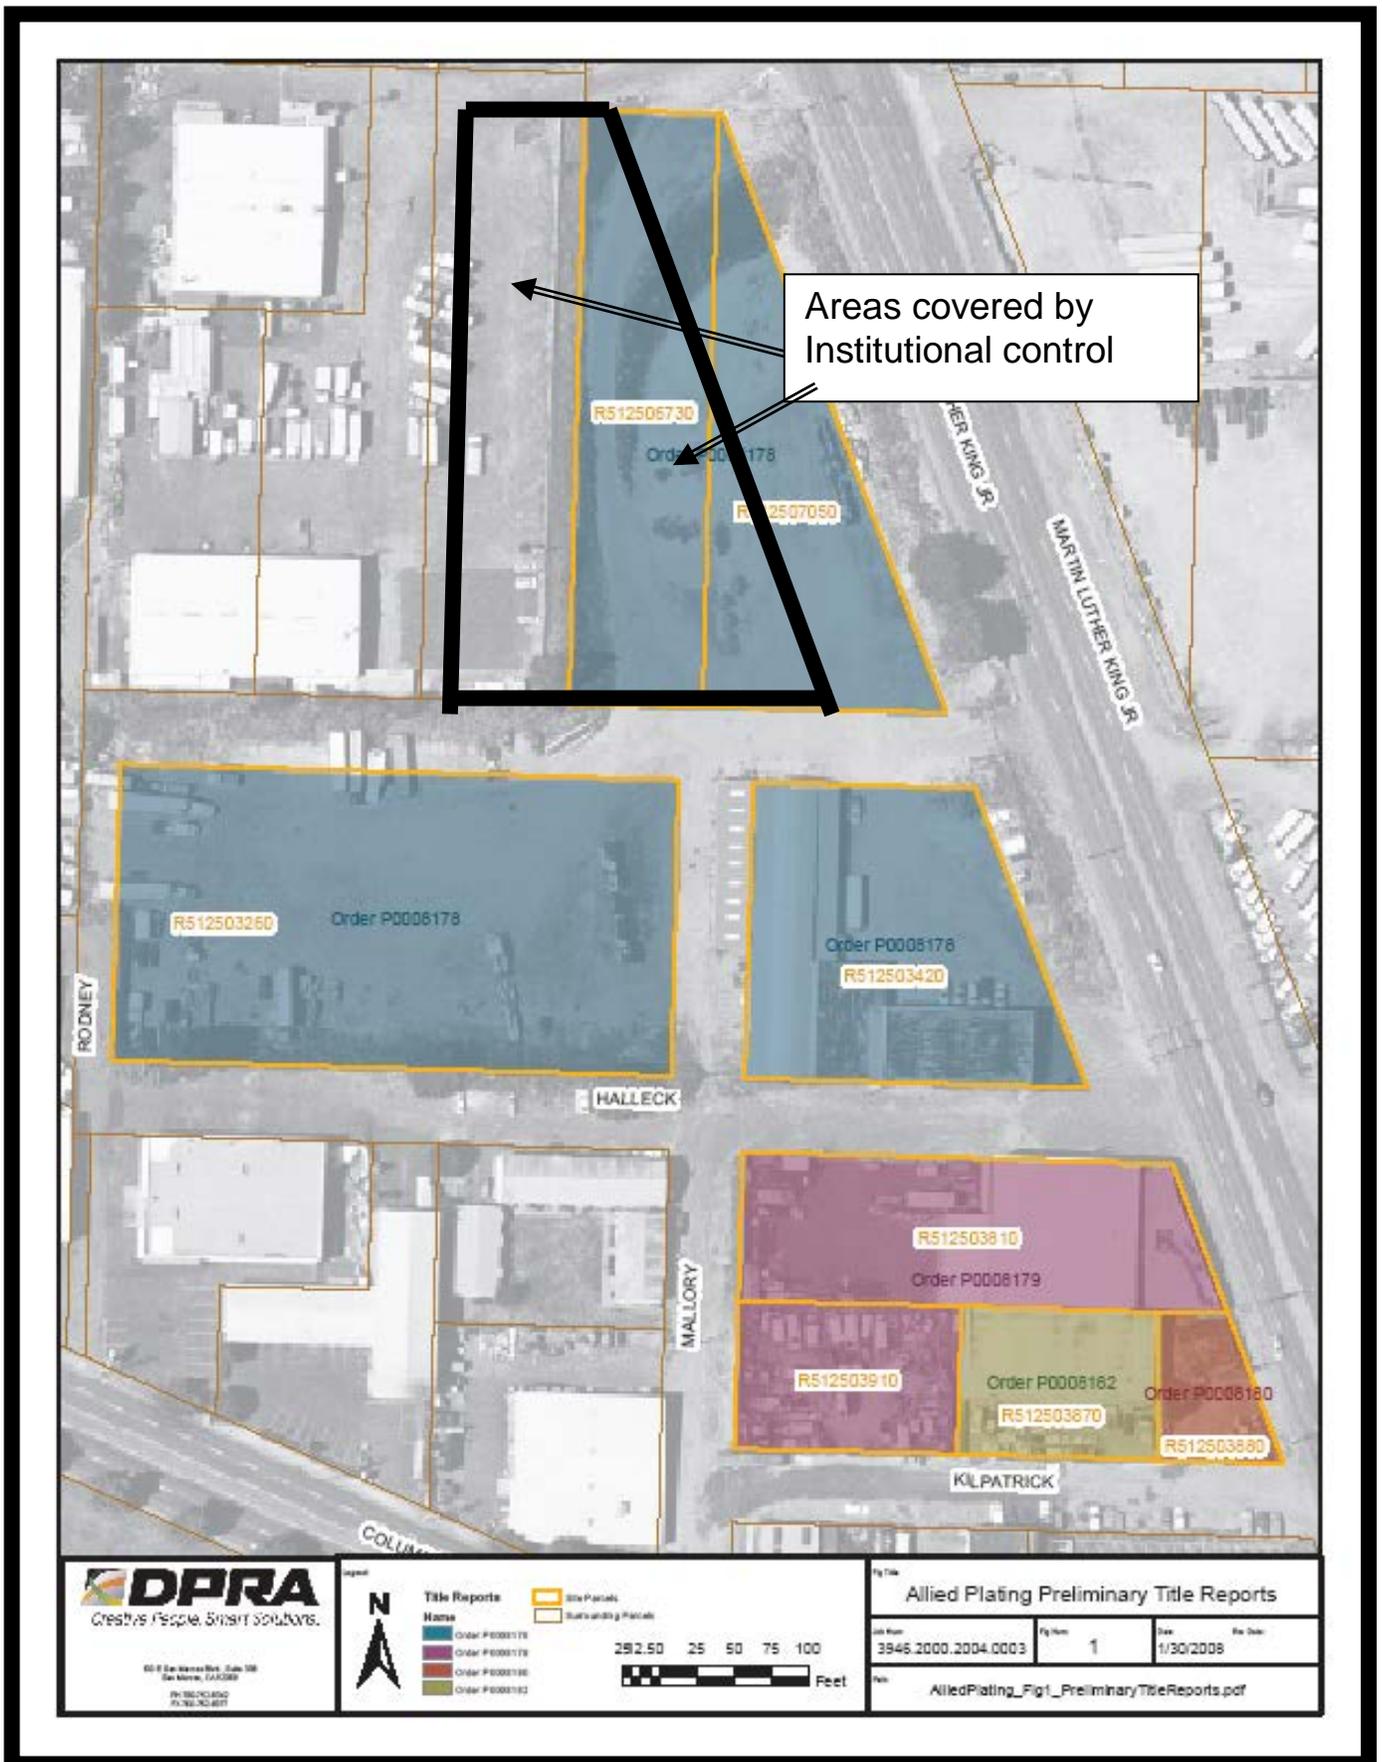
Figure 3: Property and Institutional Control Boundary

perched aquifer, the extent of the restriction was appropriately limited to the former Impoundment Area on the site (Tracts H&L in Figure 3). In 2008 a Title Search was conducted by an EPA contractor which confirmed that the Deed Restriction recorded in May, 1993 was recorded properly and remains on the property records. The search report identified two prior encumbrances (one for power poles/maintenance and the other for streets), but neither is such that they would compromise the functioning of this Institutional Control or the remedy. EPA also confirmed that the property and surrounding properties remain zoned for industrial or commercial use, consistent with the cleanup goals used to guide the removal action. The 2008 review concluded that given the post-removal risk assessment results and elimination of the MCL for nickel in 1995 there is some question whether any restriction on use of the site remains necessary. See Figure 2 for a detail photo with site features and Figure 3 for property and institutional control boundaries from the title search.

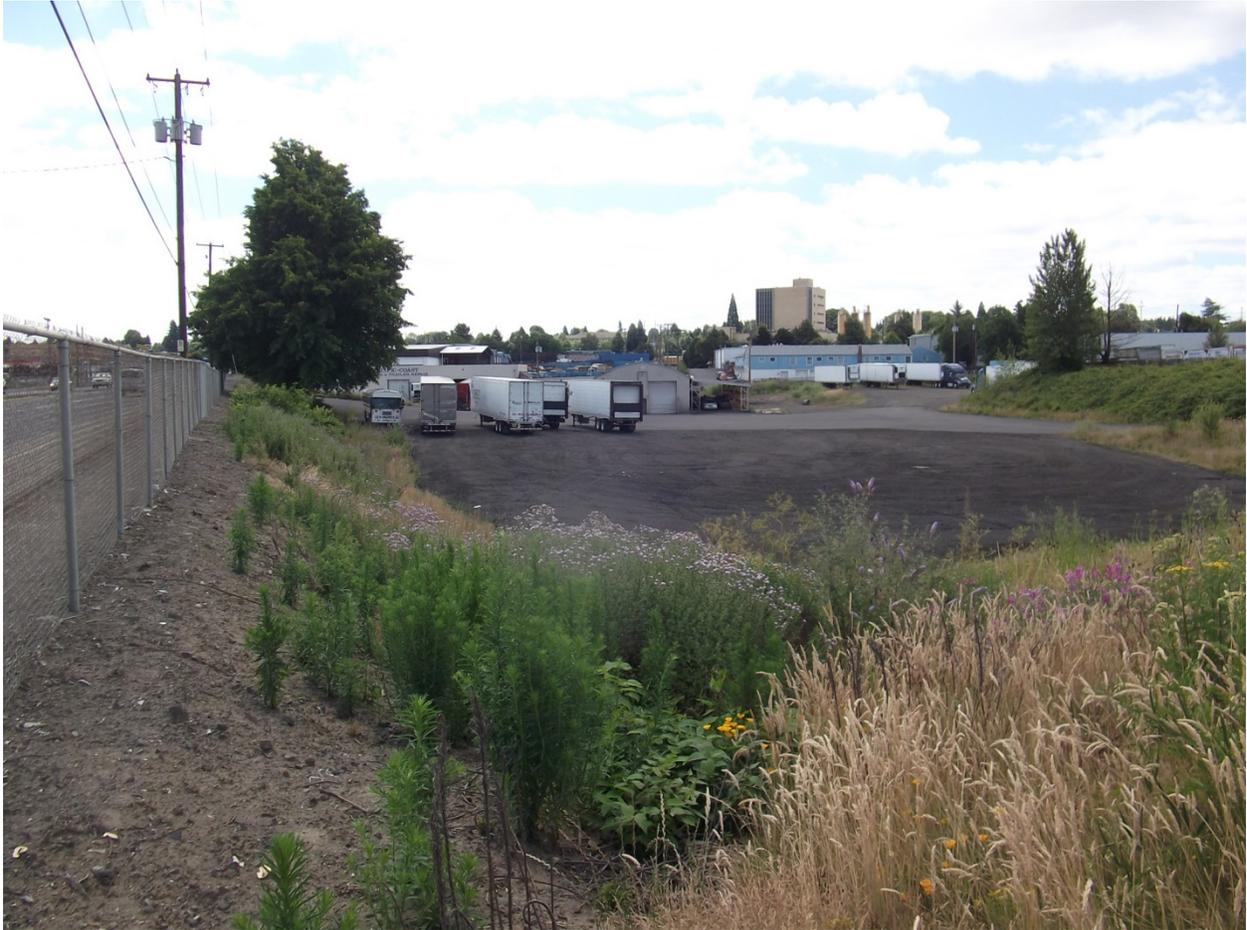
**Figure 4: Photo of Current Site Conditions**

No additional activities are required for this site. The site was remediated in 1992. In the fifteen years since the site was remediated, site inspections have noted that the area was filled with an additional 5 to 10 feet of additional fill preventing any incidental contact with the residual site contamination.

View of the site looking south. Picture shows the former impoundment area and extent of filling. Darker cover is compacted rock, and lighter cover is paving. There is no longer an elevation difference between the laydown area and the former impoundment area. The road on the left of the picture is Martin Luther King Jr. Boulevard.
