THE UNITED STATES AIR FORCE INSTALLATION RESTORATION PROGRAM

FIVE-YEAR ROD REVIEW REPORT

EIELSON AIR FORCE BASE, ALASKA

JANUARY 2004

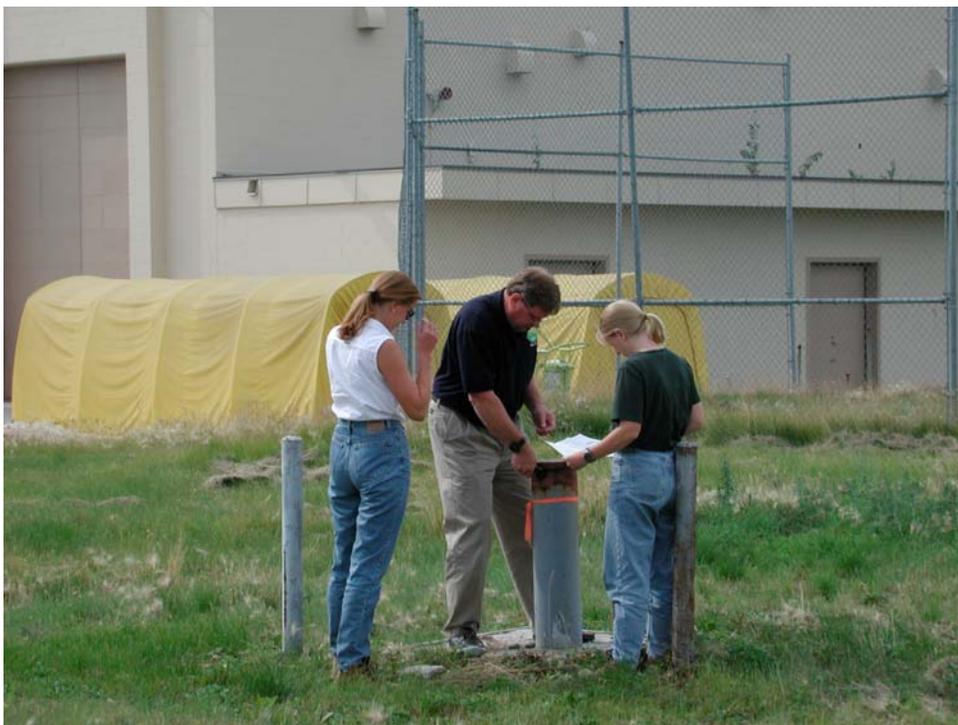
Photo 1: Site inspection team discussing monitoring well locations and sample results for site WP45/SS57. The inspection team includes USAF, USEPA, and ADEC representatives, by EA Engineering staff.

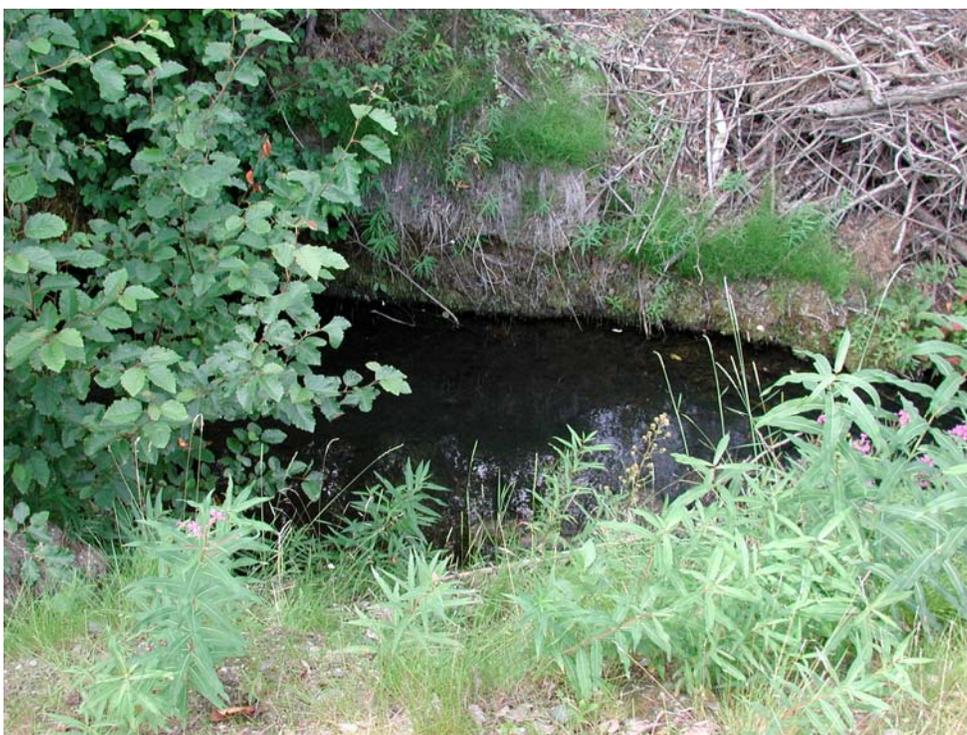
Photo 2: Garrison Slough exiting the Water Treatment Plant Pond at SS35.

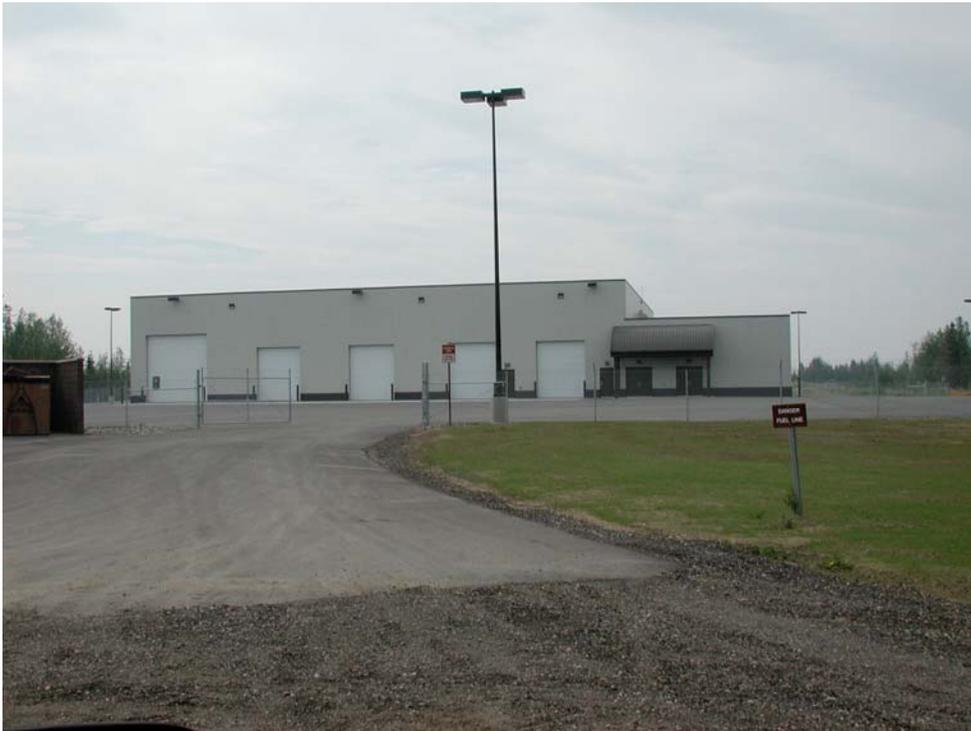
Photo 6: Munitions storage facility constructed at LF03.
