SECOND PERIODIC REVIEW

**GENERAL ELECTRIC SPOKANE SITE
SPOKANE, WA**

APRIL 2008

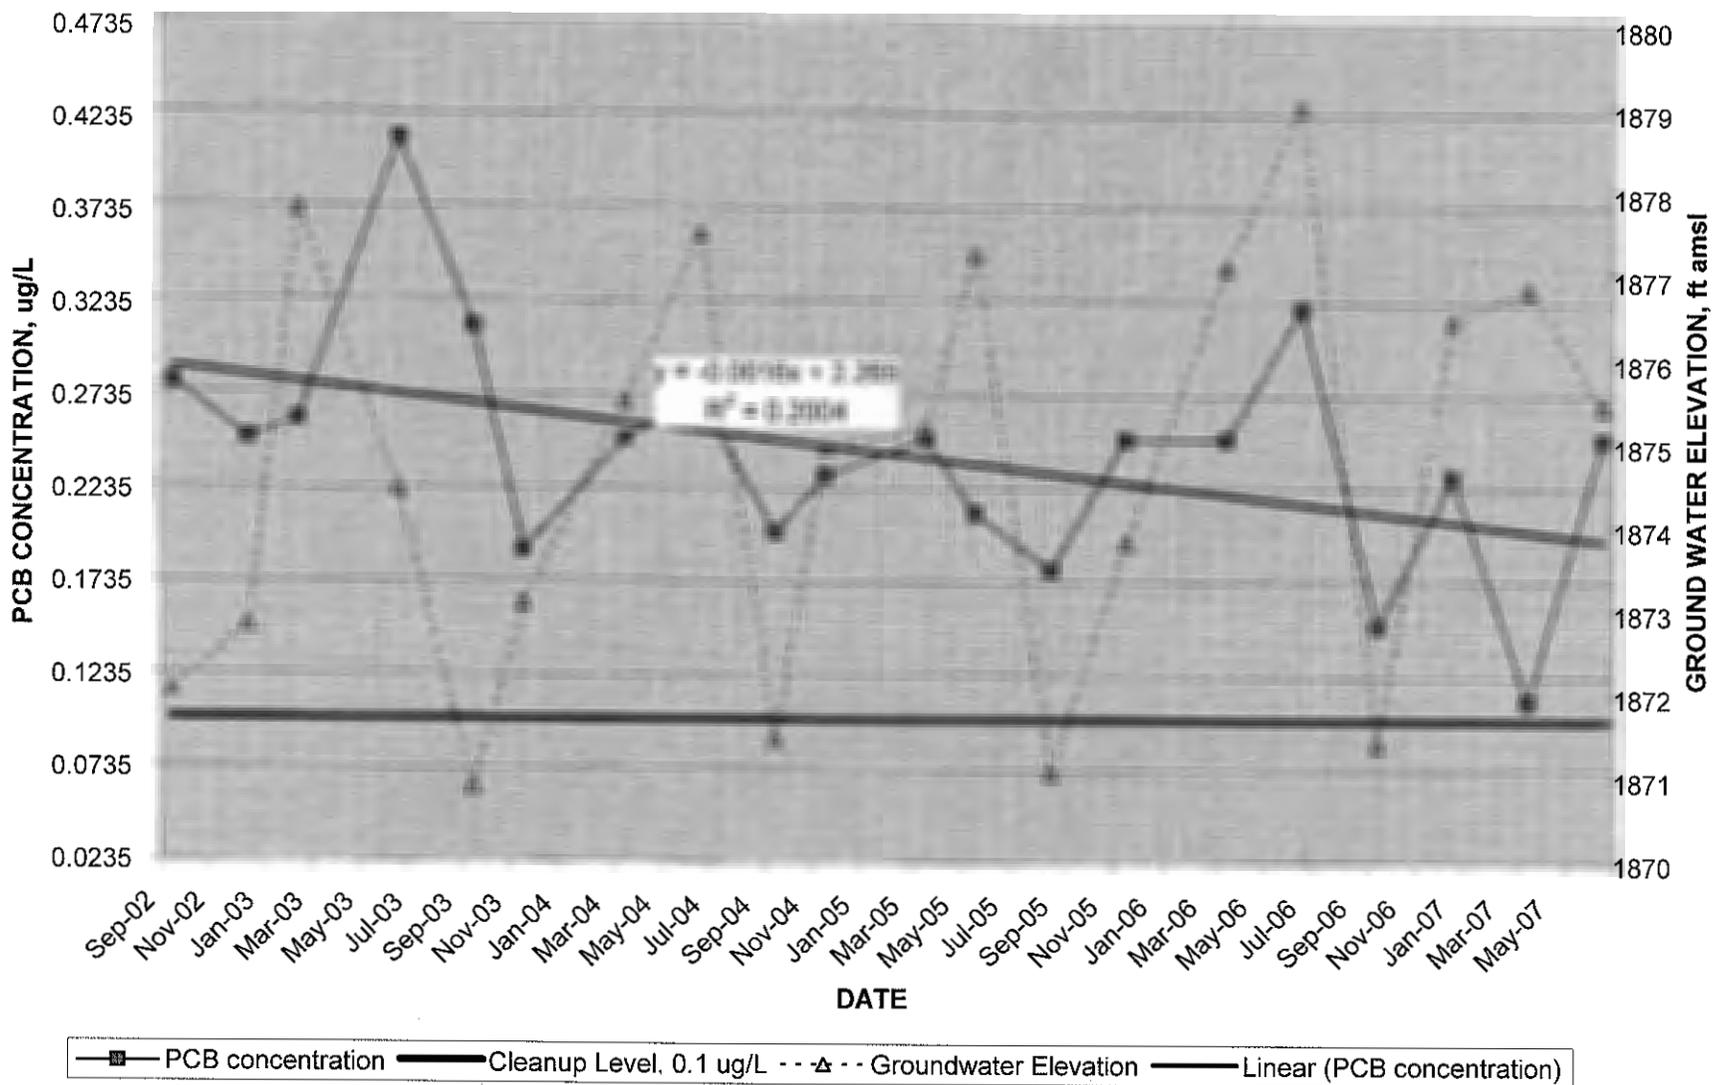
FIGURE 11. MW18 PCB CONCENTRATIONS AND GROUND WATER ELEVATIONS

PCB detections were all below the cleanup level. Higher detections occurred following high ground water elevation periods.

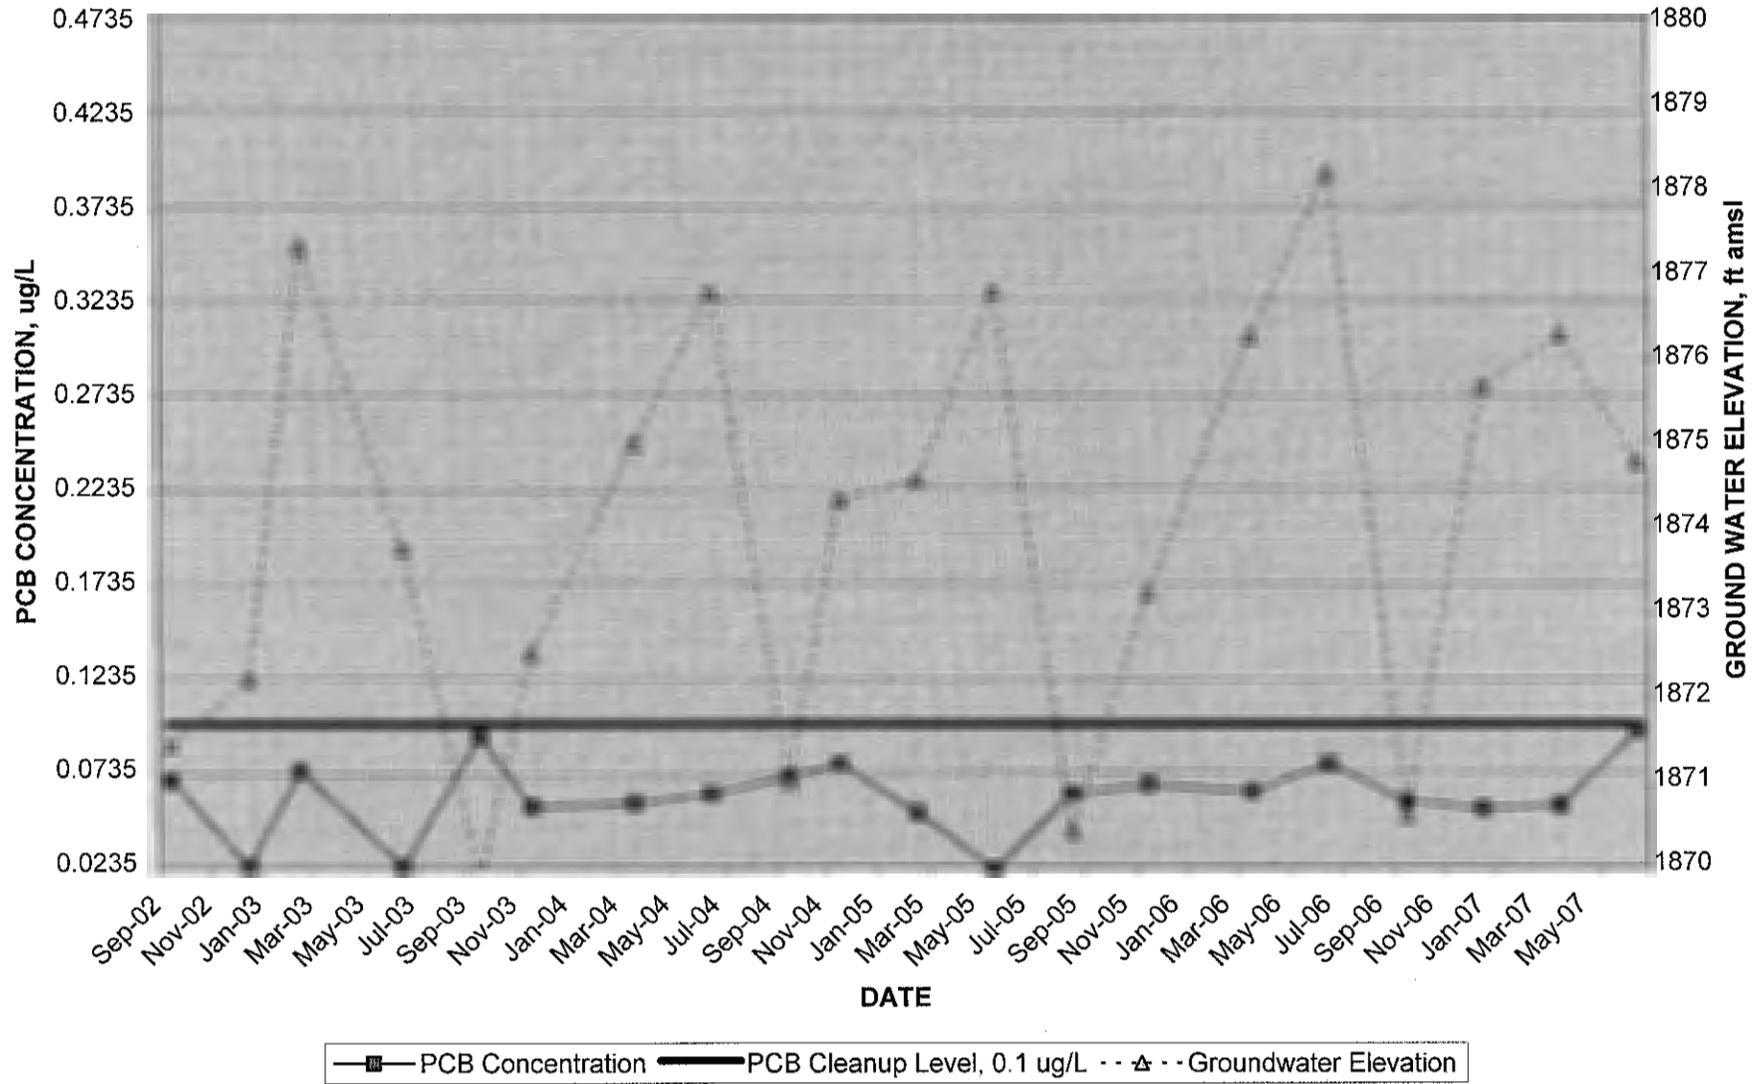
FIGURE 12. MW22 PCB CONCENTRATIONS AND GROUND WATER ELEVATIONS

This is the monitoring well that is closest to the Spokane River. PCB concentrations throughout this review period were nondetects except for one that is below the cleanup level observed in June 2003.
