**FIVE-YEAR REVIEW REPORT FOR  
JOSEPH FOREST PRODUCTS SUPERFUND SITE  
WALLOWA COUNTY, OREGON**

**U.S. Environmental Protection Agency  
Region 10  
Seattle, WA**

**Joseph Forest Products Superfund Site  
Joseph, OR  
Fourth Five-Year Review Report**

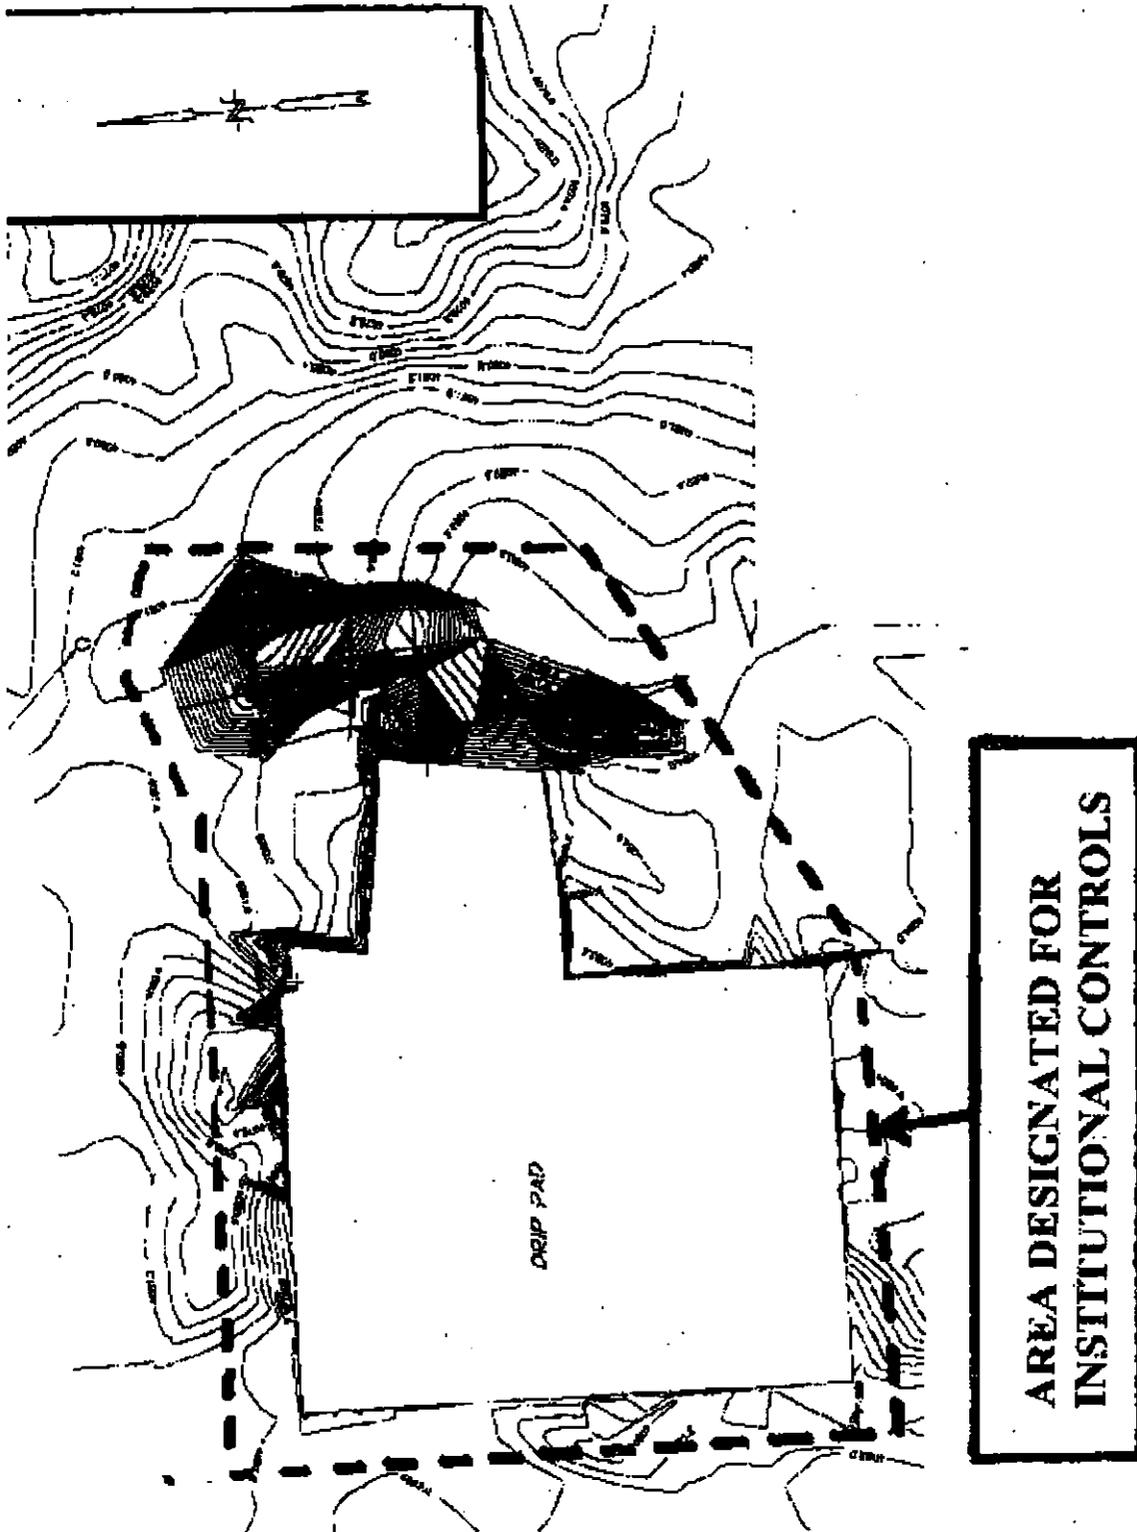
Attachment 2

The ROD required a deed restriction or an environmental notice to ensure appropriate consideration of Site conditions in future land use decisions. The majority of the Site, including all of the surface soils on Tax Lot 1000 and most of Tax Lot 802, were cleaned to levels that allowed unrestricted use. The exception was the area on Tax Lot 802 adjacent to the drip pad, a large concrete structure, where subsurface levels of contamination were based on levels that allowed for industrial use. In addition, there may be some contamination beneath the drip pad although EPA believes it is unlikely that there is extensive contamination beneath the drip pad based on the results of the drip pad decontamination work.

Issue	Recommendation and Follow-Up Action	Responsible Party	Oversight Agency	Milestone Date	Follow-Up Action: Affects Protectiveness (Y/N)?	
					Current	Future
1	Supplement or replace existing environmental notice to clearly identify the drip pad area subsurface contamination and handling requirements if the subsurface soils are disturbed and ensure that is considered in future land use decisions and activities.	Owner	USEPA	8/30/17	No	Yes
