SITCUM WATERWAY REMEDIATION PROJECT

CLEAR CREEK HABITAT IMPROVEMENT PROJECT MONITORING REPORT, 2008

GRETTE ASSOCIATES^{LLC}

JANUARY 2009

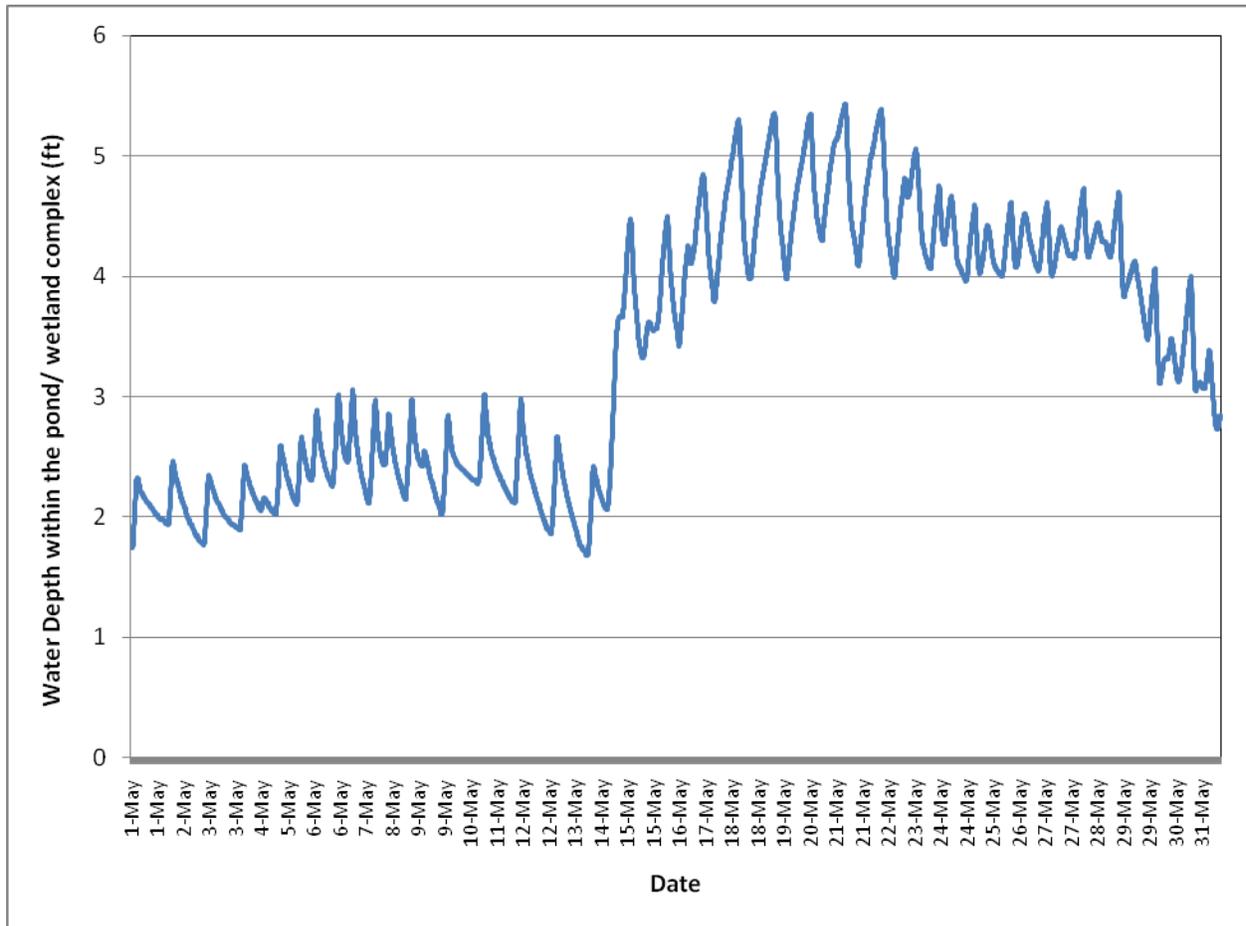
Figure 1. Tidally Induced Water Level (ft; NGVD) for the Clear Creek Habitat Improvement Project Site Pond/Wetland Complex during May 2008.

The results from May 2008 show that regular tidal-induced water level fluctuations occurred during Year 10 monitoring of the pond/wetland complex (Figure 1). The steep leading edge of each tidal curve shows that tidal flooding was unrestricted. The extended trailing edge of each tidal curve demonstrates the weirs’ effectiveness at controlling water retention within the pond/wetland complex.

The 2008 monitoring activities demonstrate that adequate inundation continues to occur within the pond/wetland complex. Previous years' monitoring results have documented salmonid and waterfowl utilization of the Clear Creek habitat area. It is expected that adequate inundation will continue to occur and fish and waterfowl will continue to utilize the habitat.
