Final Report

Taylor Lumber and Treating Superfund Site Final Construction Report

Prepared for
U.S. Environmental Protection Agency

March 2009

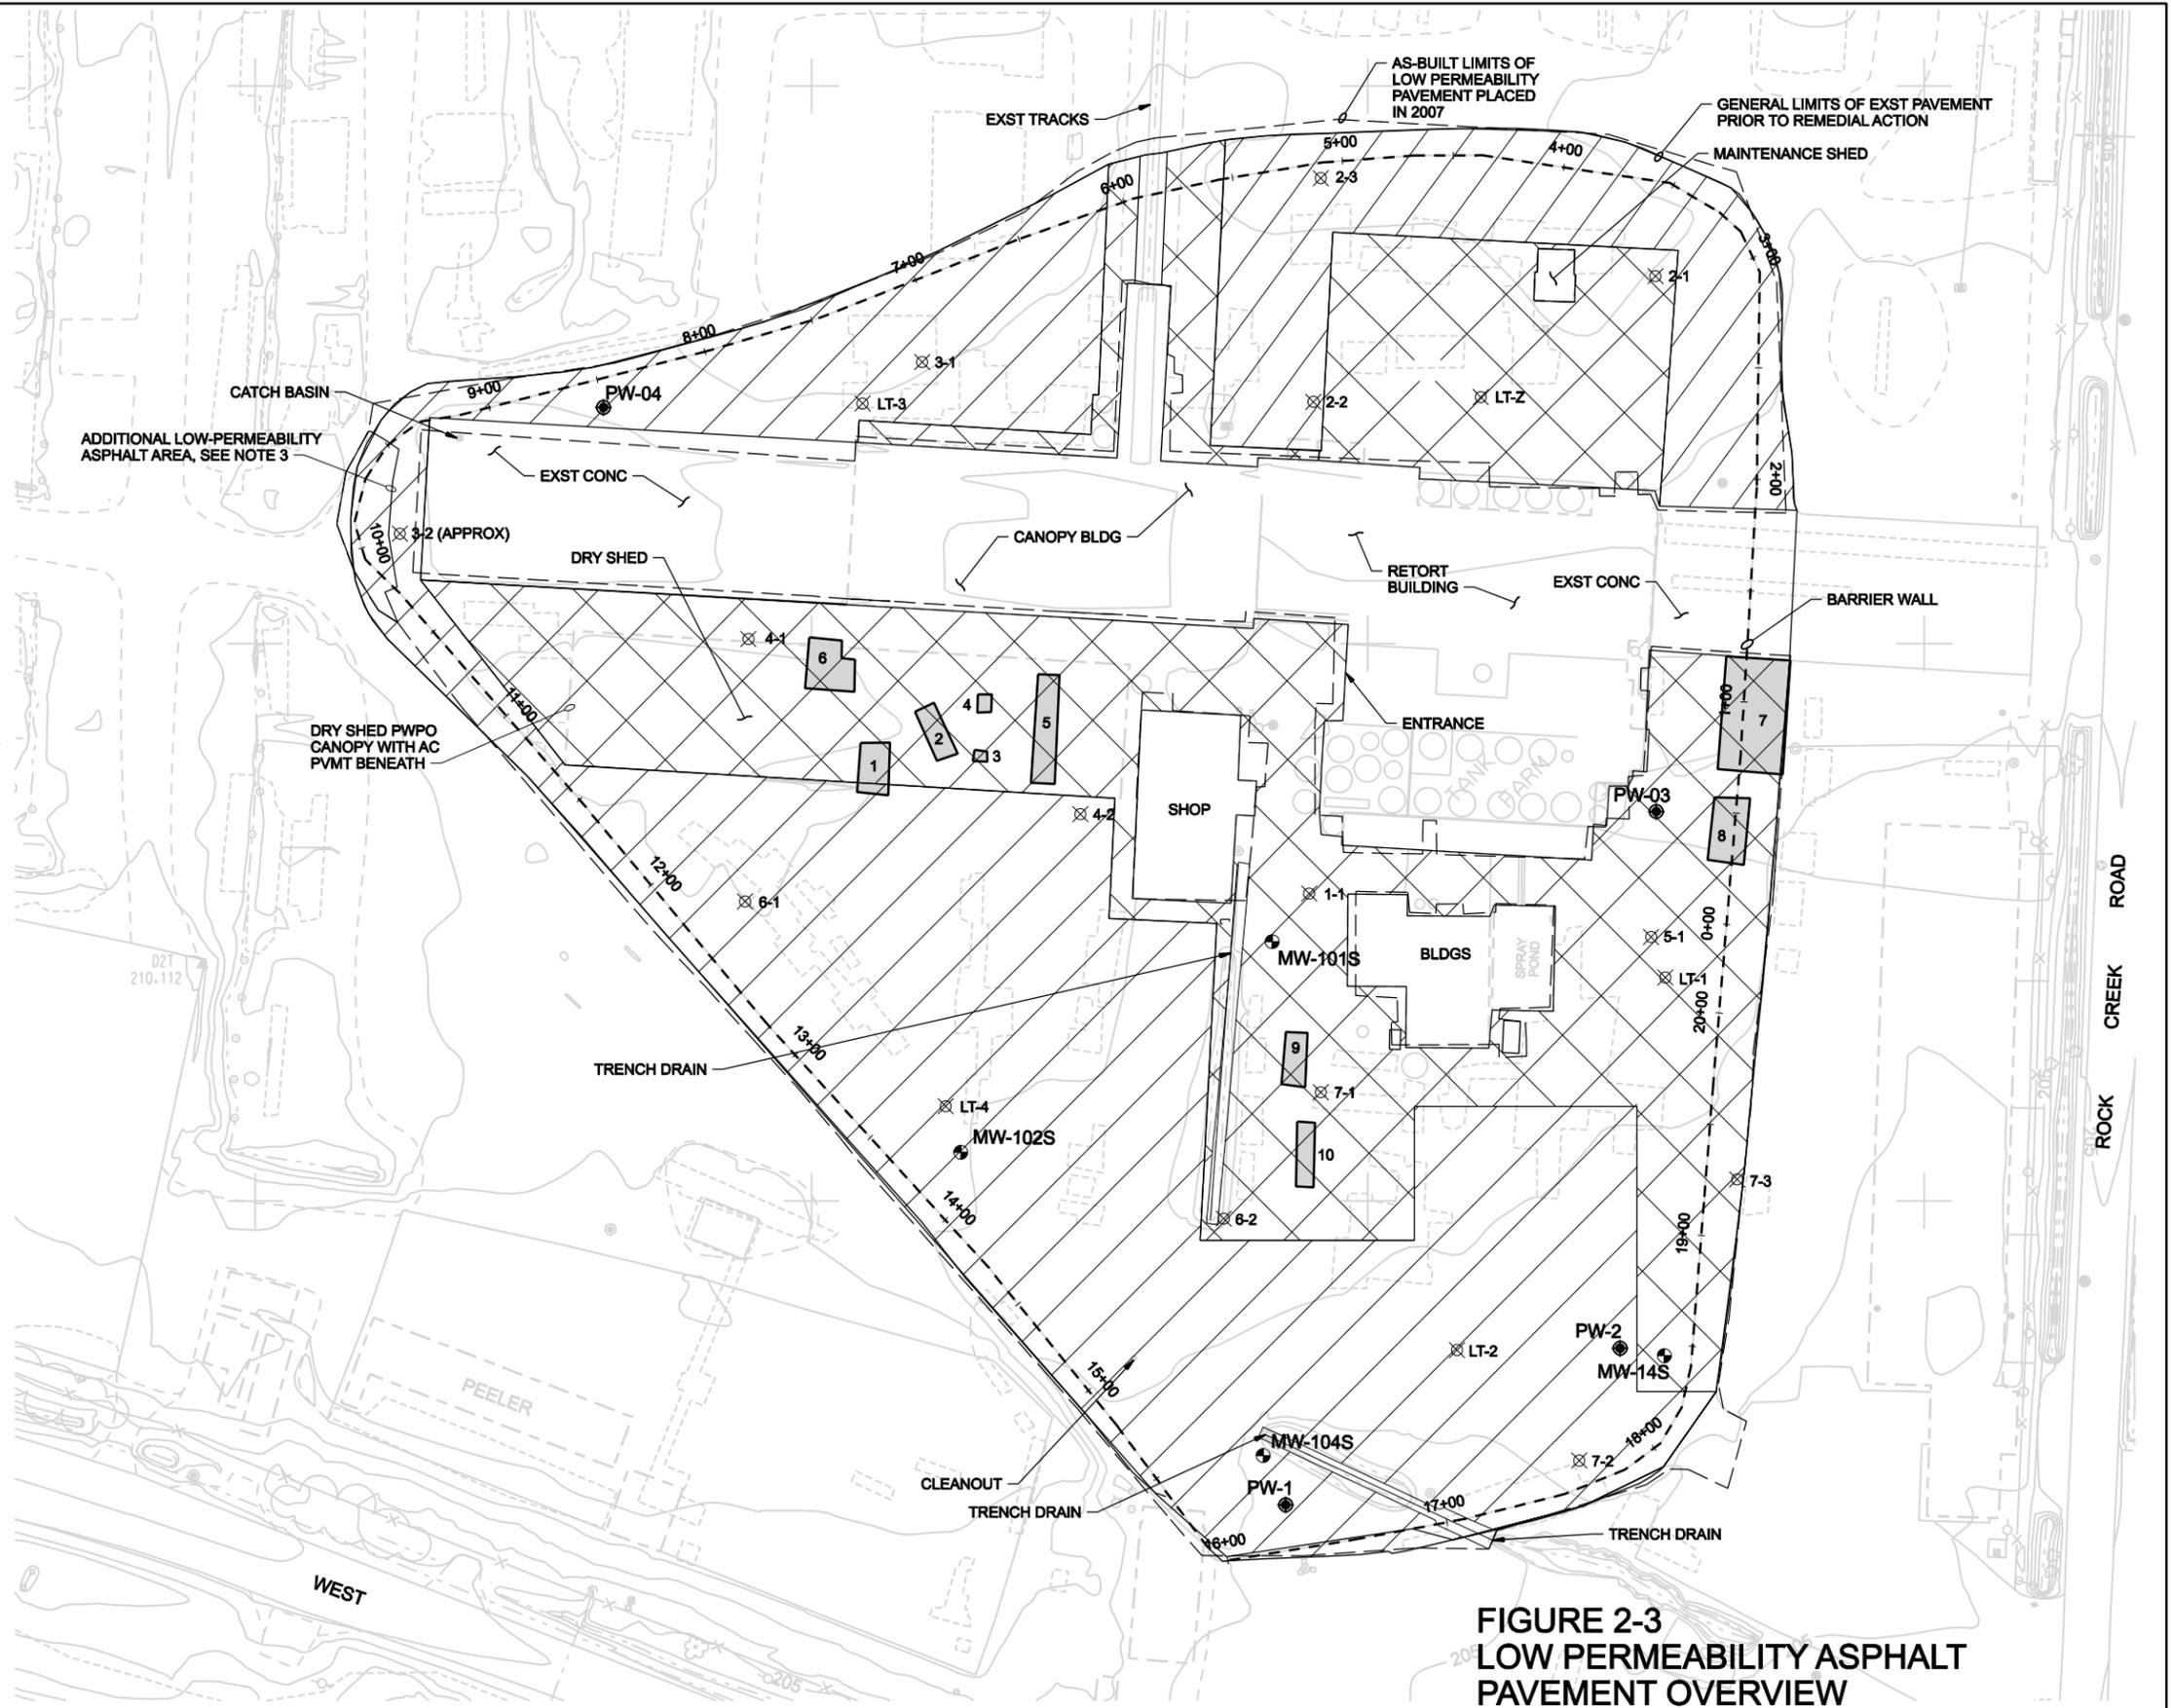
FIGURE 2-3
LOW PERMEABILITY ASPHALT
PAVEMENT OVERVIEW
 TAYLOR LUMBER AND TREATING SUPERFUND SITE

Based on the testing, only one of the core locations (location 4-1) did not meet the specified 1×10^{-8} cm/sec permeability criteria. Two core locations were found to be significantly thinner than the 4-inch thickness required by the specifications.

As noted above, two asphalt core locations were identified with thicknesses significantly below the 4 inch requirement specified. The reduced thickness raises concern about the pavements long term ability to withstand traffic loads without rutting or cracking and premature failure.

- NOTES:**
1. ASPHALT PATCHES #1, #2, #3 AND #5 FAILED SUBGRADE COMPACTION REQUIREMENTS AND ARE COVERED BY A 5-YEAR SUPPLEMENTAL WARRANTY (DATED JAN 2, 2008) FROM BAKER ROCK RESOURCES.
 2. LOW PERMEABILITY ASPHALT OVERLAY MEASURES APPROXIMATELY 5.37 ACRES. (EXCLUDING EXISTING BUILDINGS). OUTER LIMITS OF LOW PERMEABILITY ASPHALT CAP MEASURES APPROXIMATELY 6.75 ACRES (INCLUDING BUILDING ACRES).
 3. A 1,455 SF AREA OF LOW PERMEABILITY ASPHALT WAS ADDED AFTER COMPLETION OF PAVING OPERATIONS. THIS AREA WAS ADDED BECAUSE THE ORIGINAL PAVING LIMITS DID NOT EXTEND OUTSIDE OF THE BARRIER WALL CENTERLINE TO THE LIMITS SHOWN IN THE DESIGN DRAWINGS.
