**FIVE-YEAR REVIEW REPORT FOR
TAYLOR LUMBER AND TREATING SUPERFUND SITE
YAMHILL COUNTY, OREGON**

EPA ID: ORD009042532

**U.S. Environmental Protection Agency
Region 10
Seattle, Washington**

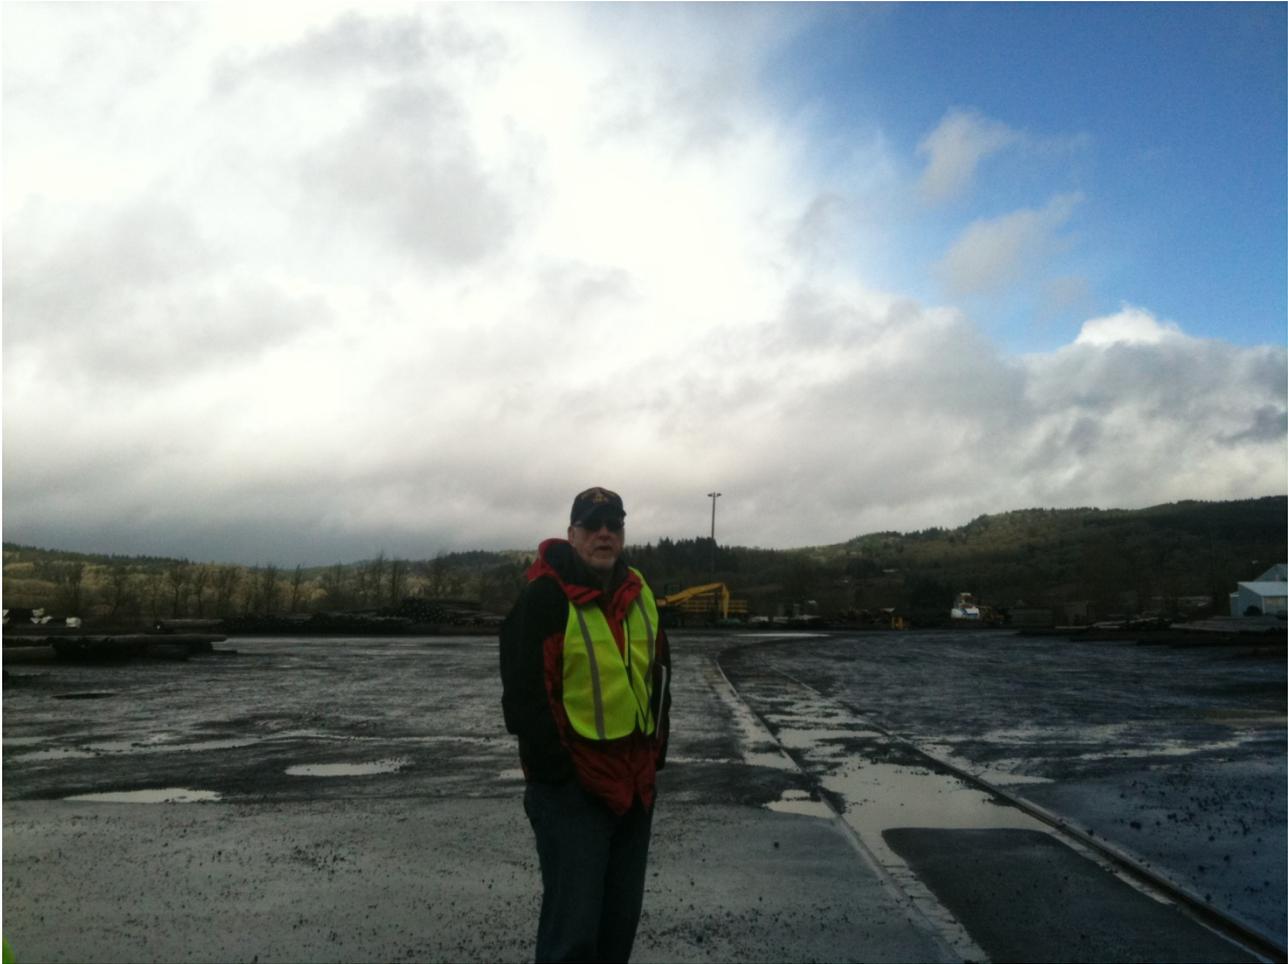
3. North edge of site showing water build-up where the railroad tracks enter the site and gravel over the MatCon surface..

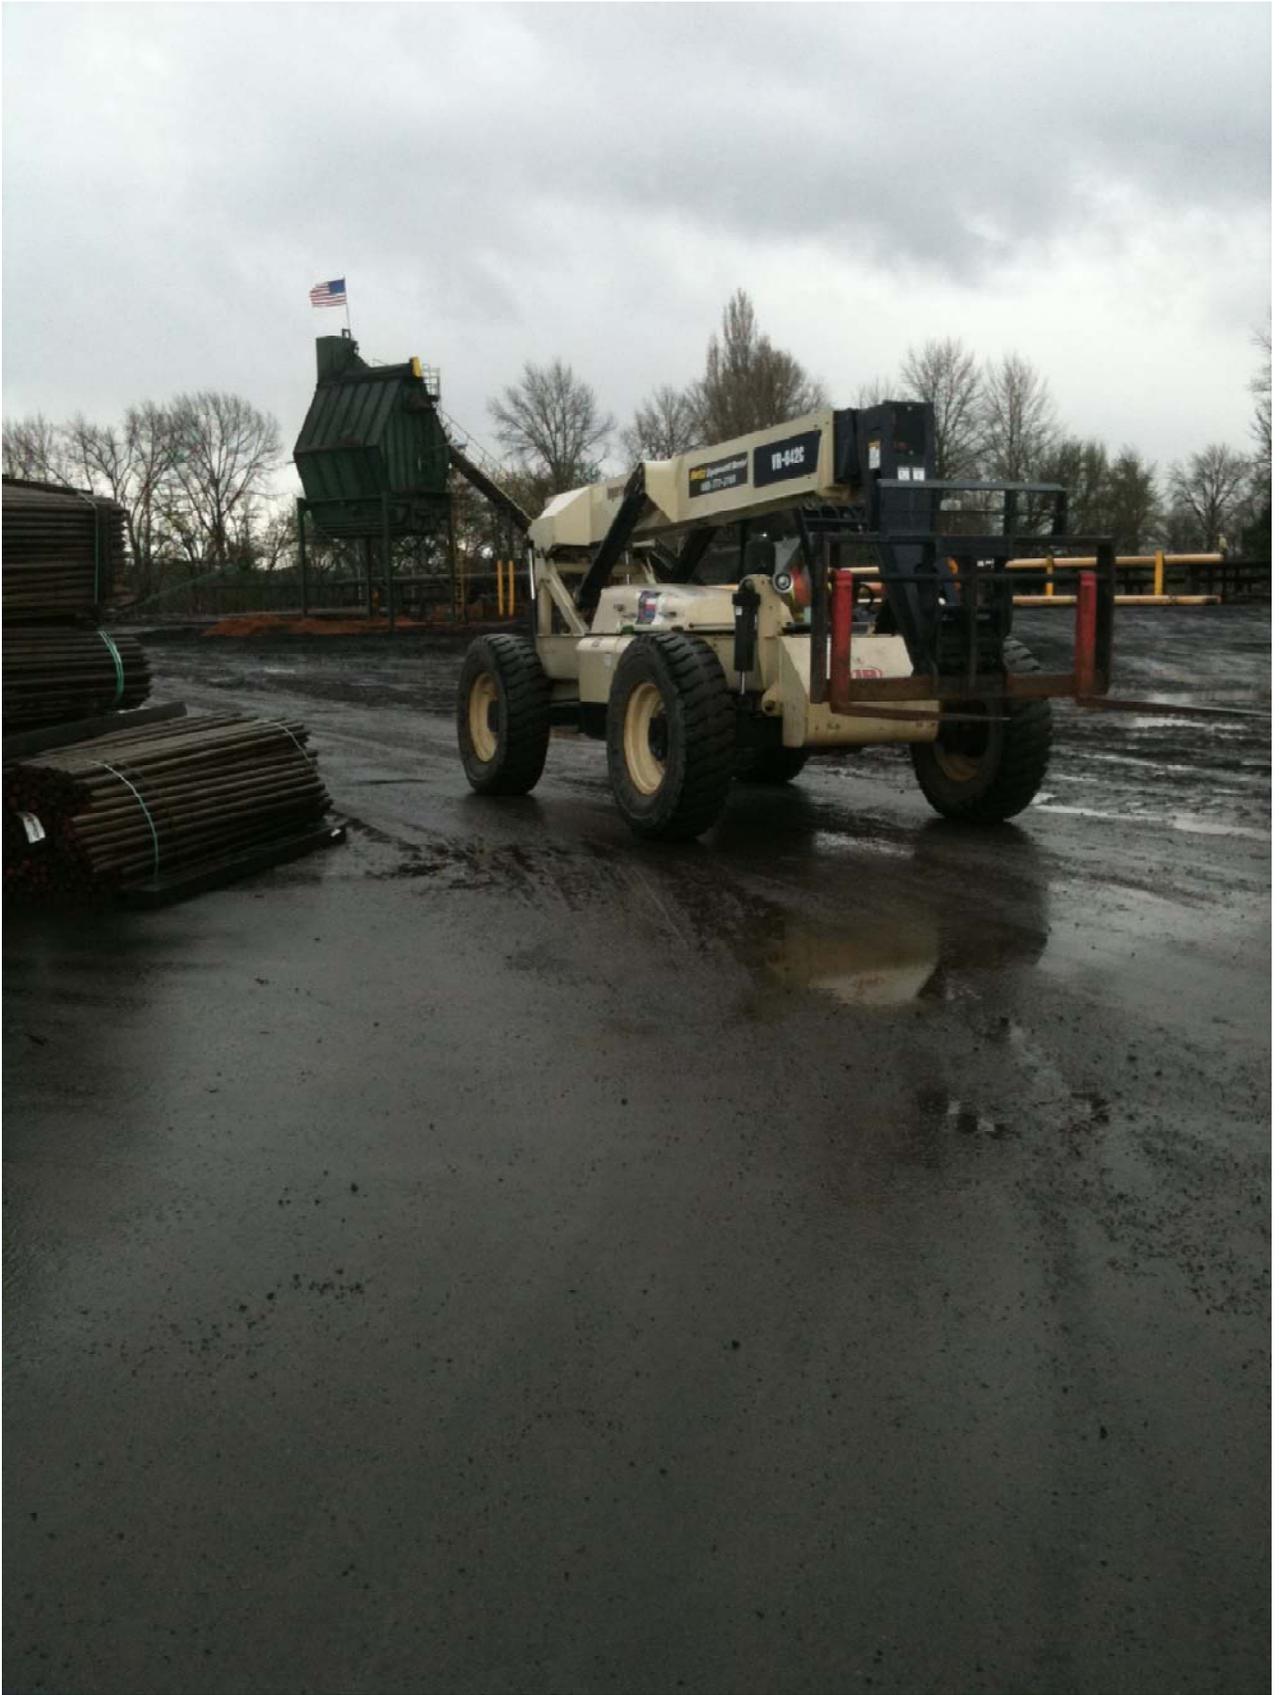
4. West edge of cap showing typical traffic path and build-up of mud and gravel on the MatCon cap's surface.

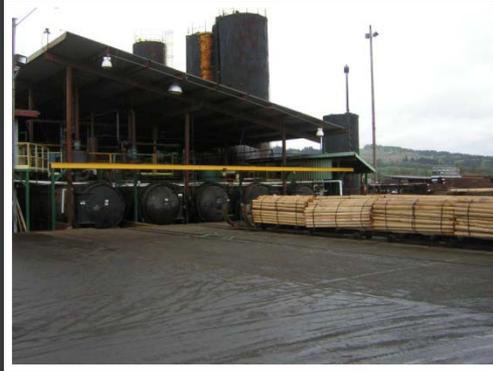
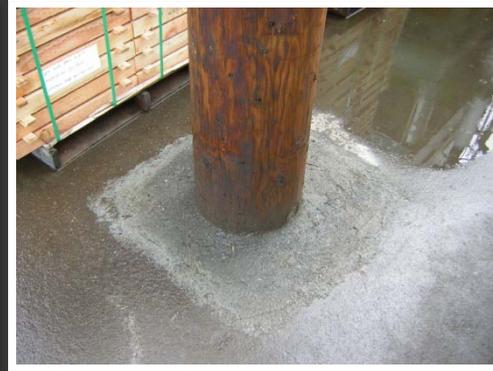
PWPO also installed a power pole through the MatCon cap and repaired the area as required by the OMP.

Patch repair in MatCon asphalt from installation of new power pole

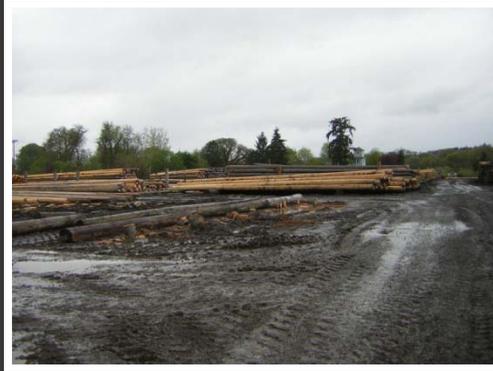
White Pole
Storage Area;
proposed
culvert work
should minimize
noticeable
drainage issues

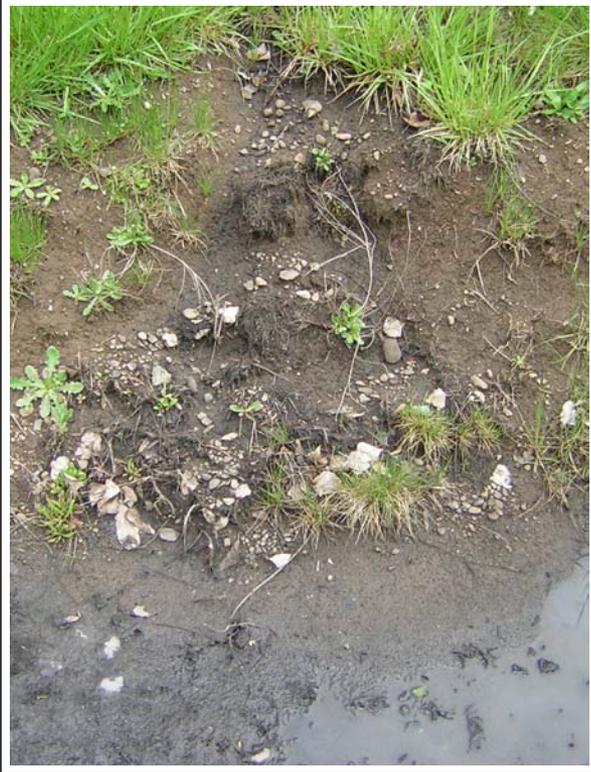
Observed discharge from the peeler area to the ditch along Highway 18B; PWPO sampled stained soil/grass for tannins/lignins and petroleum.
