OU1: Allied Landfill

OU2: Willow
Boulevard/A-Site
Landfill

OU2: Willow Boulevard/A-Site Landfill

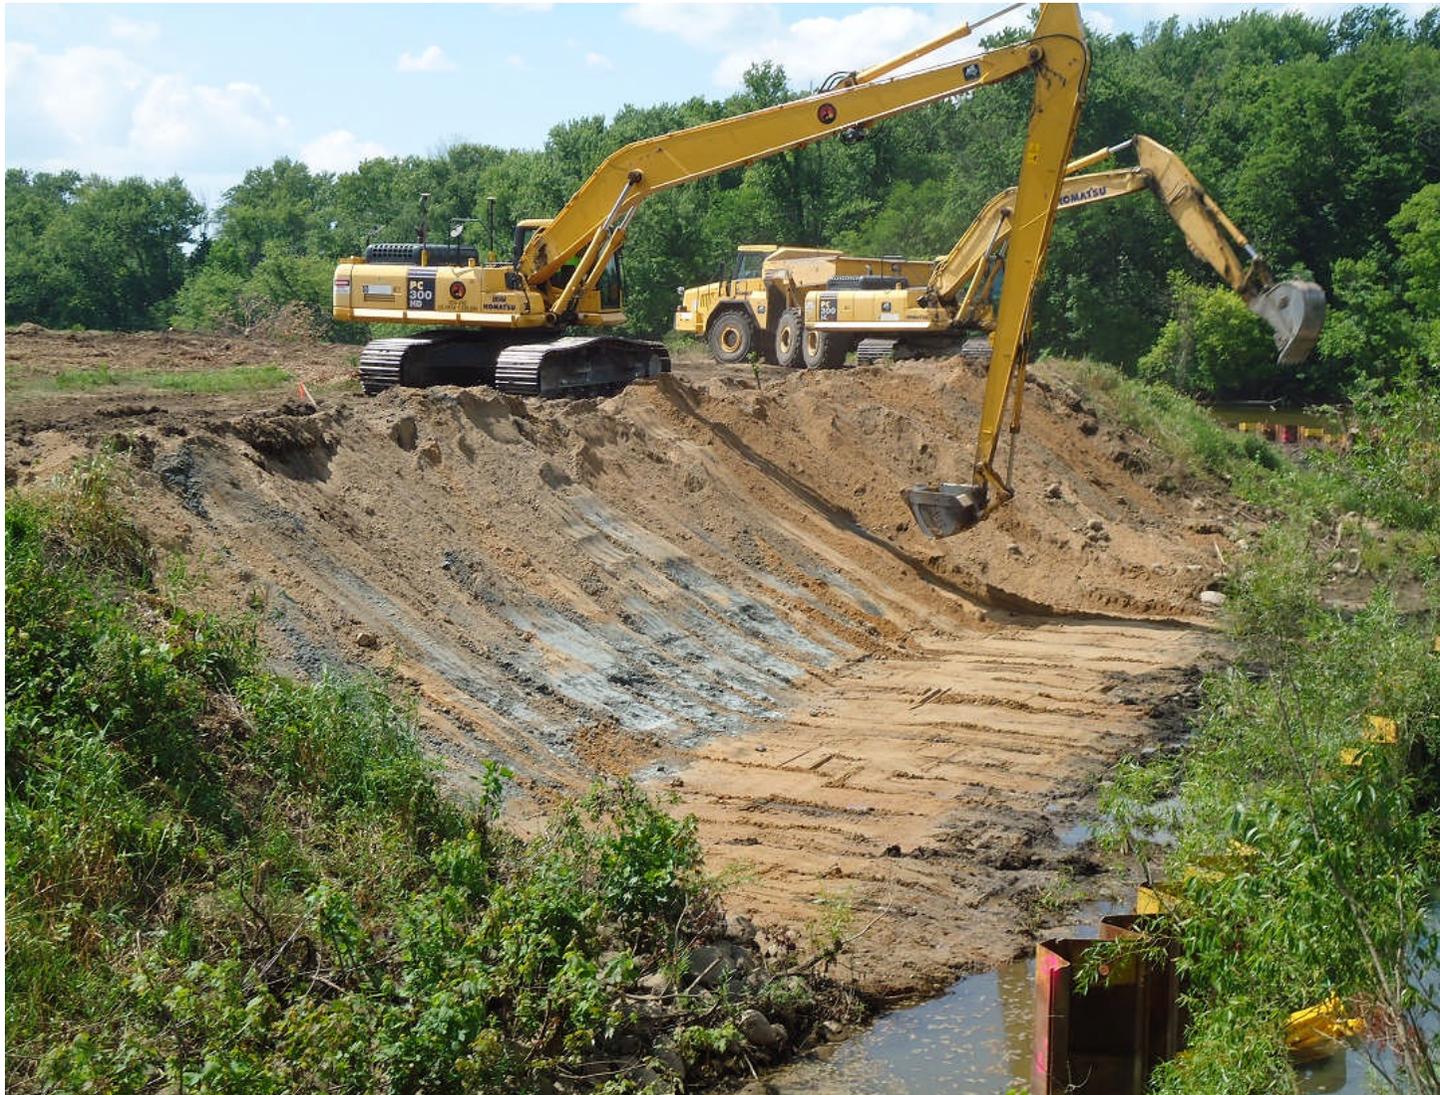
July 6, 2011 – Excavation along the eastern riverbank continues, gray paper residuals visible in the side of the bank.

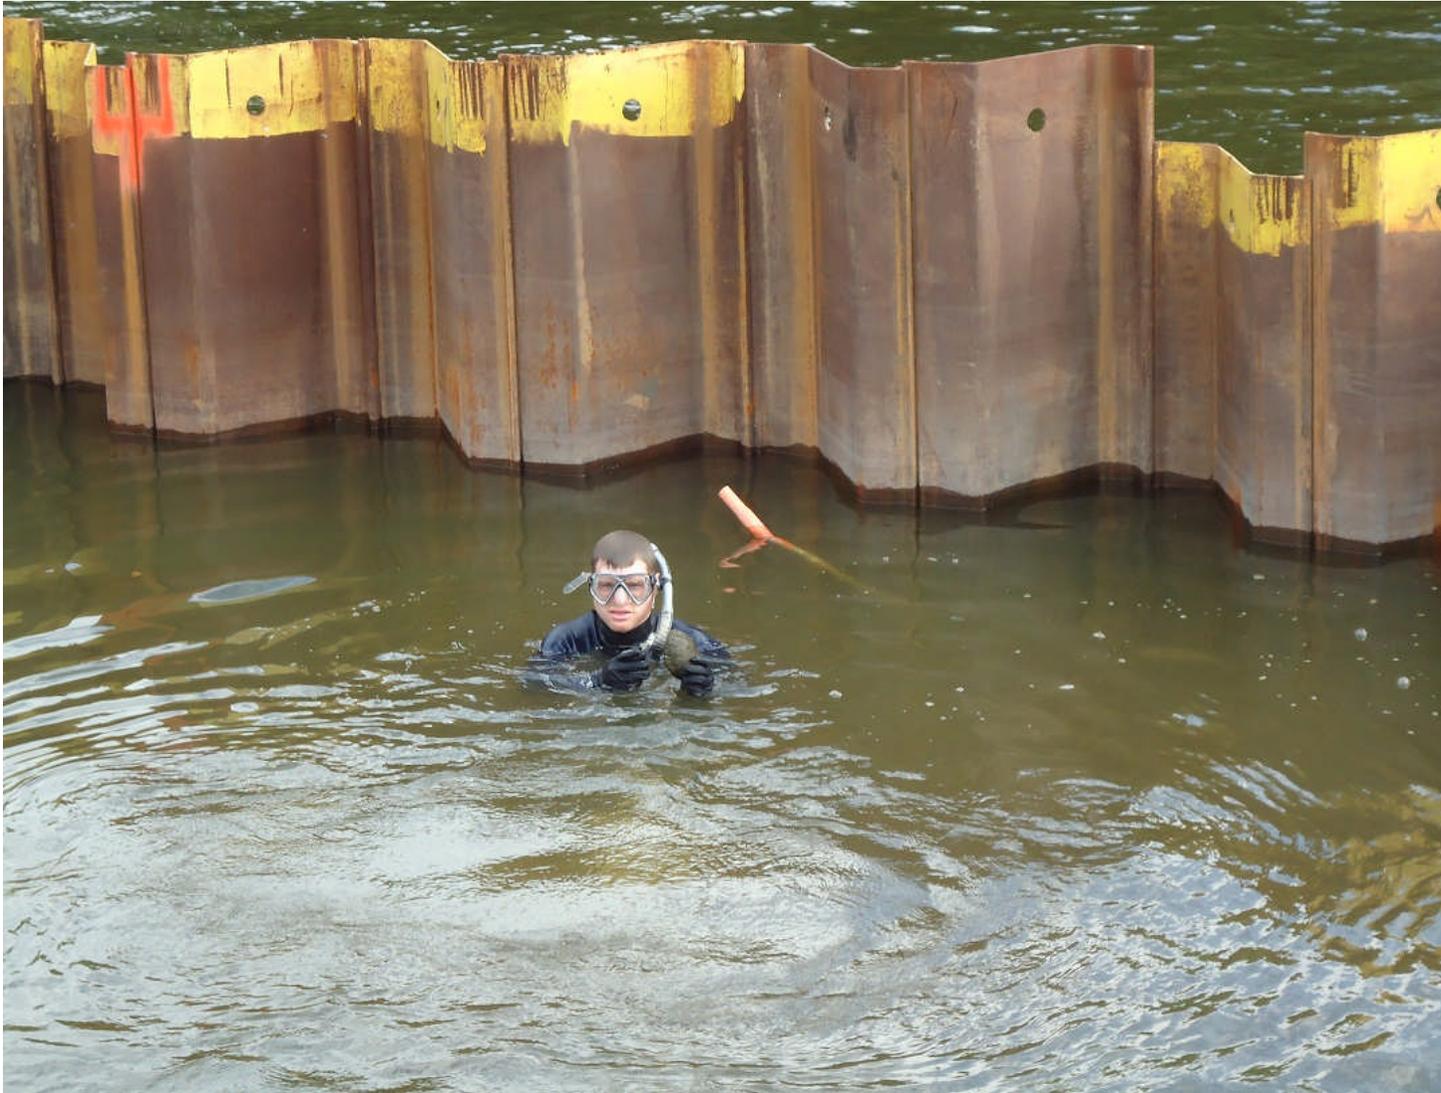
July 6, 2011 – Gathering of muscles inside of the sheet pile turbidity barrier takes place. The muscles were relocated to a similar habitat along the riverbank in the vicinity of the project site

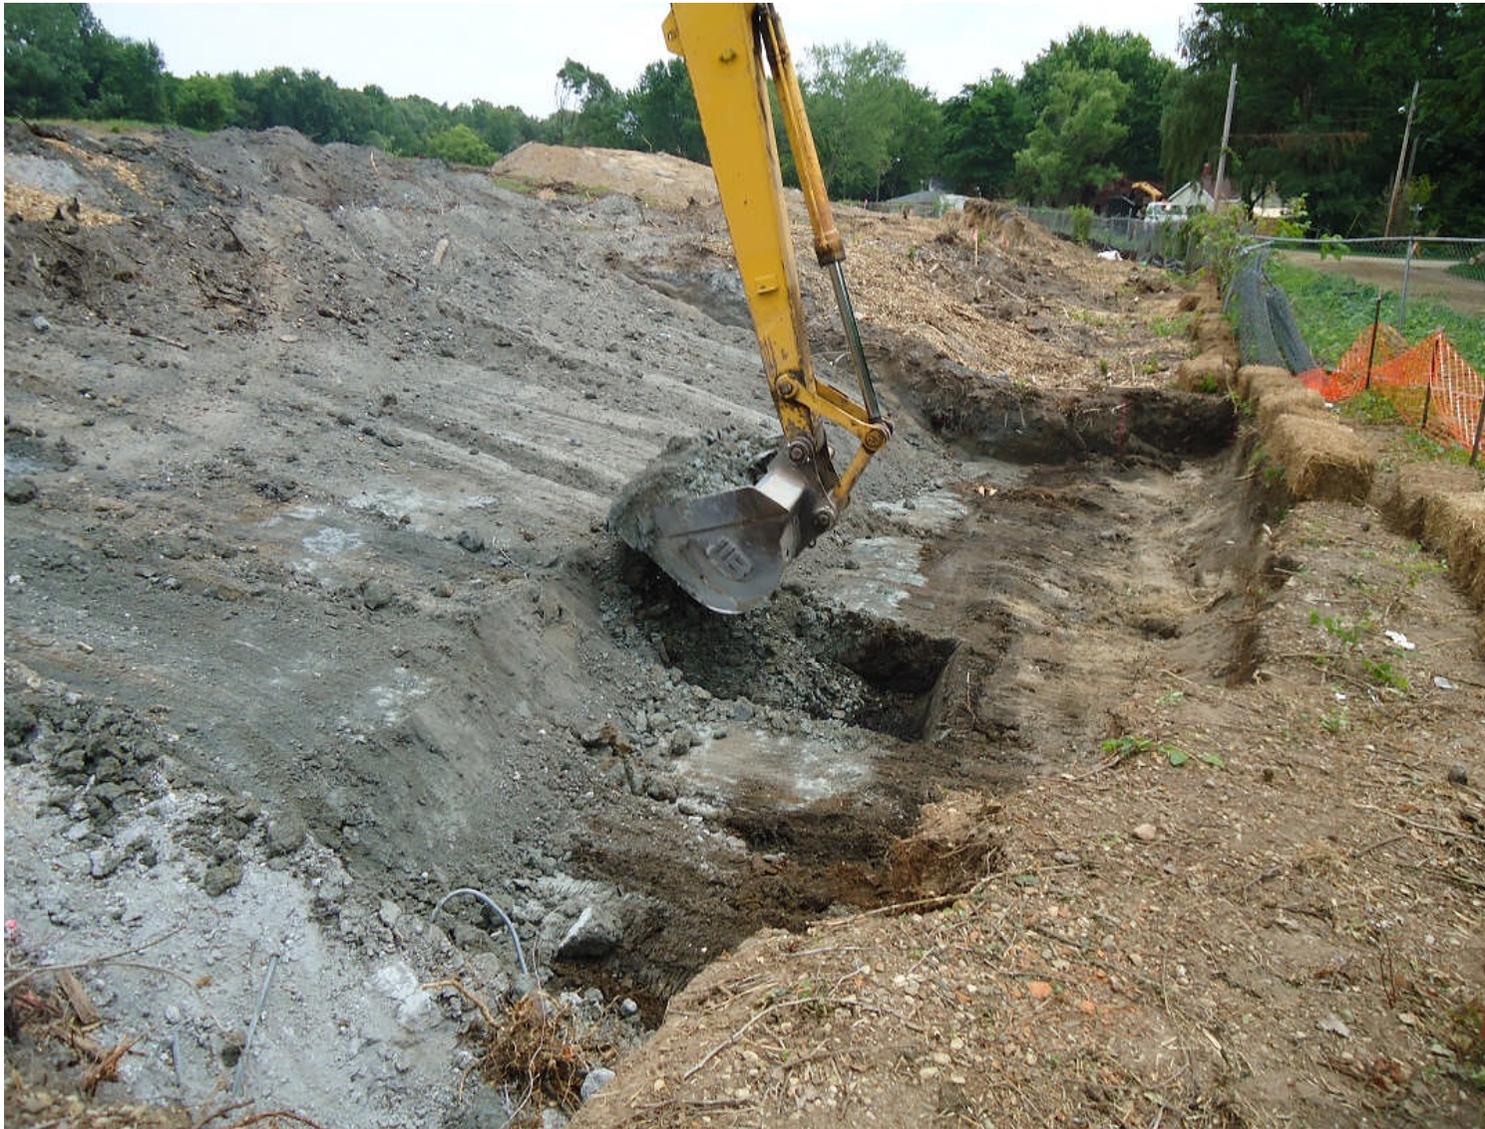
July 7, 2011 – Excavation along the southern property line and grading of the southern slope continues.

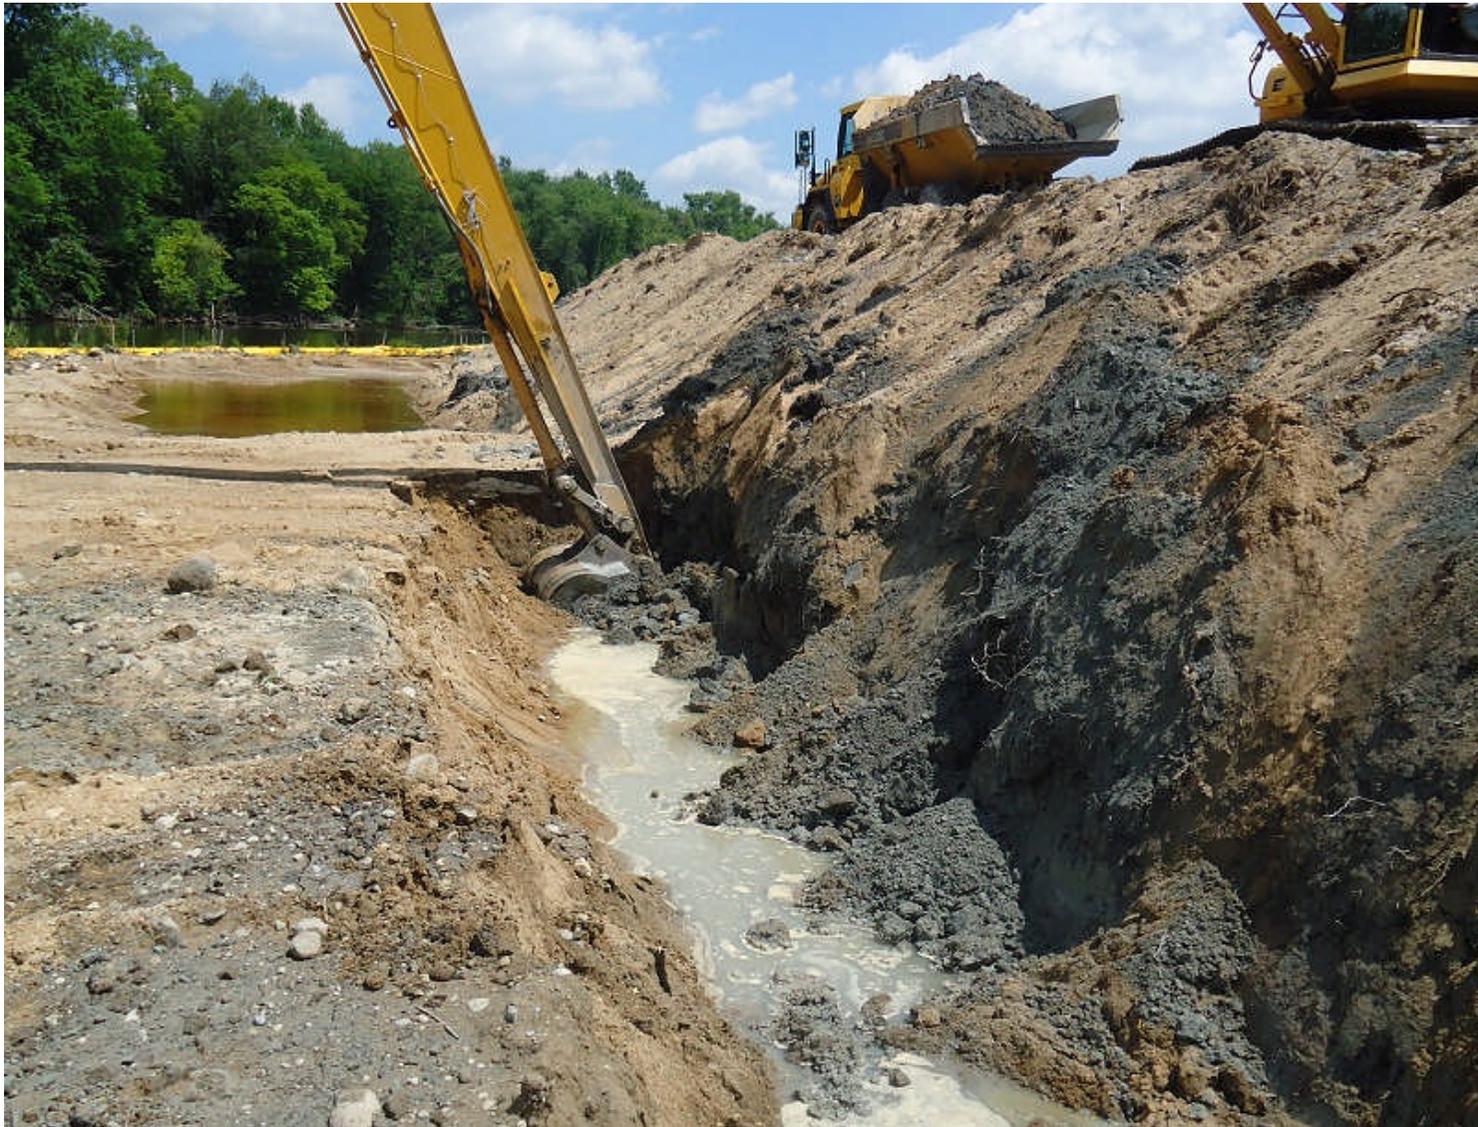
July 25, 2011 – Excavation in the toe of the western riverbank. Removed material was taken via truck to the consolidation area within the site.

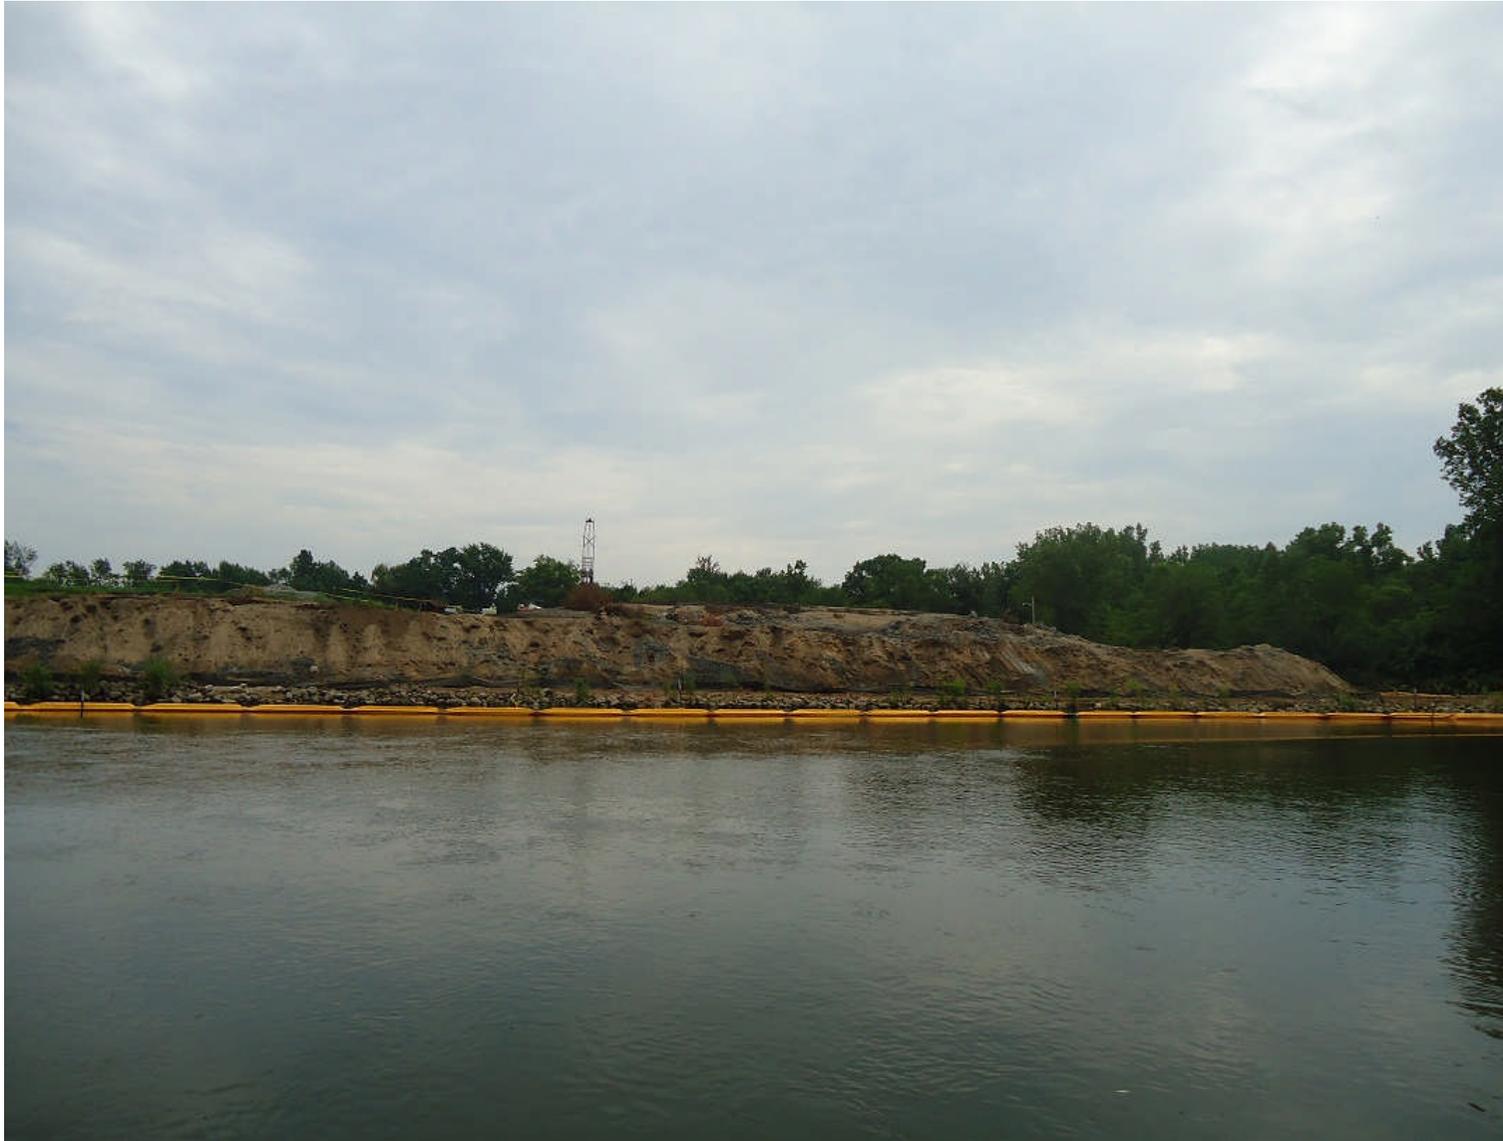
July 28, 2011 – Overview of the northern side of the landfill mid excavation with turbidity curtain installed, taken from the river.

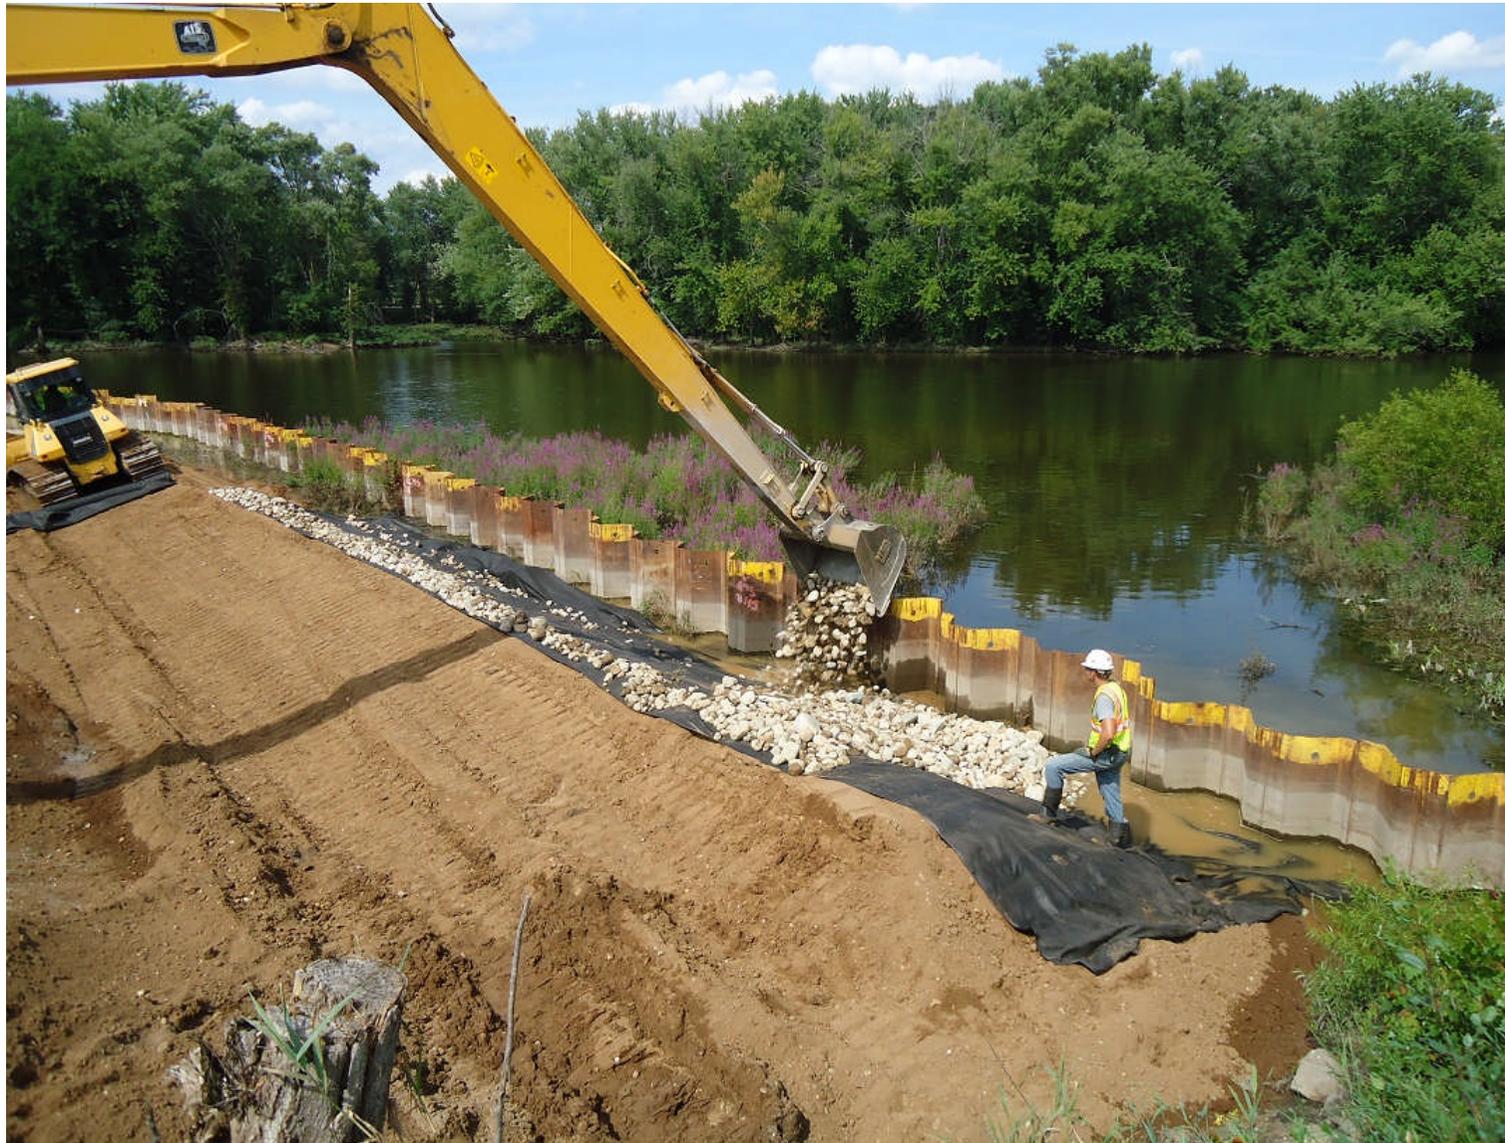
August 12, 2011 – Bank armoring with installation of fabric and habitat stone along the eastern riverbank.

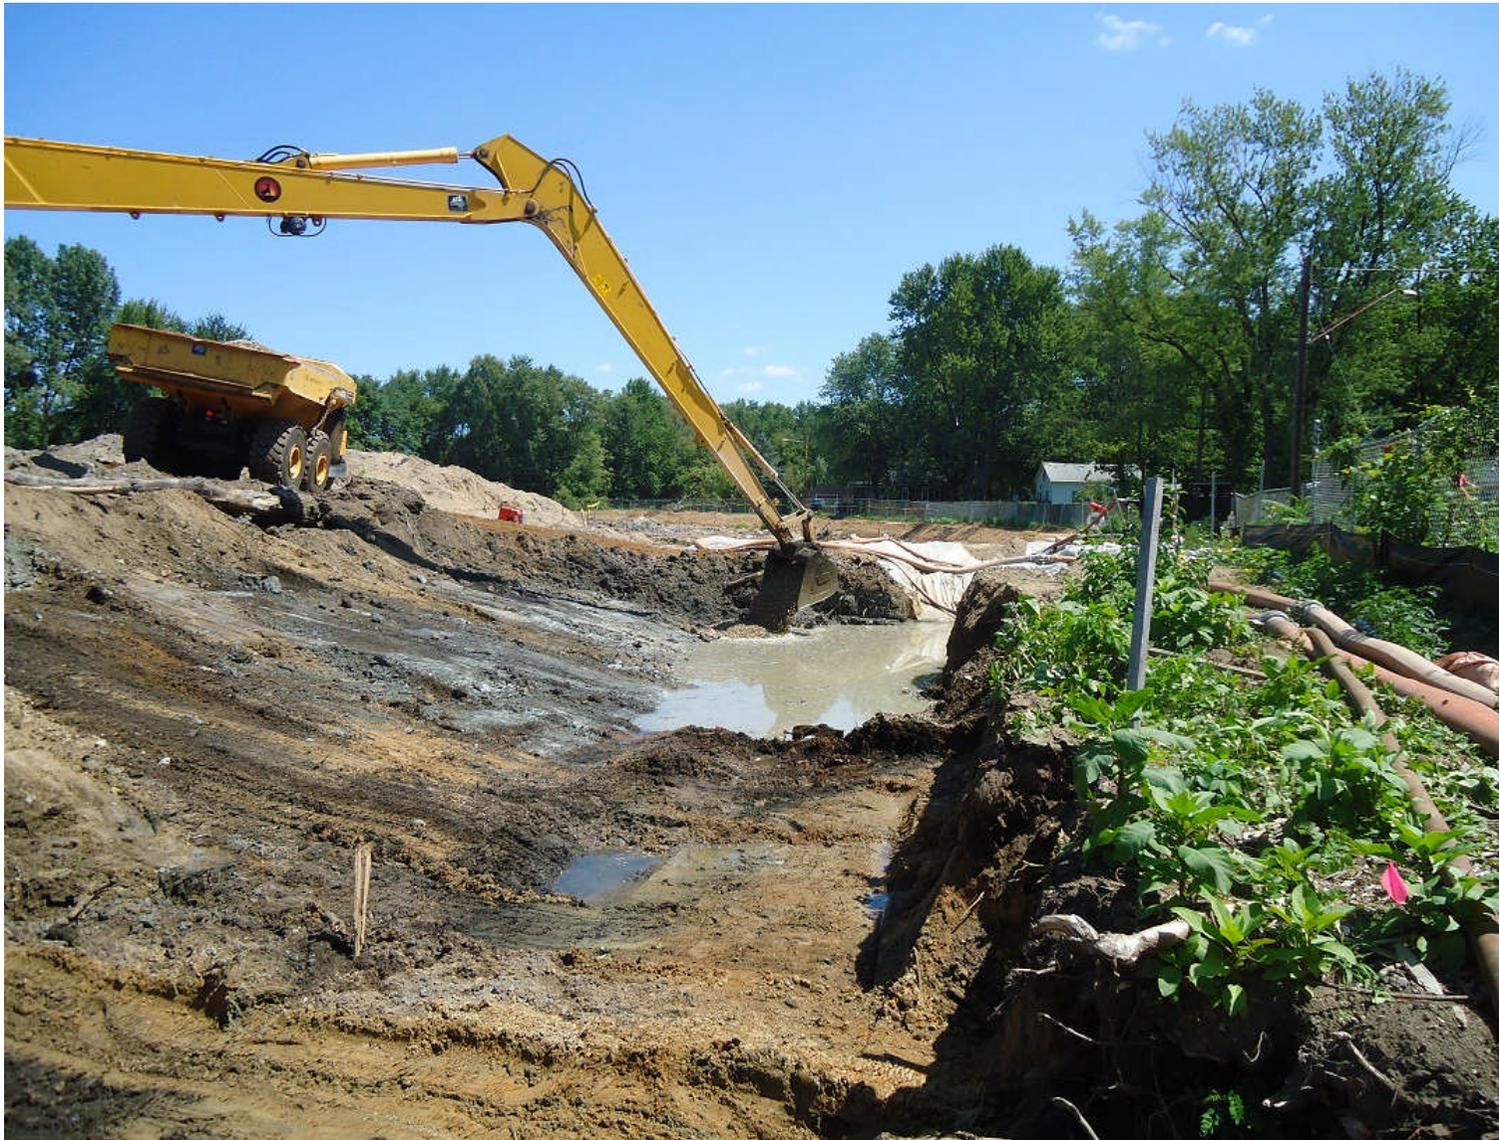
August 16, 2011 – Continued excavation along the southern property line, excavation beginning to breach the water table elevation.

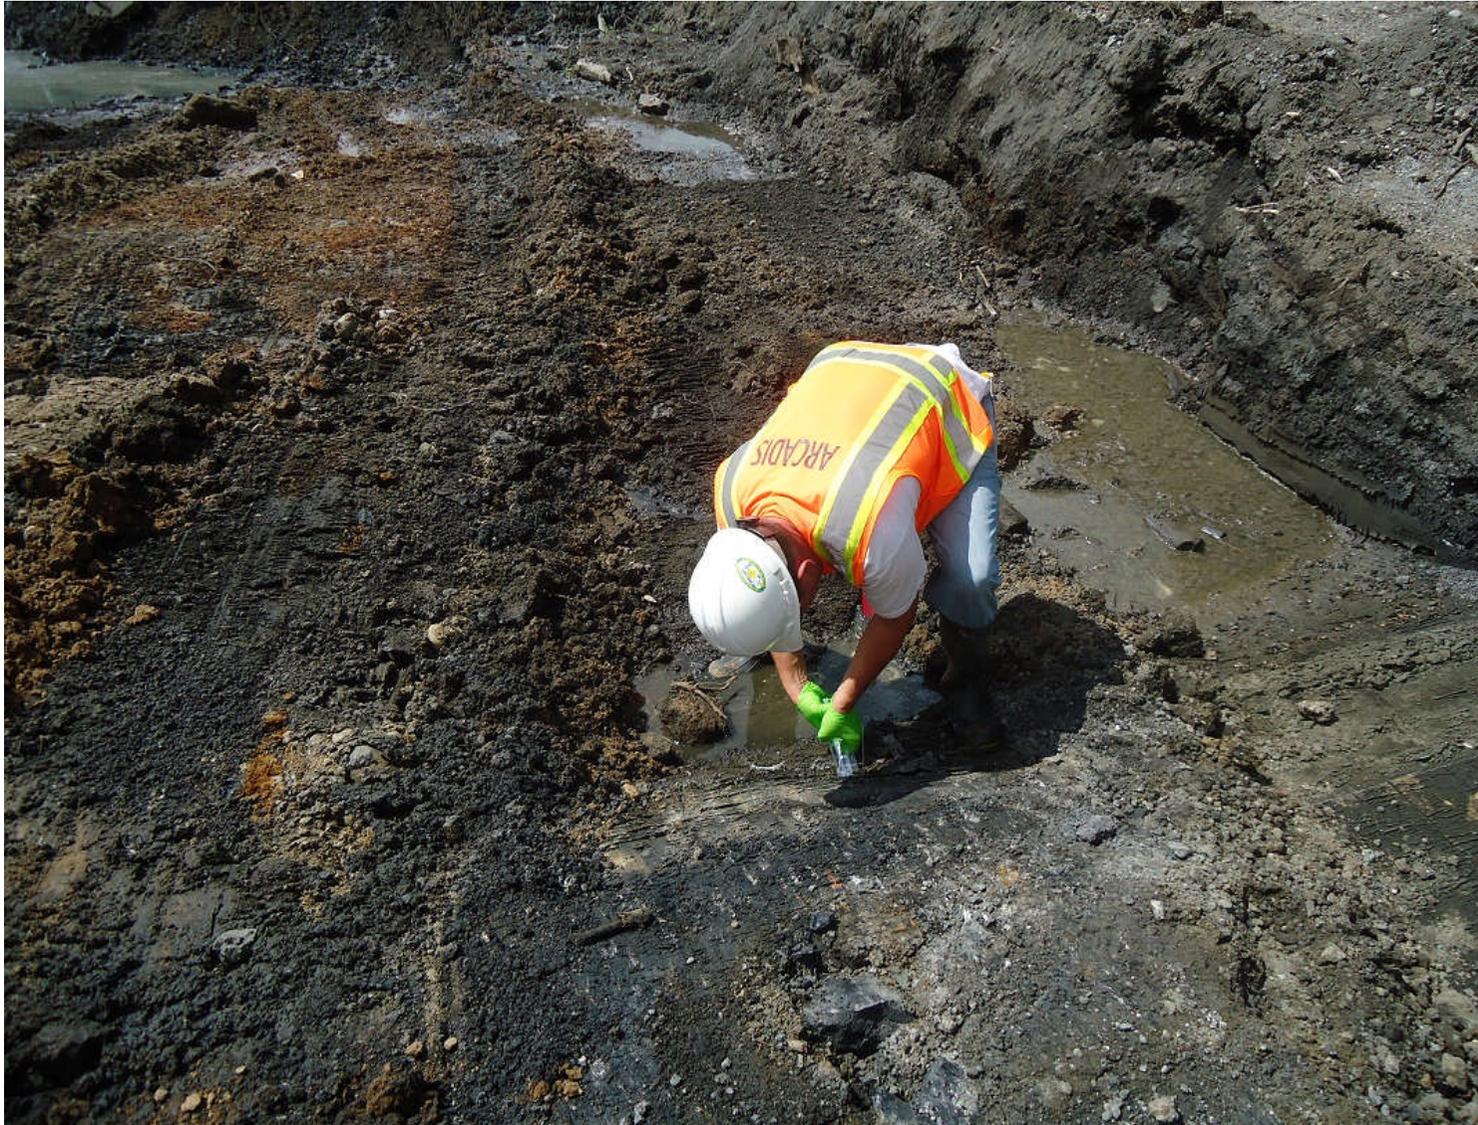
August 25, 2011 – Confirmation sampling of excavation on the southern side of the landfill.

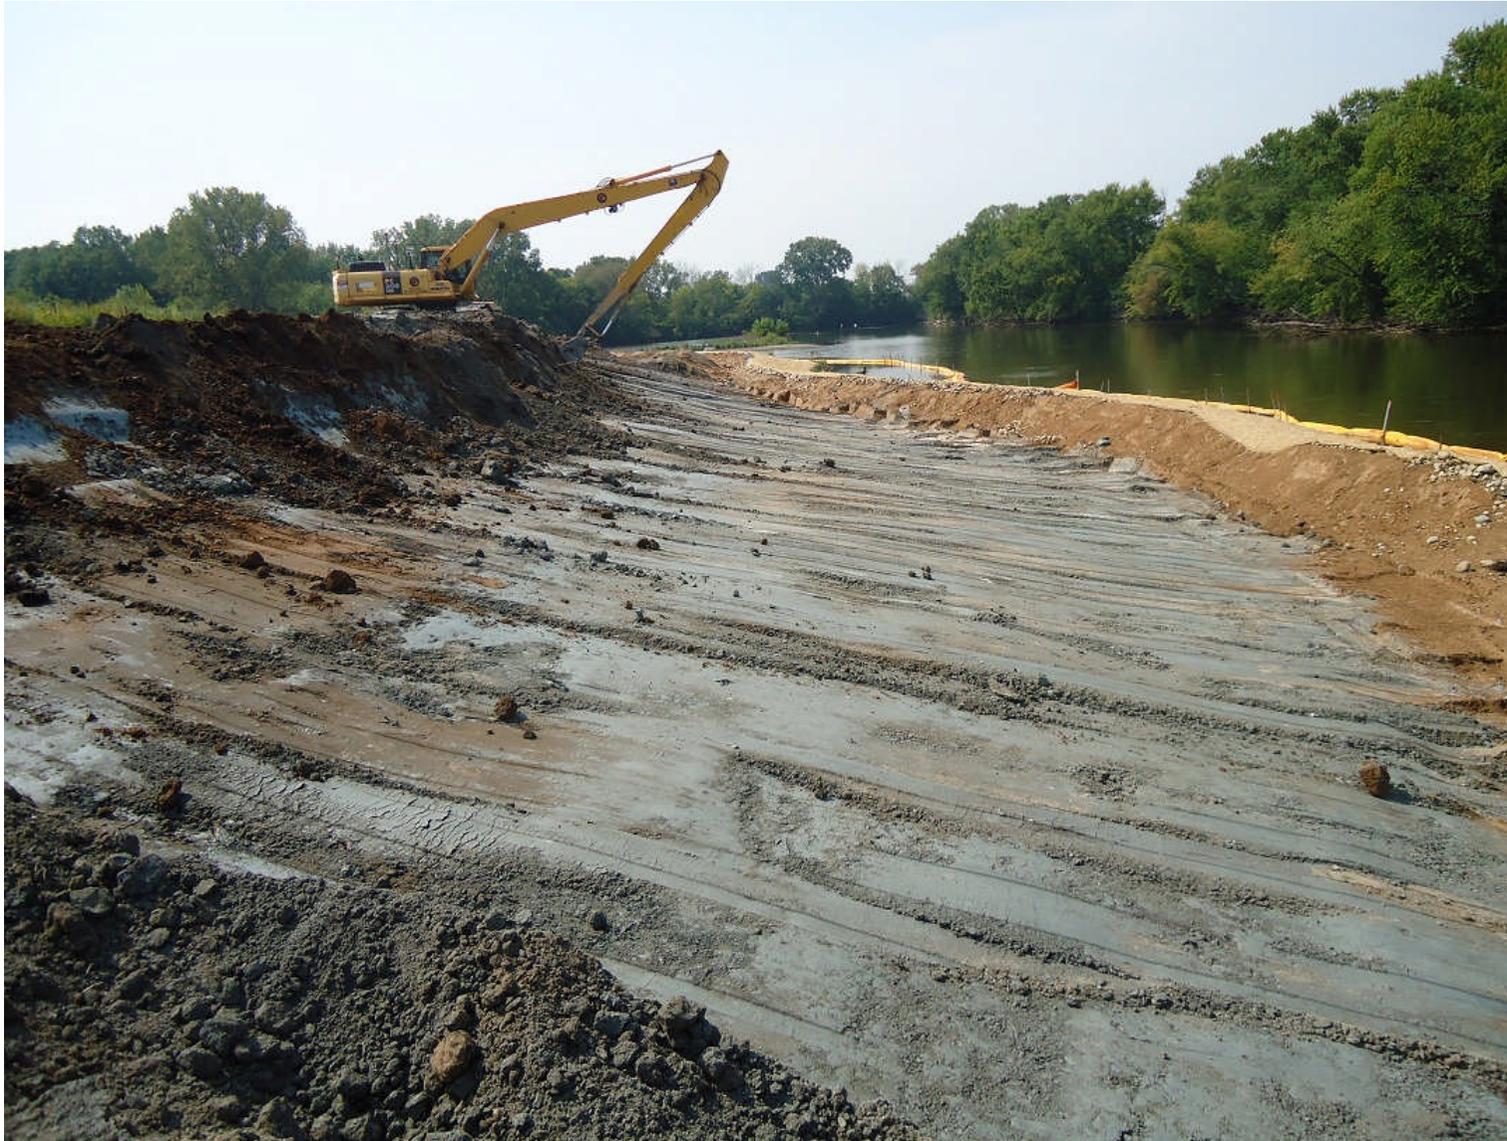
September 2, 2011 – Grading of the northern riverbank behind the 25' setback

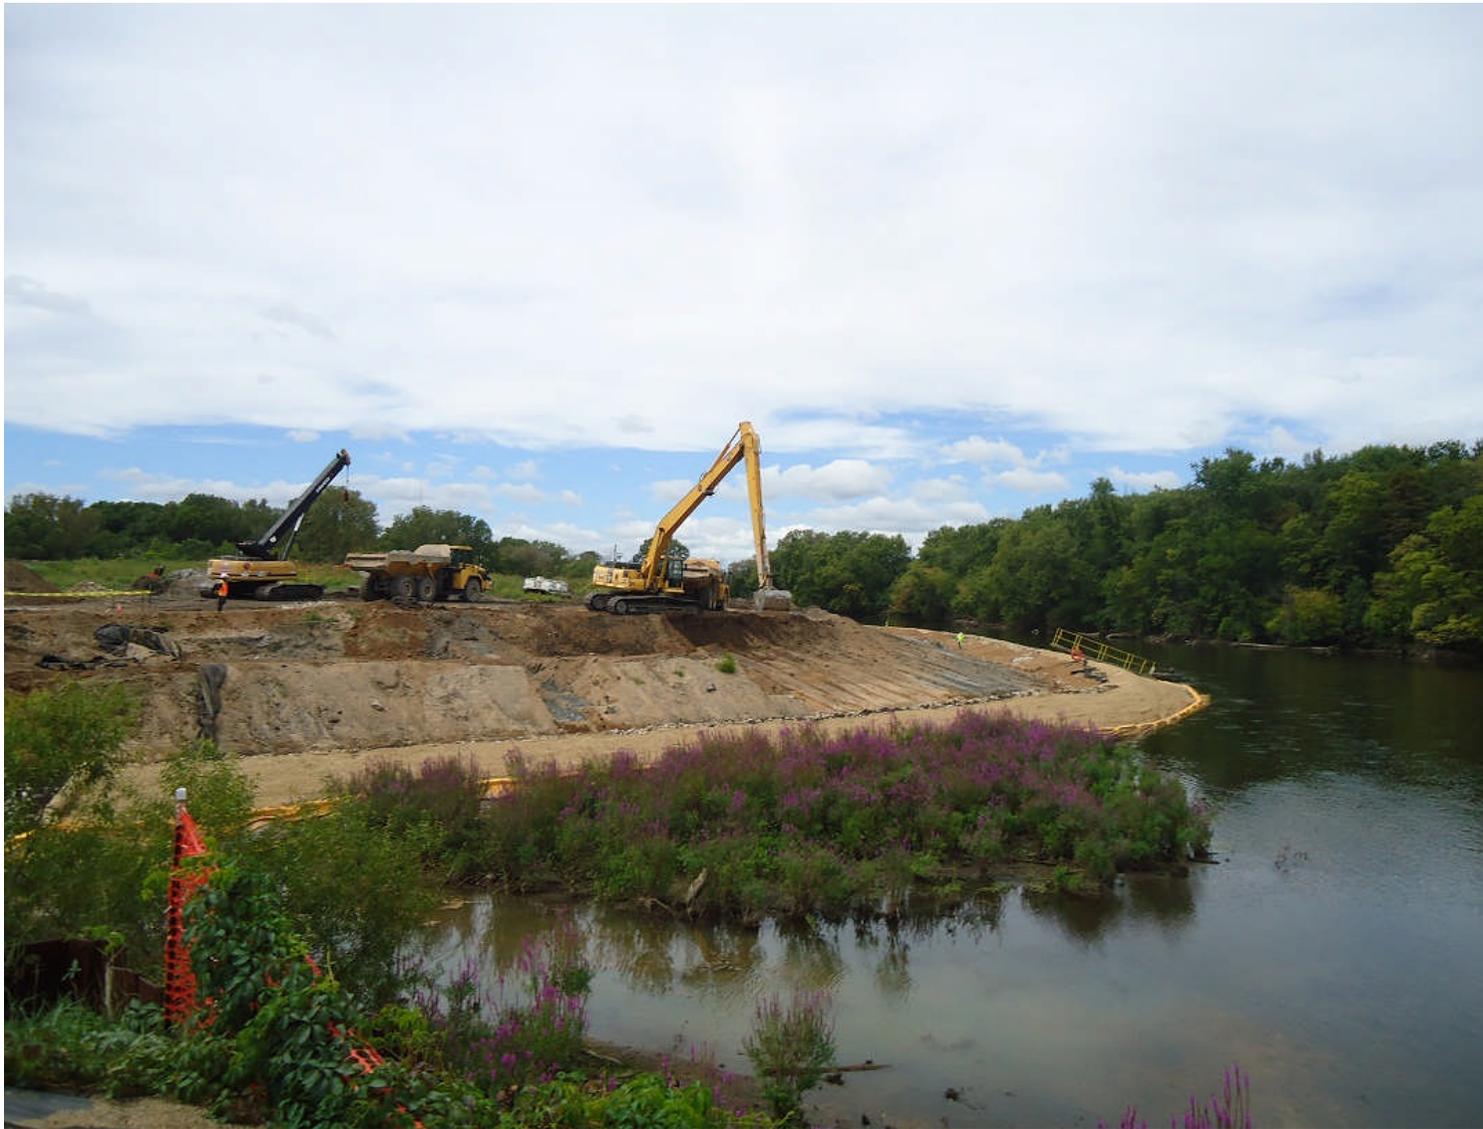
September 7, 2011 – Overview of eastern riverbank grading behind 25' setback

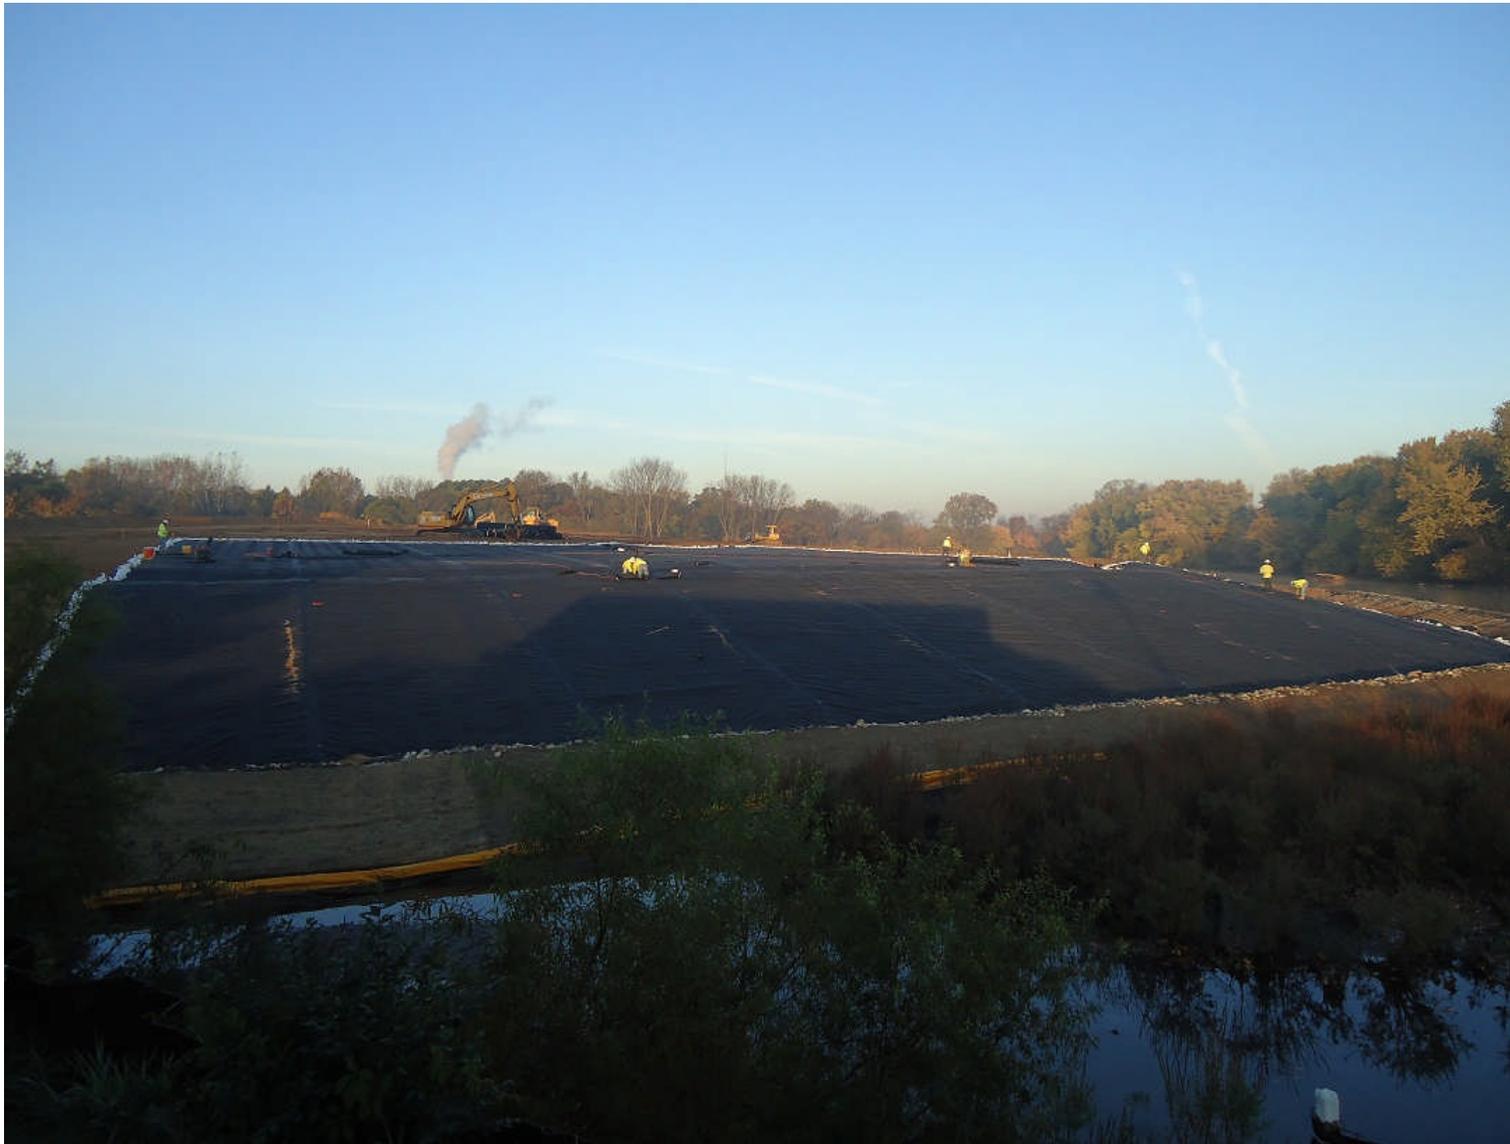
October 11, 2011 – Liner installation begins starting on eastern bank

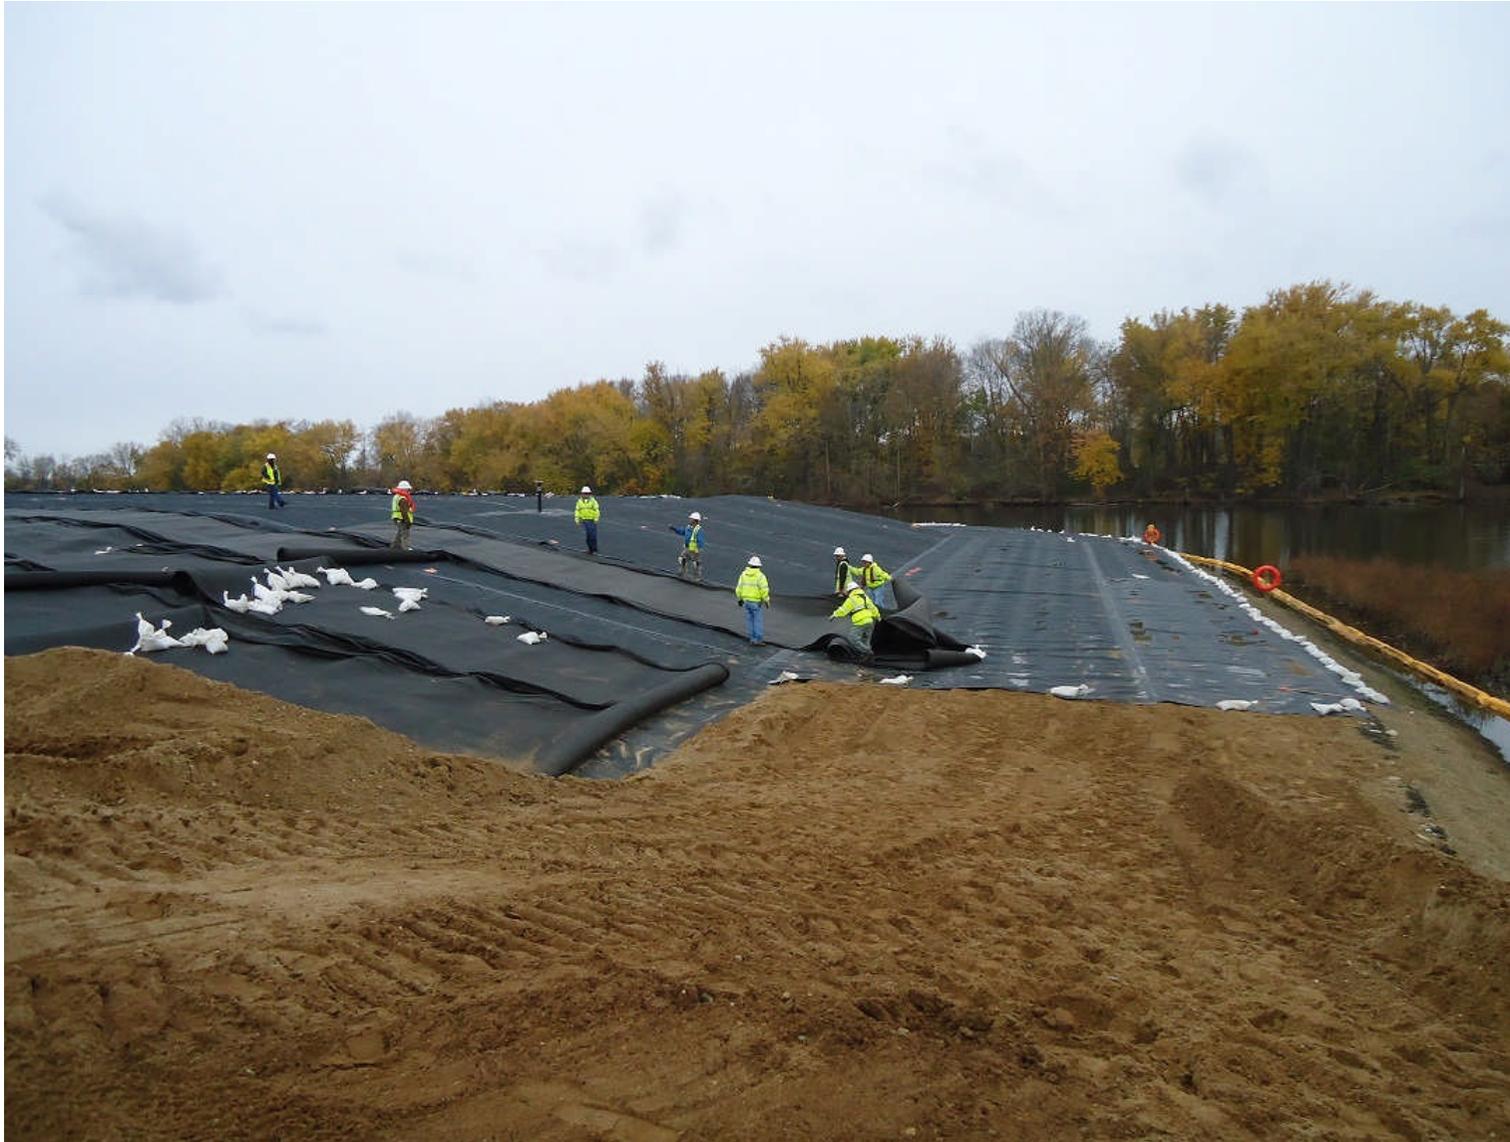
October 27, 2011 – Installation of Drainage Composite over liner on eastern slope.

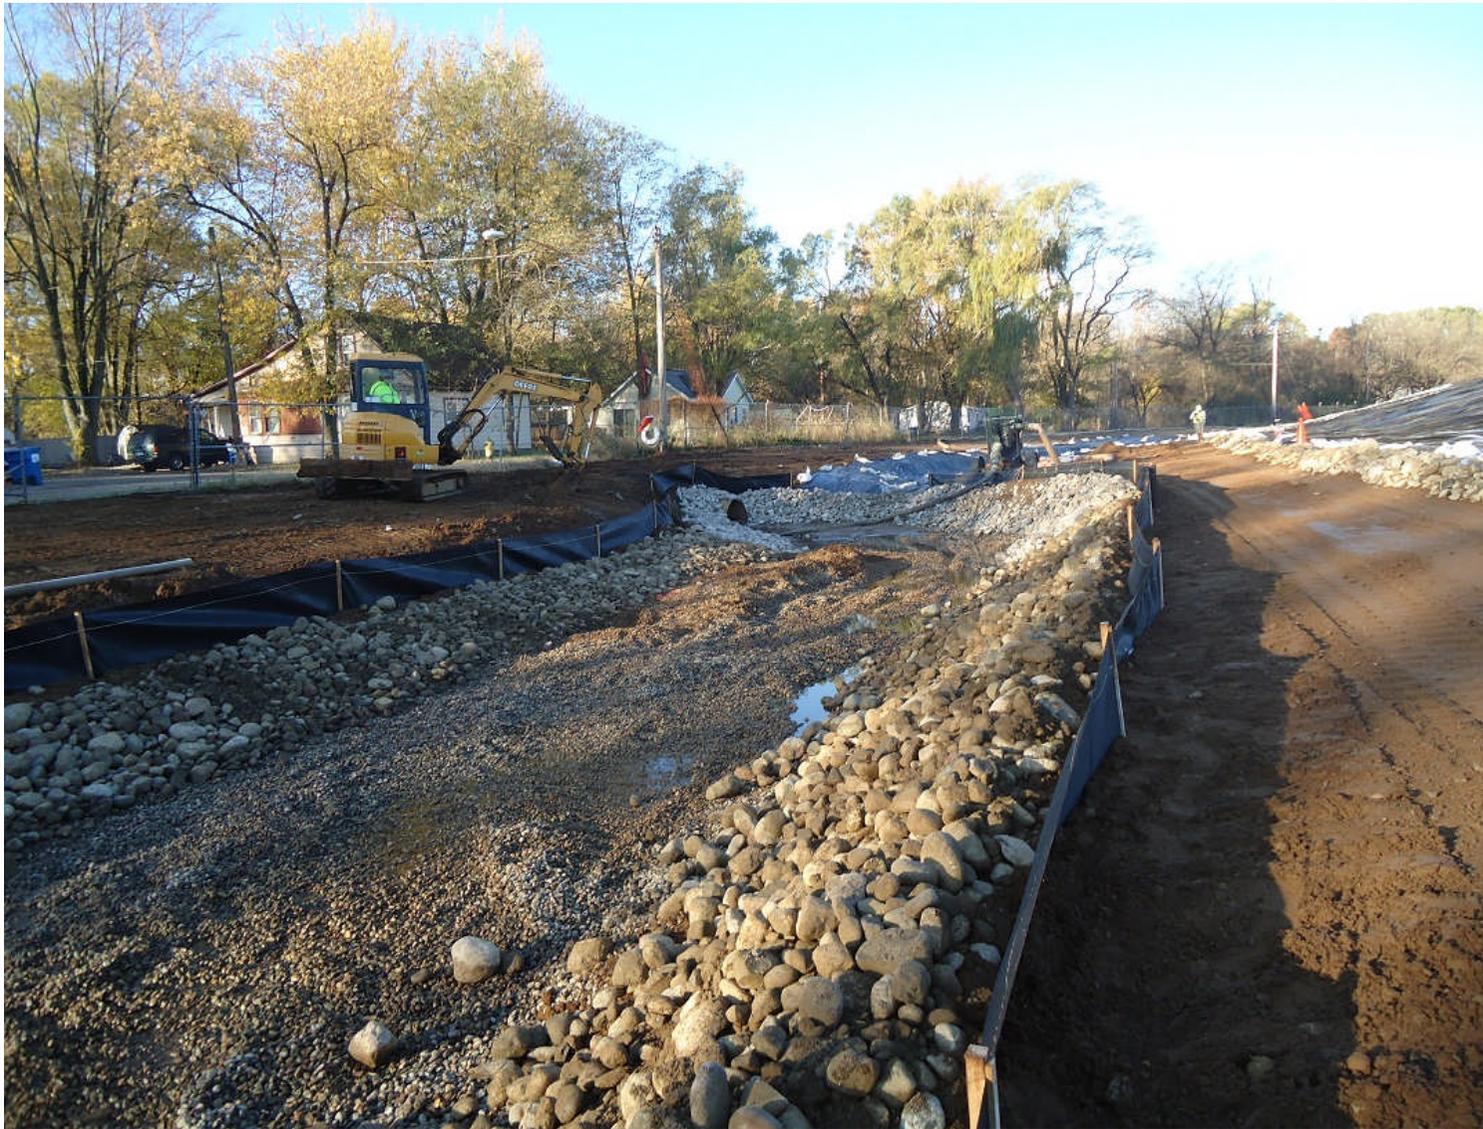
November 4, 2011 – Restored drainageway on southern the side of the landfill
