OU1: Allied Landfill

OU2: Willow
Boulevard/A-Site
Landfill

OU2: Willow Boulevard/A-Site Landfill

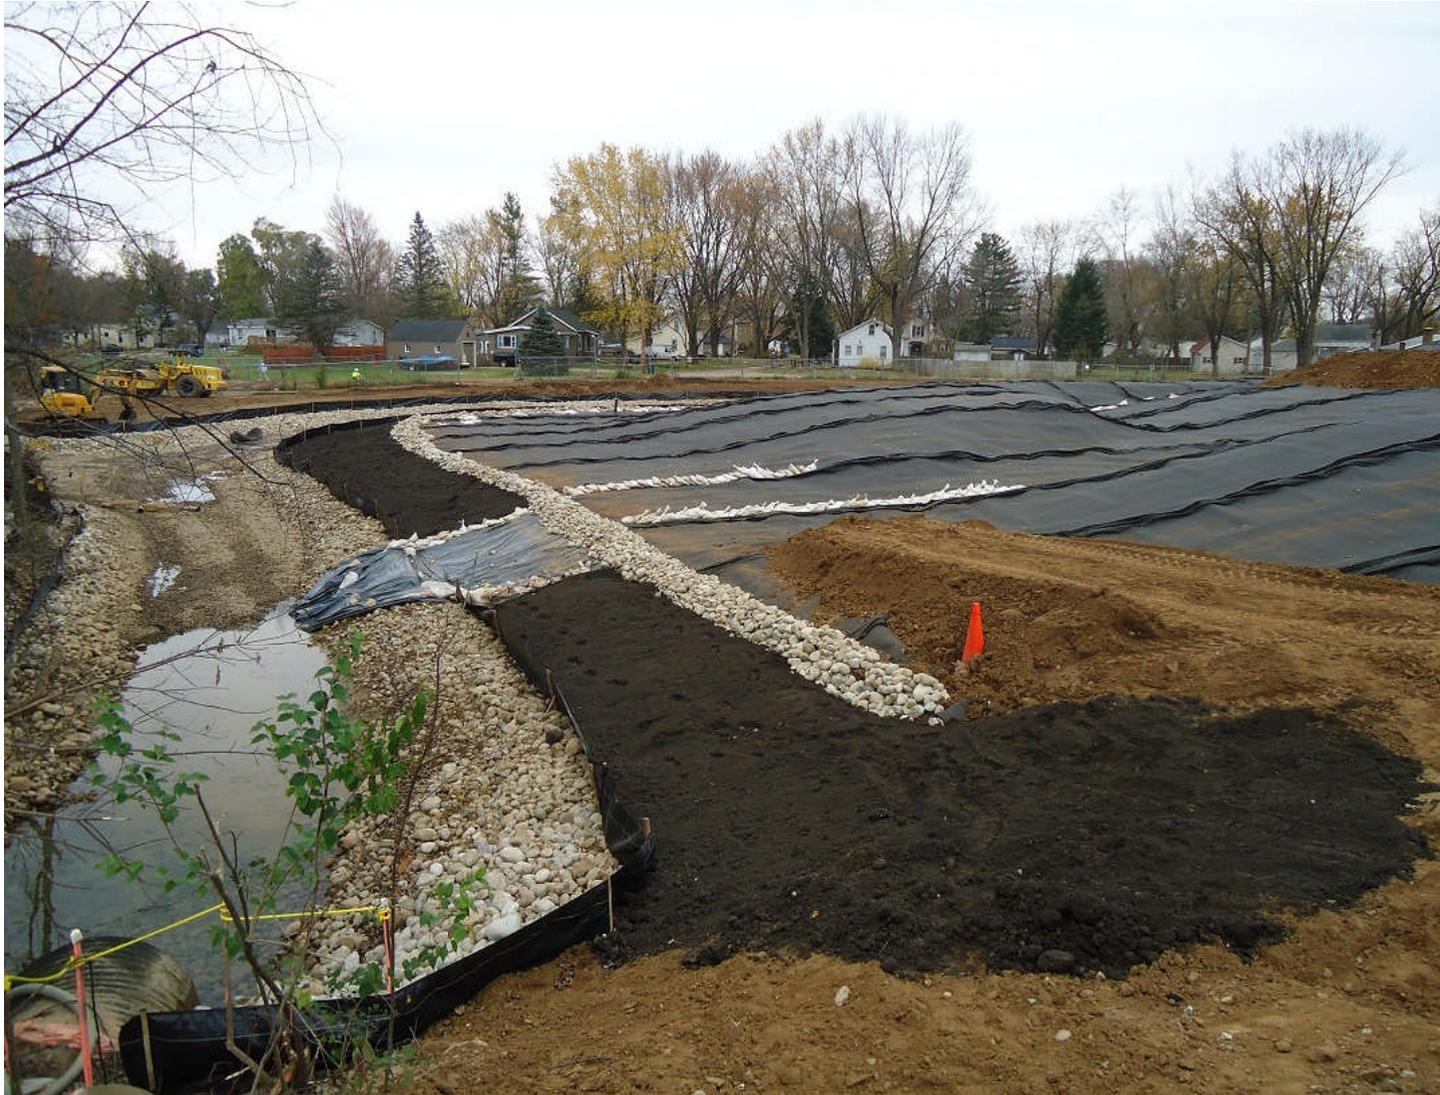
November 7, 2011 – Looking south from the land bridge over the restored eastern drainageway

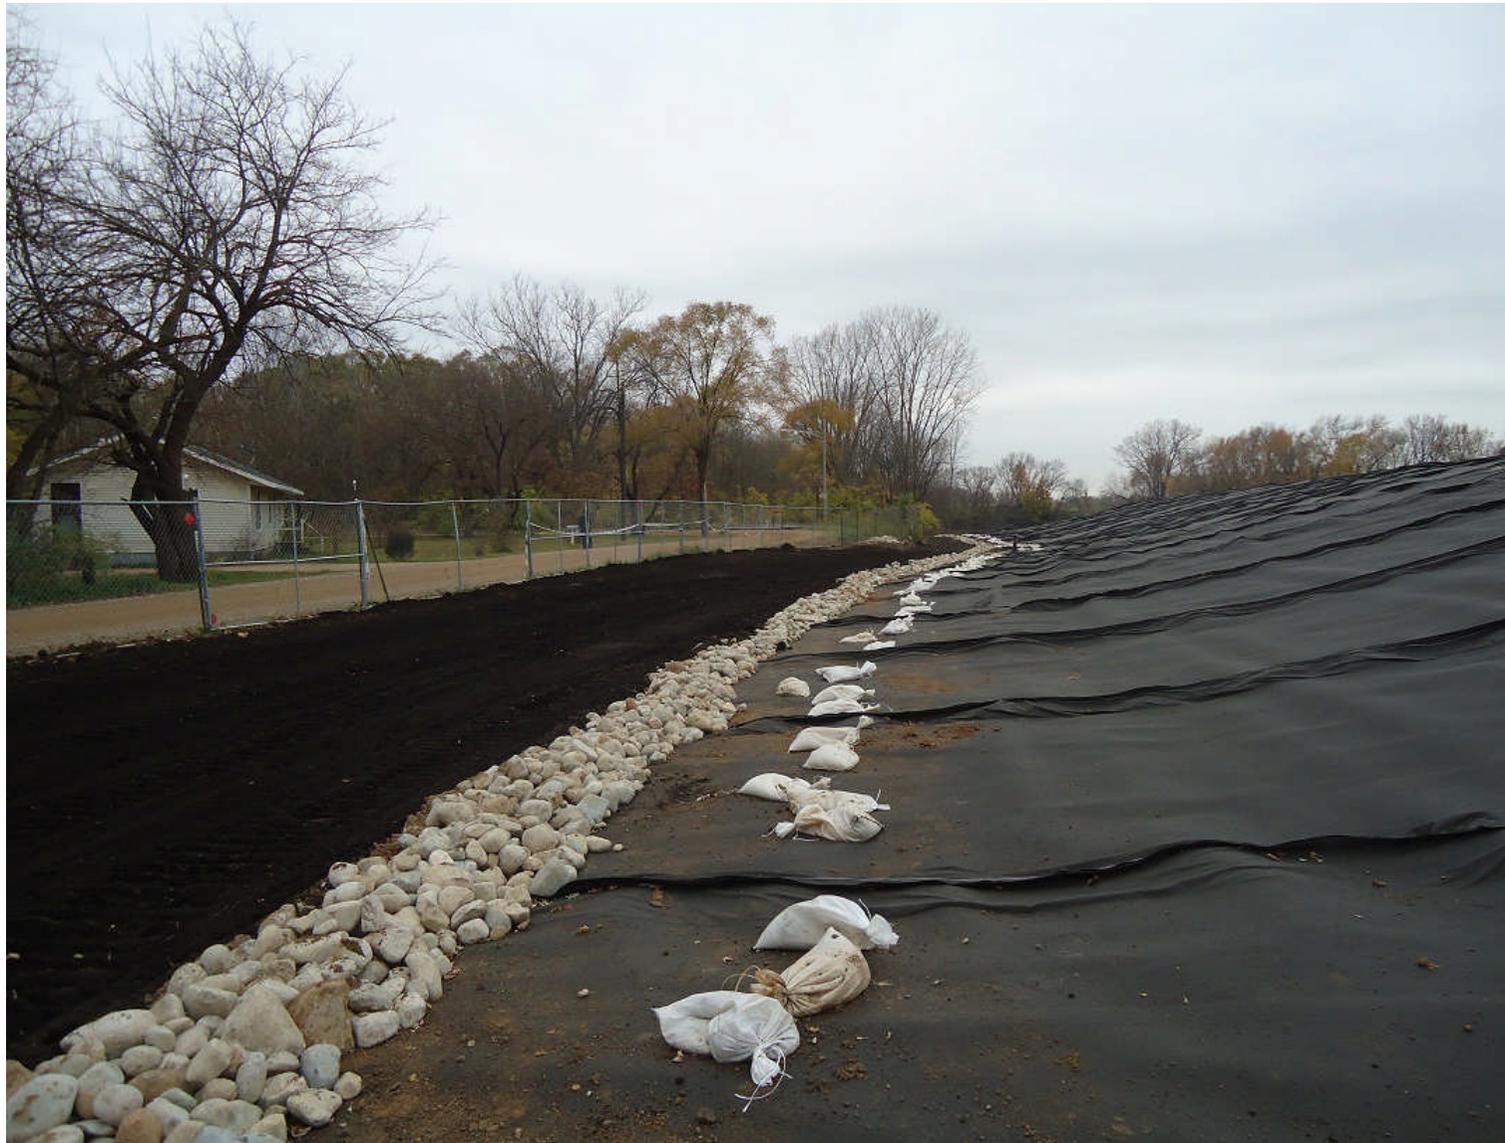
November 7, 2011 – Southern side of landfill looking west, topsoil placed along Willow Blvd

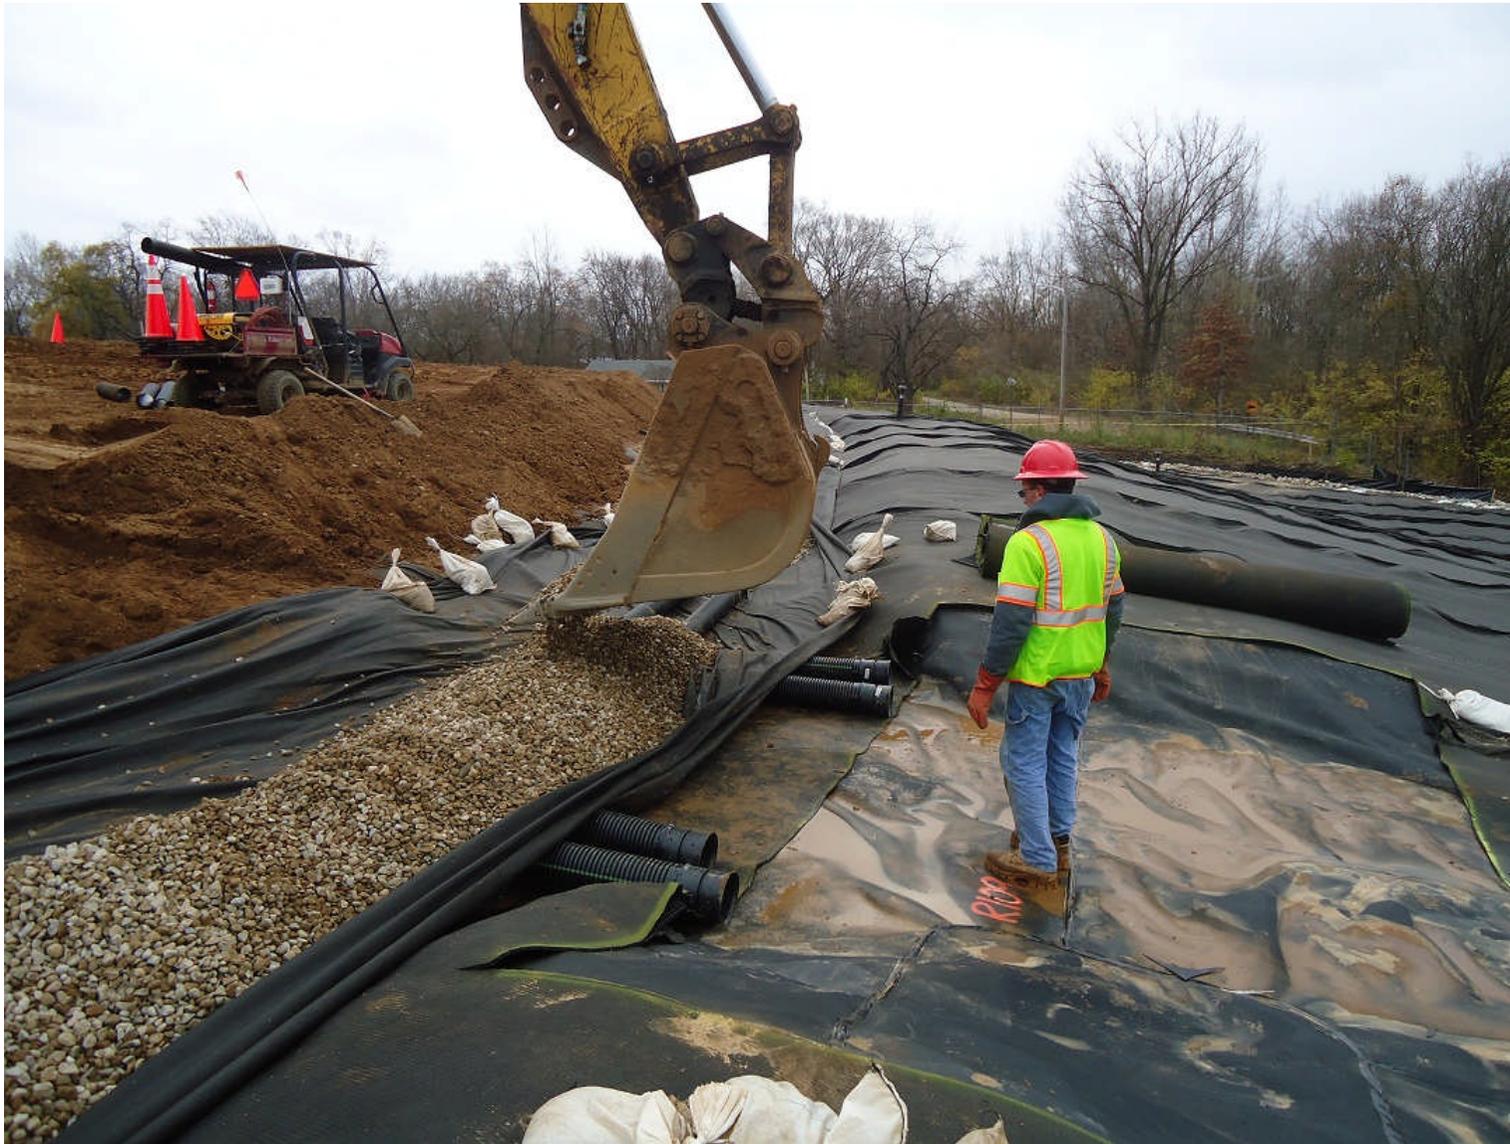
November 17, 2011 – Installation of the stormwater collection piping in the perimeter ditch continues

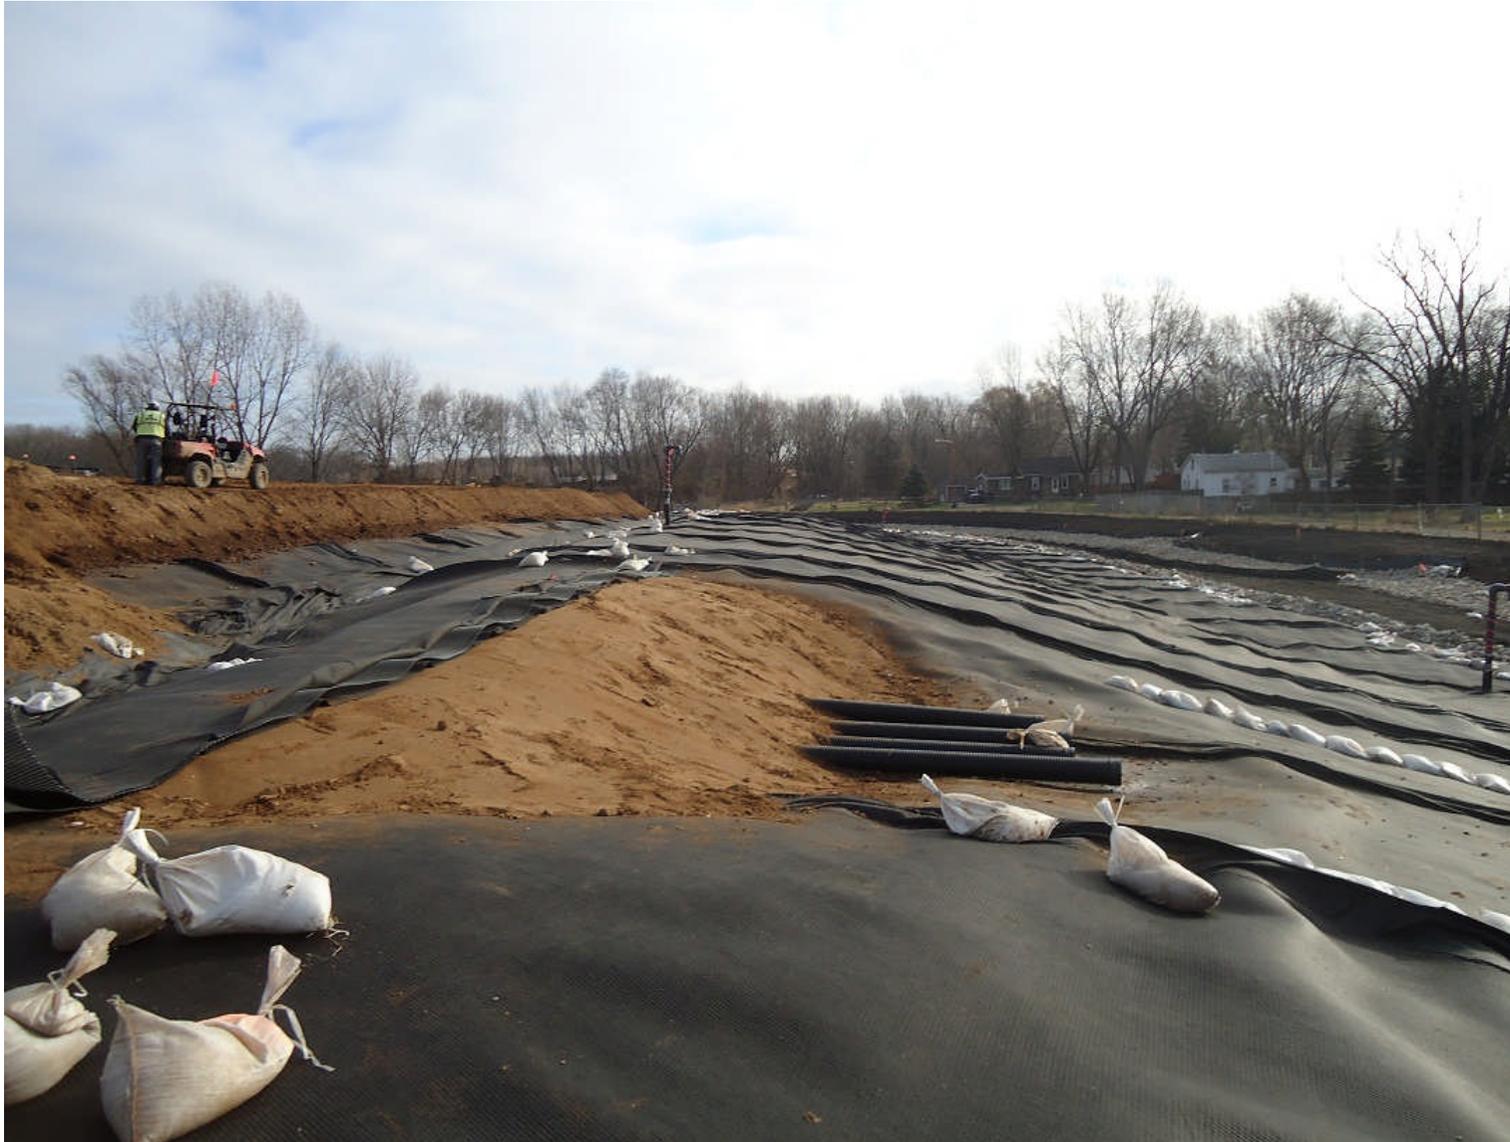
November 21, 2011 – Completed soil plug at stormwater outfall #3 on the southern side of the landfill

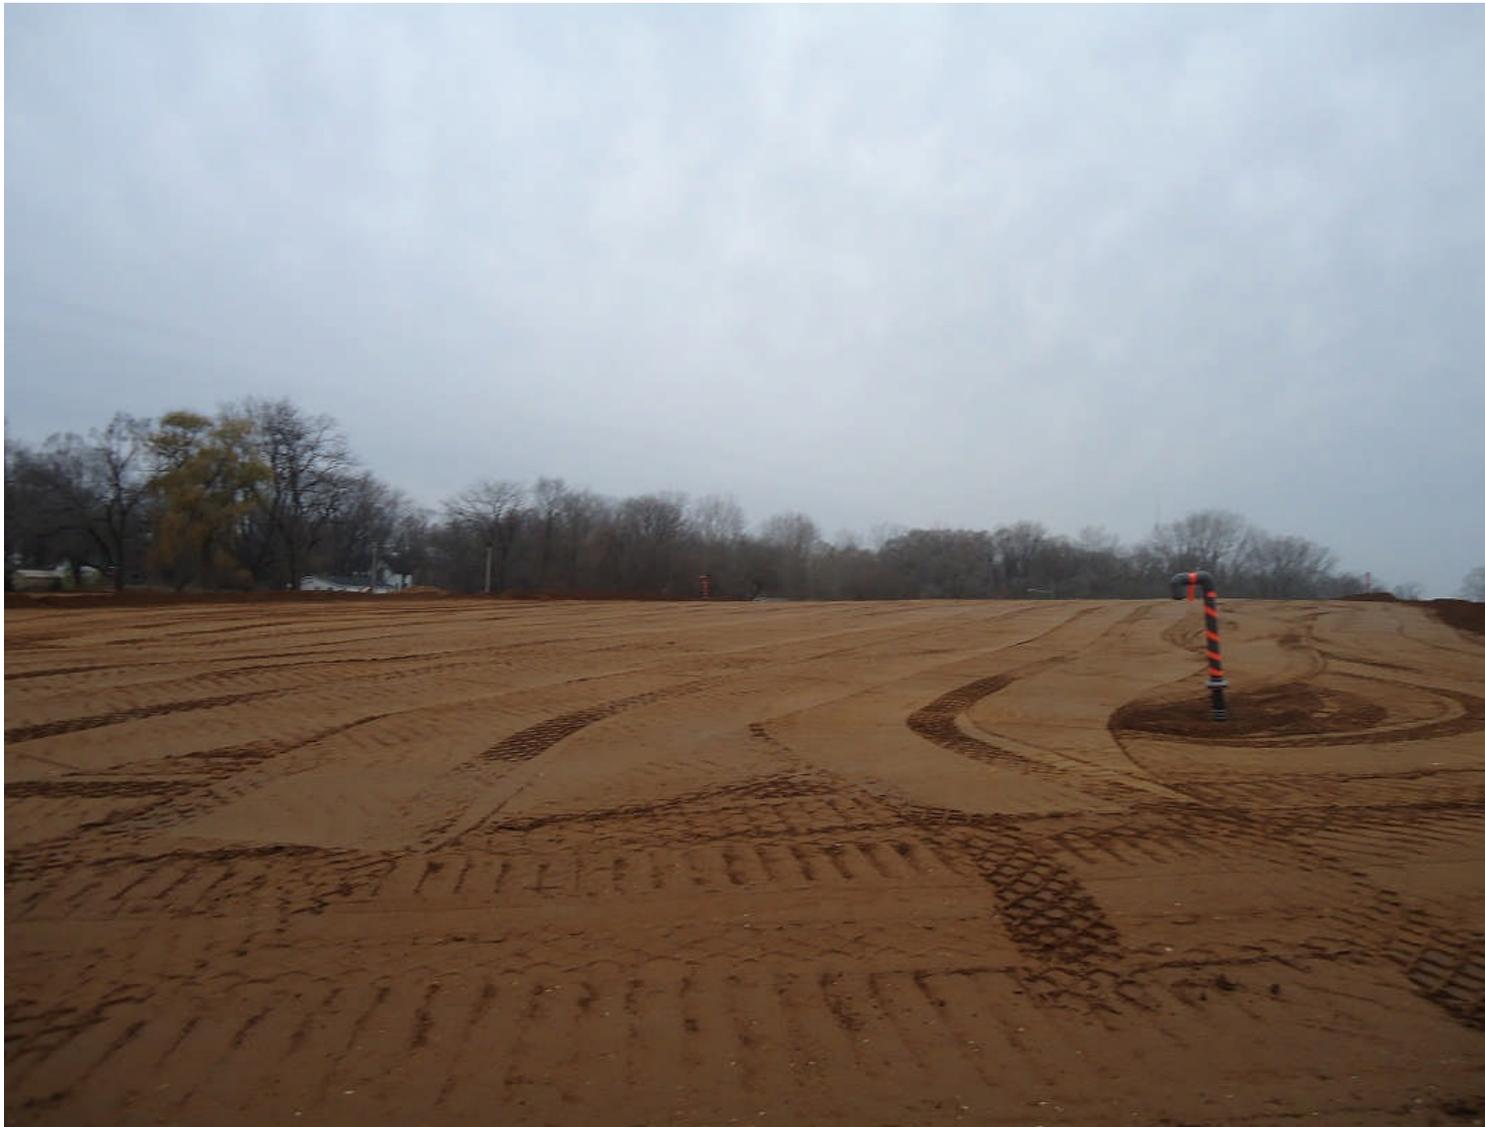
November 22, 2011 – Looking west over the top of landfill, compacted 24” sand layer atop GDC and Liner, prior to topsoil installation

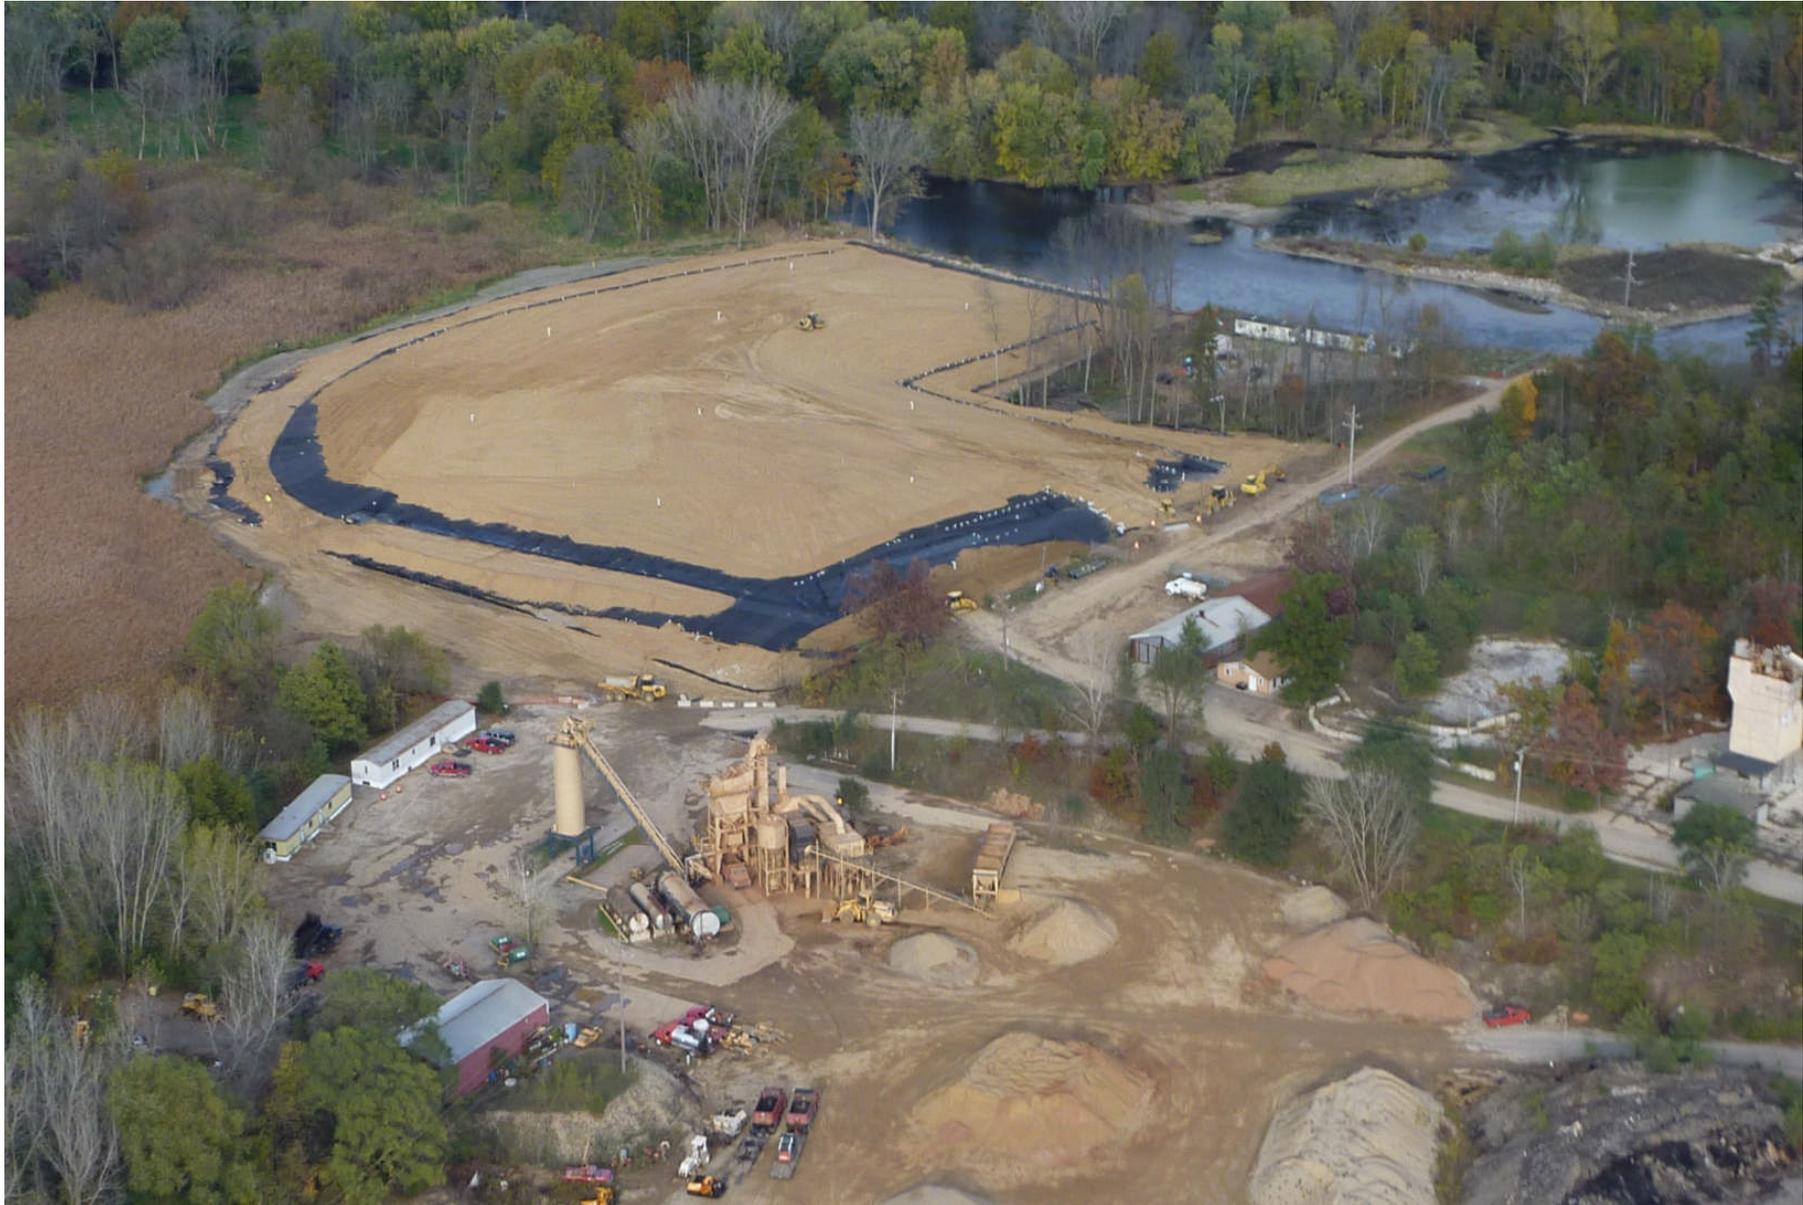
Adding Soil Cover 10/15/10
