July 1960 - Tank #2 - Red Hill

Red Hill Storage Facility Tank #13

**PRL 96-21
Emergency Repairs for Red Hill Tanks**

EMERGENCY REPAIRS FOR RED HILL TANKS

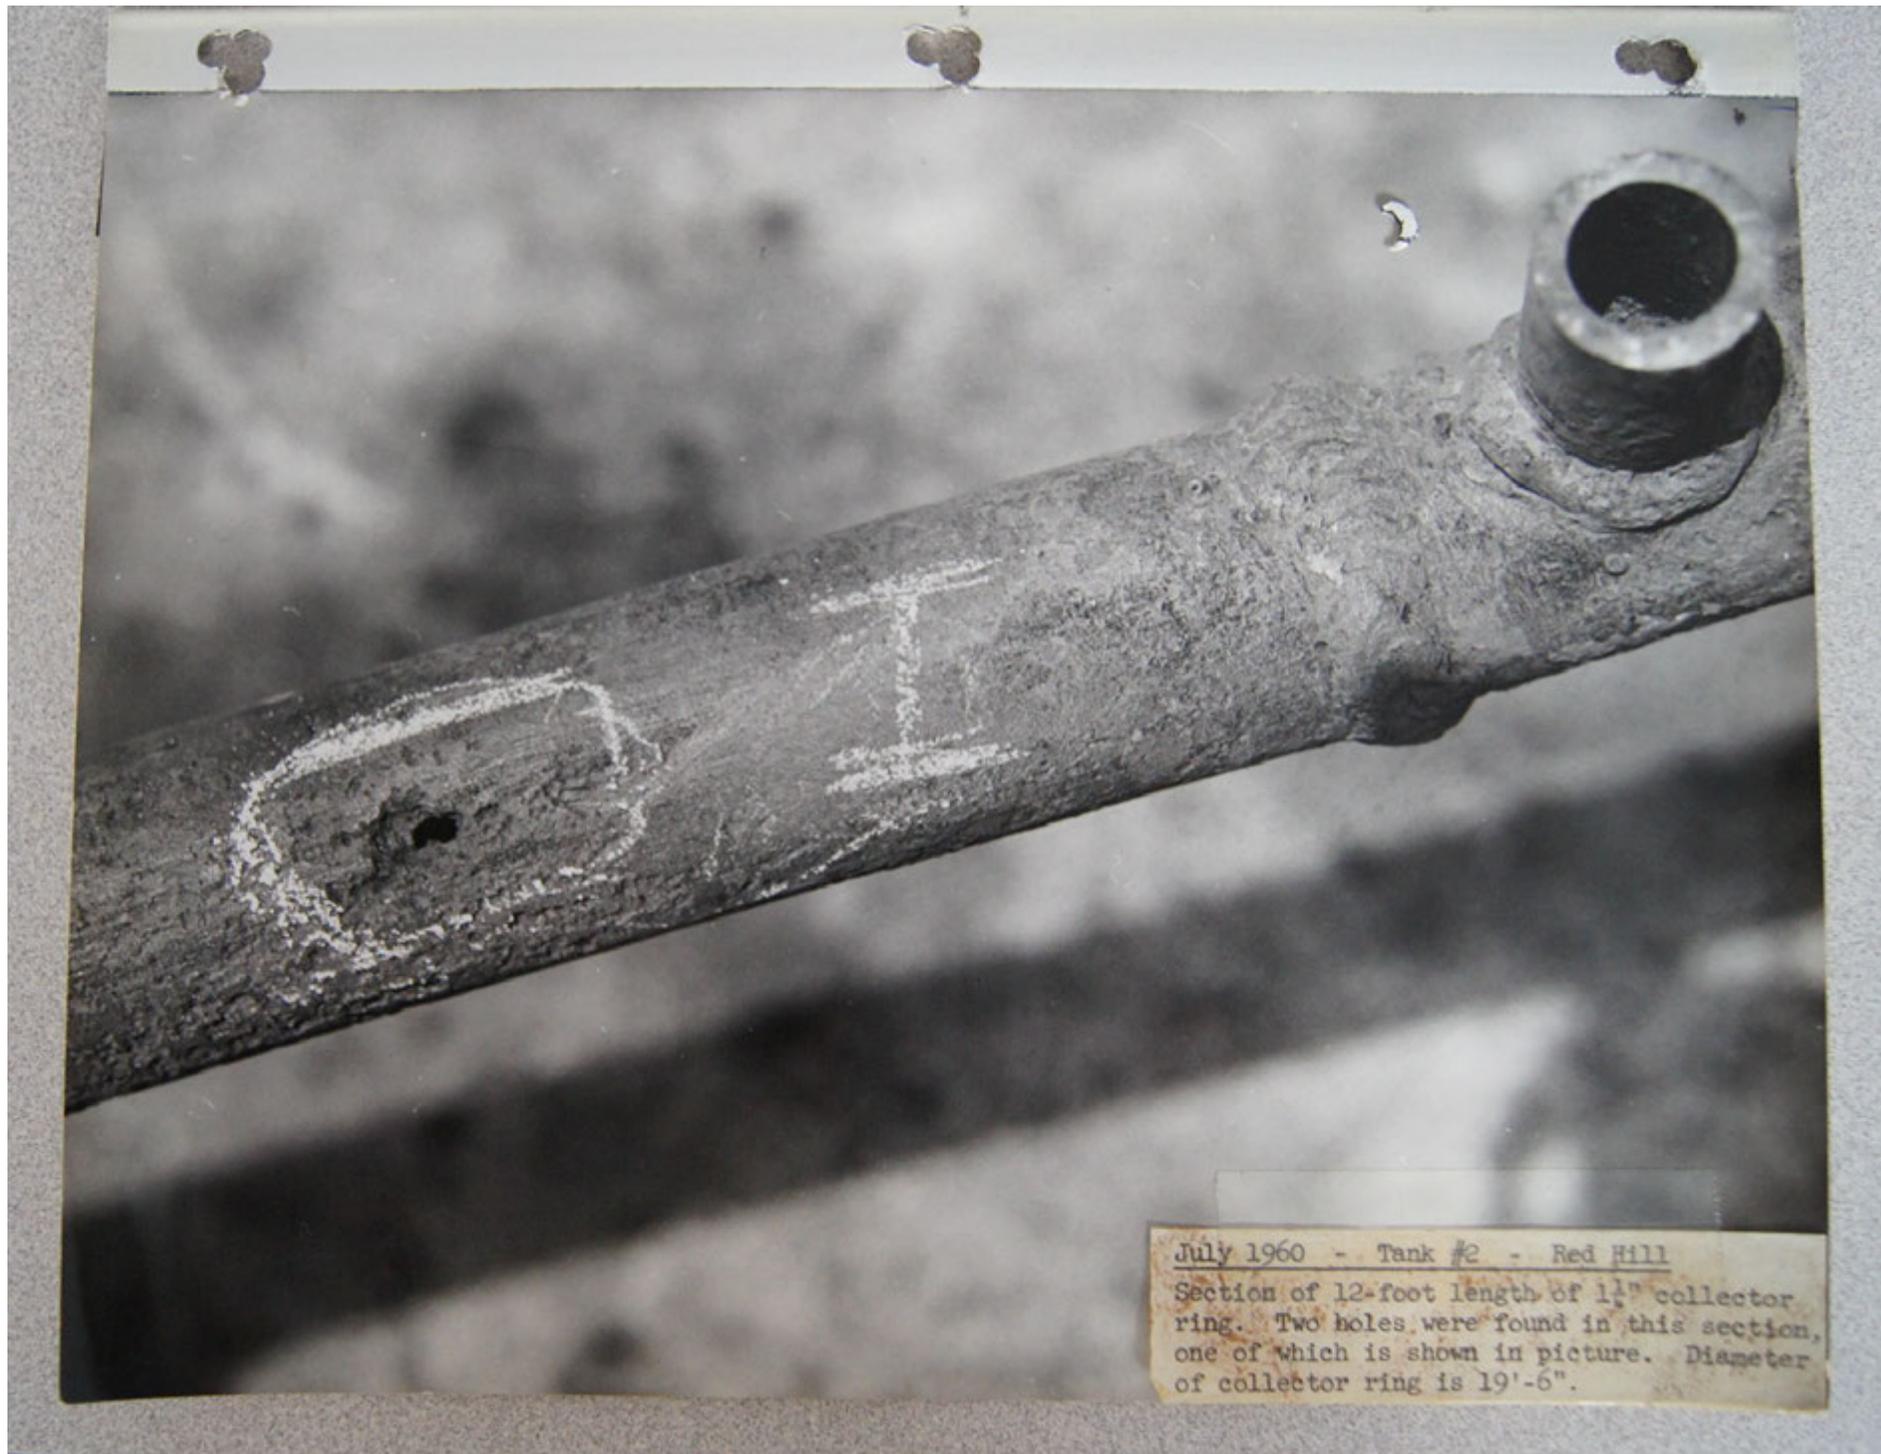
Section of 12-foot length of 1 1/2" collector ring. Two holes were found in this section, one of which is shown in picture. Diameter of collector ring is 19'-6".

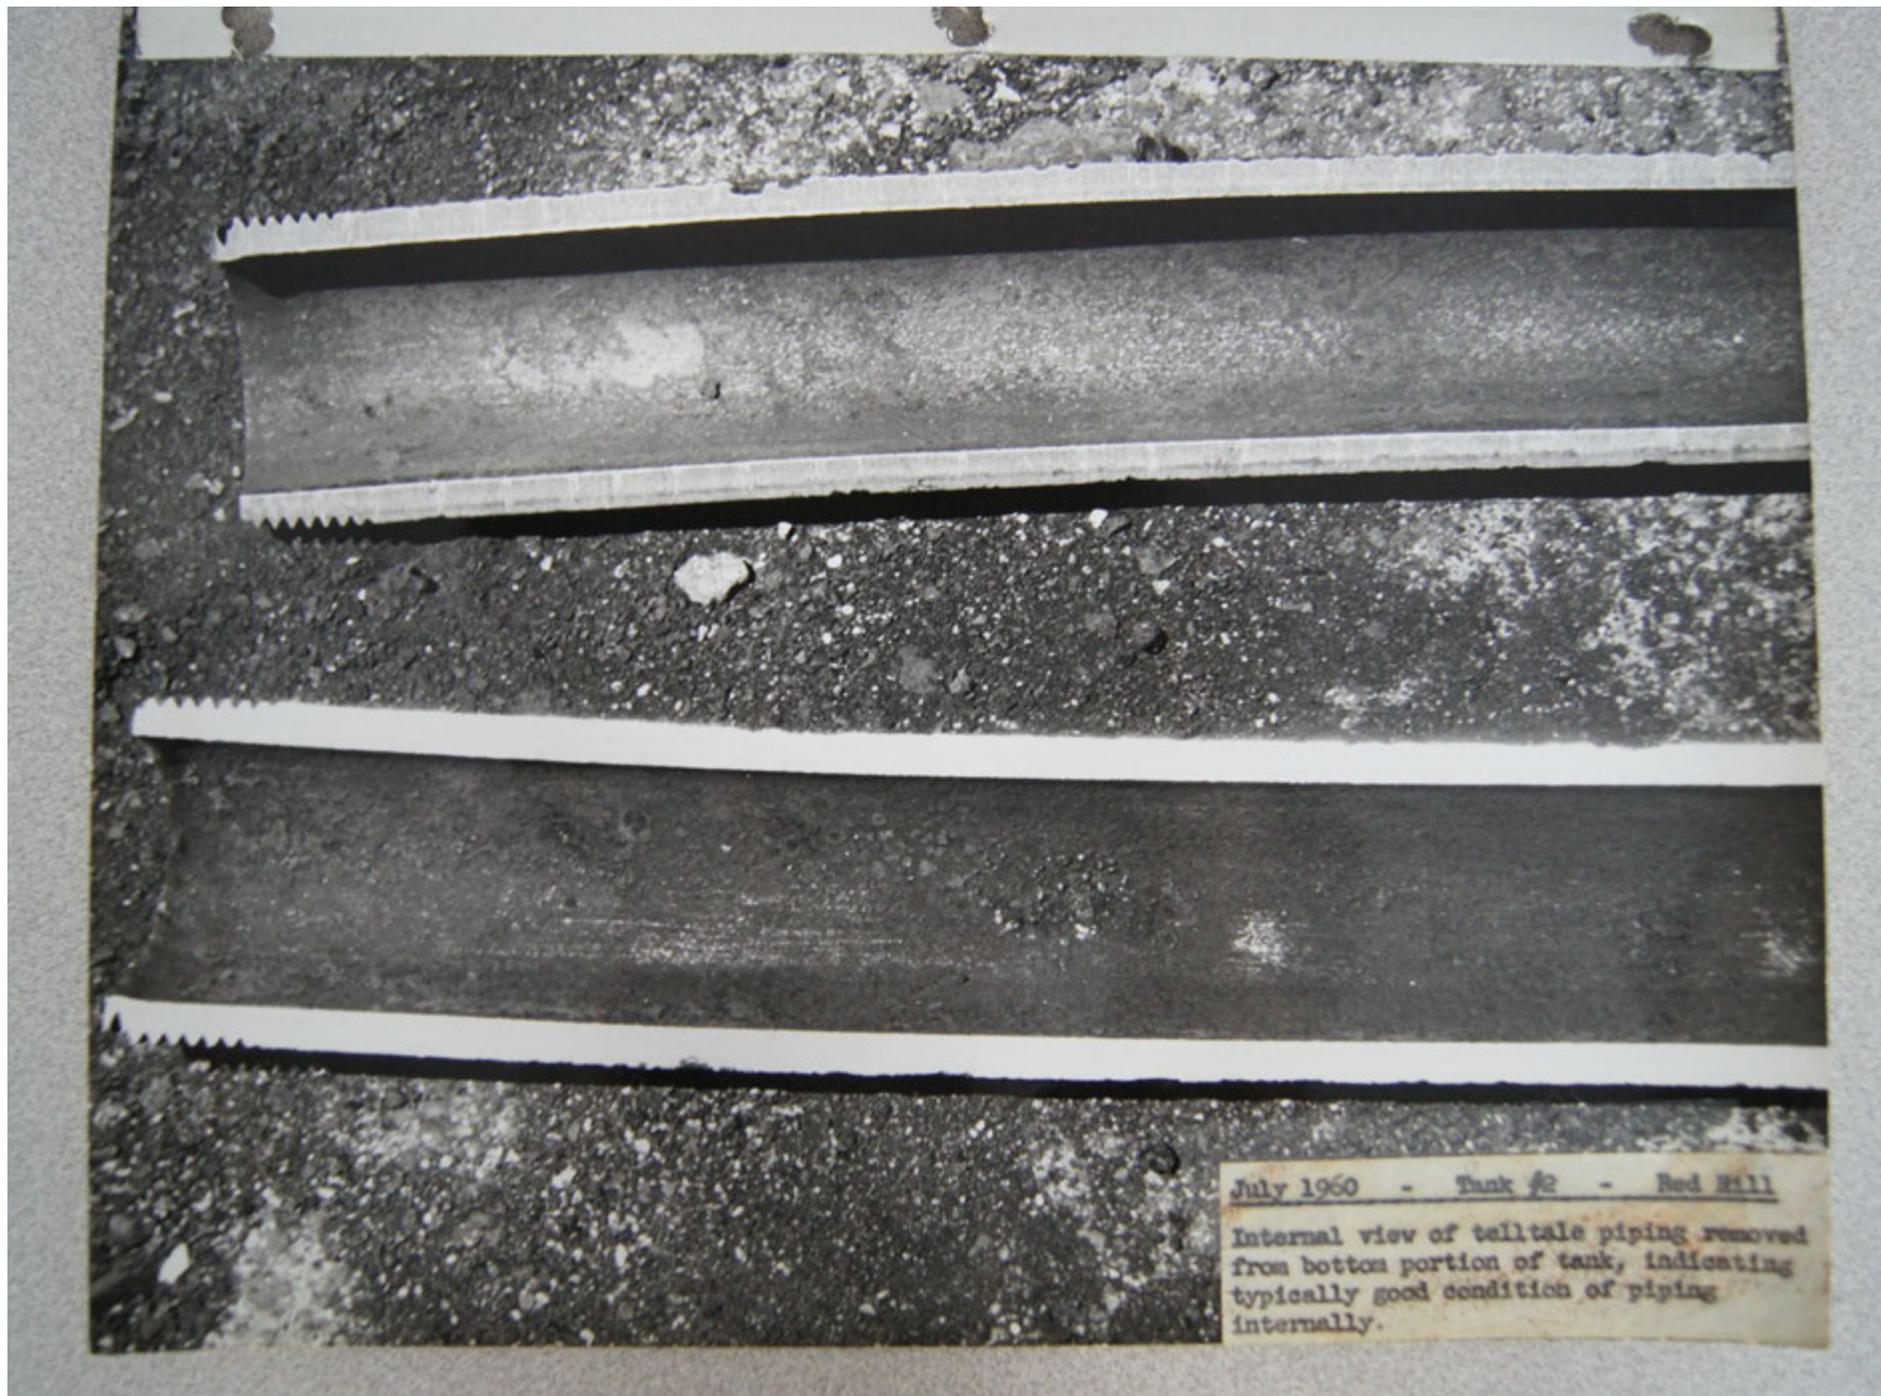
July 1960 - Tank #2 - Red Hill

Internal view of telltale piping removed
from bottom portion of tank, indicating
typically good condition of piping
internally.

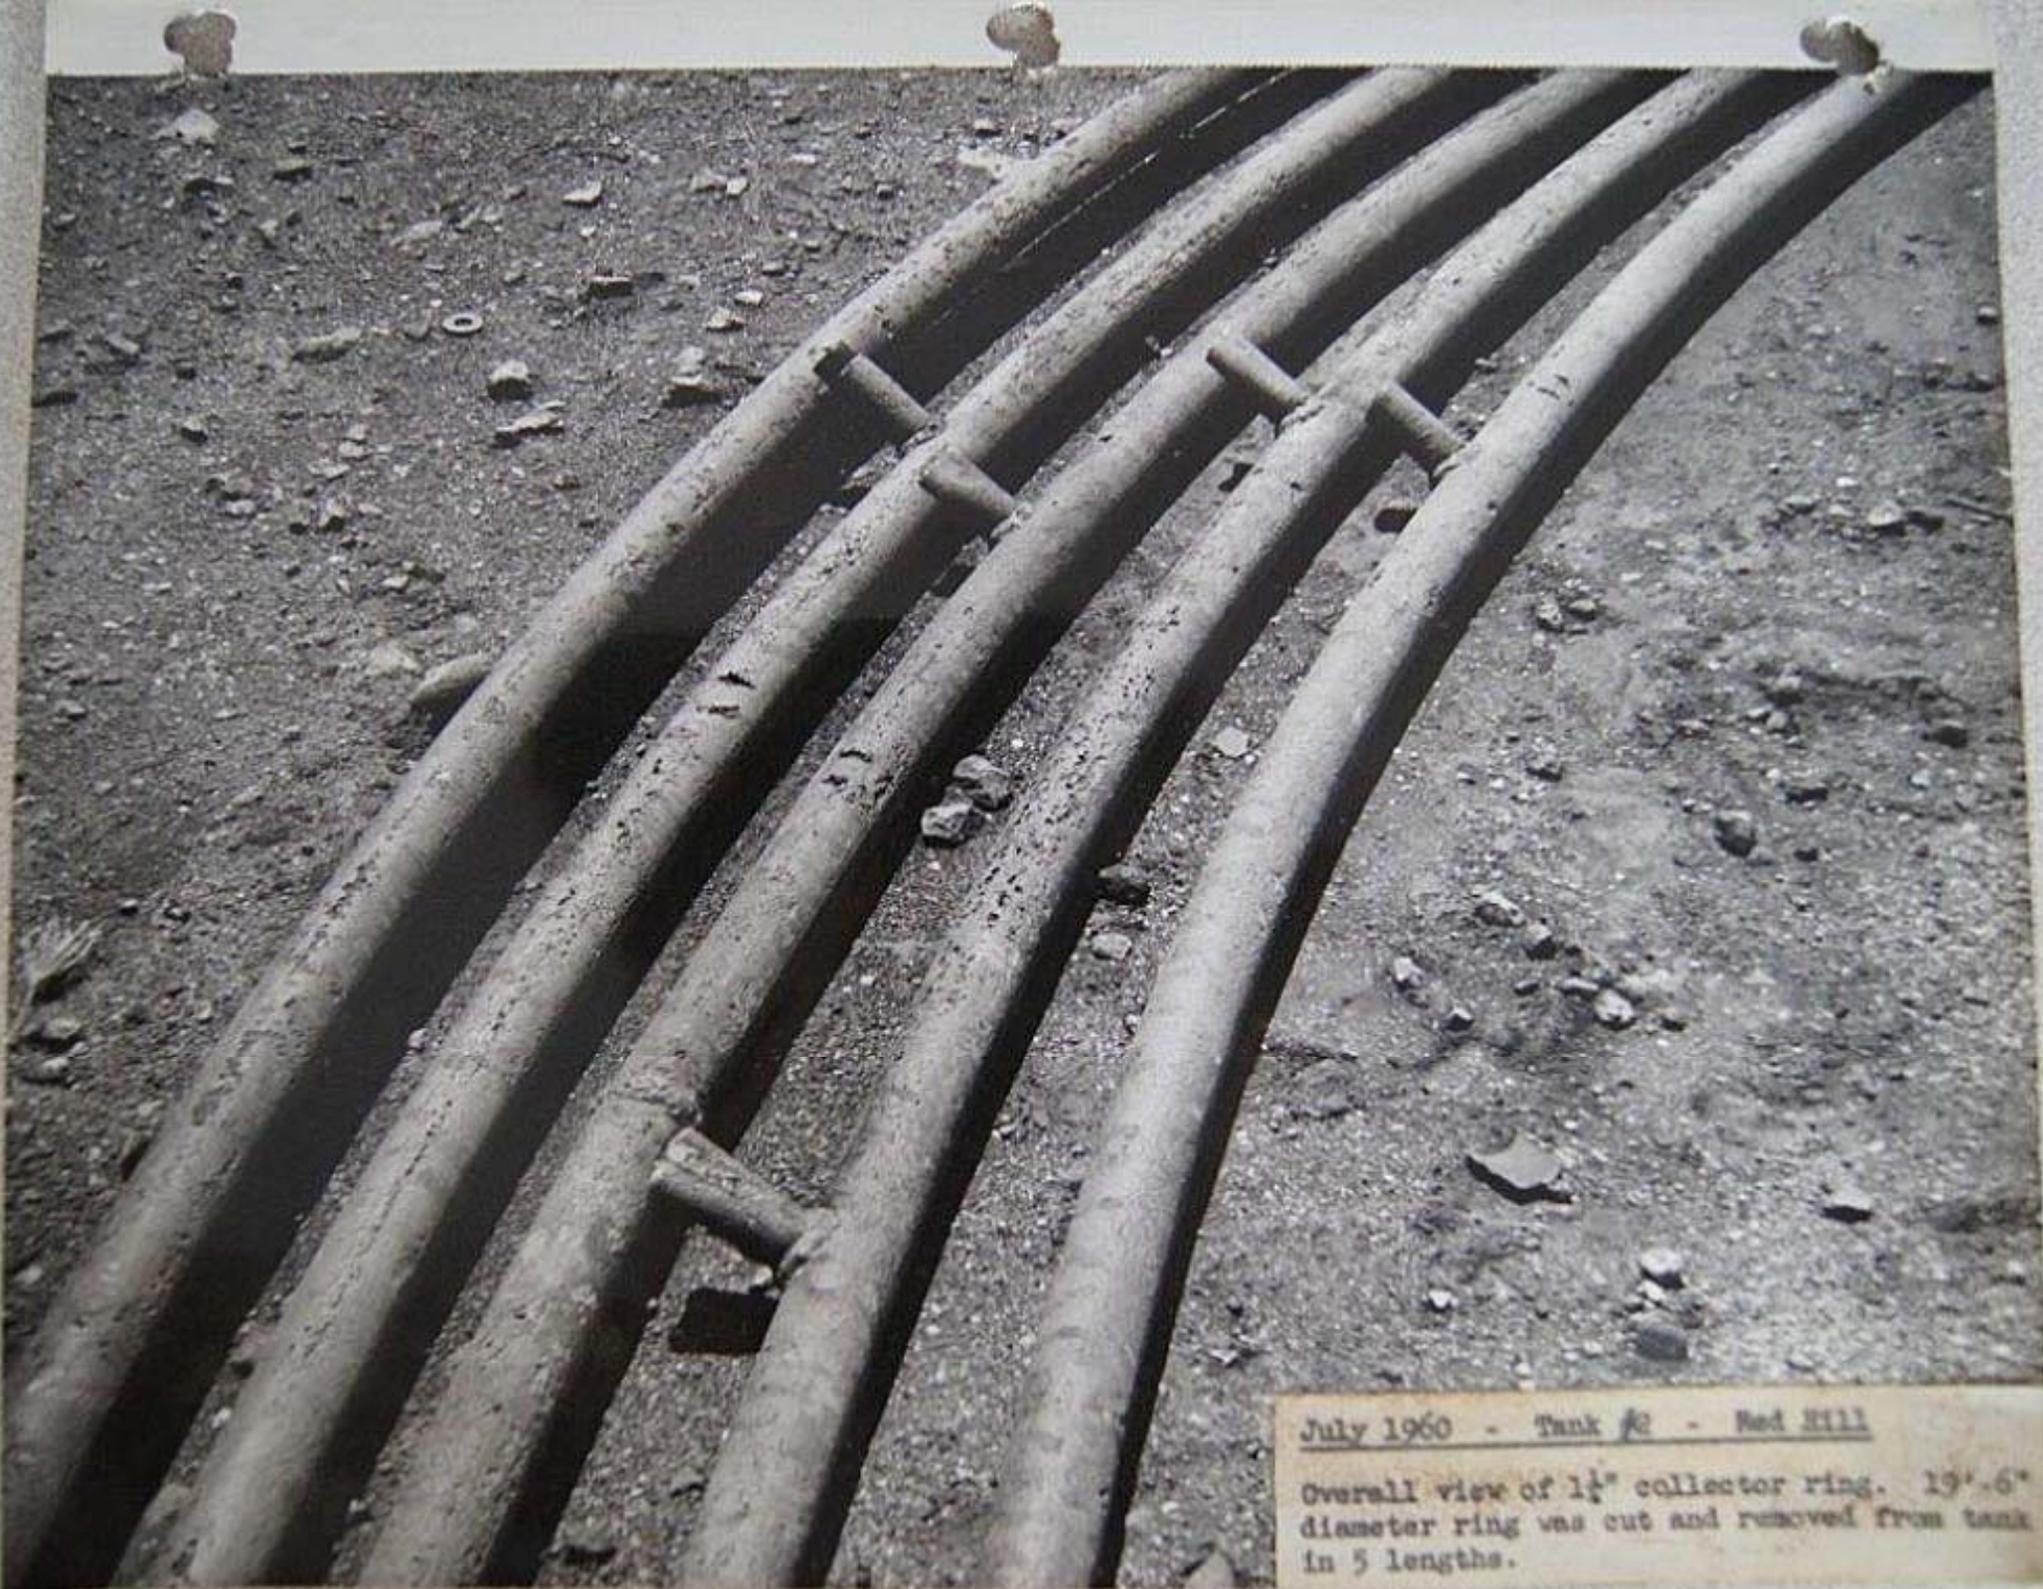
July 1960 - Tank #2 - Red Hill

Overall view of $1\frac{1}{2}$ " collector ring. 19'-6" diameter ring was cut and removed from tank in 5 lengths.

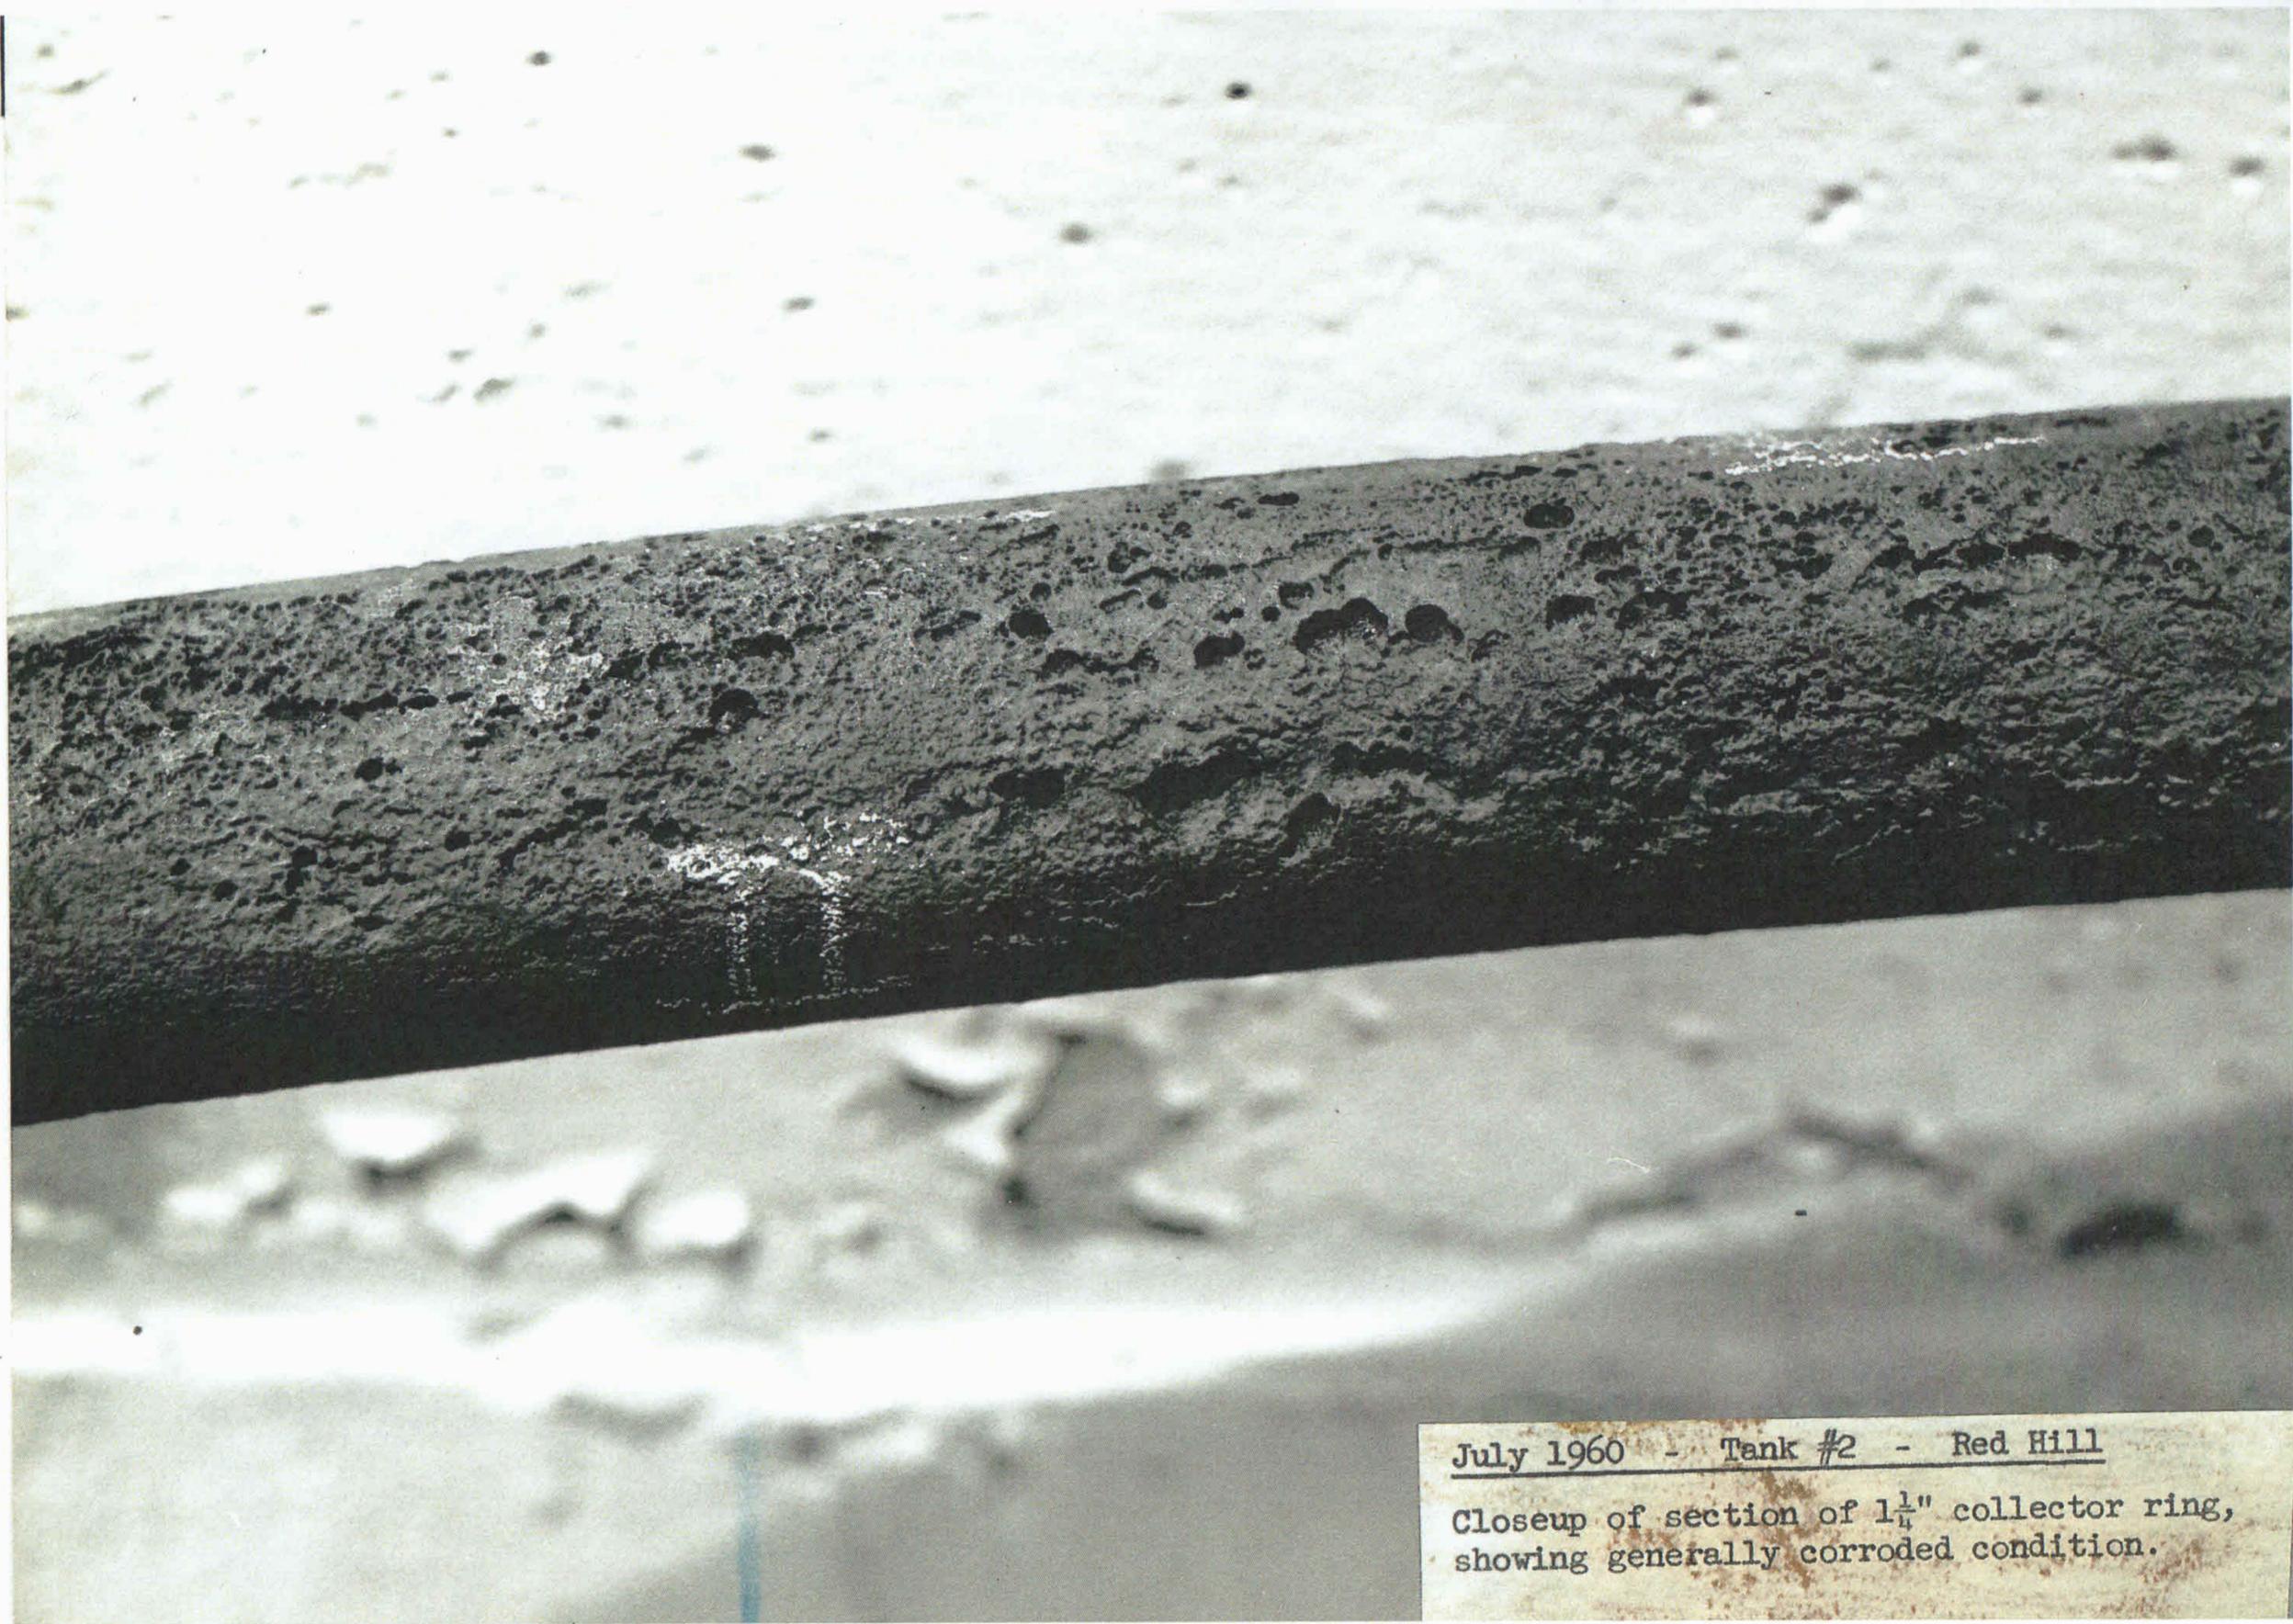
July 1960 - Tank #2 - Red Hill

Closeup of section of $1\frac{1}{4}$ " collector ring,
showing generally corroded condition.
