NPDES COMPLIANCE EVALUATION INSPECTION

NPDES Permittee: MYD Samoa, Inc.

Facility: Satala Shipyard
P.O. Box 7684, Pago Pago, Tutuila Island, American Samoa
(NPDES Permit No. AS0020026)

Date of Inspection: April 27 and 30, 2009

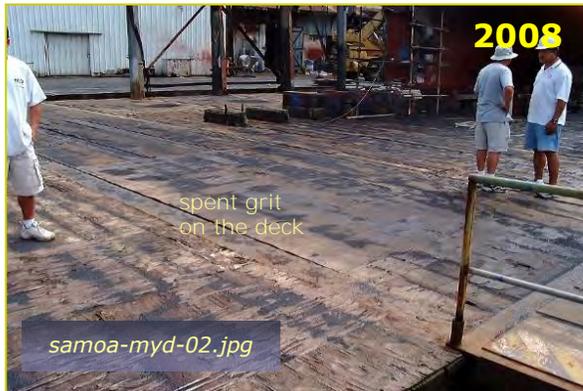
Photo #1: 3000-Ton Dry Dock Decking - April 2008
Taken By: Greg V. Arthur
Date: 04/01/08

resulting in at least two violations of the Clean Water Act. First, there was the direct loss of blasting grit and paint chip debris through gaps in the dry dock decking into the harbor. Second, there were multiple discharges of contaminated wastewaters into the harbor from the exposure of numerous shipyard sources (such as blasting grit, paint chip debris, outdoor storage areas for trash, oil stained roadways), to contact with storm water drainage.

The deck consists of removable plywood and planking without perimeter curbing. Roofing felt now is added under new plywood to better fill in the gaps between the planking on the deck directly over harbor water. The dry dock has framing and rigging that allows the unfurling of portable curtains around and over the dry dock to capture painting overspray and windborne blasting debris. On the date of this inspection, MYD Samoa indicated that new curtains with grommet kits have been procured but not yet delivered to the shipyard. See Photos #1 and #2 in Section 1.6 of this report on page 9.

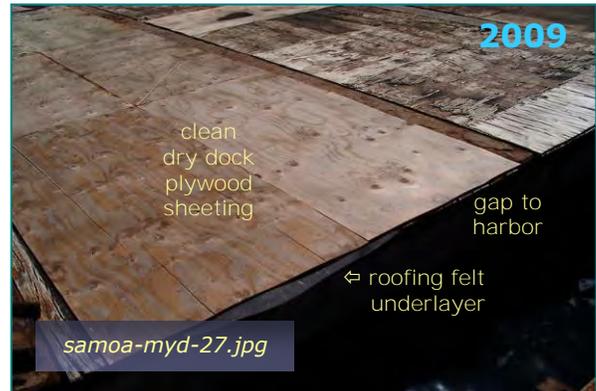
Photo #2: 3000-Ton Dry Dock Decking - April 2009
Taken By: Greg V. Arthur
Date: 04/27/09

Dry dock Drainage – Rainfall runoff is expected to drain through the gaps in the dry dock decking (although there are now fewer gaps) or directly to into the open gap over the harbor between the uncurbed dry dock and the pier. The 3000-ton dry dock was observed during this inspection to have no significant pollutant sources exposed to contact with rainfall run-off. See Photos #1 and #2 in Section 1.6 on page 9.

Compliance Status - The dry dock was found with the gaps better sealed and the deck swept, clean, and in order. In particular, there was no blasting grit, paint debris, or overspray found on the dry dock deck or alongside on the piers. The design of the dry dock, with a split down the middle and crisscrossed with chain ways, forestalls the corrective actions advanced in the EPA Order to entirely seal the deck and direct all dry dock drainage for discharge through a controlled sample point. Nevertheless, continuous capture and removal of the solids from a curtain-shrouded and gap-sealed deck (roofing felt underlayer and temporary plastic sheeting) should prevent the loss of solids through deck gaps, over the deck edge, or entrained in storm water run-off and drainage. The EPA Order is expected to be modified to rescind the corrective actions related to controlled deck drainage. See Photos #1 and #2 on page 8.

Corrective Actions - A few remaining shortcomings have been identified following the EPA Order. First, there were no curtains available to capture drifting solids within the dry dock for removal, although MYD Samoa had them on order. Second, process-related wastewaters (*hydroblast, hose cleaning, hydrotesting*) discharge uncontrolled from the dry dock deck to the harbor beneath. Additional BMPs to correct these shortcomings and to ensure the shipyard and dry dock remain swept, clean, and in order are listed in Table 3.1 on page 17.

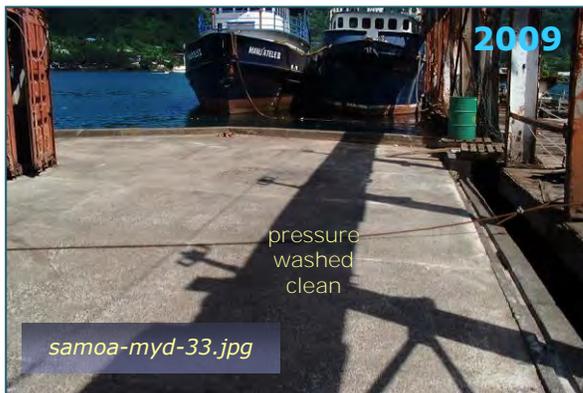
Photo #3: End of the Pier - April 2009
Taken By: Greg V. Arthur
Date: 04/27/09

Catch Basin #1 Drainage – Catch Basin #1 includes the piers and landings around the 800-ton dry dock and two buildings. Catch Basin #1 was observed to be swept, in order, cleaned, and pressure washed, with no significant pollutant sources left exposed to contact with storm water run-off. The numerous pollutant sources observed last year were no longer found. In particular, the open storage of spent blasting grit and material debris adjacent to the 800-ton dry dock and the winch room was entirely removed. The trash piles, oily barrels, spent materials, and equipment on the landing were also removed. The pavement between the dry dock and harbor was pressure washed clean. There was curbing along the open harbor but not around the 800-ton dry dock. Catch Basin #1 drainage collects to a sump outfitted with siphon overflows to the harbor, designated as discharge point NPDES-001. No oily drainage was observed flowing into and through the discharge sump and no sheen was observed in the harbor around NPDES-001. See Photos #3, #4, #7, #8, #9, and #10 in Section 1.6 on page 10.

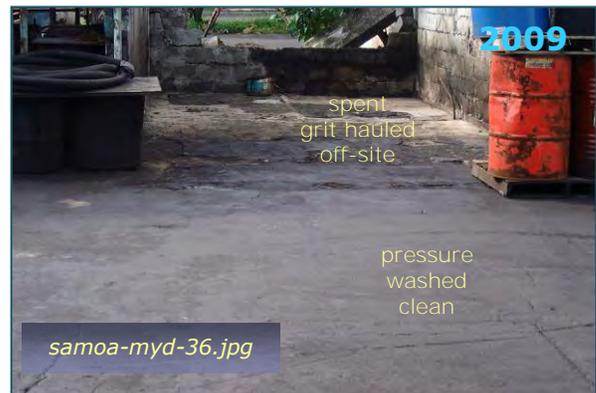
Photo #4: Eliminated Spent Grit Storage - April 2009
Taken By: Greg V. Arthur
Date: 04/27/09

On the day of this inspection, these BMPs were observed have been effective in keeping much of the spent grit out of the harbor. In particular, (1) many of the gaps in the decking were underlain with roofing felt; (2) there was little spent grit on the deck and none on the surrounding piers; (3) there was no wet grit residue left on the deck after sweeping; and (4) the stockpile of spent grit stored next to the 800-ton dry dock was removed. However, spent grit blown to the dry dock edges would not be captured until MYD Samoa installs the new curtains. See Photos #1, #2, #4, #5, and #6 in Section 1.6 on page 9.

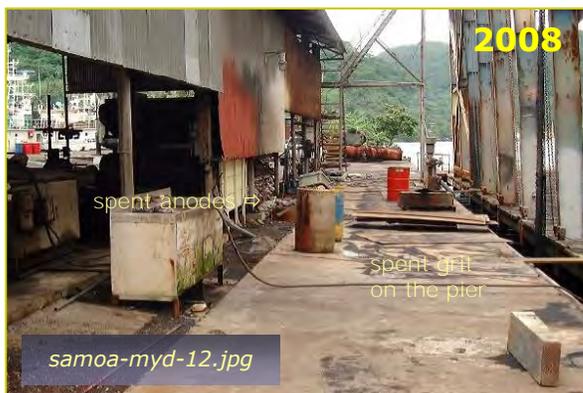
Photo #5: Catch Basin #3 - April 2008
Taken By: Greg V. Arthur
Date: 04/01/08

Fabrication Shop - Sheet metal fabrication and welding work is performed in an open but roofed building located near the South Dock just south of the 3000-ton dry dock within the storm drainage watershed referred to as Catch Basin #3. The metal fabrication work includes sheet metal shearing, welding, rolling, and bending. The EPA inspector observed that scrap and materials, such as spare zinc anodes, were no longer stored exposed to the rain along the outside of the building. The cement driveway between the shops and the dry dock appeared to slope from the shops toward the dry dock and the gap that opens to the harbor waters below. See Photos #5 and #6 in Section 1.6 of this report on page 9.

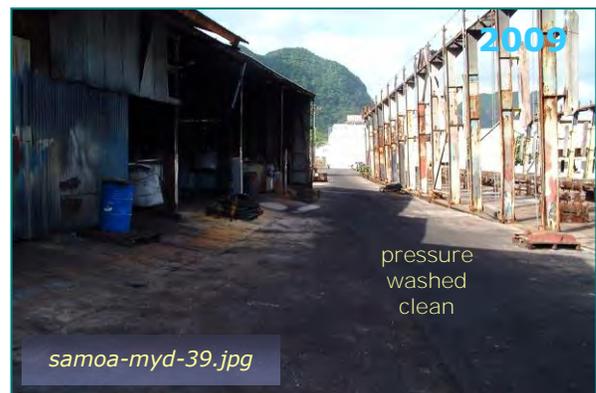
Photo #6: Catch Basin #3 - April 2009
Taken By: Greg V. Arthur
Date: 04/30/09

Catch Basin #3 Drainage – Catch Basin #3 includes the South Dock and the pier side landings between the fabrication and machining buildings and the 3000-ton dry dock. Catch Basin #3 was observed to be swept, in order, and cleaned, with no significant pollutant sources exposed to contact with rainfall run-off. Spent blasting grit was not found on the landings south of the dry dock. Zinc anodes, barrels, materials, scrap, and debris were no longer stored outside and around the fabrication and machining buildings. No boat repair work was being done by the ship crews on the South Dock. Most of the drainage collects to a sump outfitted with siphon overflows to a short canal leading to the harbor, and designated as discharge point NPDES-003. No sheen was observed in the canal and harbor around NPDES-003. There is curbing along the South Dock but not on the pier around the 3000-ton dry dock. Around the dry dock, the landing slants toward the open gap over the harbor between the uncurbed pier and the dry dock. See Photos #5, #6, and #12 in Section 1.6 on pages 9 and 10.

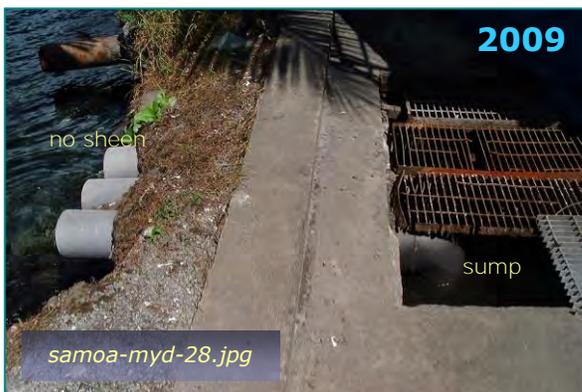
Photo #11: Discharge Sump 002 – April 2009
Taken By: Greg V. Arthur
Date: 04/27/09

Catch Basin #2 Drainage – Catch Basin #2 encompasses buildings and pier side landings north and east of the 3000-ton dry dock. Catch Basin #2 was observed to be swept, in order, and cleaned, with no significant pollutant sources exposed to contact with rainfall run-off. Spent blasting grit was not found on the landings north of the dry dock. There is curbing along the open harbor but not on the pier around the 3000-ton dry dock. The drainage collects to a sump outfitted with siphon overflows to the harbor, designated as discharge point NPDES-002. No sheen was observed in the harbor around NPDES-002. See Photo #11 in Section 1.6 on page 10.
