**Re: September 29, 2010 Clean Water Act Inspection
And Termination of EPA Administrative Order CWA-309(a)**

NPDES COMPLIANCE EVALUATION INSPECTION

NPDES Permittee: MYD Samoa, Inc.

Facility: Satala Shipyard
P.O. Box 7684, Pago Pago, Tutuila Island, American Samoa
(NPDES Permit No. AS0020026)

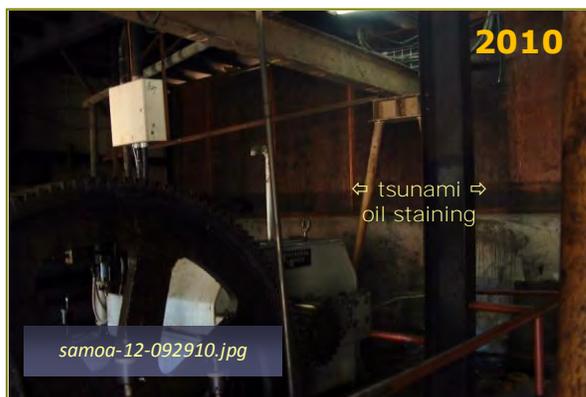
On the date of this inspection, evidence of unrepaired damage from the tsunami included failure of both ends of the 3000-ton dry dock seawall, destruction of the outboard wind break curtains, deck planking loss, and the washout of the winch gear box lubricating pit. See Photos #1, #2, #3, and #4 in Section 1.5 of this report on pages 8 and 9.

Photo #1: Engine Winch Room – 6' tsunami levels
Taken By: Greg V. Arthur
Date: 09/29/10

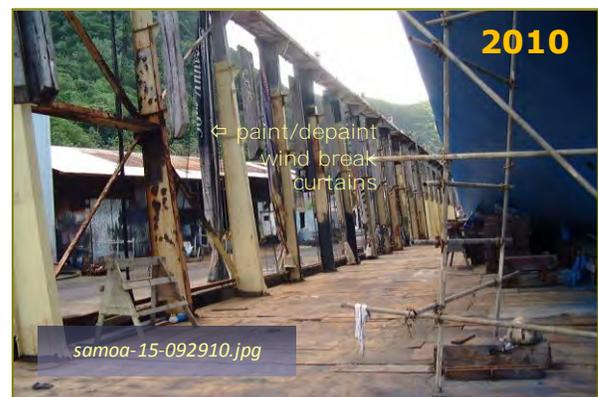
On the day of this inspection, these BMPs were observed to have not been effectively deployed. In particular, (1) some plywood decking was damaged exposing some gaps to the harbor beneath; (2) the deck was not swept; (3) there were deposits of grit on the deck and adjacent piers; and (4) the wind break curtains were missing on the windward side of the dry dock. Spent grit blown to the dock edges cannot be captured until MYD Samoa installs new curtains. See Photos #2, #3, and #4 in Section 1.5 on pages 8 and 9.

- Dry dock Drainage – Rainfall runoff can drain through the gaps in the dry dock decking or directly to into the open gap over the harbor between the uncurbed dry dock and the pier. Deposits of spent blasting grit were observed on the 3000-ton dry dock. The deposits of spent grit onto the surrounding pier landings indicates that MYD Samoa grit blasted without unfurling wind break curtains. See Photos #2, #3, and #4 in Section 1.5 on pages 8 and 9.

Photo #2: 3000-Ton Dry Dock – wind break curtains
Taken By: Greg V. Arthur
Date: 09/29/10

Part III.B.3(b)(4) of the NPDES permit requires curtains to be unfurled on the sides of the dry dock during sandblasting and painting in order to prevent the loss of spent blasting grit, paint chips, and paint overspray to the receiving waters. On the day of this inspection, there were deposits of spent blasting grit on the landings indicating that sandblasting and painting occurred without the effective unfurling of the curtains.

- MYD Samoa must, to the greatest extent practical, seal the dry dock deck in order to prevent the loss of any solids into the harbor through gaps in the decking, always deploy curtains to capture all spent blasting grit on the dry dock, and after each shift keep the dry dock deck swept, clean, and in order.
- MYD Samoa must repair the tsunami-damaged curbing, and install either curbing or drainage trenching around the dry docks.
- MYD Samoa must, to the greatest extent practical, minimize storm water contact with all process equipment, materials, debris, and wastes.

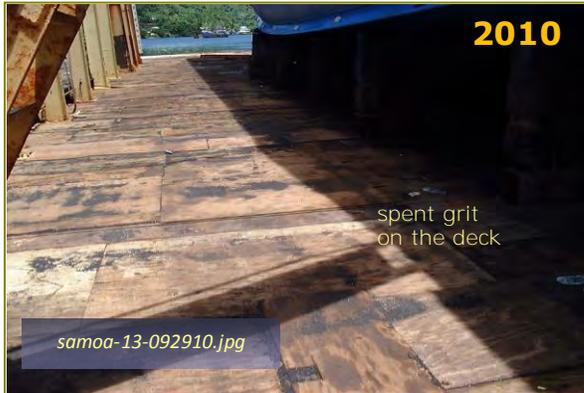
Photo #3: 3000-Ton Dry Dock Decking – Sept 2010
Taken By: Greg V. Arthur
Date: 09/29/10

Parts III.B.2(D1) and III.B.3(b)(4) of the NPDES permit requires the dry dock to be sealed to the greatest extent practical and the deck to be completely covered in order to prevent the loss of solids into the harbor through gaps in the decking. The dry dock was found with the sealable gaps for the most part sealed, although the condition of the plywood and the roofing felt underlayment showed some damage. MYD Samoa indicated that some of the damage was tsunami related, even though the tsunami occurred one year previous.

Parts III.B.2(D3) and III.B.3(b)(4) of the NPDES permit requires the dry dock deck to be dry broomed or vacuumed cleaned at the end of each shift to remove solids including spent blasting grit, removed scale, trash, and rust, in order to prevent the loss of storm water entrained solids into the harbor through gaps in the decking or over the deck edge. Deposits of spent blasting grit on the deck indicate that solids are not removed at the end of each shift.

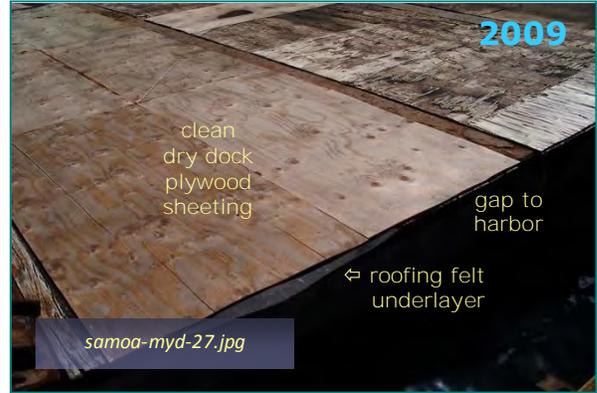
Photo #4: 3000-Ton Dry Dock Decking – April 2009
Taken By: Greg V. Arthur
Date: 04/27/09

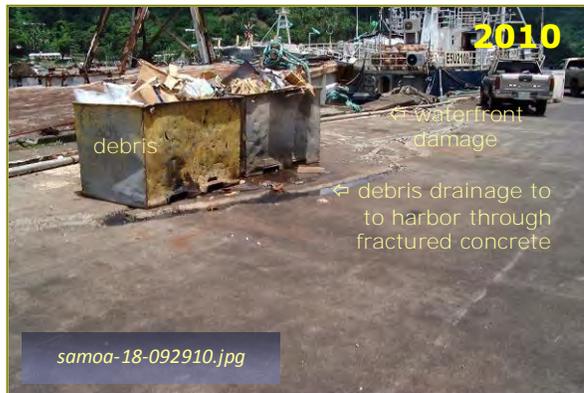
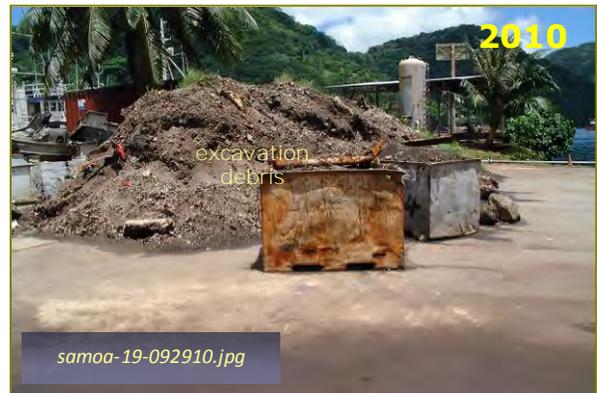
South Dock - Ships berthing takes place next to the shipyard in an area called the South Dock extending south of the 3000-ton Dry Dock and the harbor, within the storm water drainage watershed referred to as Catch Basin #3. Extensive unrepaired tsunami-caused damage to the South Dock sea wall was still evident with structural concrete fracturing along the waterfront, and debris, excavation soils, and scrap awaiting removal. See Photos #5 and #6 in Section 1.5 of this report on page 9.

- Catch Basin #3 Drainage – Catch Basin #3 includes the South Dock and the pier side landings between the fabrication and machining buildings and the 3000-ton dry dock. Catch Basin #3 was observed to have deposits of spent blasting grit on the landing north of the dry dock, and tsunami-related excavation soils and debris bins uncovered and exposed to contact with rainfall run-off. There were no materials, scrap, or debris stored outside and around the fabrication and machining buildings, and no boat repair work done by the ship crews on the South Dock. There is curbing along the South Dock but not on the pier around the 3000-ton dry dock. Around the dry dock, the landing slants toward the open gap over the harbor between the uncurbed pier and the dry dock. Most of the drainage collects to a sump outfitted with siphon overflows to a short canal leading to the harbor, and designated as discharge point NPDES-003. However, tsunami damage to the South Dock fractured the pavement and curbing, and some drainage drains through cracks to the harbor. No sheen was observed in the canal and harbor around NPDES-003. See Photos #5, #6, and #14 in Section 1.5 on pages 9 and 10.

Photo #5: Catch Basin #3 – South Dock
Taken By: Greg V. Arthur
Date: 09/29/10

Photo #6: Catch Basin #3 – South Dock
Taken By: Greg V. Arthur
Date: 09/29/10

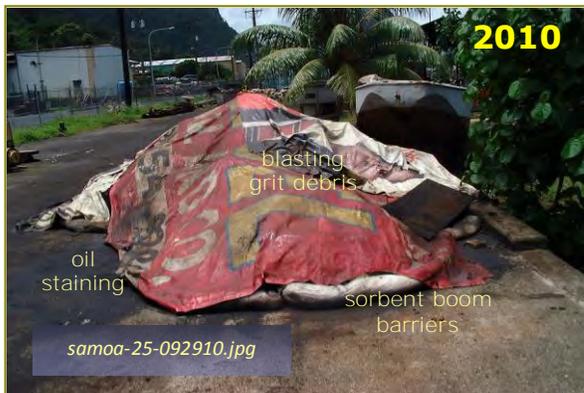
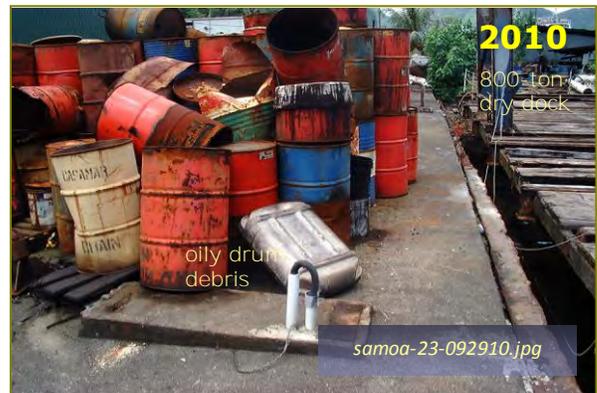
800-Ton Cradle Dry Dock - The smaller of the two dry docks was found on this inspection to be decommissioned and awaiting repair as it was in the previous year, with additional unrepaired tsunami-caused damage, and debris accumulation around and under the dry dock. The landings around the 800-ton dry dock are within the storm water drainage watershed referred to as Catch Basin #1. MYD Samoa hopes to repair and commission the 800-ton dry dock back into service at an undetermined future date. The design of this dry dock is similar to the larger one. See Photos #7 and #8 in Section 1.5 of this report on page 9.

- Catch Basin #1 Drainage – Catch Basin #1 includes the piers and landings around the 800-ton dry dock and two buildings. Catch Basin #1 was observed to have significant pollutant sources left exposed to contact with storm water run-off and to have tsunami-damaged curbing along the waterfront. In particular, there were (1) uncovered trash and barrel piles, (2) a covered but ineffectively boomed grit debris pile, (3) oil staining on the pavement leading from the blasting grit debris pile to the uncurbed gap around the 800-ton dry dock, (4) oil staining on the concrete near the discharge sump, and (5) tsunami-damaged curbing along the waterfront west of the discharge sump. With intact curbing, Catch Basin #1 drainage collects into a discharge sump outfitted with siphon overflows to the harbor, designated as discharge point NPDES-001. On the date of this inspection, no oily drainage was observed flowing into and through the discharge sump and no sheen was observed in the harbor around NPDES-001. See Photos #7, #8, #9, #10, #11, and #12 in Section 1.5 on pages 9 and 10.

Photo #7: Catch Basin #1 – near 800-ton dry dock
Taken By: Greg V. Arthur
Date: 09/29/10

Photo #8: Catch Basin #1 – near 800-ton dry dock
Taken By: Greg V. Arthur
Date: 09/29/10

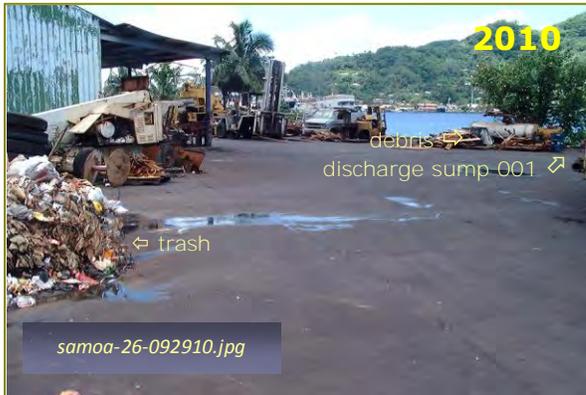
Photo #9: Catch Basin #1 – Sept 2010
Taken By: Greg V. Arthur
Date: 09/29/10

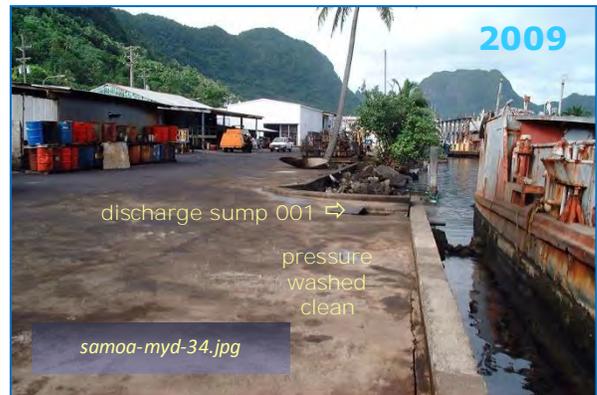
Photo #10: Catch Basin #1 – April 2009
Taken By: Greg V. Arthur
Date: 04/30/09

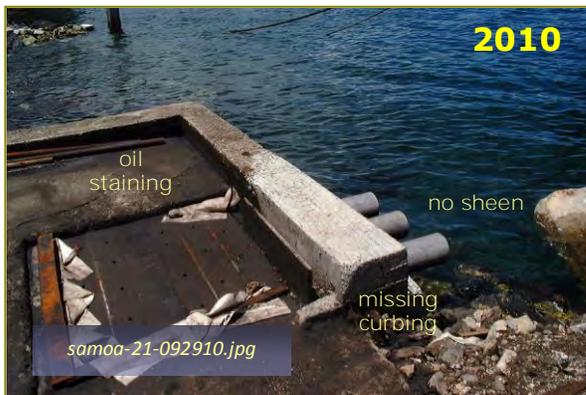
Photo #11: Catch Basin #1 - discharge sump 001
Taken By: Greg V. Arthur
Date: 09/29/10

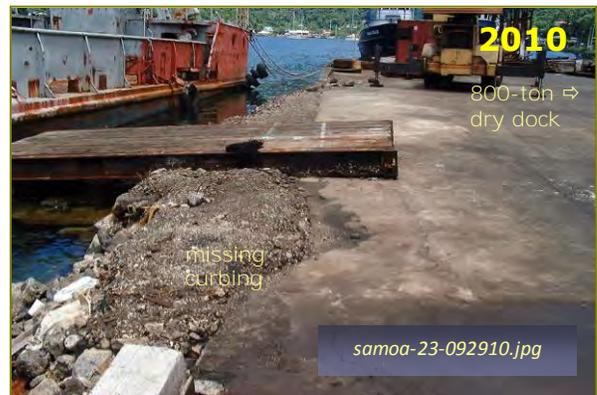
Photo #12: Catch Basin #1 – damaged waterfront
Taken By: Greg V. Arthur
Date: 09/29/10

Part III.B.1(S5) of the NPDES permit requires curbing along the harbor to be maintained. Tsunami damage includes the fractured South Dock sea wall and the missing curbing west of outfall 001.

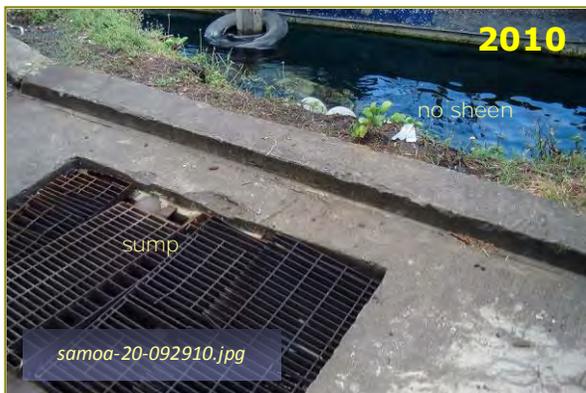
and cleaned, with no other significant pollutant sources exposed to contact with rainfall run-off. There is curbing along the open harbor but not on the pier around the 3000-ton dry dock. The drainage collects to a sump outfitted with siphon overflows to the harbor, designated as discharge point NPDES-002. No sheen was observed in the harbor around NPDES-002. See Photo #13 in Section 1.5 on page 10.

Photo #13: Discharge Sump 002 – Sept 2010
Taken By: Greg V. Arthur
Date: 09/29/10

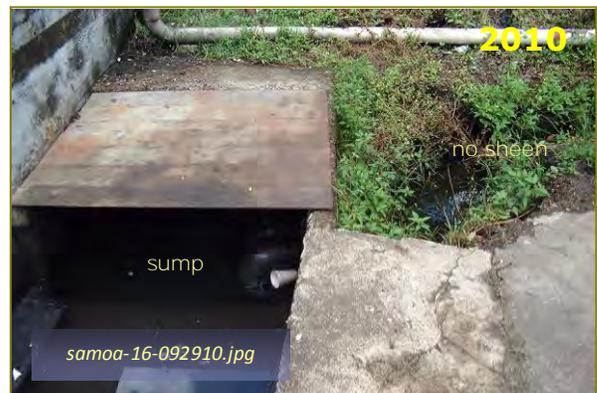
Photo #14: Discharge Sump 003 – Sept 2010
Taken By: Greg V. Arthur
Date: 09/29/10

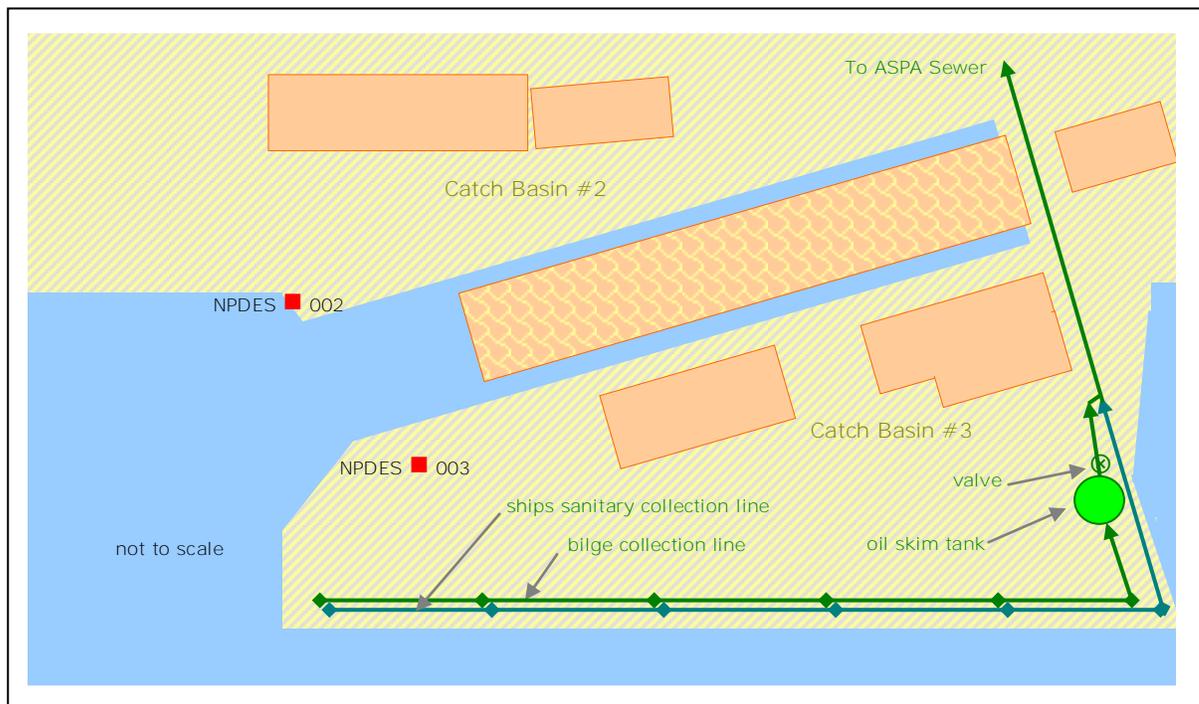
Figure 3.2.8
Schematic of Possible Upgrades - Shipboard Wastewater Handling

no shipyard facilities to handle vessel-related wastewaters. Although ships continue to generate shipboard wastewaters while in dock, there was no observed evidence of discharge from shipboard sources. MYD Samoa further indicates that no shipboard wastewaters are accepted, and that they would consider the connection of dock facilities to the ASPA sewers.

- MYD Samoa should consider providing a connection for ships sanitary wastewaters to the ASPA domestic sewer system. See Figure 3.2.8 on page 18 of this report.
