Appendix B PHOTOGRAPH LOG

**City of Mesa, AZ - Municipal Separate Storm Sewer System (MS4)
(Permit No. AZS000004) Photograph Log**
Evaluated by: Scott Coulson (PG Environmental, LLC)

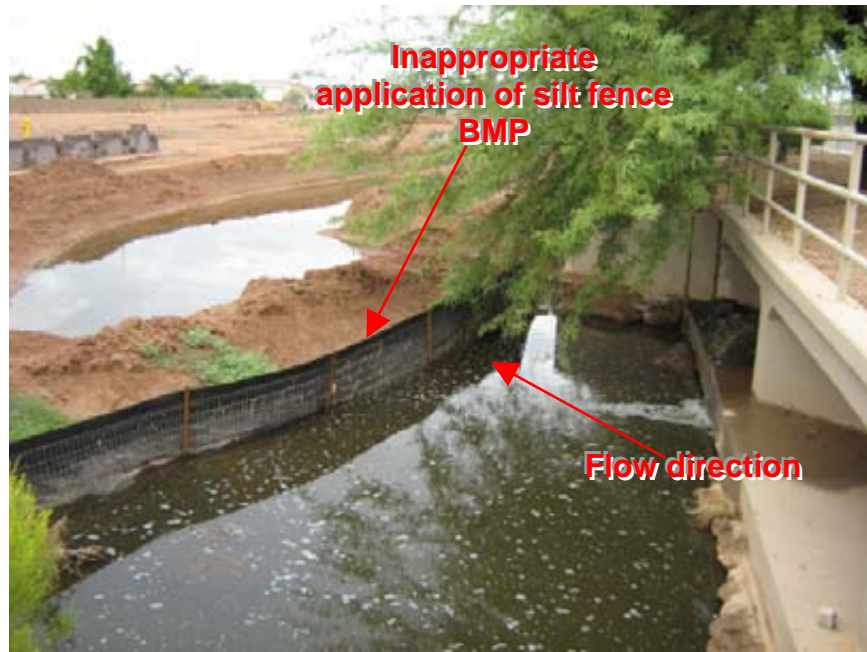
Photograph 1: Mountain View Village Center
Drainage channel conveys flow into the northeast side of the site, where a silt fence BMP had been improperly implemented in an area of concentrated flow

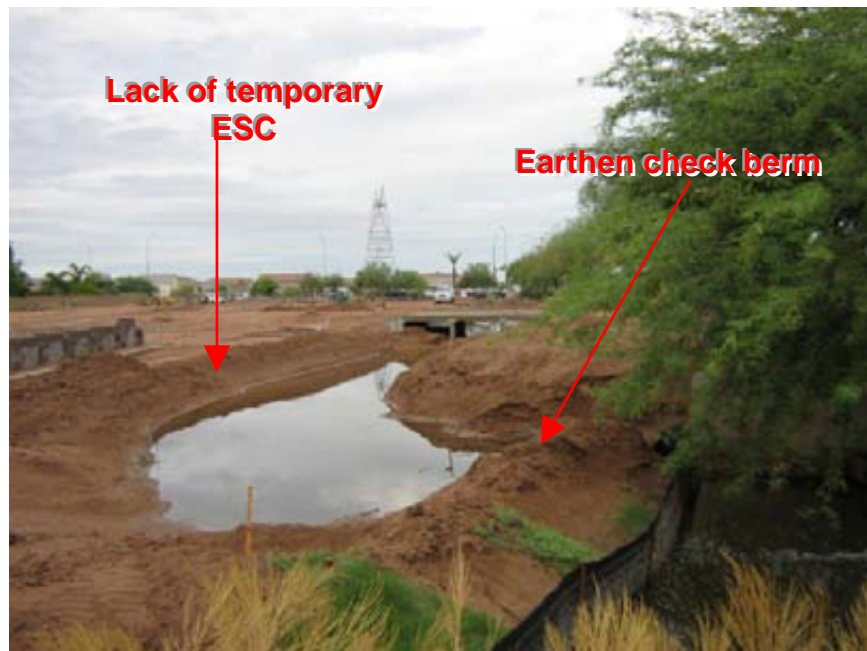
Photograph 2: Mountain View Village Center
View of drainage channel leading west across the site and earthen check berms installed along this course

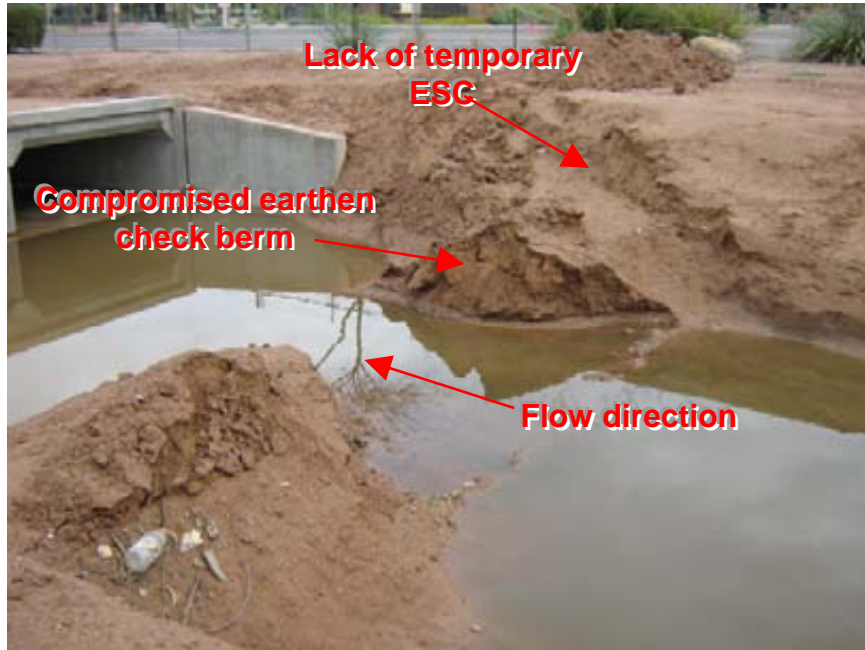
Photograph 3: Mountain View Village Center
Earthen check berm consisting of unconsolidated fill had been placed within the drainage channel and was compromised by a recent flow event

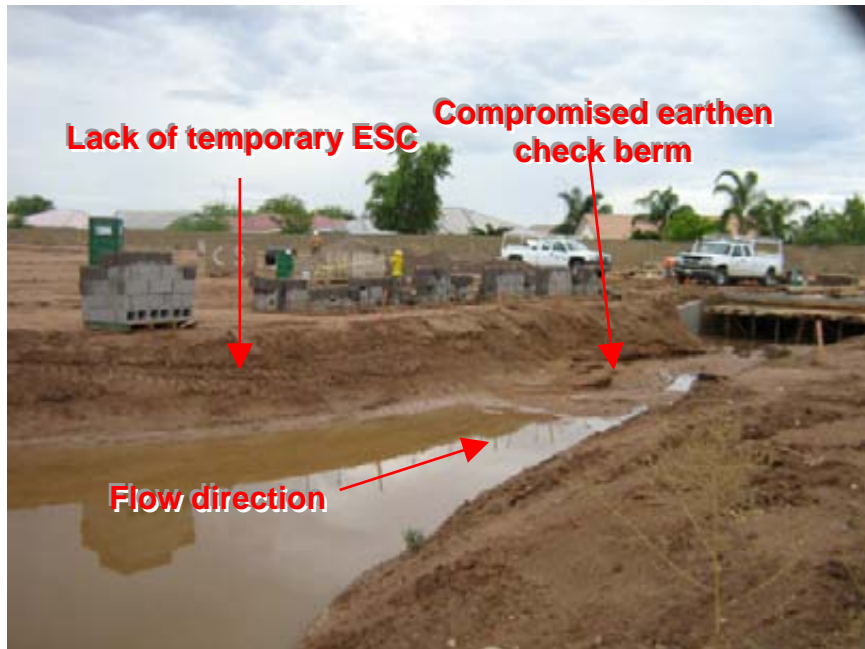
Photograph 4: Mountain View Village Center
Lack of temporary ESC between the large expanse of disturbed construction site area and the flowing drainage channel

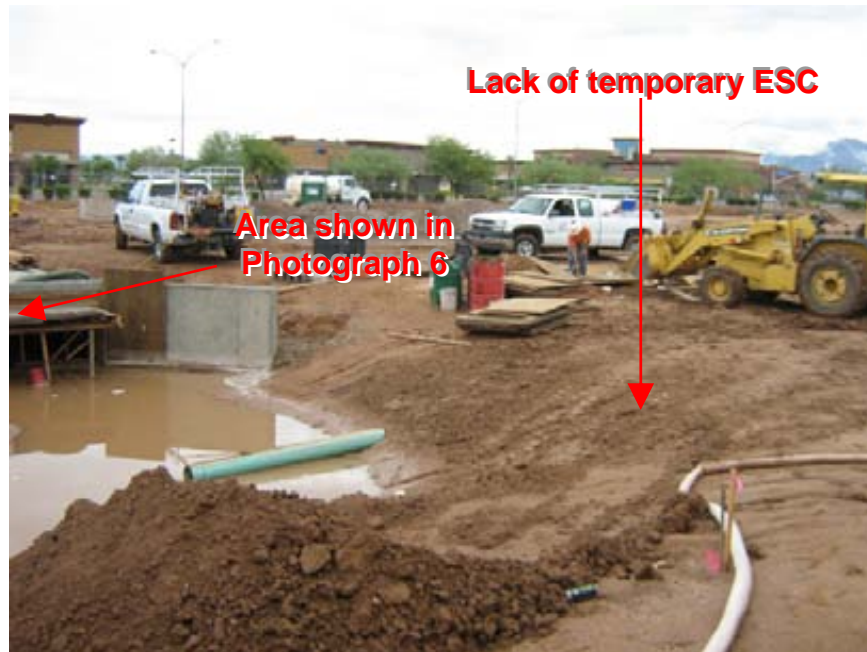
Photograph 5: Mountain View Village Center
Lack of temporary ESC between the large expanse of disturbed construction site area and the flowing drainage channel

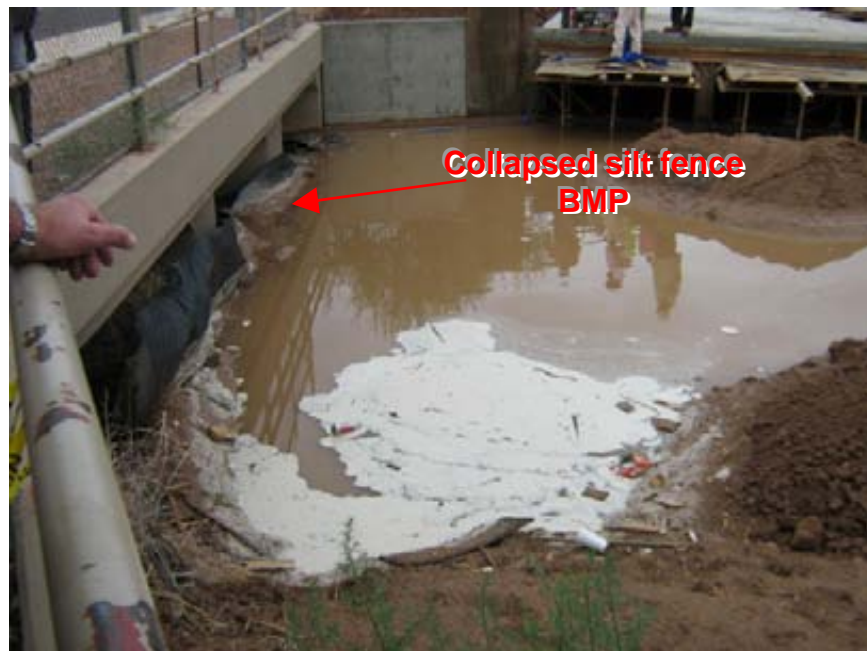
Photograph 6: Mountain View Village Center
Collapsed silt fence BMP installed within the concentrated flow of the drainage channel prior to exiting the site

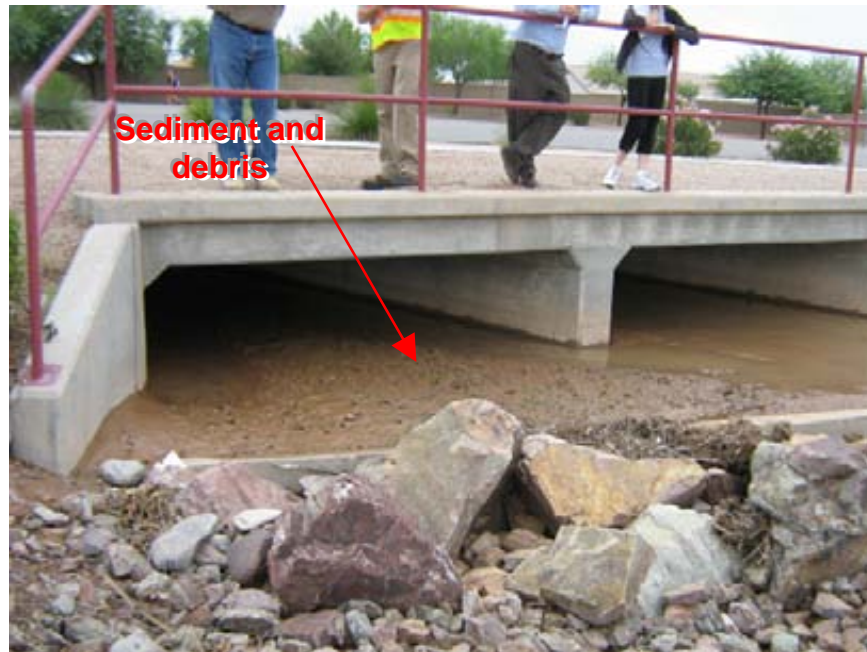
Photograph 7: Mountain View Village Center
Sediment and debris were observed in the drainage channel
above the flow control structure

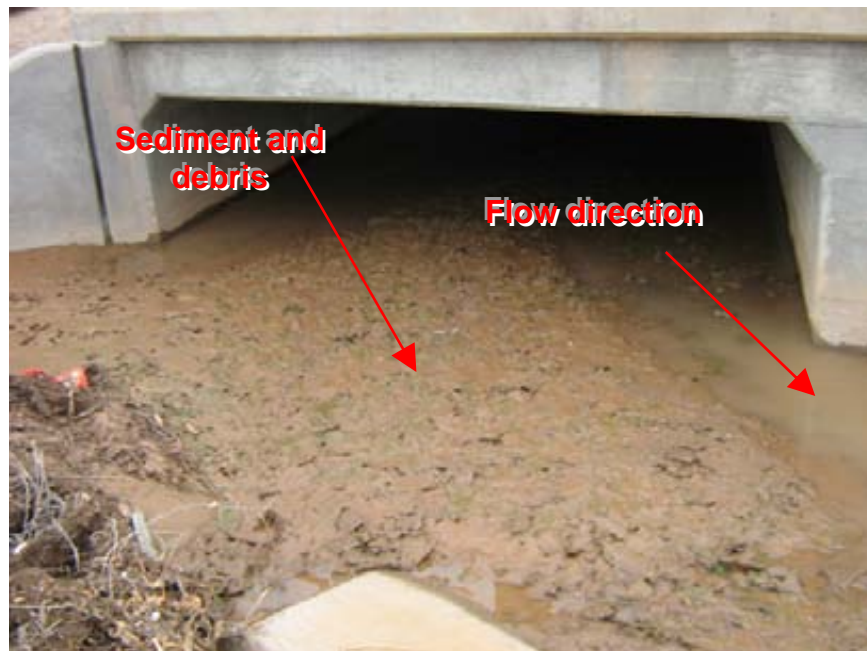
Photograph 8: Mountain View Village Center
Close-up view of area shown in Photograph 7 depicting sediment deposition
directly downstream of the failed silt fence shown in Photograph 6

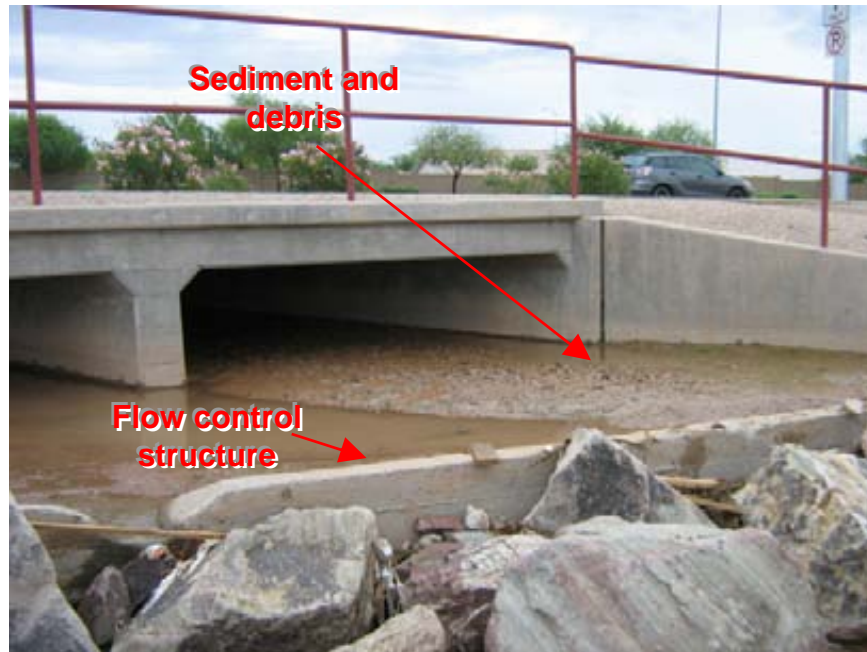
Photograph 9: Mountain View Village Center
View of sediment deposition on the opposite side of the failed silt fence shown in Photograph 6

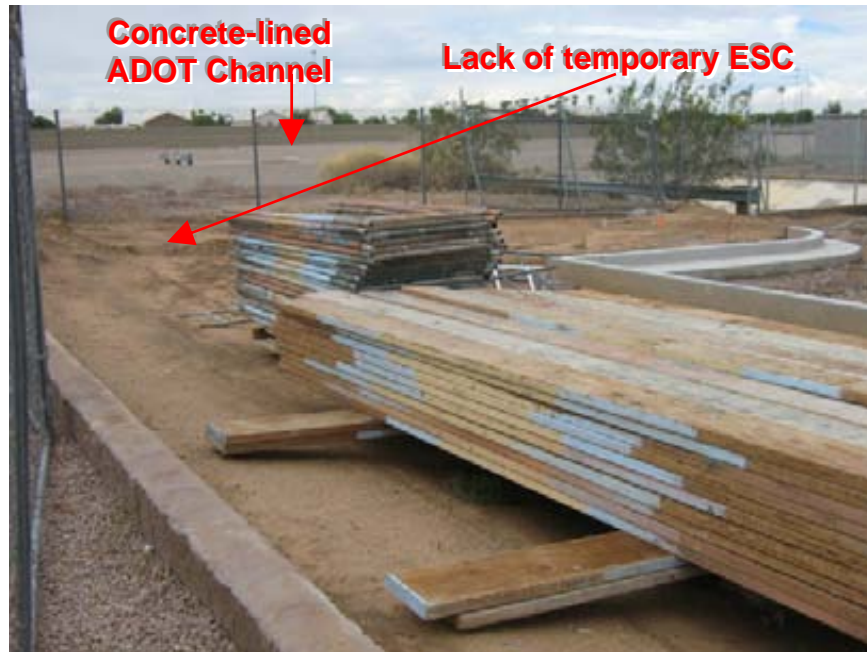
Photograph 11: Superstition Springs Commerce Center
View showing proximity of site to the ADOT Channel and lack of BMPs

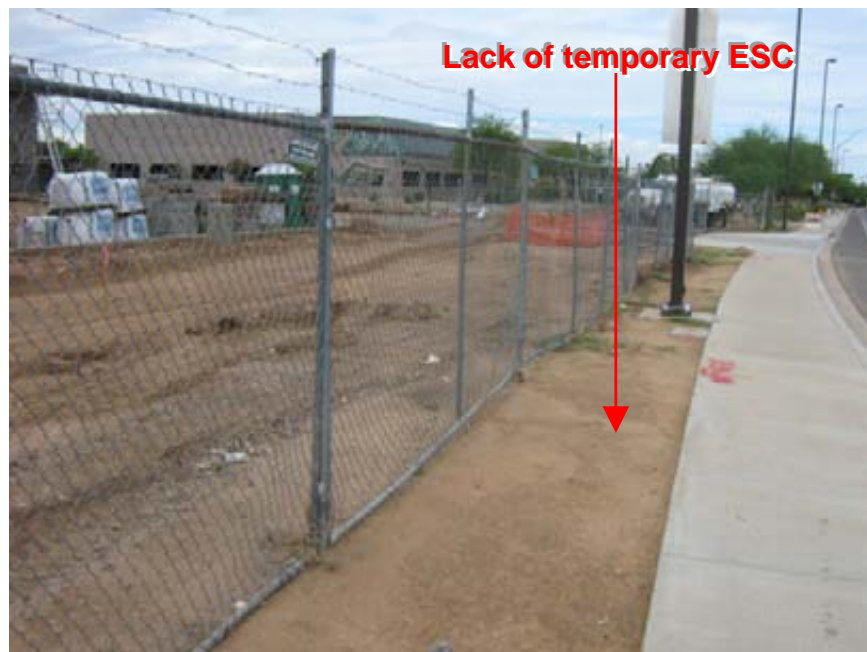
Photograph 12: Superstition Springs Commerce Center
BMPs were not implemented as perimeter control along Hampton Avenue, between the disturbed area and the offsite curb and gutter flowline

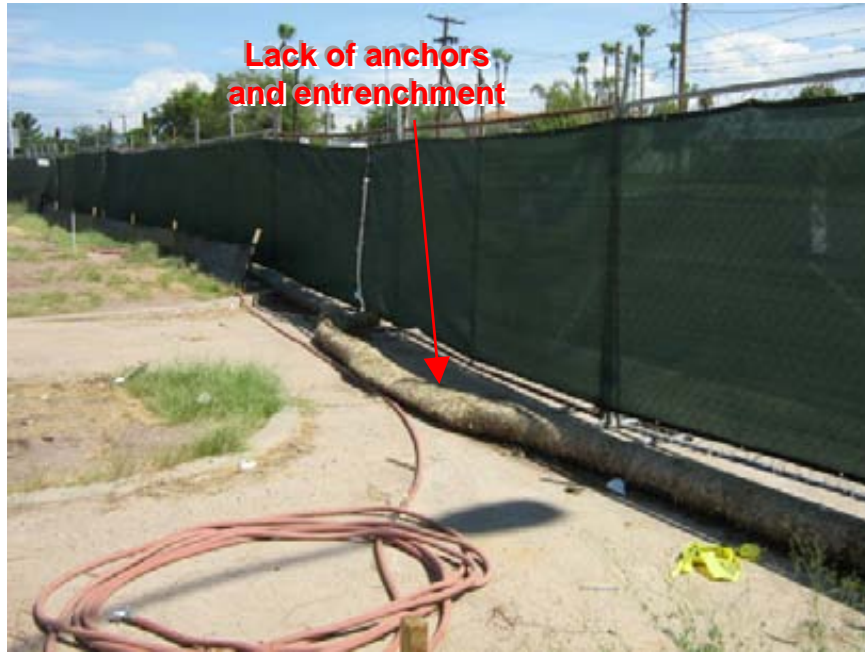
Photograph 15: Mesa Municipal Court
Straw wattles were installed on an impervious surface, and therefore were not properly entrenched or anchored to create an adequate seal

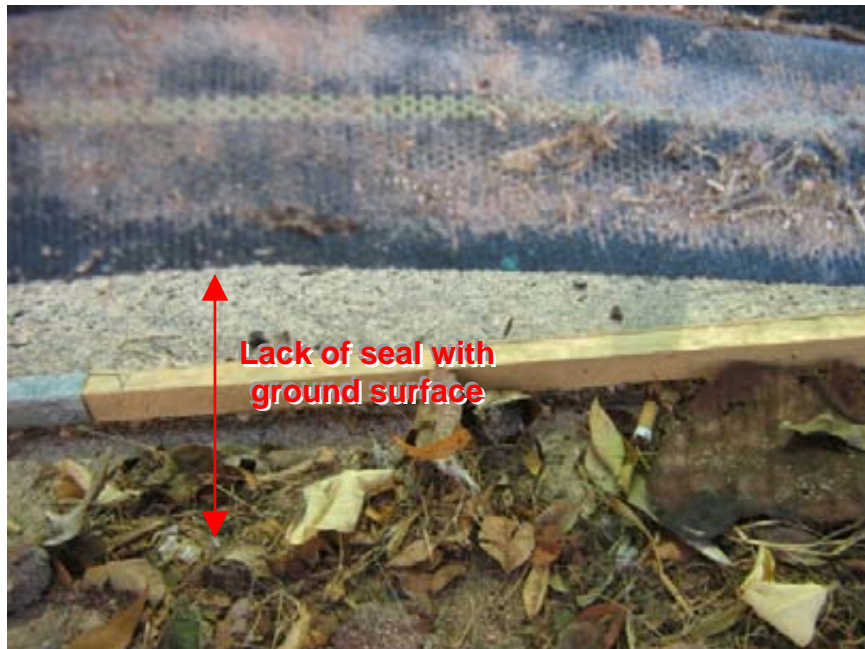
Photograph 16: Mesa Municipal Court
Sections of the silt fence along the southern perimeter were not maintained with adequate entrenchment

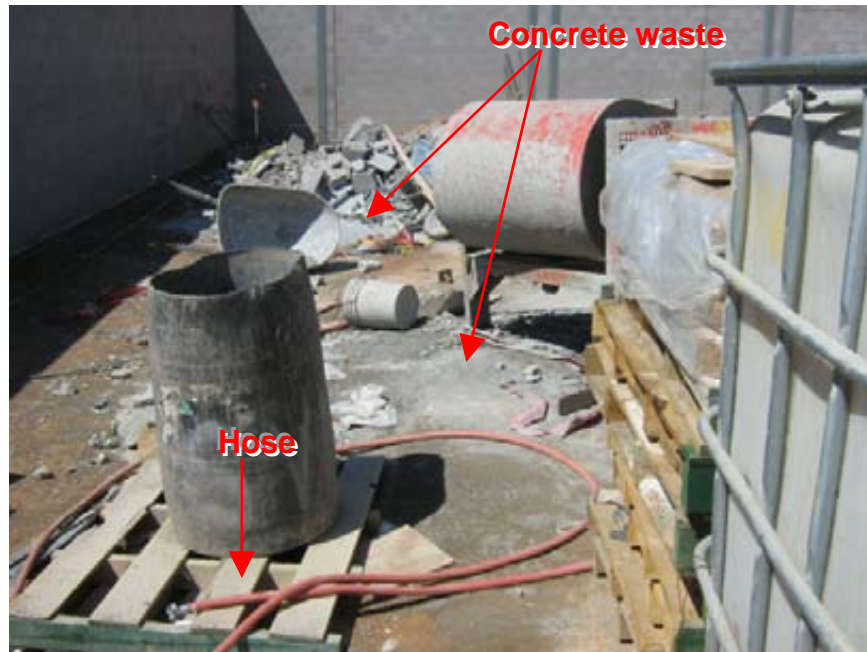
Photograph 17: Mesa Municipal Court
Concrete waste and washout hose located near mixer

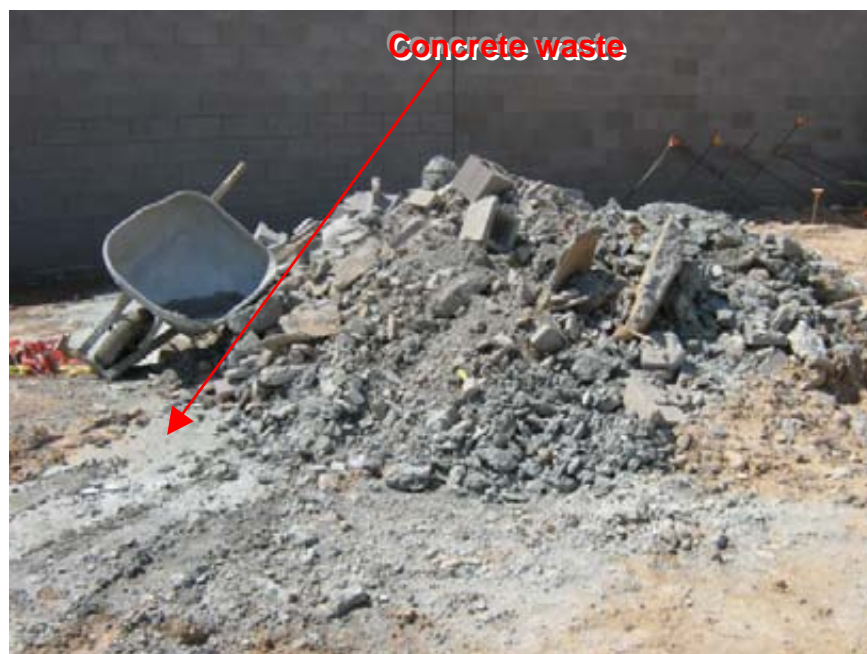
Photograph 18: Mesa Municipal Court
Close-up view of concrete waste shown in background of Photograph 17
