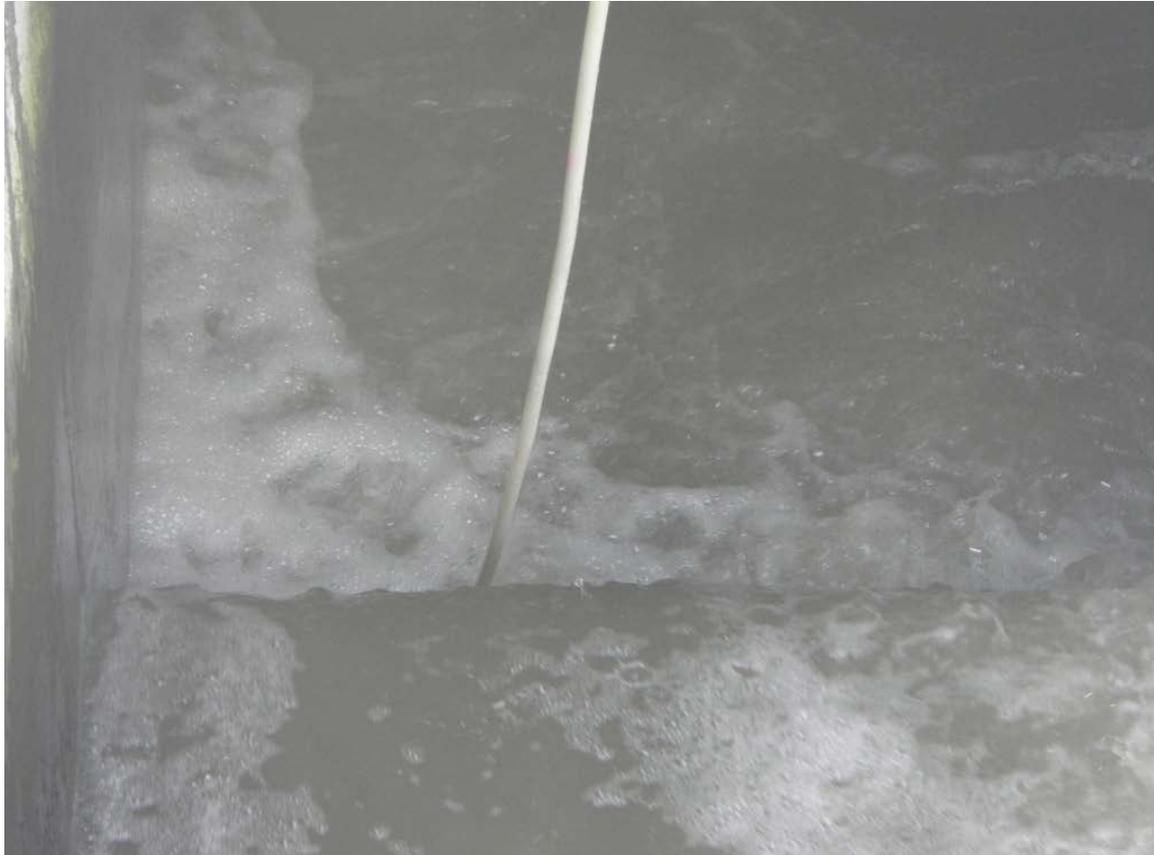
Picture 1: Influent sampler tubing reaching into influent wastewater channel at Northern STP.

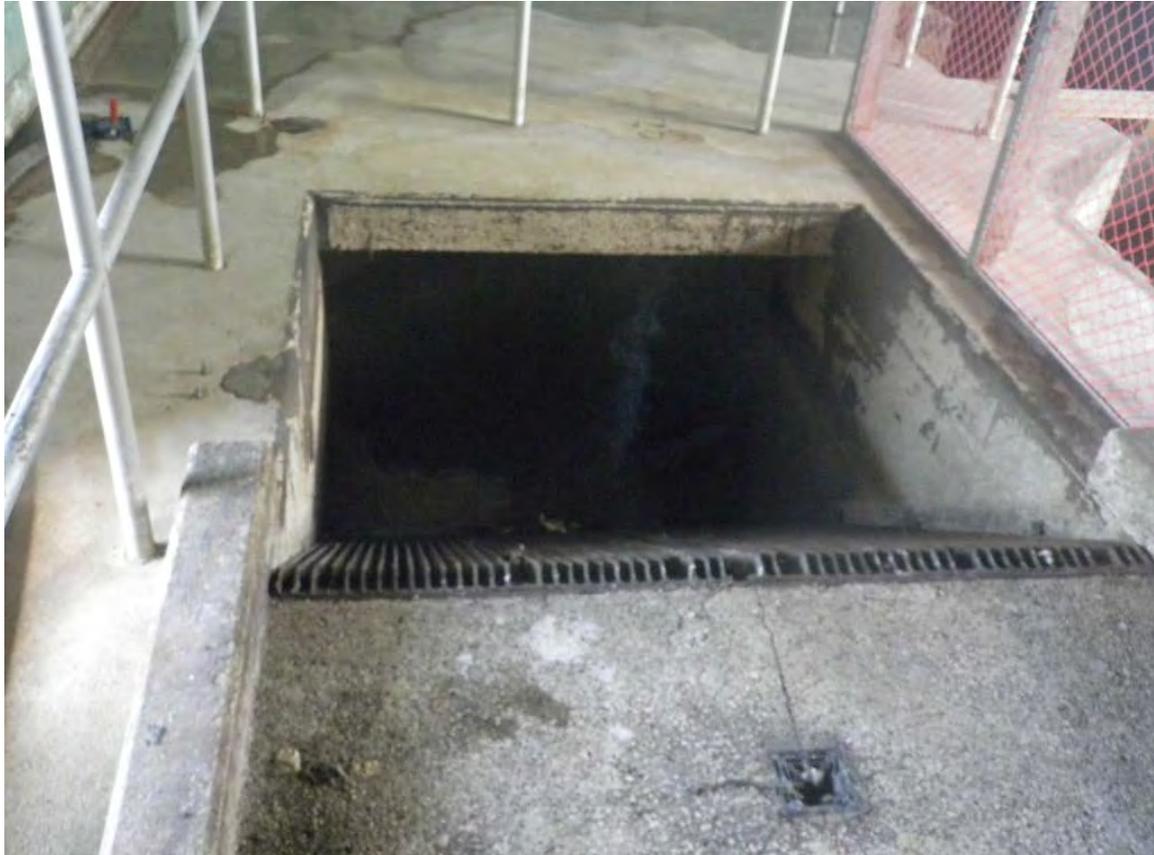
Picture 2: Manual bar screen for influent channel at Northern STP.

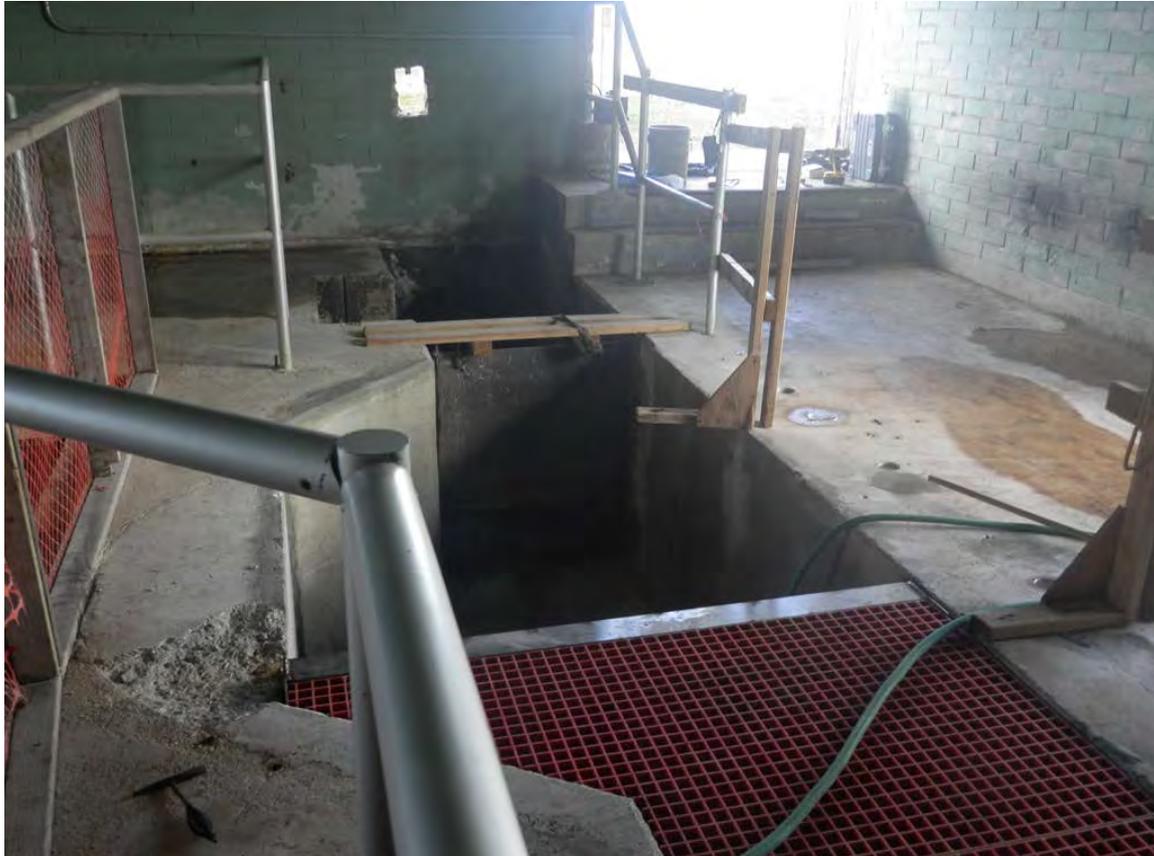
Picture 3: Right side influent channel blanked off for head works upgrades at Northern STP.

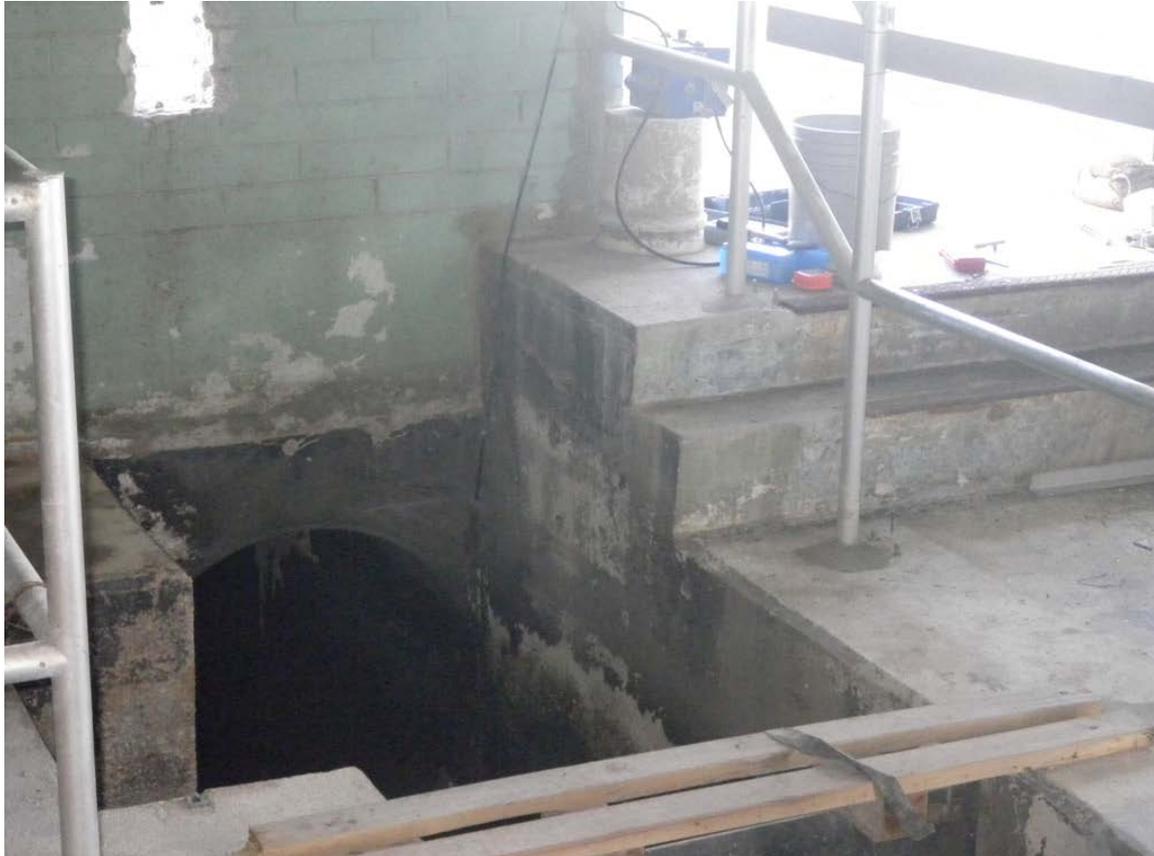
Picture 4: Temporary flow meter installed in influent channel at Northern STP.

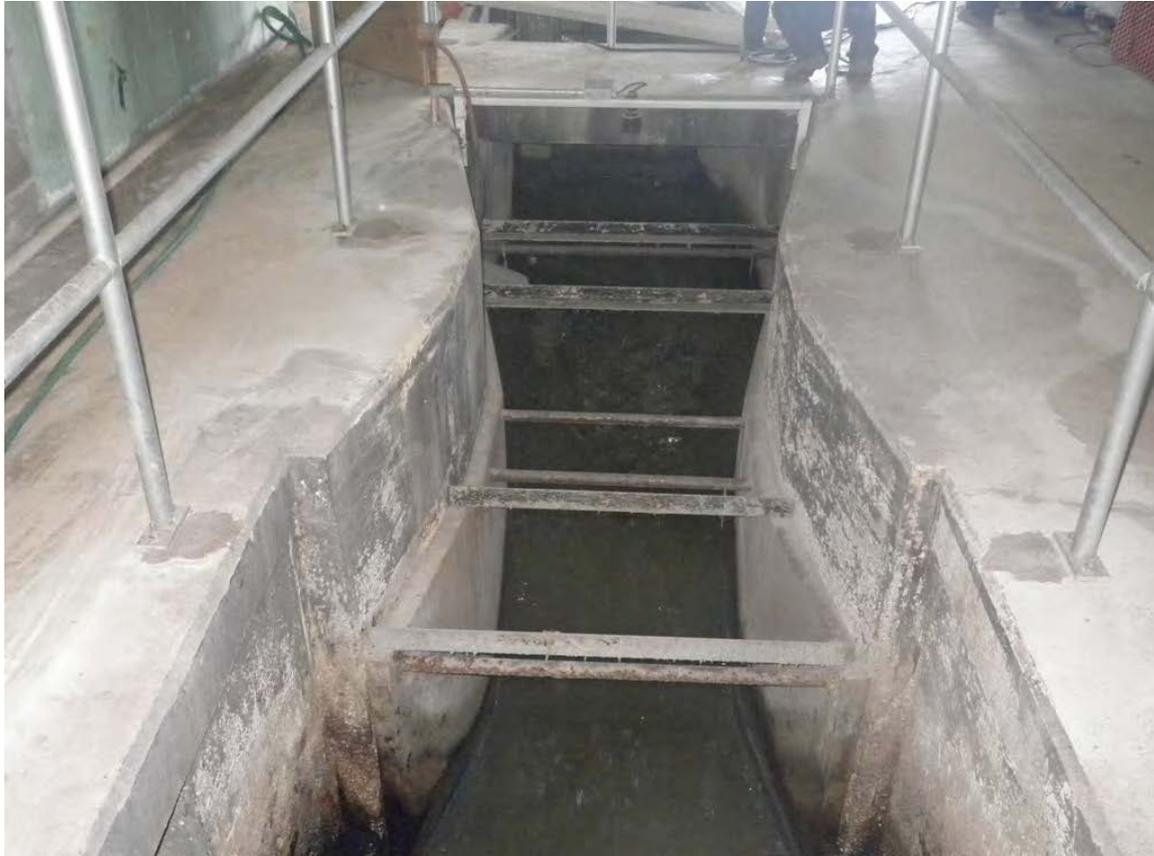
Picture 5: Influent Parshall flume out of service at Northern STP.

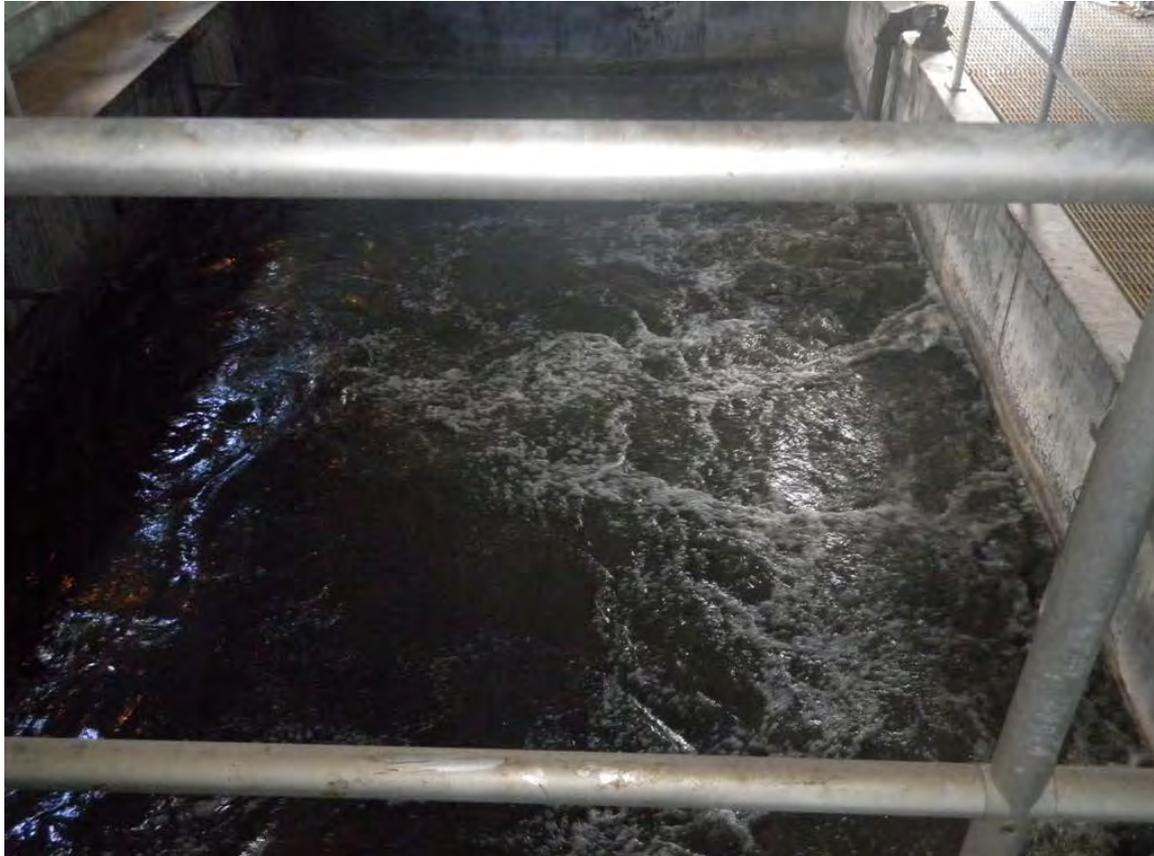
Picture 6: Aerated grit chamber inside head works building at Northern STP.

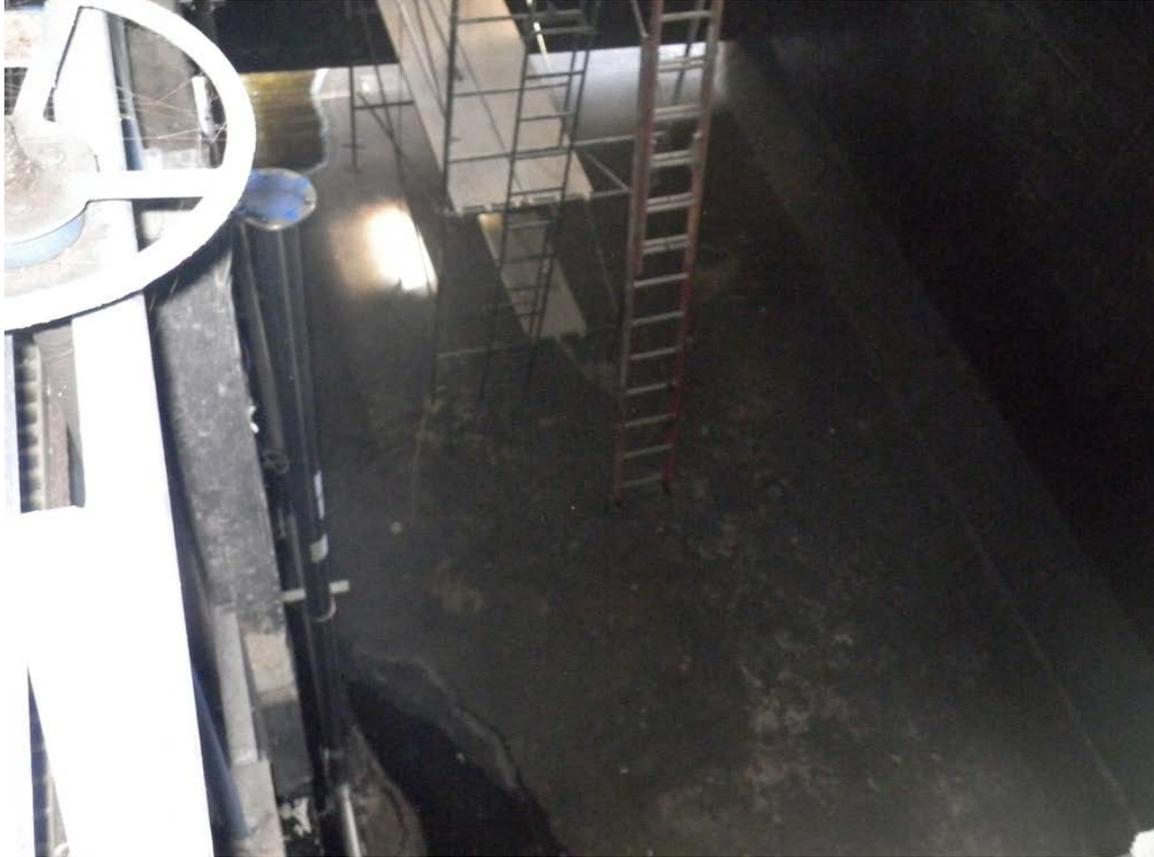
Picture 7: Out of service aerated grit chamber being retrofitted as a rapid mix tank at Northern STP.

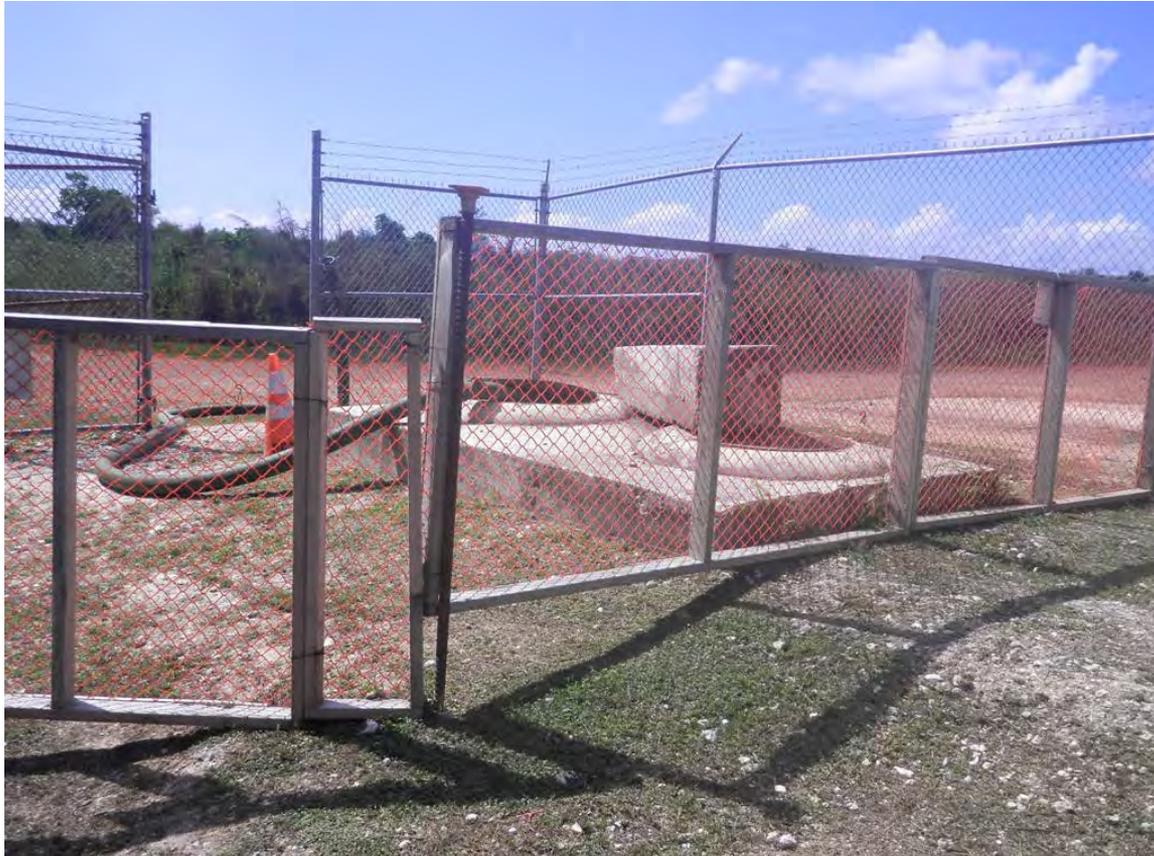
Picture 8: Septage dump station at Northern STP. Manholes connect to influent channel. Head works building is to the left.

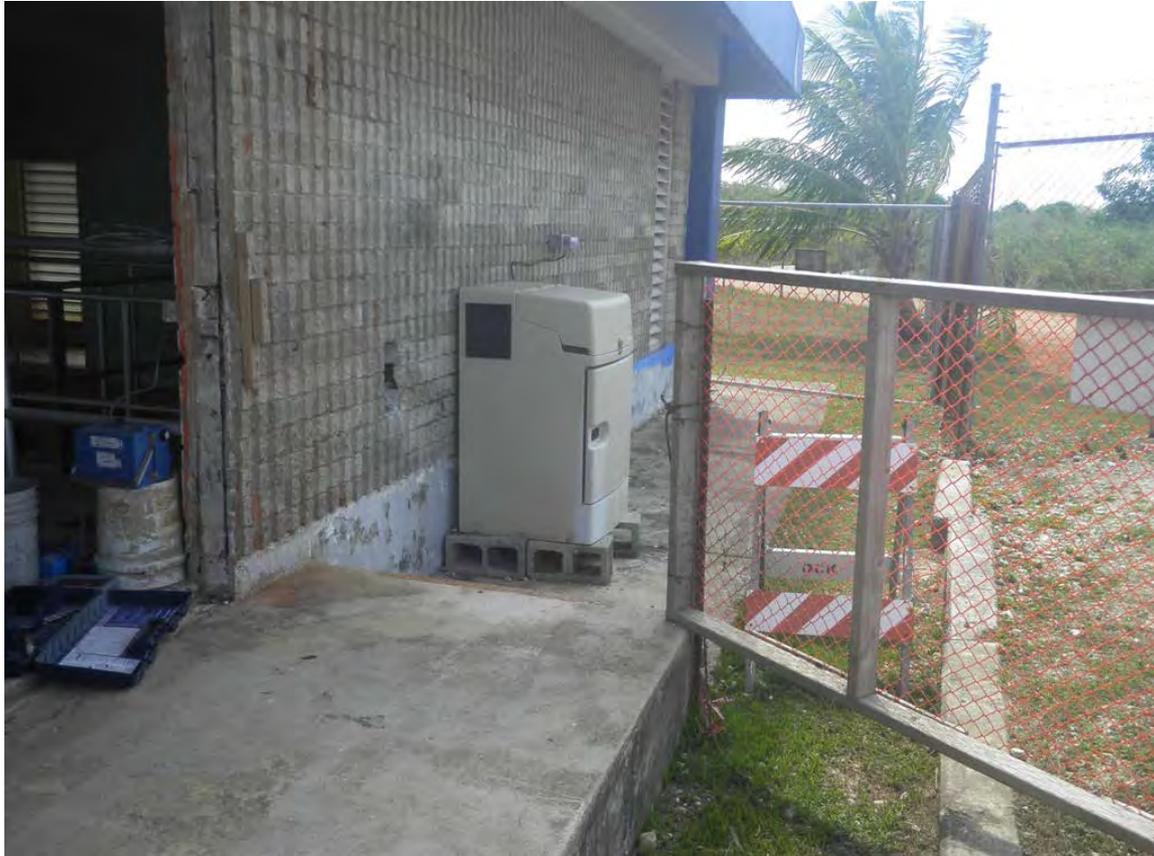
Picture 9: Influent sampler for Northern STP head works.

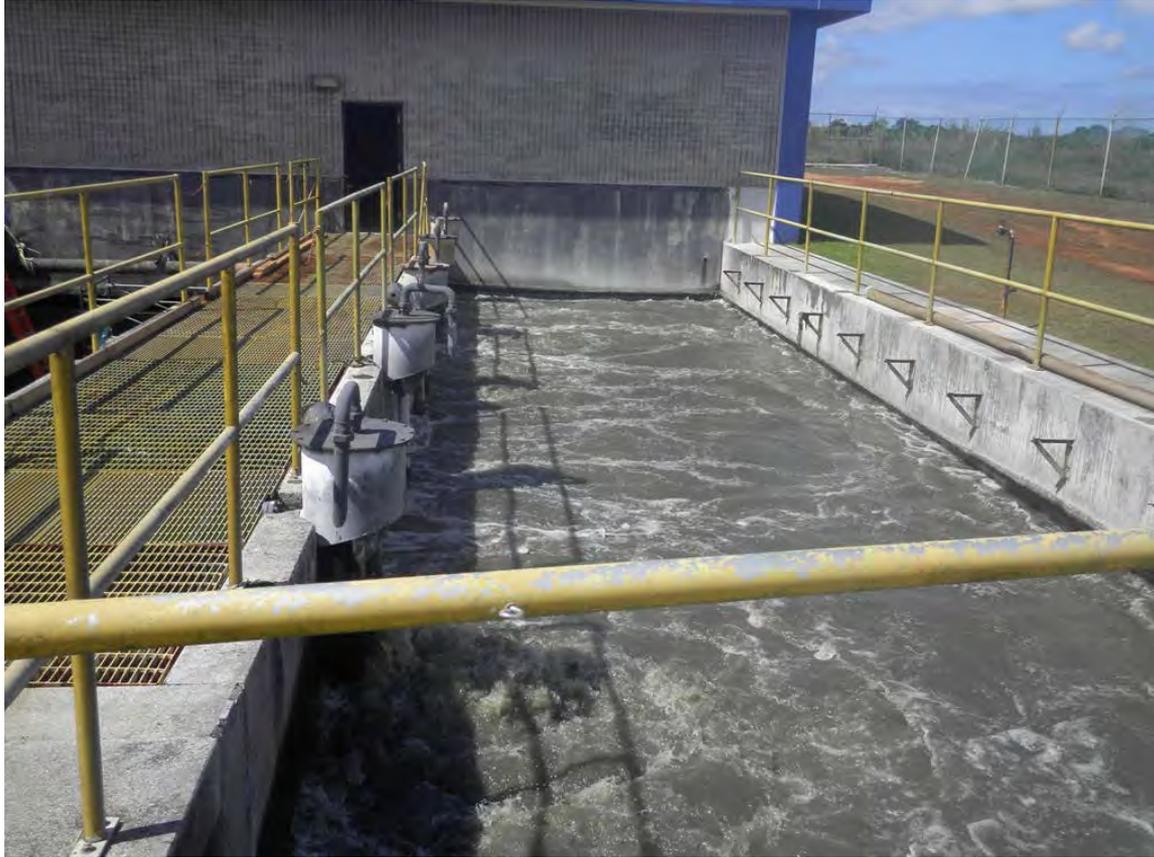
Picture 10: Aerated grit chamber at Northern STP.

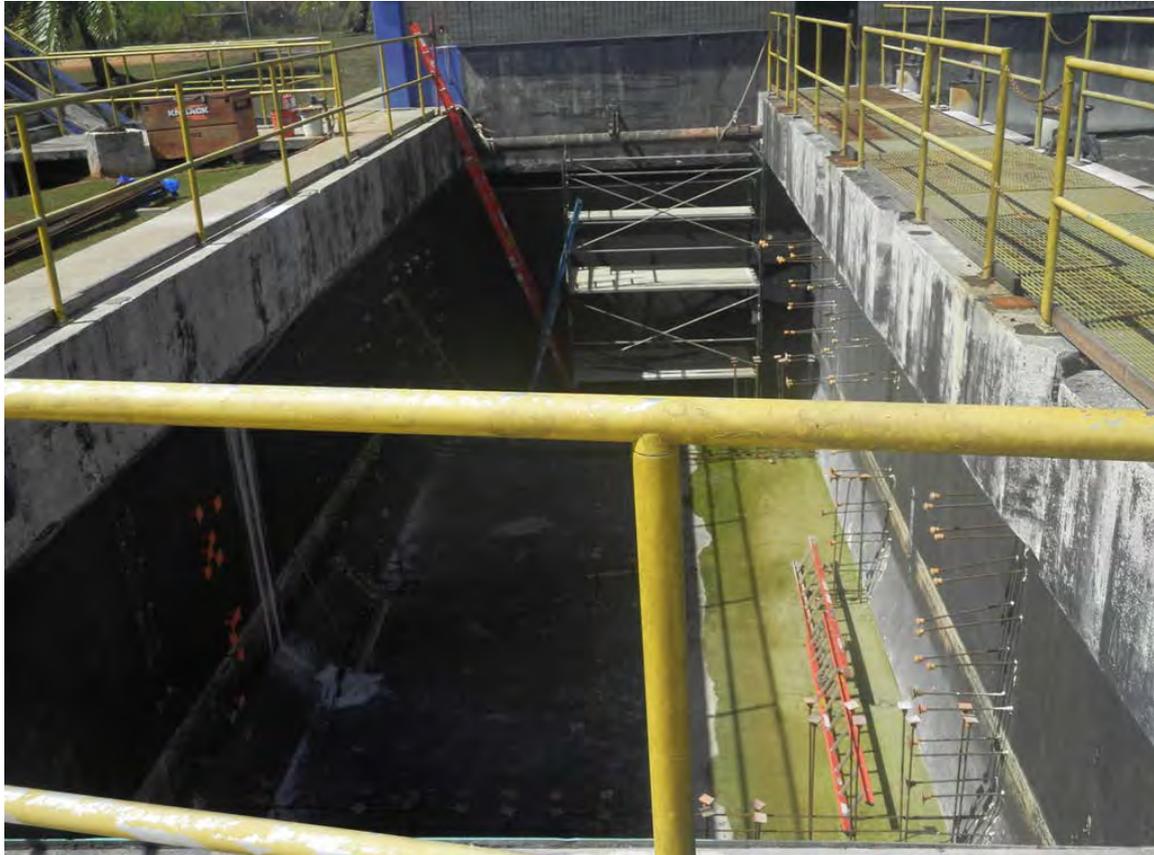
Picture 11: Aerated grit chamber removed from service for conversion to flocculant mix tank at Northern STP.

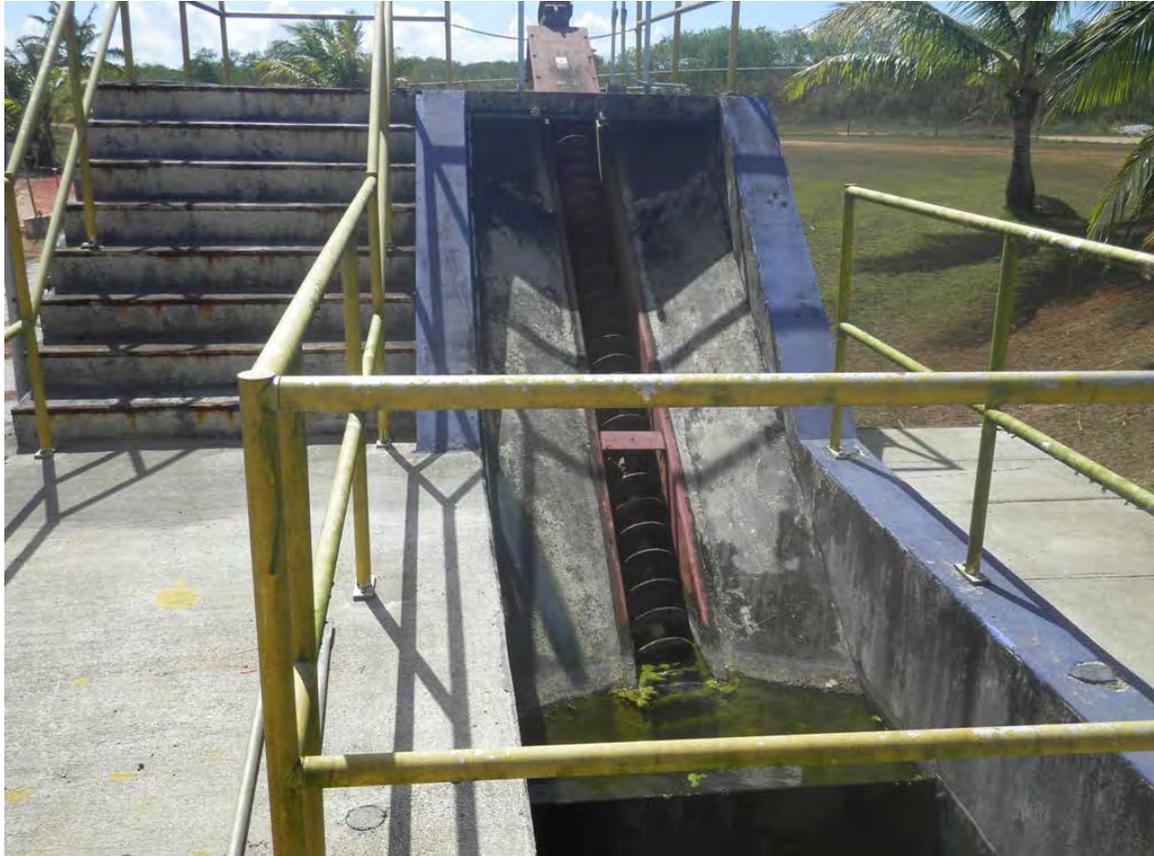
Picture 12: Out of service screw pump for grit removal at Northern STP.

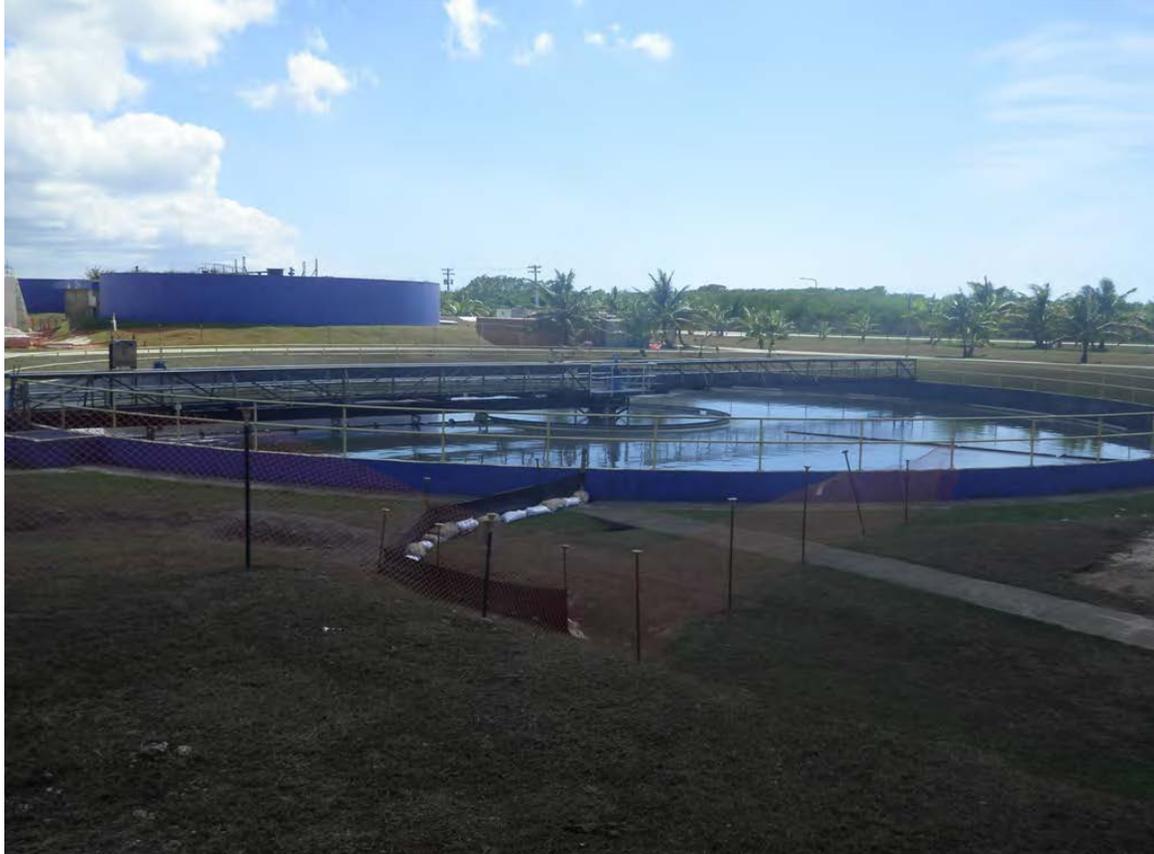
Picture 13: Primary clarifier at Northern STP.

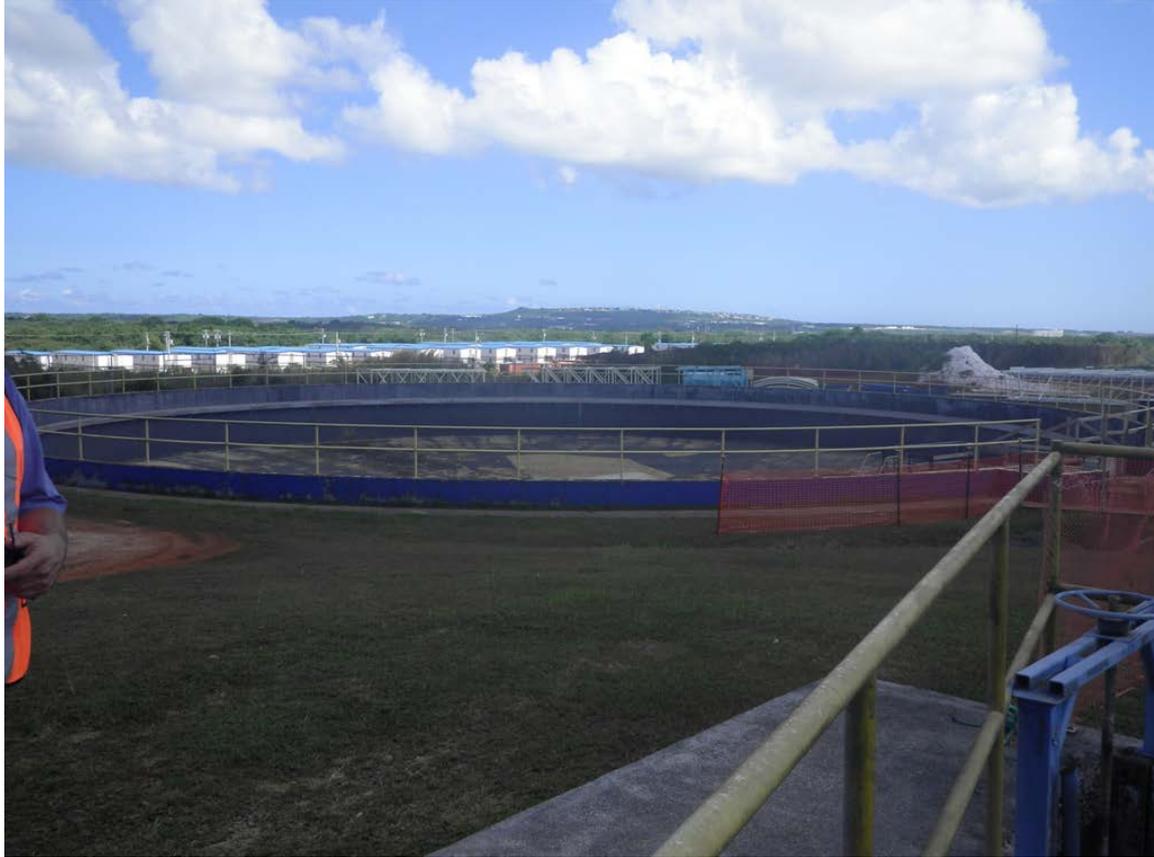
Picture 14: Out of service primary clarifier at Northern STP.

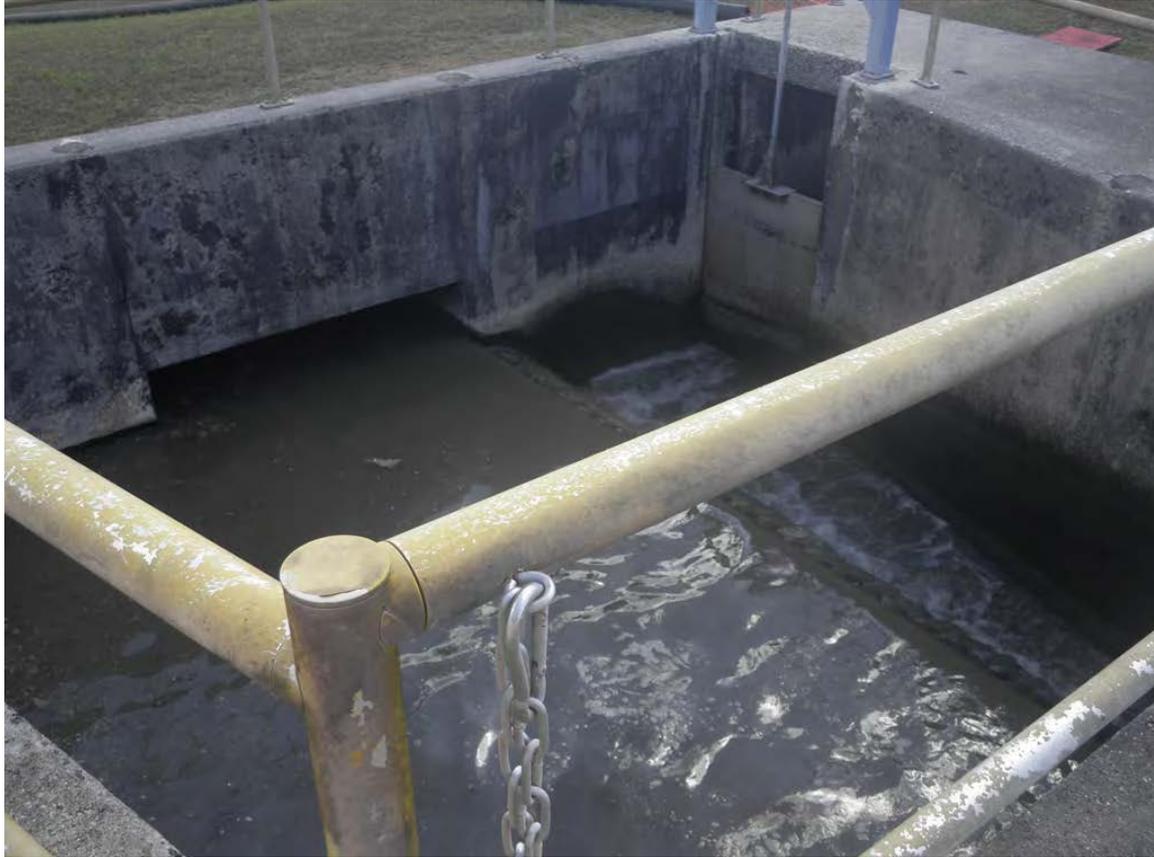
Picture 15: Flow splitter box directing influent wastewater to each of the primary clarifiers from grit removal. Northern STP.

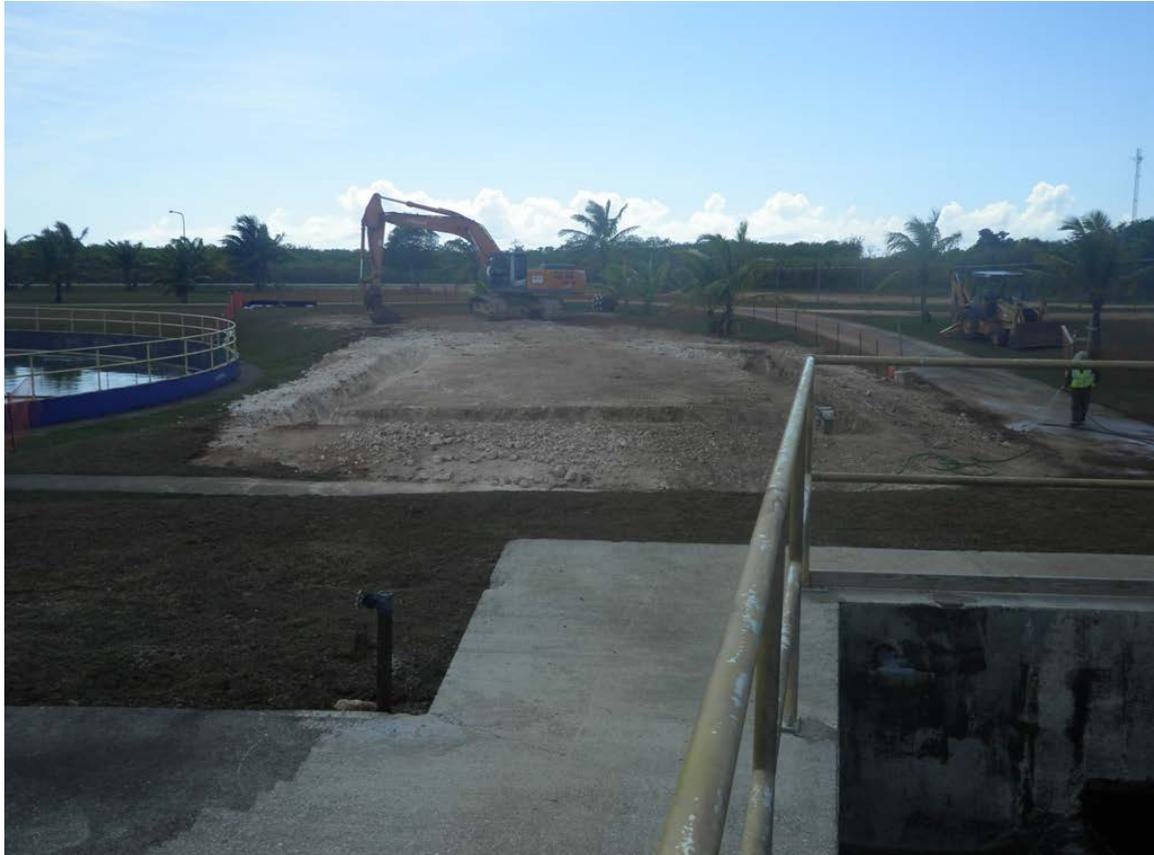
Picture 16: Construction of building pad for chemical storage building for polymer flocculant at Northern STP.

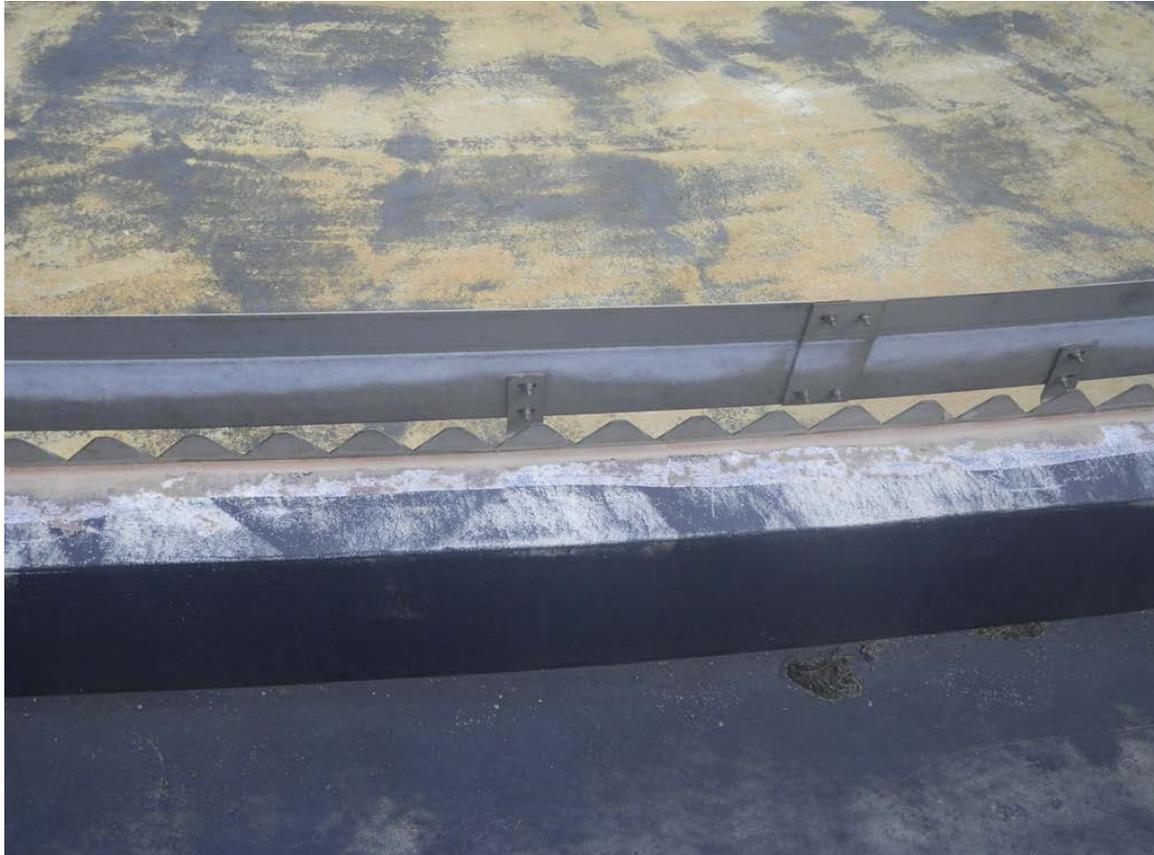
Picture 17: Newly renovated effluent weir for primary clarifier being upgraded at Northern STP.

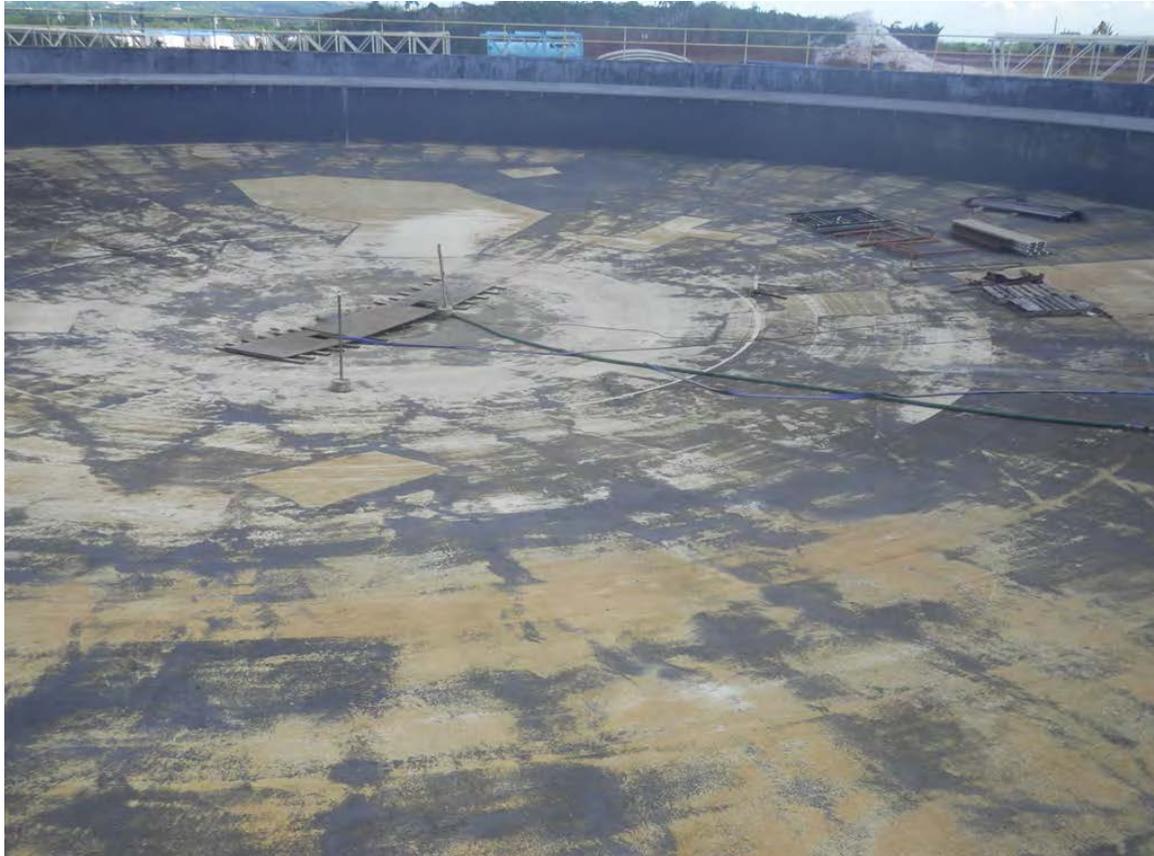
Picture 18: Primary clarifier being renovated at Northern STP.

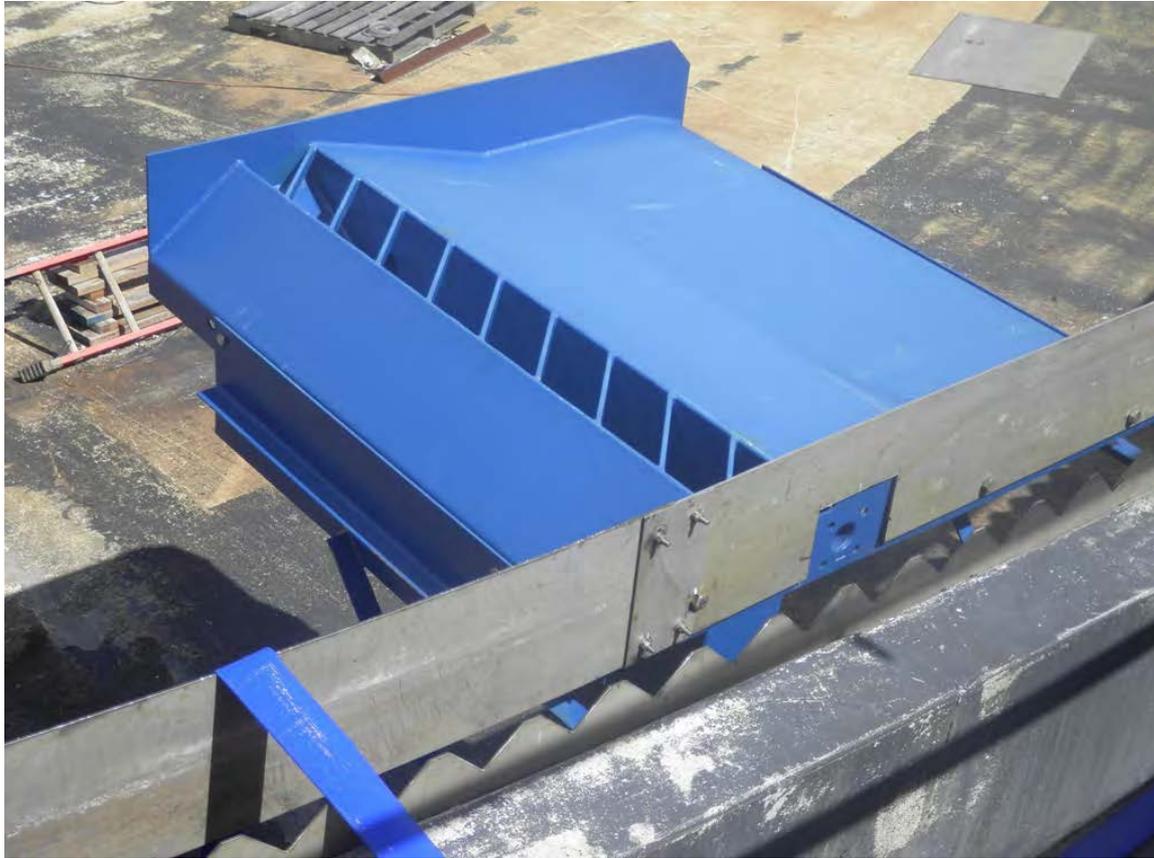
Picture 19: Replacement scum box for primary clarifier at Northern STP.

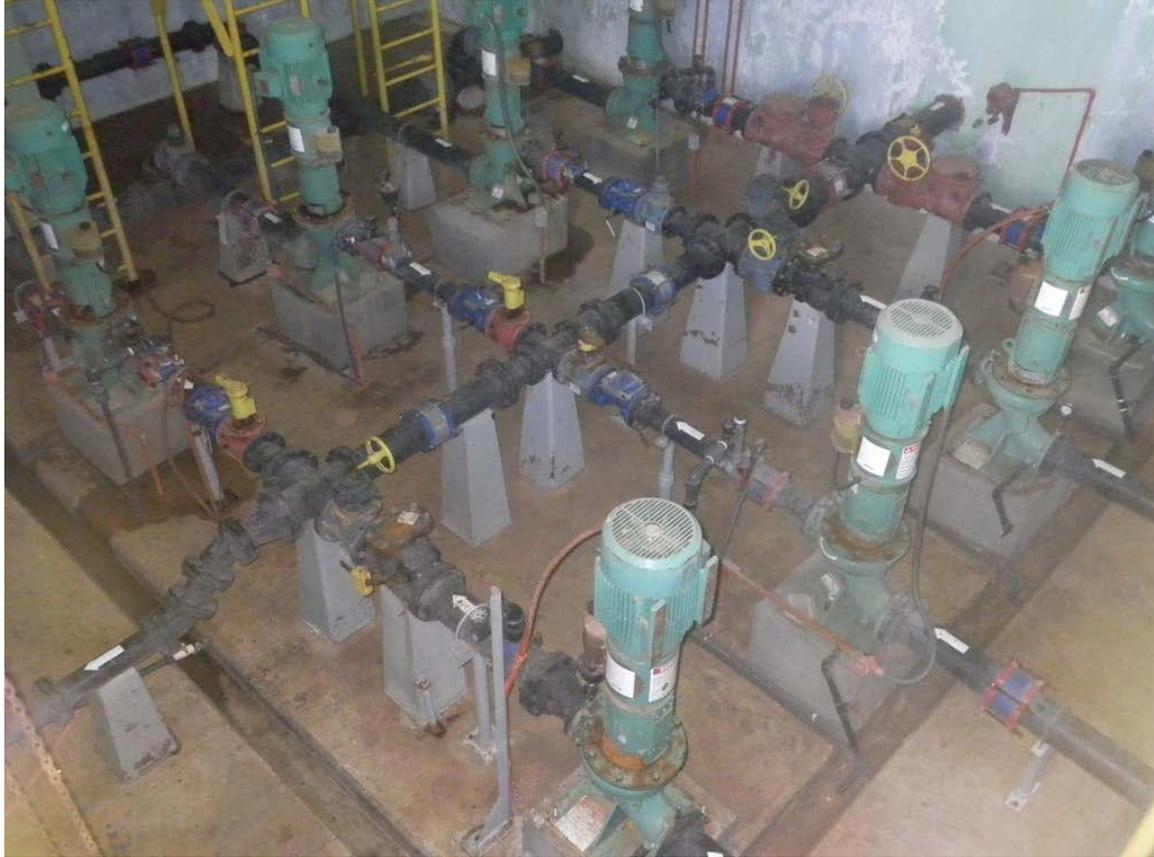
Picture 20: Solids pump gallery for primary clarifiers at Northern STP.

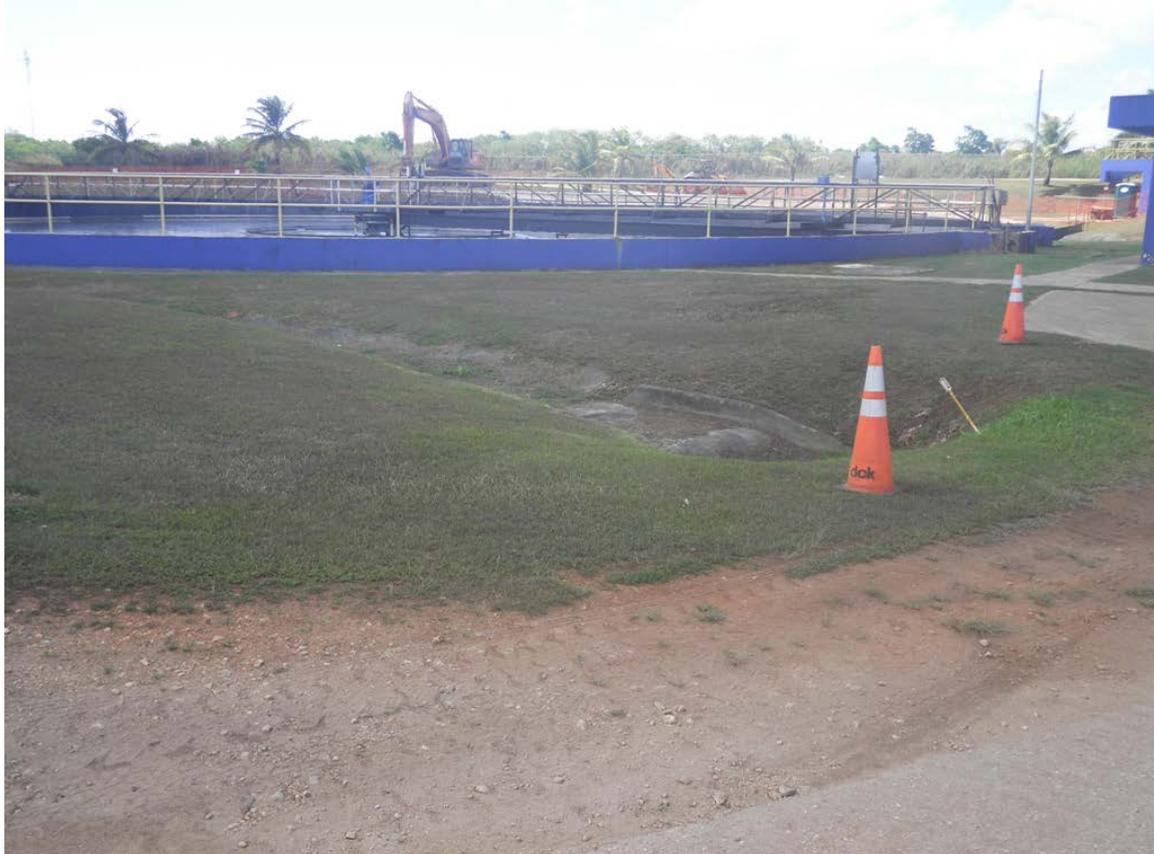
Picture 21: Storm drain at Northern STP. Located between primary clarifiers.

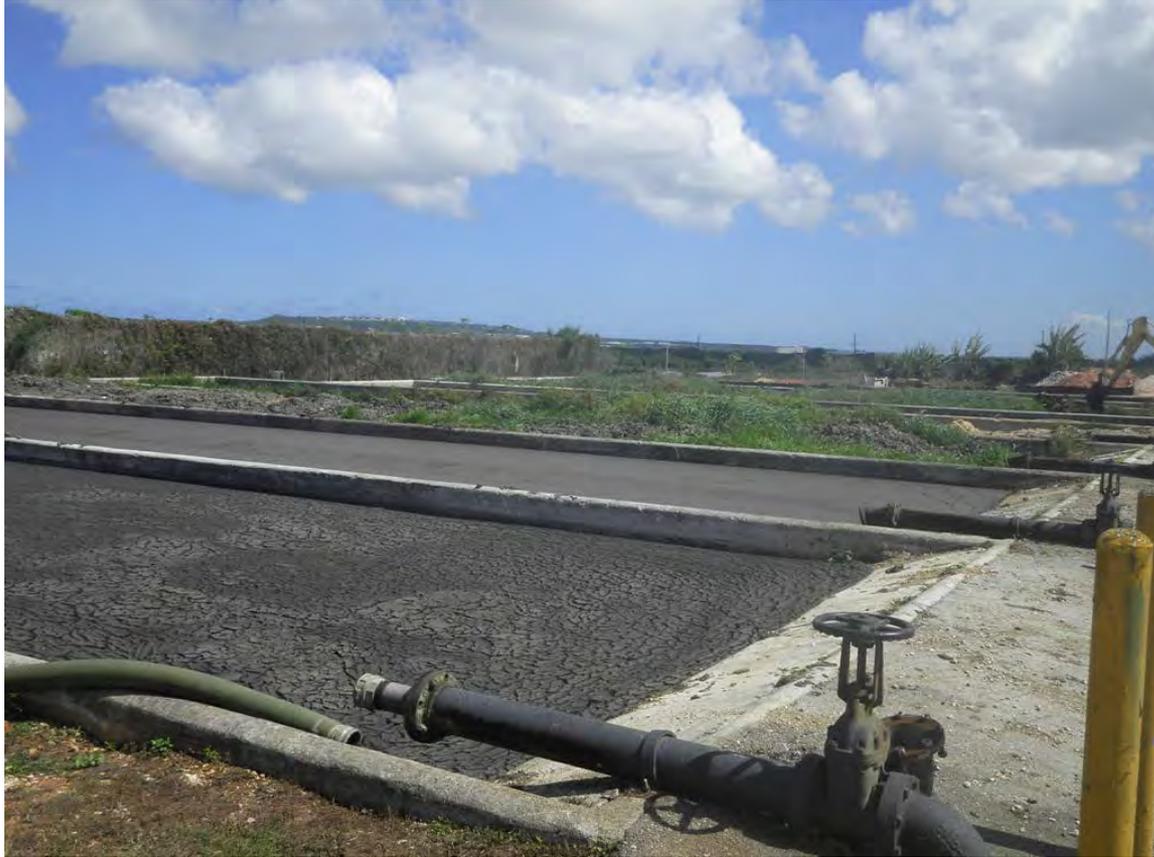
Picture 22: Sludge drying beds at Northern STP.

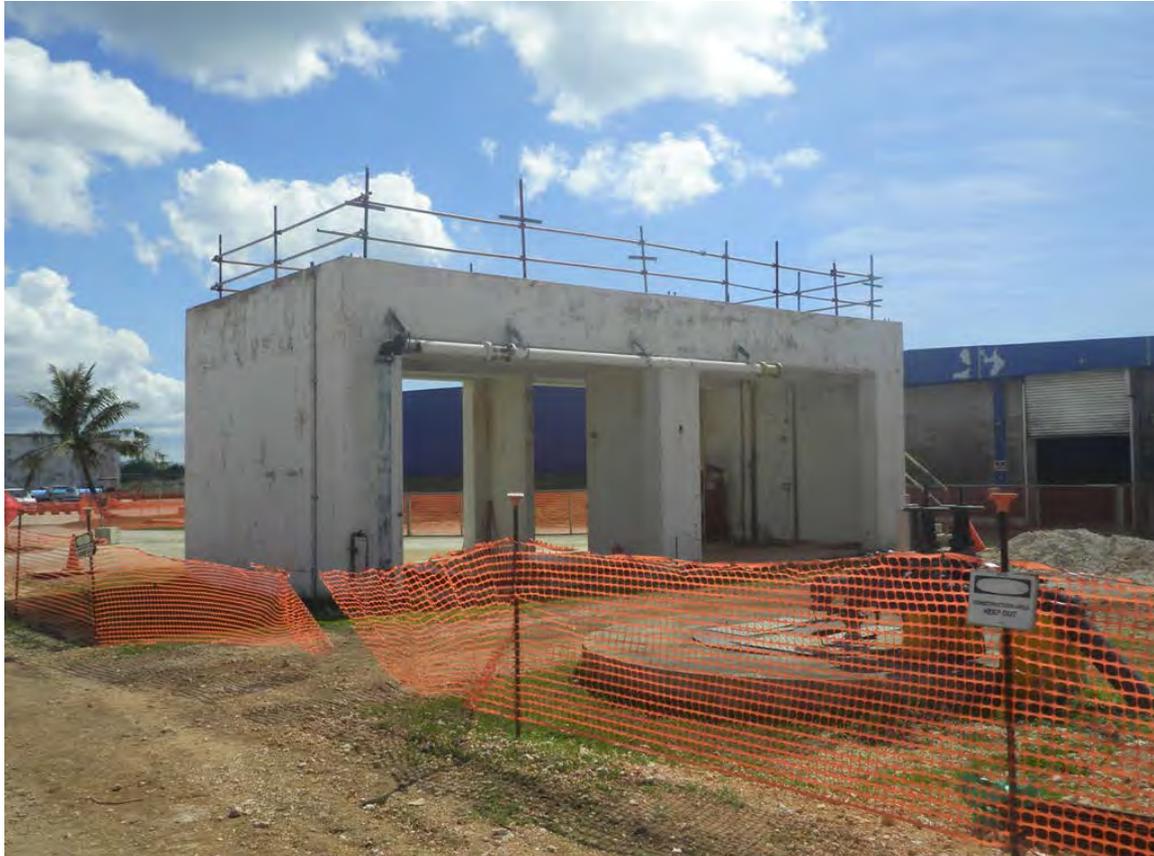
Picture 23: Former dewatering building being reconstructed for plant upgrade at Northern STP.
