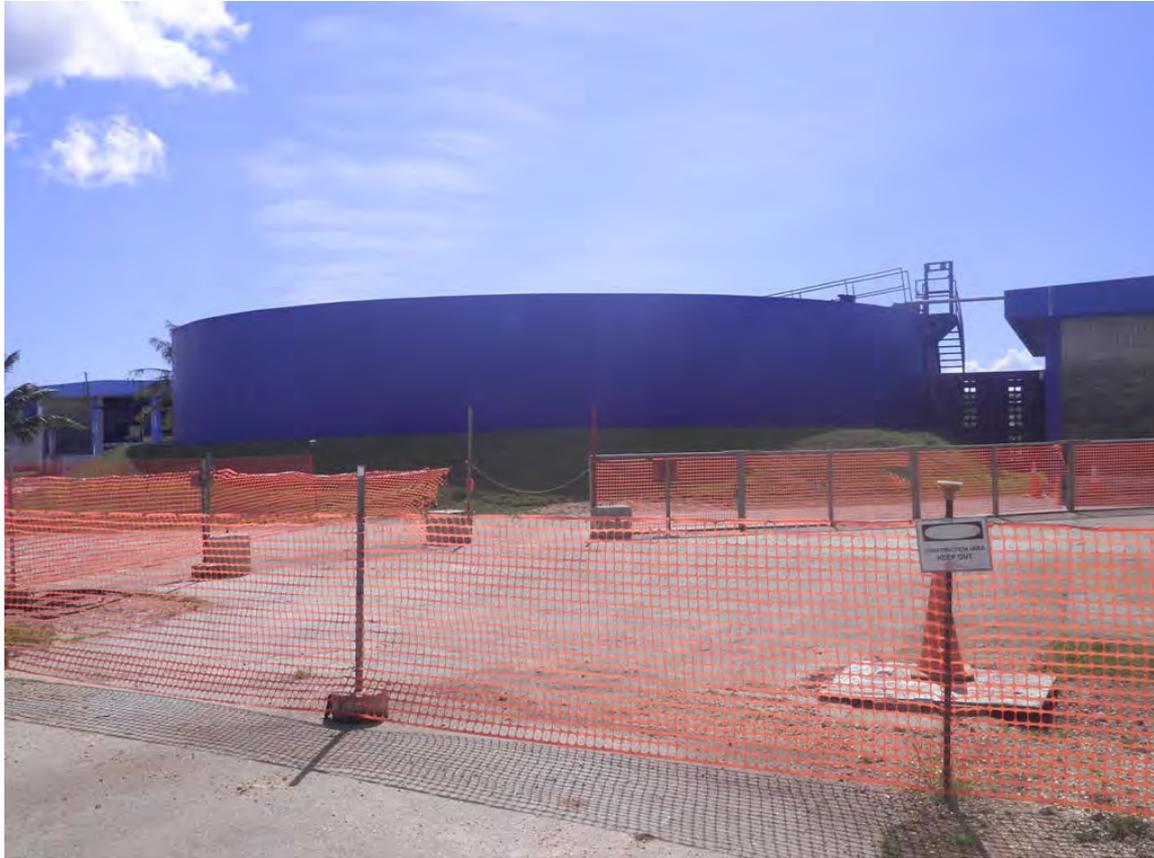
Picture 24: Out of service anaerobic digester at Northern STP.

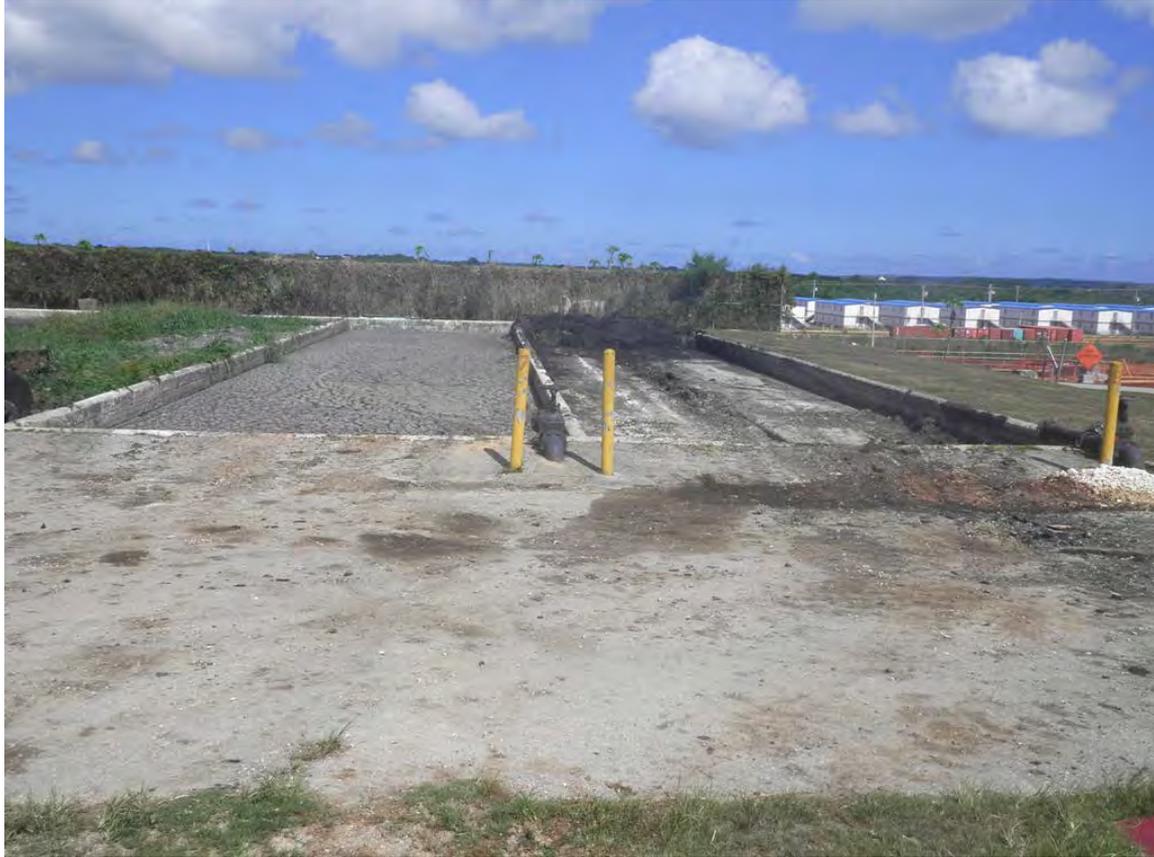
Picture 25: Sludge drying beds being cleaned at Northern STP.

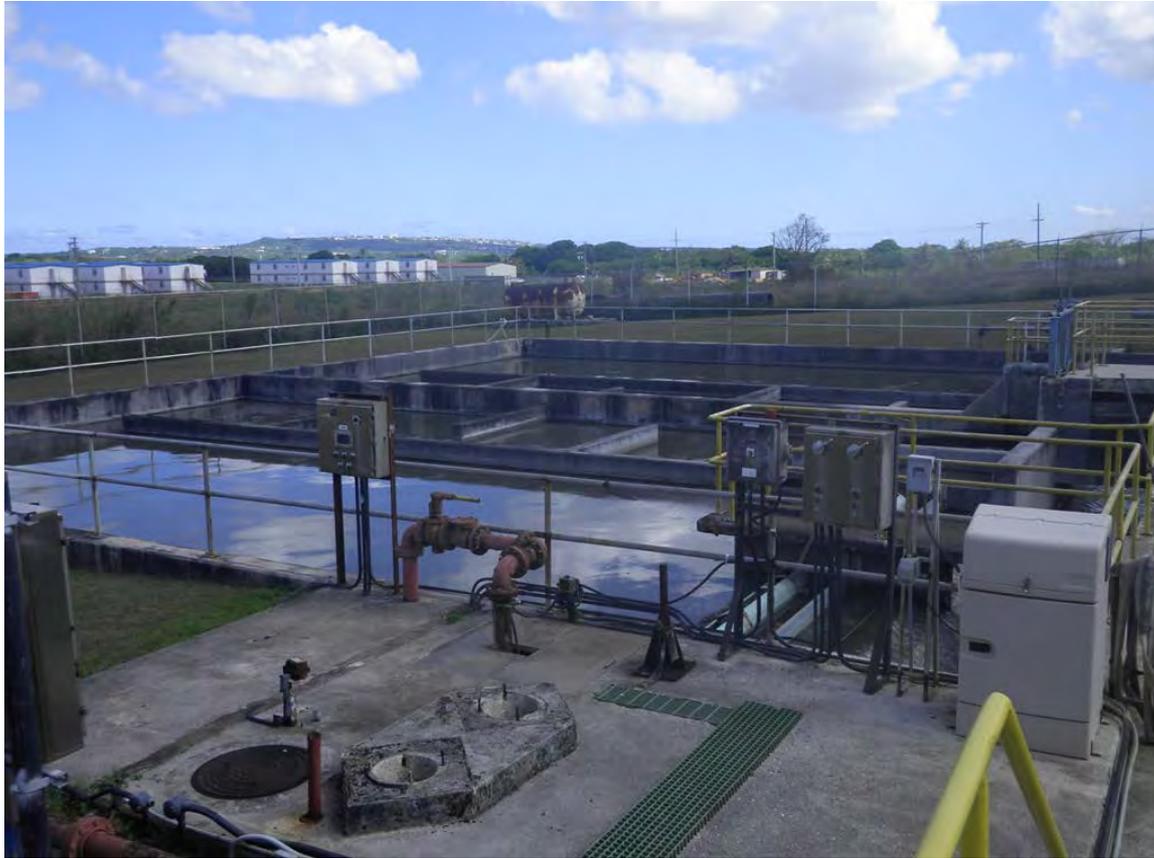
Picture 26: Overlooking shot of chlorine contact tanks at Northern STP. Tanks were not in use for disinfection.

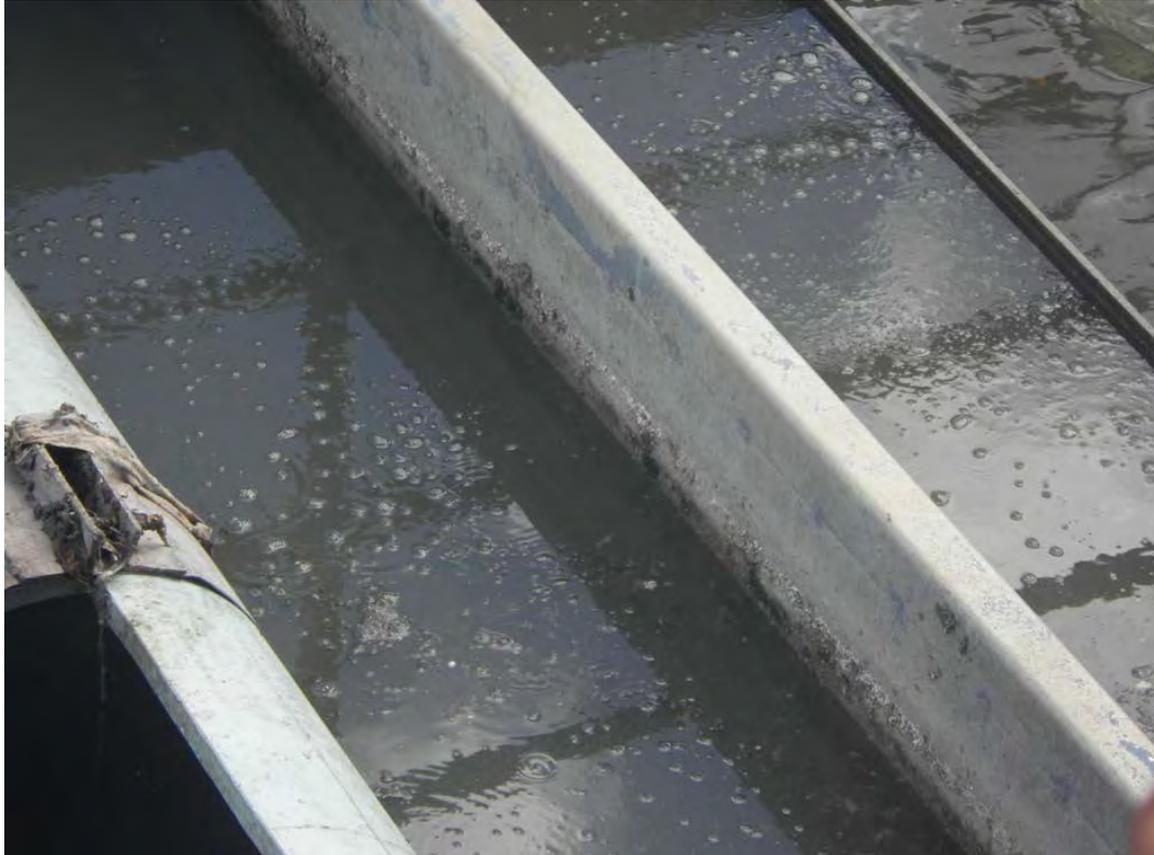
Picture 27: Gas bubbles on the surface of the chlorine contact tanks.
Possibly methane from fermentation of organic matter in the tanks.

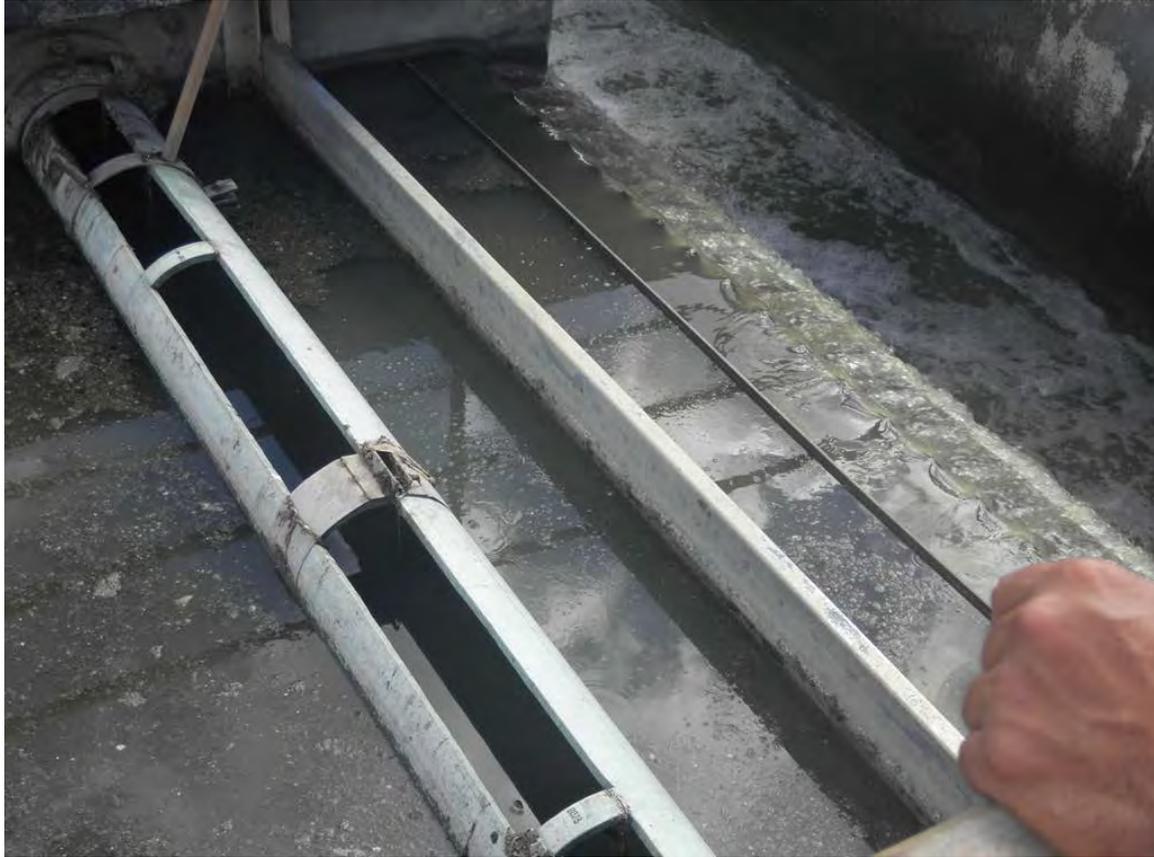
Picture 28: Discharge over the effluent weir of one of the two chlorine contact tanks at Northern STP.

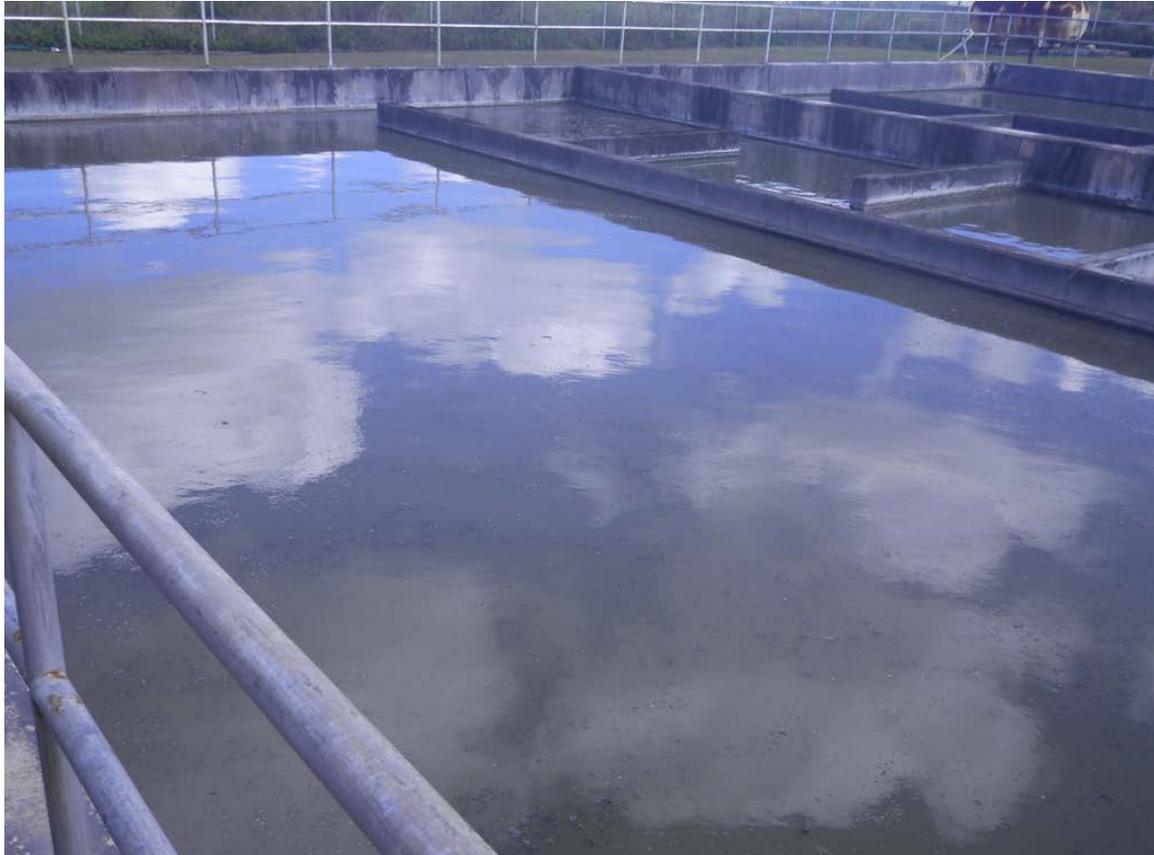
Picture 29: Solids on the surface of the chlorine contact tank at Northern STP.

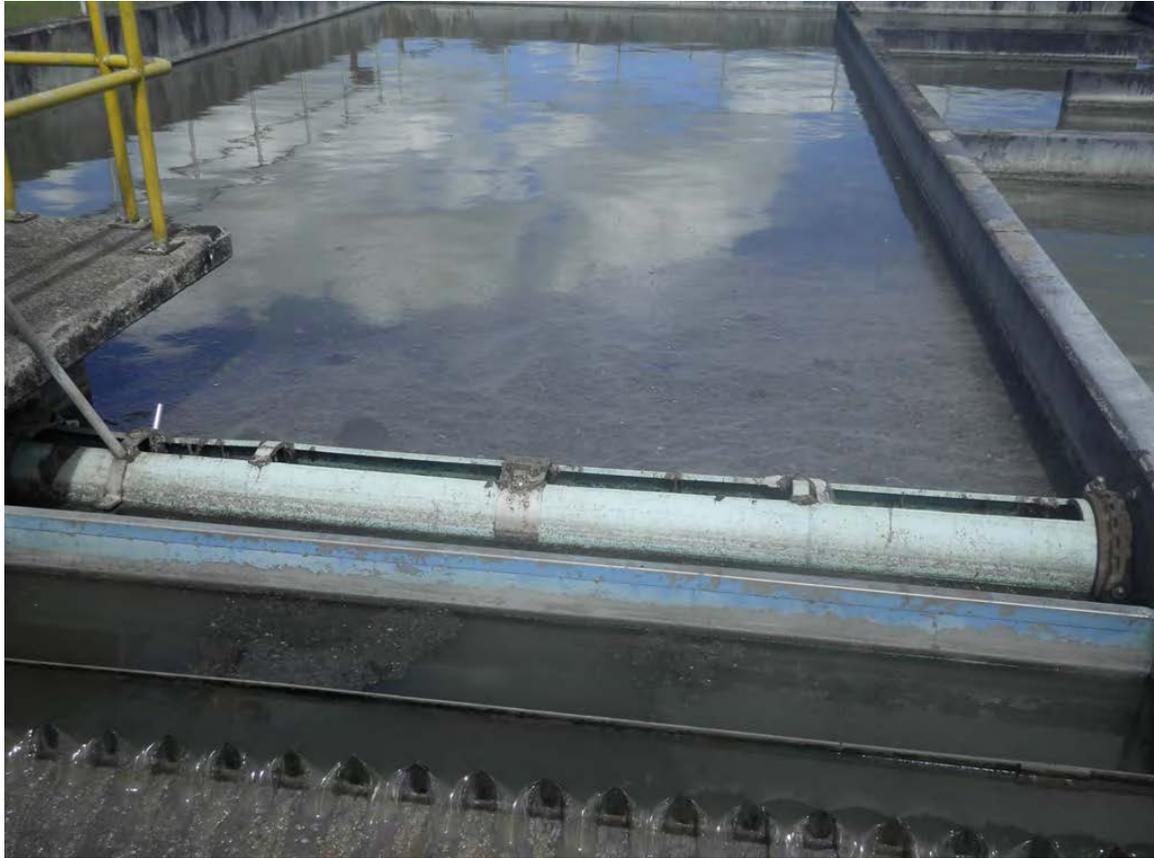
Picture 30: Chlorine contact tank discharge showing surface skimmer.

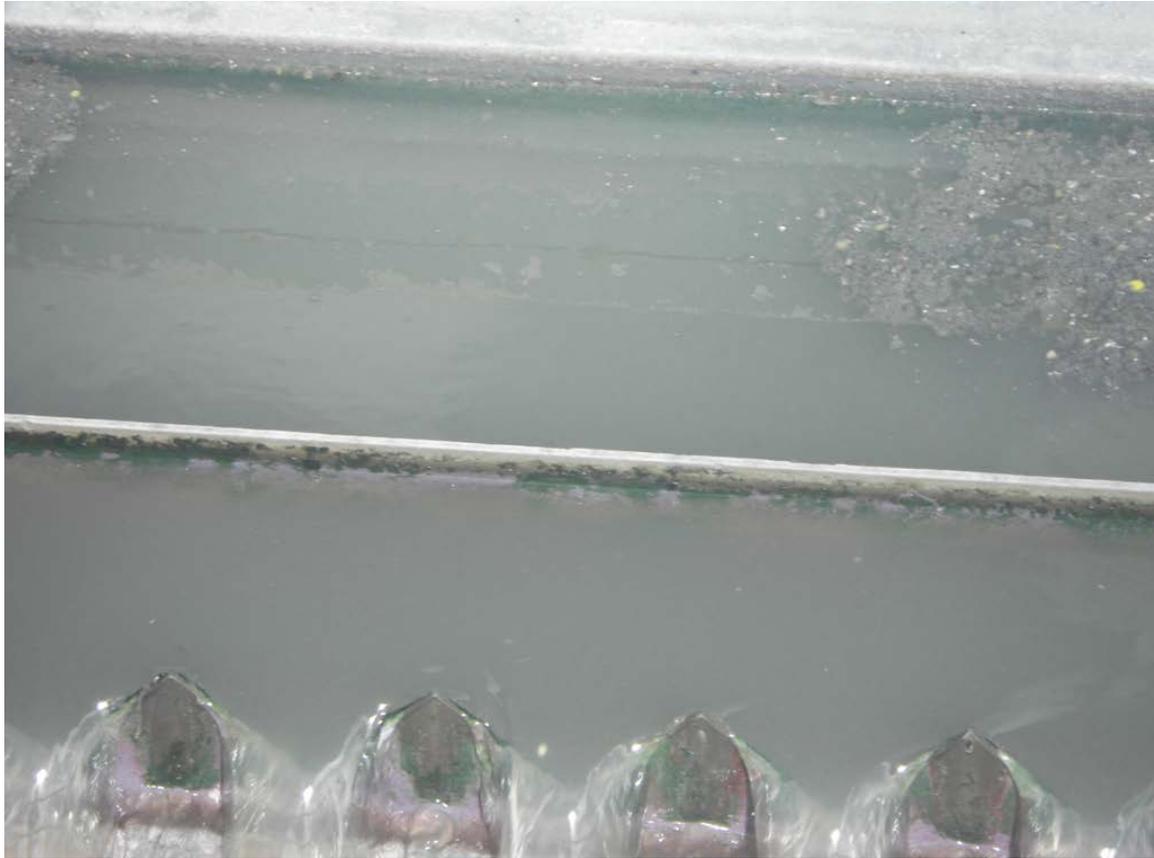
Picture 31: Close up view of effluent at Northern STP chlorine contact tank.

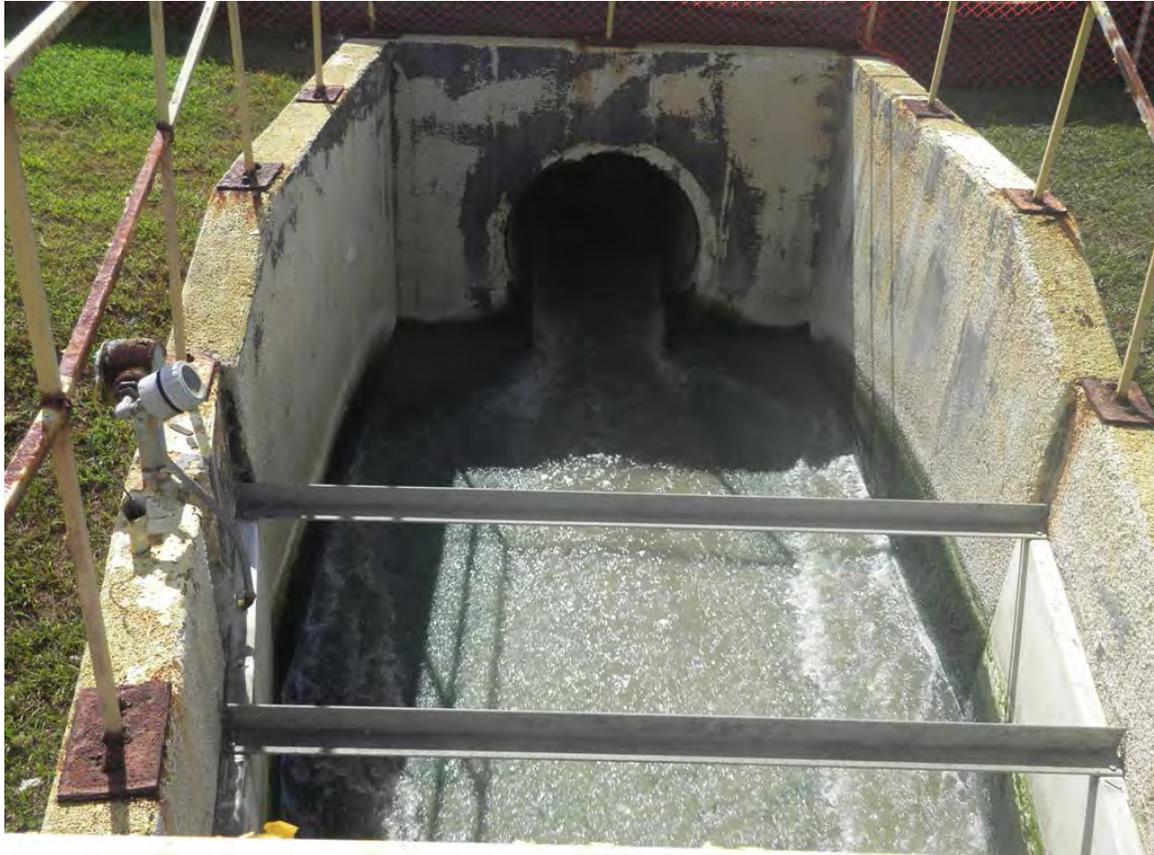
Picture 32: Discharge from primary clarifiers to chlorine contact tank through Parshall flume (out of frame). Northern STP.

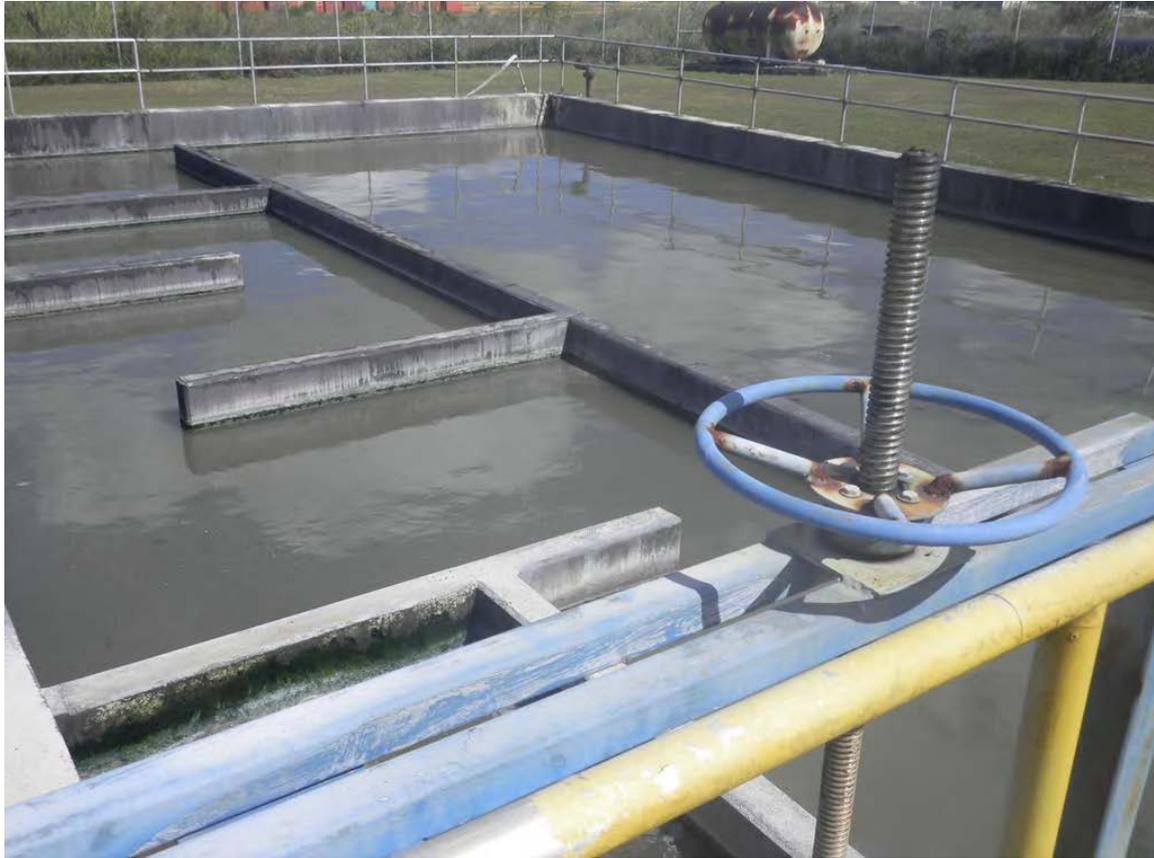
Picture 33: Chlorine contact tank (right hand side) at Northern STP.

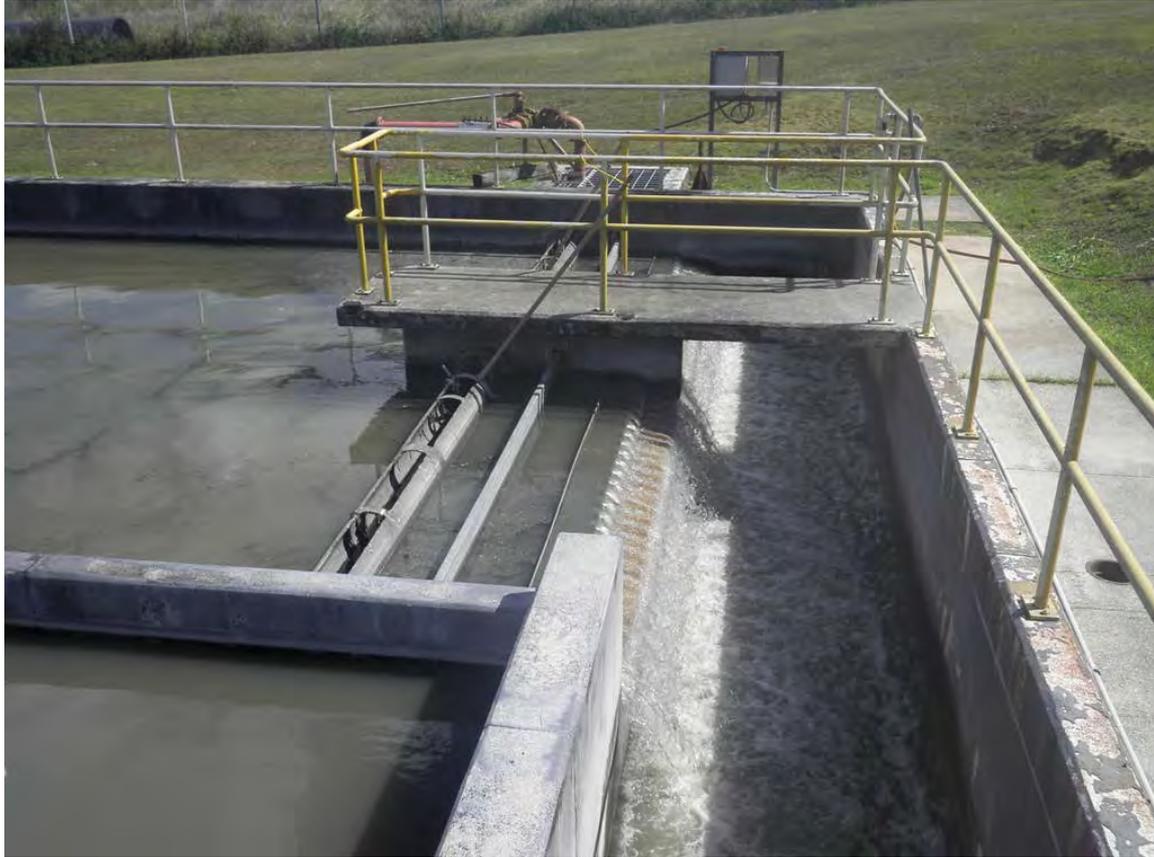
Picture 34: Effluent discharge from right hand chlorine contact tank.

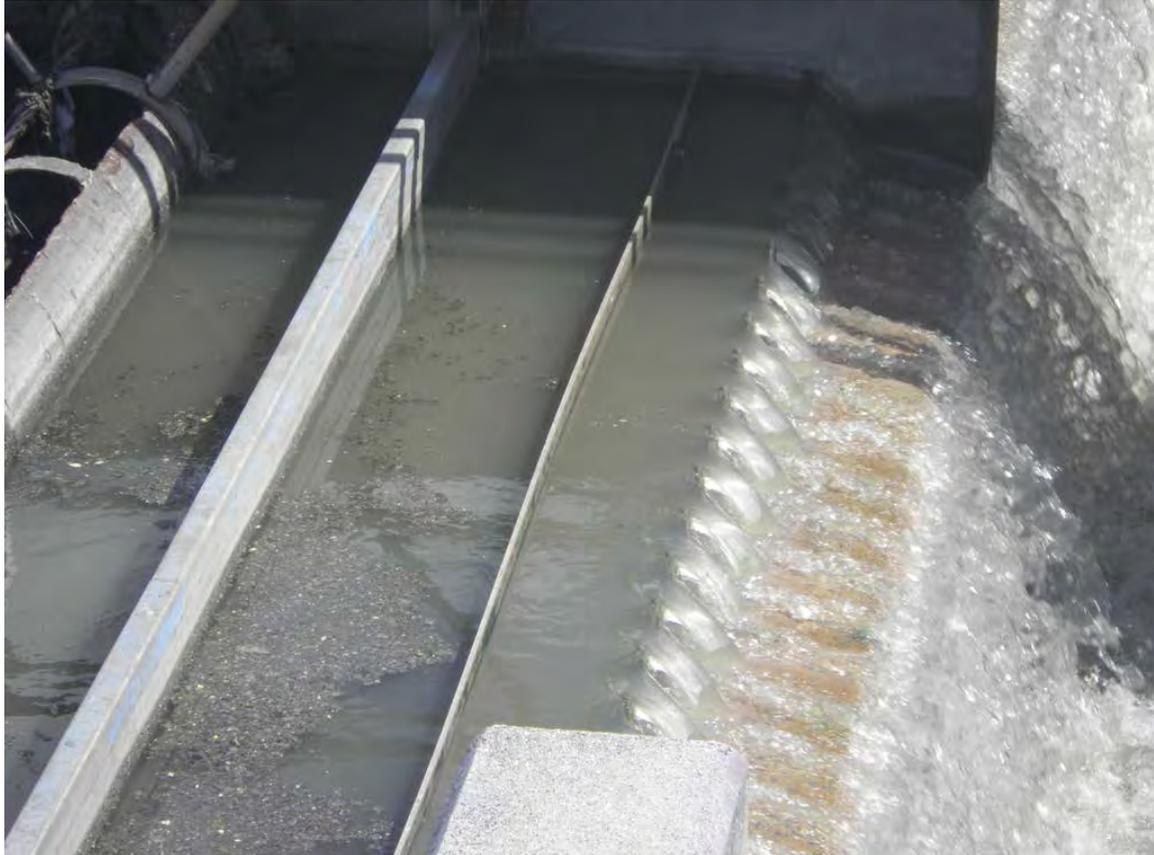
Picture 35: Close up view of effluent from right hand chlorine contact tank at Northern STP.

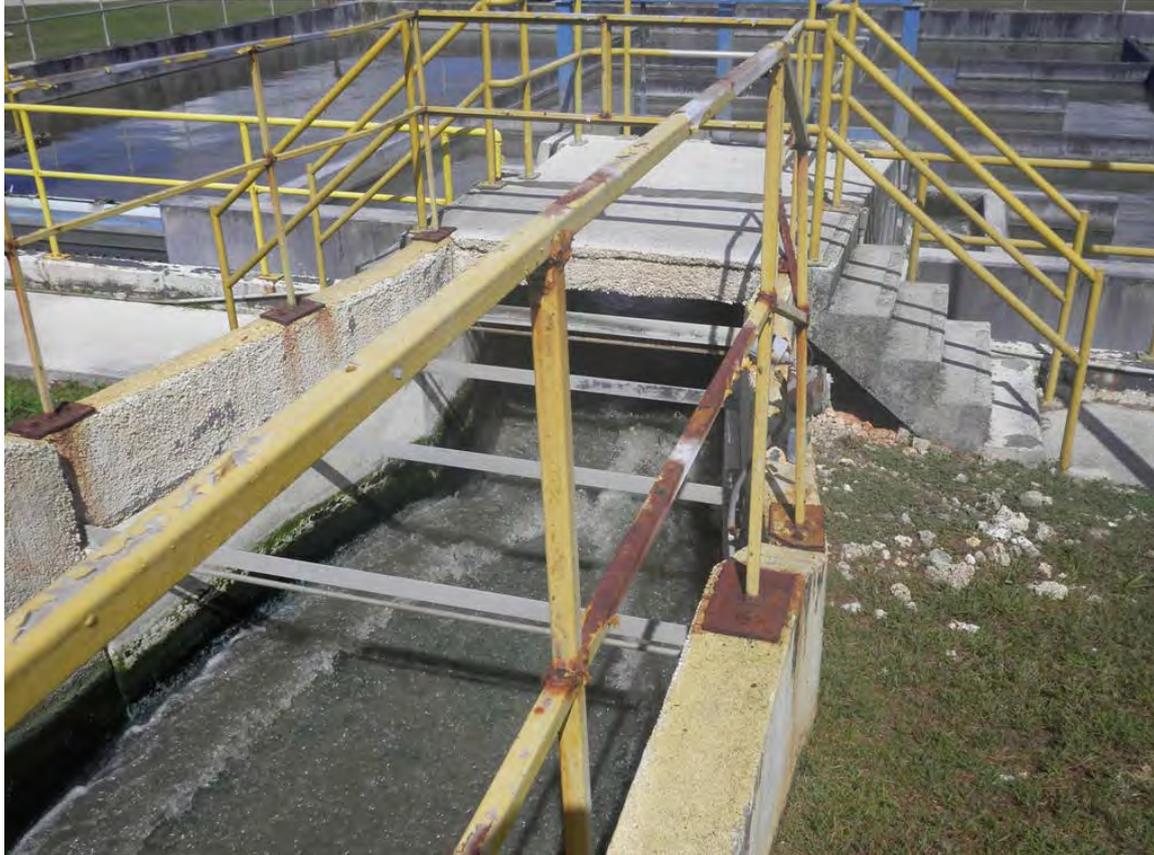
Picture 36: Out of service Parshall flume to chlorine contact tanks at Northern STP.

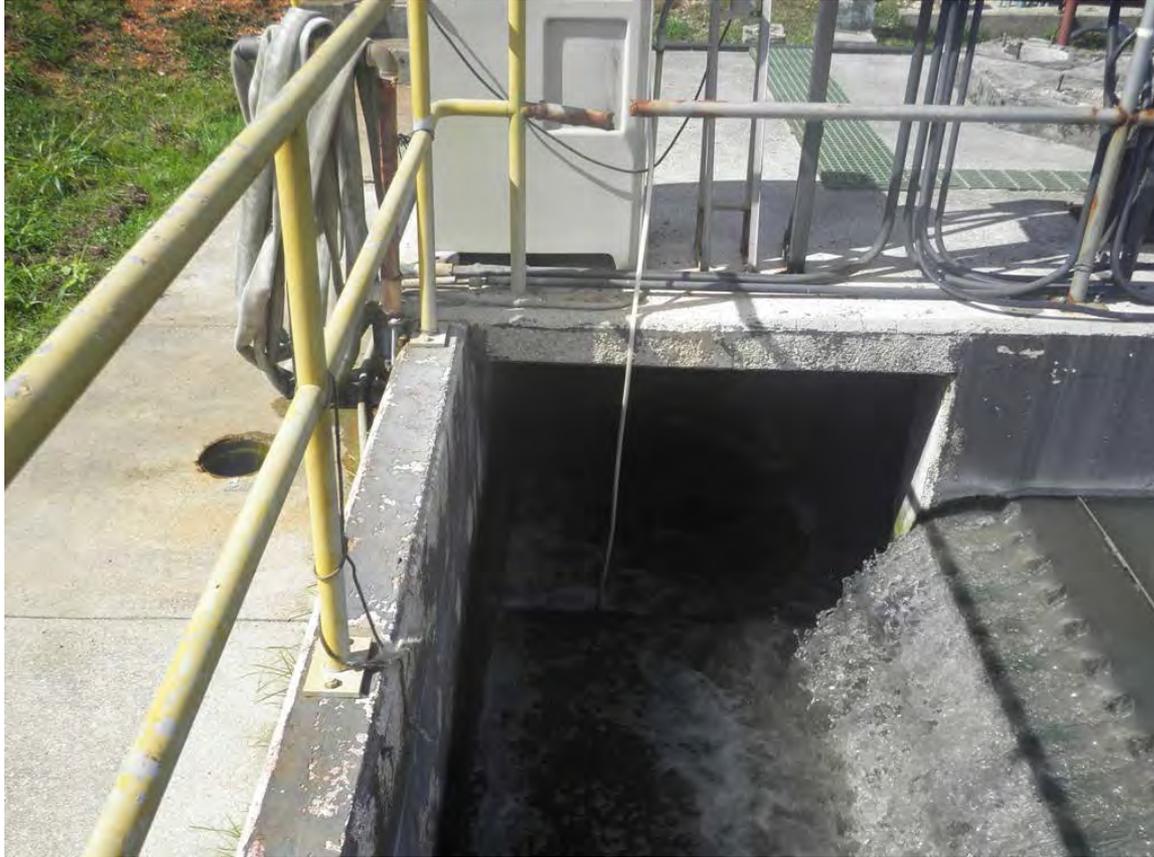
Picture 37: Effluent sampler and tubing for combined discharge from chlorine contact tanks at Northern STP.
