Municipality/Organization: City of Malden
EPA NPDES Permit Number: MA041046
MADEP Transmittal Number: 041088
**Annual Report Number
& Reporting Period:** No. 9: April 1, 2011-March 31, 2012

NPDES PII Small MS4 General Permit Annual Report

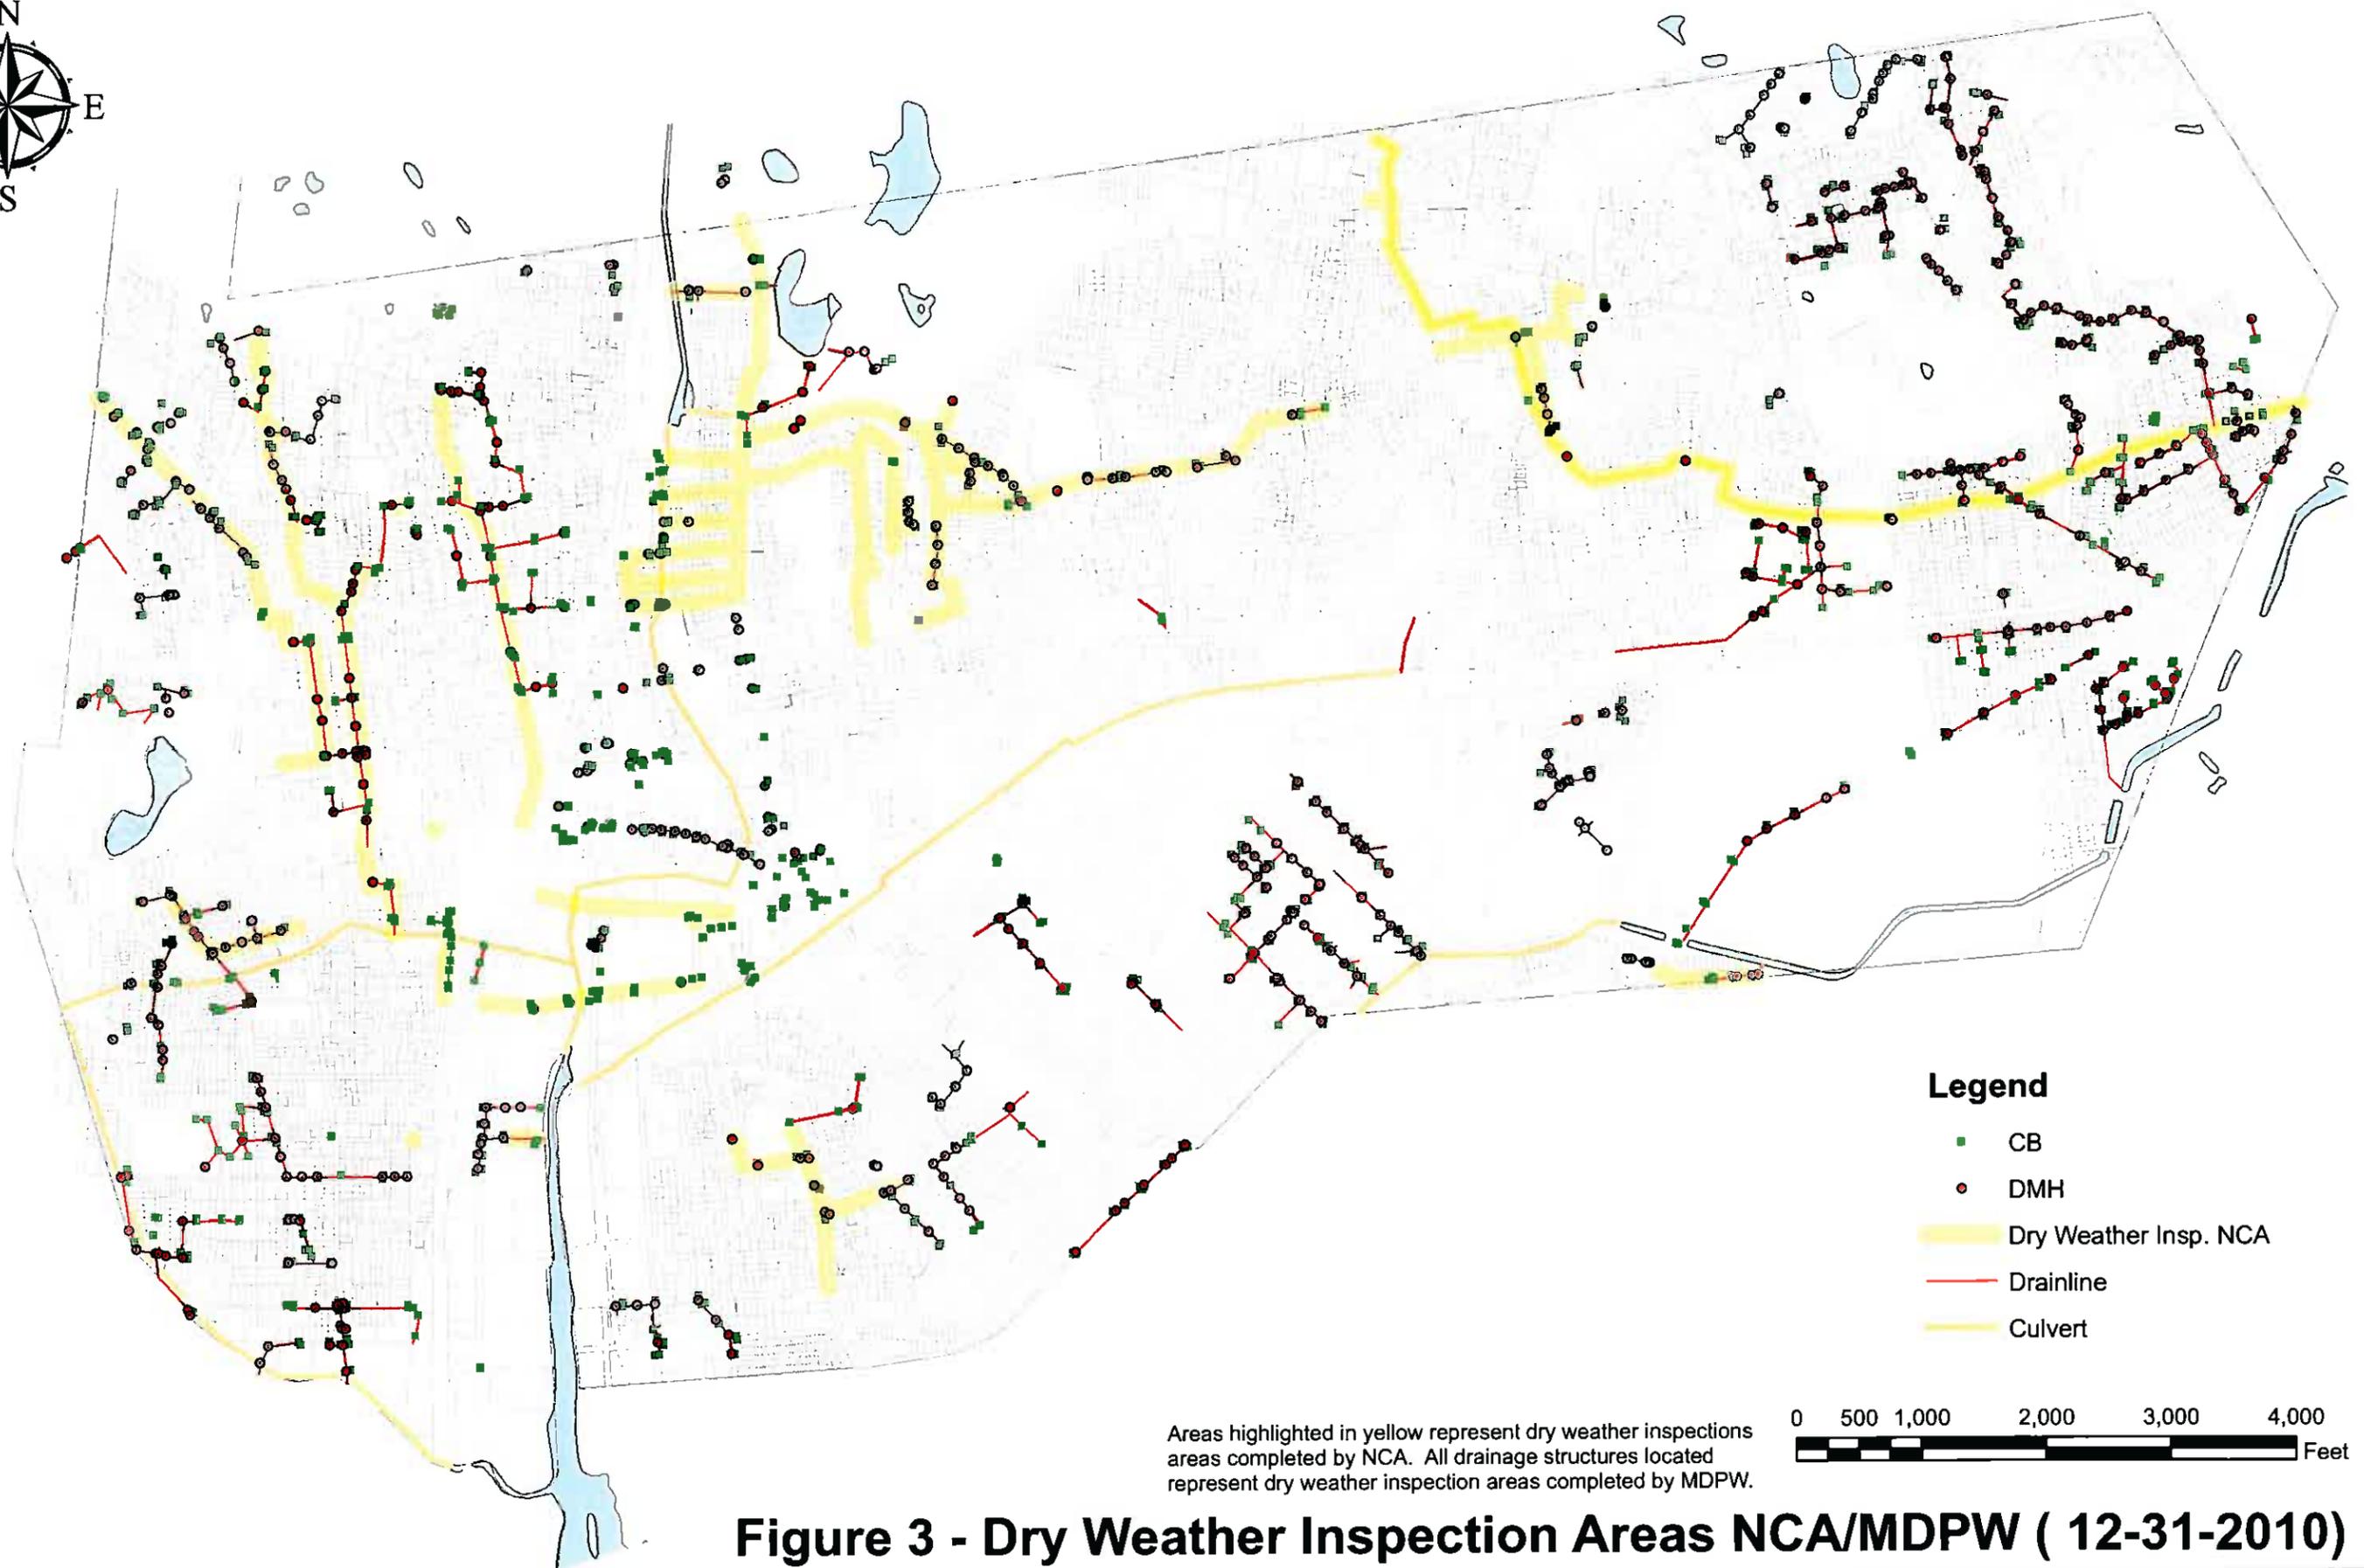
Figure 3 - Dry Weather Inspection Areas NCA/MDPW (12-31-2010)

Representatives of NCA and MDPW personnel continue to conduct targeted dry weather inspections of the City's infrastructure. This is an interactive or systematic program that has extended across the entire City, resulting in the identification and correction of infrastructure deficiencies and improvements to the general quality of stormwater discharges. Areas selected for inspection are generally based upon the results of the outfall sampling program and/or the identification of dry weather flows by MDPW staff during their routine maintenance and infrastructure locating program. Dry weather inspections conducted during this reporting period have not revealed any illicit discharges, or connections. A map depicting the approximate locations where targeted dry weather inspections have been conducted by NCA to date is presented as Figure 2. Areas inspected by DPW staff for illicit connections/discharges consist of portions of the infrastructure that are addressed during the catch basin cleaning program. During this effort, infrastructure components are mapped and the corresponding attributes are located. During this reporting period, the frequency of dry weather inspections by MDPW personnel was hindered due to a serious injury to the team leader. Overall portions of the municipal infrastructure that have been addressed by the compliance team including the targeted subset areas are summarized on Figure 3.

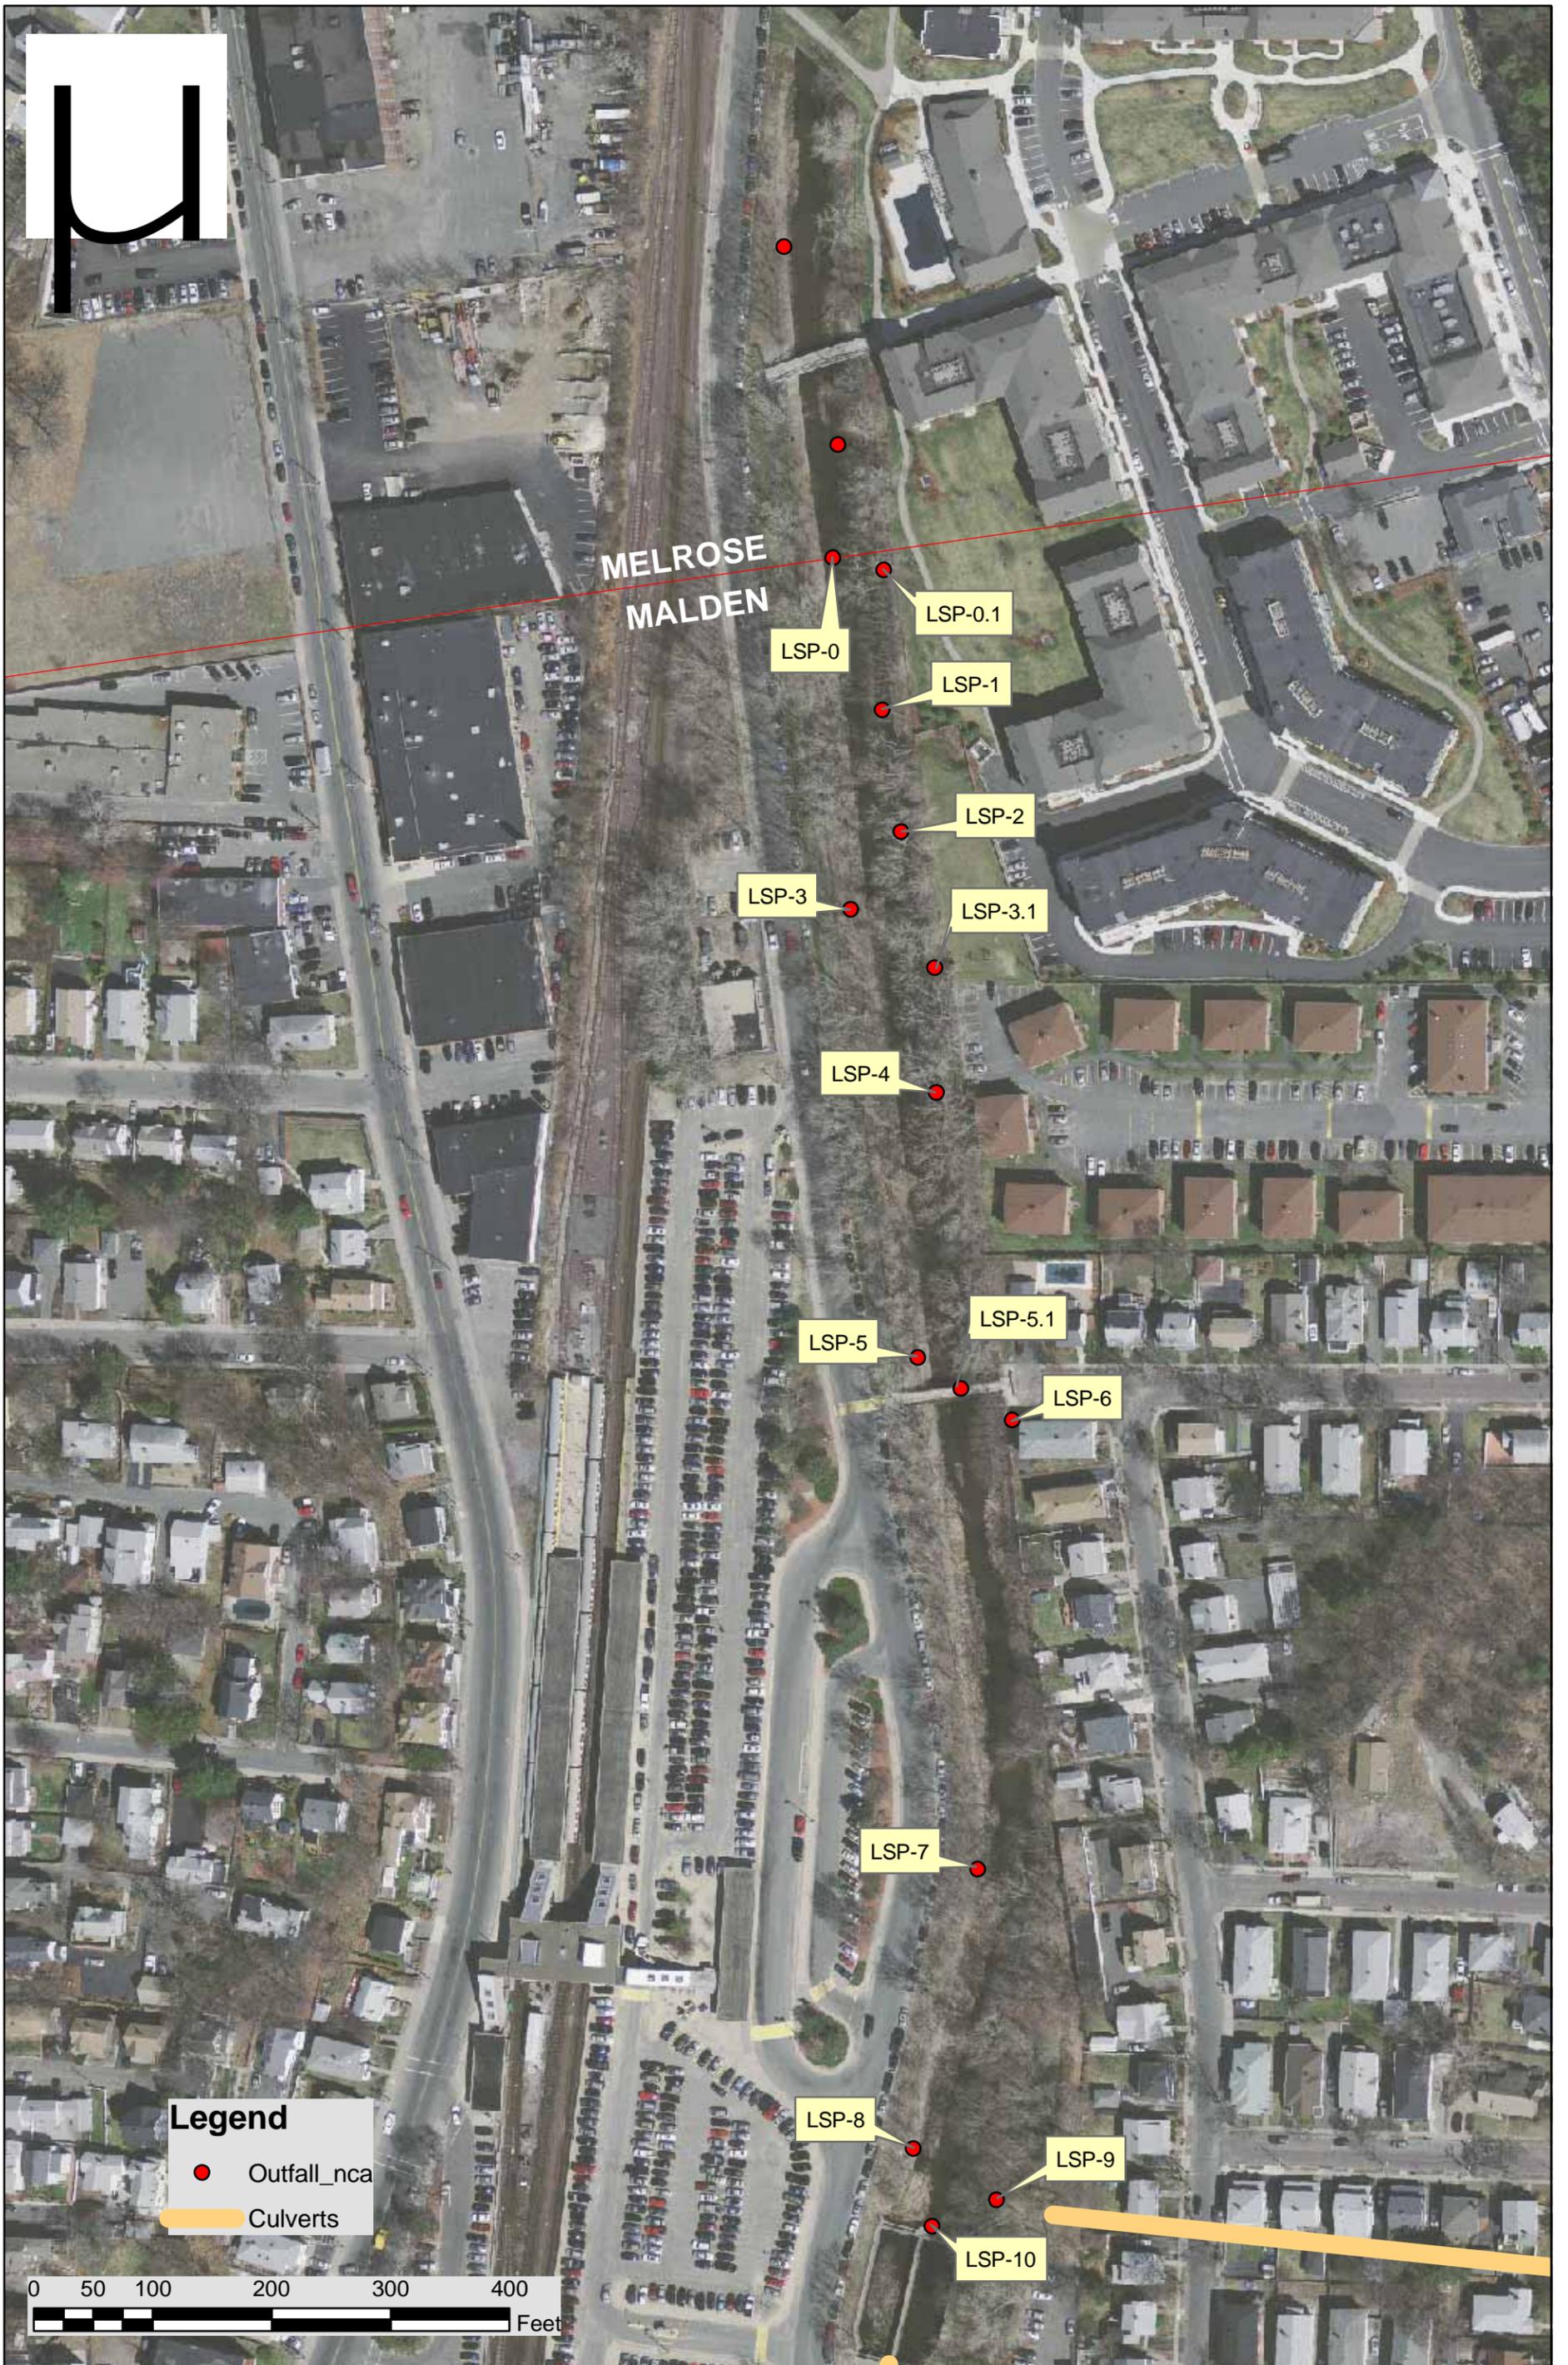
Figure 5 - Lower Spot Pond Brook Outfalls

During this permit year, the Stormwater Compliance Team conducted several dry weather sampling events within Lower Spot Pond Brook. A summary of the results obtained from dry weather sampling may be referenced from Attachment A. As shown, elevated E. coli levels were encountered at LSP-4 during both sampling events conducted during this reporting period. It is to be noted that base flow, as groundwater, is consistently observed within this drainage network. Due to high E. coli levels at outfall LSP-4, a comprehensive evaluation of the flow conveyance network associated with LSP-4 located within the Elrich Drive residential complex was completed on 10 February 2012. Given the proximity of the sewer and drain lines to LSP-4, as well as the settlement of the drain line in the area of Buildings 1054 and 1056 Elrich Drive, the focus of assessment activities was directed towards the sewer laterals and nearby drainage line servicing the two apartment buildings.

Based upon the information provided by the City, sewer flows generated from Buildings 1054 and 1056, tie into a single sewer line located in close proximity to the drainage network associated with LSP-4. To investigate the possibility of exfiltration from the sewer laterals, fluorescent dye was introduced by flushing water using a sink connection located within the basement of Building 1054. Subsequently this process was then repeated within Building 1056. In each instance, indications of dye were noted within drain manhole DMH-4 following termination of water flow through the sewer lines.

The observations noted by the Stormwater Compliance Team were provided to the owner of the Elrich Drive property. Recommendations made by the SCT involved restoring the integrity of the main drainage line to stop the discharges that have been documented at LSP-4. Working with representatives of the Malden Engineering Department, repairs to the sewer laterals in the area of Buildings 1054 and 1056 were completed. It is proposed to resample LSP-4 following the occurrence of a major rainfall event to evaluate the nature of proposed repair stormwater quality dry weather discharges. Additional details pertaining to the results obtained from the dry weather inspections may be referenced Attachment B.

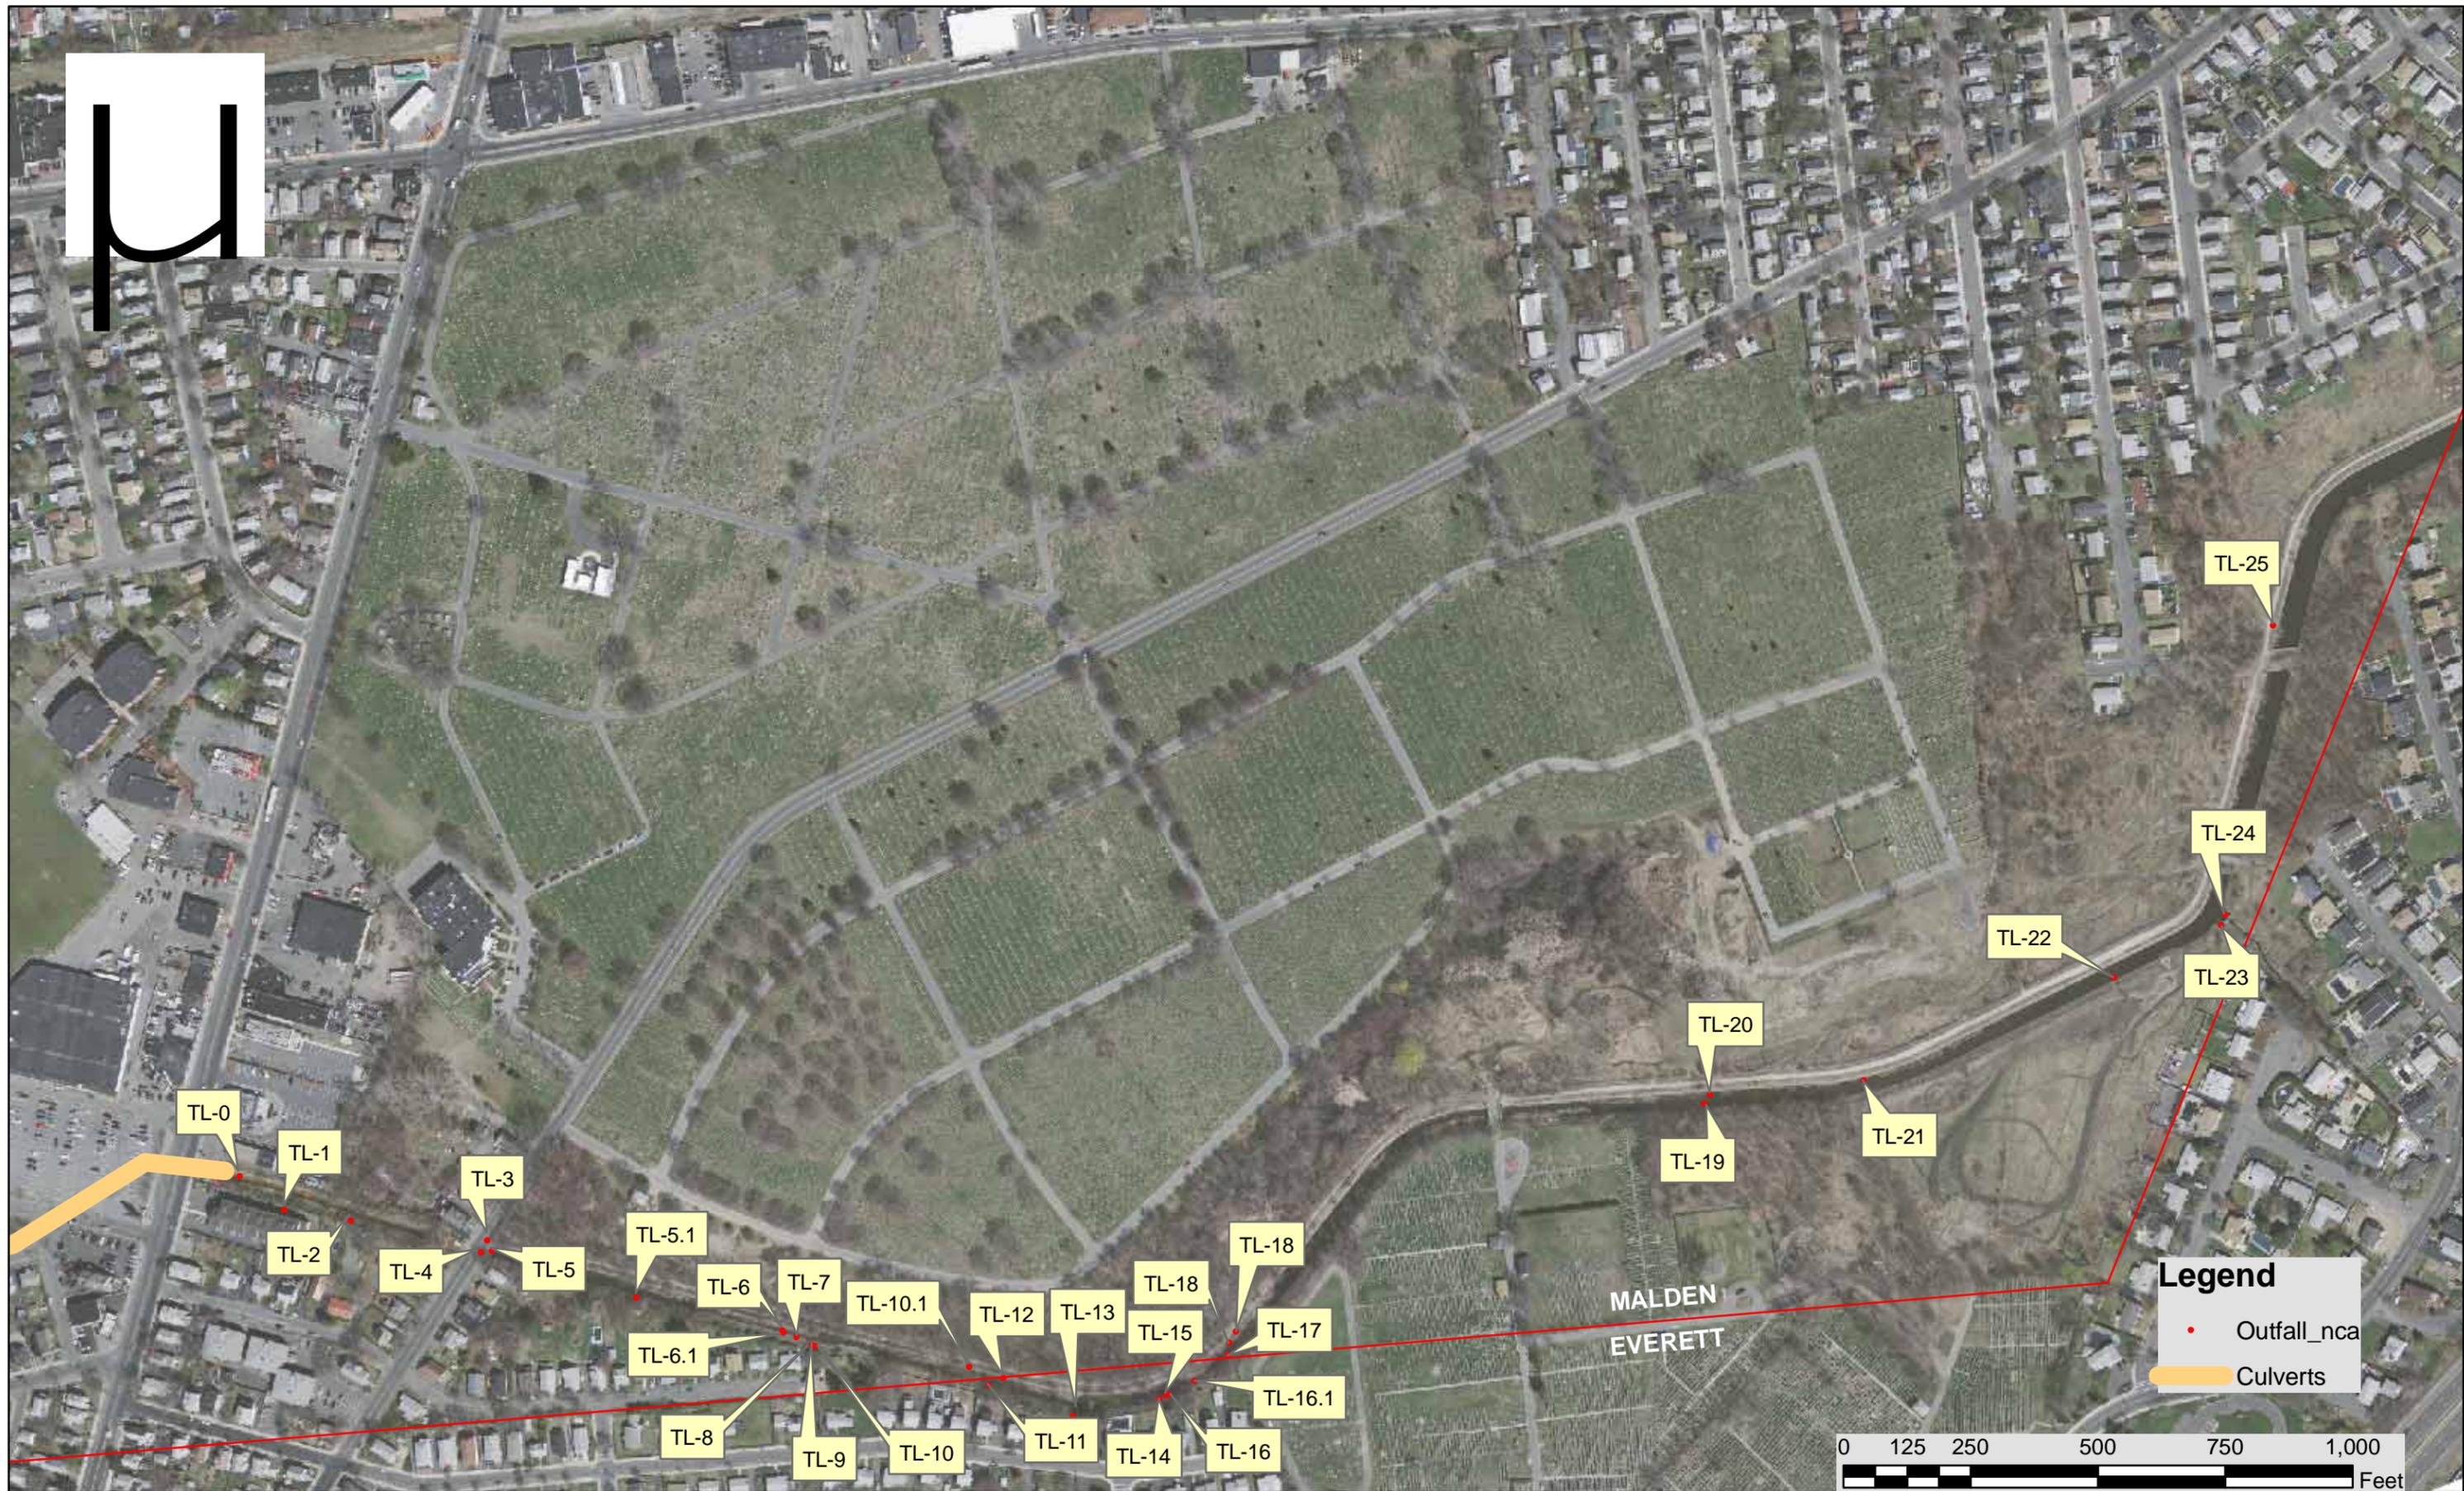
Figure 7 - Town Line Brook Outfalls (updated 11-10-11)

Town Line Brook begins as surface runoff near the Malden and Everett city boundary and is culverted until it daylights into an open concrete lined trapezoidal channel at Broadway. Base flow conditions exist within Town Line, which emanate from culverted flows that originate in the Town of Everett. Significant tidal influences also exist in the form of an approximate 2-3 foot change in surface water elevation between Broadway and the remaining length of the culvert to the Revere City line. As shown on Figure 7, a total of 29 outfalls to Town Line Brook have been identified; four (4) of which were observed flowing during the dry weather event conducted on 8 November 2011.

As shown on Table 2.0, the most recent dry weather sampling event at Town Line Brook on 8 November 2011 revealed E coli levels ranging from 8.5 col/100ml (TL-3) to 96 col/100ml (TL-0). It should be noted that Trifone Brook (TL-24) was not sampled, as the water proximate to the discharge point into Town Line Brook was stagnant. This is most likely due to significant tidal changes that have been noted in the past. Based upon the data obtained, three (3) major sources of dry weather bacteria loading to the open channel portion of Town Line Brook have been identified, including culverted flows from the City of Everett, discharges from storm drainage within lower Hadley Street, in Everett (TL-9), and from Trifone Brook (TL-24). As stated previously, mass balance sampling has been performed at Hadley Street to the Everett city line and contributions from both Trifone Brook and the upper most sampling location for Town Line Brook suggest that these contributions are emanating from areas outside the City of Malden. The monitoring of these outfalls will be continued during future reporting periods.

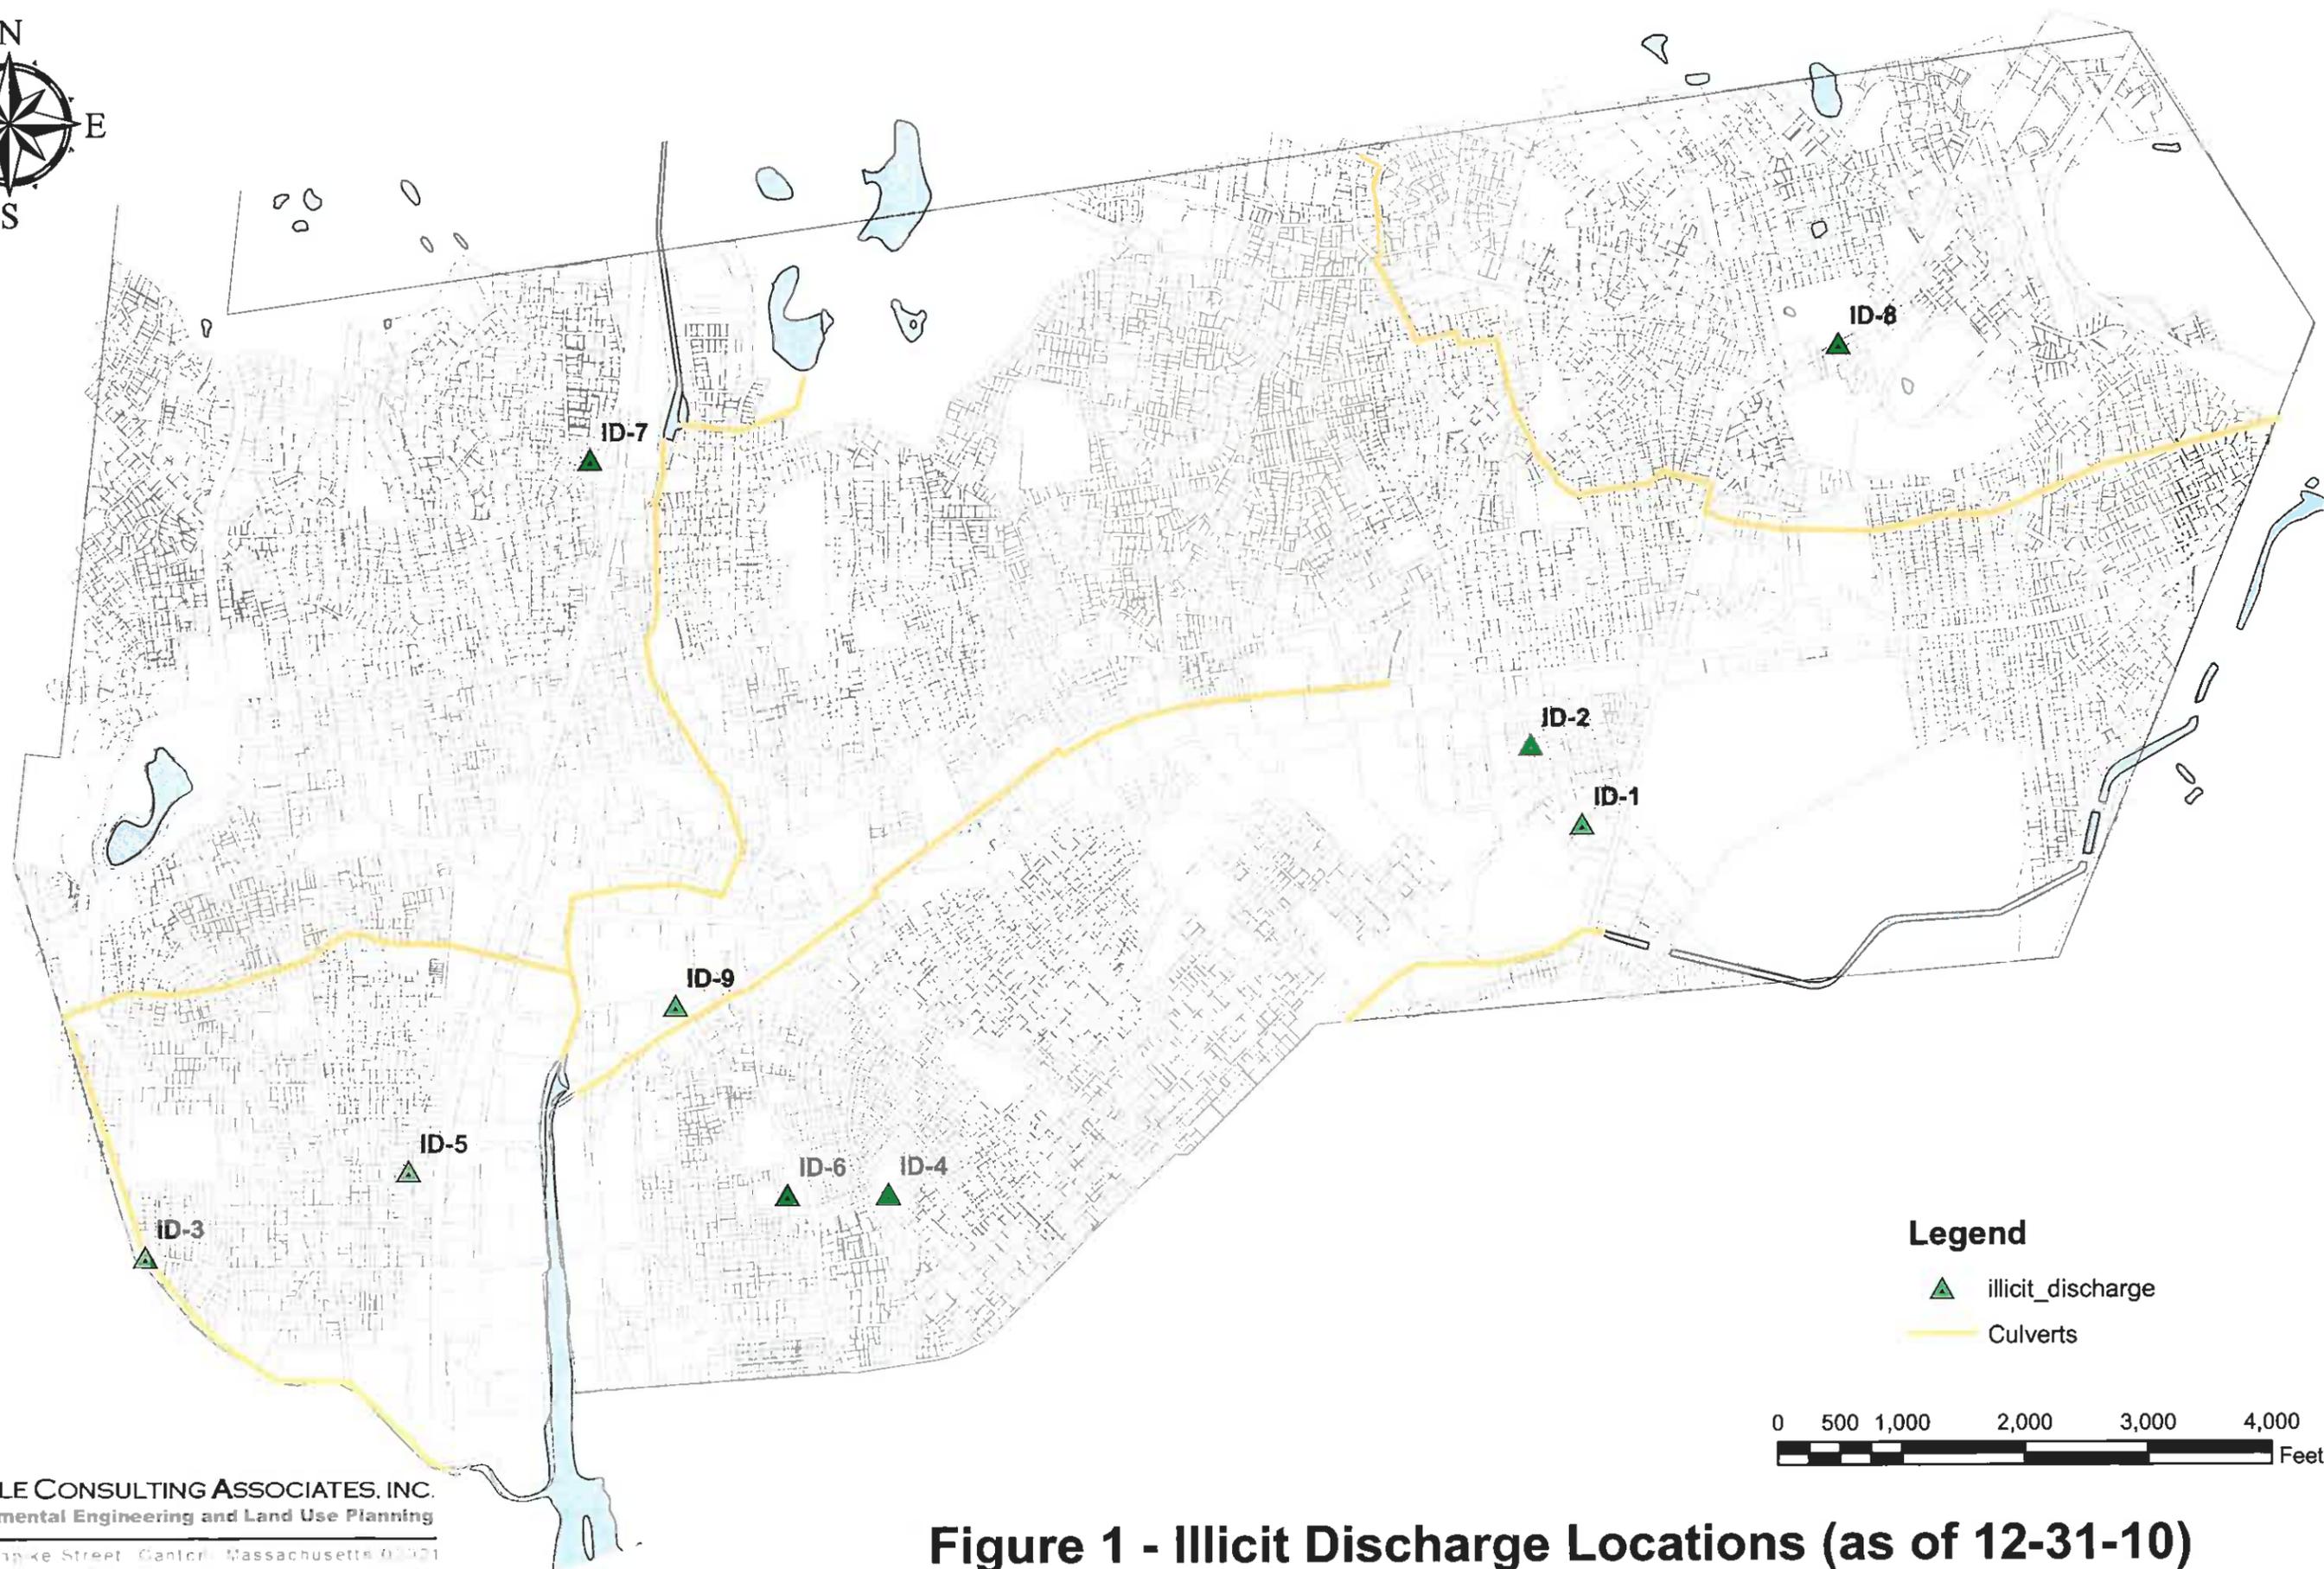
Figure 1 - Illicit Discharge Locations (as of 12-31-10)

During this reporting period, no illicit discharges were identified. A summary of the illicit discharges/connections identified to date is presented on Figure 1 and Table 1.0. It should be noted that due to personnel shortages and winter maintenance requirements, as well as snow melt, targeted dry weather inspections and drainage system mapping were reduced relative to the summer and fall reporting periods.

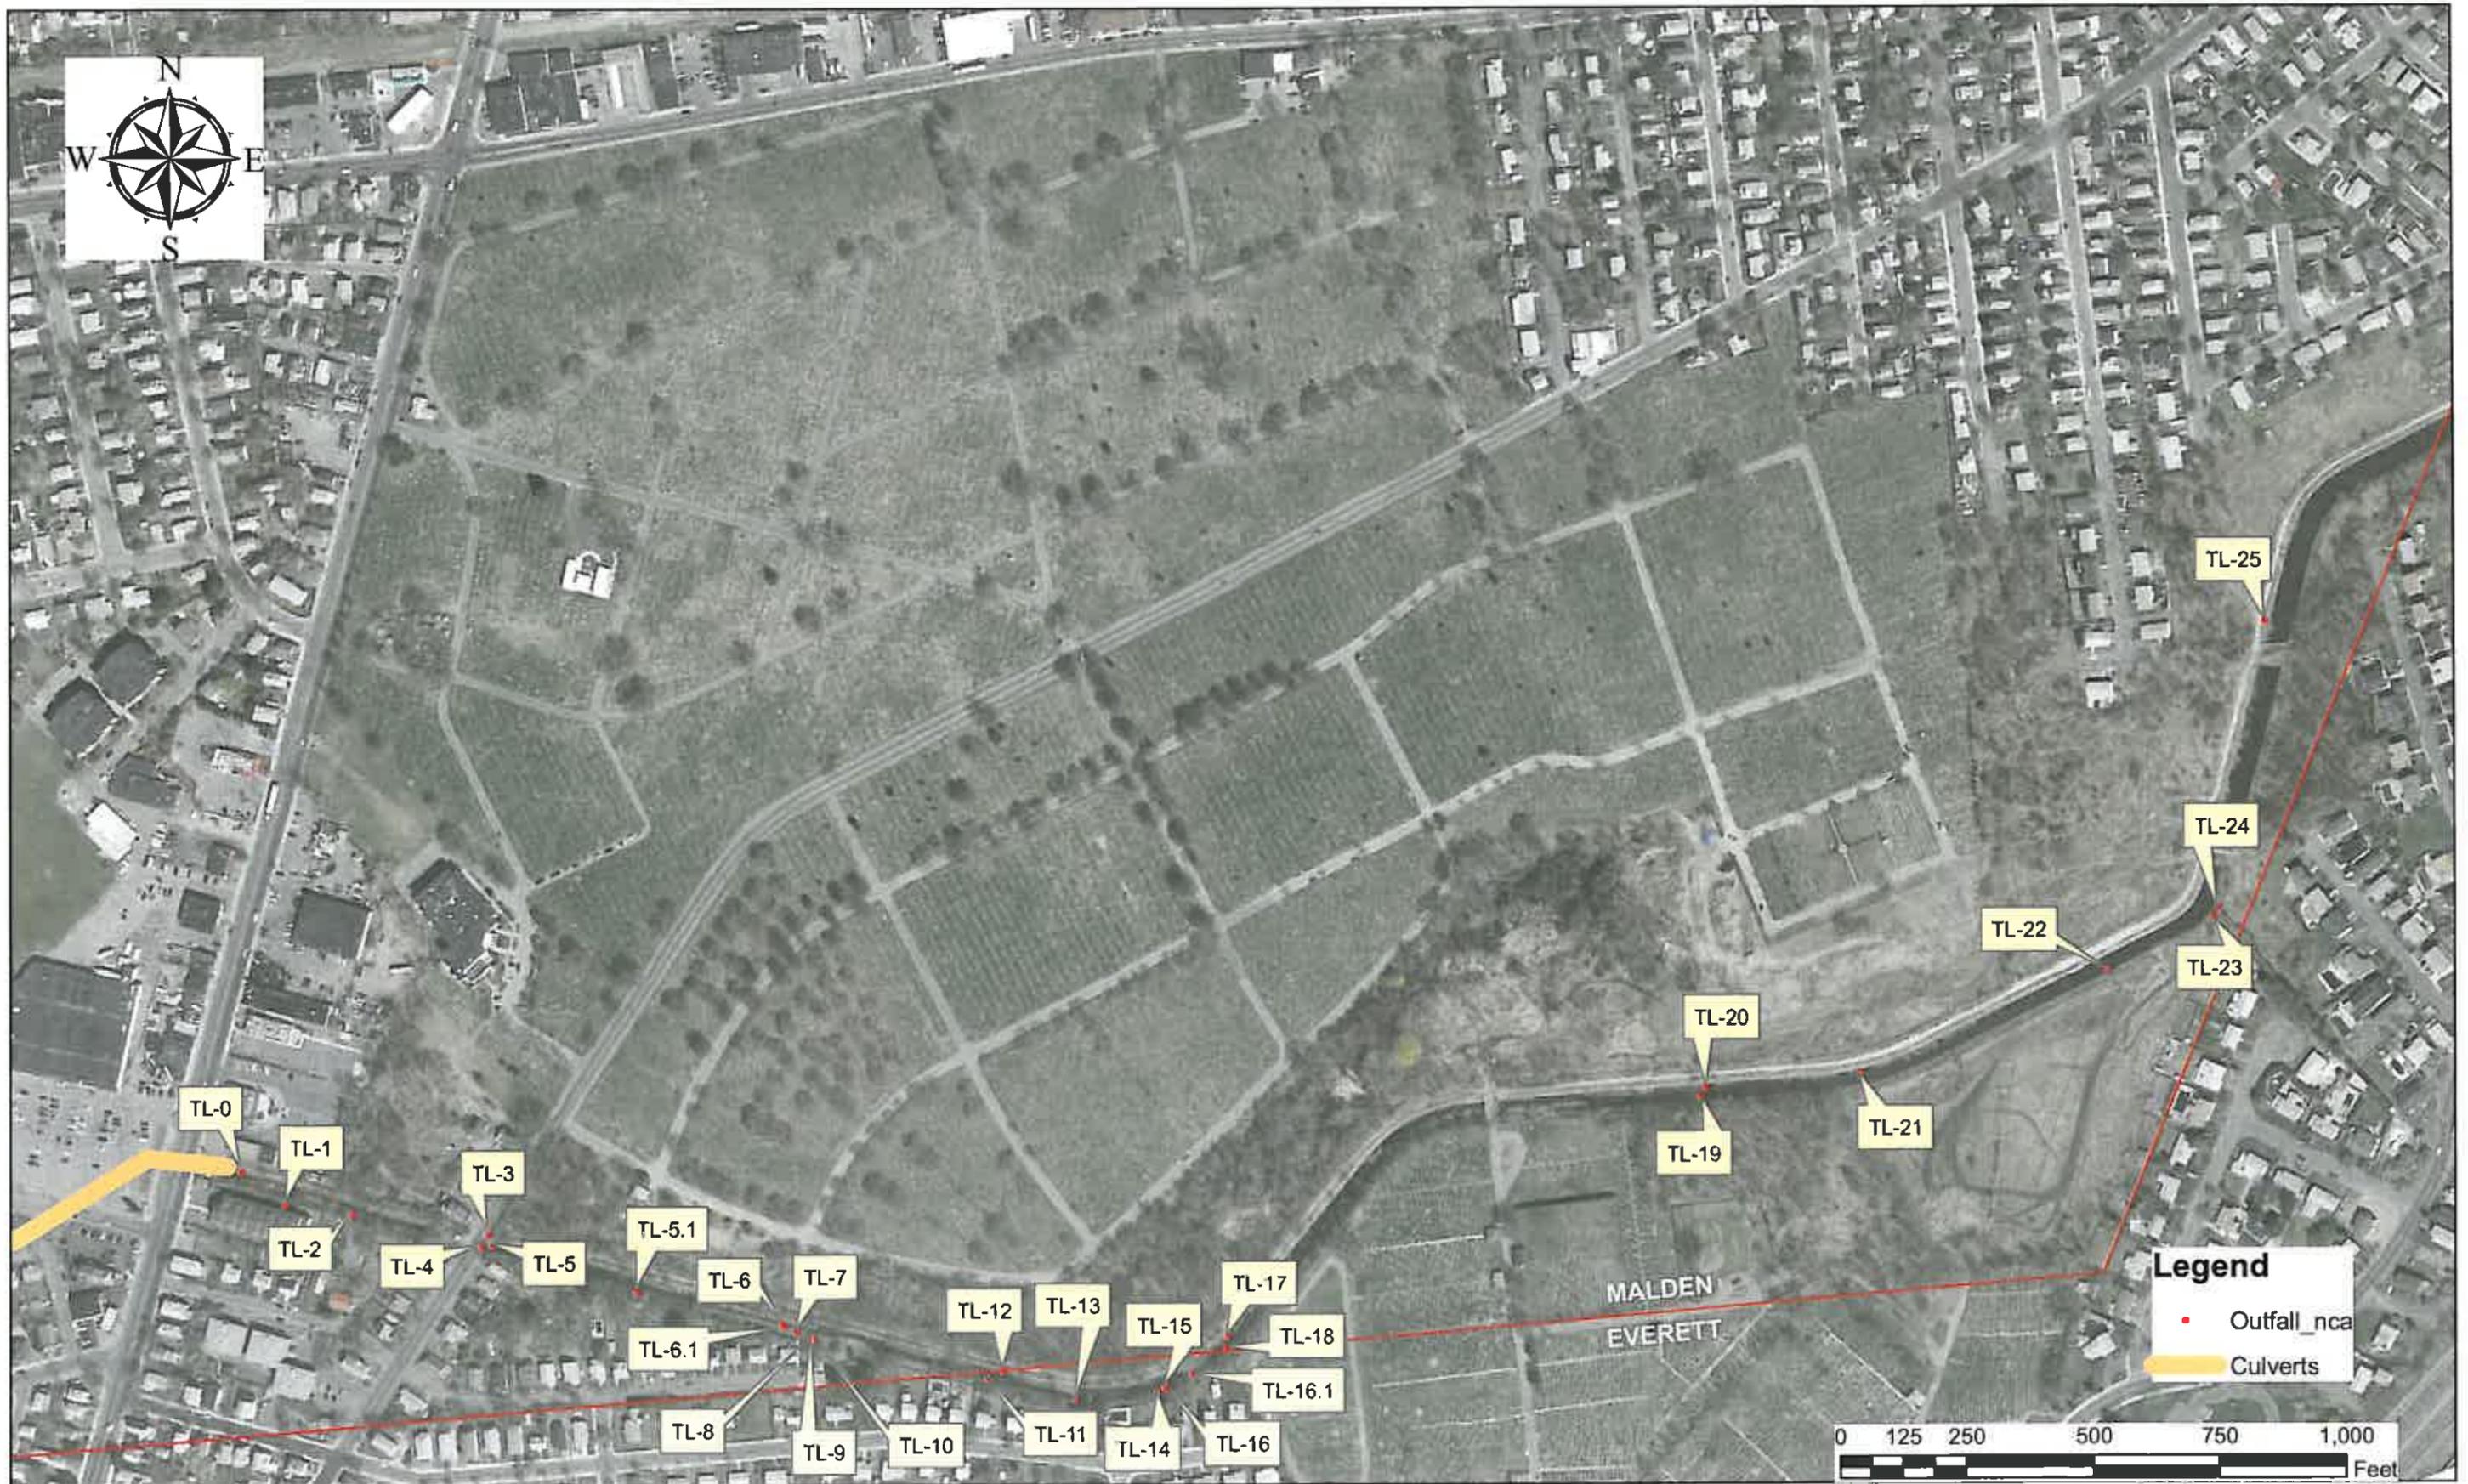
Figure 7 - Town Line Brook Outfalls

Town Line Brook begins as surface runoff west of Broadway near the Malden and Everett city boundary and is culverted until it daylights into an open concrete lined trapezoidal channel at Broadway. Base flow conditions exist within Town Line, which emanate from culverted flows that originate in the Town of Everett. Significant tidal influences in the form of an approximate a 2-3 foot change in surface water elevation was observed from Broadway and over the remaining length of the culvert to the Revere City line. As shown on Figure 7, a total of 29 outfalls to Town Line Brook have been identified to date, five (5) of which have been observed as flowing during dry weather conditions.

E coli levels (2,400 col/100ml) have been detected within dry weather open channel flow within Town Line Brook immediately adjacent to Lynn Street. The levels encountered at Lynn Street may be attributable to flushing as a result of the significant tidal changes noted. Based upon the data obtained to date, three major sources of dry weather bacteria loading to the open channel portion of Town Line Brook have been identified including culverted base flows from the City of Everett, discharges from storm drainage within lower Hadley Street (TL-9), and from Trifone Brook (TL-24). As described above, mass balance sampling has been performed at Hadley Street to the Everett city line and contributions from both Trifone Brook and the upper most sampling location for Town Line Brook suggest that these contributions are emanating from areas outside the City of Malden. The monitoring of these outfalls will be continued during future reporting periods; however, this condition appears related to upstream flows emanating from Everett.
