Municipality/Organization: City of Malden
EPA NPDES Permit Number: MA041046
MADEP Transmittal Number: 041088
Annual Report Number & Reporting Period: No. 11: April 1, 2013-March 31, 2014

NPDES PII Small MS4 General Permit Annual Report

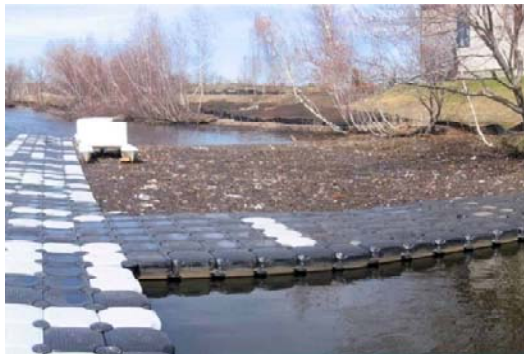
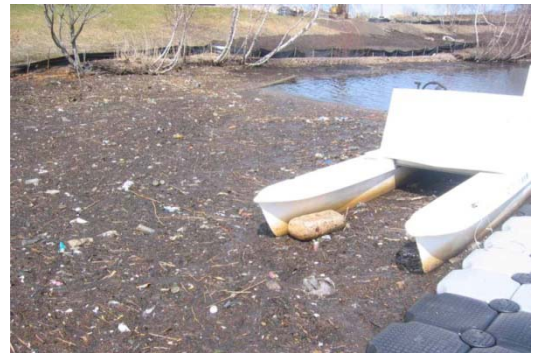
MDPW staff maintains two (2) trash booms across the Malden River to retain the significant amount of trash and debris that is generated during the urban system primarily during rainfall events. Prior to this, extensive trash/debris depositions occurred along the banks of the Malden, and in particular within the vicinity of the Tuft Boathouse and Phase I of the River’s Edge project, as depicted within the following photographs shown below. The maintenance of these trash booms have resulted in a significant improvement in surface water conditions for both passive and recreational activities associated with the River. The development of the Friends of the Malden citizens group is expected to further advance this goal.

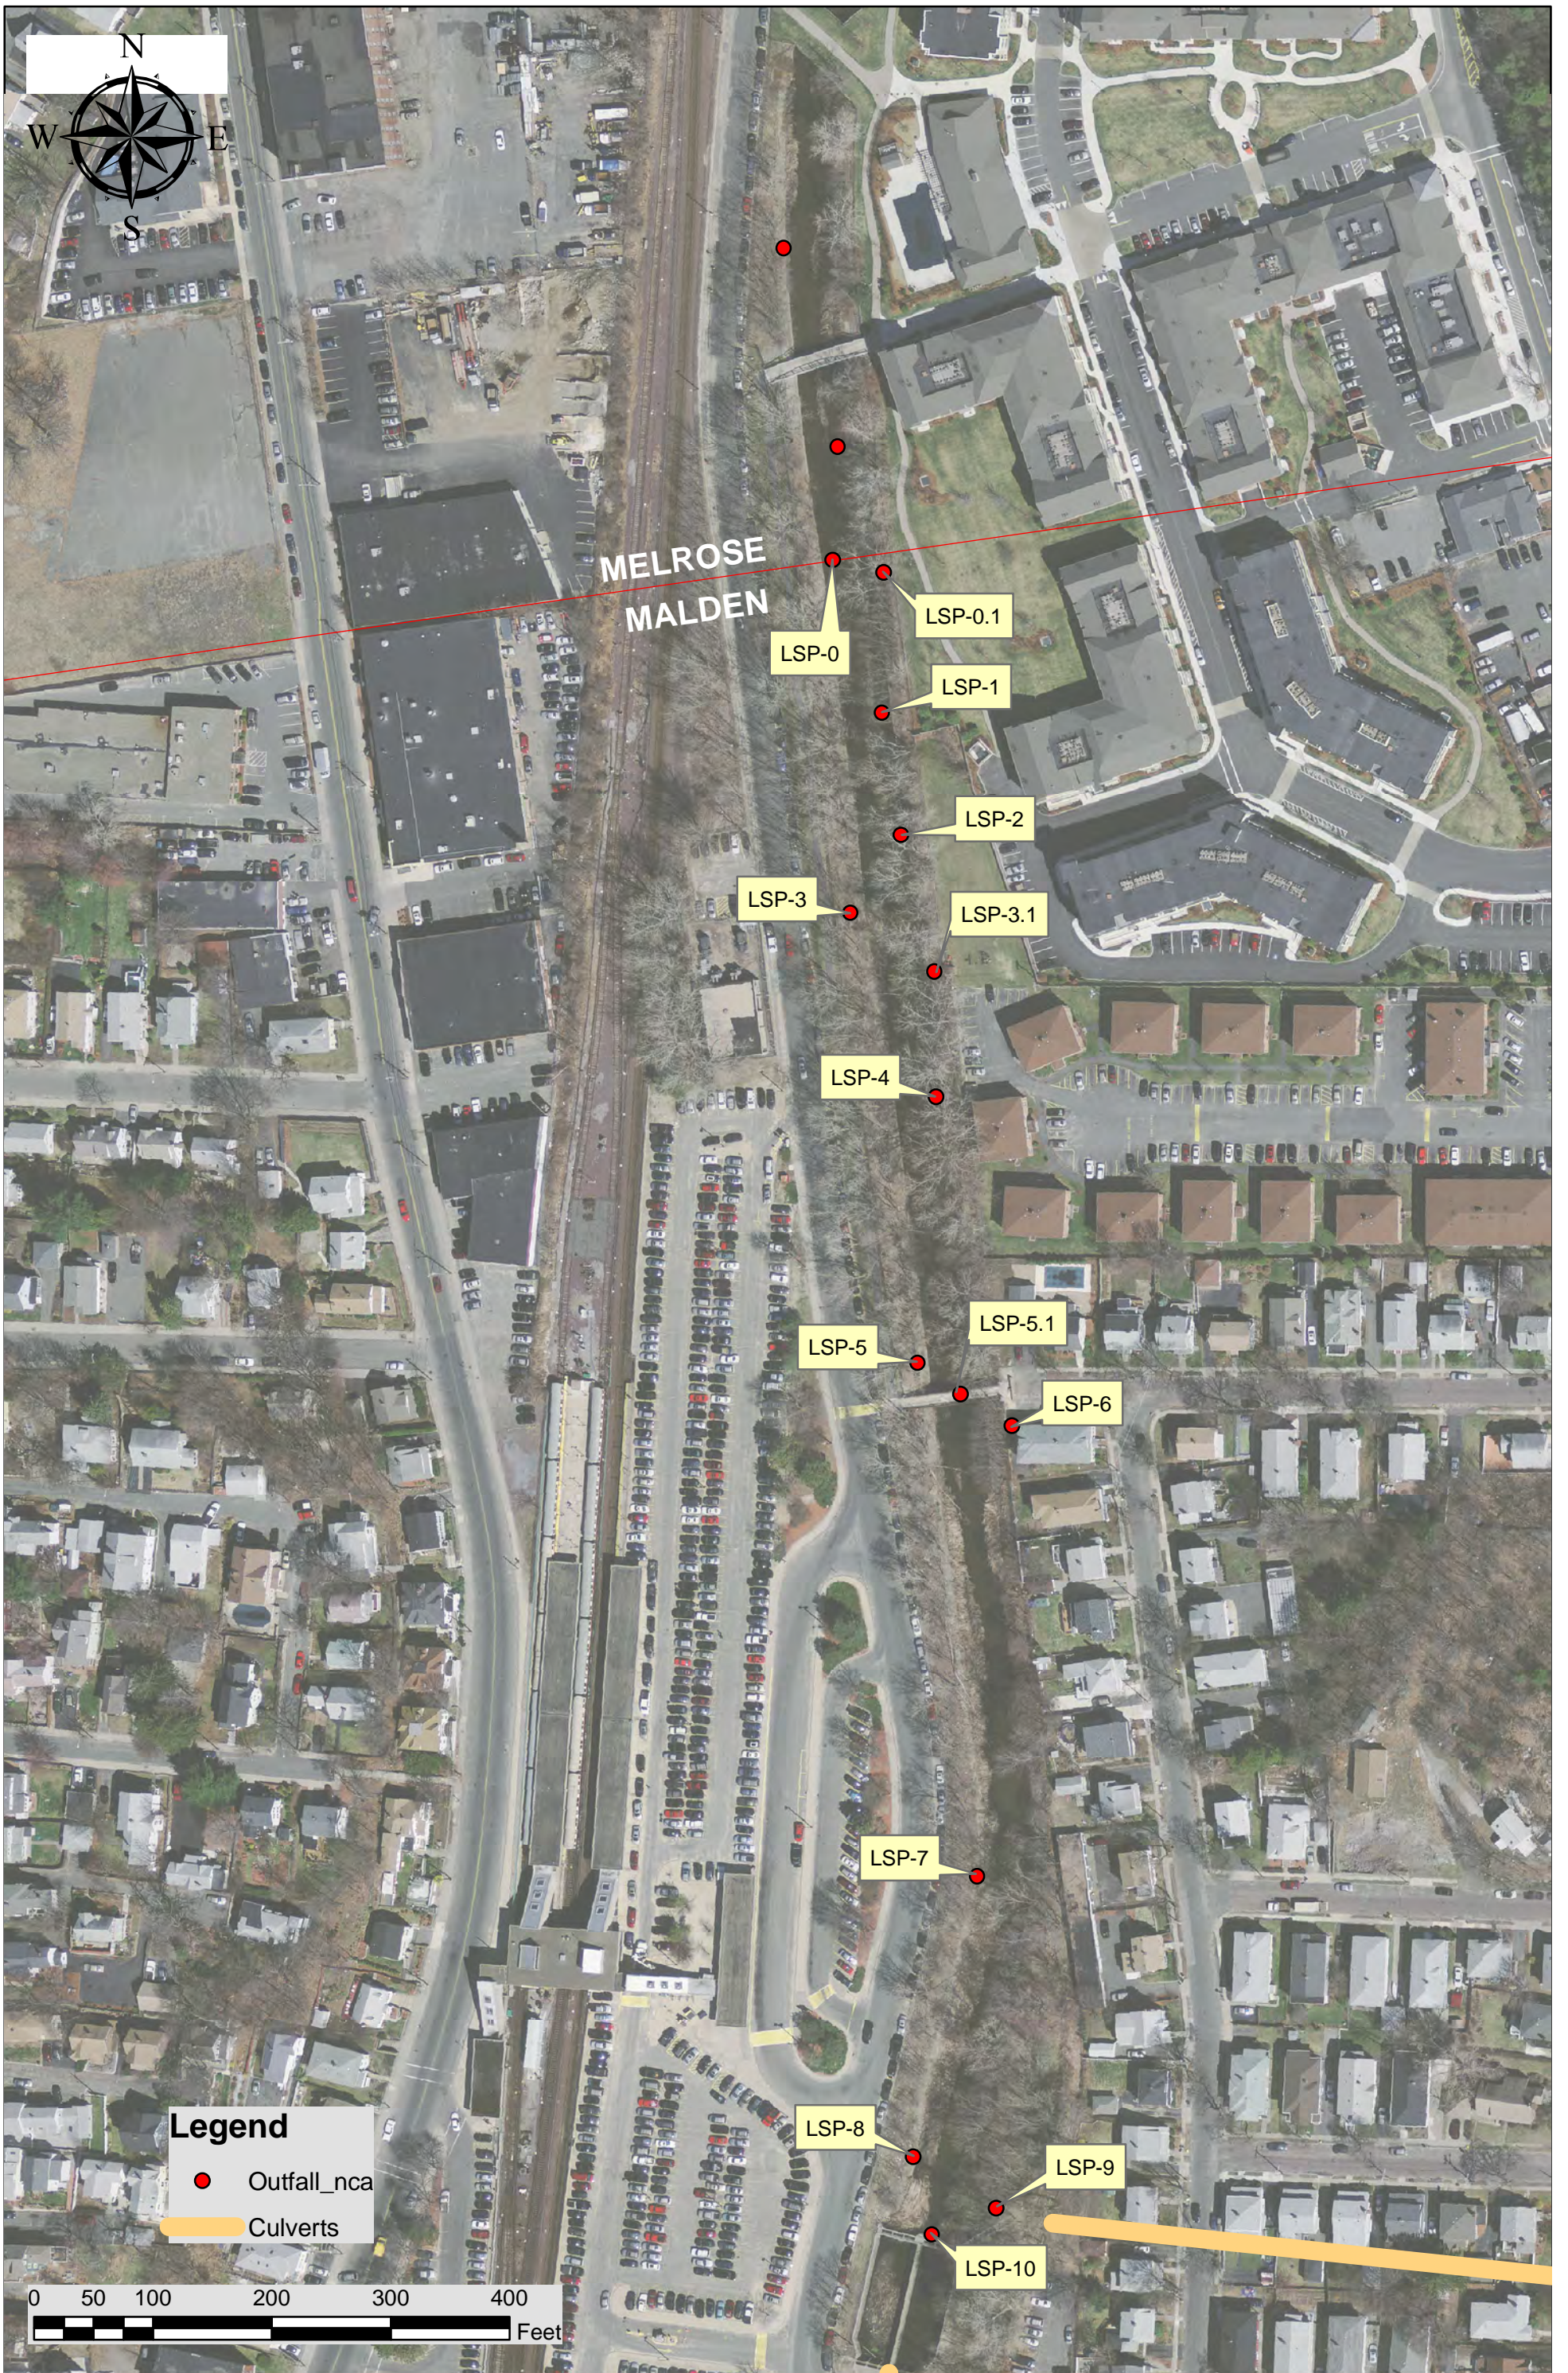
Figure 5 - Lower Spot Pond Brook Outfalls

The Stormwater Compliance Team has conducted numerous dry weather sampling events to investigate the elevated E. coli levels encountered previously at LSP-4, an outfall for the drainage system located within Eldrich Drive (Figure 5). Base flow, as groundwater, is consistently observed within this drainage network and to isolate potential sewage contributions to this base flow, a comprehensive evaluation of the flow conveyance network associated with LSP-4 was completed in February 2012. Given the proximity of the sewer and drain lines to LSP-4, as well as the settlement of the drain line in the area of Buildings 1054 and 1056 Elrich Drive, the focus of assessment activities was directed towards the sewer laterals and nearby drainage line servicing the two apartment buildings. Following dye testing by the Compliance Team, camera surveys performed by representatives of the property owner confirmed that compromises to the laterals servicing two (2) residential building had occurred. Recommendations made by the SCT involved restoring the integrity of the main drainage line to stop the discharges that have been documented at LSP-4. Working with representatives of the Malden Engineering Department, repairs to the sewer laterals in the area of Building 1054 and 1056 were completed by the property owner in March 2012. Since that time, several attempts have been made to collect a dry weather flow sample from LSP-4, however due to base flow within the Lower Spot Pond Brook; this sample location has been inaccessible. A sample from LSP-4, as well as upstream manhole E13-MH4 were collected during this reported period and as shown on Table 3.0, an E. coli level of 2,000 MPN/100 ml was detected at each location. Although still elevated, the levels detected have decreased significantly relative to concentrations detected in 2012. The City Engineering Department is in the process of contacting the property owner to discuss the most recent sampling results.

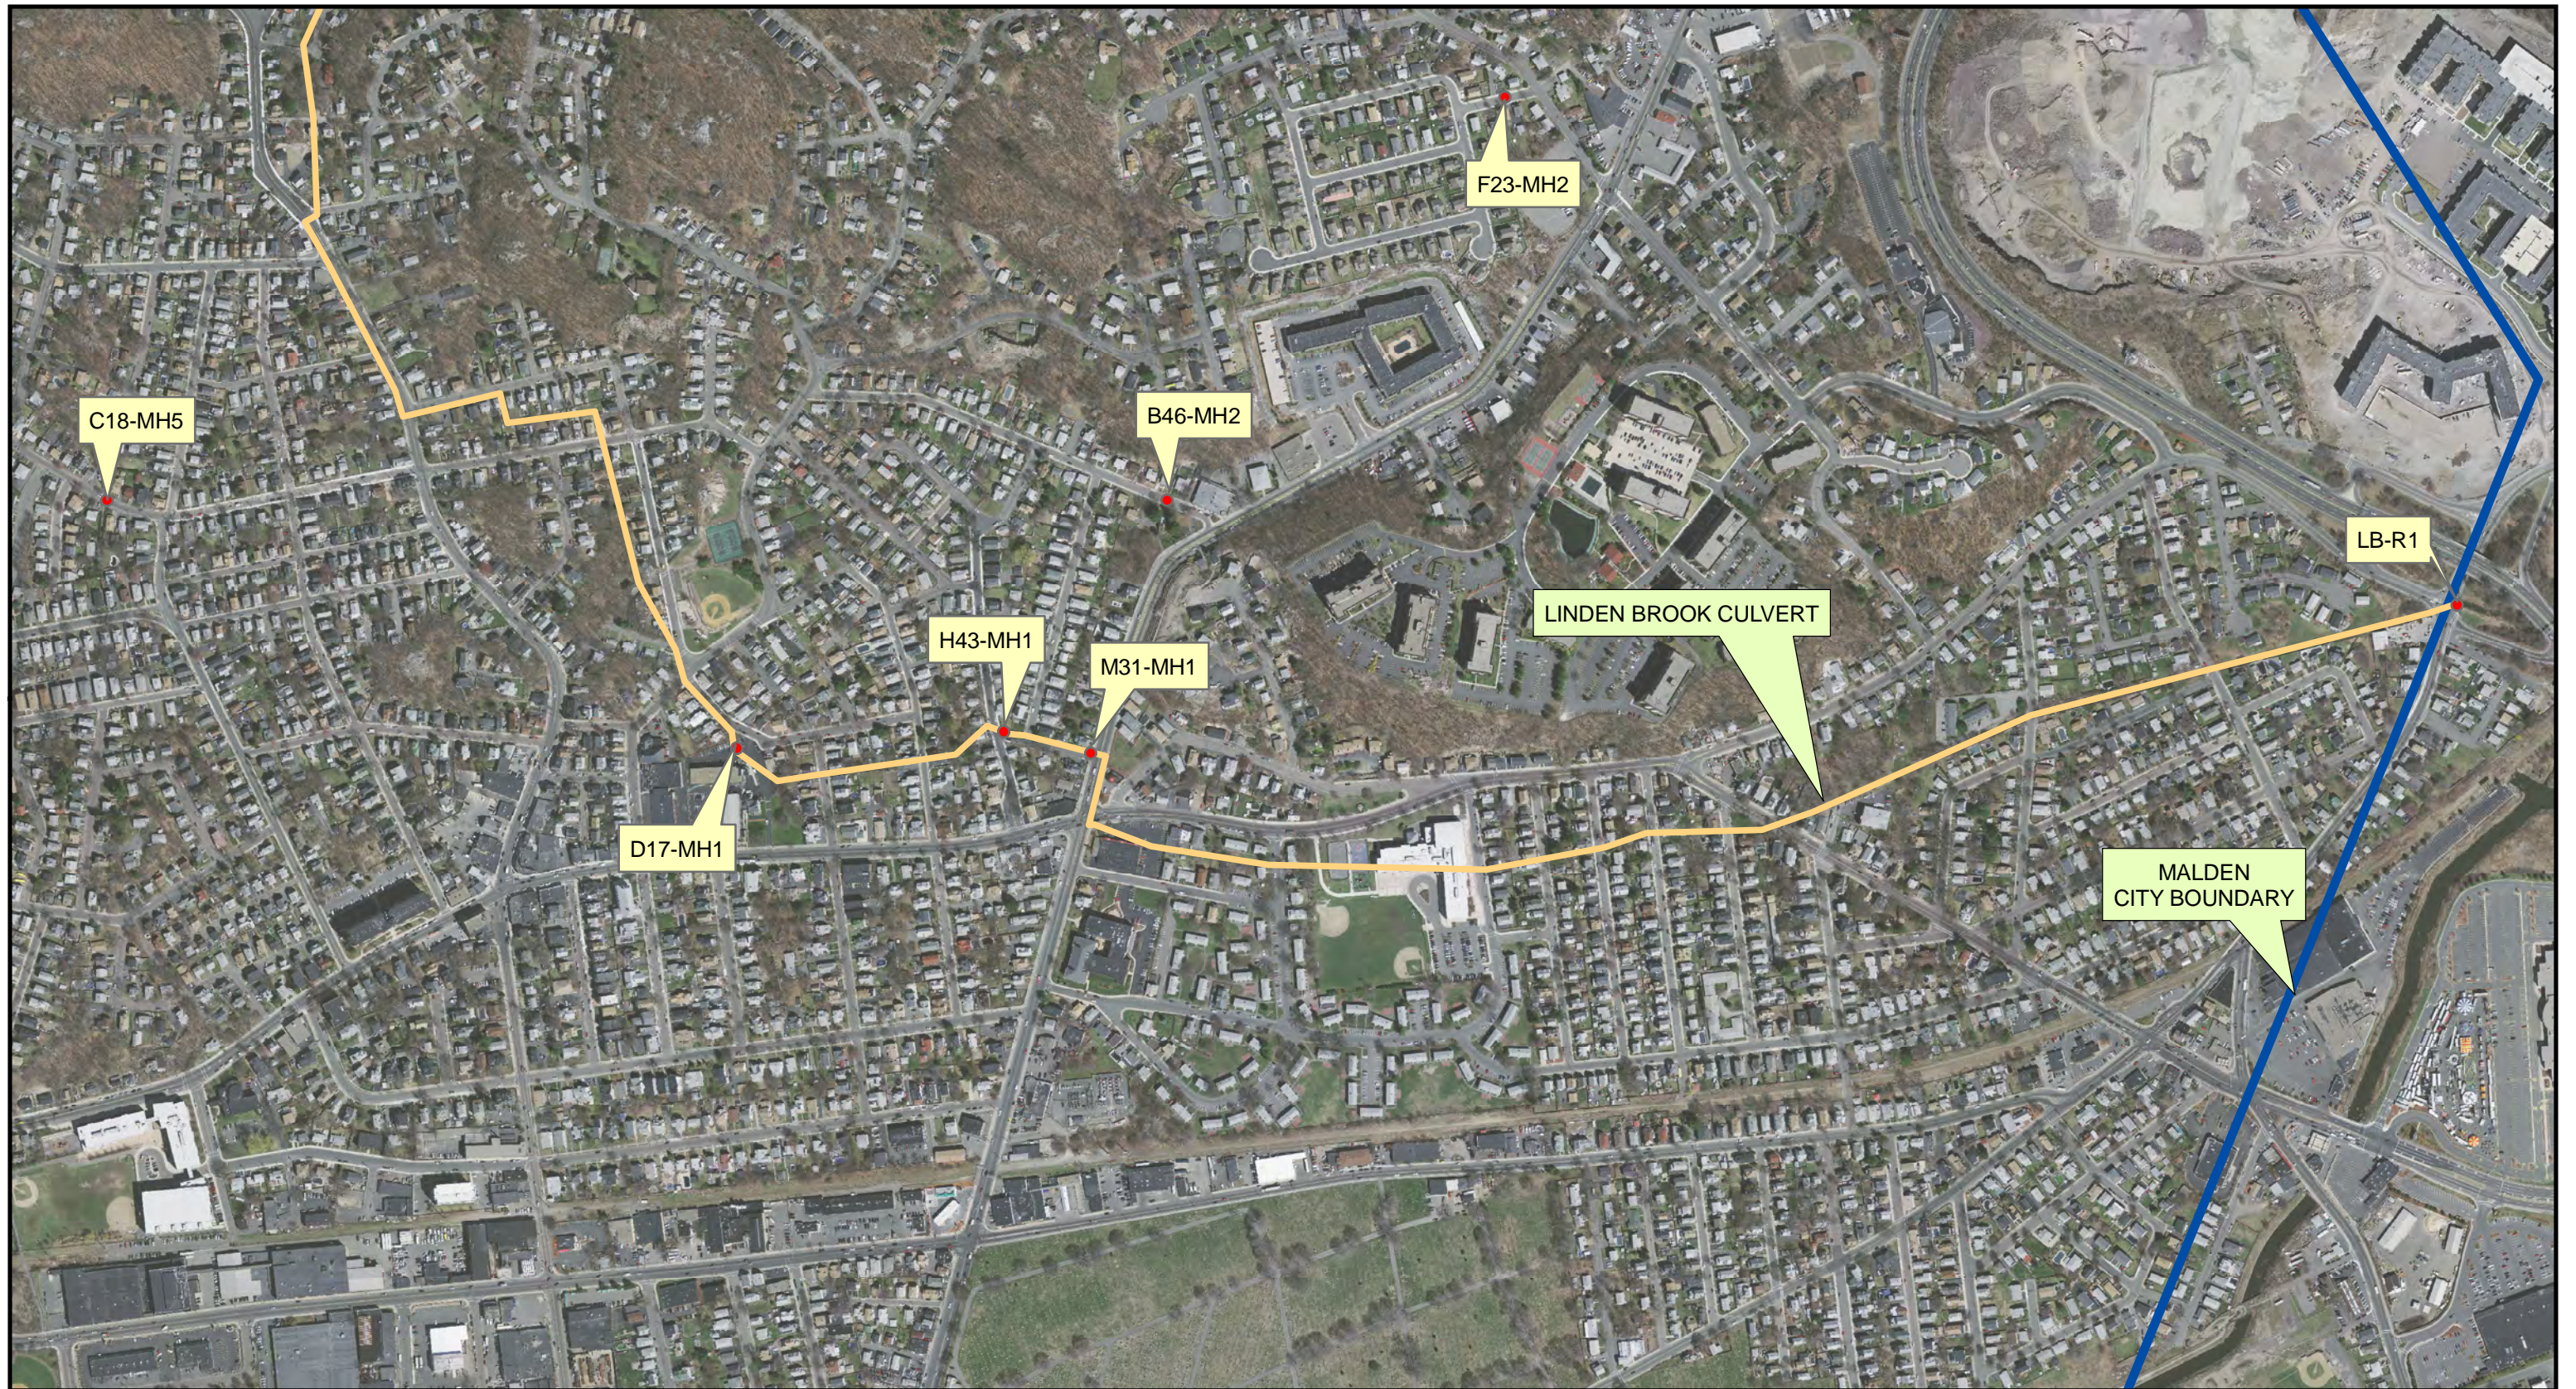
Figure 7 - Dry Weather Sampling Program
MALDEN, MASSACHUSETTS

During the September 2012 sampling event, representatives of the USEPA collected a water sample from outfall LBR-1 (Figure 7), located in Revere, where distinct indications of sewage odors were noted. Consistent with identification of strong sewage odors and immediately apparent from a review of Table 3.0 is the significantly elevated level of E. coli (>241,920 MPN/100 ml) detected in sample LBR-1. To assess this condition and as described in prior status reports, the City of Malden contracted with National Water Main Cleaning Company, under the supervision of CDM Smith. As summarized in the following excerpt from an email to the City of Malden from CDM Smith, it is believed that line blockage due to grease build up may have been a crucial factor for the conditions identified at LBR-1, in addition to a “minor” defect in the form of a leaky joint. Although maintenance was routinely performed on this siphon, the extent of grease build up indicates that a higher frequency of cleaning and maintaining is necessary to further understand the condition.

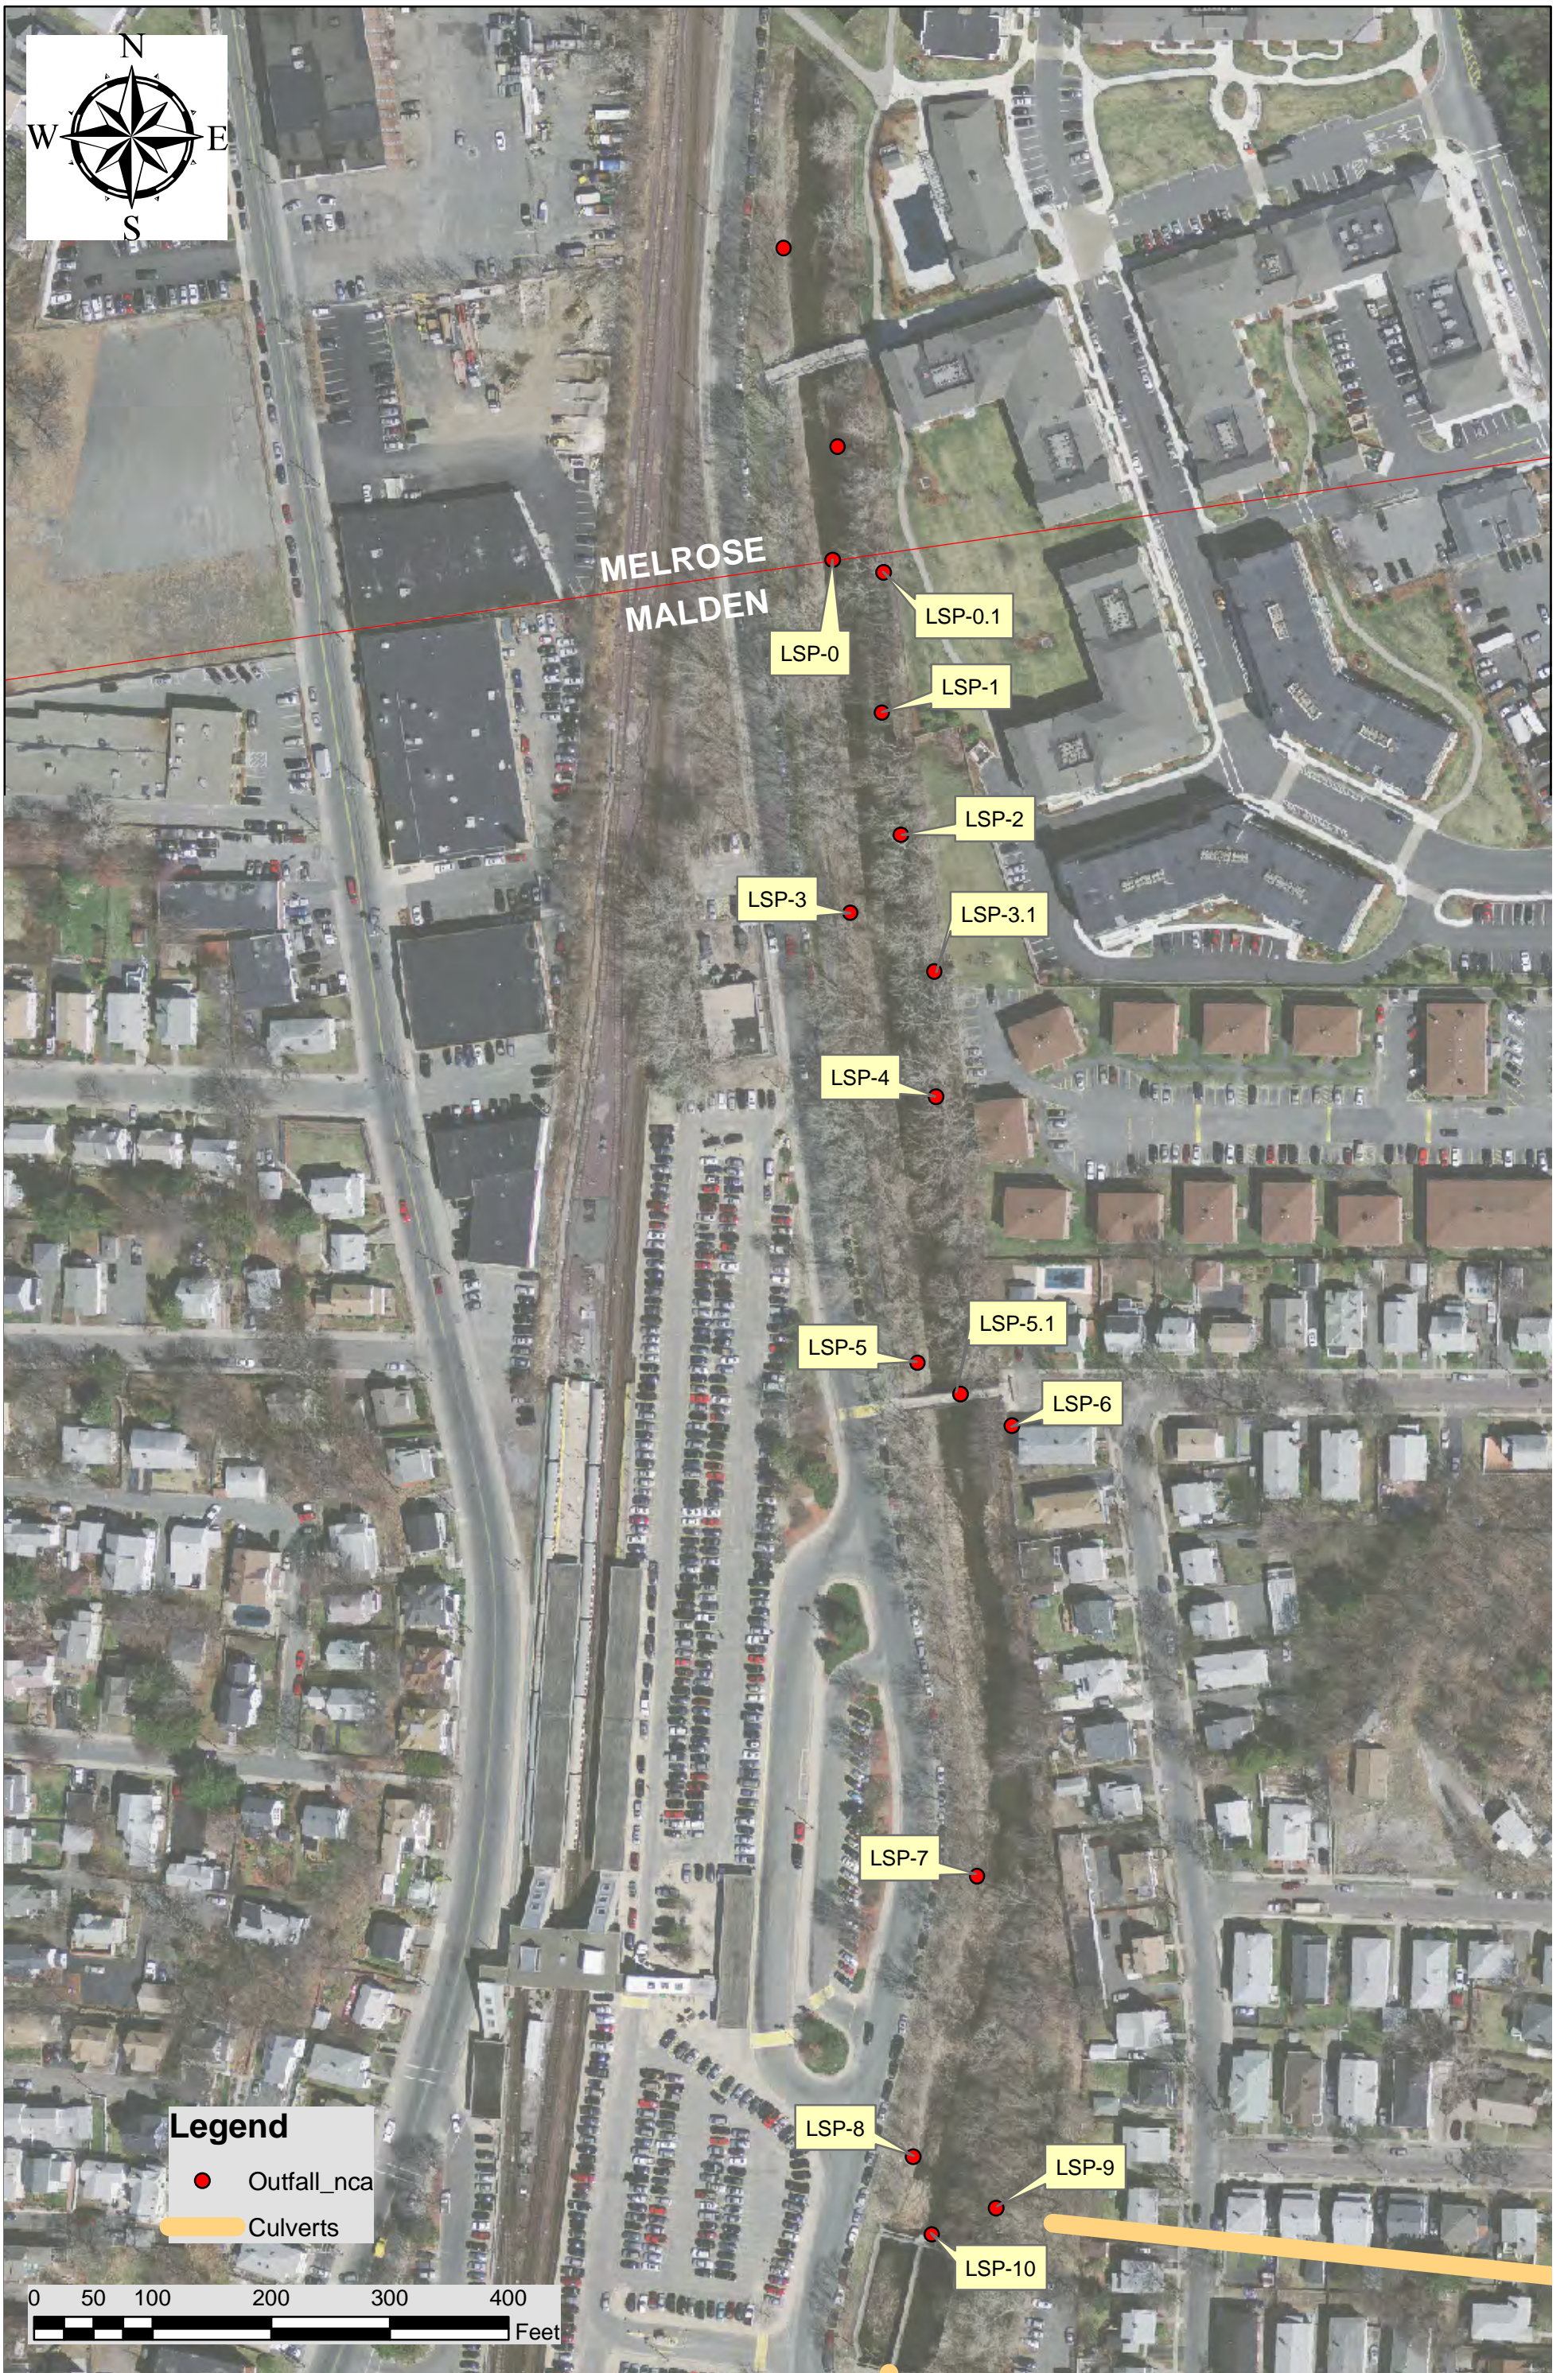
Figure 7 - Lower Spot Pond Brook Outfalls

The Stormwater Compliance Team has conducted numerous dry weather sampling events to investigate the elevated E. coli levels encountered previously at LSP-4, an outfall for the drainage system located within Eldrich Drive (Figure 7). Base flow, as groundwater, is consistently observed within this drainage network and to isolate potential sewage contributions to this base flow, a comprehensive evaluation of the flow conveyance network associated with LSP-4 was completed in February 2012. Given the proximity of the sewer and drain lines to LSP-4, as well as the settlement of the drain line in the area of Buildings 1054 and 1056 Elrich Drive, the focus of assessment activities was directed towards the sewer laterals and nearby drainage line servicing the two apartment buildings. Following dye testing by the Compliance Team, camera surveys performed by representatives of the property owner confirmed that compromises to the laterals servicing two (2) residential building had occurred. Recommendations made by the SCT involved restoring the integrity of the main drainage line to stop the discharges that have been documented at LSP-4. Working with representatives of the Malden Engineering Department, repairs to the sewer laterals in the area of Building 1054 and 1056 were completed by the property owner in March 2012. Several attempts have been made to collect a dry weather flow sample from LSP-4, however due to base flow within the Oak Grove

Channel; this sample location has been inaccessible. It is anticipated that during the next reporting period, a dry weather sample will be collected from LSP -4 to evaluate the effect of the sewer lateral repair.
