**Municipality/Organization:** City of Malden  
**EPA NPDES Permit Number:** MA041046  
**MADEP Transmittal Number:** 041088  
**Annual Report Number  
& Reporting Period:** No. 12: April 1, 2014-March 31, 2015

## NPDES PII Small MS4 General Permit Annual Report

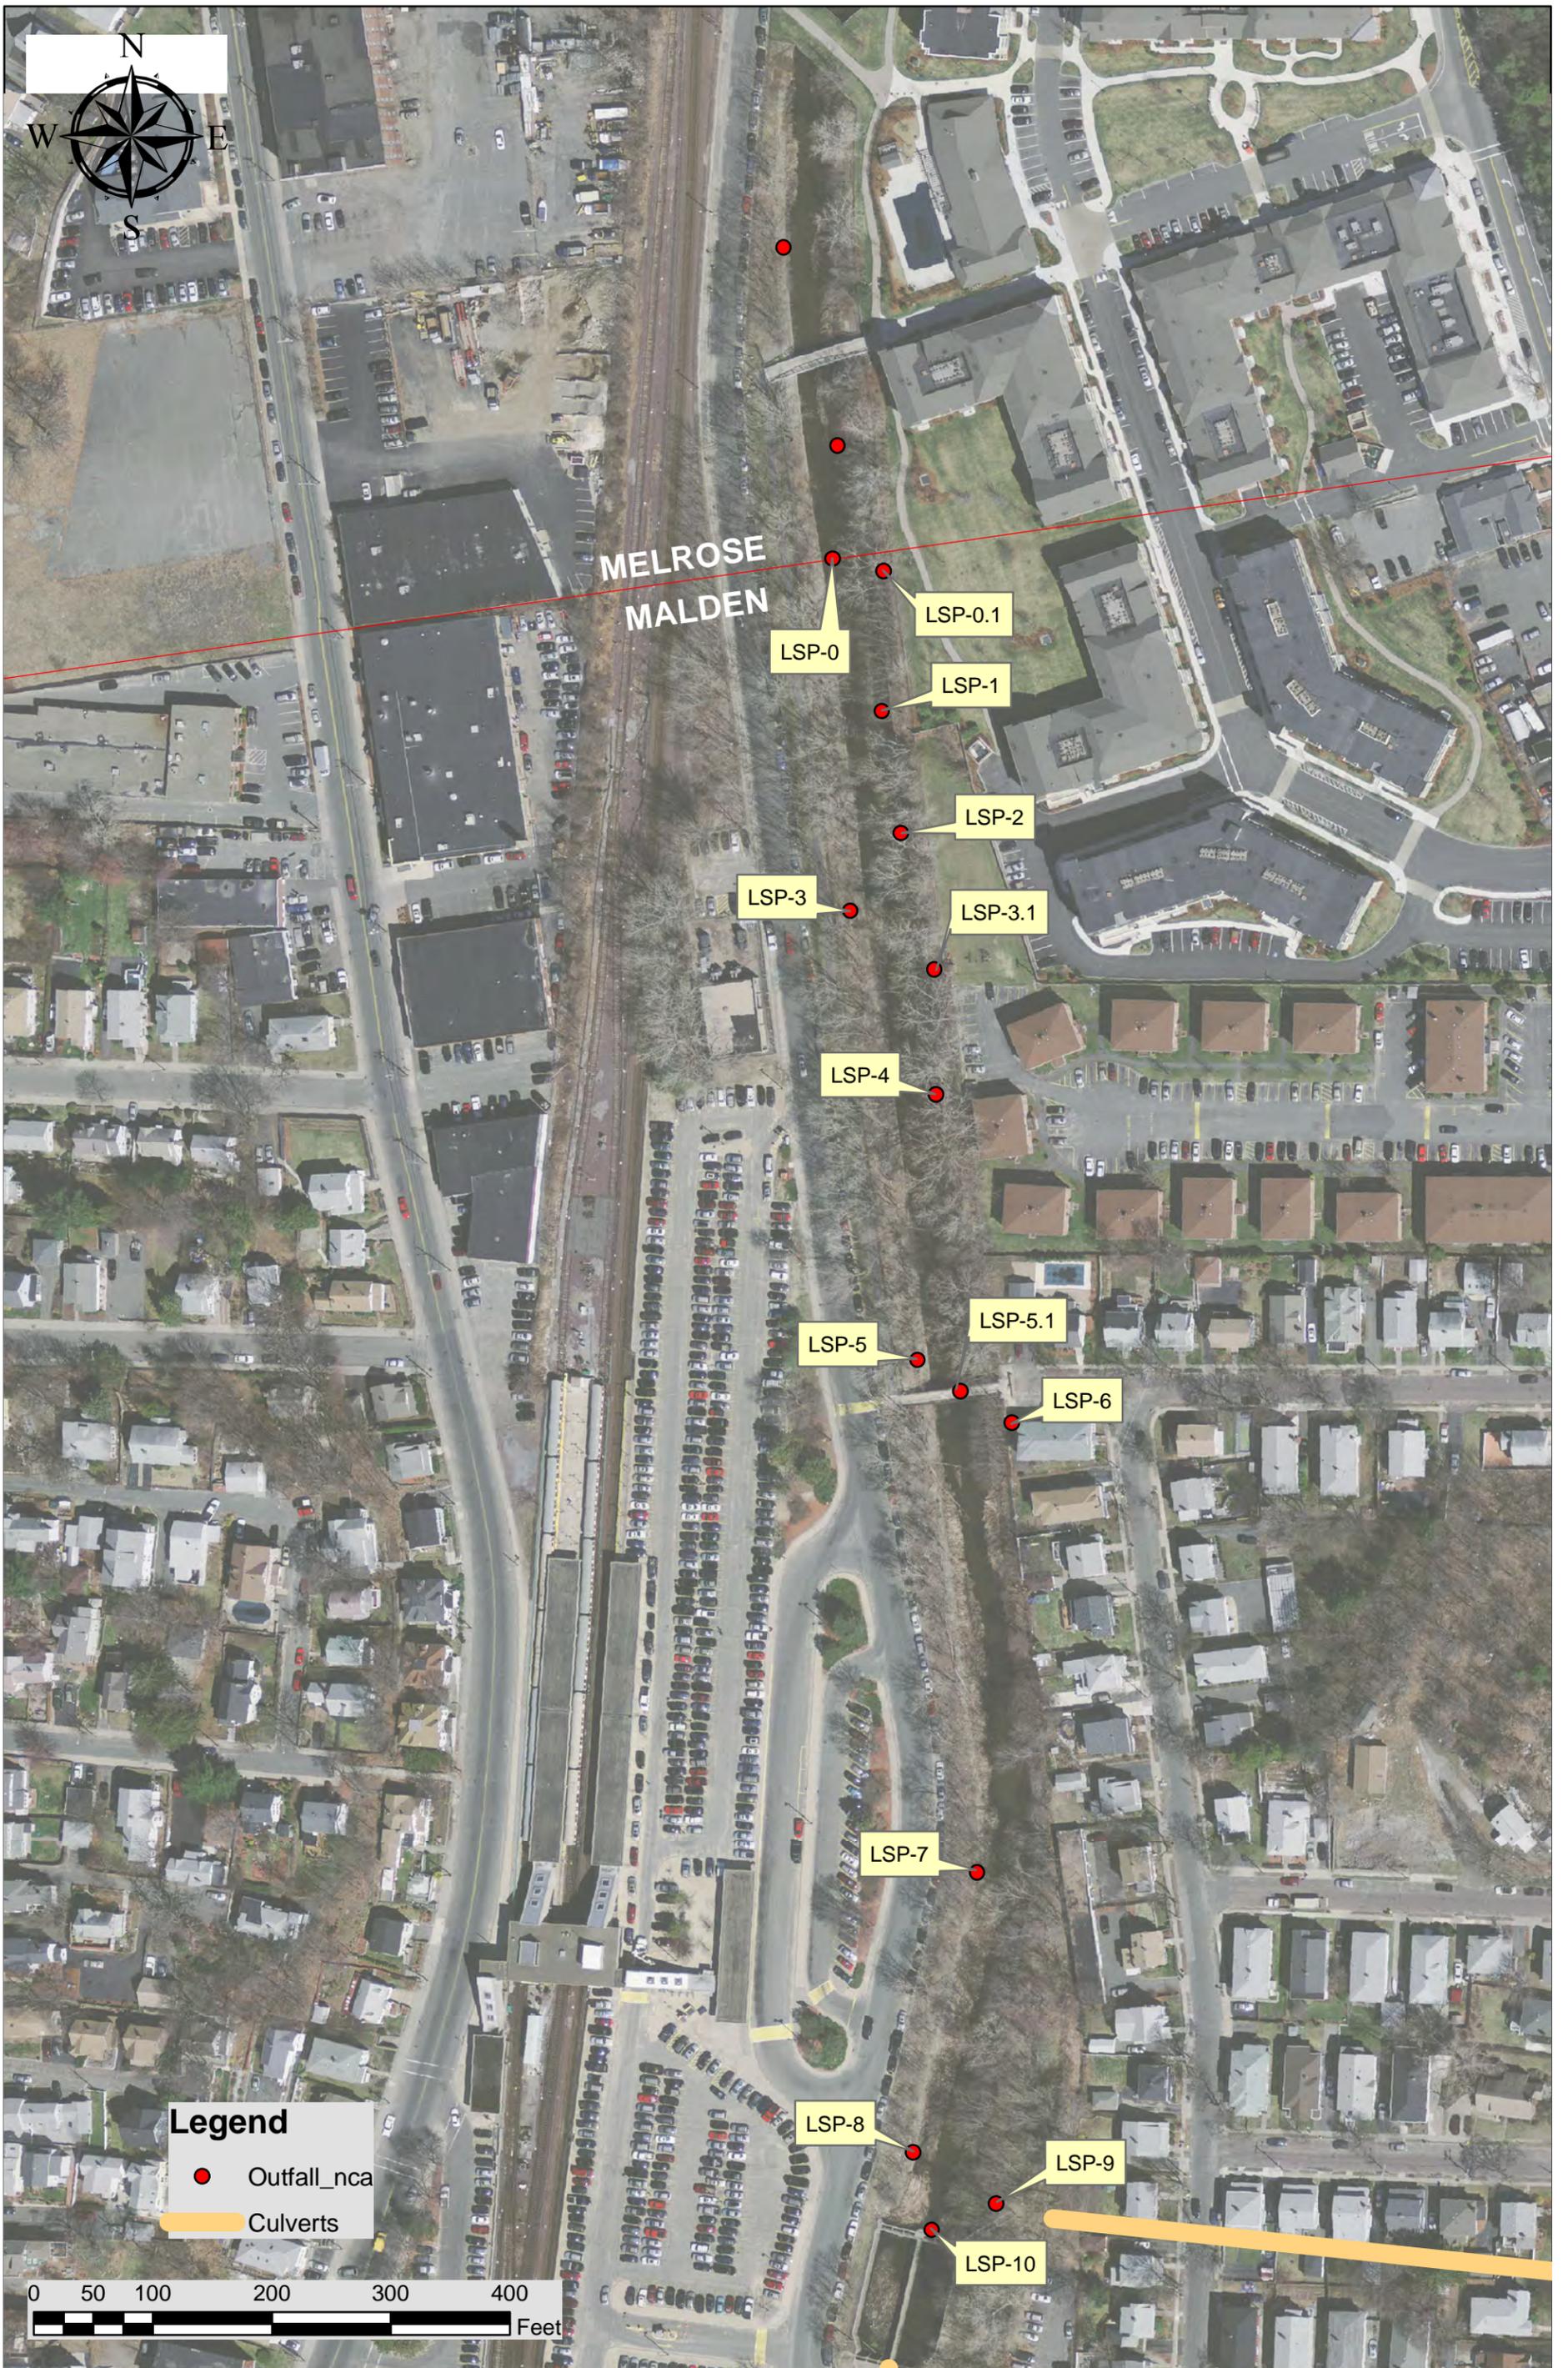
**Figure 5 - Lower Spot Pond Brook Outfalls**

The Stormwater Compliance Team has conducted numerous dry weather sampling events to investigate the elevated E. coli levels encountered previously at LSP-4, an outfall for the drainage system located within Eldrich Drive (Figure 5). Base flow, as groundwater, is consistently observed within this drainage network and to isolate potential sewage contributions to this base flow, a comprehensive evaluation of the flow conveyance network associated with LSP-4 was completed in February 2012. Given the proximity of the sewer and drain lines to LSP-4, as well as the settlement of the drain line in the area of Buildings 1054 and 1056 Elrich Drive, the focus of assessment activities was directed towards the sewer laterals and nearby drainage line servicing the two apartment buildings. Following dye testing by the Compliance Team, camera surveys performed by representatives of the property owner confirmed that compromises to the laterals servicing two (2) residential building had occurred. Recommendations made by the SCT involved restoring the integrity of the main drainage line to stop the discharges that have been documented at LSP-4.

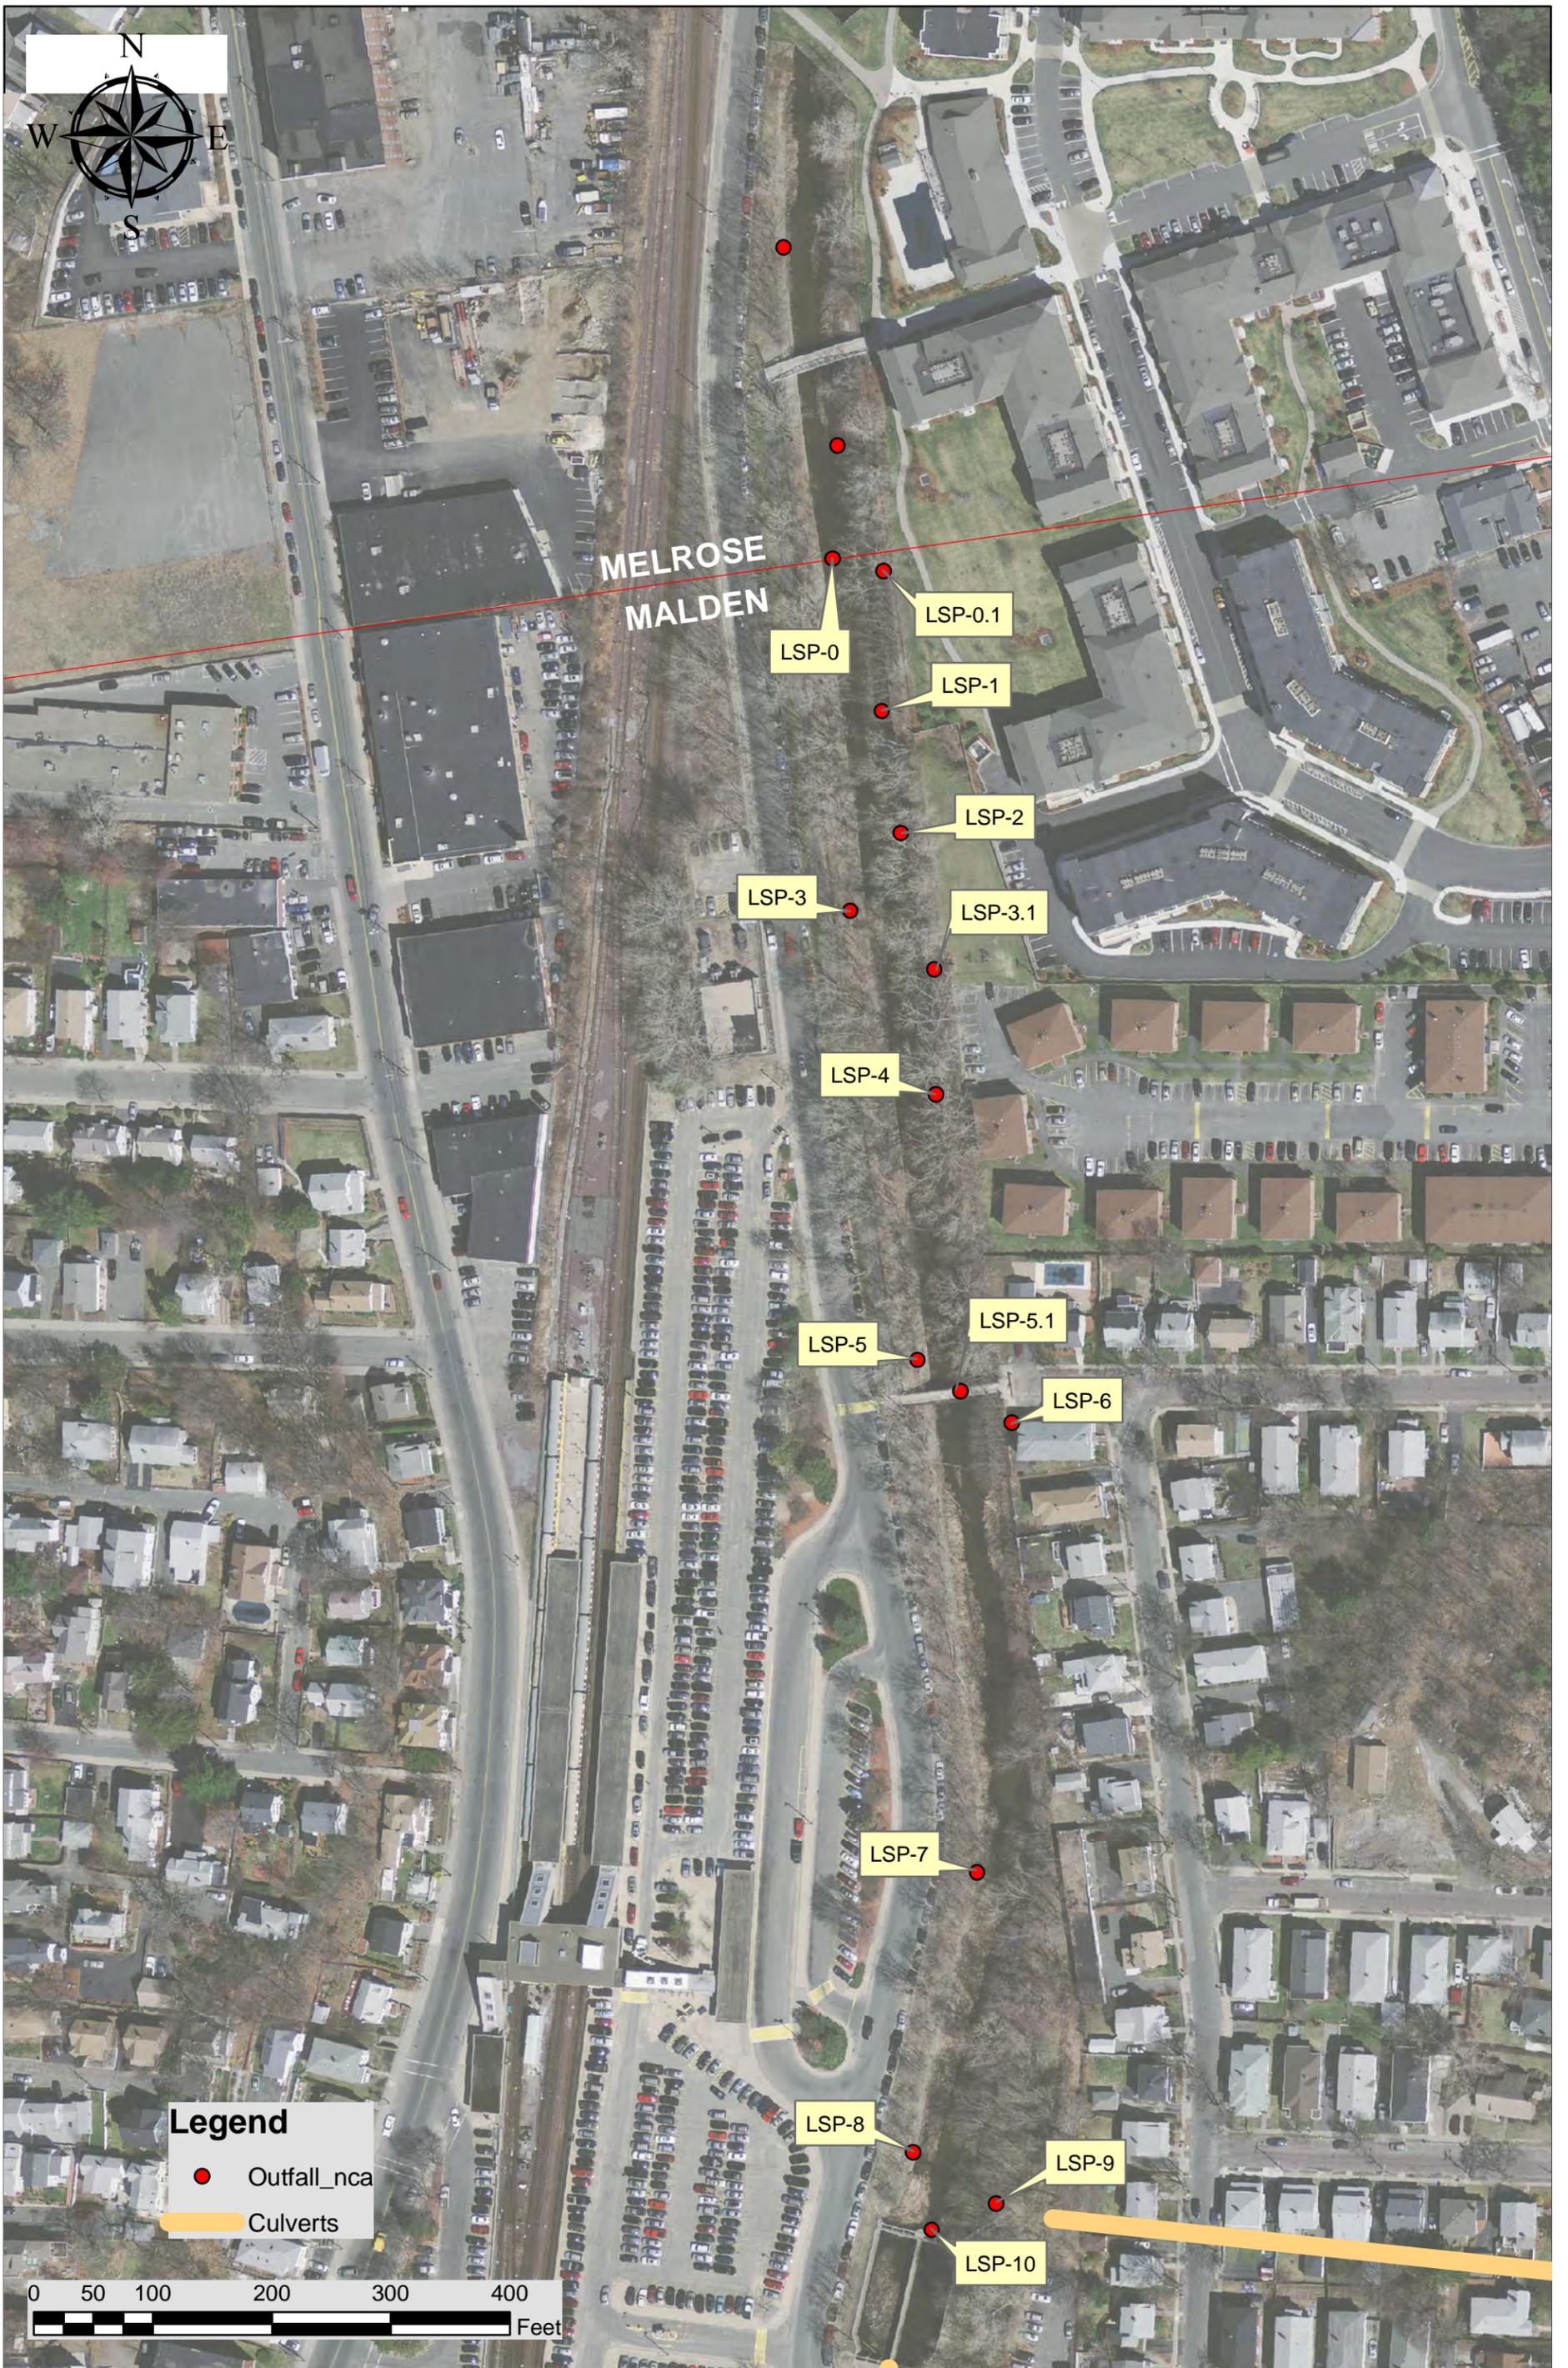
**Figure 5 - Lower Spot Pond Brook Outfalls**

The Stormwater Compliance Team has conducted numerous dry weather sampling events to investigate the elevated E. coli levels encountered previously at LSP-4, an outfall for the drainage system located within Eldrich Drive (Figure 5). Base flow, as groundwater, is consistently observed within this drainage network and to isolate potential sewage contributions to this base flow, a comprehensive evaluation of the flow conveyance network associated with LSP-4 was completed in February 2012. Given the proximity of the sewer and drain lines to LSP-4, as well as the settlement of the drain line in the area of Buildings 1054 and 1056 Elrich Drive, the focus of assessment activities was directed towards the sewer laterals and nearby drainage line servicing the two apartment buildings. Following dye testing by the Compliance Team, camera surveys performed by representatives of the property owner confirmed that compromises to the laterals servicing two (2) residential building had occurred. Recommendations made by the SCT involved restoring the integrity of the main drainage line to stop the discharges that have been documented at LSP-4.
