Municipality/Organization: City of Malden
EPA NPDES Permit Number: MA041046
MADEP Transmittal Number: 041088
**Annual Report Number
& Reporting Period:** No. 13: April 1, 2015-March 31, 2016

NPDES PII Small MS4 General Permit Annual Report

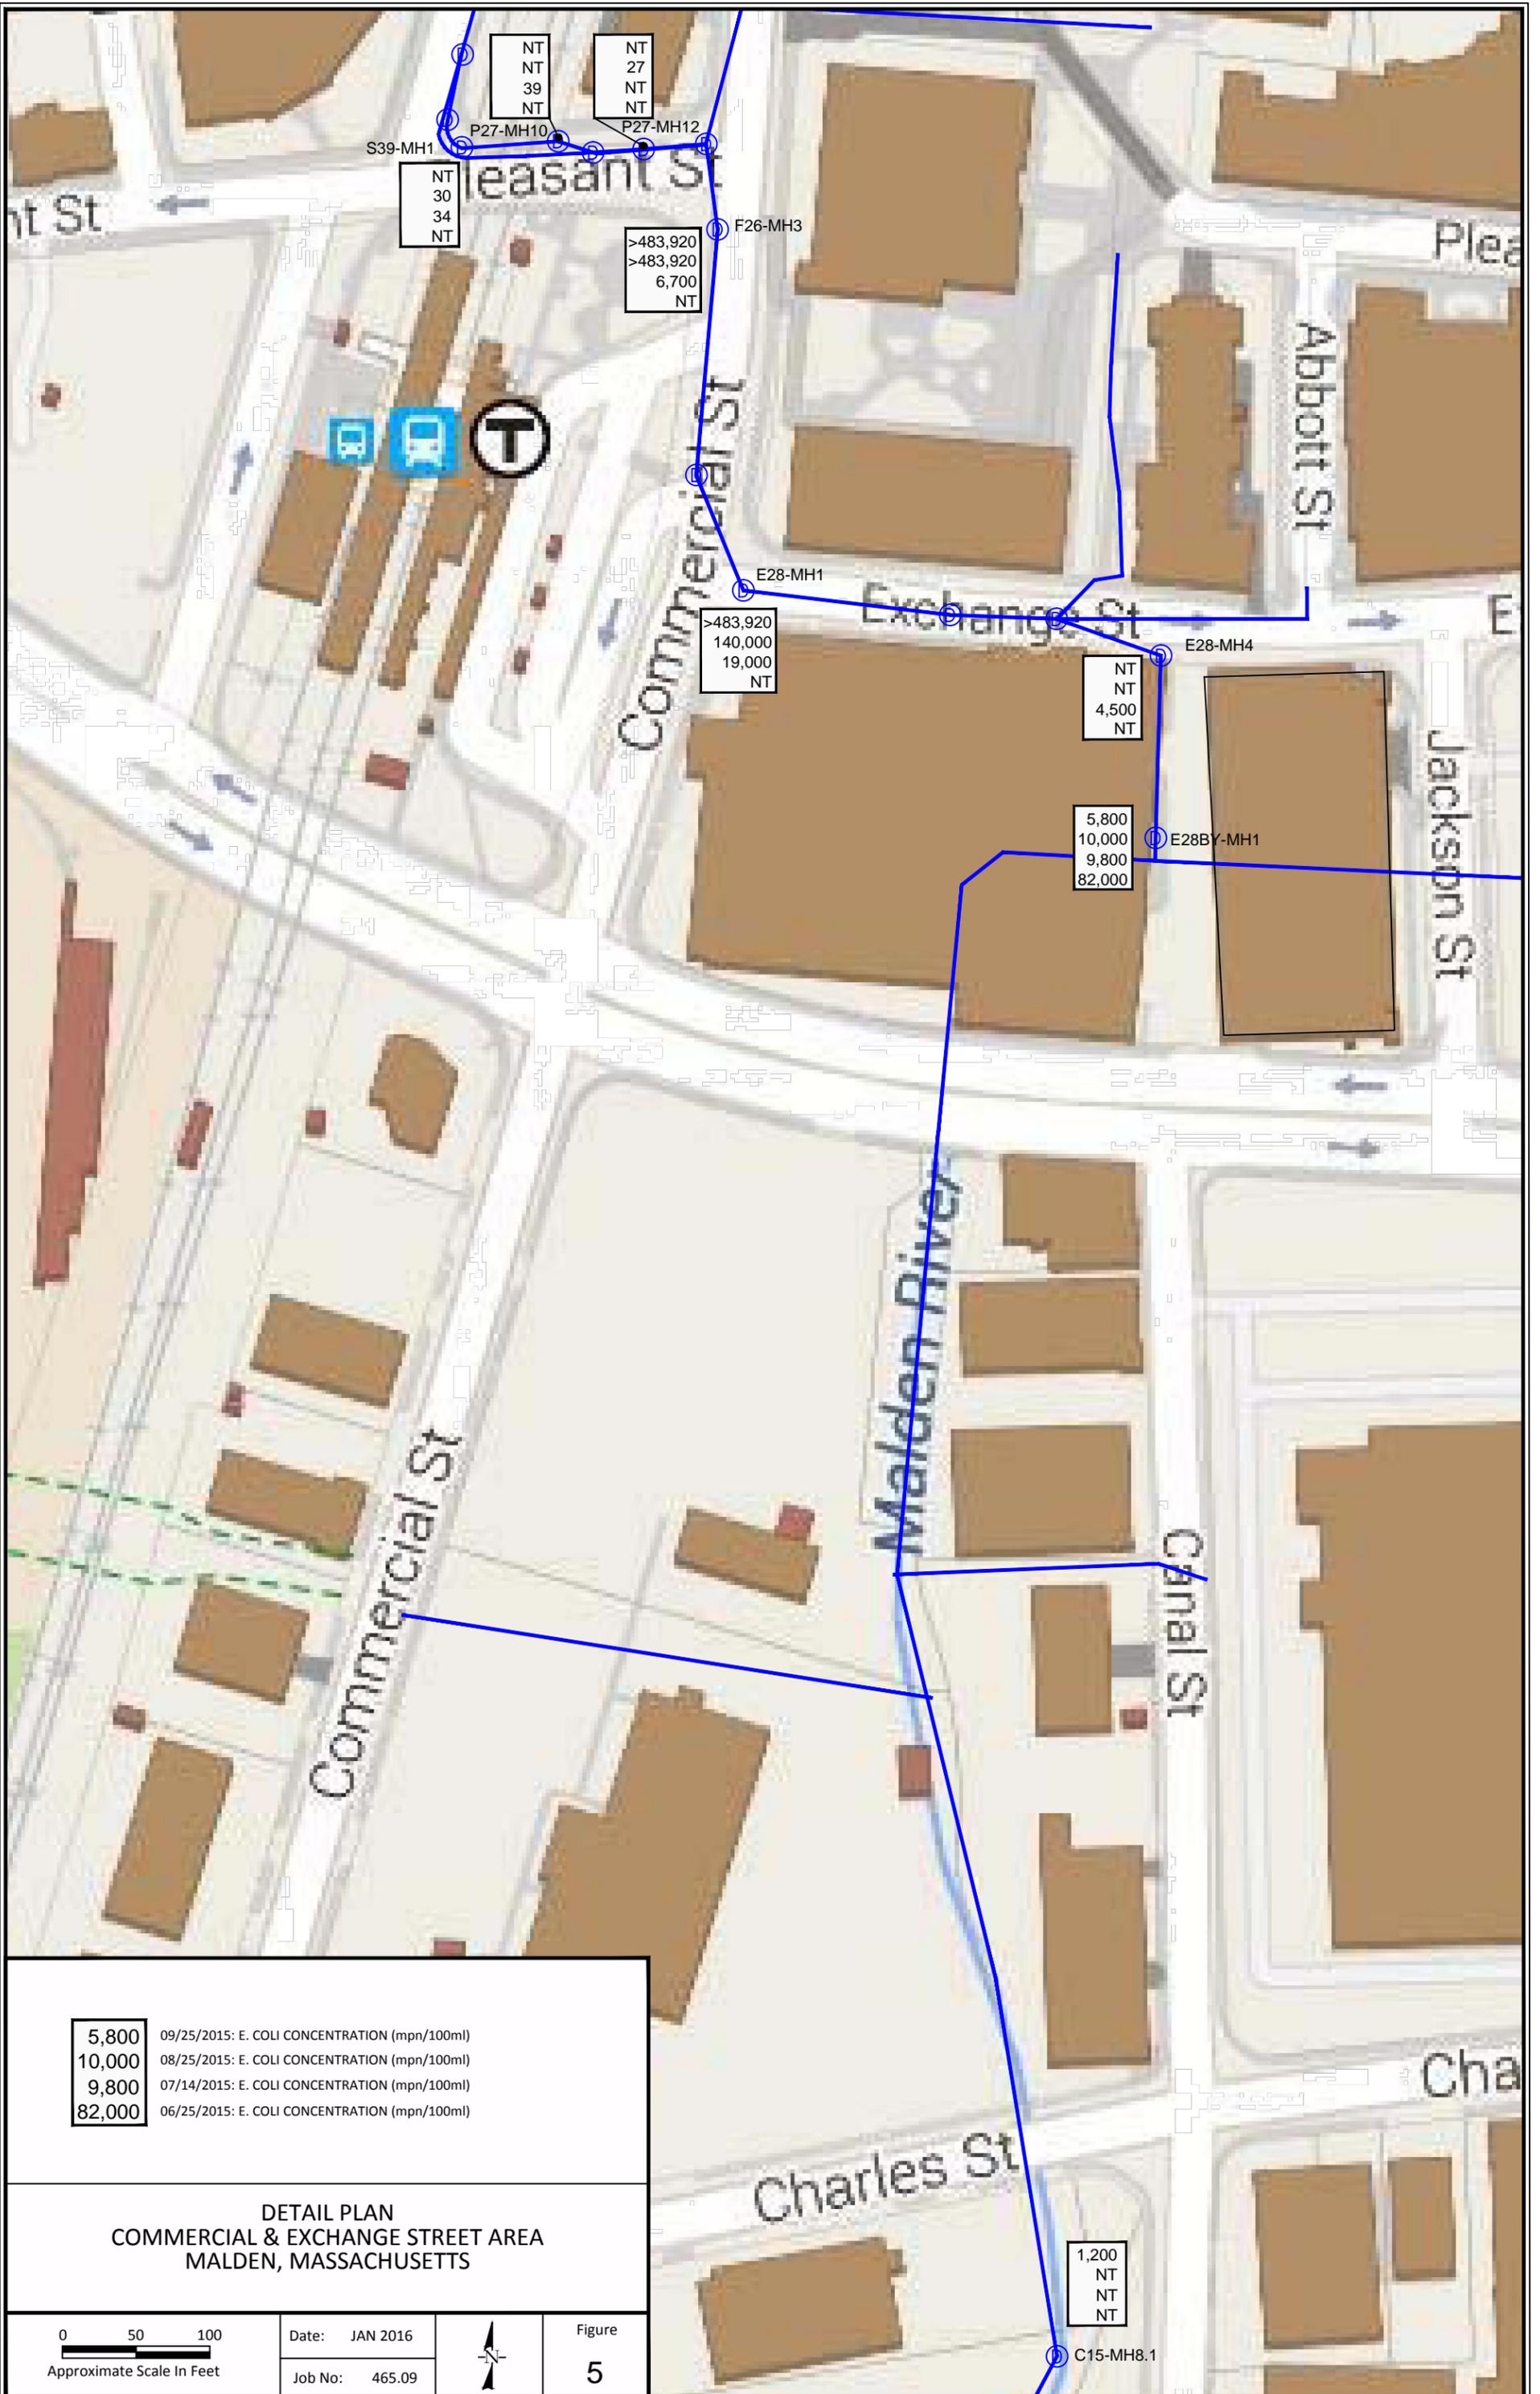
DETAIL PLAN
 COMMERCIAL & EXCHANGE STREET AREA
 MALDEN, MASSACHUSETTS

During this reporting period, three (3) sampling events were conducted within the Exchange Street/Florence Street portion of the Malden River watershed in response to the detection of high *E. coli* levels during a 25 June 2015 dry weather sampling event at manhole E28BY-MH1, which is located between Route 60 and Exchange Street (Figure 5). As outlined with the last status report, an evaluation of the drainage manhole revealed an approximate 48-inch RCP line with a flow that was observed to be approximately 10 – 12 gallons per minute. Based upon a review of historic plan information, as well as field observations, it appears the flow moves in a southerly direction into the Spot Pond Brook culvert, which ultimately discharges into the Malden River. Due to the high levels of *E. coli* encountered at E28BY-MH1, an additional sampling round was conducted on 14 July, 2015 by the Stormwater Compliance Team at E28BY-MH1 and several upstream drain manholes located on Exchange Street, Commercial Street and Pleasant Street. As shown on Table 3.0 and Figure 5, an *E. coli* concentration of 9,800 MPN/100ml was encountered at E28BY-MH1. Elevated *E. coli* concentrations were also detected at three (3) of the five (5) upstream manholes, with the highest levels encountered at E28-MH1 (19,000 MPN/100ml), which is approximately 400 feet northwest of E28BY-MH1 (Figure 5).

As summarized on Table 3.0 and Figure 5, a significant decrease in *E. coli* concentrations was observed at manholes S39-MH1 and P27-MH10, located in Pleasant Street. It is important to note that the Pleasant Street sampling waters are upstream of the flows containing high bacteria levels. Specifically, it is seen that *E. coli* levels of 30 and 34 MPN/100 mL were detected at S39-MH1 when elevated levels of *E. coli* were detected at E28-MH1 and F26-MH3. On 25 August 2015, another sampling round was conducted in the area, with the highest *E. coli* levels detected at manhole F26-MH3 (>483,920 MPN/100ml), which is located at the intersection of Pleasant and Commercial Streets. A concentration of 140,000 MPN/100ml was also detected at downstream manhole E28-MH1, where high *E. coli* levels were initially encountered during the 14 July sampling event. A significant decrease in *E. coli* levels was detected at manhole P27-MH12 (27 MPN/100ml), which is located at the intersection of Pleasant and Commercial Streets, approximately 90 linear feet upstream of F26-MH3, where the highest *E. coli* levels were detected during the 25 August sampling event.

at E28BY-MH1, where a concentration of 5,800 MPN/100ml was encountered. To determine if the elevated E. coli levels encountered within the drainage system in the Exchange Street area were impacting the Malden River, a sample was collected from the closest accessible manhole upstream of the river. This manhole, (C15-MH8.1) is located south of Charles Street and approximately 330 feet north of the Malden River (Figure 5). As shown on Table 3.0, an E. coli level of 1,200 MPN/100ml was detected. It should be noted that the water in manhole C15-MH8.1 was stagnant at the time of sampling. Further, the inspection of E39-MH1 revealed strong sewage odor and the evaluation of both the sewage and drainage infrastructure indicated that the invert elevations for the piping systems were very close. As the comprehensive assessment of the drainage system in the Exchange Street/Commercial Street area revealed no illicit connections or discharges, it is likely that the elevated E. coli levels are attributable to sewer discharge infiltration. In response to the observations recorded within the Exchange Street area, representatives of CDM were requested to review the results of their inflow/ infiltration investigation in the area and according to CDM, no significant or obvious signs of infiltration or exfiltration were noted. The City has allocated targeted emergency funding from the upcoming sewer repair contract to re-line the sewer lines in Pleasant and Exchange Streets, however according to City representatives, this work will not begin until August of 2016. In the interim, the City is in the process of hiring a water main company to camera the area of concern to investigate as necessary. Following the winter season, an increase in sampling frequency for E. coli will be initiated in the Pleasant and Exchange Street area.

5,800	09/25/2015: E. COLI CONCENTRATION (mpn/100ml)
10,000	08/25/2015: E. COLI CONCENTRATION (mpn/100ml)
9,800	07/14/2015: E. COLI CONCENTRATION (mpn/100ml)
82,000	06/25/2015: E. COLI CONCENTRATION (mpn/100ml)

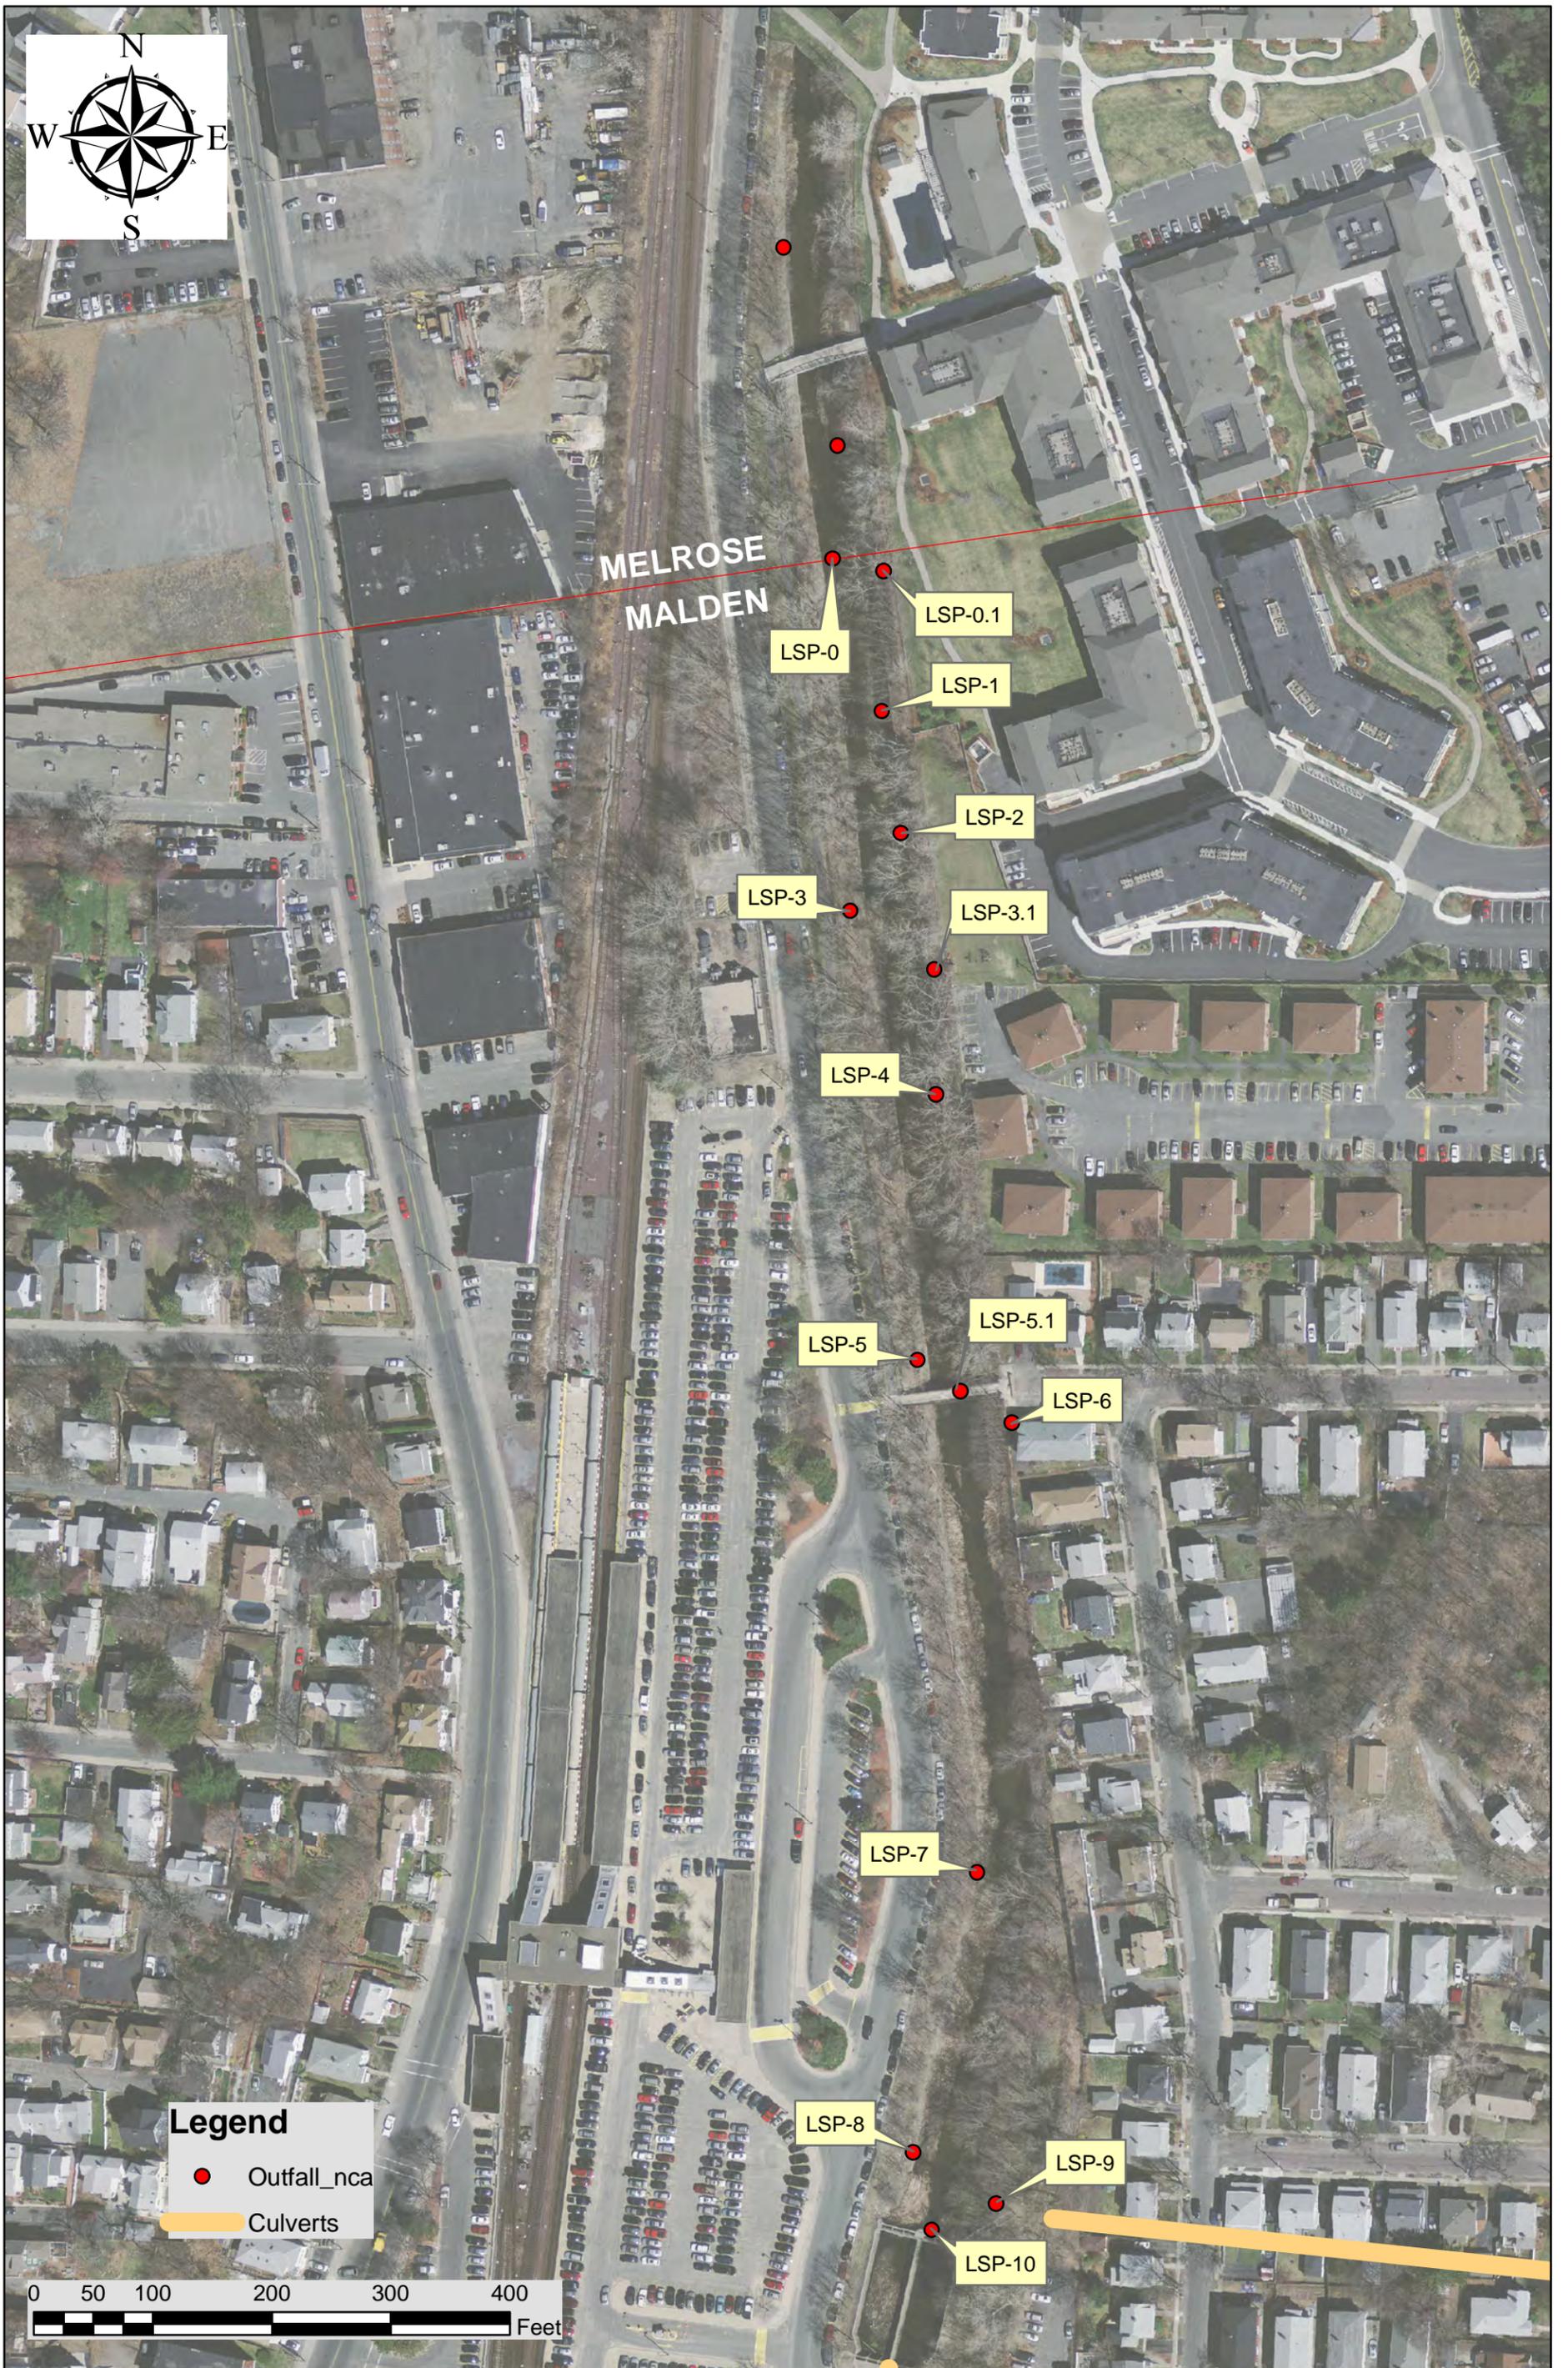
Figure 6 - Lower Spot Pond Brook Outfalls

The Stormwater Compliance Team has conducted numerous dry weather sampling events to investigate the elevated E. coli levels encountered previously at LSP-4, an outfall for the drainage system located within Eldrich Drive (Figure 6). Base flow, as groundwater, is consistently observed within this drainage network and to isolate potential sewage contributions to this base flow, a comprehensive evaluation of the flow conveyance network associated with LSP-4 was completed in February 2012. Given the proximity of the sewer and drain lines to LSP-4, as well as the settlement of the drain line in the area of Buildings 1054 and 1056 Elrich Drive, the focus of assessment activities was directed towards the sewer laterals and nearby drainage line servicing the two apartment buildings. Following dye testing by the Compliance Team, camera surveys performed by representatives of the property owner confirmed that compromises to the laterals servicing two (2) residential building had occurred. Recommendations made by the SCT involved restoring the integrity of the main drainage line to stop the discharges that have been documented at LSP-4.

Working with representatives of the Malden Engineering Department, repairs to the sewer laterals in the area of Building 1054 and 1056 were completed by the property owner in March 2012. Since that time, and as summarized on Table 3.0, dry weather flow samples collected from LSP-4 has decreased significantly relative to concentrations detected in 2012. However, during the 2 July 2014, an E. coli concentration of 110,000 MPN/100 ml was detected at LSP-4. An additional sample was collected on 5 November 2014, with an E. coli concentration of 3,200 MPN/100 ml detected. Field observations noted at that time by NCA included an increased discharge relative to prior sampling events. According to the City Engineering Department, the Eldrich Drive complex is under new ownership and the City has attempted to contact the property owner numerous times to discuss the sampling results, however the owner has been unresponsive. Accordingly, more formal enforcement measures are under consideration at this time.

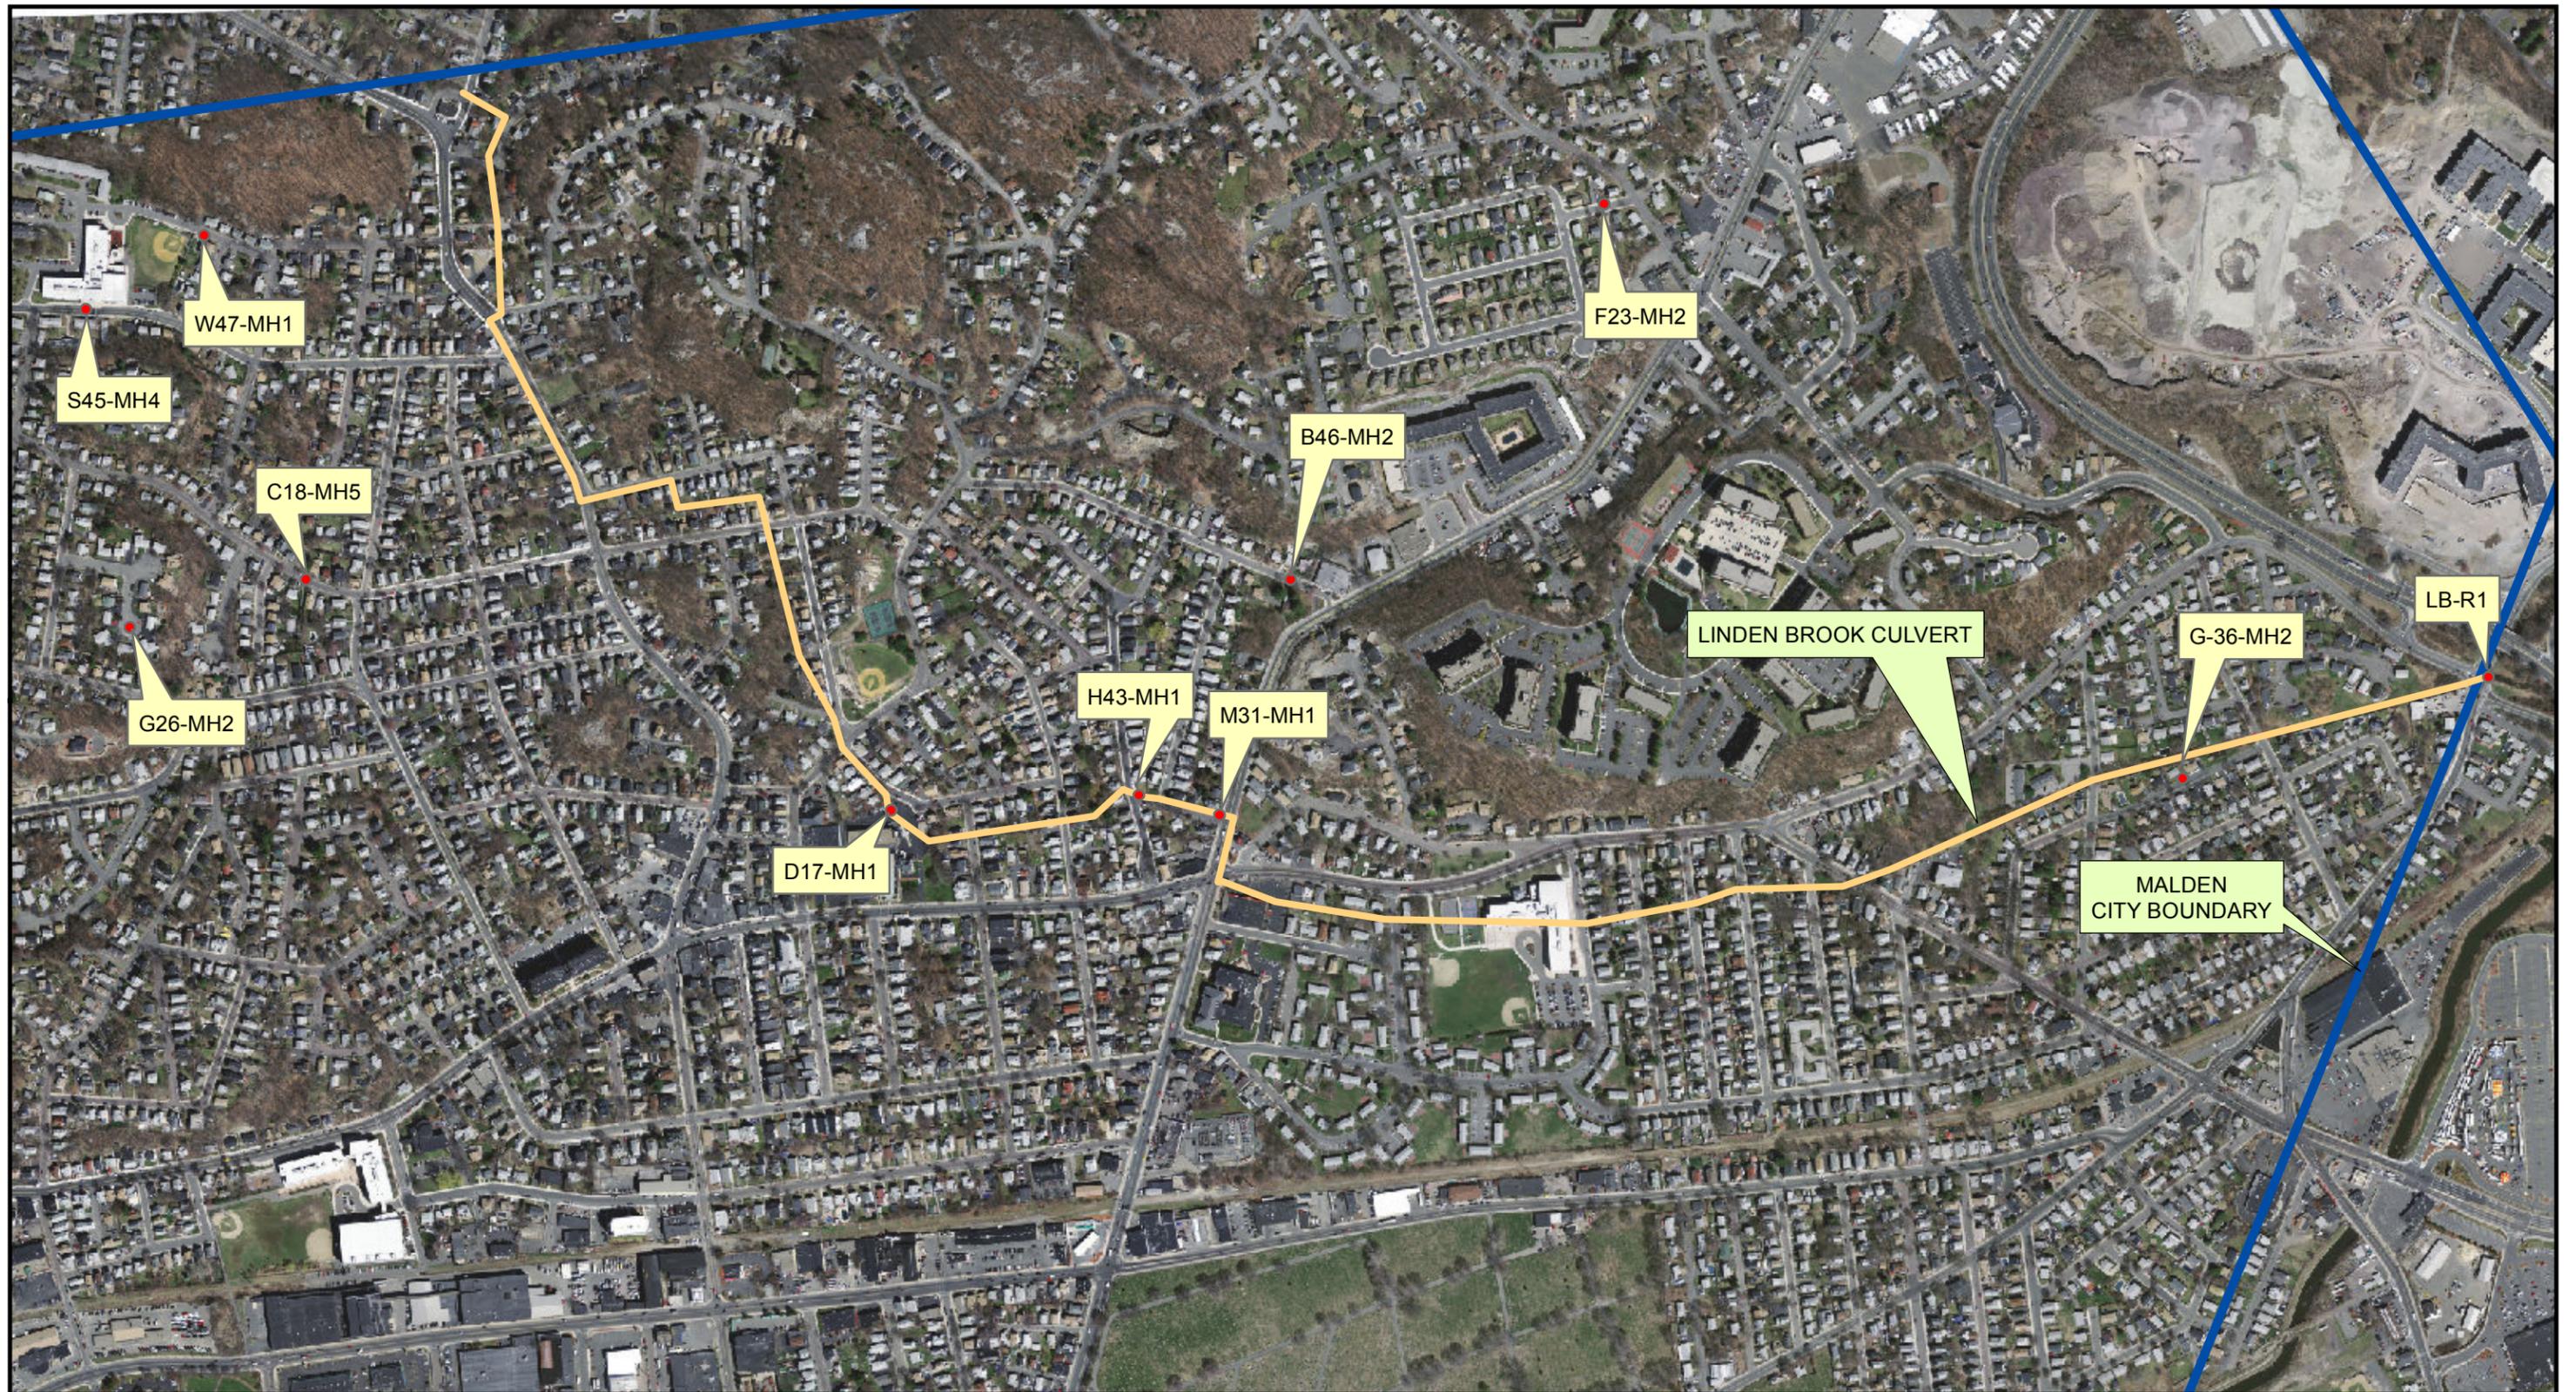
Figure 8 - Dry Weather Sampling Program-Linden Brook
MALDEN, MASSACHUSETTS

Linden Brook Culvert is the major stormwater conveyance network located in northeasterly portions of the City. Dry weather inspections have revealed base flow throughout the culvert at all times, with *E. coli* levels detected historically within the mid-portion of the culvert, at manholes D17-MH1 and H43-MH1 (Figure 8) during prior sampling efforts. Flow isolation studies performed to date within this portion of the City had not revealed any specific source conditions for the results of prior sampling. Flow isolation studies have been continued for dry weather Flow # 18, which was identified in the areas of Cherry and Sylvan Streets, a part of the Linden Brook culvert (Figure 8) watershed. Dry weather flow samples collected from drainage manhole (C18-MH5) located on Cherry Street contained elevated *E. coli* levels and to further assess this condition, dry weather flows were sampled again from the approximate manhole locations shown on Figure 8. Reference to Table 3.0, indicates that the *E. coli* levels encountered at drainage manhole C18-MH5 contained an *E. coli* level of 1,300 MPN/100 ml. An upstream dry weather flow sample relative to C18-MH5 was also collected from a manhole located on Winship Street (W47-MH1), with a level of 1,700 MPN/100 ml of *E. coli* identified. This concentration is in the range of the *E. coli* level quantified at C18-MH5 (1,300 MPN/100 ml). As this flow (Flow 18) originates along Sylvan Street, proximate to the Forestdale School, a dry weather flow sample was collected from drainage manhole S45-MH4 along Sylvan Street, with a level of 8.5 MPN/100 ml of *E. coli* identified. After the winter season, dry weather sampling will be continued within the Linden Brook watershed.

During the September 2012 sampling event, conducted with representatives of the USEPA, a water sample was collected from outfall LBR-1 (Figure 8), located in Revere, at which time distinct indications of sewage odors were noted. Consistent with identification of strong sewage odors and immediately apparent from a review of Table 3.0 is the significantly elevated level of *E. coli* (>241,920 MPN/100 ml) detected in sample LBR-1. To assess this condition and as described in prior status reports, the City of Malden contracted with National Water Main Cleaning Company, under the supervision of CDM Smith. As summarized in the following excerpt from an email to the City of Malden from CDM Smith, it is believed that line blockage due to grease build up may have been a crucial factor for the conditions identified at LBR-1, in addition to a “minor” defect in the form of a leaky joint. Although maintenance was routinely performed on this siphon, the extent of grease build up indicates that a higher frequency of cleaning and maintaining is necessary to further understand the condition.

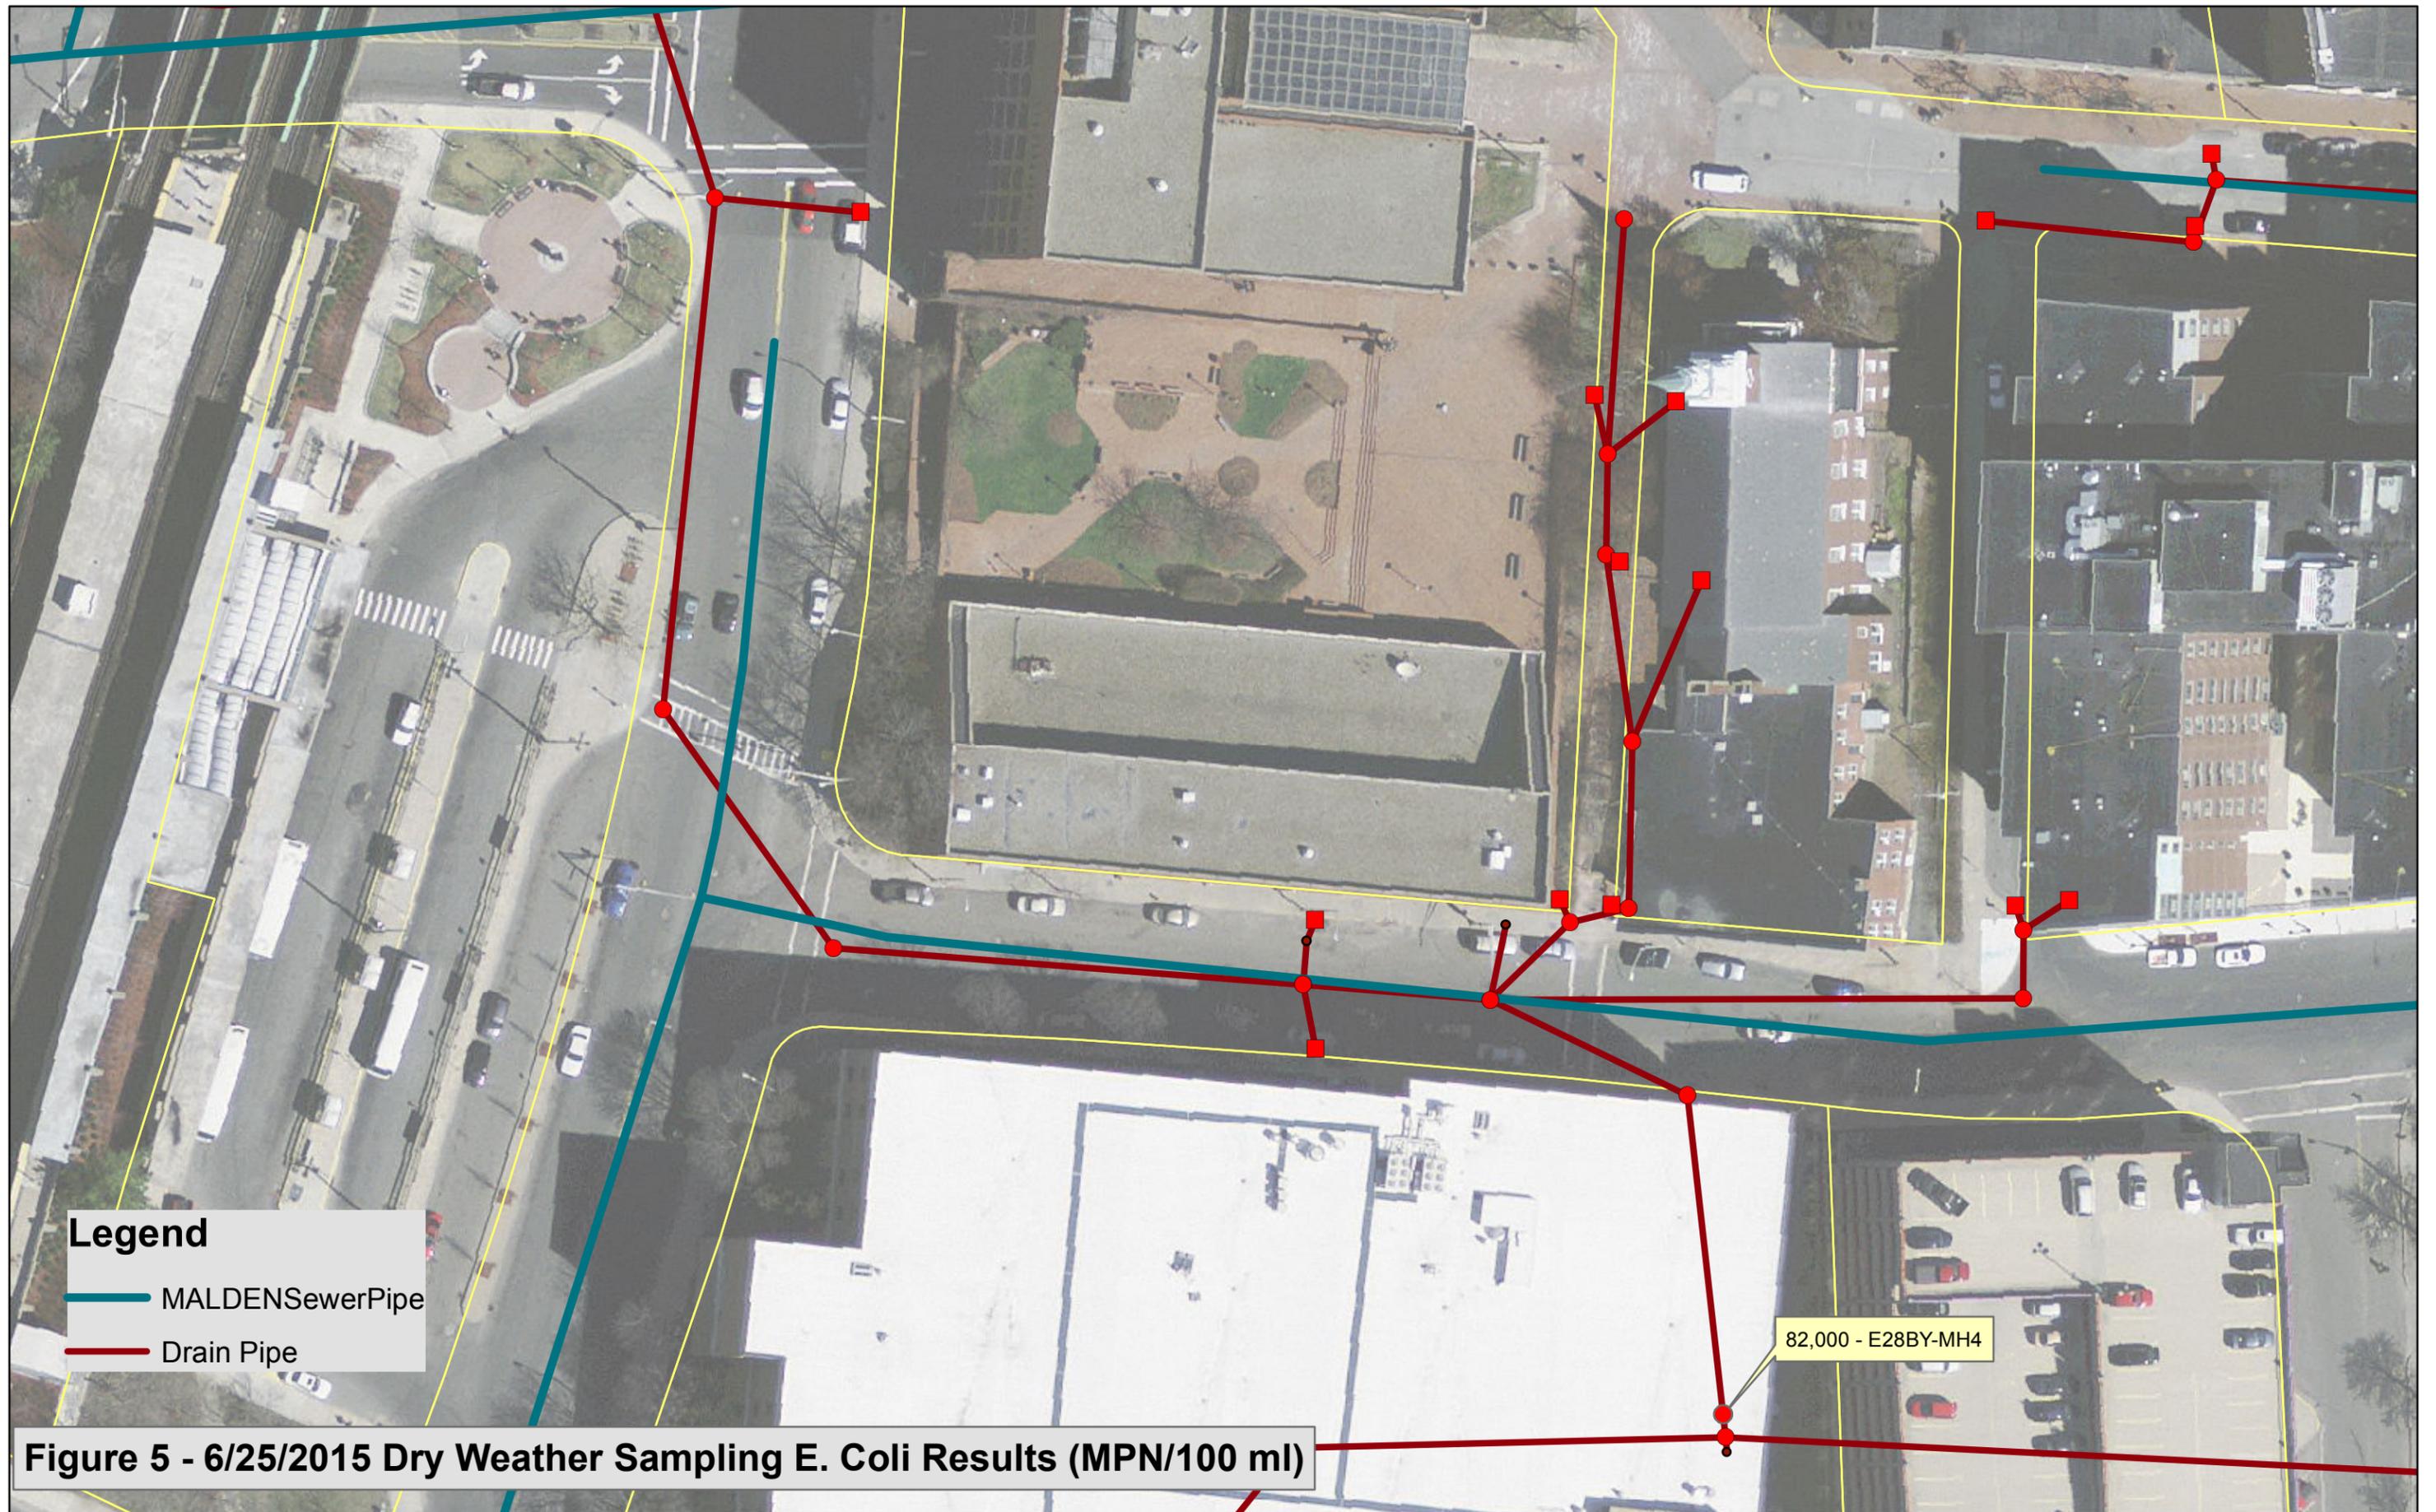
Figure 5 - 6/25/2015 Dry Weather Sampling E. Coli Results (MPN/100 ml)

During the 25 June 2015 dry weather sampling event, NCA also sampled manhole E28BY-MH1, which is located between Route 60 and Exchange Street (Figure 5). An evaluation of the drainage manhole revealed an approximate 48-inch RCP line with a flow that was observed to be approximately 10 – 12 gallons per minute. A sample was collected from E28BY-MH1 during this reporting period and as shown on Table 3.0, an E. coli level of 82,000 MPN/100 ml was detected. Based upon a review of historic plan information, as well as field observations, it appears the flow moves in a southerly direction into the Spot Pond Brook culvert, which ultimately discharges into the Malden River. Due to the high levels of E. coli encountered an ongoing evaluation of the drainage network proximate to the Exchange and Florence Street area is currently underway and the results to be obtained will be presented at the end of the next reporting period. At this time, the focus of ongoing investigations is being directed towards recent utility repairs that have been performed within the applicable watershed.

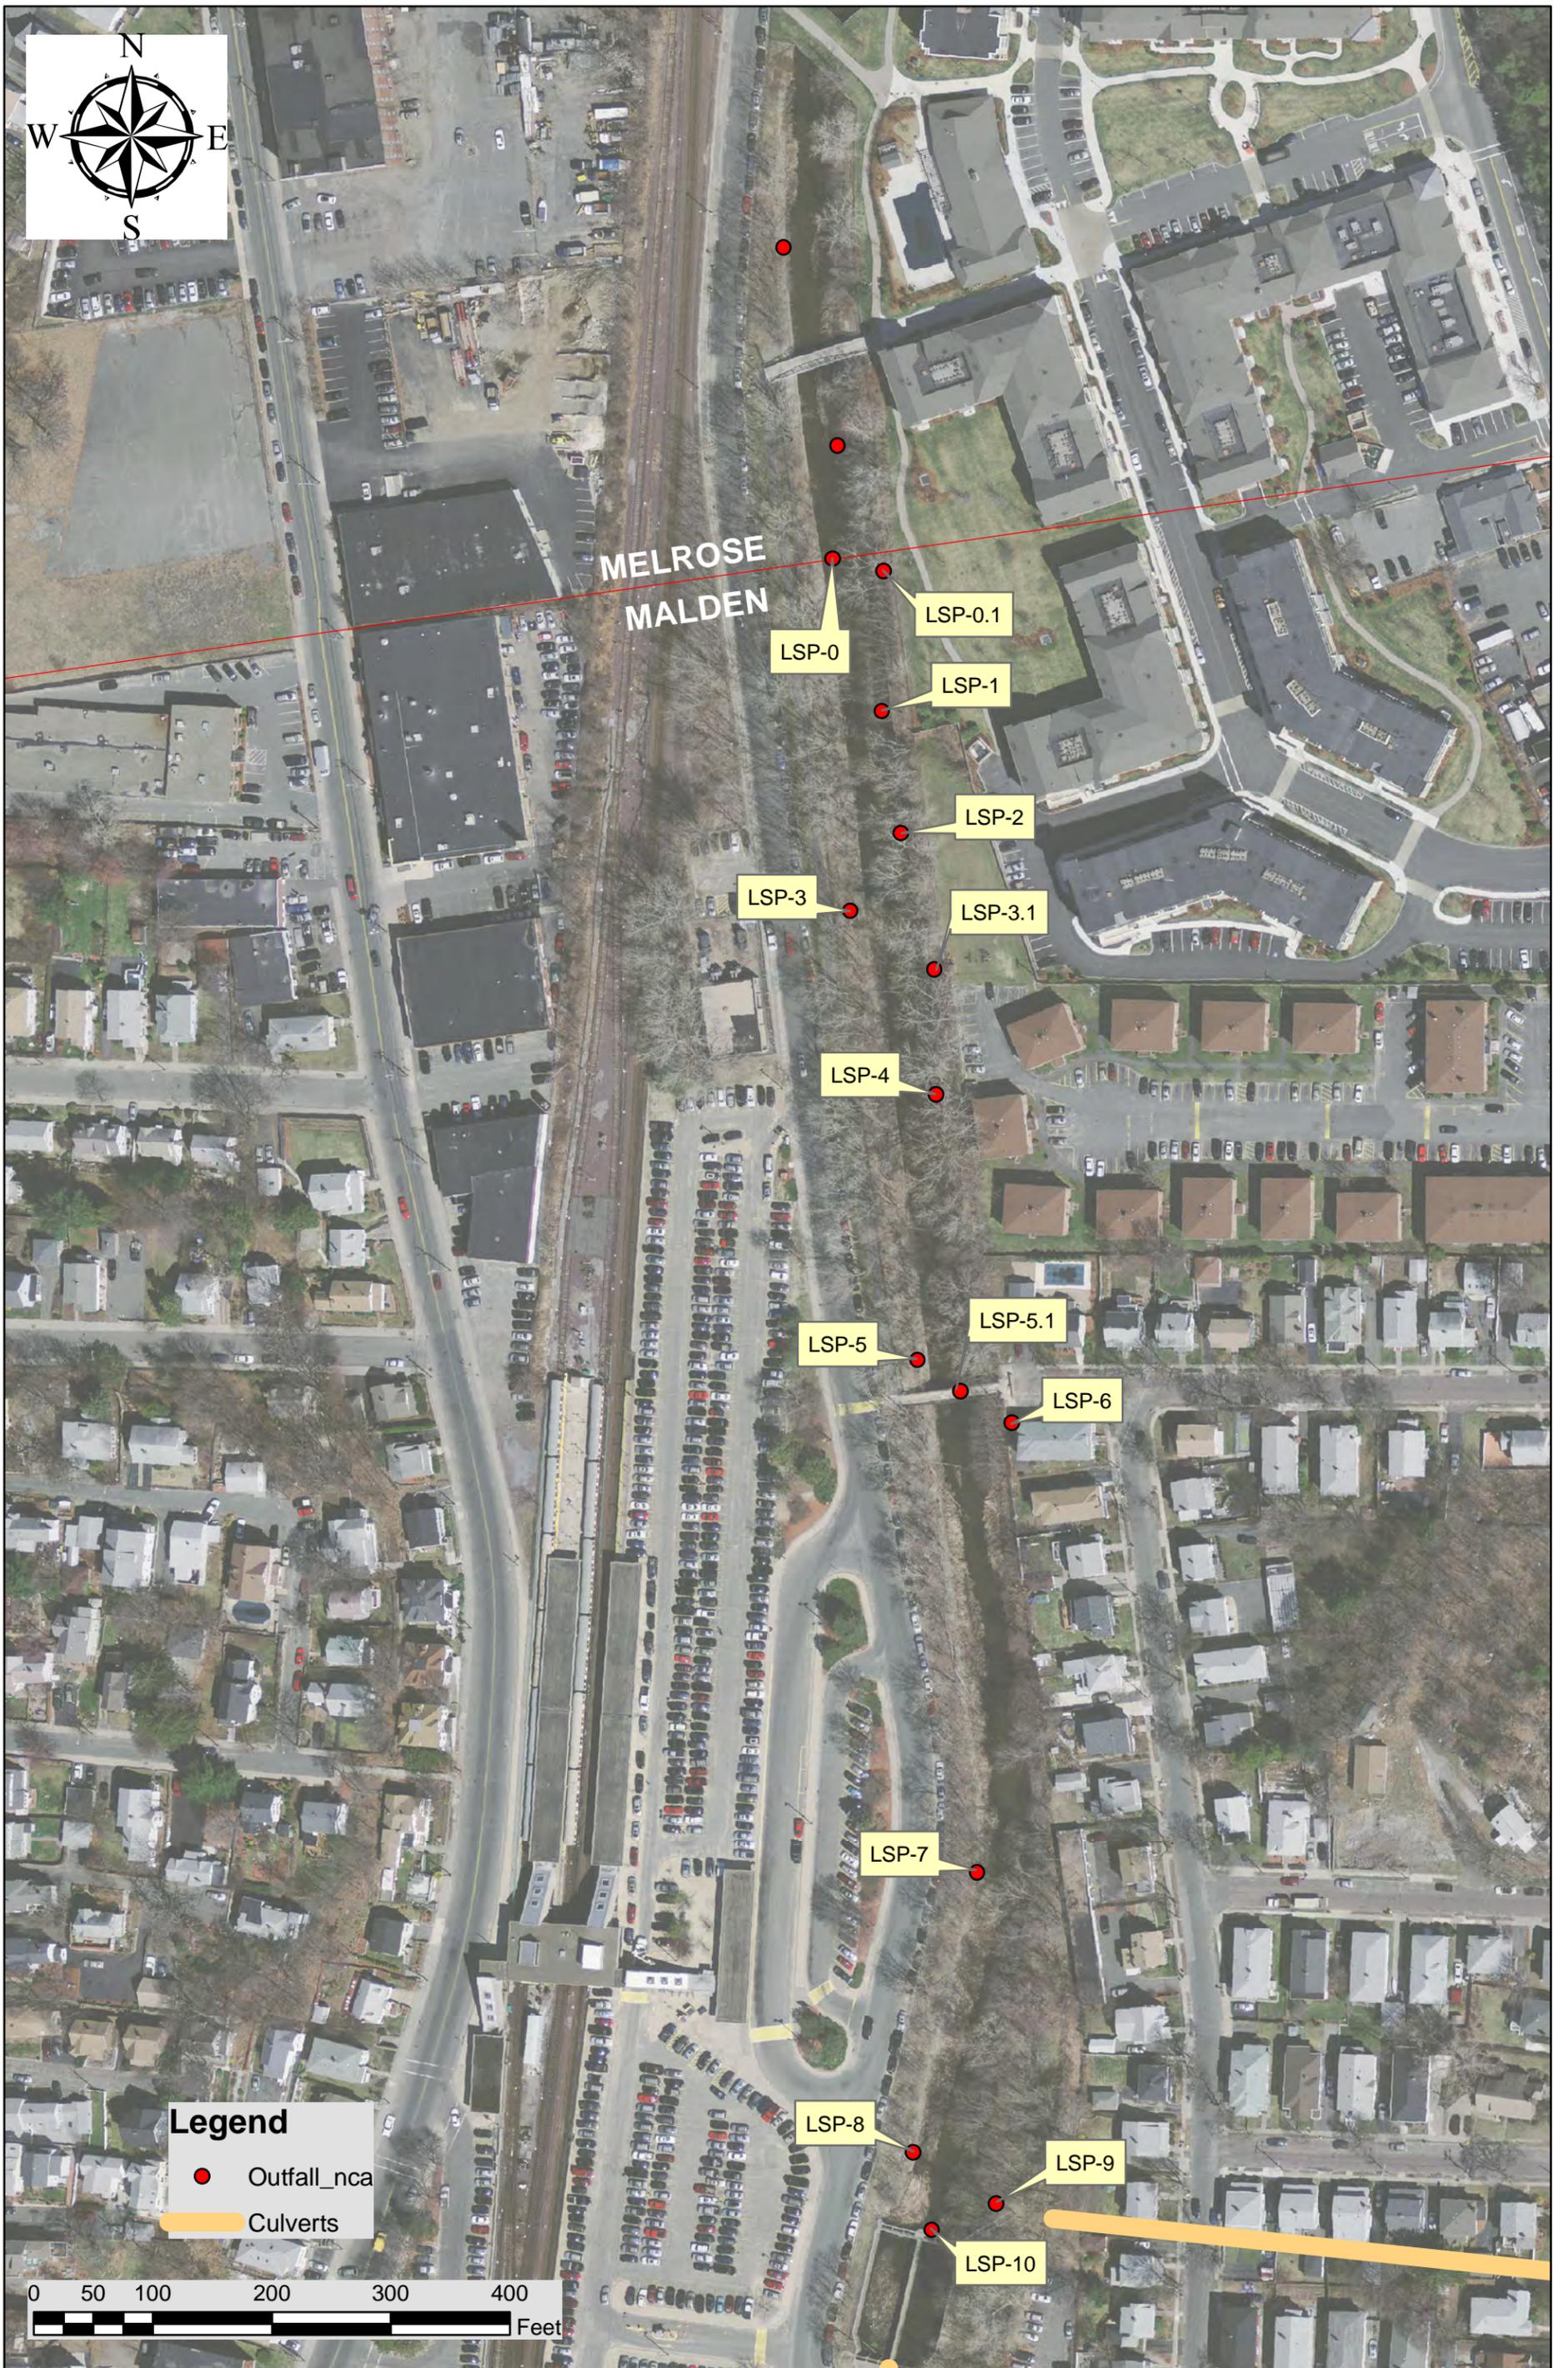
Figure 6 - Lower Spot Pond Brook Outfalls

The Stormwater Compliance Team has conducted numerous dry weather sampling events to investigate the elevated E. coli levels encountered previously at LSP-4, an outfall for the drainage system located within Eldrich Drive (Figure 6). Base flow, as groundwater, is consistently observed within this drainage network and to isolate potential sewage contributions to this base flow, a comprehensive evaluation of the flow conveyance network associated with LSP-4 was completed in February 2012. Given the proximity of the sewer and drain lines to LSP-4, as well as the settlement of the drain line in the area of Buildings 1054 and 1056 Elrich Drive, the focus of assessment activities was directed towards the sewer laterals and nearby drainage line servicing the two apartment buildings. Following dye testing by the Compliance Team, camera surveys performed by representatives of the property owner confirmed that compromises to the laterals servicing two (2) residential building had occurred. Recommendations made by the SCT involved restoring the integrity of the main drainage line to stop the discharges that have been documented at LSP-4.

Working with representatives of the Malden Engineering Department, repairs to the sewer laterals in the area of Building 1054 and 1056 were completed by the property owner in March 2012. Since that time, and as summarized on Table 3.0, dry weather flow samples collected from LSP-4 has decreased significantly relative to concentrations detected in 2012. However, during the 2 July 2014, an E. coli concentration of 110,000 MPN/100 ml was detected at LSP-4. An additional sample was collected on 5 November 2014, with an E. coli concentration of 3,200 MPN/100 ml detected. Field observations noted at that time by NCA included an increased discharge relative to prior sampling events. According to the City Engineering Department, the Eldrich Drive complex is under new ownership and the City has attempted to contact the property owner numerous times to discuss the sampling results, however the owner has been unresponsive. Accordingly, more formal enforcement measures are being implemented at this time.
