Municipality/Organization: City of Malden
EPA NPDES Permit Number: MA041046
MADEP Transmittal Number: 041088
**Annual Report Number
& Reporting Period:** No. 13: April 1, 2015-March 31, 2016

NPDES PII Small MS4 General Permit Annual Report

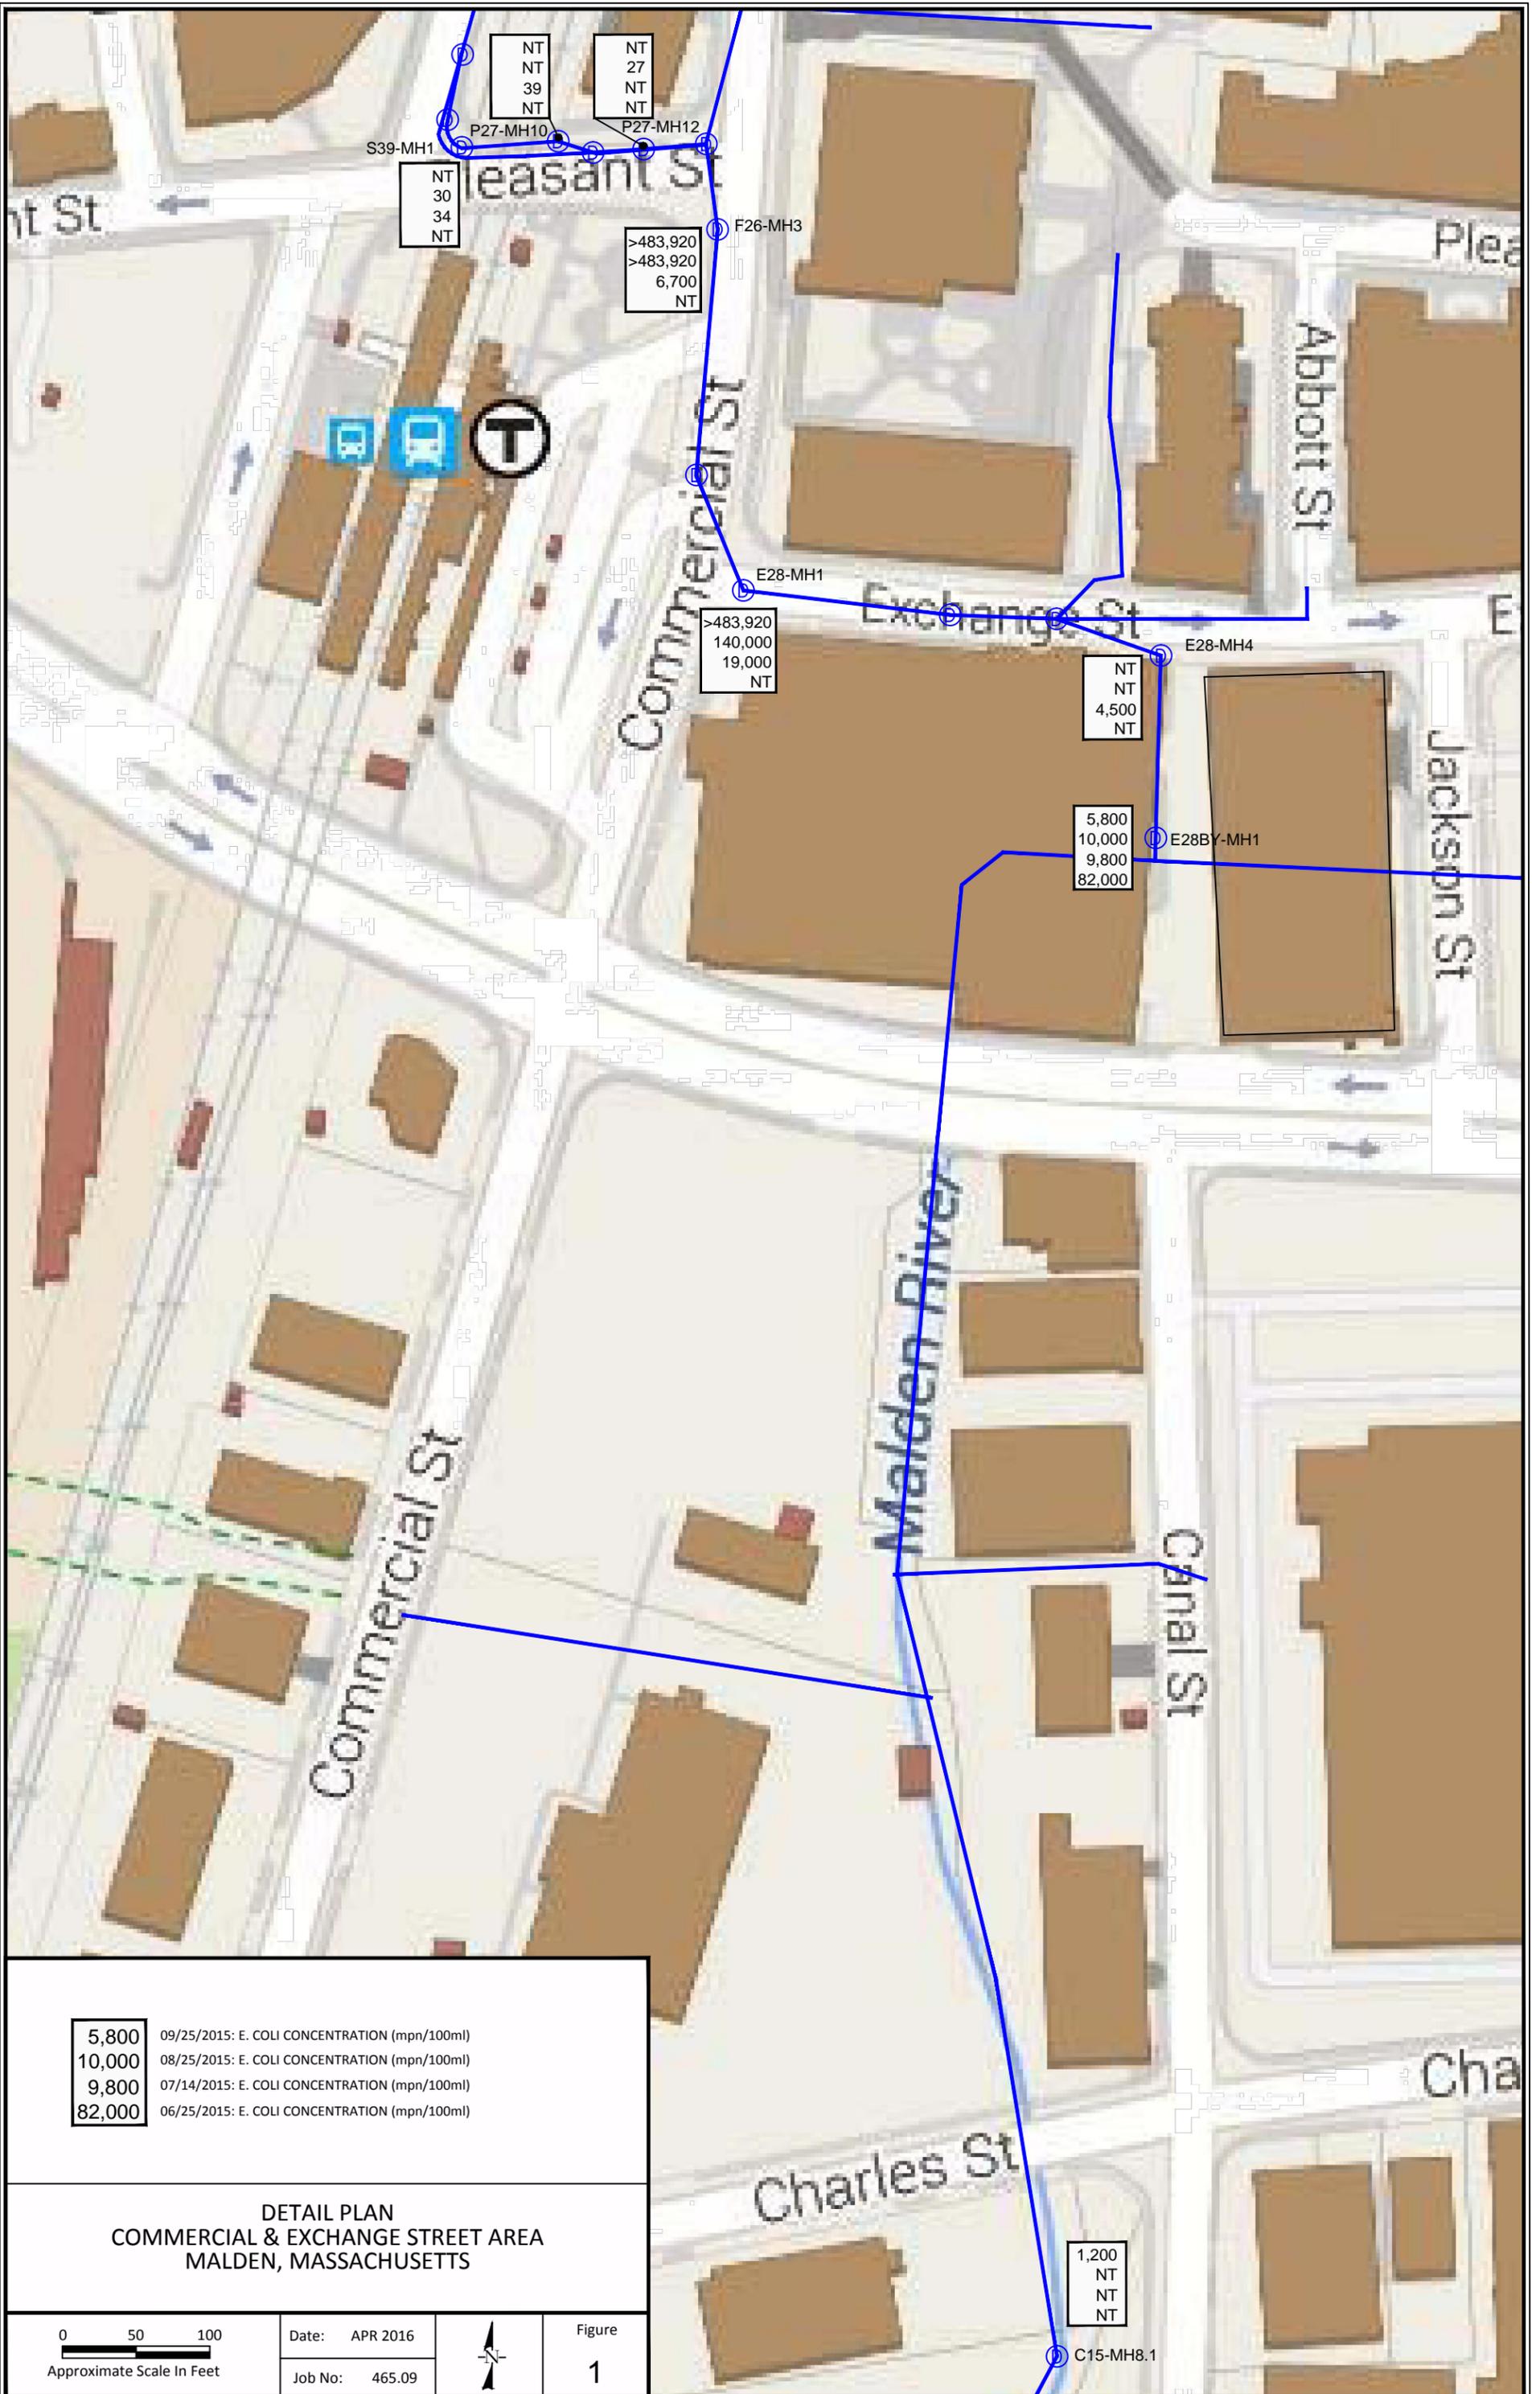
DETAIL PLAN
 COMMERCIAL & EXCHANGE STREET AREA
 MALDEN, MASSACHUSETTS

5,800	09/25/2015: E. COLI CONCENTRATION (mpn/100ml)
10,000	08/25/2015: E. COLI CONCENTRATION (mpn/100ml)
9,800	07/14/2015: E. COLI CONCENTRATION (mpn/100ml)
82,000	06/25/2015: E. COLI CONCENTRATION (mpn/100ml)
